LaPlatte River Corridor Plan

Reaches M6 – M11

Towns of Charlotte and Shelburne, Vermont

Prepared by the LaPlatte Watershed Partnership
April, 2008

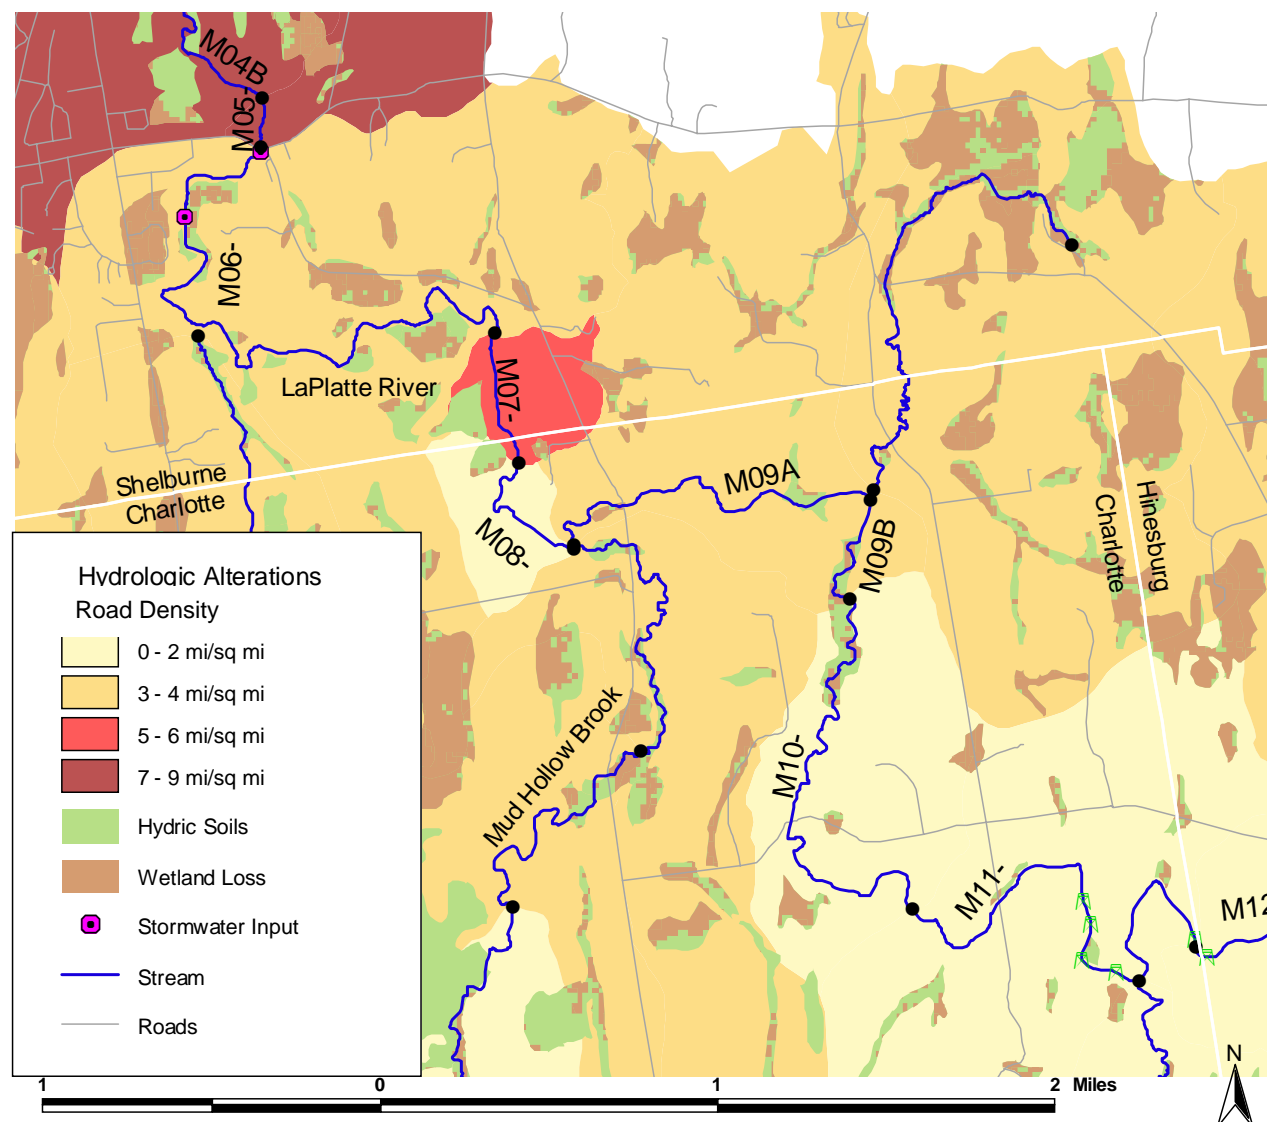
Figure 5.2. Hydrologic Regime Map. Note that no dams were present on the reaches examined in this plan.

The subwatersheds are shaded according to the density of roads. Road density is listed in 4 categories, related to effects on streams. Road density has been correlated to percent impervious cover following work by Fitzgerald (2007). In Fitzgerald's research, a road density of 4% correlated to 5% impervious cover, which was the threshold for impacts to stream geomorphology described by Fitzgerald (2007).

Stormwater inputs were only seen in reach M06, however more stormwater inputs are likely, as they may enter tributaries before entering the mainstem and therefore were not identified during the assessment. An inventory of stormwater infrastructure and outfalls would be useful to determine the extent of stormwater impacts in the watershed.

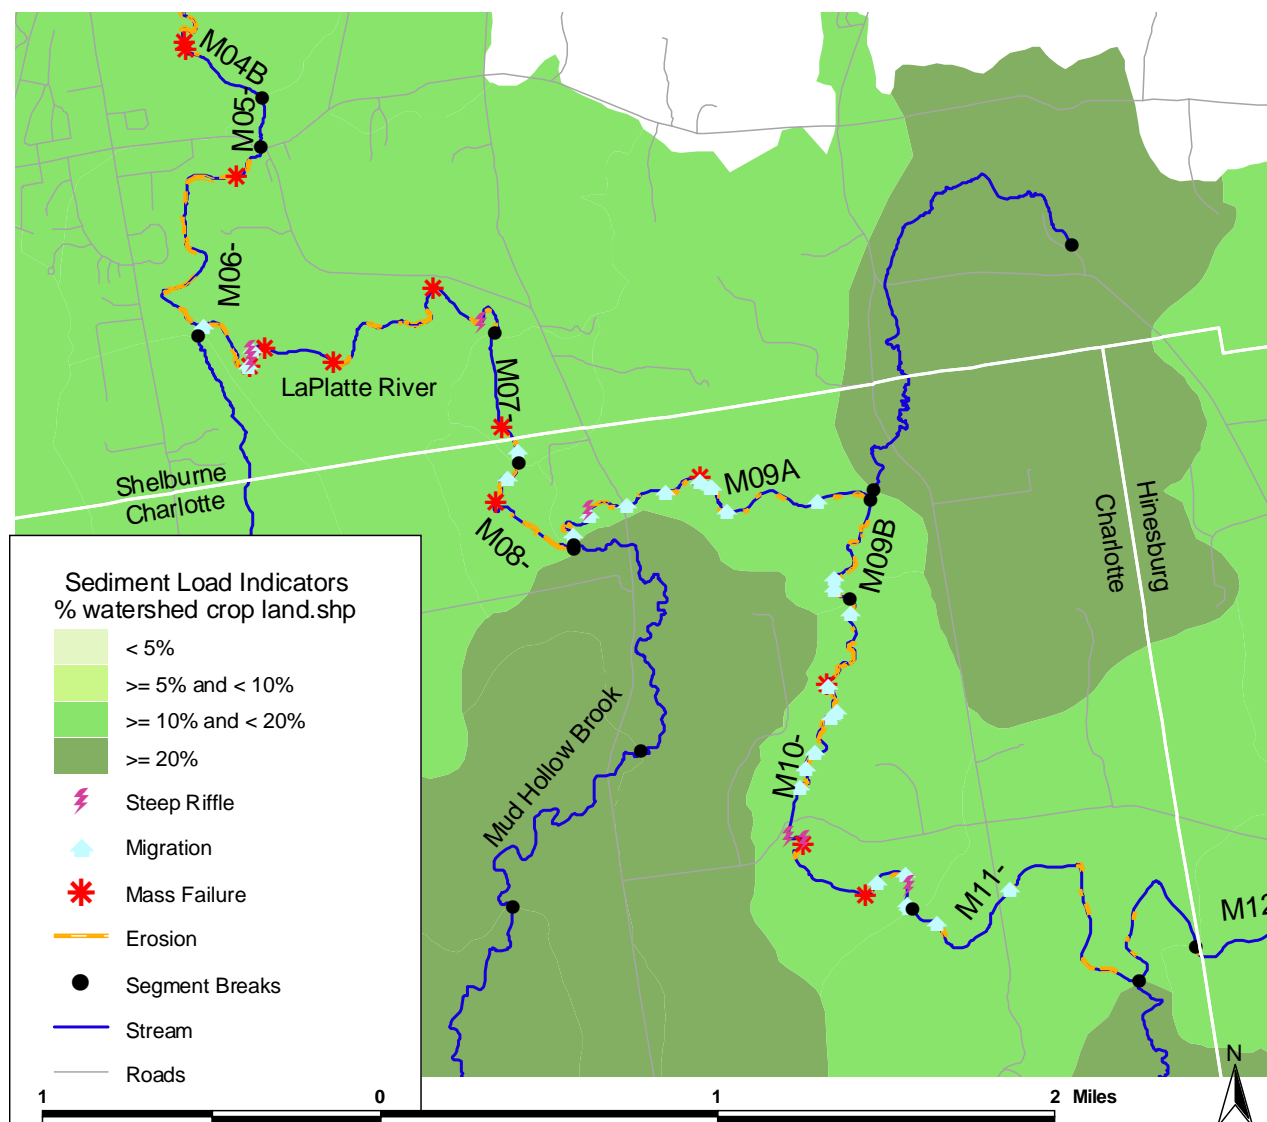
Figure 5.3. Sediment Load Indicators Map. All subwatershed cropland coverages were over 10% with some over 20%. Tributary rejuvenation was observed in reaches M06 and M09A.

Subwatersheds in Figure 5.3 are shaded according to the percent cropland in each. Cropping tends to result in exposed soils, prone to erosion. Other sources of sediment such as bank erosion, channel migration, and mass failures are also highlighted.

The subwatersheds in the study area had over 10% cropland use with tributary streams (including Mud Hollow Brook) having over 20% cropland use. Such high percentages of cropland can contribute significantly to the sediment load. Additionally, many areas of bank erosion, channel migration, and mass failures were present, contributing sediment to the stream.

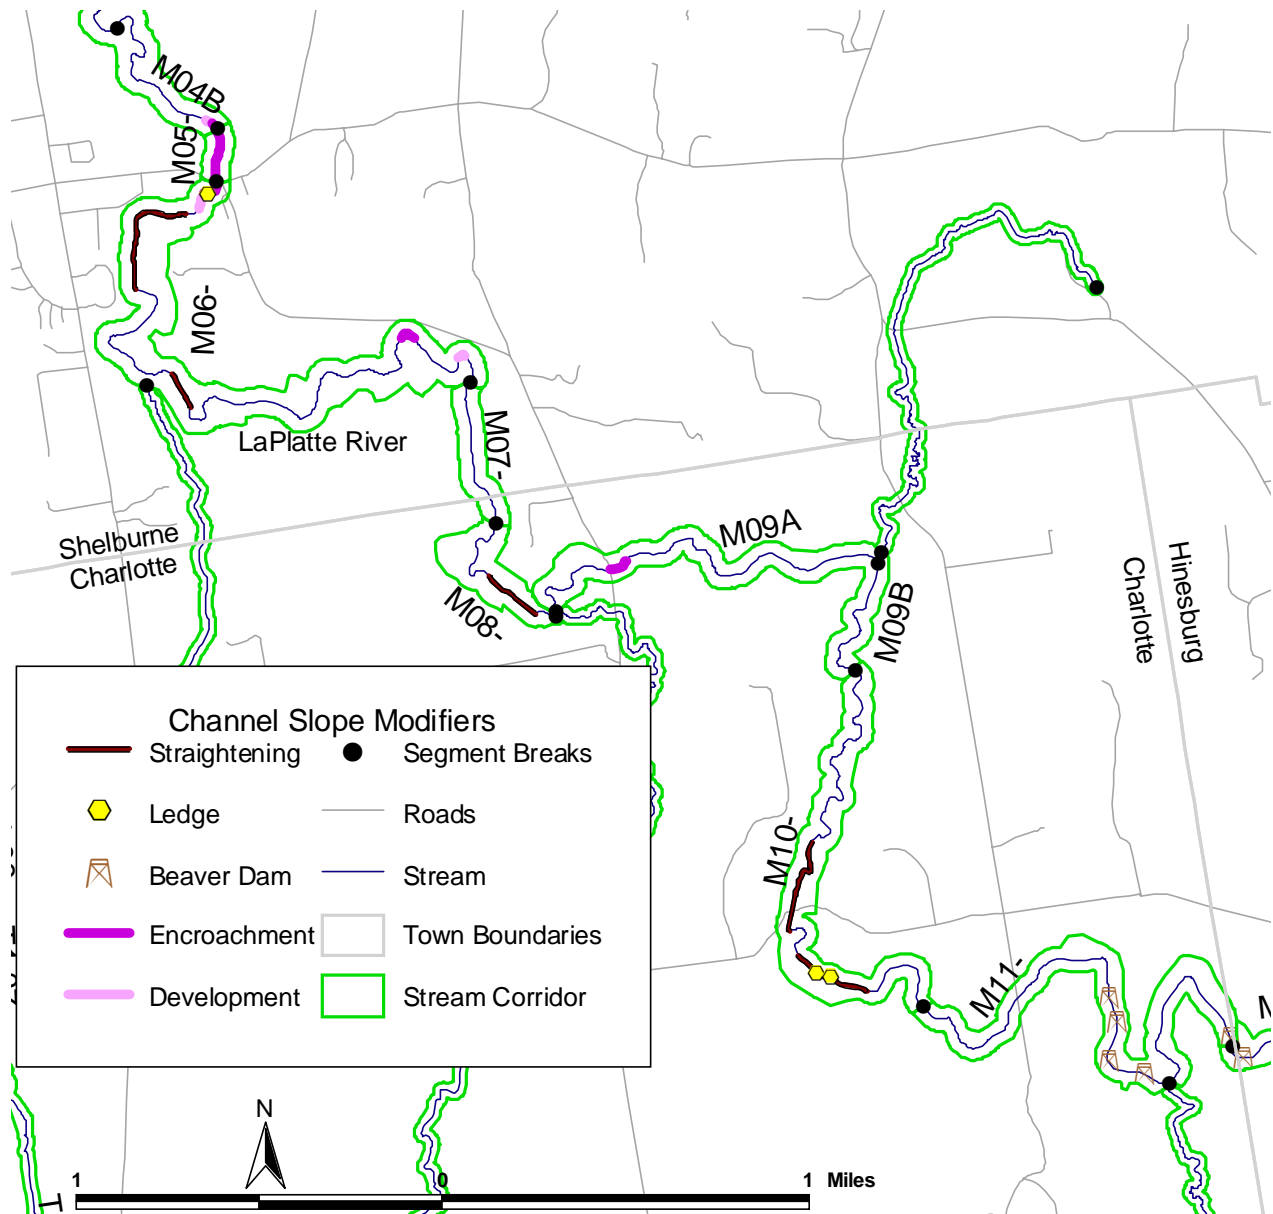
Figure 5.4. Channel Slope Modifiers Map. No dams were in the study area, although beaver dams were seen in reach M11.

Historical channel straightening affects sections of reaches M06, M08, and M10, resulting in increased channel slope. Bedrock ledges provide grade control, limiting channel incision, at the

downstream end of reach M06 and in reach M10. Overall, relatively little development, roads or berms have encroached into the stream corridor.

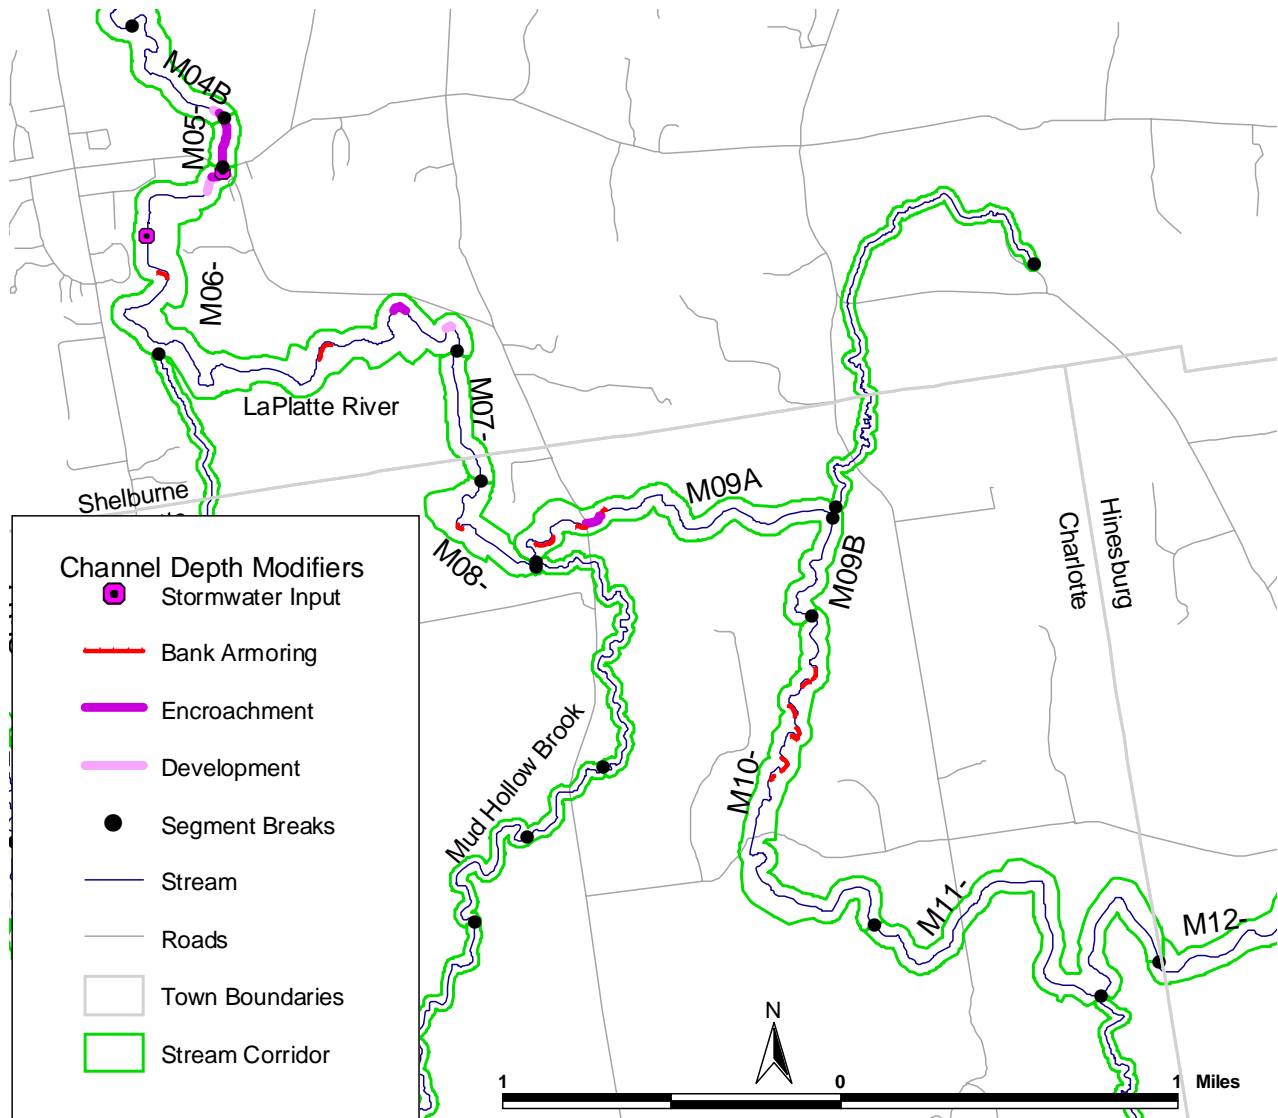
Figure 5.5. Channel Depth Modifiers Map. No documentation or signs of dredging were found, although past dredging activities may have occurred, especially in straightened sections.

Some areas of bank armoring (riprap) were identified and could impact channel depth. Additionally, straightening, as shown in figure 5.4, can also lead to channel incision. Channel incision was noted in all study reaches except for reach M11.

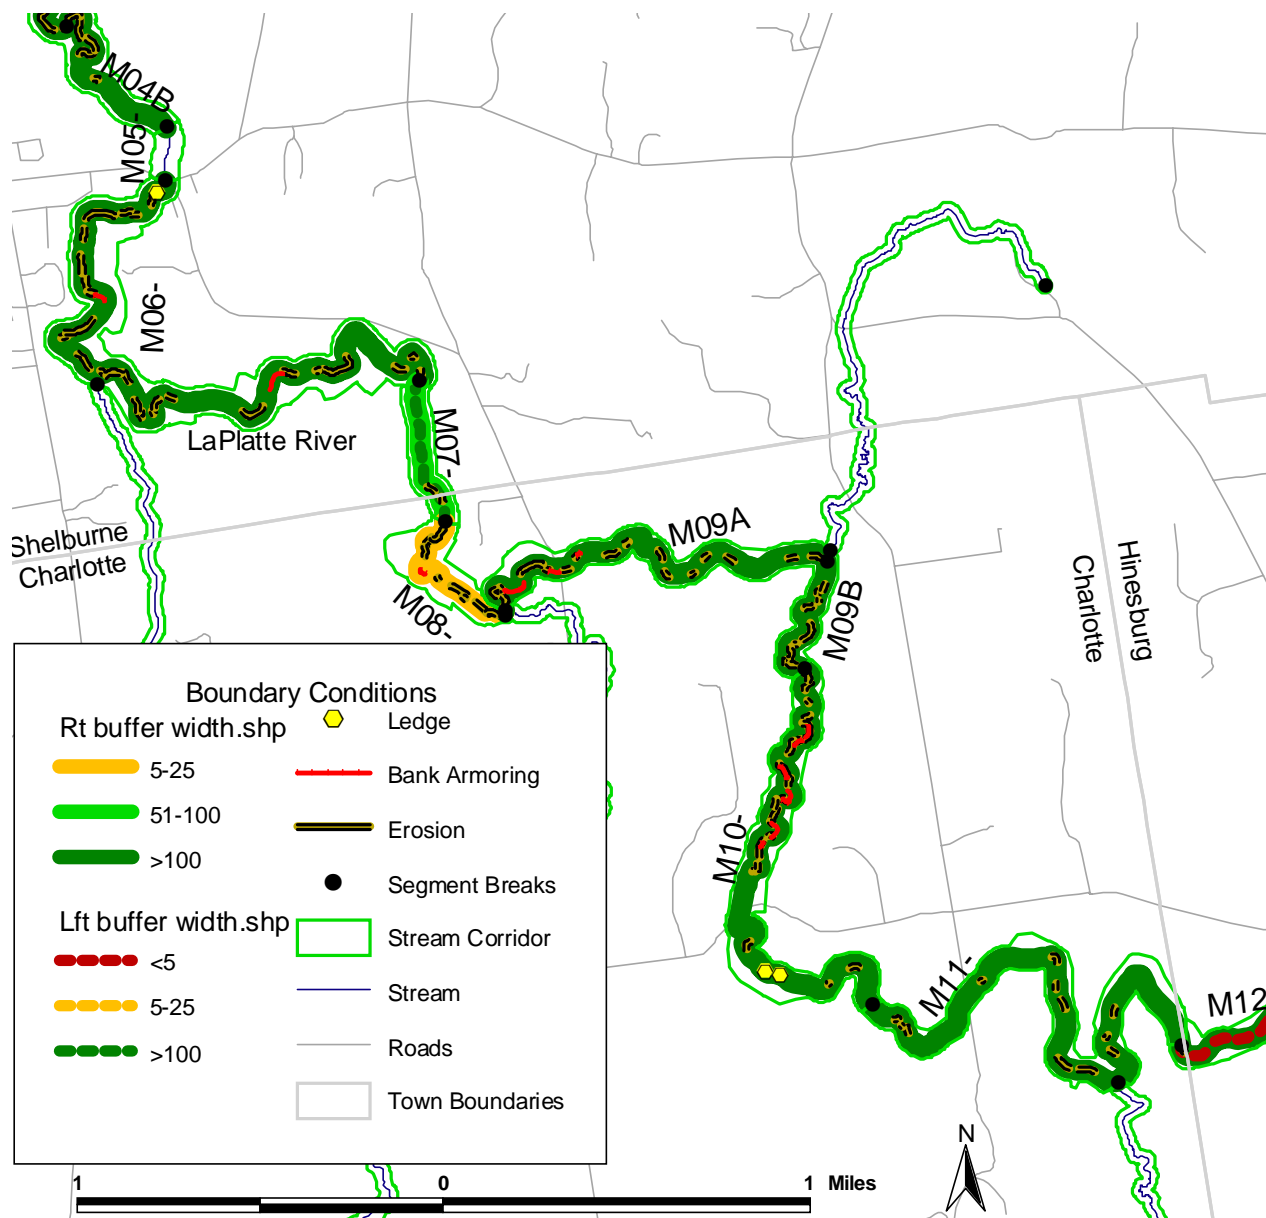
Figure 5.6. Boundary Conditions Map. No dams were present in the study reaches.

Removal of woody bank vegetation can decrease boundary resistance, leading to bank erosion and channel migration. Reach M08 had reduced buffer width (5-25 feet) and significant bank erosion. Other reaches had adequate woody buffer widths, although some areas within the reaches had low buffer widths, such as in M06, M09A, and M10.

Bank armoring is often installed to prevent bank erosion, if only temporarily. Reach M10 had brush revetments installed in an attempt to provide bank stability. Many of the revetments had failed at the time of assessment. Rock riprap armoring was present in M06 and M09A, increasing the resistance to bank erosion at these sites, but transferring the erosive power downstream.

Ledges provided bed resistance at the downstream end of M06 and in M10. Otherwise bed and bank materials were comprised mostly of non-cohesive sands and gravels, with the exception of cohesive clay banks present in reach M10. Table 5.1 summarizes by reach stressors contributing to departure from equilibrium conditions at the watershed and reach scales.

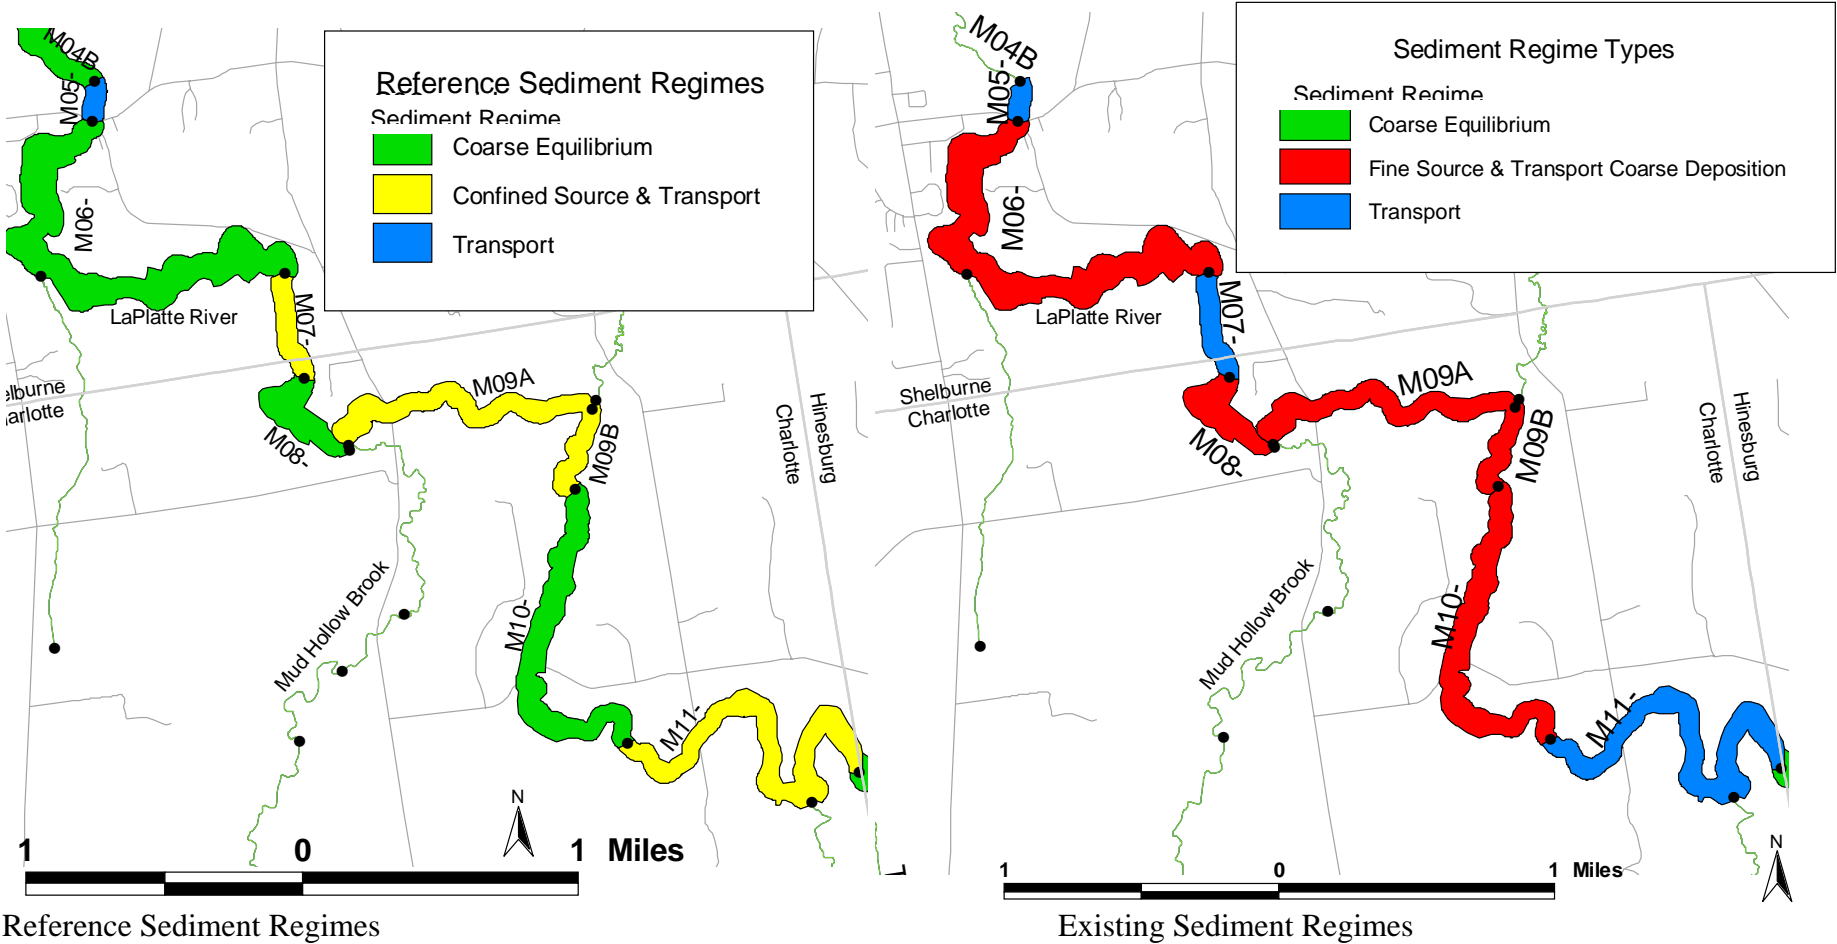
The reference sediment regimes in the study area (Figure 5.7) were alternating sections of Transport (M05, M07, M09, M11) and Coarse Equilibrium areas (M06, M08, M10). Existing sediment regime types, based on Phase 2 data, show departures in regime in all but the most confined transport areas, M07 and M11. Reaches M06, M08, and M10 have changed from Coarse Equilibrium regimes to Fine Source and Transport, Coarse Deposition regimes. This indicates an increase in fine sediments produced in these reaches and transported downstream, as also illustrated in figure 5.3. Segments M09A and M09B experienced a departure in sediment regime from Transport to Fine Source and Transport, Coarse Deposition. This indicates that while these segments may be storing more coarse sediment than they were under reference conditions, they are now considered sources of fine sediments. Deposition of coarse sediments can lead to large bar features that induce channel migration and can lead to channel avulsions and flood damage.

Figure 5.7. Reference and existing sediment regimes for the LaPlatte study area. Reaches M07, M09, and M11 have valley slopes less than 2% so have reference sediment regimes of Confined Source and Transport rather than Transport.

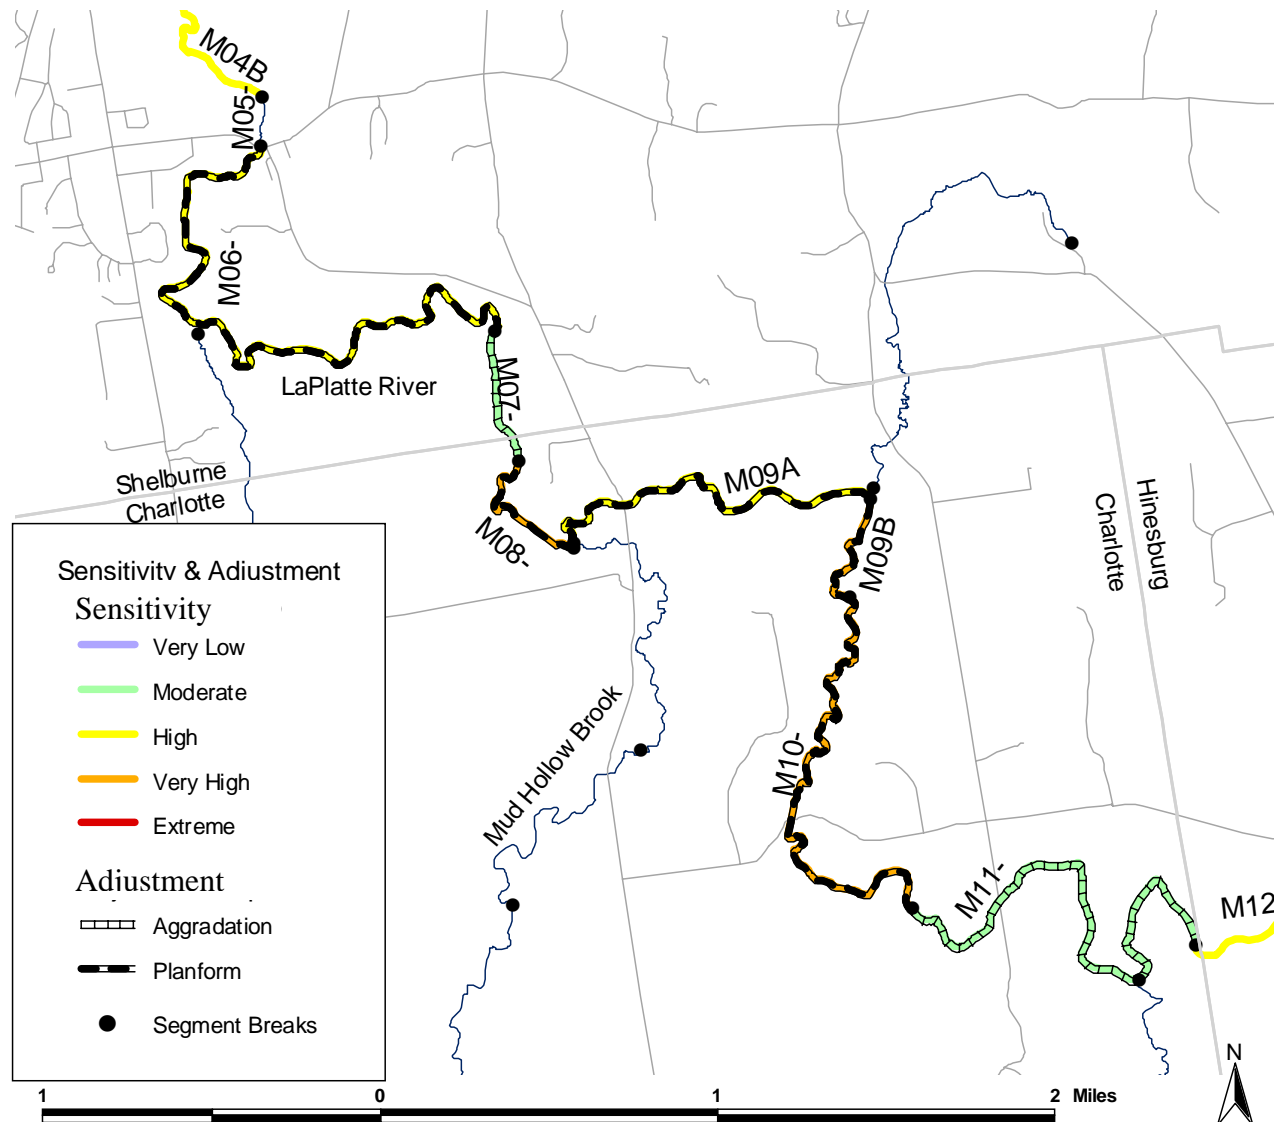
Figure 5.8. Stream Sensitivity and channel adjustment process.

All reaches in the study area except for M07 and M11 show high to very high sensitivity with lateral channel migration (planform) being the dominant adjustment process. This implies that continued and future stressors to these reaches are likely to result in further channel migration, avulsion, and/or flood damage.
