STORMWATER MANAGEMENT PLAN FOR ALBURGH

FINAL REPORT

Stone Project ID 14-053

March 19, 2015

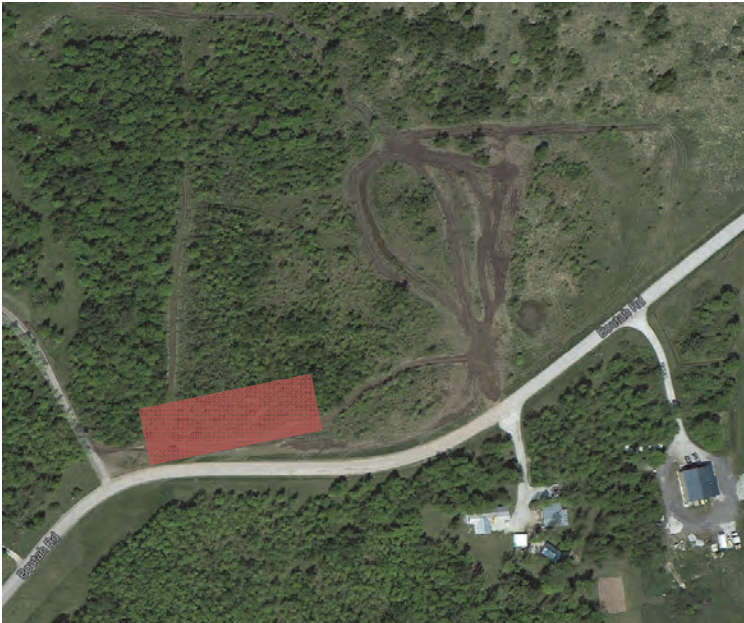
Problem Area ID: LC-10	Latitude: 44.978305°	Longitude: -73.247539°
Watershed: Lake Champlain

Location: Boutah Rd, slightly east of Metevier Dr		
Problem Type: Erosion		
Identification Source: SWMP Assessment		
Ownership: Private		
Classification: 2

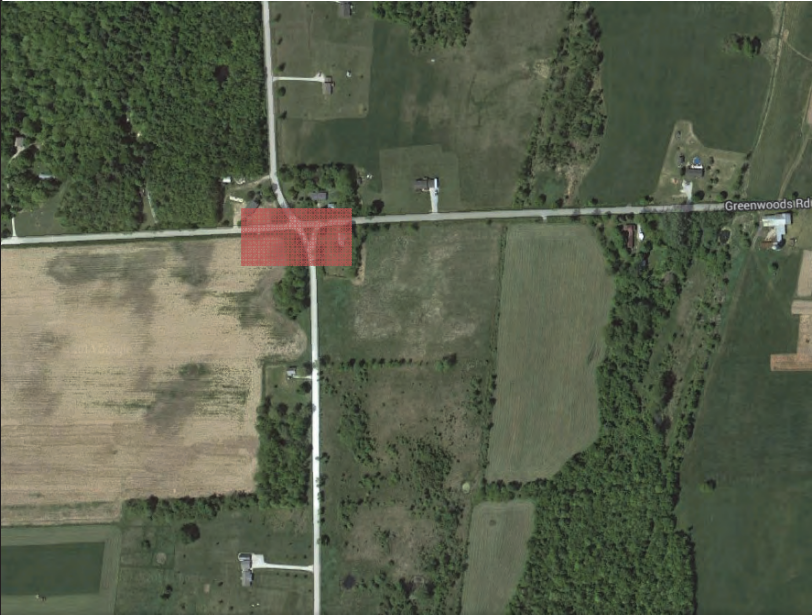
Problem Area ID: LC-11	Latitude: 44.991542°	Longitude: -73.236530°
Watershed: Lake Champlain

Description of Observed Conditions:
 The green space in the Y-intersection of Littlewoods Rd and Boutah Rd offers an opportunity for a stormwater retrofit that would better manage stormwater runoff from the adjoining road surfaces.

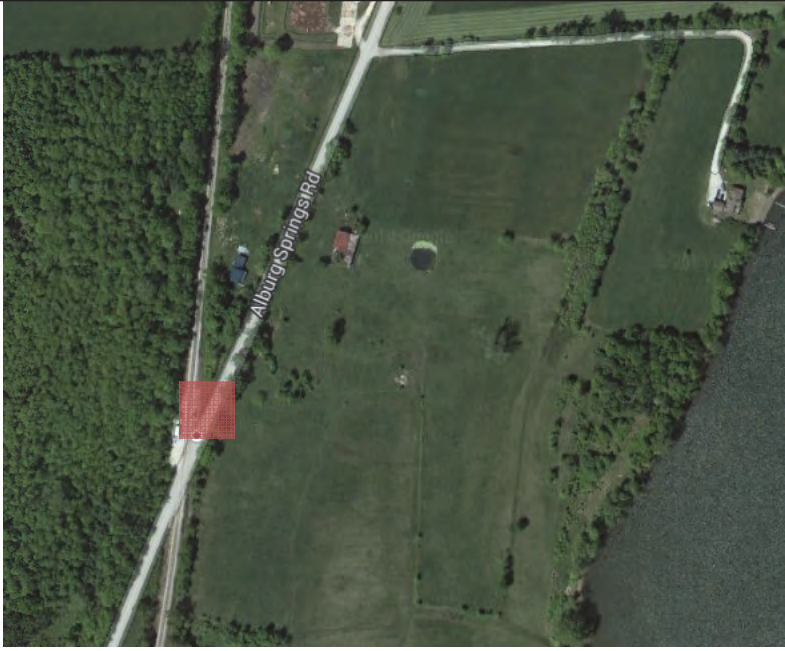
Problem Area ID: LC-14	Latitude: 44.982968°	Longitude: -73.227821°
Watershed: Lake Champlain

Description of Observed Conditions:
 Downstream end of culvert is perched <1' above channel; evidence of direct animal access at upstream end of culvert

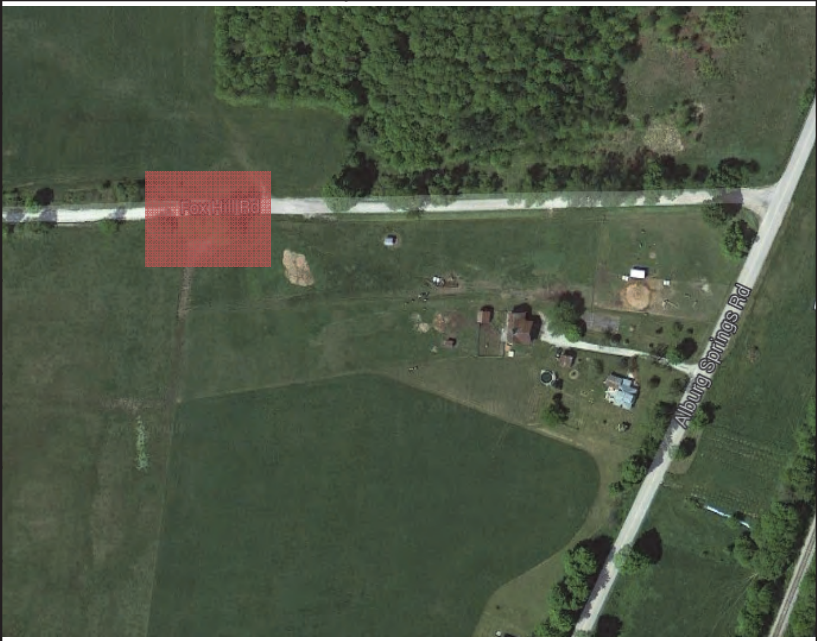
Problem Area ID: LC-15	Latitude: 44.982968°	Longitude: -73.227821°
Watershed: Lake Champlain

Description of Observed Conditions:
 Downstream end of cross culvert is discharging directly into recently tilled annual cropland and actively eroding; unclear if animals have direct access to upstream area. This concern has been forwarded to the Agency of Agriculture.

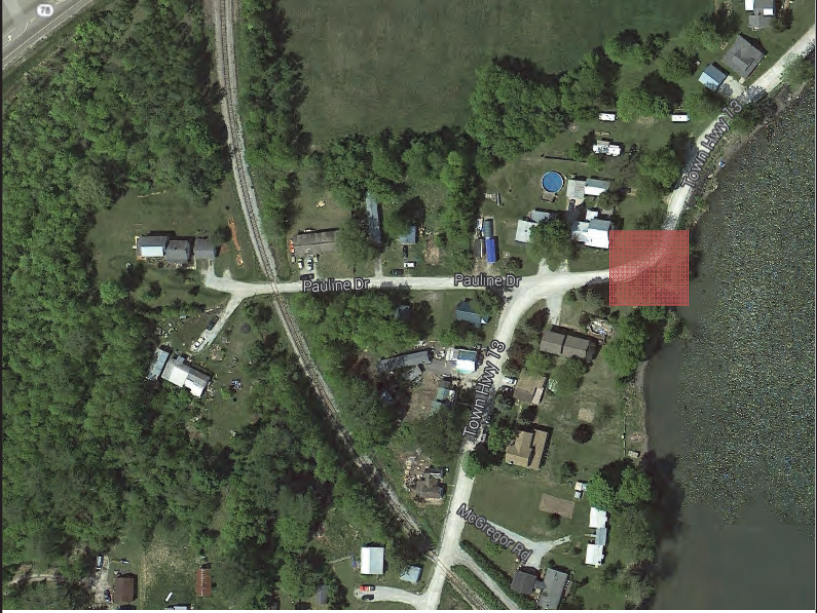
Problem Area ID: LC-16	Latitude: 44.974031°	Longitude: -73.228671°
Watershed: Lake Champlain

Description of Observed Conditions:
 Extremely steep boat launch is providing a direct conduit for stormwater runoff from the neighborhood to Lake Champlain; shoulder of boat launch is actively eroding. Town has indicated plans for resurfacing East Alburgh Rd in 2015, which could offer an opportunity to redirect and better manage stormwater runoff from this neighborhood.

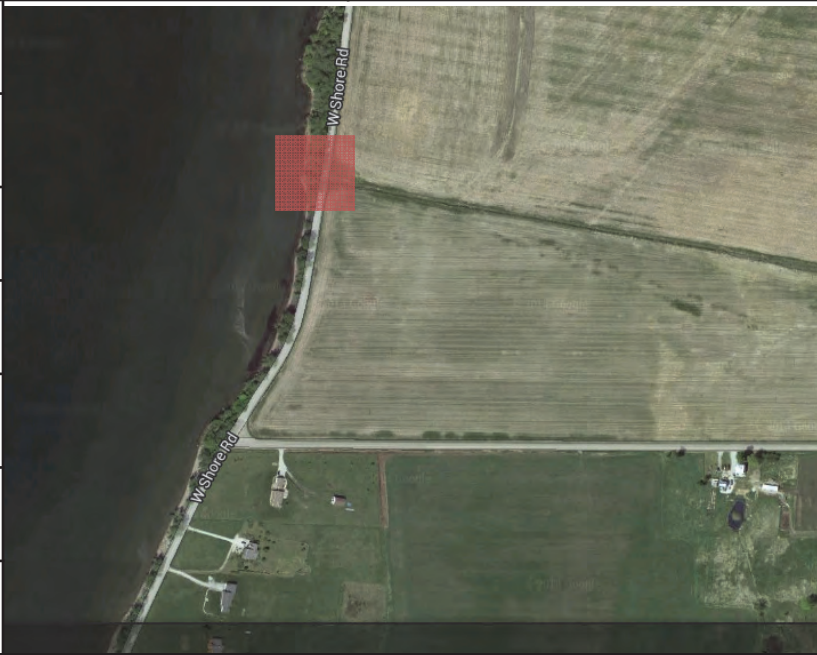
Problem Area ID: LC-17	Latitude: 44.953410°	Longitude: -73.305922°
Watershed: Lake Champlain

Description of Observed Conditions:
 Ditch draining two farm fields with very narrow buffers discharges directly into Lake Champlain; significant sediment deposits below culvert. This concern has been forwarded to the Agency of Agriculture.

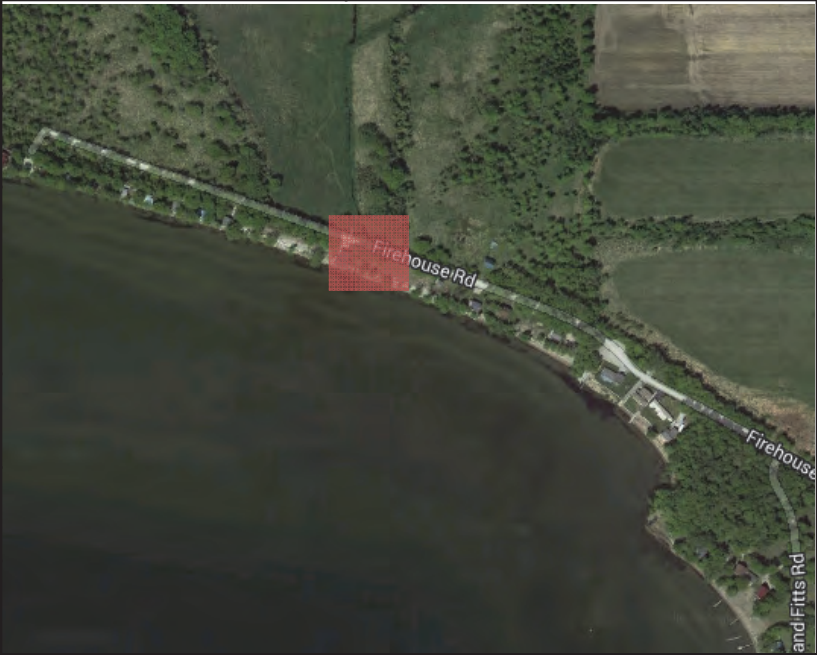
Problem Area ID: LC-18	Latitude: 44.983771°	Longitude: -73.314765°
Watershed: Lake Champlain

Significant unstabilized areas on Firehouse Road immediately adjacent to Lake was observed in June. It was suggested that this work might have been undertaken to ensure it was completed in advance of shoreline management requirements scheduled to take effect July 1. In revisiting the site in mid-August, vegetation had established, although the drainage feature shown in Photo 2 below continued to show some evidence of on-going erosion/sedimentation.

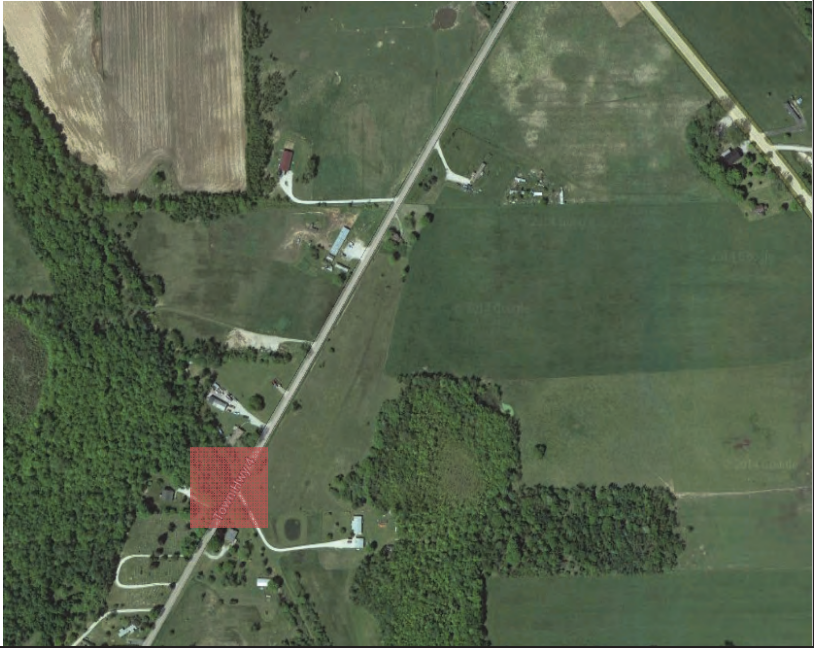
Problem Area ID: MC-01	Latitude: 44.954049°	Longitude: -73.281799°
Watershed: Mud Creek

Location: Town Highway 4, ~2000 ft SW of Route 2		
Problem Type: Infrastructure		
Identification Source: VOBCIT Inventory		
Ownership: Public		
Classification: 2

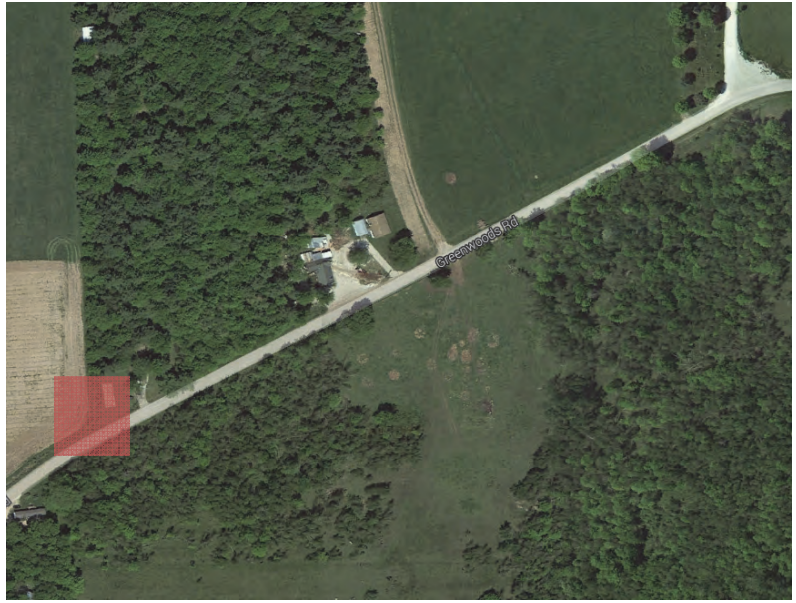
Problem Area ID: MC-02	Latitude: 45.004297°	Longitude: -73.247359°
Watershed: Mud Creek

Location: Greenwood Rd, approx ¼ mile west of Henry Rd		
Problem Type: Erosion		
Identification Source: Town		
Ownership: Public/Private		
Classification: 3

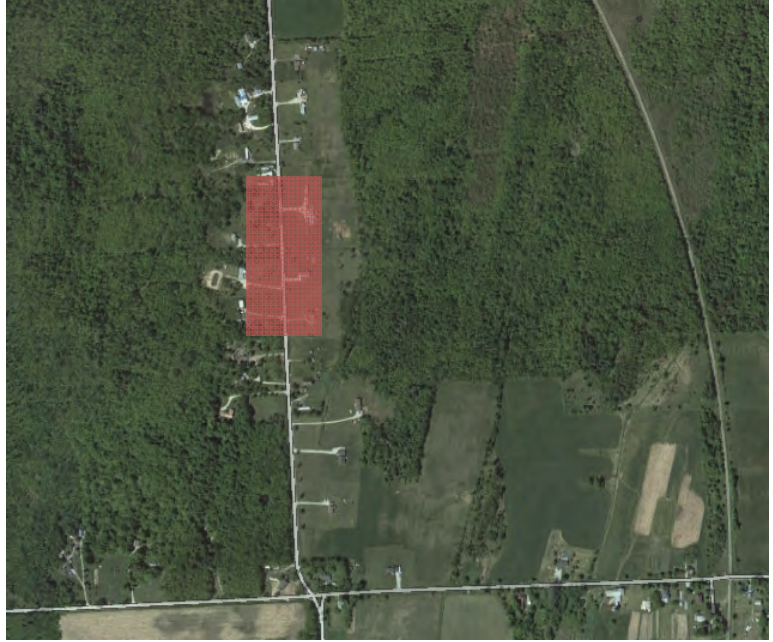
Problem Area ID: MC-03	Latitude: 45.004297°	Longitude: -73.247359°
Watershed: Mud Creek

Location: Greenwood Rd, approx ½ mile north of Littlewoods Rd		
Problem Type: Drainage/Erosion		
Identification		
Source: Town		
Ownership: Public/Private		
Classification: 2

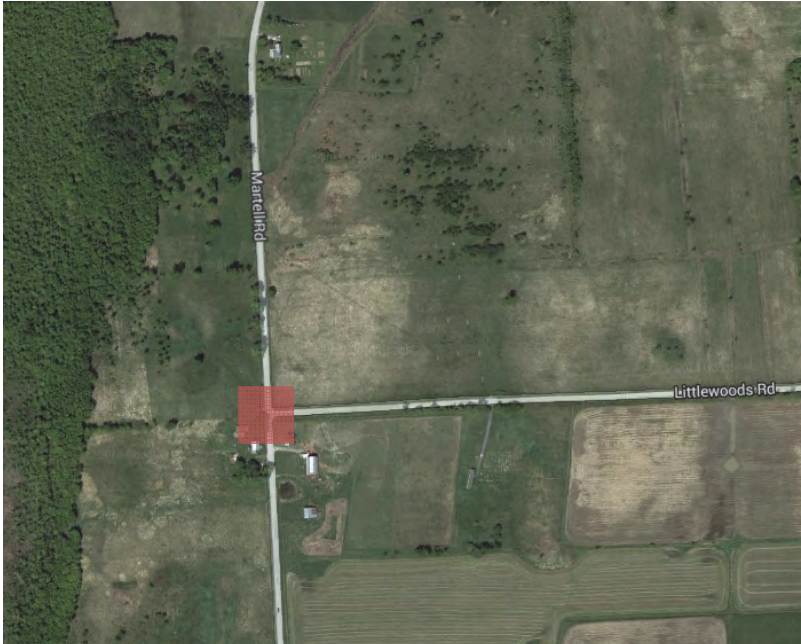
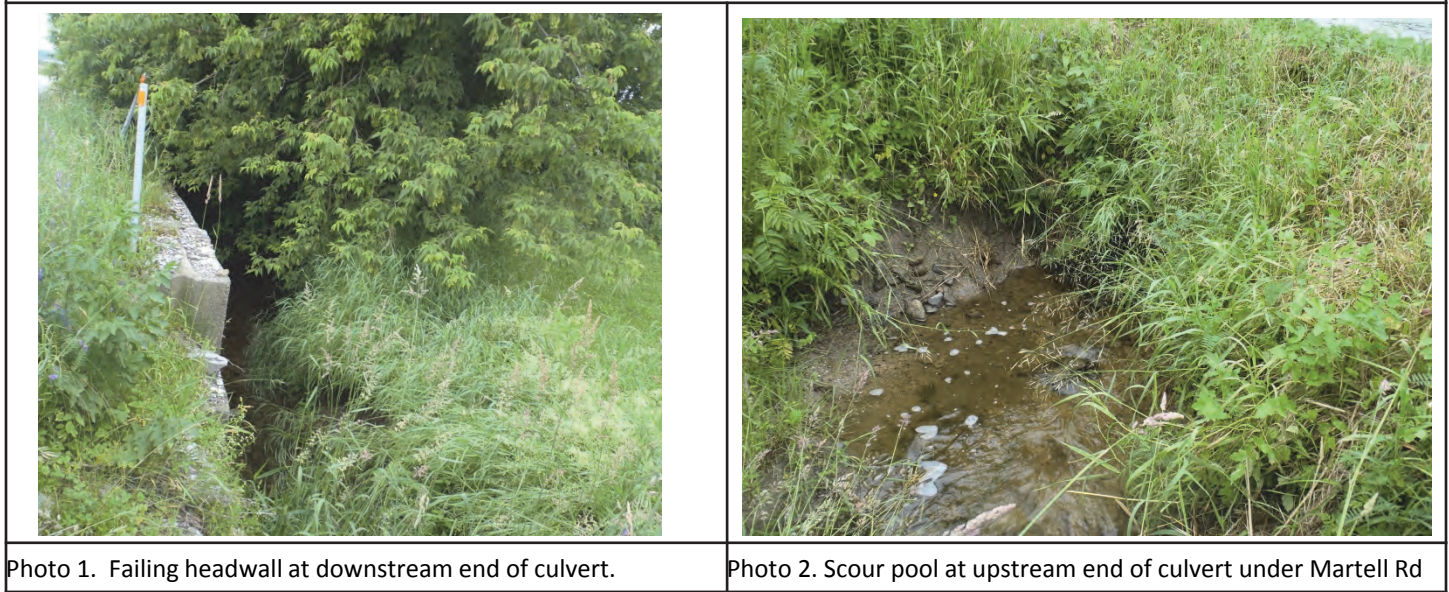
Problem Area ID: MC-05	Latitude: 44.990902°	Longitude: -73.261842°
Watershed: Mud Creek

Description of Observed Conditions:
 Culvert carrying stormwater runoff from the southside of Littlewoods Rd under Martell Rd has significant scour pools at both ends. The headwall at the downstream end of the culvert is failing and the road shoulder is collapsing.

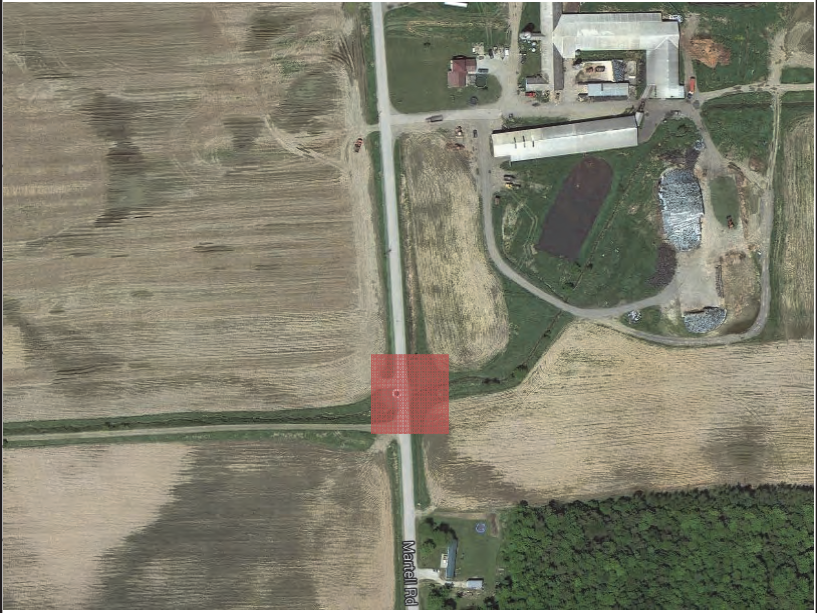
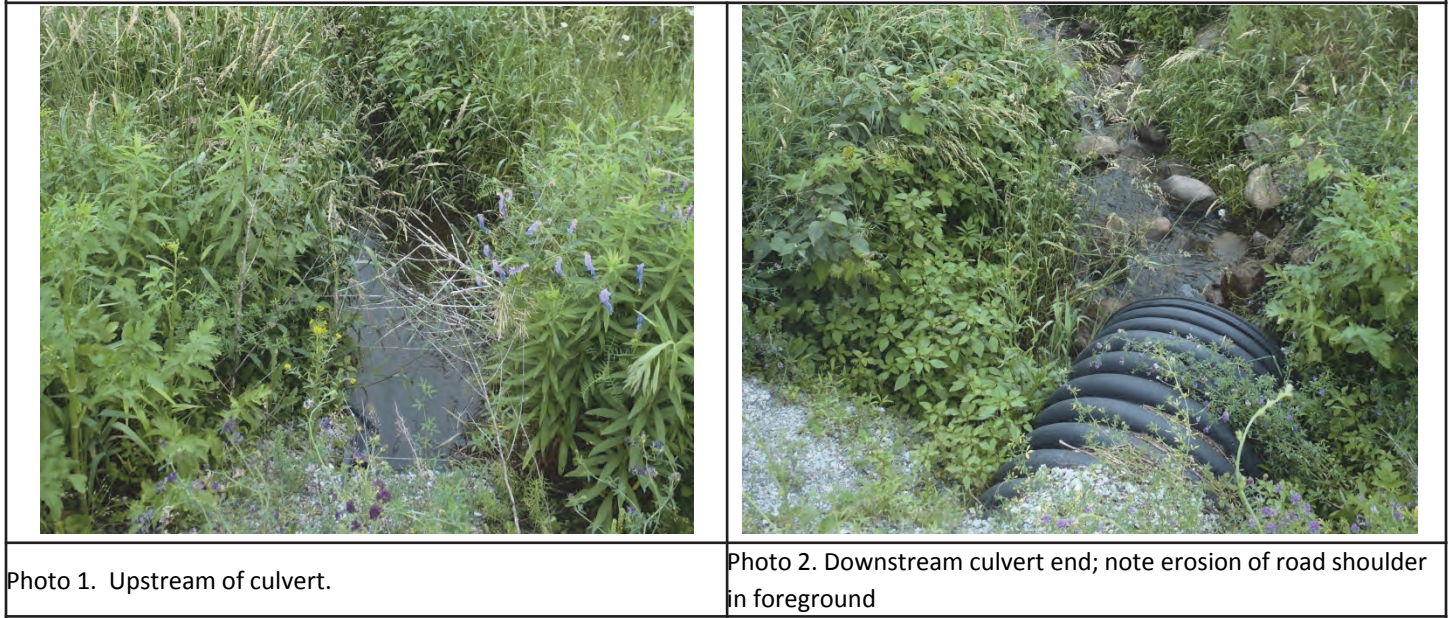
Problem Area ID: MC-06	Latitude: 44.982961°	Longitude: -73.261199°
Watershed: Mud Creek

Description of Observed Conditions:
 Culvert carrying unnamed tributary to Mud Creek under Martell Rd is poorly aligned with stream and appears undersized. Road shoulder is eroding over downstream end of culvert; upstream end appears okay.

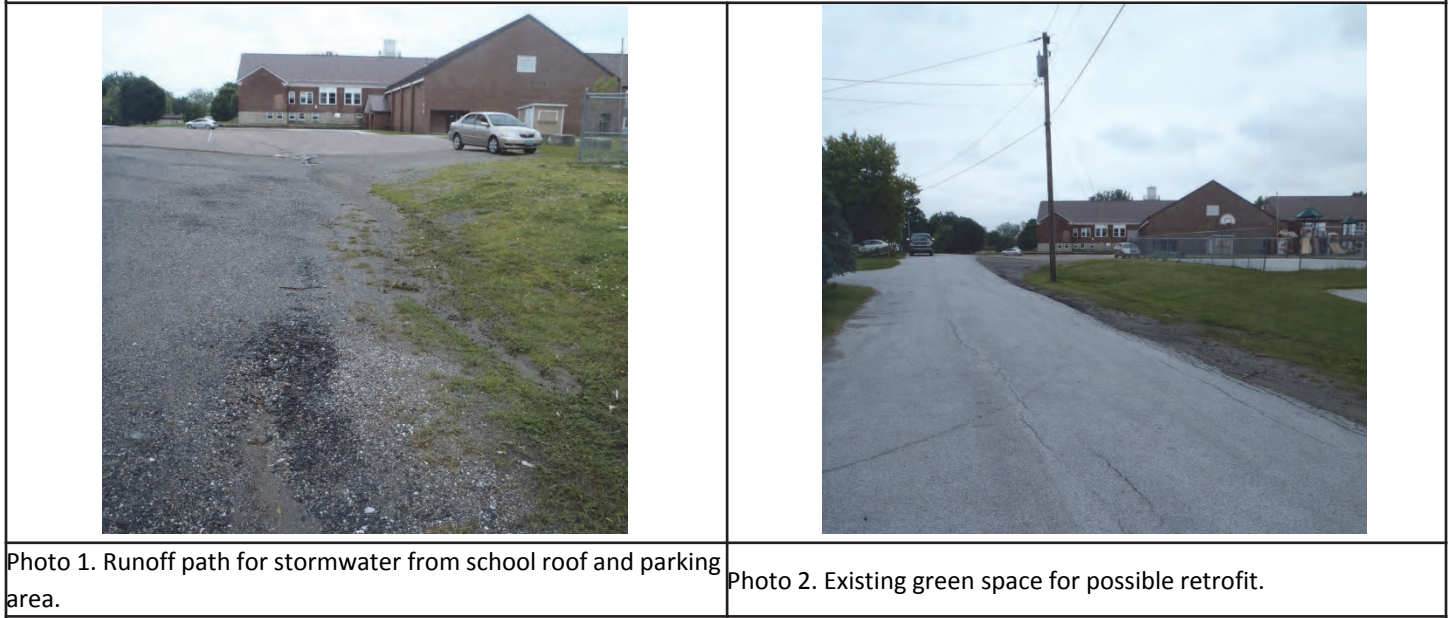
Description of Observed Conditions:
 Stormwater runoff from roof of school and attendant parking lot is currently unmanaged, but there is a green space between School St and the basketball court that could be retrofit to capture, filter and slow the runoff.

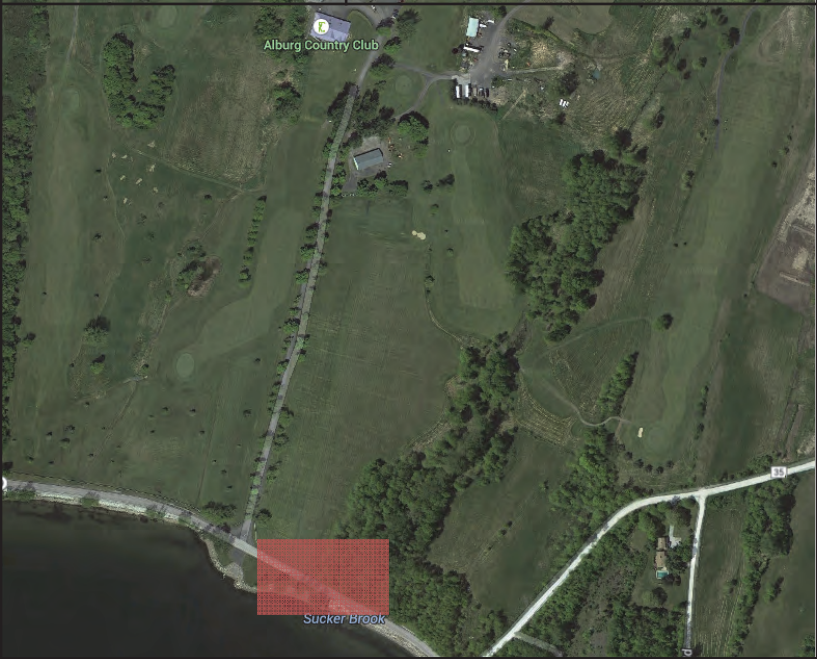
Problem Area ID: SB-01	Latitude: 44.903273°	Longitude: -73.305425°
Watershed: Sucker Brook

Location: Route 129, by Alburgh Country Club		
Problem Type: Erosion		
Identification Source: SWMP Assessment		
Ownership: Private		
Classification: 3
