## **APPENDIX C**

**Problem Area Summary Sheets (8½"x11")**

**Project: SW-1** **Problem Area Summary**

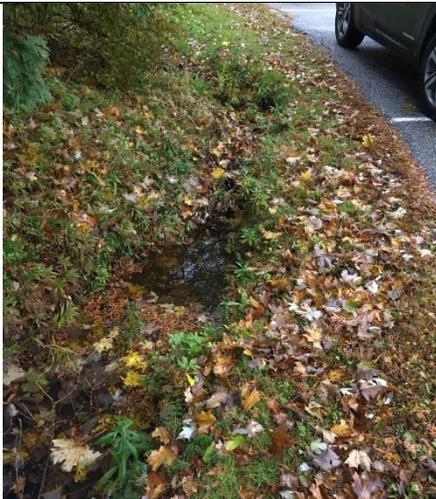
**Site Description:** An eroded channel extends from the west end of the swale to the north, around the parking lot (Photo 1).

**Photo 1:** Eroded channel along the Fisher Elementary School Parking Lot.

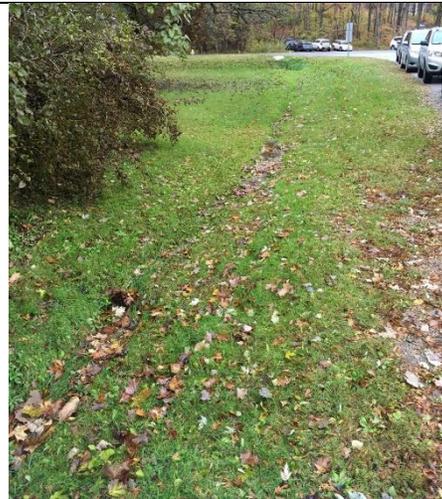
**Photo 2:** Existing swale to retrofit.

**BMP Description:** Install a meandering naturalized channel with storage for small runoff events in the current swale location to slow and infiltrate water (Photo 2).

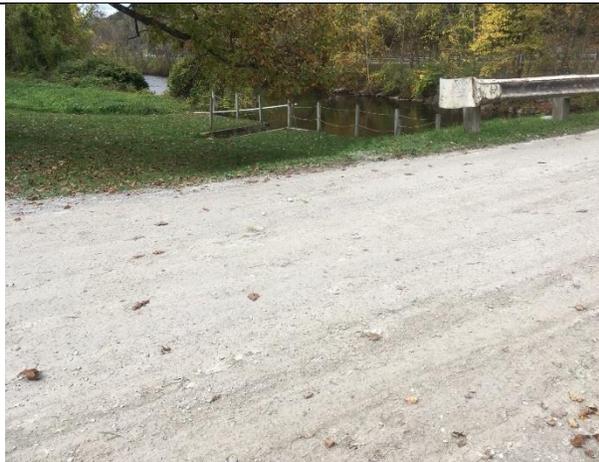
**Site Description:** Runoff from the gravel parking lot for the church and river access as well as a portion of Covered Bridge Road drains into the Batten Kill (Photo 1).

**Photo 1:** Runoff from the road drains into the Batten Kill.

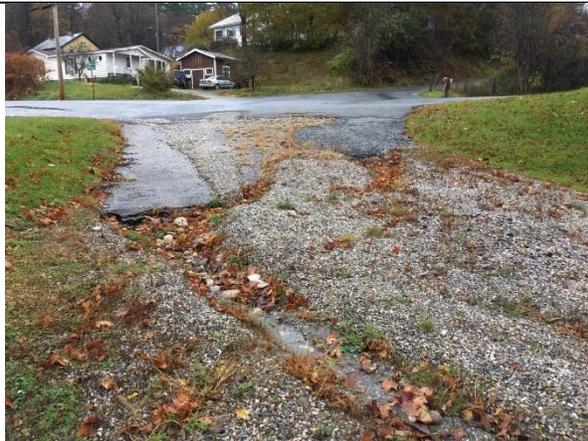
**Site Description:** Runoff from Chittenden Drive, Munn Terrace, and a parking area drains to a former loading dock for Miles Lumber Company (Photos 1 & 2). May be within the railroad ROW. Runoff enters a standpipe and is diverted directly into the underground stream.

**Photo 1:** Runoff from Munn Drive and Chittenden Drive bypasses a paved berm and flows toward the loading dock during large rain events.

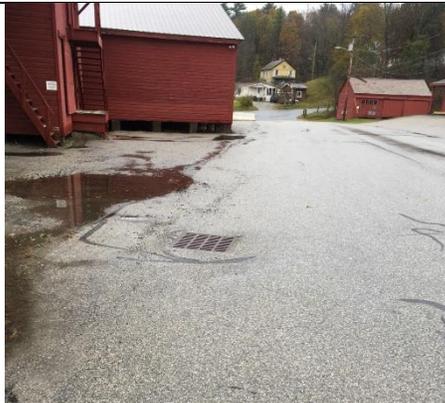
**Site Description:** Water from roads and Miles Lumber Company parking and rooftops drains to a catch basin (Photos 1 & 2). May be within the Vermont Railway ROW.

**Photo 1:** Runoff from Miles Lumber Company impervious surfaces drains to a catch basin.

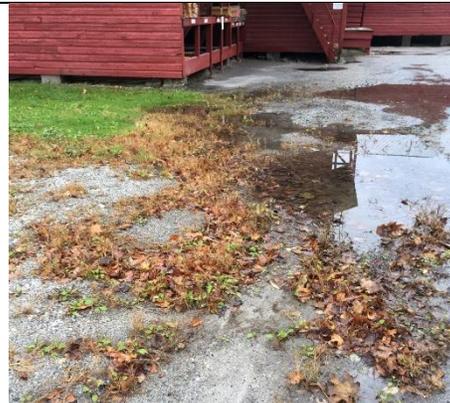
**Photo 2:** Green space to the west may provide space for a BMP installation.

**BMP Description:** The grassy area south of storage sheds by railroad may have space for WQv treatment. Assess opportunities to reduce peak flows in the stormwater drainage network.

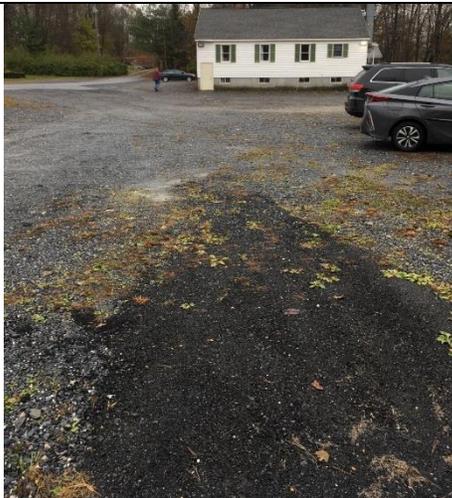
**Site Description:** Runoff from the gravel parking lot drains to a catch basin located in the middle of the lot (Photo 1). The catch basin outlets to an intermittent stream on a steep slope to the north and west.

**Photo 1:** Runoff from the gravel parking lot drains directly to a catch basin.

**BMP Description:** Cap the catch basin in the center of the parking lot and install a linear infiltration basin at northwest of the parking lot to treat runoff (Photo 2).

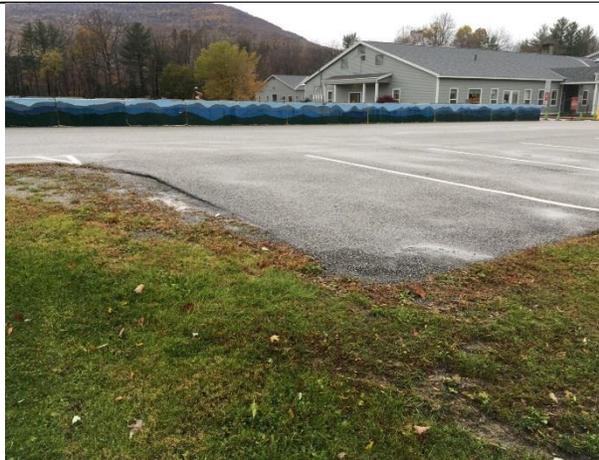
**Site Description:** Runoff from the paved parking lot enters a catch basin in the adjacent greenspace (Photo 1). This runoff then drains south to an outfall located in a forested area adjacent to a first order stream.

**Photo 1:** Catch basin receives runoff from the paved parking lot at the school.

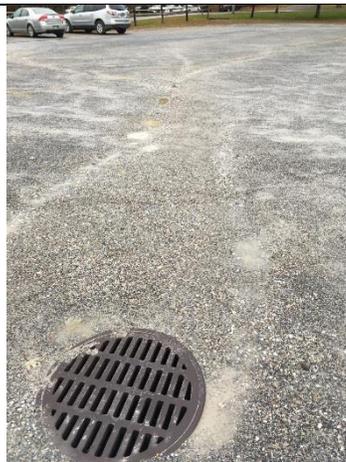
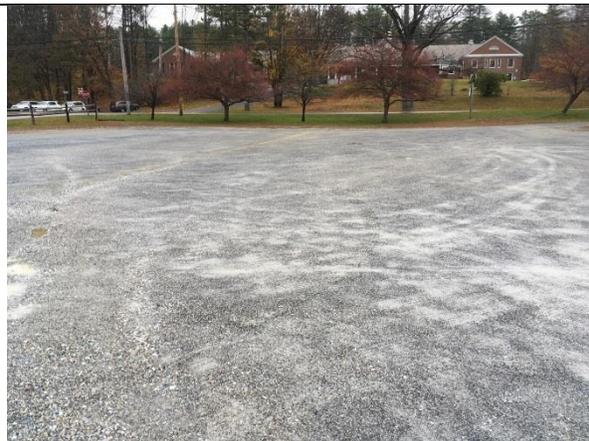
**Site Description:** Runoff from the library’s gravel parking lot drains to a catch basin located in the middle of the lot (Photos 1 & 2). This runoff then drains south to an outfall located in a forested area adjacent to a first order stream.

**Photo 1:** Runoff from the gravel parking lot drains directly to a catch basin. **Photo 2:** Gravel parking lot at the library.

**BMP Description:** Consider paving the parking lot to reduce fine sediment loading. A deep sump catch basin conveying runoff to a swirl separator or underground chambers may be installed to trap sediment.

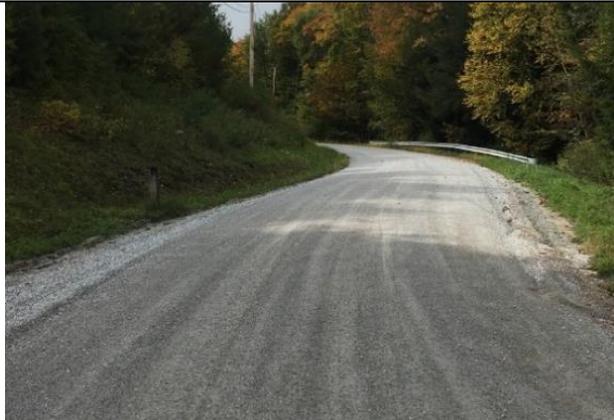
**Site Description:** The east side of Birch Grove Road has rill erosion along the roadway and at the intersection with Ball Mountain Road (Photos 1 & 2). 400' of ditch along the west side of the 9% slope road lacks stone. Segments associated with the site are rated very high and high priority by VTDEC for bringing up to MRGP standards. This road segment ranked 18<sup>th</sup> (top 6%) in the water quality prioritization based on REI data.

**Photo 1:** Unstable drainage ditches along Birch Grove Road.

**BMP Description:** Install minimum 6-8" minus stone in drainage ditches. Crown road to direct water into existing ditch to the east and remove grader berms to allow water to sheet flow to the west. Follow VTANR/VTrans road stormwater management guidance to ensure consistency with MRGP design standards.

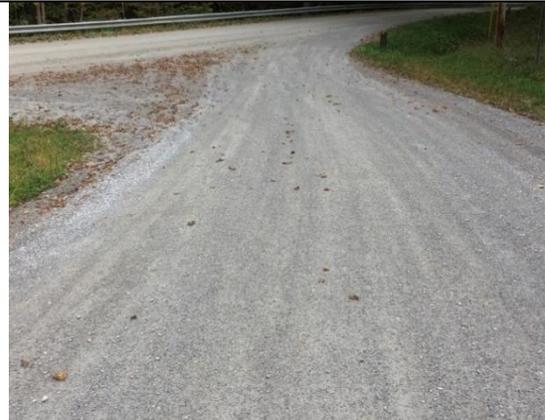
**Photo 2:** Grader berms prevent water from sheeting off the road, causing rill erosion of the roadway.

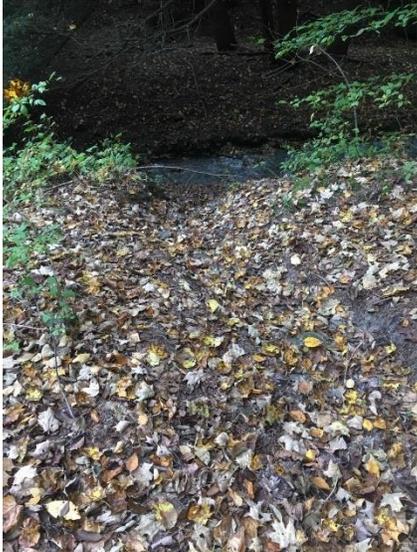
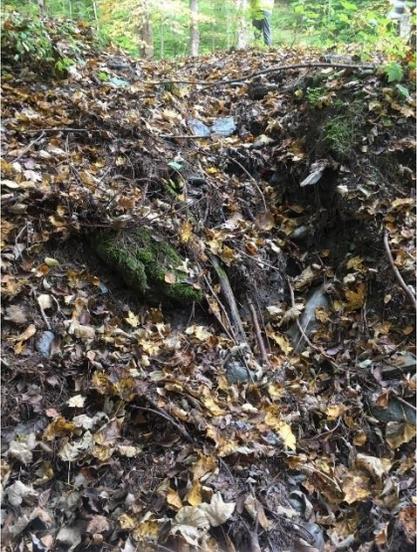
<b>Location:</b>	Ball Mountain Road			
<b>Latitude:</b>	43.04687 N			
<b>Longitude:</b>	-73.17439 W			
<b>Land Ownership:</b>	Town			
<p><b>Site Description:</b> The road embankment is severely eroded (Photos 1 &amp; 2). The runoff and sediment are conveyed directly into Dry Brook. This road segment ranked 11<sup>th</sup> (top 3%) in the water quality prioritization based on REI data.</p>

<p><b>Photo 1:</b> Eroded conveyance from Ball Mountain Road to Dry Brook.</p>		<p><b>Photo 2:</b> Significant erosion of the Ball Mountain Road embankment.</p>		
<p><b>BMP Description:</b> Stabilize the conveyance with large stone keyed in to an elevation at least 2 feet lower than the deepest part of the channel. Follow VTANR/VTrans road stormwater management guidance to ensure consistency with MRGP design standards.</p>

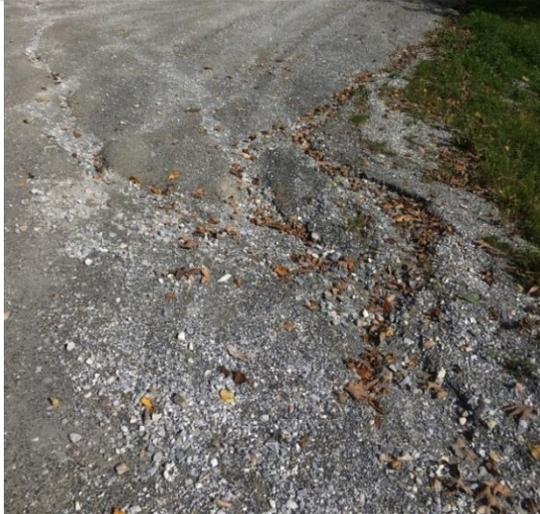
<b>Location:</b>	Wilcox Road from Mountain View Drive to Route 313 Intersections			
<b>Latitude:</b>	43.0982 N			
<b>Longitude:</b>	-73.2017 W			
<b>Land Ownership:</b>	Town			
<p><b>Site Description:</b> Runoff from Mountain View Drive and Wilcox Road is causing rill erosion along the roadway (Photos 1 &amp; 2). The lower segments of Wilcox Road and Mountain View Drive are rated high priority by VTDEC for bringing up to MRGP standards. This road segment ranked 30<sup>th</sup> (top 9%) in the water quality prioritization based on REI data.</p>

<p><b>Photo 1:</b> Rill erosion along Wilcox Road shoulder.      <b>Photo 2:</b> Rill erosion of the roadway.</p>				
<p><b>BMP Description:</b> Install 100' of ditches lined with minimum 6-8" minus stone along Mountain View Drive. Improve 300' of grass lined ditches along Wilcox Road. Remove grader berms and crown road to allow water to access ditches. Follow VTANR/VTrans road stormwater management guidance to ensure consistency with MRGP design standards.</p>

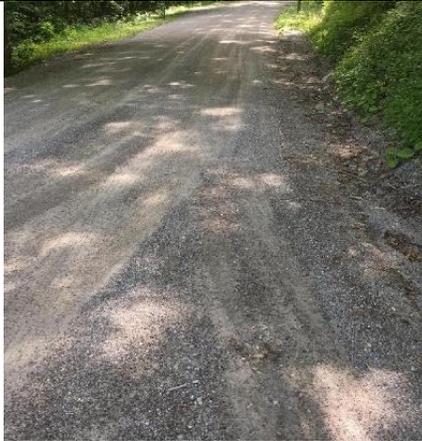
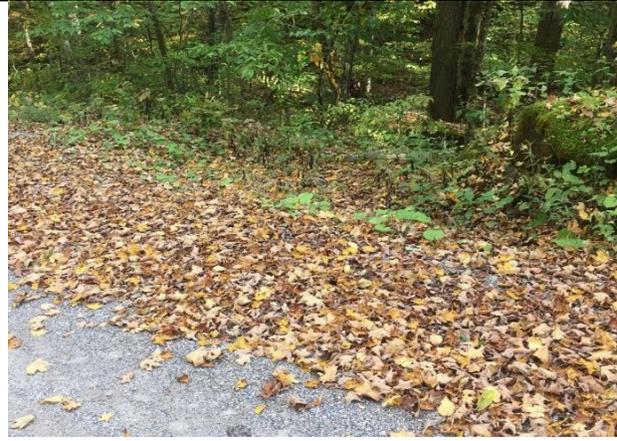
**Site Description:** The road has an unstable drainage ditch and two areas where runoff drains via poor conveyances toward the adjacent stream (Photos 1 & 2). The lowest segment of Benedict Hollow Road is rated very high priority by VTDEC for bringing up to MRGP standards. This road segment ranked 23<sup>rd</sup> (top 7%) in the water quality prioritization based on REI data.

**Photo 1:** The high slope segment has unlined ditches with unstable eroding areas. **Photo 2:** Eroded conveyance toward stream.

**BMP Description:** Stabilize 100' of ditch with minimum 6-8" minus stone. Stabilize the two conveyances to the stream with stone or vegetation. Consider adding check dams along the conveyance to trap sediment. Follow VTANR/VTrans road stormwater management guidance to ensure consistency with MRGP design standards.

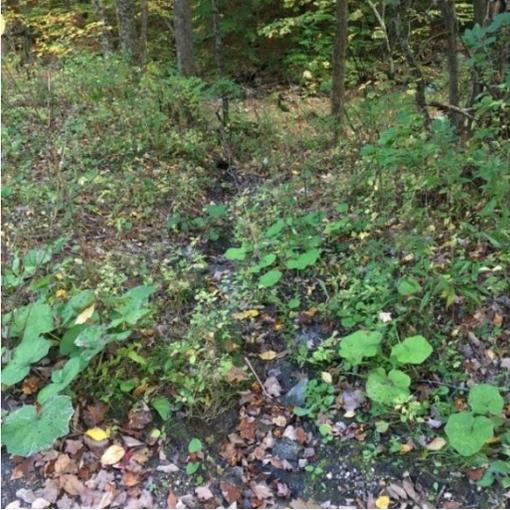
<b>Location:</b>	Benedict Hollow Road			
<b>Latitude:</b>	43.0800 N			
<b>Longitude:</b>	-73.2033 W			
<b>Land Ownership:</b>	Town			
<p><b>Site Description:</b> No culvert is present to convey water across the road, causing it to pool and erode the roadway and embankment. A 15' gully is developing down the embankment 50' from a stream (Photos 1 &amp; 2). This road segment ranked 100<sup>th</sup> (top 31%) in the water quality prioritization based on REI data.</p>

<p><b>Photo 1:</b> Erosion from the roadway to the adjacent floodplain and stream.</p>		<p><b>Photo 2:</b> Eroded channel on slope adjacent to floodplain and stream.</p>		
<p><b>BMP Description:</b> Install a cross culvert to convey water under the road. Stabilize the outlet and road embankment with stone. Consider installing a sediment trap to prevent eroded sediment from entering the stream. Follow VTANR/VTrans road stormwater management guidance to ensure consistency with MRGP design standards.</p>

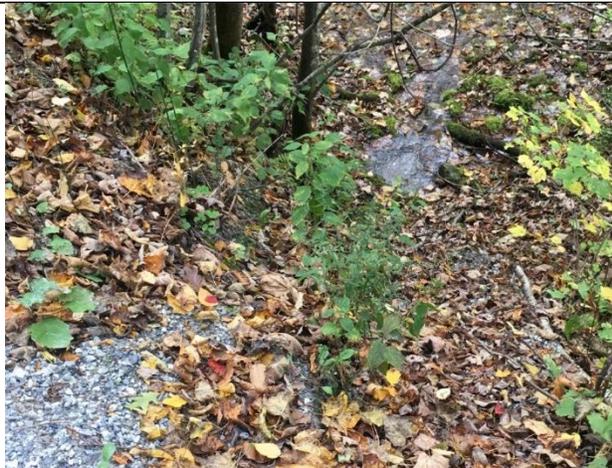
**Site Description:** A 15' long and 8' tall stretch of road embankment is eroding directly into a wetland alongside a Batten Kill flood chute (Photo 1). Flowing water from a spring emerging from the slope is undermining the road embankment (Photo 2). This road segment ranked 120<sup>th</sup> (top 38%) in the water quality prioritization based on REI data.

**Photo 1:** Eroding conveyance to a wetland.

**BMP Description:** Stabilize road embankment with large stone keyed in to an elevation at least 2 feet lower than base of the embankment. Follow VTANR/VTrans road stormwater management guidance to ensure consistency with MRGP design standards. Consider installing French mattress to provide drainage and prevent groundwater from undermining the road.

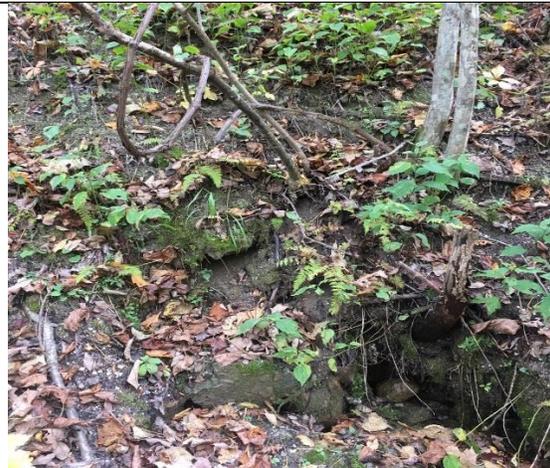
**Photo 2:** Eroding road embankment.

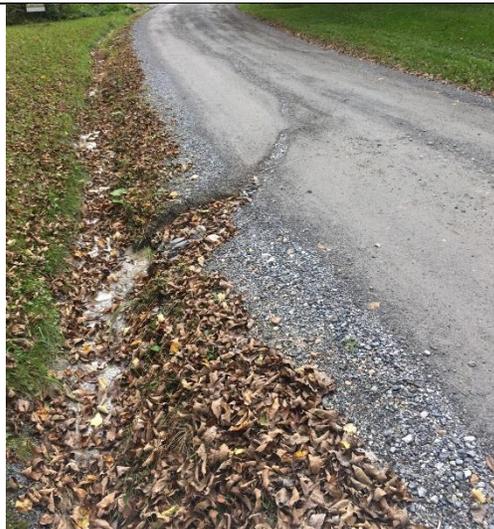
**Site Description:** Water runs down the middle of the road, eroding the roadway. No ditch is present on the west side of the road, causing erosion alongside the road. The ditch on the east side of the road is paved. At the end of the paved ditch, there is 100' of rill erosion from the stonewall to the stream (Photos 1 & 2). Erosion extends uphill to the private section of the road, which lacks ditches. This road segment ranked 16<sup>th</sup> (top 5%) in the water quality prioritization based on REI data.

**Photo 1:** Eroded roadway and ditch along West Mountain Inn Road.

**BMP Description:** Improve road drainage by installing stone-lined ditches and armoring existing ditches on the east side of the road. Cross culverts and driveway culverts should also be considered to minimize erosion. Consider adding a sediment trap to catch road materials before they enter the stream.

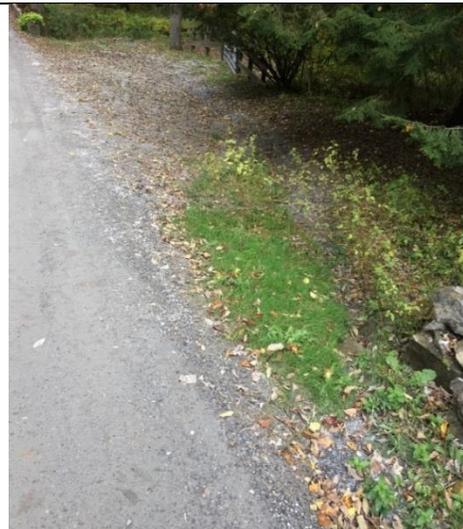
**Photo 2:** Sediment deposits adjacent to the stream crossing.

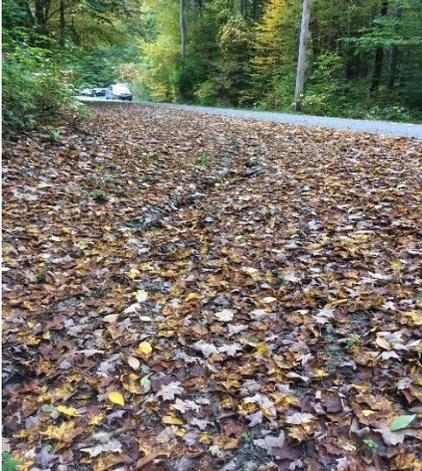
<b>Location:</b>	Raven Rock Road			
<b>Latitude:</b>	43.1110 N			
<b>Longitude:</b>	-73.1440 W			
<b>Land Ownership:</b>	Town			
<p><b>Site Description:</b> This area has 115' of rill erosion on both sides of the road (Photo 1). An eroded conveyance 200' long on the south side of the road flows toward the adjacent stream (Photo 2). This road segment ranked 70<sup>th</sup> (top 22%) in the water quality prioritization based on REI data.</p>

<p><b>Photo 1:</b> Eroded channel alongside Raven Rock Road.</p>		<p><b>Photo 2:</b> Eroded flow path extends to the adjacent stream.</p>		
<p><b>BMP Description:</b> Install a stone or grass-lined ditch and driveway culvert on the south side of the road. Consider adding a sediment trap at the conveyance on the south side of the road to catch road materials before they enter the stream. Follow VTANR/VTrans road stormwater management guidance to ensure consistency with MRGP design standards.</p>

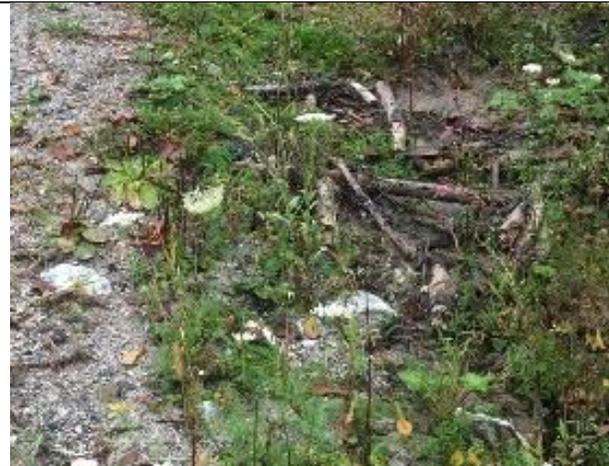
**Site Description:** Grader berms along the road are causing water to run along the roadway and erode the road surface. Water exits the roadway via a poor conveyance that is eroding the road embankment near a cross culvert outlet. Sediment is accumulating in the ditch on the inside bend (Photos 1 & 2). This road segment ranked 13<sup>th</sup> (top 4%) in the water quality prioritization based on REI data.

**Photo 1:** Sediment accumulation in the ditch and at the culvert inlet.

**BMP Description:** Remove grader berms. Stabilize the conveyance with minimum 6-8" minus stone (12" minus stone recommended). Clean-out the drainage ditch and stabilize with stone where needed. Follow VTANR/VTrans road stormwater management guidance to ensure consistency with MRGP design standards.

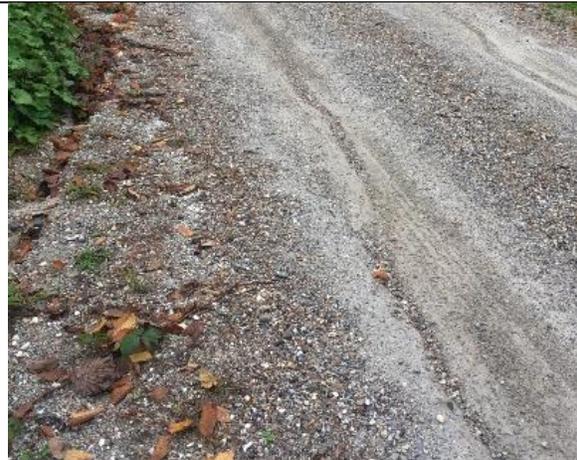
**Photo 2:** Erosion along Fisher Road, with a secondary ditch forming.

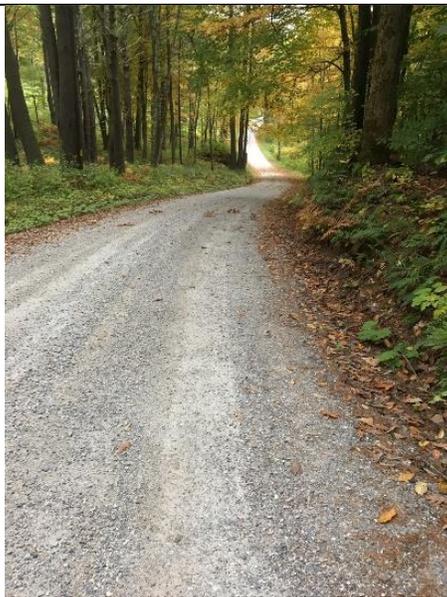
**Site Description:** Ditches are absent along both sides of a steep section of road, causing water to flow down the roadway and erode the road surface (Photos 1 & 2). This road segment ranked 36<sup>th</sup> (top 11%) in the water quality prioritization based on REI data.

**Photo 1:** Steep sections of road lack stable ditches. **Photo 2:** Road is slightly sunken and eroded where ditches are absent.

**BMP Description:** Install drainage ditches on both sides of the road and stabilize them with minimum 6-8" minus stone. Follow VTANR/VTrans road stormwater management guidance to ensure consistency with MRGP design standards.

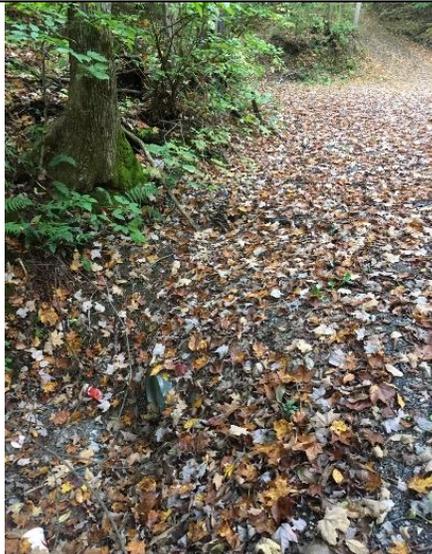
**Site Description:** Ditches are absent along both sides of a steep section of road, causing water to flow down the roadway and erode the road surface (Photo 1). The section of drainage ditch on the southwest side of the road segment is unstable and eroding (Photo 2). The segment associated with the site is rated very high priority by VTDEC for bringing up to MRGP standards. This road segment ranked 23<sup>rd</sup> (top 7%) in the water quality prioritization based on REI data.

**Photo 1:** An unstable drainage ditch.

**BMP Description:** Install drainage ditches on both sides of the road and stabilize them with minimum 6-8" minus stone. Follow VTANR/VTrans road stormwater management guidance to ensure consistency with MRGP design standards.

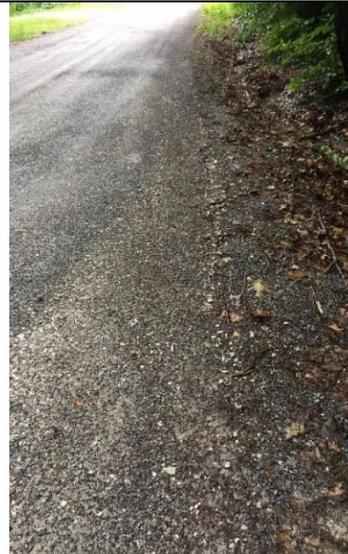
**Photo 2:** Erosion is present on both sides of the road.

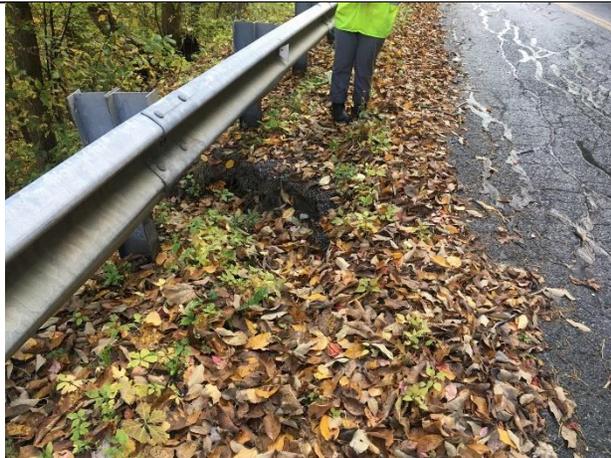
**Site Description:** This area has a severely eroded conveyance down a steep slope draining directly to the stream on the north side of the road (Photos 1 & 2). Rill erosion is present on the south side of the road due to shallow unstable drainage ditches. This road segment ranked 3<sup>rd</sup> (top 1%) in the water quality prioritization based on REI data.

**Photo 1:** Eroded conveyance along the road embankment.

**BMP Description:** Stabilize the conveyance with minimum 6-8" minus stone (recommended 12" minus stone). Line ditches on the north side of the road with stone. Consider replacing driveway culvert with a larger diameter pipe. Follow VTANR/VTrans road stormwater management guidance to ensure consistency with MRGP design standards.

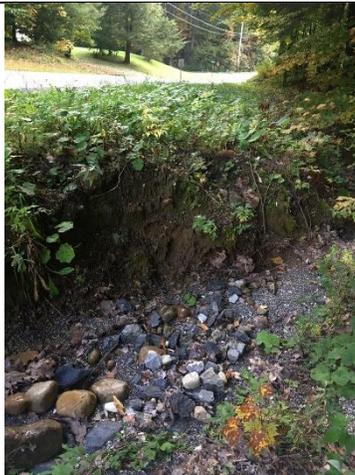
**Site Description:** Severe erosion is present at the culvert header and road embankment. Sediment from the eroding embankment is accumulating in the ditch (Photos 1 & 2). This road segment ranked 6<sup>th</sup> (top 2%) in the water quality prioritization based on REI data.

**Photo 1:** Eroded drainage ditch with accumulation of sediment.

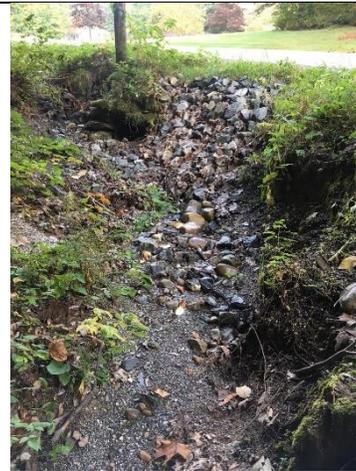
**Photo 2:** Eroded conveyance along the road embankment.

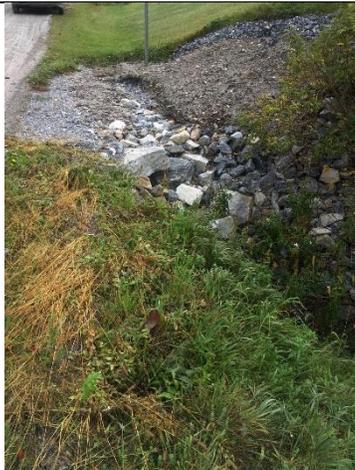
**Site Description:** Ditches on both sides of the road near the intersection with Route 7A are eroding toward a culvert that crosses the highway (Photos 1 & 2). There are some rocks placed before the culvert inlet that have trapped some of the sediment. This road segment ranked 32<sup>nd</sup> (top 10%) in the water quality prioritization based on REI data.

**Photo 1:** Eroded roadside with accumulation of sediment.

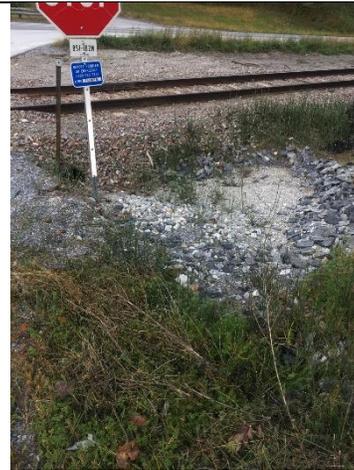
**Photo 2:** Accumulation of road sediment near a culvert inlet.

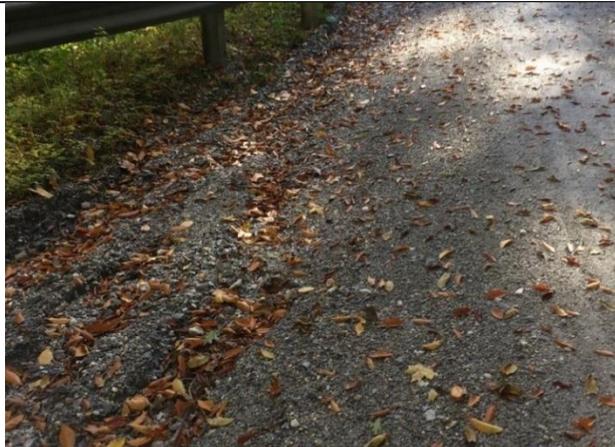
**Site Description:** A board along the base of the guardrail is concentrating runoff, which is causing severe erosion of the road surface and embankment near the outlet of a cross culvert (Photos 1 & 2). There is 30' of rill erosion on the road and 20' of gully erosion down the road embankment. Large amounts of gravel have accumulated at the culvert outlet. This road segment ranked 37<sup>th</sup> (top 12%) in the water quality prioritization based on REI data.

**Photo 1:** Rill erosion from concentrated runoff along the guardrail.

**BMP Description:** Stabilize the road embankment with stone, beginning at the tail end of the board along the guardrail. Crown as much of the road as possible into the ditch opposite the guardrail. Consider installing a sediment trap in the forested area downslope of the road embankment.

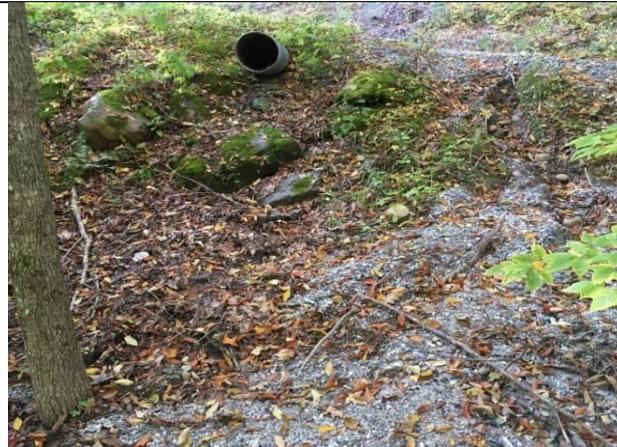
**Photo 2:** Erosion of the road embankment at the cross culvert.

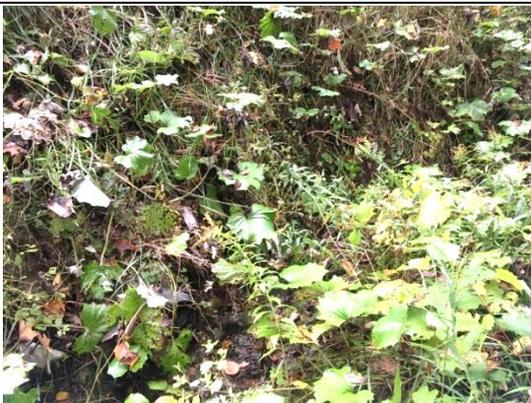
**Site Description:** The corrugated metal culvert conveys a small channel with an approximately 28.5-acre drainage area. The culvert capacity is estimated at 12.5 cfs, a flow exceeded in the 25-year flood event. Moderate erosion is present at the inlet and outlet (Photos 1 & 2).

**Photo 1:** Erosion at the culvert inlet header.

**BMP Description:** Install a larger structure with headers stabilized with stone. The recommended culvert size for an intermittent stream crossing of comparable drainage area is 30-36" in diameter.
