Stormwater Master Plan Lake Bomoseen Watershed, Castleton and Hubbardton, Vermont

December 15, 2016

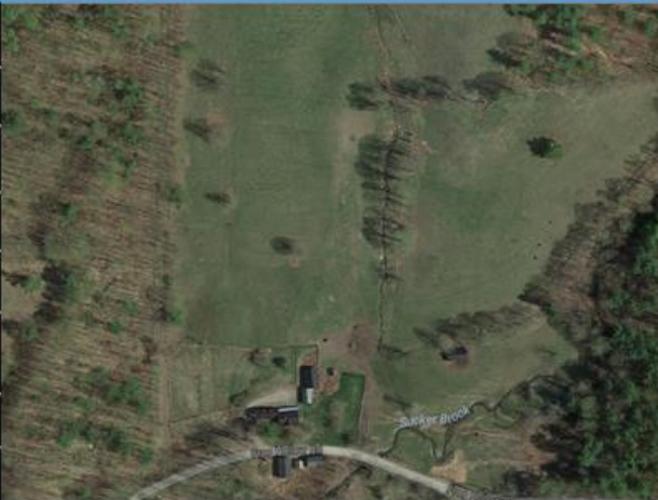
LAKE BOMOSEEN #4		PROBLEM AREA SUMMARY
Site ID: Map4	Design: No

Site Description: Livestock exclusion fencing opportunities in three sections of Sucker Brook near St. John Road. The first at the SJR crossing is 500 LF, at the next farm 1550 LF, and at Biddie Knob Rd 700 LF, for a total of 2750 LF feet of fencing opportunities.

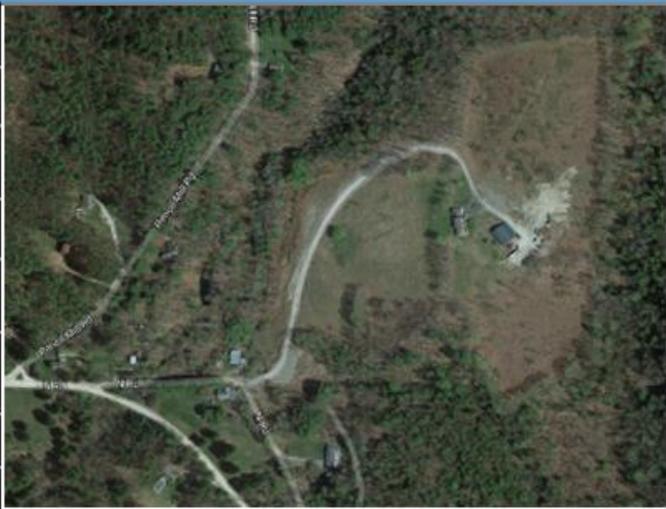
LAKE BOMOSEEN #8		PROBLEM AREA SUMMARY
Site ID: Map8	Design: No

Site Description: Private Driveway off Stables Road with large area of exposed earth on slopes exceeding 10%. This site contributes a significant source of fine sediment entering the tributary at the driveway bridge, as observed in field. Gravel drive and ditch exceeds 10% slope. Nearly an acre of unpaved surfaces drain to this area from upslope in addition to large house/rooftop.

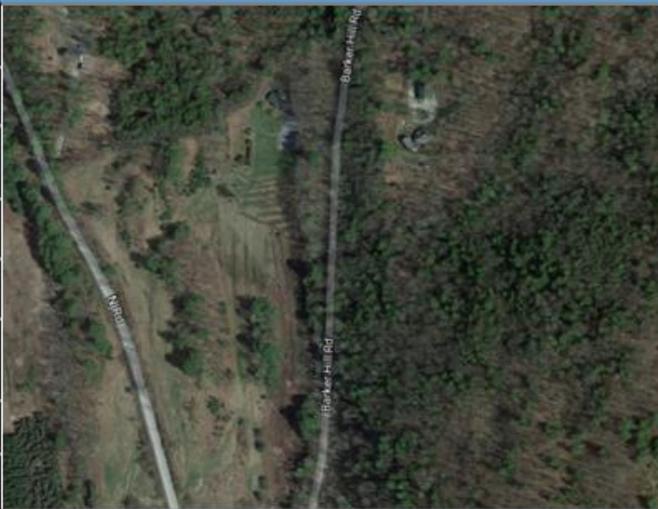
LAKE BOMOSEEN #9		PROBLEM AREA SUMMARY
Site ID: Map9	Design: No

Site Description: Likely gully site visible in aerial photos and with LiDAR. Field to south appears to be ditched leading to potential gully location. Field access difficult - need landowner permission (tried to visit on 8-18, but no one home); can see tall erosion along creek banks from the yard.

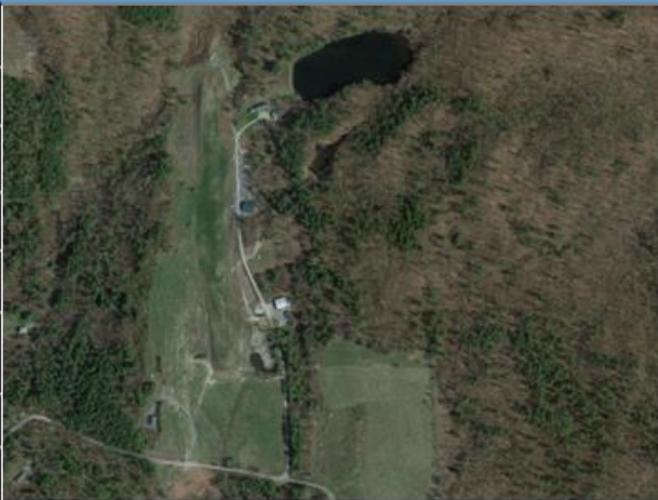
LAKE BOMOSEEN #12		PROBLEM AREA SUMMARY
Site ID: Map12	Design: No

12	Stream Channel/ Bank Erosion	Cleared areas of steep land at end of Barker Hill Road associated with the Mortimer Brown Landing Strip. Channel and bank erosion noted on aerial photos.	High	High	Low	High	Approximately 6 acres of recently cleared land along a perennial tributary. Approx. 5 acres of impervious surfaces including gravel areas and buildings draining into a pond with sediment seen on aerial photo.
44	Stream Channel/ Bank Erosion	Multiple areas of bank erosion on Sucker Brook in between Route 30 and North Road. Some areas are moderate sources of sediment to channel and lack buffer.	Moderate	Moderate	Moderate	Moderate	Approximately 300 ft of bank erosion with height 4-5ft upstream of Route 30. Channel is moderately incised and is actively widening in areas where post-Irene sediment deposits are large.
45	Stream Channel/ Bank Erosion	Large mid channel bar - 150ft long x 25ft wide x 2-3ft deep; flood chute and floodplain access above bar. Decent floodplain access and sediment storage in channel/floodplain	Moderate	Moderate	Moderate	Moderate	Approximately 150 ft of bank erosion with height 2-3ft downstream of North Road. Channel is actively widening through post-Irene sediment deposits. Good floodplain access; flood chute is found upstream of bar.

Site Description: Cleared areas of steep land at end of Barker Hill Road associated with the Mortimer Brown Landing Strip. Channel and bank erosion noted on aerial photos. Approximately 6 acres of recently cleared land along a perennial tributary. Approx. 5 acres of impervious surfaces including gravel areas and buildings draining into a pond with sediment seen on aerial photo. Need property permission to access.

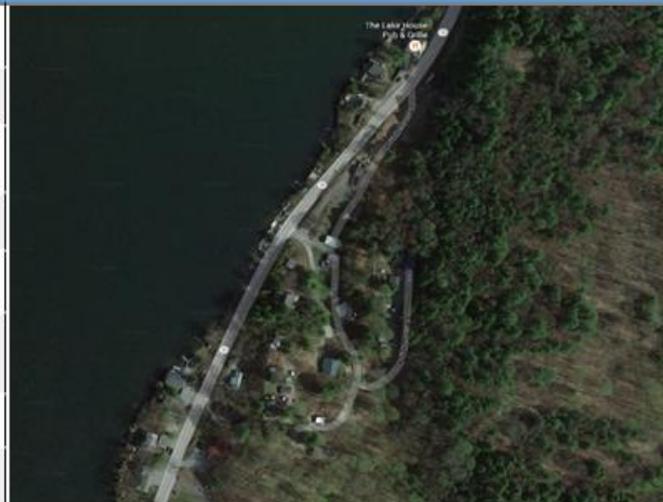
LAKE BOMOSEEN #13 **PROBLEM AREA SUMMARY**

Site Description: Cliff Dwellers Road with 5-6 homes draining to the west down very steep (10-20%) gravel drive. Fine sedimentation likely in culvert at intersection with Route 30. Needs field follow-up for additional assessment. Road and ditch has slopes >10% with 0.25 acre gravel road draining to ditches, plus the drainage from short driveways serving the homes.

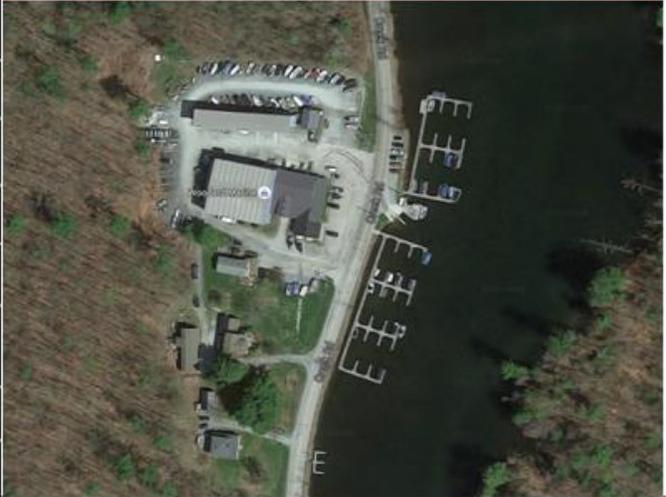
LAKE BOMOSEEN #20		PROBLEM AREA SUMMARY
Site ID: Map20	Design: Yes

Site Description: New catch basin installed by Town in Woodard Marina parking lot. Potential location for Vortechs swirl unit or other enhanced catch basin.

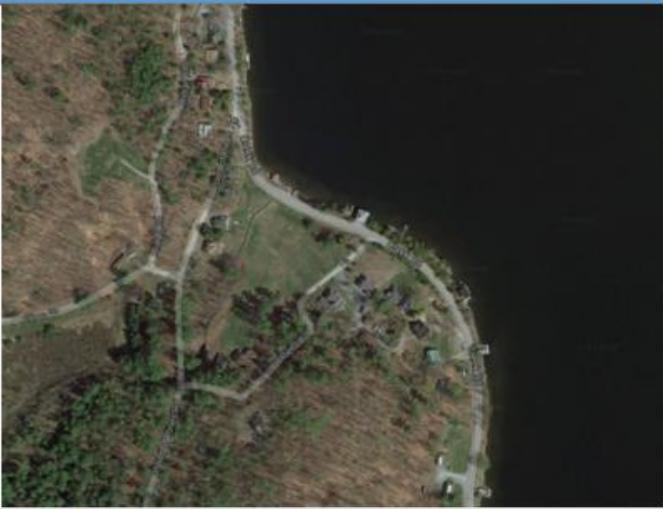
LAKE BOMOSEEN #27		PROBLEM AREA SUMMARY
Site ID: Map27	Design: No

Site Description: Drop inlet with catch basin just north of Creek Road and Point of Pines intersection. Catch basin takes runoff from ditch upslope. Very little sediment storage in basin due to limited sump. Upslope road and ditch has 5-10% slope with 0.25 acre gravel road draining to ditches

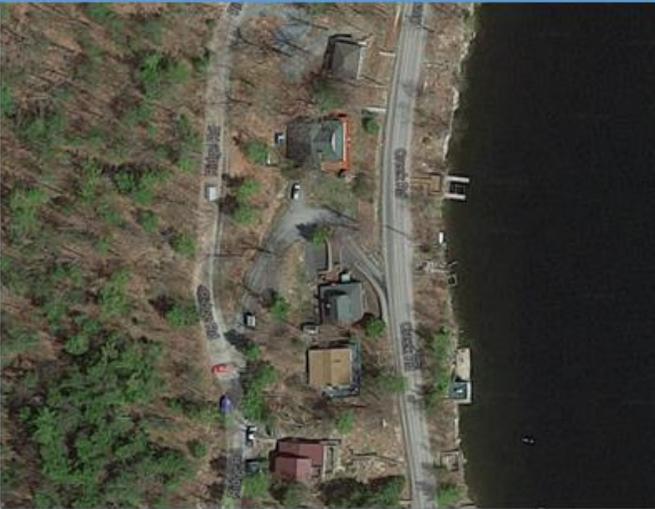
LAKE BOMOSEEN #28 **PROBLEM AREA SUMMARY**

Site Description: Shared driveways west of Creek Road, located 300 feet north of Point of Pines Road, drains to a catch basin on Creek Road. Very tight site, probably limited space for new stormwater BMPs. The site needs a larger catch basin with a sump along Creek Road. The houses and gravel surfaces cover 0.25 acre and sections of the gravel drive leading to Creek Road are >20% slope.

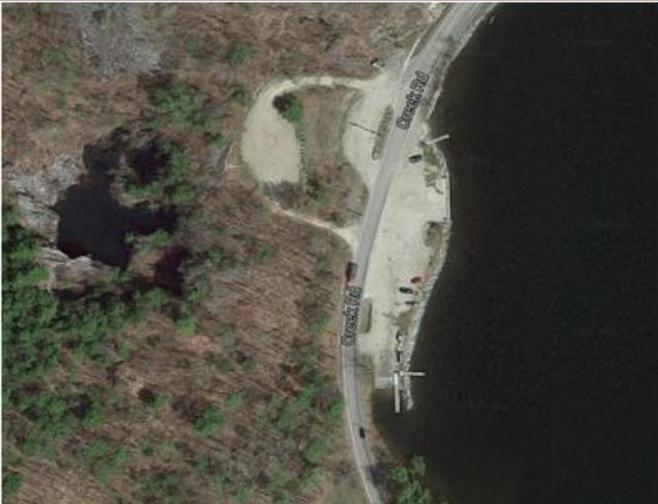
LAKE BOMOSEEN #29		PROBLEM AREA SUMMARY
Site ID: Map29	Design: Yes

Site Description: Green Dump fishing access has 2 locations where stormwater drains to low points and treatment of runoff could be enhanced with an engineered infiltration area. Highly visible public location. Gravel parking area approx 0.5ac draining directly to lake.

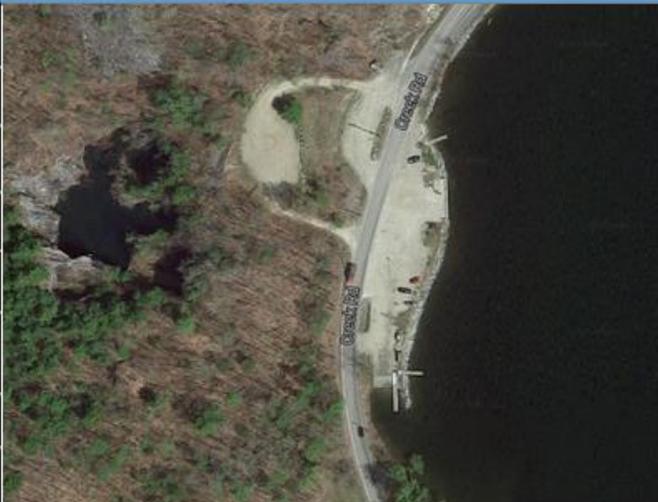
LAKE BOMOSEEN #31		PROBLEM AREA SUMMARY
Site ID: Map31	Design: Yes

Site Description: Public beach known as Green Dump. Consider planting plan for shade and stormwater improvements.

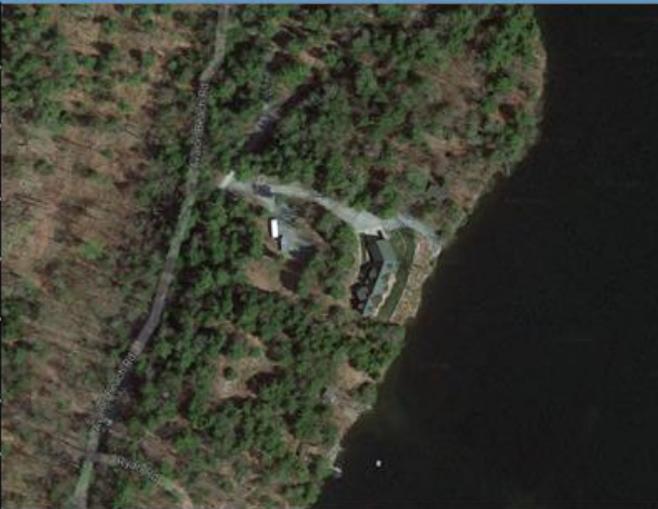
LAKE BOMOSEEN #34 **PROBLEM AREA SUMMARY**

Site Description: Large, new house on Avalon Beach Road with steep gravel driveway and boat launch down to the lake. Houses and gravel surfaces cover 0.4 acre; Portions of gravel driveway leading down to lake have >15% slope and rilling erosion was noted in field.

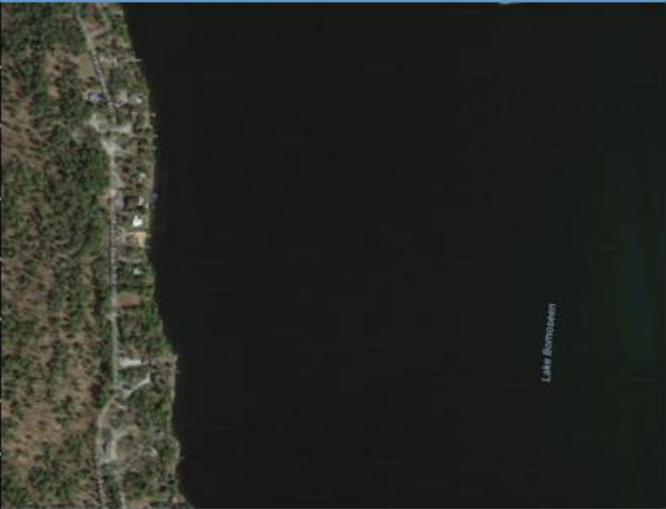
LAKE BOMOSEEN #34/36 **PROBLEM AREA SUMMARY**

35	Driveway Runoff & Erosion	Avalon Beach Road has several steep driveways down to lake; Some driveways are gravel and some paved. Several new mound systems noted in field on west side of road.	Moderate	Moderate	N/A	Moderate	Houses and gravel surfaces >0.5ac; Portions of gravel driveways leading down to lake >15% and rilling erosion noted in field. HSG D indicates increased runoff potential upslope.
40	Driveway Runoff & Erosion	Short gravel driveway and patios (no buffer) draining to lake off Indian Point Road; Potential neighborhood opportunity for rooftop disconnects, shoreline buffer plantings, etc.	Low	Low	N/A	Low	Houses and gravel surfaces approx 0.25ac; Slopes generally <5%. HSG A indicates limited runoff potential and potential for infiltration treatment practices.

Site Description: Avalon Beach Road has several steep driveways down to lake; Some driveways are gravel and some paved. Several new mound systems noted in field on west side of road. Avalon neighborhood stormwater project - rooftop disconnects, driveway erosion, septic systems. Houses and gravel surfaces cover 0.4 acre; Portions of gravel driveway leading down to lake have >15% slope and rilling erosion was noted in field.

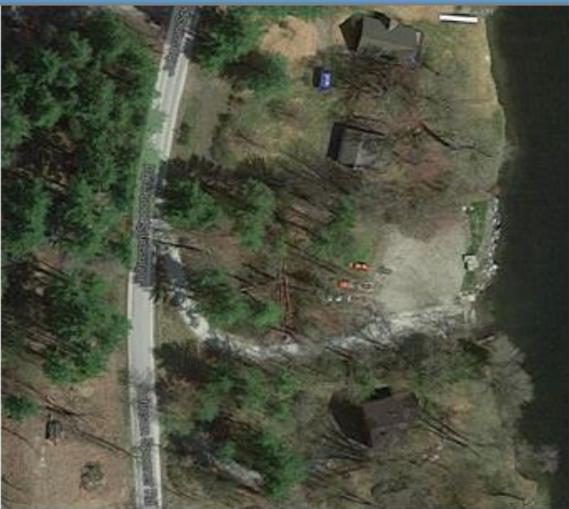
LAKE BOMOSEEN #38		PROBLEM AREA SUMMARY	
Site ID: Map38	Design: Yes

Site Description: Runoff from a steep fishing access off of Johnson Spooner Rd is entering the lake. There is some space in the parking area (west / north near the lakeshore to implement at potential BMP along west/north side of parking lot. Space is tight. Approximately 0.25acre impervious surfaces with slopes >10% on access road.

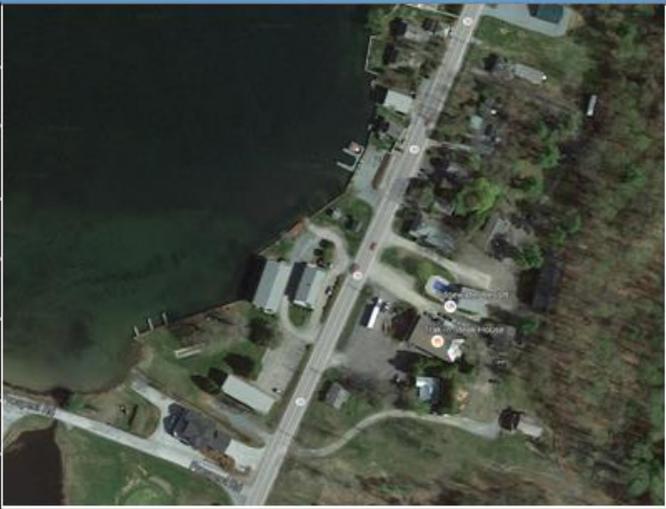
LAKE BOMOSEEN #41		PROBLEM AREA SUMMARY
Site ID: Map41	Design: Yes

41	Stormwater BMP	Edgewater Resort on Route 30. Many stormwater retrofit opportunities including rooftop disconnects, small infiltration/detention basins, and ditch improvements	High	High	High	High	Approx 2.5ac of impervious surface with many areas having slopes 5-10%. HSG C and D indicate increased runoff potential upslope.
2	Stream Channel/ Bank Erosion	Intermittent stream along Pencil Mill Road with potential channel erosion noted in GIS.	Low	Low	N/A	Low	70 acre (0.1 sqmi) drainage area upstream is mostly forested. May be worth checking erosion along Pencil Mill Road ditch but upstream drainage not worthy of treatment.

Site Description: Edgewater Resort on Route 30. Many stormwater retrofit opportunities including rooftop disconnects, small infiltration/detention basins, and re-routing of stormwater down to network along Rt 30. Approx 2.5ac of impervious surface with many areas having slopes 5-10%.

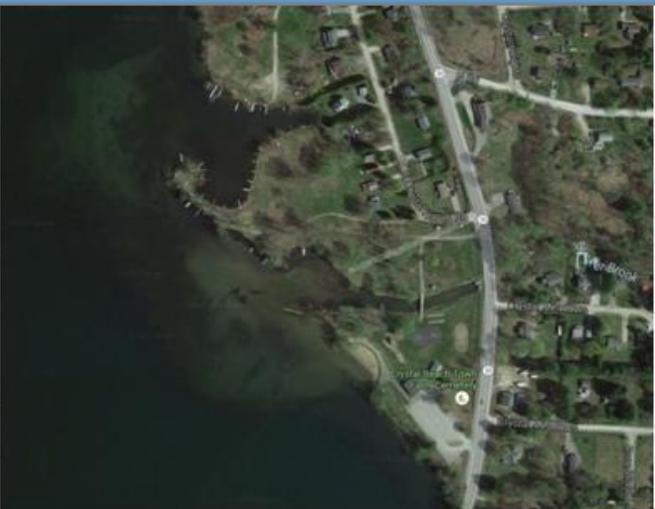
LAKE BOMOSEEN #44		PROBLEM AREA SUMMARY
Site ID: Map44	Design: Yes

Date Observed	8/18/16	
Location	Edgewater Resort on Route 30	
Waterbody	Lake Bomoseen	
SGA Reach	N/A	
Latitude	43.66165N	
Longitude	73.18856W	
Land Ownership	Private	
Site Ranking	High

Site Description: Multiple areas of bank erosion on Sucker Brook in between Route 30 and North Road. Some areas are moderate sources of sediment to channel and lack buffer. Approximately 300 ft of bank erosion with height 4-5ft upstream of Route 30. Channel is moderately incised and is actively widening in areas where post-irene sediment deposits are large.

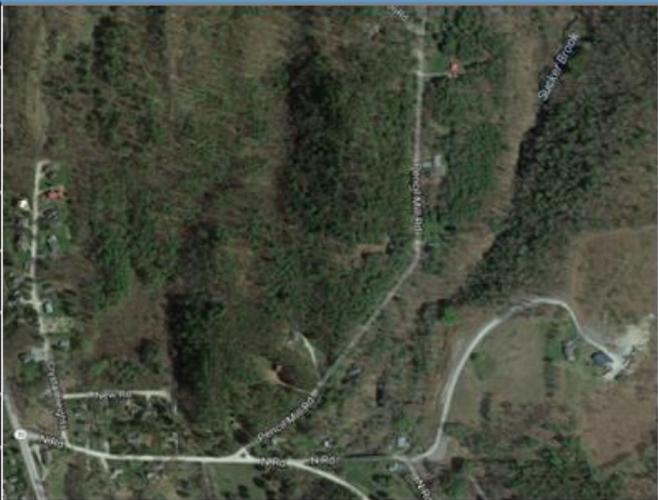
LAKE BOMOSEEN #46		PROBLEM AREA SUMMARY
Site ID: Map46	Design: Yes

Date Observed	8/18/16	
Location	Sucker Brook	
Waterbody	Sucker Brook	
SGA Reach	T02.05-s1.02-s1.01	
Latitude	43.66358N	
Longitude	73.18297W	
Land Ownership	Private	
Site Ranking	High

Site Description: Multiple areas of bank erosion and mass wasting on valley side slopes on Sucker Brook upstream of Stables Road. Some slopes are major sources of coarse and fine sediment. Abandoned slate quarry. Approximately 300 ft of bank erosion and mass failures with height 6-12ft upstream of Stables Road crossing. Site is an abandoned slate quarry and sediment is mobilized downstream in moderate/large floods.

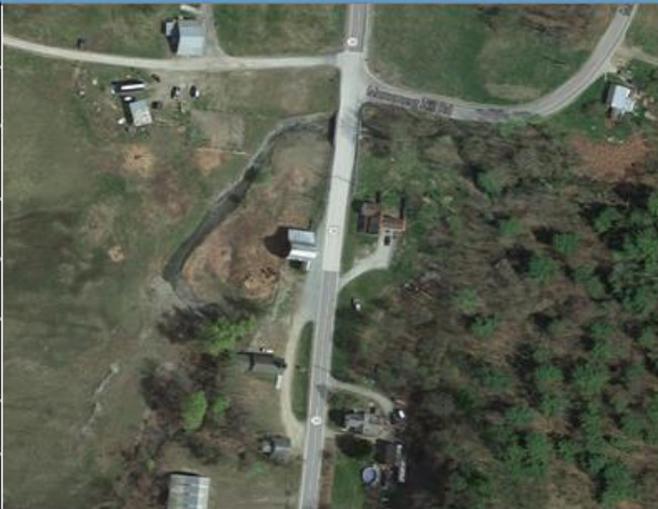
LAKE BOMOSEEN #48		PROBLEM AREA SUMMARY
Site ID: Map48	Design: No

Date Observed	Prior and 8/18/16	
Location	Giddings Brook horse pasture	
Waterbody	Lake Bomoseen	
SGA Reach	N/A	
Latitude	43.70698N	
Longitude	73.18492W	
Land Ownership	Private	
Site Ranking	High

Site Description: Fencing and buffer needed along horse pasture on Giddings Brook, southwest of the intersection with Monument Hill Road and Route 30 in Hubbardton.
