TOWN OF GEORGIA

STORMWATER MANAGEMENT PLAN

FINAL REPORT

Stone Project ID 112475-W
February 20, 2013

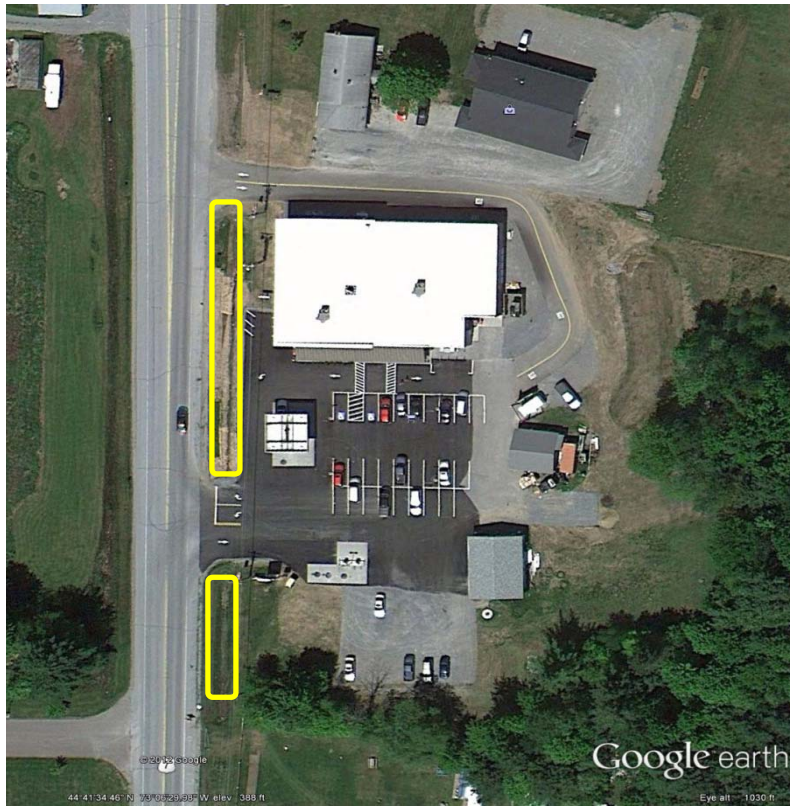
Figure 1. Treatment opportunities along U.S. Route 7 near the Georgia Market Property.

Multiple treatment opportunities exist along U.S. Route 7. The roadside ditches along this stretch of road are rather deep. Existing catch basins and driveway culverts could be retrofitted with flow-control devices; the roadside ditches, given their depth, could provide significant storage of stormwater. Further gains could be achieved by enhancing infiltration capabilities in these areas. Potentially suitable locations for retention and infiltration practices along Route 7 are shown below in Figures 1, 2 and 3.

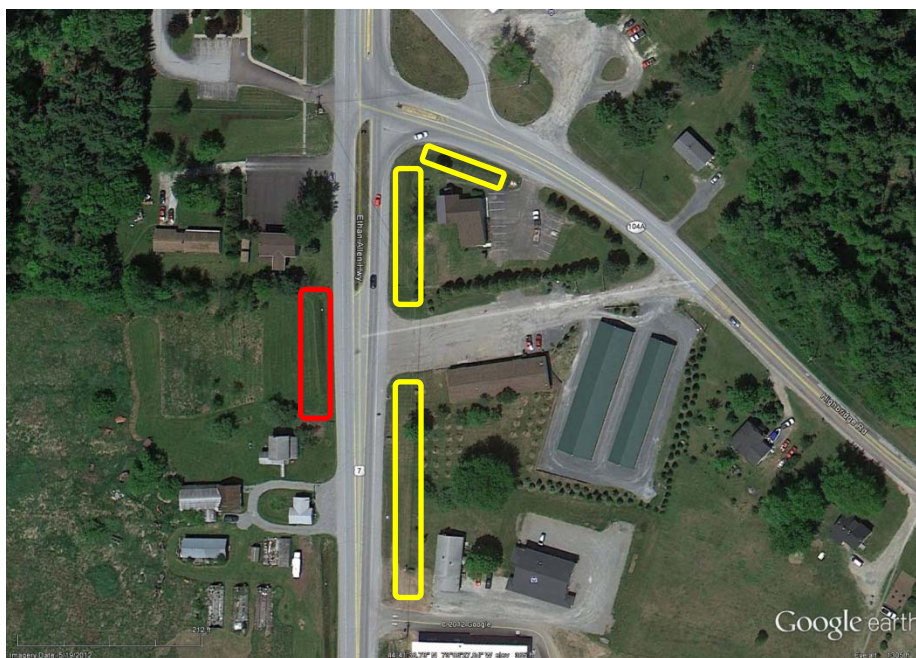
Figure 2. Potential stormwater treatment areas along U.S. Route 7 and VT Route 104A north of the Georgia Market property.

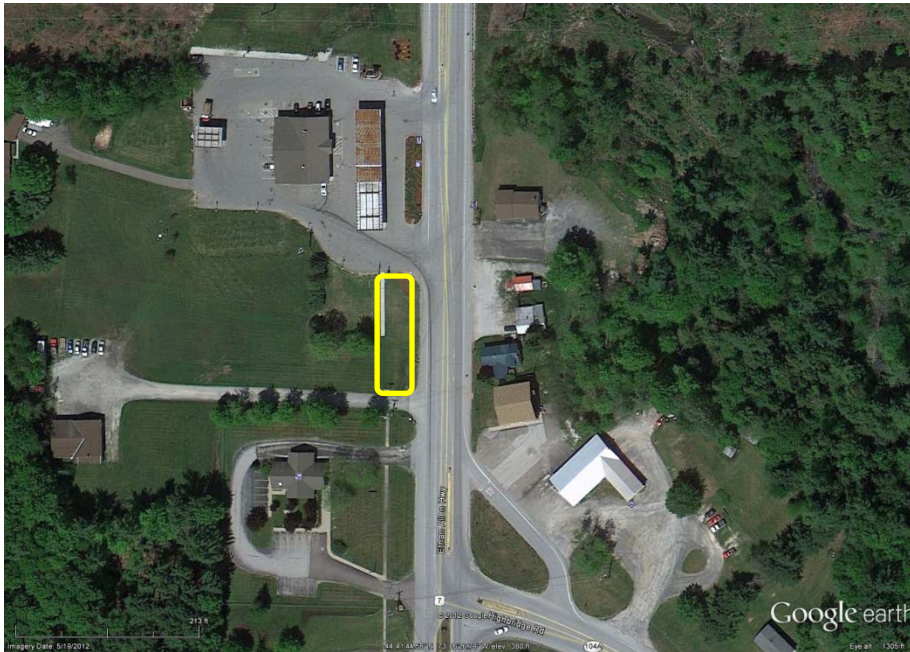
Figure 3. Potential location for stormwater treatment along the west side of Route 7, north of VT Route 104A, between the People's Trust Bank and the Mobil gas station.

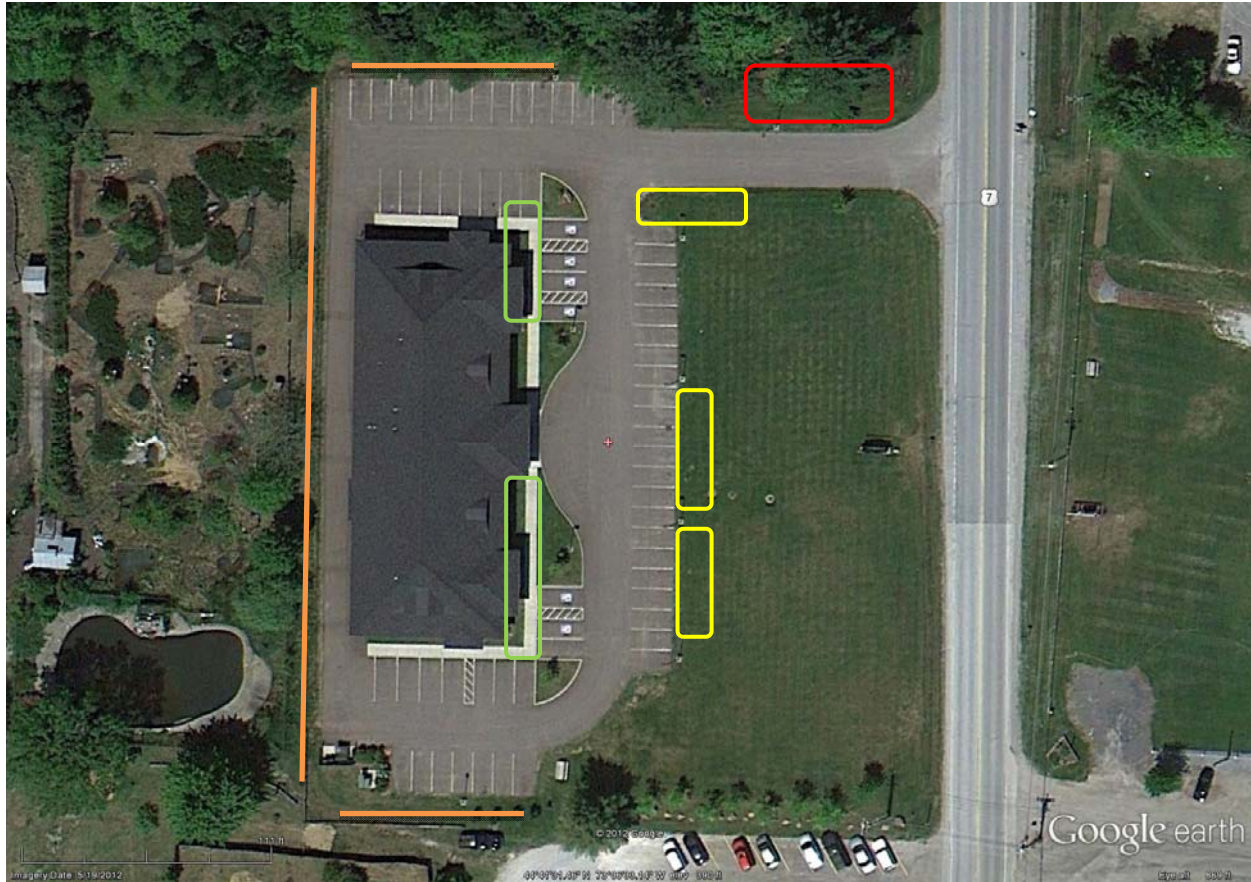
USDA-NRCS Soil Surveys report Deerfield loamy, fine sand. Treatment potential for this property is quite high, given the well-drained soils, space for treatment practices, and existing infrastructure suitable for retrofitting. As highlighted in Figure 4, below:

Figure 4. Potential treatment opportunities at the Georgia Eye Center / Northwest Occupational Health Building.

- Roof runoff could be treated by redirecting the existing downspouts to route stormwater through rain gardens or similar soak-away practices (shown in green on Figure 4).
- Runoff from the parking lot could be treated with bioretention basins designed to encourage infiltration (shown in yellow on Figure 4).
- The grass swale which flows clockwise from the southern end of the parking lot to the roadside ditch at the northeast corner of the property could be retrofitted with concrete weirs or check dams, and flow control apparatus to enhance infiltration (shown in orange on Figure 4).
- An additional or alternative stormwater treatment option would be to create a bioretention/infiltration basin or similar structure at the north end of the property between the

existing stormwater outfall and the existing roadside ditch along the west side of Route 7 (shown in red on Figure 4).

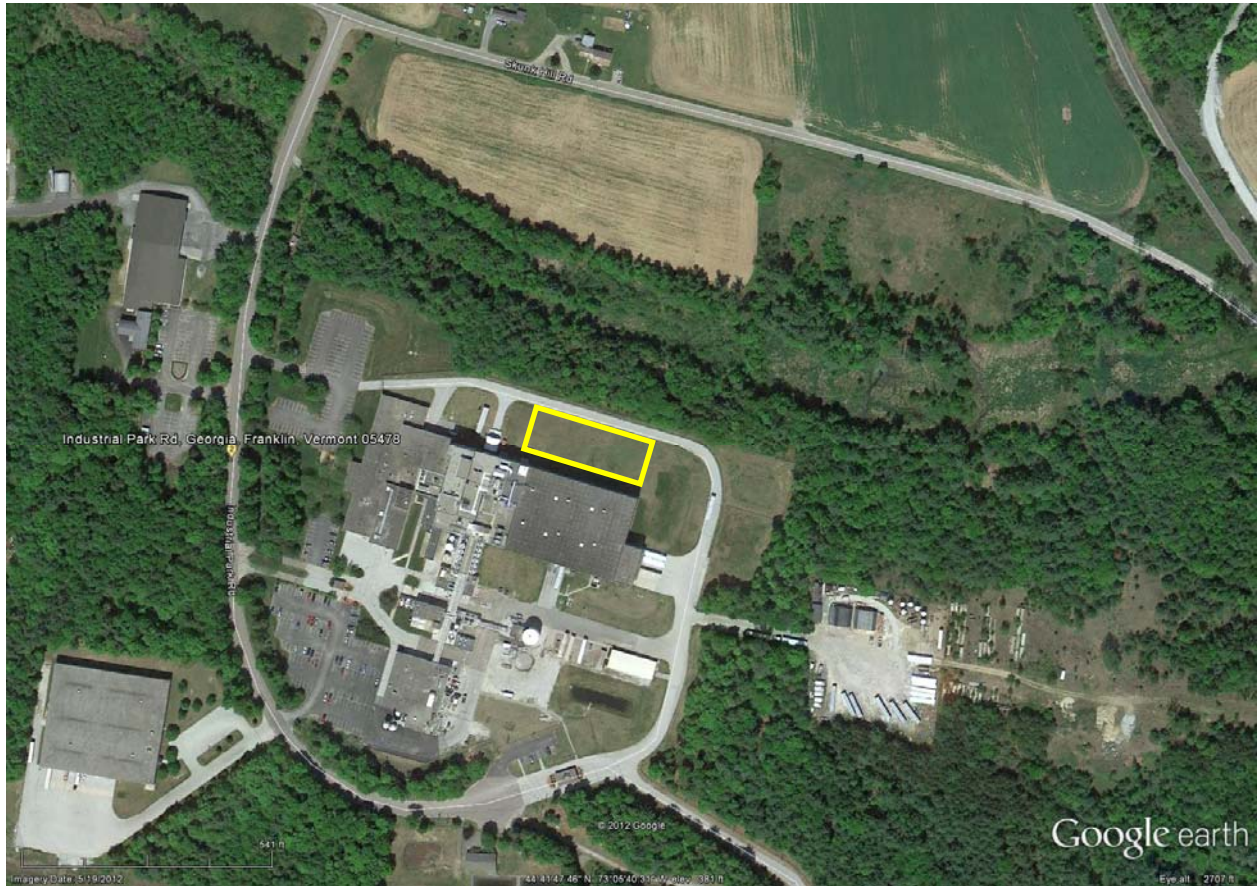
The Georgia Industrial Park contains a large amount of impervious area. This property is served by permitted stormwater treatment facilities that include dry wells and dry ponds. Soils at the Industrial Park are dominated by sands (hydrologic soil group A), so any stored runoff is likely to quickly infiltrate. Although it would be relatively straightforward to retrofit these facilities, it is unclear whether they routinely discharge or if any stored water simply infiltrates. Before proceeding with retrofits, the facility should be monitored to evaluate the frequency of discharge following storm events, with particular attention given to the detention pond highlighted in Figure 8. There are several low cost/low-tech means for evaluating whether an overflow event occurs, including placing small wood blocks in the outfall that would be washed away during an overflow event. If evidence of significant discharge is found, opportunities can then be assessed to improve treatment by modifying the existing facility, or by slowing or infiltrating stormwater closer to the source.

Figure 8. Georgia Industrial Park off Skunk Hill Rd. Detention area is highlighted in yellow.

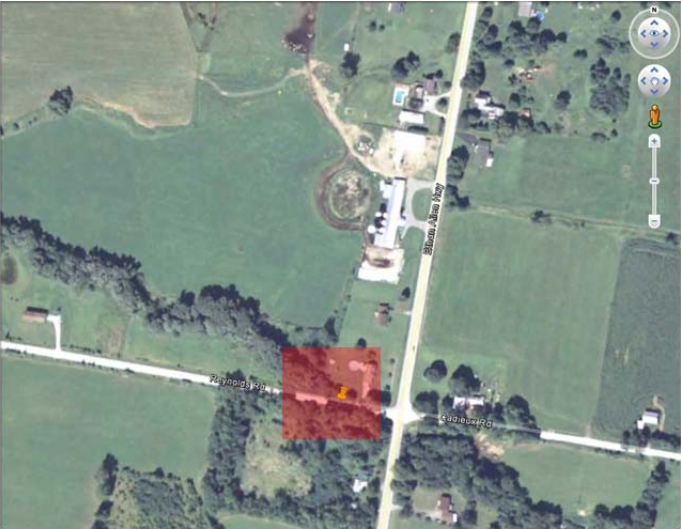
Watershed:	Mill River													
Location:	Reynolds Rd., just east of intersection with Route 7													
Problem Type:	Drainage/Culvert													
Identification Source:	Fluvial Erosion Hazard Mapping and Phase 2 SGA Report													
Ownership:	Local													
Classification Level:	2b													
Problem Description:														
Stormwater pipe inputs along Mill River from road crossings and agriculture field drainage ditches causing incision and stream departure.

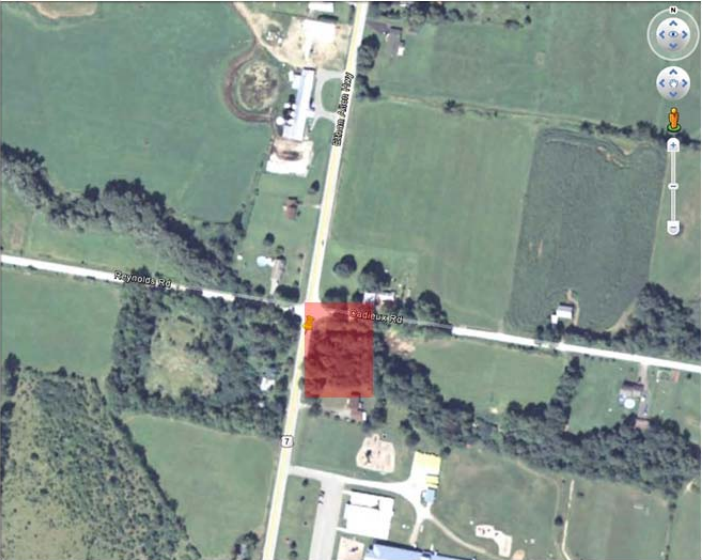
Watershed:	Mill River													
Location:	Cadieux Rd., just east of intersection with Route 7													
Problem Type:	Altered Geomorphology													
Identification Source:	Fluvial Erosion Hazard Mapping and Phase 2 SGA Report													
Ownership:	Local													
Classification Level:	1 – geomorphology 3 – road runoff													
Problem Description:														
<p>Gullies have formed along the roadside and are contributing sediment to Mill River. Significant erosion is occurring within this reach of the Mill River, attributed to historic channel straightening and increased flows associated with road runoff.</p>

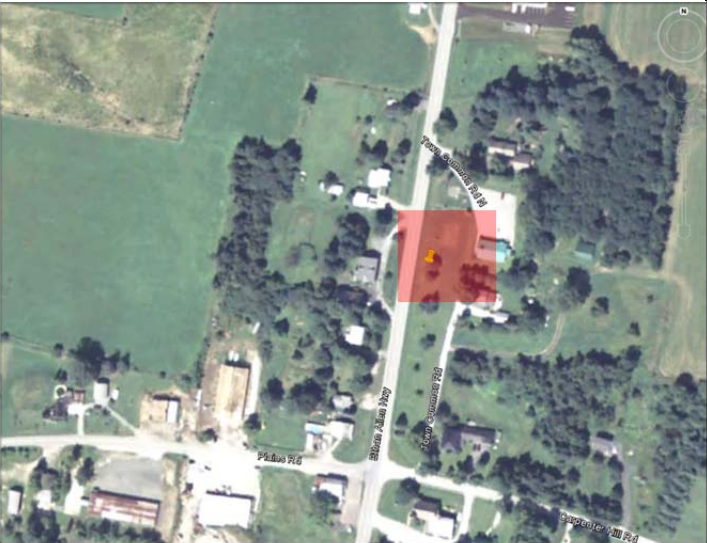
Watershed:	Mill River													
Location:	Route 7, north of the intersection with Plains and Carpenter Hill Rds													
Problem Type:	Local Drainage													
Identification Source:	Fluvial Erosion Hazard Mapping and Phase 2 SGA Report													
Ownership:	Local/State													
Classification Level:	3													
Problem Description:														
Stormwater pipe inputs along Mill River from road crossings and agricultural field drainage ditches causing incision and stream departure.

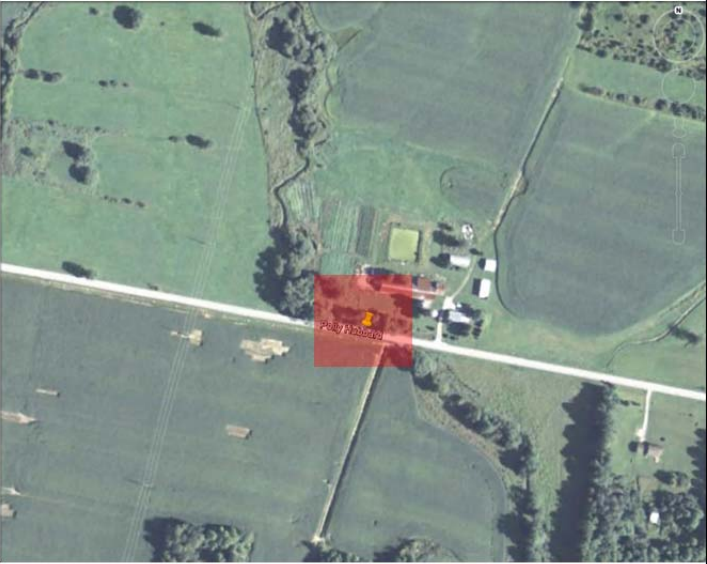
Watershed:	Mill River													
Location:	Polly Hubbard Rd., about ½ mile east of Georgia Middle Rd													
Problem Type:	Altered Geomorphology													
Identification Source:	Fluvial Erosion Hazard Mapping and Phase 2 SGA Report													
Ownership:	Private													
Classification Level:	1 – road alignment 3 – riparian buffer													
Problem Description:														
<p>Much of the original woody riparian vegetation has been removed as a result of agricultural activities, residential development, and road infrastructure – leading to significant erosion in and along the stream channel.</p>

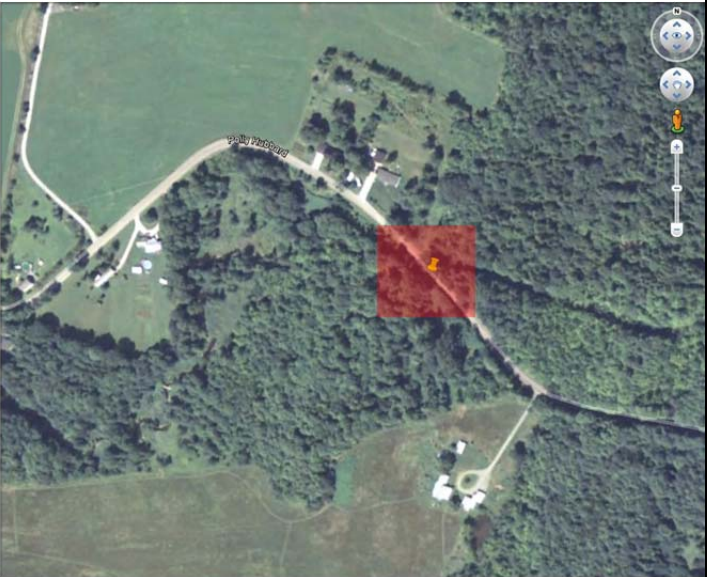
Watershed:	Mill River													
Location:	Polly Hubbard Rd., about ½ mile west of the intersection with Route 7													
Problem Type:	Altered Geomorphology													
Identification Source:	Fluvial Erosion Hazard Mapping and Phase 2 SGA Report													
Ownership:	Private/Local													
Classification Level:	1 – geomorphology 3 – road runoff													
Problem Description:														
Significant erosion and mass failure in mainstem in reaches.

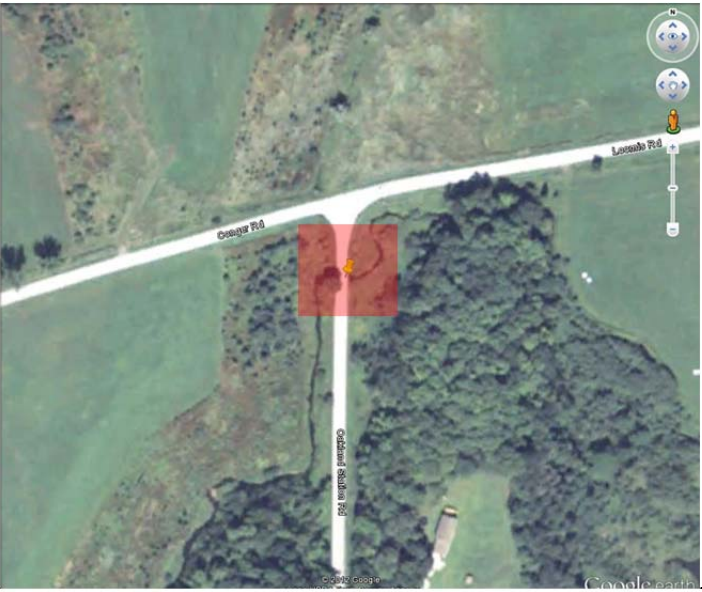
Significant streambank erosion is occurring at the Oakland Station Road- Mill River crossing. Mill River crosses under Oakland Station Road via a concrete box culvert just south of Conger and Loomis Roads. Unmanaged road runoff is causing erosion behind the southeast wingwall (Figure 6), and past stabilization attempts appear to be failing. Erosion from this source could be minimized with improved management of road runoff coupled with bank stabilization that includes properly sized riprap keyed-in below the scour depth of the stream bed.

The outlet of the box culvert drops steeply to a scour pool. This appears to be a barrier to aquatic organism passage. If this blockage is truly blocking the passage of fish and other aquatic organisms, retrofit options should be considered to improve the connectivity of the stream by lessening or removing the drop between the box culvert and the scour pool below. A tail-water control structure, such as a rock weir at the end of the scour pool, can raise the pool surface to create better passage conditions.

This structure appears to be in serviceable condition. However, when this box culvert reaches the end of its service life, it should be replaced with a structure that meets current State of Vermont design standards. This will help ensure sediment transport equilibrium, reduce erosion hazards, and maximize the ecological integrity of this road-stream crossing.

Watershed:	Mill River													
Location:	Oakland Station Rd., near intersection with Conger Rd													
Problem Type:	Altered Geomorphology													
Identification Source:	Fluvial Erosion Hazard Mapping and Phase 2 SGA Report													
Ownership:	Local													
Classification Level:	1 – geomorphology 3 – road runoff													
Problem Description:														
Erosion and mass failure on embankment of box culvert carrying Mill River under Oakland Station Rd.

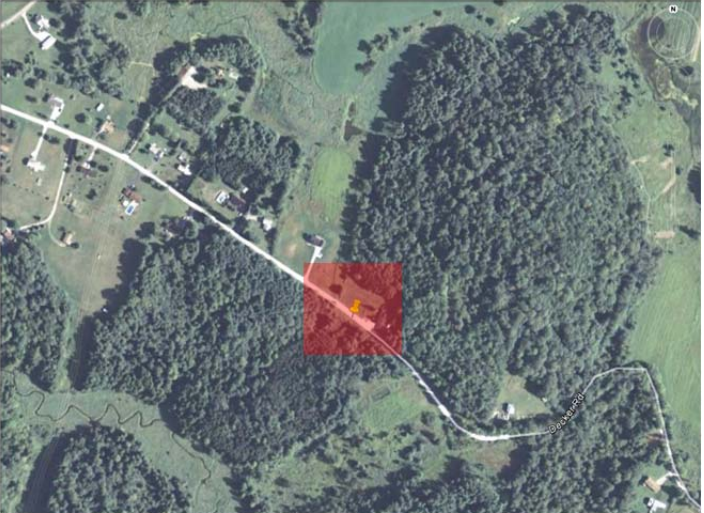
Watershed:	Stonebridge Brook													
Location:	Decker Rd., about 1000' west of intersection with Sodom Rd													
Problem Type:	Local Drainage/Erosion													
Identification Source:	field visit													
Ownership:	unknown													
Classification Level:	3													
Problem Description:														
Significant quantities of fill being placed along the southside of Decker Rd.

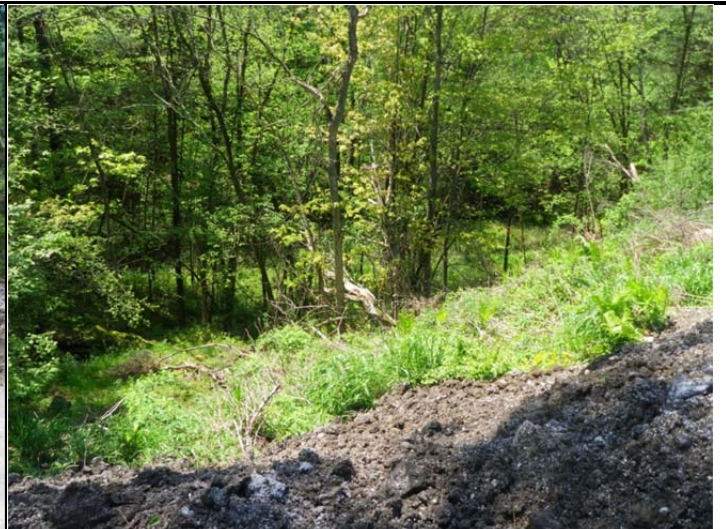
Photo 2. Natural area below placed fill

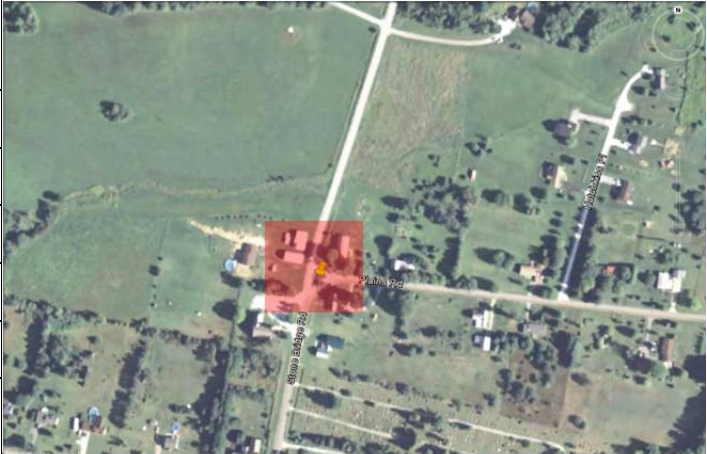
Watershed:	Mill River													
Location:	"Y" @ Plains/Middle Rd													
Problem Type:	Local Drainage													
Identification Source:	Town Feedback													
Ownership:	Local													
Classification Level:	3													
Problem Description:														
Culvert occasionally plugs at "Y" intersection.

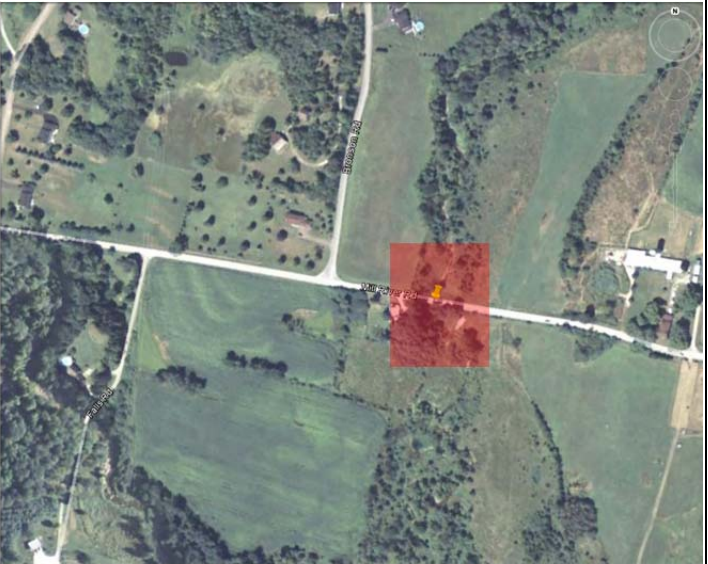
Watershed:	Rugg Brook													
Road Name:	Mill River Rd., east of the intersection with Bronson Rd													
Problem Type:	Altered Geomorphology													
Identification Source:	Fluvial Erosion Hazard Mapping and Phase 2 SGA Report													
Ownership:	Private/Local													
Classification Level:	1 – geomorphology 3 – road runoff													
Problem Description:														
Erosion and mass failure on embankment of box culvert carrying Rugg Brook under Mill River Rd.

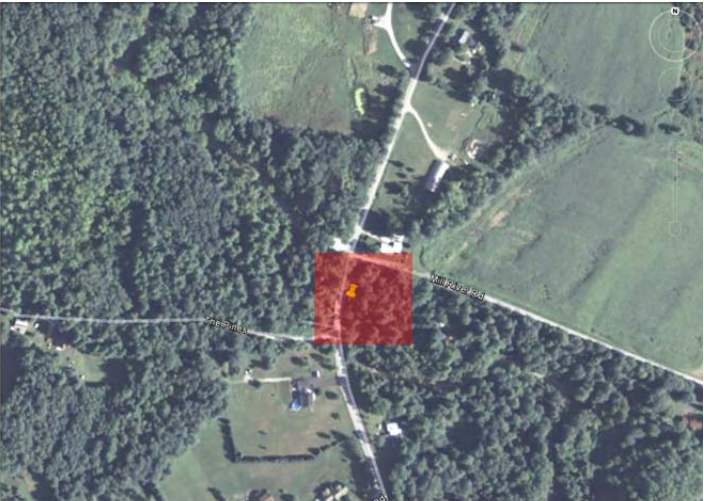
Watershed:	Mill River													
Location:	Georgia Shore Rd., south of intersection with Mill River Rd													
Problem Type:	Culvert/Bridge													
Identification Source:	Town Feedback													
Ownership:	Local													
Classification Level:	1													
Problem Description: On-going streambank failure(s) creating concern for the long-term stability of the bridge crossing Mill River on Georgia Shore Road.

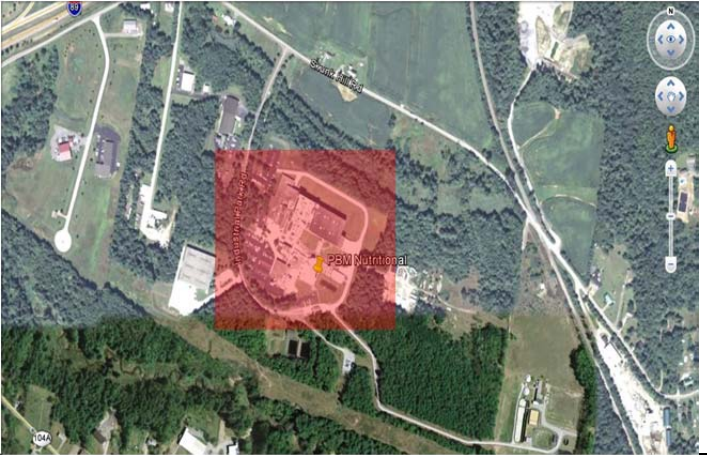
Problem Description: Ponds that were designed and installed prior to 2002 are used to treat stormwater runoff.

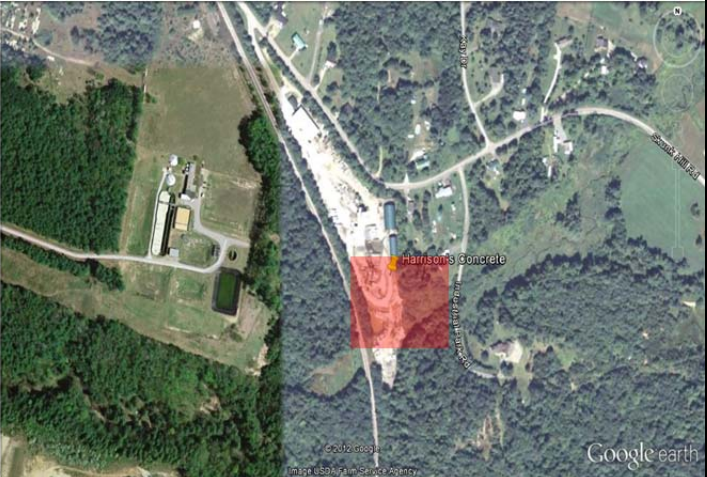
Watershed:	Deer Brook													
Road Name:	Skunk Hill Rd., southeast of the railroad crossing													
Problem Type:	Local Drainage													
Identification Source:	DEC SW Mapping													
Ownership:	Private													
Classification Level:	3													
Problem Description:

This facility is currently operating under an individual stormwater discharge permit as well as Vermont's Multi-Sector General Permit (MSGP) for Stormwater Discharges; its ultimate outfall sends stormwater over a steep embankment to Deer Brook.

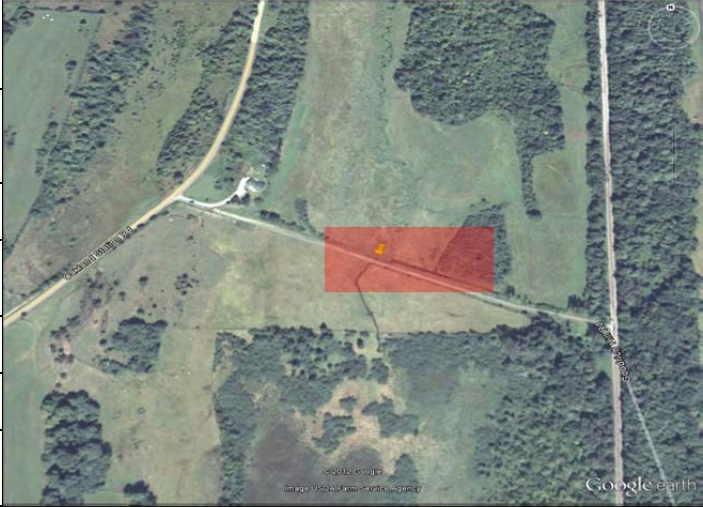
Road Name: TH45 Goodrich Hill Rd, east of Oakland Station Rd		
Problem Type: Culvert/Bridge		
Identification Source: Bridge and Culvert Inventory Data		
Ownership: Local		
Classification Level: 1		
Problem Description:		
Culvert on TH45 poorly aligned with stream approach at a sharp bend.

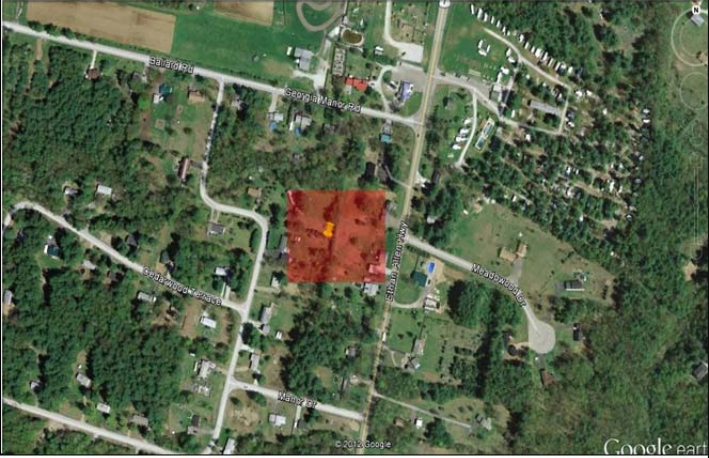
Watershed:	Stone Bridge Brook													
Location:	Manor Dr/Cedarwood Tr													
Problem Type:	Local Drainage													
Identification Source:	Town Feedback													
Ownership:	Local													
Classification Level:	3													
Problem Description:														
Localized flooding on Manor Drive, Cedarwood Terrace and Rt. 7.

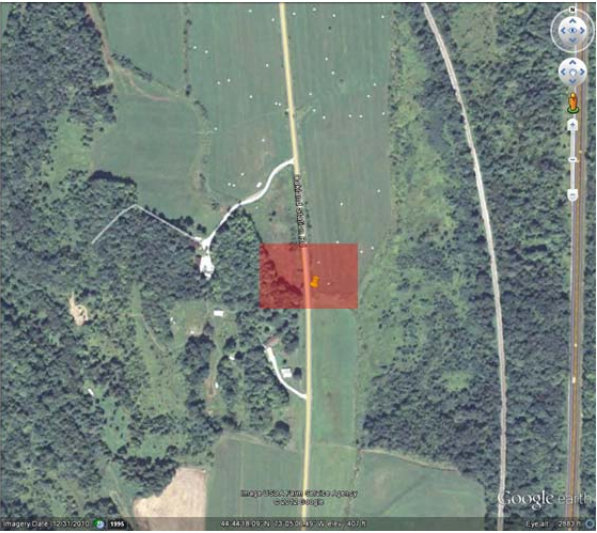
Watershed:	Deer Brook													
Location:	Oakland Station Rd., 1500' south of the intersection with Cary Rd													
Problem Type:	Local Drainage/Culvert													
Identification Source:	Bridge and Culvert Inventory Data													
Ownership:	Local													
Classification Level:	1													
Problem Description:														
Culvert on Oakland Station Road poorly aligned and located.

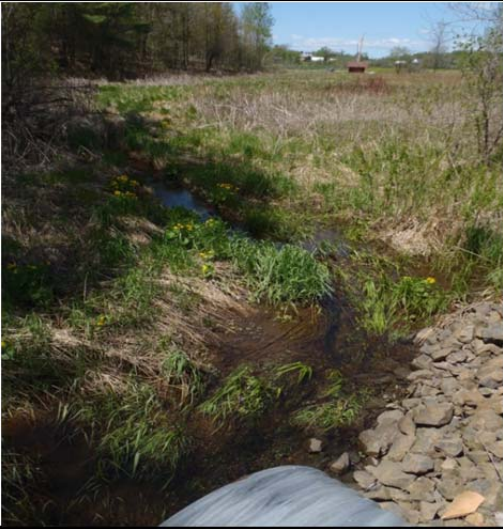
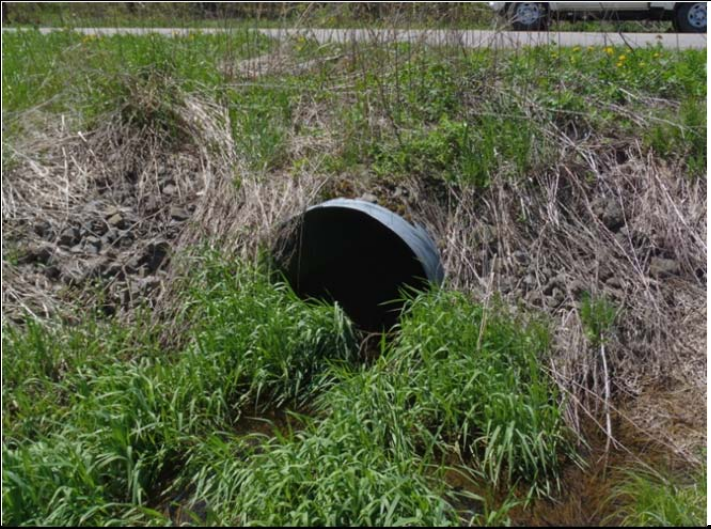
Photo 1. Looking upstream, "L" forms @ culvert	Photo 2. Outfall

Description of Observed Conditions:
Relatively new 48" corrugated metal culvert, outlet partially obstructed. Culvert appears to be poorly aligned for stream; may have been installed in a manner to accommodate drainage ditch carrying in flow from the south.

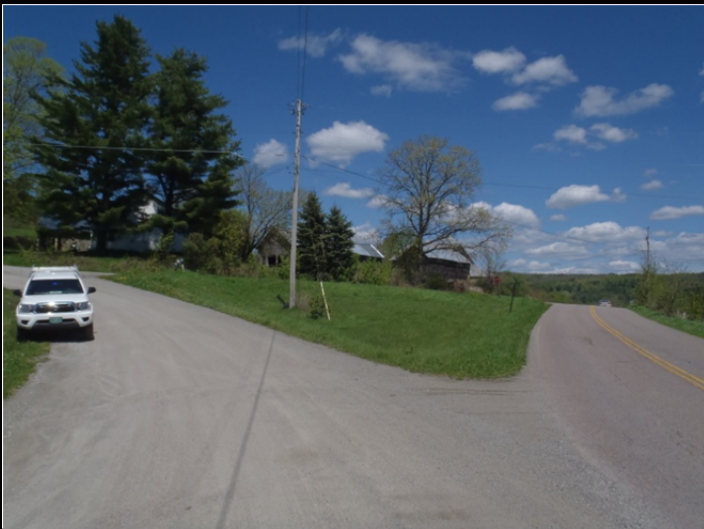
Photo 1. Y intersection

Culvert from south corner of the "Y" across Carpenter Hill Road is partially obstructed; standing water in triangle. Some apparent erosion along the west shoulder of the north-south connector between Carpenter Hill and Oakland Station; drainage ditch is directly connected to the unnamed tributary to Deer Brook. The 2011 Town Plan recommends improvement to all Y-shaped intersections; improved stormwater management could be readily incorporated into such a project.

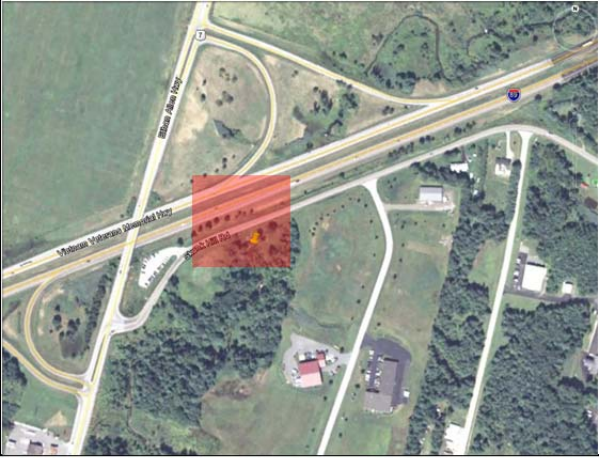
Problem Description: Brook straightened and culverted to pass under I-89.

Description of Observed Conditions: 10.5' metal corrugated culvert; culvert diameter is significantly less than the width of the stream immediately downstream. Culvert invert is at least 6" above stream bottom. Scour is occurring downstream of culvert, likely due to increased stream velocities exiting culvert.

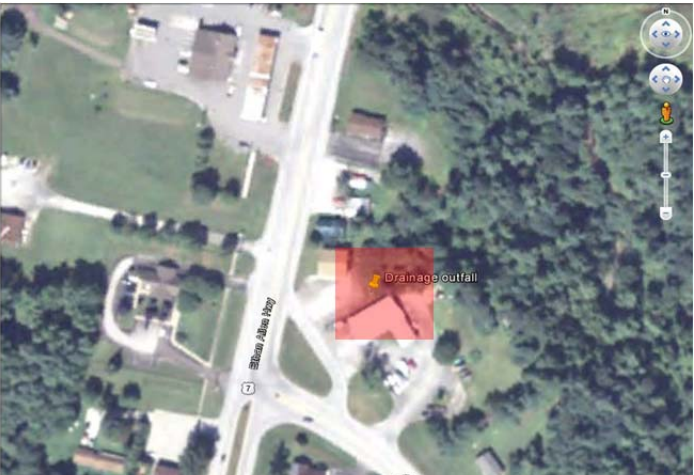
Watershed:	Deer Brook													
Location:	Rt. 7/Rt.104A													
Problem Type:	Local Drainage													
Identification Source:	DEC Deer Brook Gully Remediation Study													
Ownership:	Private, State													
Classification Level:	4													
Problem Description:														
Stormwater runoff has created a large gully leading down to Deer Brook. The head of the gully is located near the intersection of Rt. 7 and Rt. 104A.

Erosion visible along Route 7 (Photo 2) and along bank down to stream. Signs of sediment loading and iron staining. Flow in the gully is primarily fed by stormwater. Corrugated 18" plastic culvert crossing Rt. 7, drains ditch from west side of road (Photo 1). DEC has developed a comprehensive list of alternatives to remediate the gully. DEC's efforts were focused on addressing the head cuts and slumping in the gully itself and reducing sediment loading to the Deer Brook and secondarily on the implementation of practices upstream of the gully, within its watershed, that would help in reducing stormwater quantity. See DB 14 for more information on "upland" options.

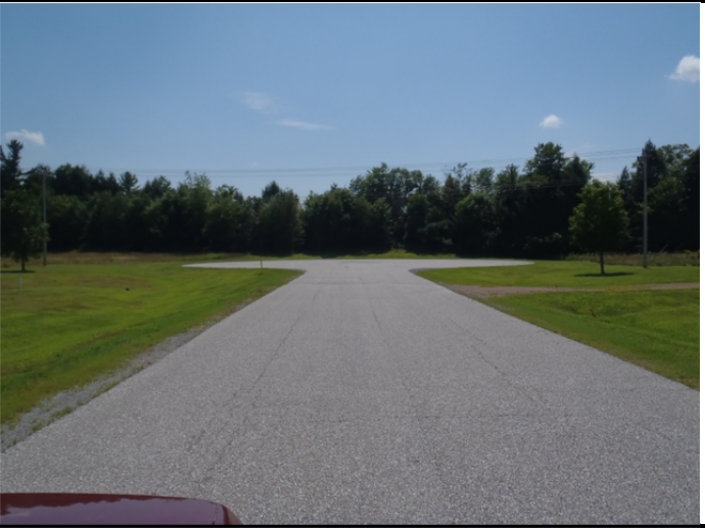
Watershed:	Mill River													
Location:	Plains Rd, near intersection with Route 7													
Problem Type:	Future Opportunities													
Identification Source:	Town Plan													
Ownership:	Local													
Classification Level:	2b													
Problem Description:														
A handful of oversized parking areas were identified during problem area field surveys.

Photo 1. Parking lot at vehicle storage facility	Photo 2. Unused cul-de-sac in industrial park

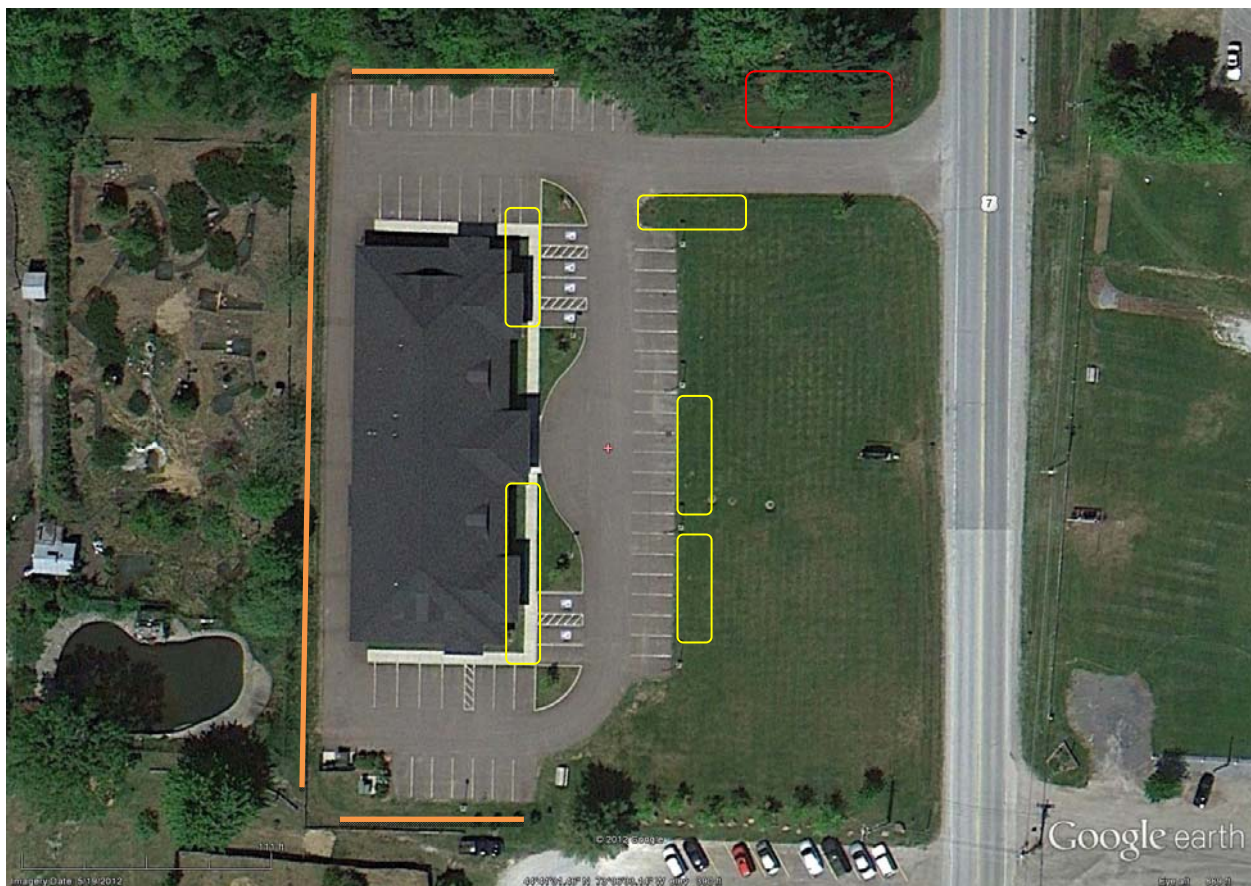
Figure 1. Potential treatment opportunities at the Georgia Eye Center/ Northwest Occupational Health Building. Rain-Garden and bioretention opportunities highlighted in yellow and open channel opportunities highlighted in orange.

The building housing the *Georgia Eye Center* and *Northwestern Occupational Health* includes approximately one acre of impervious area, which is nearly 50% of the parcel. Impervious surfaces include the building roof, sidewalk, and asphalt parking area. The roof is drained by gutters with downspouts connected to the stormwater drain. The parking lot is drained by two catch basins – one within the asphalt footprint and one

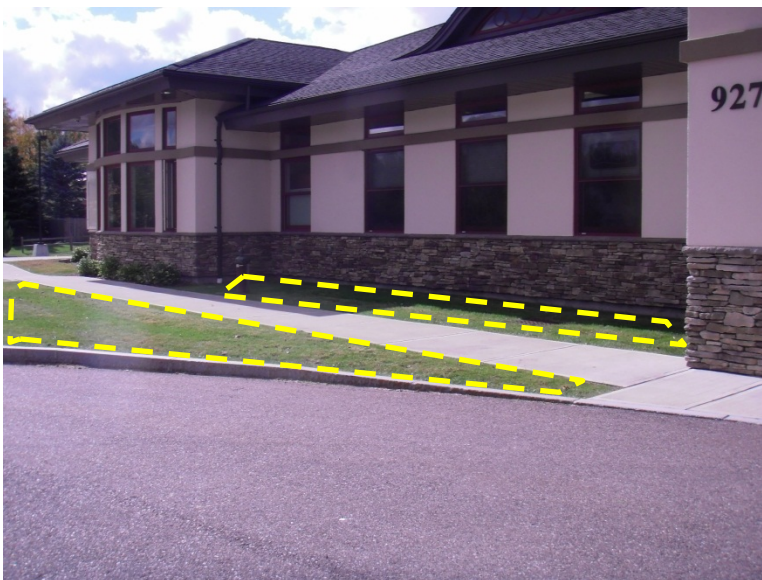
Figure 2. Example of area where roof runoff could be routed to a rain garden.

Roof runoff could be treated by redirecting the existing downspouts to route stormwater through rain gardens or similar soak-away practices. Overflow drains could be connected to existing stormwater drain at the location of the downspouts. The result would be a relatively simple, low risk retrofit that would increase infiltration, and reduce stormwater discharge emanating from the roof top.

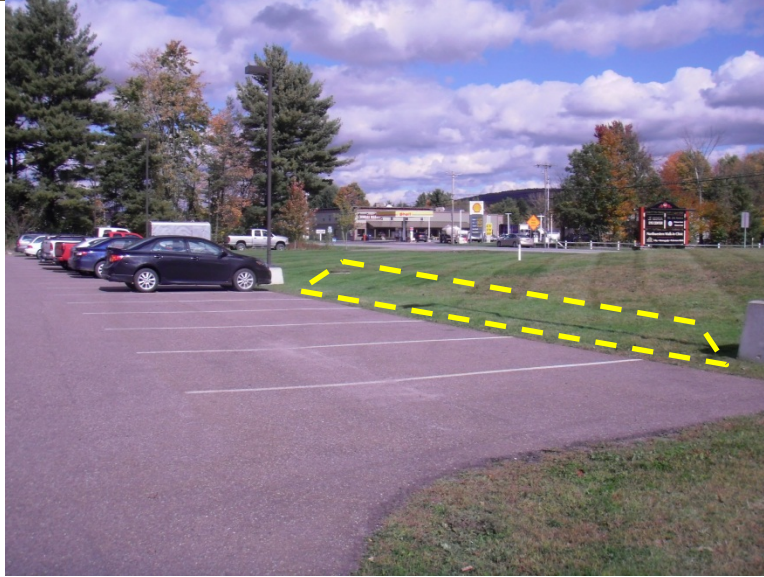
Figure 3. Catch basin is located beneath red pickup truck in the photo. Stormwater from half of parking lot could be routed to lawn area shown right half of photo.

Runoff from the parking lot could be treated with bioretention basins designed to encourage infiltration. The southern half of the front parking area drains east, toward the front lawn and north towards to basin near the middle of the lot. Stormwater south of the catch basin could be intercepted and routed to a bioretention area designed to maximize infiltration. Drainage exceeding the capacity of the treatment practice would backup into the existing catch basin at reduced rate compared to present conditions.

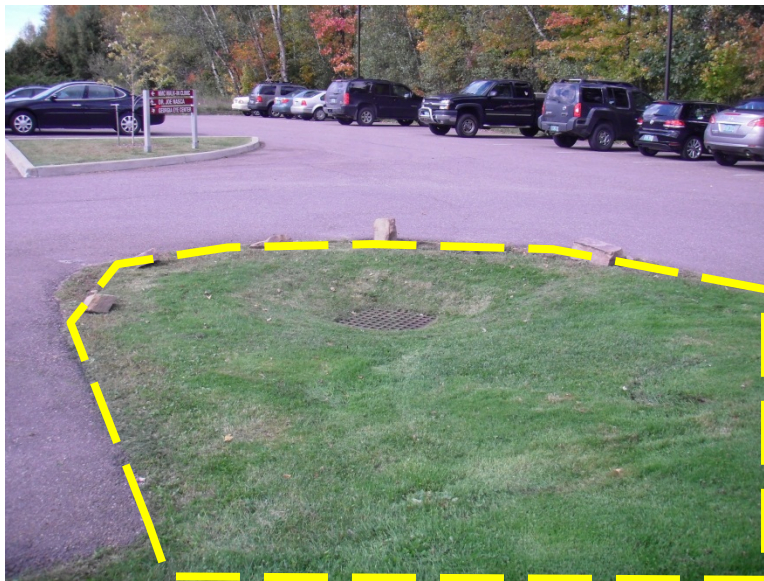
Figure 4. Existing catch basin that could be retrofitted and integrated into a stormwater treatment practice.

Similarly, stormwater runoff from the north half of the parking lot and access drive drains to a catch basin located in a grassed median near the access drive. A bioretention area designed to maximize infiltration could be constructed here. The existing catch basin could be being retrofitted with a flow control device while remaining to serve as the overflow outlet for the treatment.

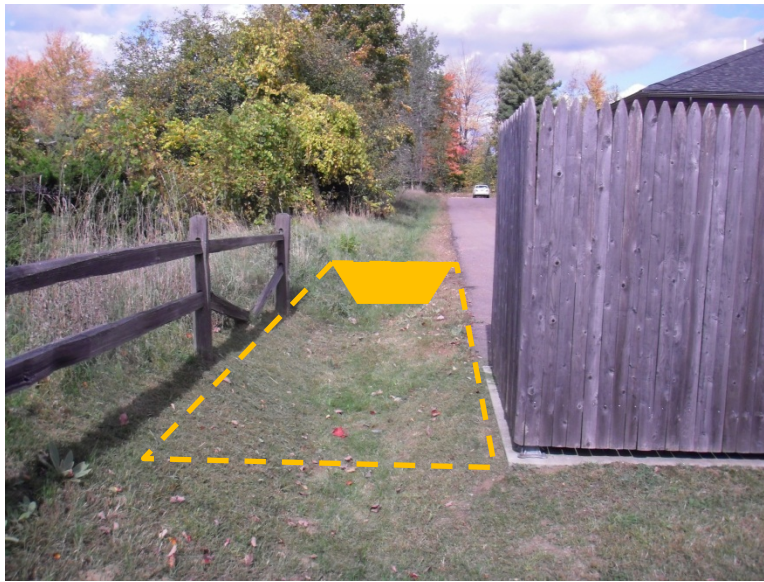
Figure 5. Existing grass swale could be modified to encourage infiltration.

The remaining paved area which surrounds the building drains to a grass swale which flows clockwise from the southern end of the parking lot to the roadside ditch at the northeast corner of the property. With simple modifications such as concrete weirs or check dams, and flow control apparatus, this swale could be retrofitted to enhance infiltration.

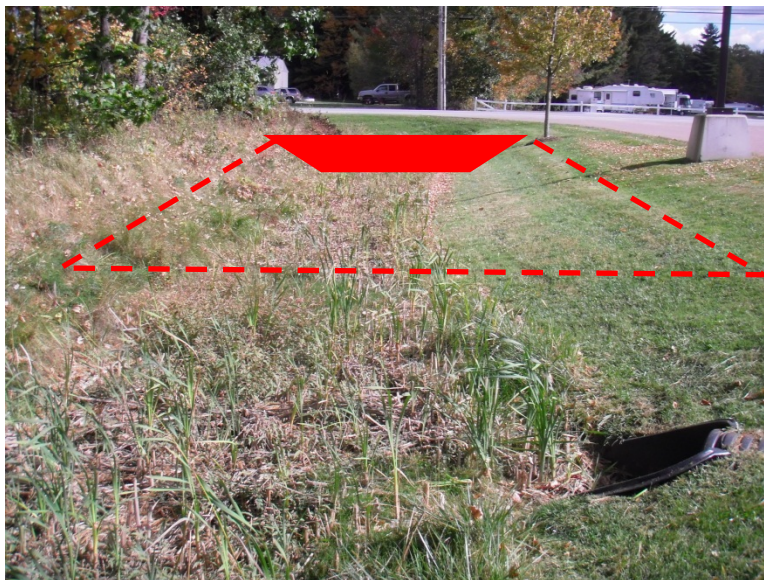
Figure 6. A bioretention basin could be located between the existing stormwater outfall and road side ditch.

An additional or alternative stormwater treatment option would be to create a bioretention/infiltration basin or similar structure at the north end of the property between the existing stormwater outfall and the existing roadside ditch along the west side of US Route 7.

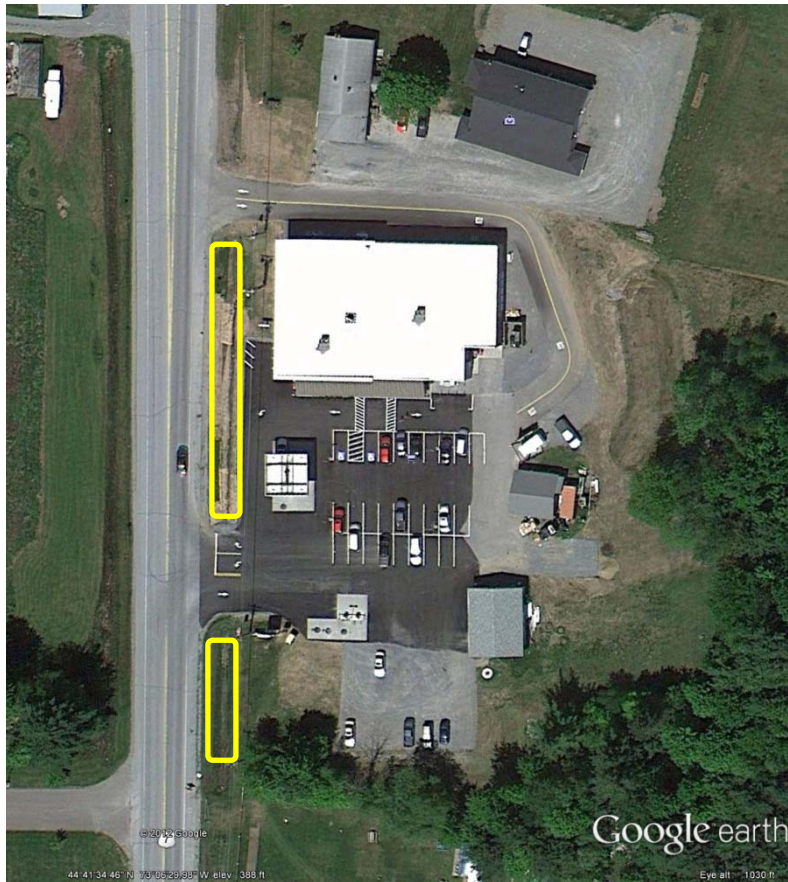
Figure 7. Treatment opportunities along U.S. Route 7 near the Georgia Market Property.

The southern-most location denoted in Figure 7 receives stormwater via ditch conveyance from Rt. 7 as far south as Ballard Rd. This includes the Georgia Eye Center/Northwest Occupational Health Property. The next site to the north then includes approximately 0.25 acres of the 1 acre Georgia Market impervious area. The stormwater from the remaining 0.75 acres is treated via a recently installed vegetated swale at the back of the property.

could be achieved by enhancing infiltration capabilities in these areas. Potentially suitable locations for retention and infiltration practices along Route 7 are provided in Figure 7.

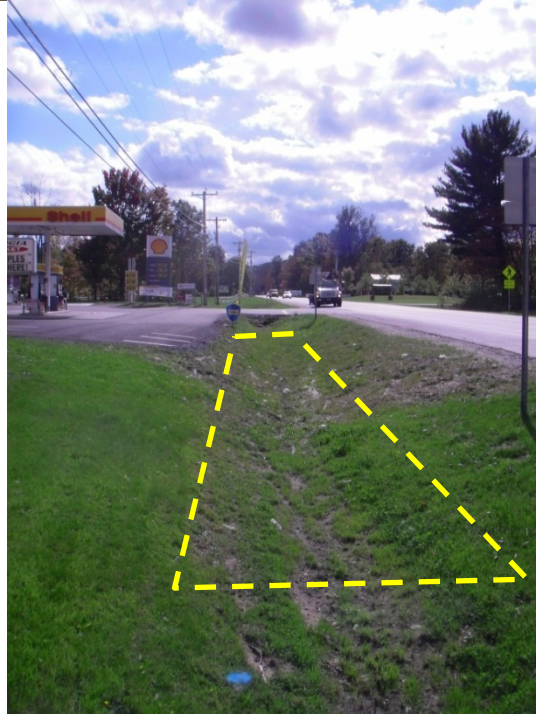
Figure 8. Looking south along the east side of Route 7 in front of the Georgia Market.

Location of the proposed flow control device is behind the photographer.

Directly in front of the market the wide, deep roadside ditch could be used for storage and infiltration by installing a simple flow-control device on the existing culvert under the drive that accesses the back of the Georgia Market property. This could serve to treat all upstream stormwater. Figure 8 shows a photo with a rough location of the proposed treatment practice.

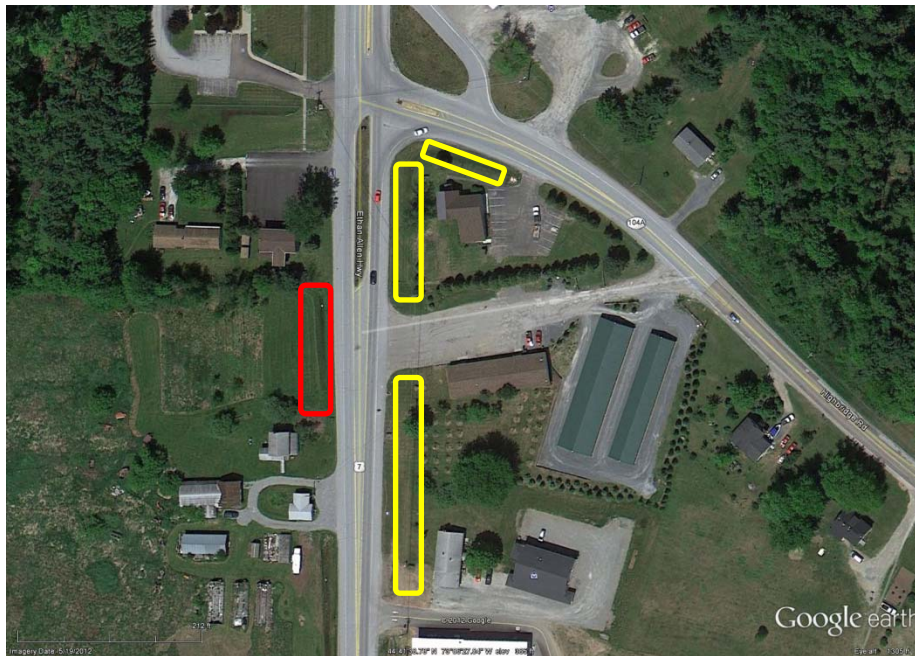
Figure 9. Potential stormwater treatment areas along U.S. Route 7 and VT Route 104A north of the Georgia Market property.

Heading south along the east side of Rt. 7, more opportunities exist for in-ditch treatment of stormwater. Three potential locations for treatment are shown in **Error! Reference source not found.**

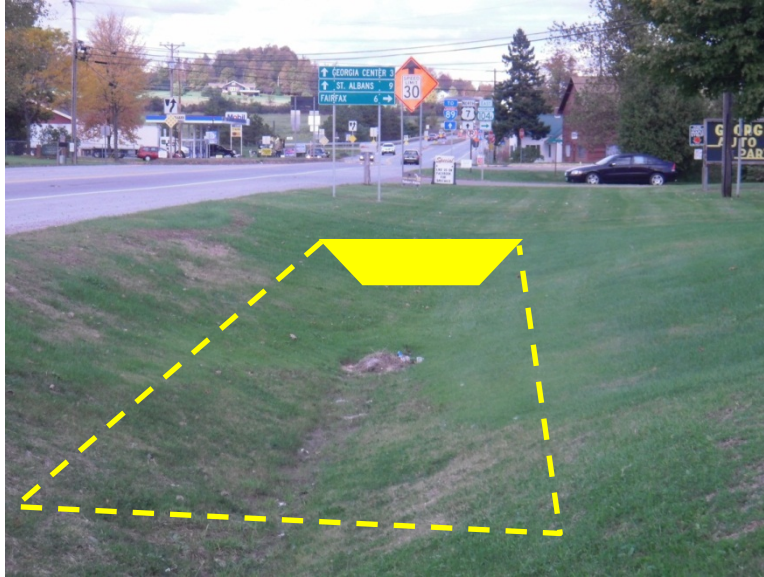
Figure 10. Looking north along Route from the Georgia Market property. The existing stormwater catch basin (center of photo) and ditch could be modified to provide temporary storage and increase infiltration.

The next section of roadside ditch between the, Georgia Market and Georgia Auto Parts properties, is drained by an existing catch basin. Adding a riser with a flow control device to this catch basin, along with a downstream check dam would increase storage potential at this site and decrease flow rates (Figure 10)..
