TOWN OF GEORGIA

STORMWATER MANAGEMENT PLAN

FINAL REPORT

Stone Project ID 112475-W
February 20, 2013

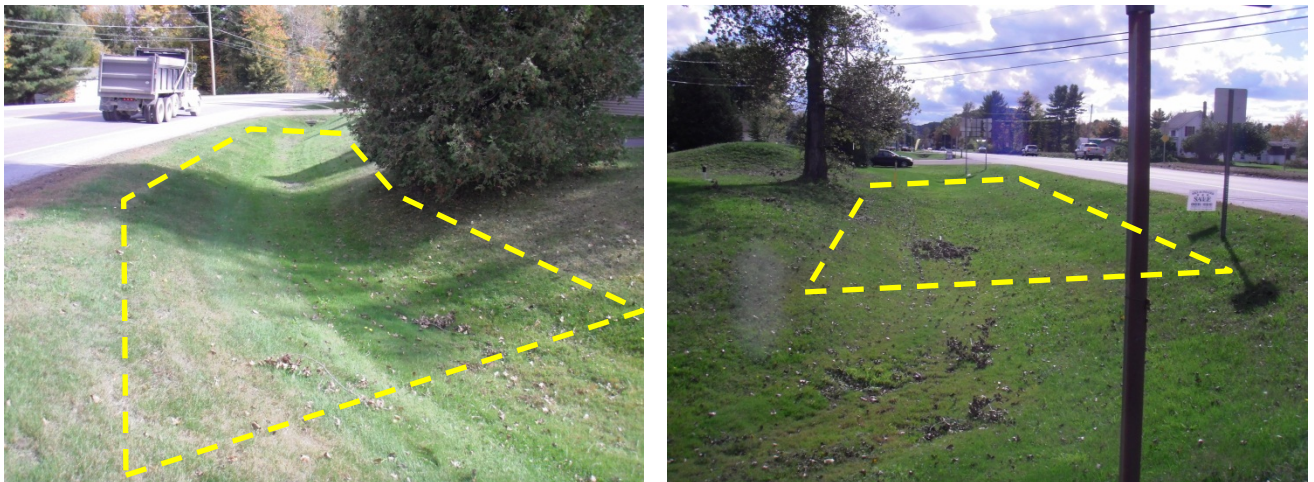
Figure 11. View of roadside ditches looking south. VT Rt. 104A (left) and US Rt. 7 (right).

A similar practice could be implemented near the at the Rt. 7 and VT Rt. 104A intersection; see Figure 11. Adding a riser pipe with a flow-control device to the existing catch basin would increase the storage potential and infiltration in each ditch.

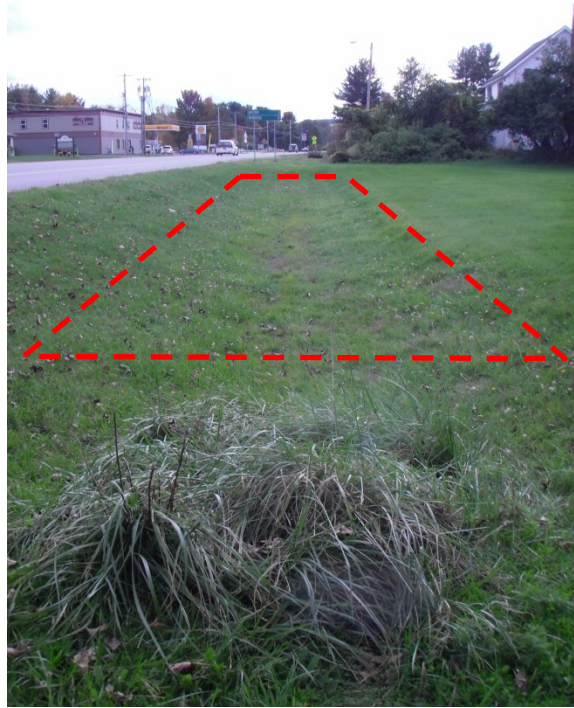
Figure 12. Potential treatment location along west side of Rt. 7, south of KA Hairdesigns.

The existing catch basin (surrounded by tall grass in photo) could be retrofitted with a standpipe and flow control device. The other location is to the north of this is located between the People's Trust Bank and the Mobil gas station. See Figure 13.

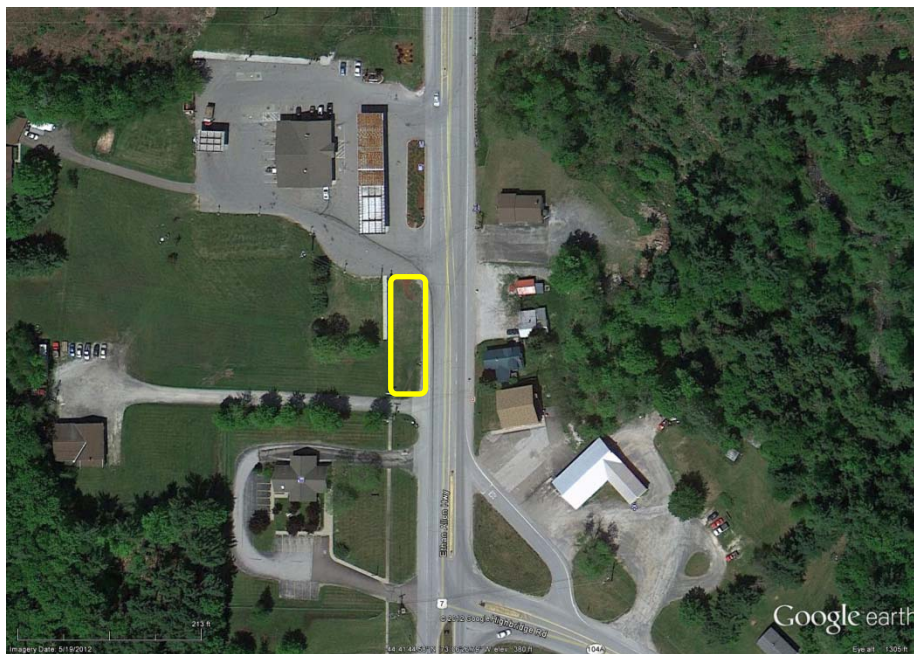
Figure 13. Potential location for stormwater treatment along the west side of Route 7, north of VT Route 104A.

Similar to those previously mentioned, adding a simple, flow-control retrofit such as a weir with a flow control device prior to the driveway culvert would allow stormwater to be temporarily stored and/or infiltrated (Figure 14).

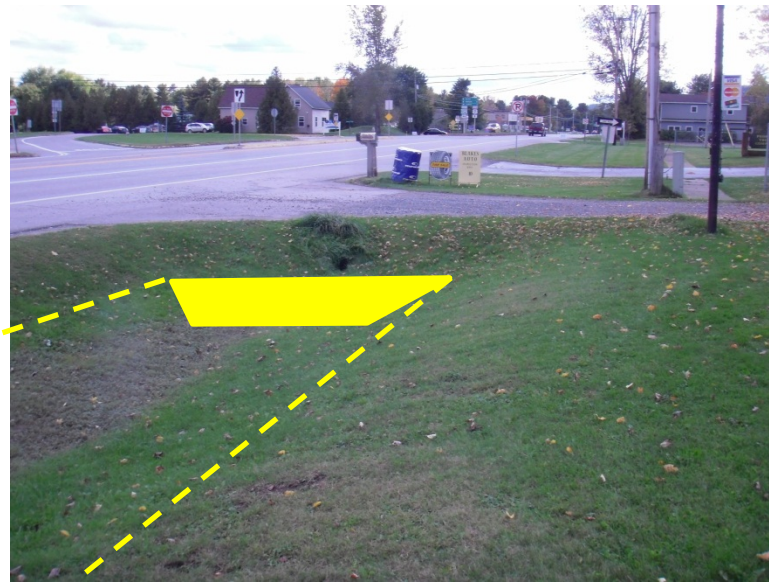
Figure 14. Potential location for stormwater treatment along Rt. 7 south of Mobil Station

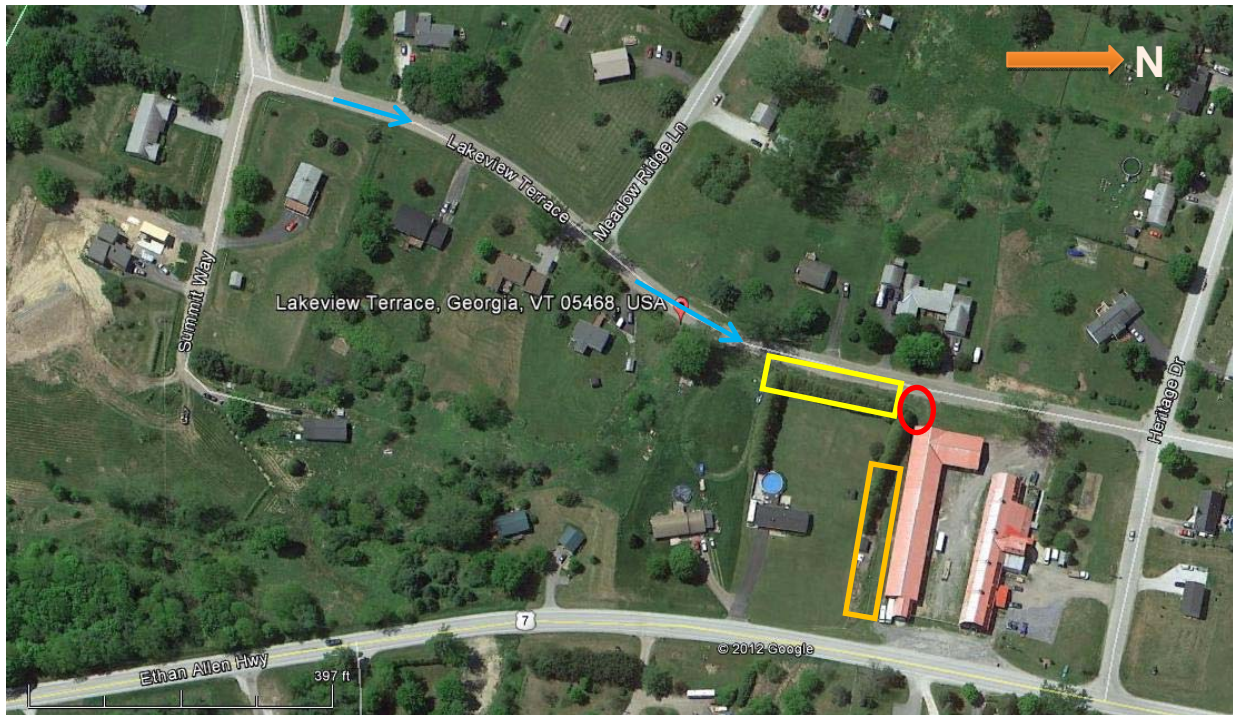
Figure 15. Red Barn property and surrounding neighborhood. Location of existing scour hole shown in red. Potential STP locations shown in yellow and orange.

Stormwater draining down Lakeview Terrace from south to north discharges from the roadside ditch between the Red Barn Storage property and the neighboring property to the west (Figure 15). Where the channel turns west, away from the road, a significant scour hole approximately 7-8 ft wide and 3-4 ft deep has developed (Figure 16). Eroded soil is then conveyed with stormwater along the Red Barn Storage property before crossing under Rt. 7 and flowing to Arrowhead Mountain Lake via a small tributary. Two potential solutions merit consideration.

Repair and reinforcement of the scoured channel of the scoured channel would reduce sediment loads downstream. Installation of a STP such as a bioretention basin, in the existing roadside ditch along the hedge row (upstream of the scour hole) would work to improve water quality and also prevent future degradation (i.e. erosion or scouring) of the channel (see Figure 17Figure 17). Soils in this area are Hydrologic Class B soils—well-drained and suitable for infiltration¹¹. Any practice that is implemented should include features to promote infiltration.

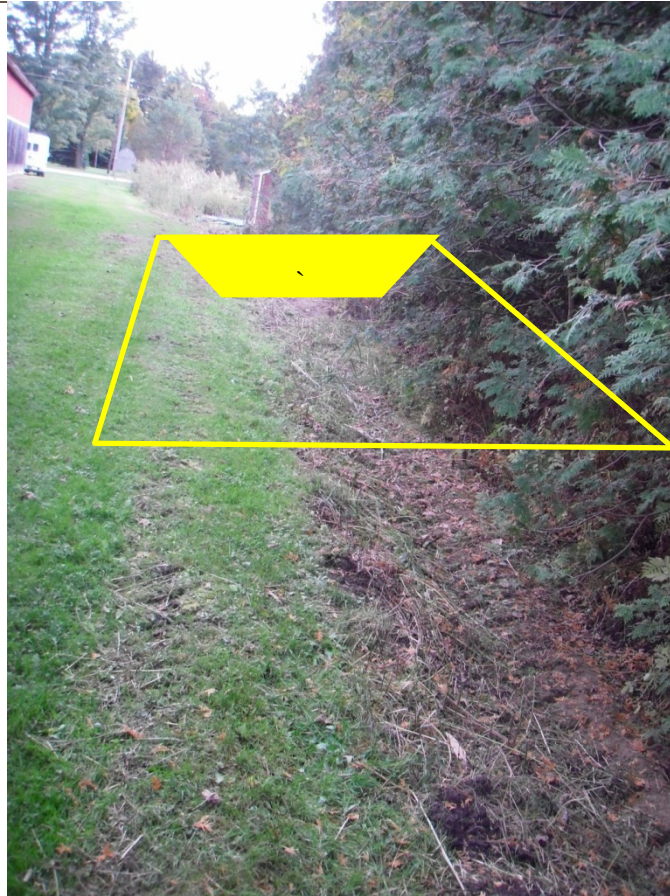
Figure 17. Potential location for stormwater treatment along Lakeview Terrace near the Red Barn Rental Business property.

An alternative or addition to a solution along Lakeview Terrace would be to locate a treatment practice encouraging infiltration along the southern border of the Red Barn Storage property. Locating the treatment practice in this location would increase the available land area and potential for infiltration. Soils here are Hydrologic soil group (HSG) A—very well-drained, with a lower water table. This location would also include the added benefit of capturing the roof runoff from half of the Red Barn Rental structure (approximately 5700 ft²). The drawback of this option is that it is outside the town right-of-way, and would require cooperation from a private landowner.

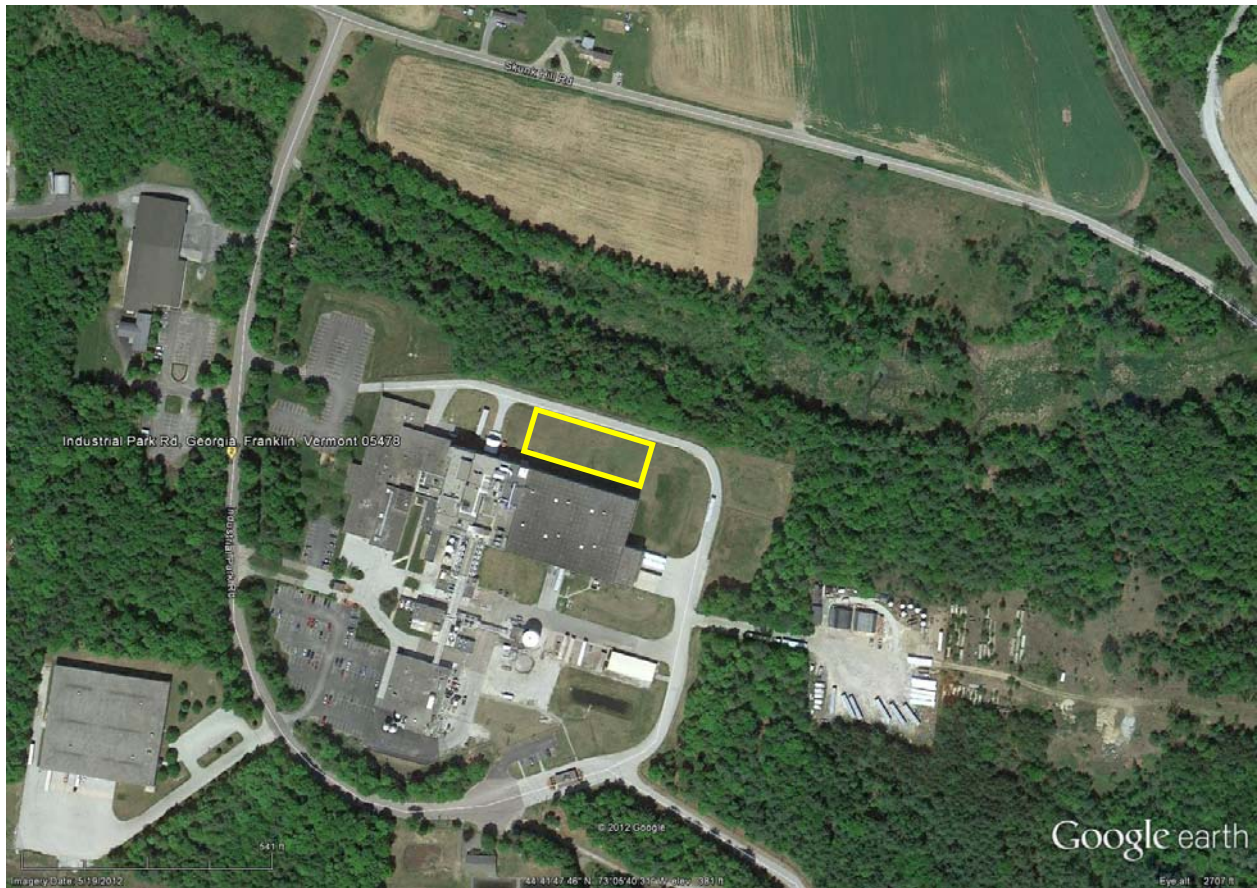
Figure 18. Georgia Industrial Park off of Skunk Hill Rd. Detention area highlighted in yellow.

The Georgia Industrial Park contains a large amount of impervious area. This property is equipped with permitted stormwater treatment facilities, largely in the form of dry wells and dry ponds (Figure 18). Soils are HSG A and therefore stored water is likely to quickly infiltrate. Before considering any potential retrofits to these facilities, we recommend monitoring to determine whether the facilities discharge. Stone suggests that these facilities be monitored for the presence of discharge following storm events with particular attention being paid to the detention pond highlighted in Figure 18. If evidence of significant discharge is found, further investigation can assess if opportunities may exist to improve the treatment by modifying the existing facility, or reducing or slowing stormwater closer to the source.
