STORMWATER MANAGEMENT PLAN FOR HIGHGATE

FINAL REPORT

Stone Project ID 112475-W

March 1, 2013

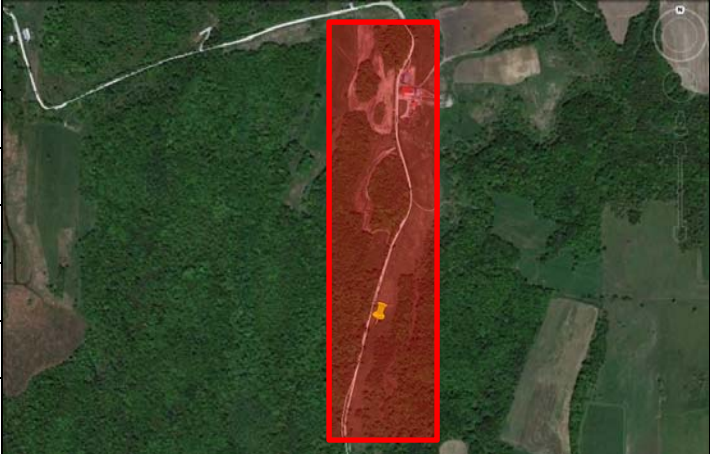
Watershed:	Rock River													
Location:	Rollo Rd.													
Problem Type:	Local Drainage													
Identification Source:	LCBP CSA Model													
Ownership:	Local													
Classification Level:	3													
Problem Description:														
LCBP's Missisquoi Bay Basin Critical Source Area model indicated that Rollo Road may be a significant source of phosphorous and sediment pollution due to its steep grade and proximity to the Rock River.

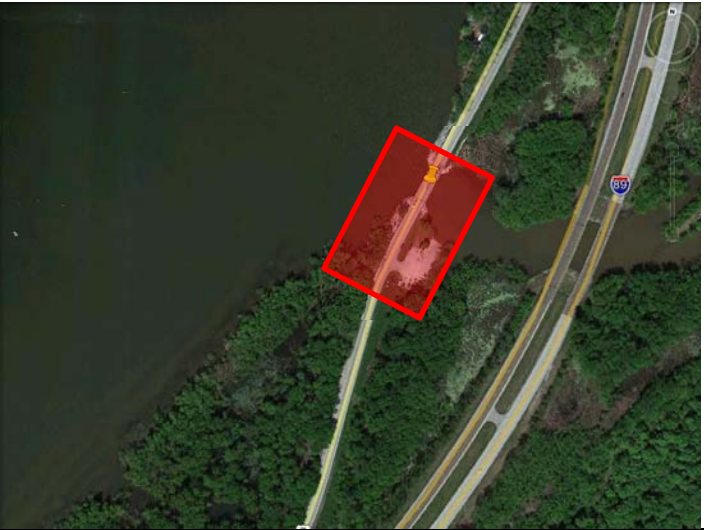
Watershed:	Rock River													
Location:	Route 7, as it crosses over the mouth of the Rock River													
Problem Type:	Flooding													
Identification Source:	Town Feedback													
Ownership:	State													
Classification Level:	1													
Problem Description:														
River often overflows its banks along Rt. 7, flooding the road.

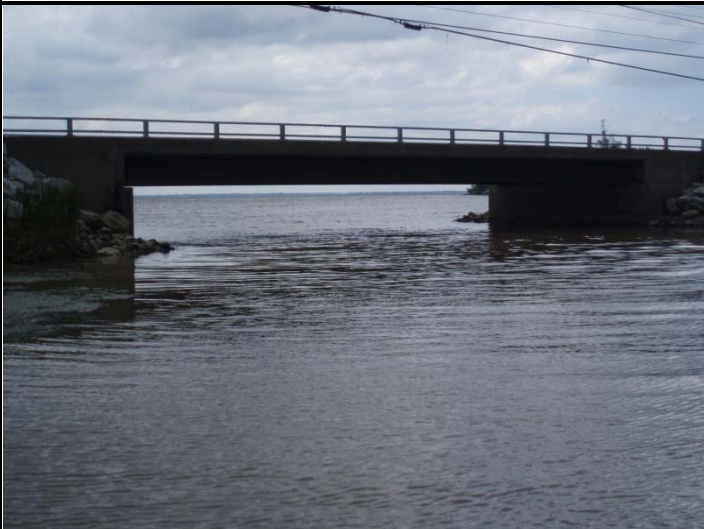
Photo 1. Route 7 bridge over the Rock River

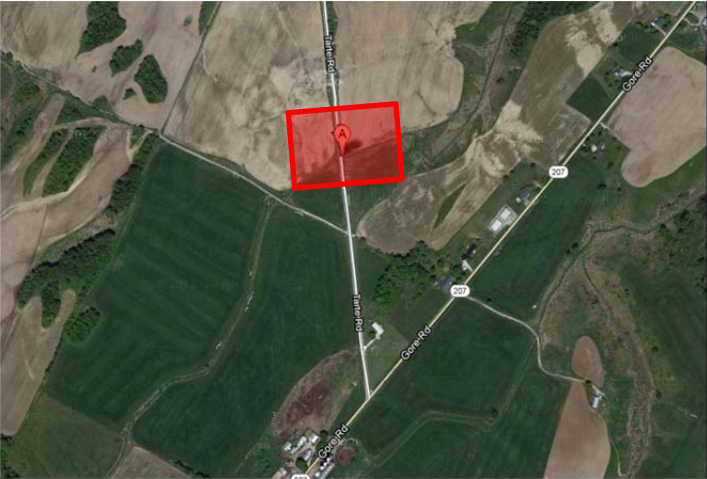
Watershed:	Rock River													
Location:	Tarte Rd, just north of the intersection with Gore Rd													
Problem Type:	Culvert/Bridge Issue													
Identification Source:	SGA, Rock River													
Ownership:	Local													
Classification Level:	2a													
Problem Description:														
Culvert is constricting bankfull channel width.

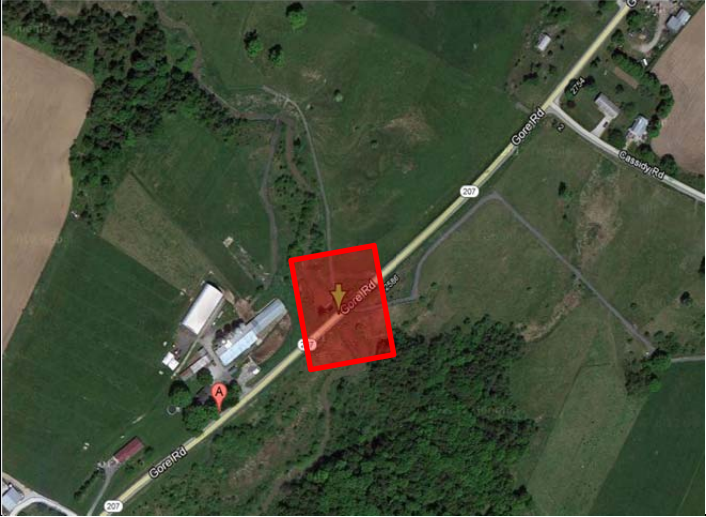
Location: Gore Rd, southeast of intersection with Cassidy Rd		
Problem Type: Culvert/Bridge Issue		
Identification Source: SGA, Rock River		
Ownership: Local		
Classification Level: 1		
Problem Description:		
Bridge is constricting bankfull channel width.

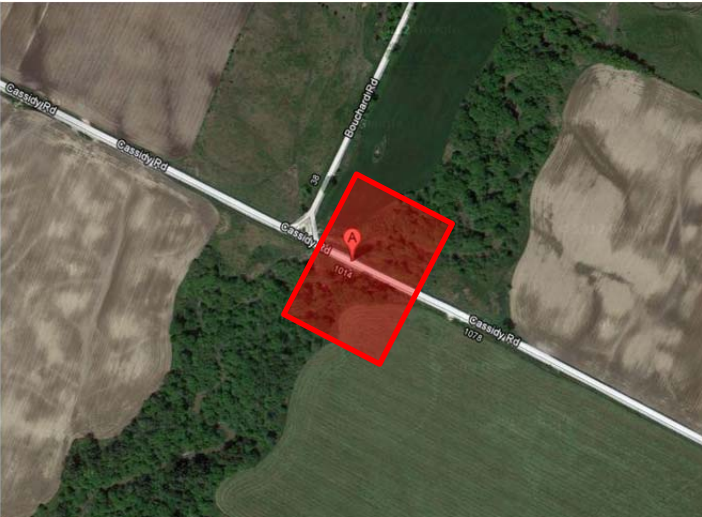
Location: Cassidy Rd, just east of intersection with Bouchard Rd		
Problem Type: Culvert/Bridge Issue		
Identification Source: SGA, Rock River		
Ownership: Private		
Classification Level: 1		
Problem Description:		
Bridge is constricting bankfull channel width.

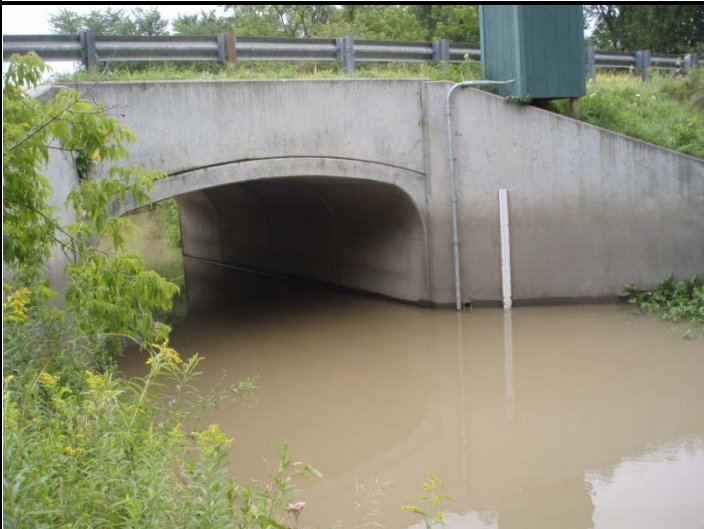
Photo 1. Downstream of bridge

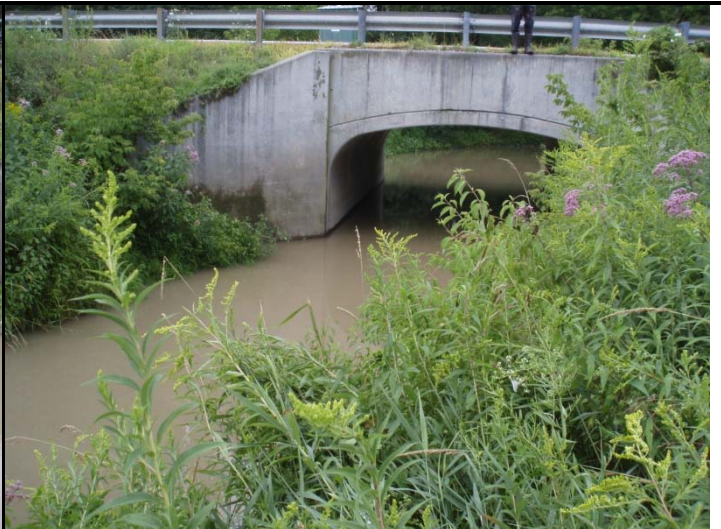
Photo 2. Upstream of bridge

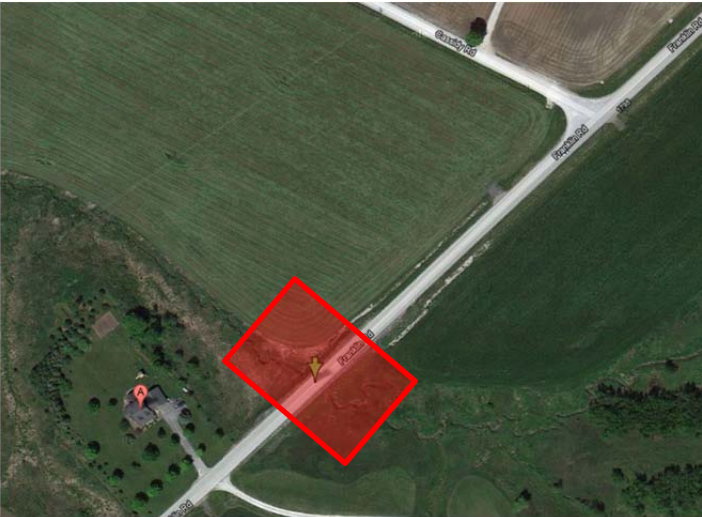
Watershed:	Rock River													
Location:	Franklin Rd, southeast of the intersection with the Cassidy Rd													
Problem Type:	Culvert/Bridge Issue													
Identification Source:	SGA, Rock River													
Ownership:	Local													
Classification Level:	1													
Problem Description:														
Bridge is constricting bankfull channel width.

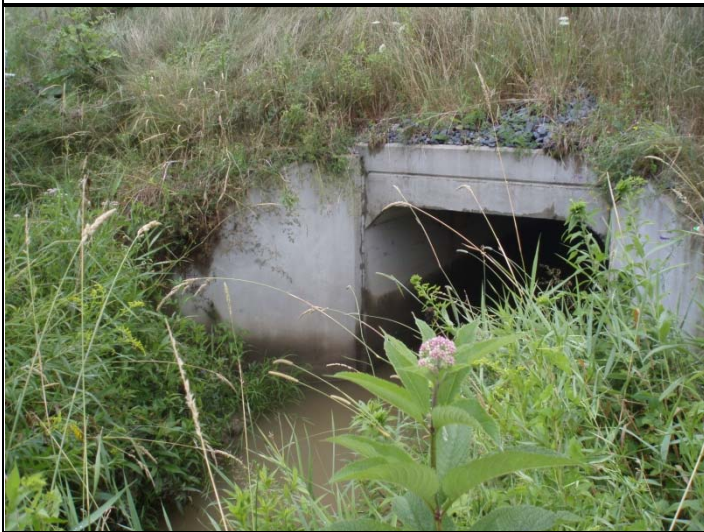
Photo 1. Downstream of bridge

Minor erosion at outlet, no sign of damage to upstream side. Label on bridge notes "Bridge number C17655, 6x6 "B" B-3, installed 9/13/05."

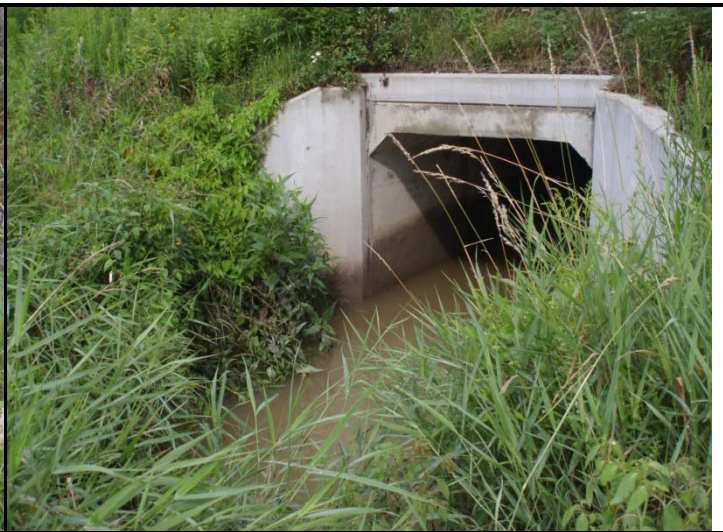
Photo 2. Upstream of bridge

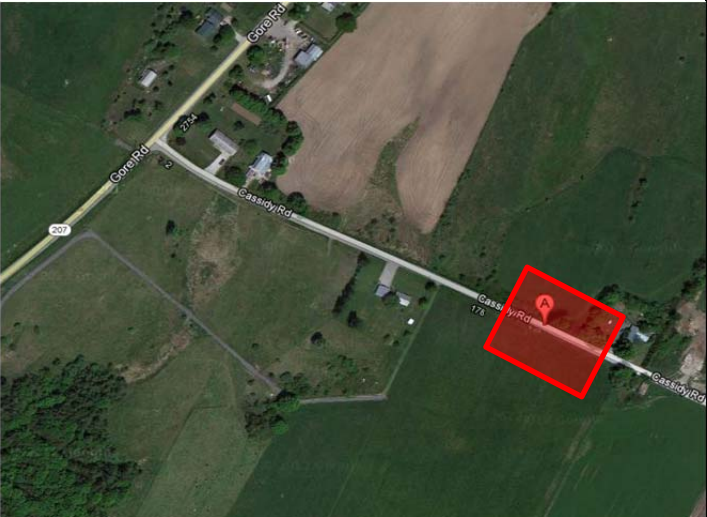
Location: Cassidy Rd, east of the intersection with the Gore Rd		
Problem Type: Culvert/Bridge Issue		
Identification Source: SGA, Rock River		
Ownership: Local/Private		
Classification Level: 2a		
Problem Description:		
Culvert is constricting bankfull channel width.

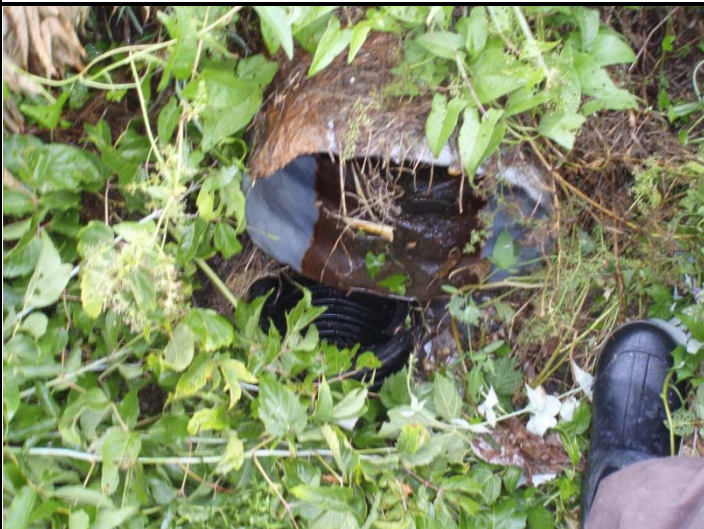
Photo 1. Downstream culvert drains to pipe

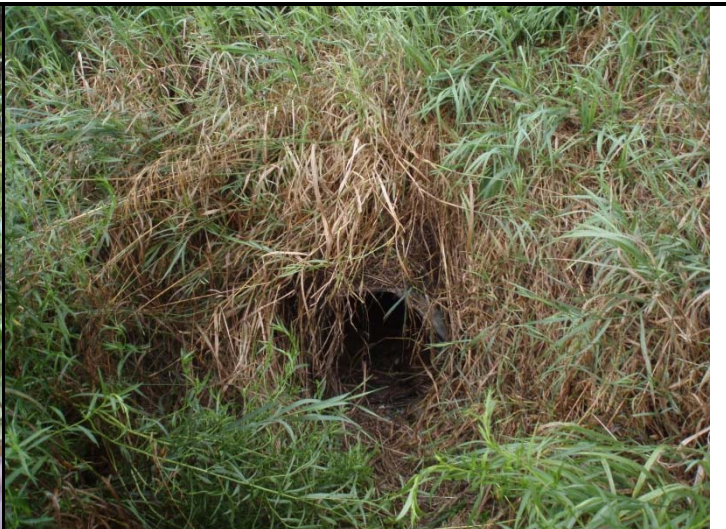
Photo 2. Upstream culvert in dense veg. of road ditch

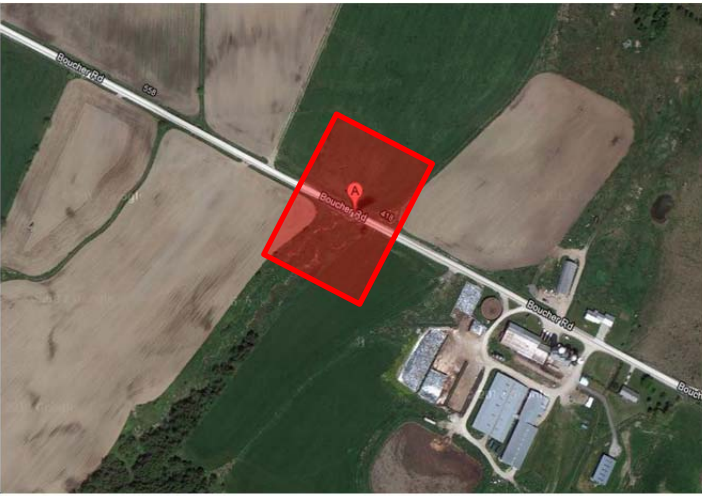
Watershed:	Rock River													
Location:	Boucher Rd, between Tarte Rd and Gore Rd													
Problem Type:	Culvert/Bridge Issue													
Identification Source:	SGA, Rock River													
Ownership:	Local													
Classification Level:	2a													
Problem Description:														
Culvert is constricting bankfull channel width.

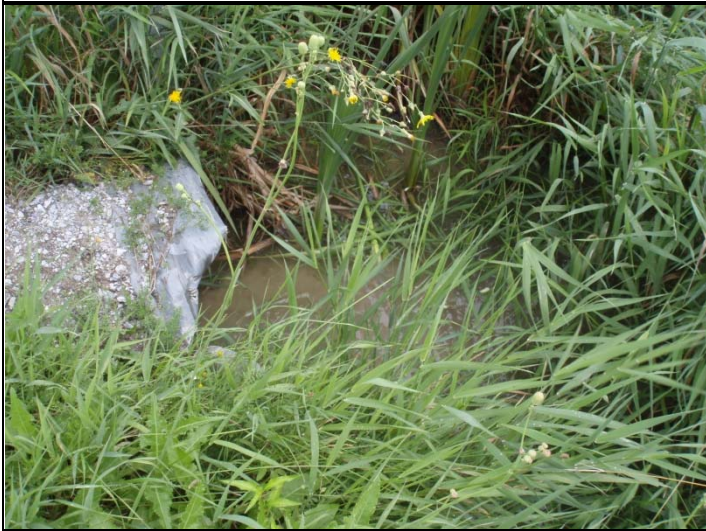
Photo 1. Upstream culvert

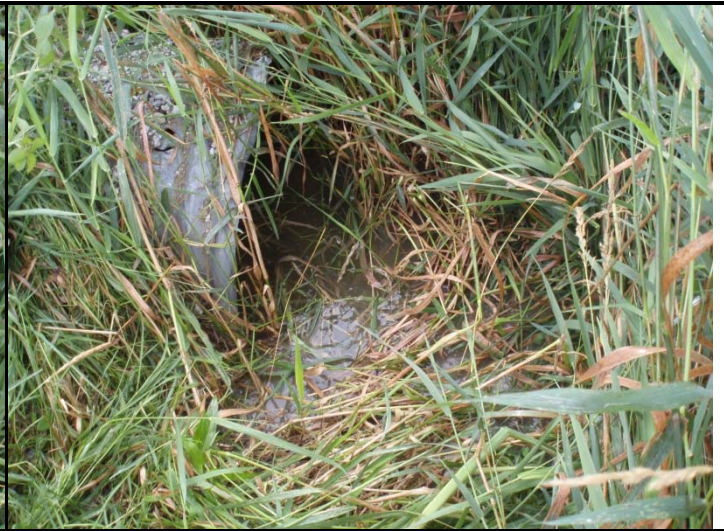
Photo 2. Downstream culvert

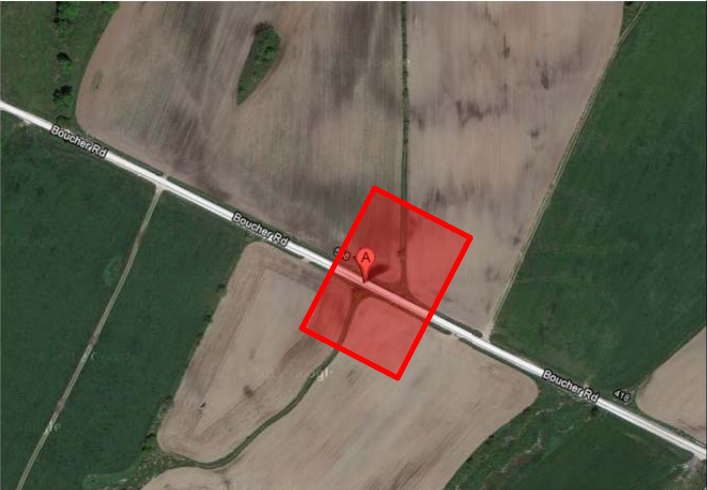
Watershed:	Rock River													
Location:	Boucher Rd, between Tarte Rd and Gore Rd													
Problem Type:	Culvert/Bridge Issue													
Identification Source:	SGA, Rock River													
Ownership:	Local/Private													
Classification Level:	2b													
Problem Description:														
Culvert is constricting bankfull channel width.

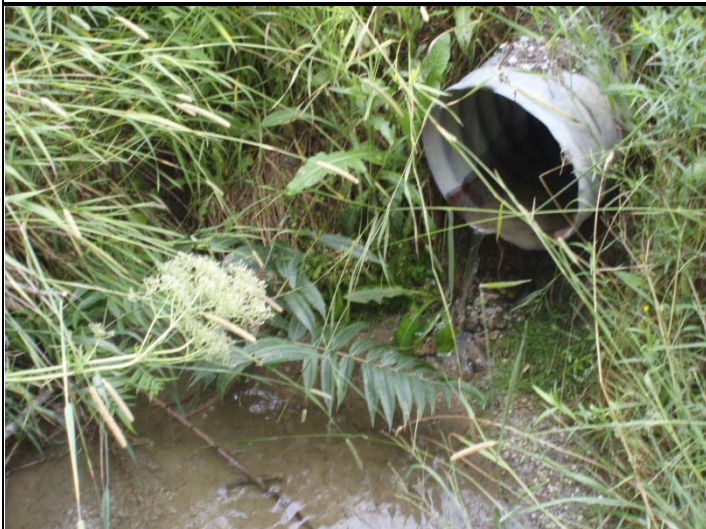
Photo 1. Downstream culvert

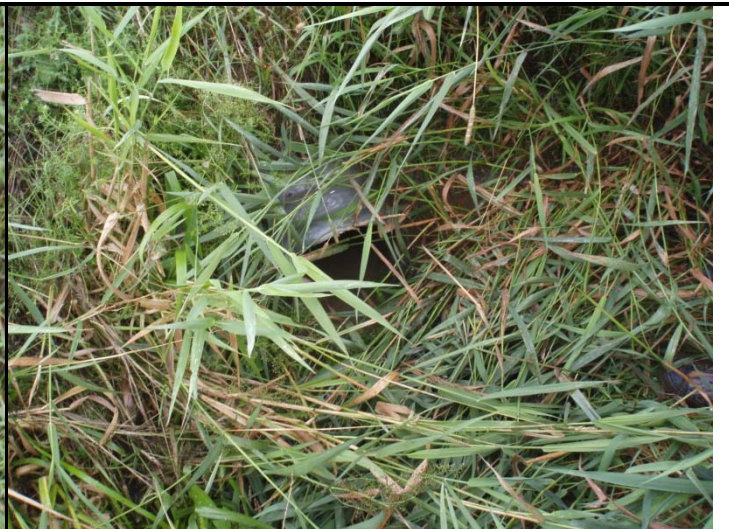
Photo 2. Upstream culvert

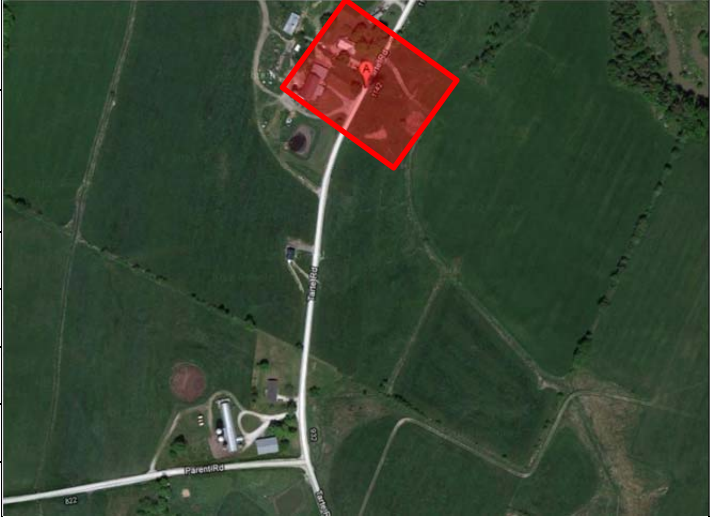
Culvert is undersized and unable to convey moderate or high flows.

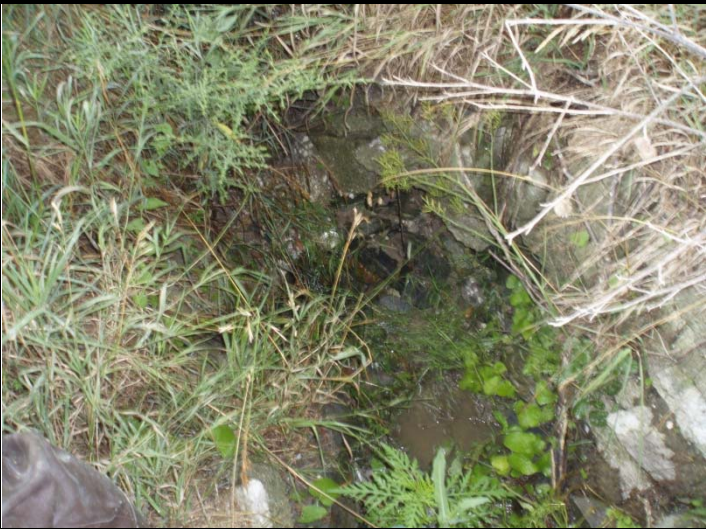
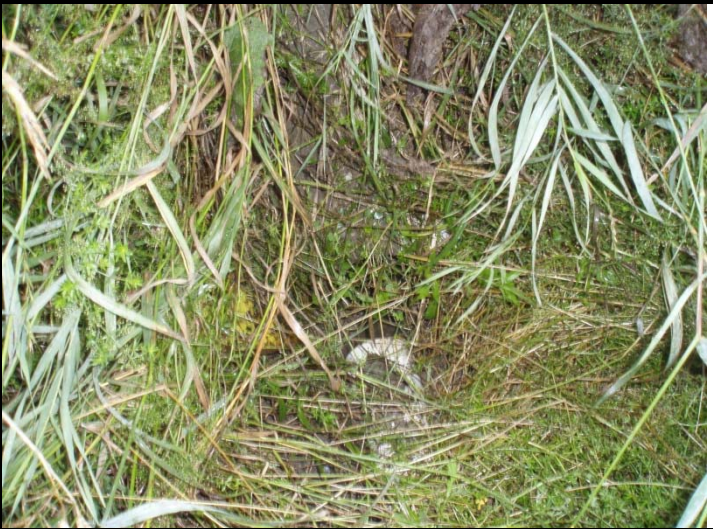
Photo 1. Under-road culvert outfall	Photo 2. 4" white pipe downstream of culvert

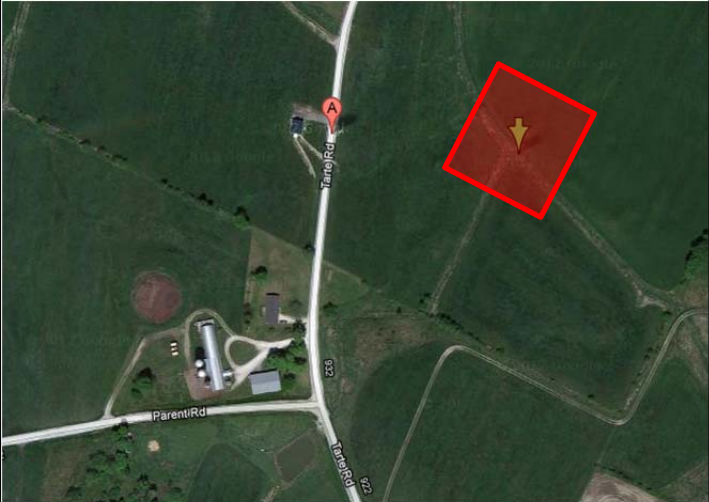
Watershed:	Rock River													
Location:	Tarte Rd, north of the intersection with Parent Rd													
Problem Type:	Culvert/Bridge Issue													
Identification Source:	SGA, Rock River													
Ownership:	Private													
Classification Level:	3													
Problem Description:	Culvert is constricting bankfull channel width.

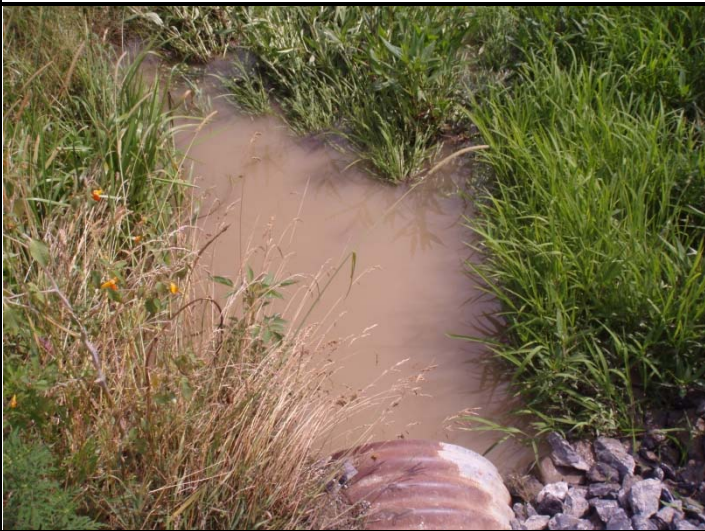
Photo 1. Upstream of farm road bridge

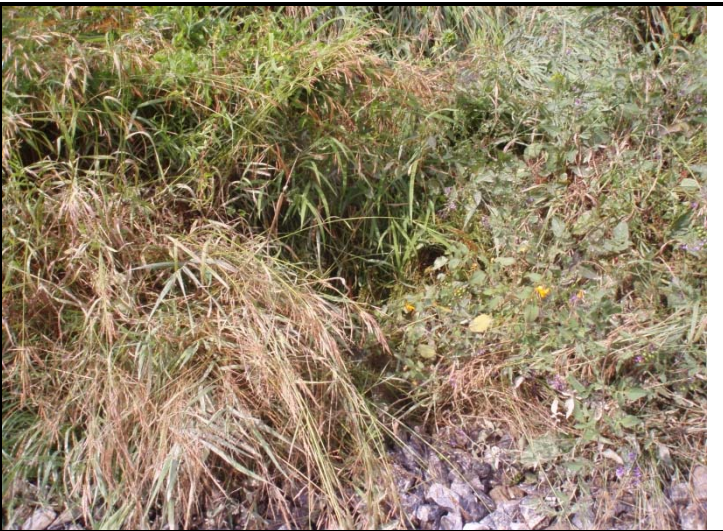
Photo 2. Downstream of farm road bridge

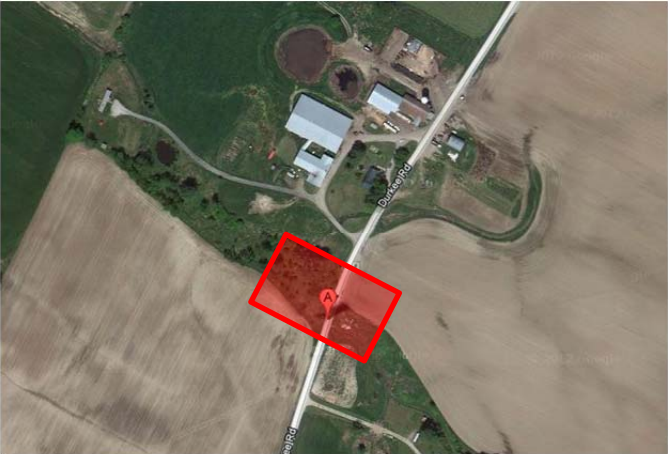
Watershed:	Rock River													
Location:	Durkee Rd													
Problem Type:	Culvert/Bridge Issue													
Identification Source:	SGA, Rock River													
Ownership:	Local													
Classification Level:	2b													
Problem Description:														
Culvert is constricting bankfull channel width.

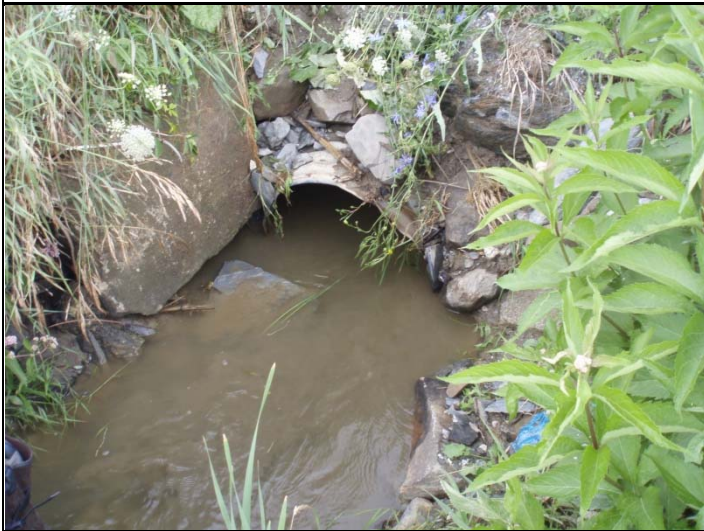
Photo 1. Upstream of culvert

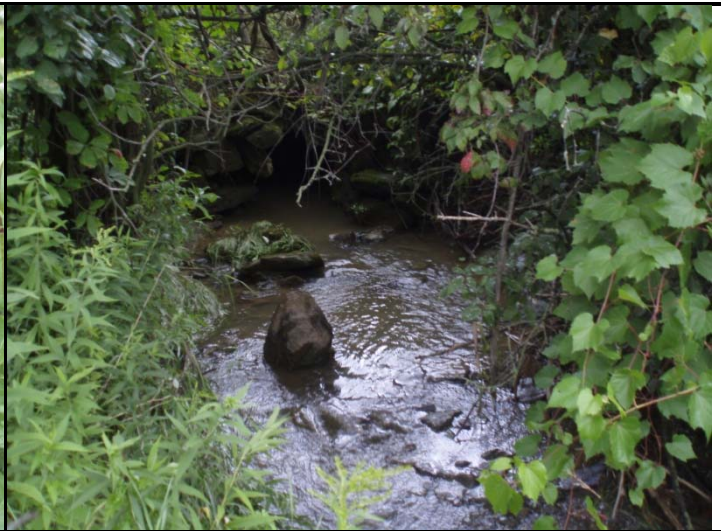
Photo 2. Downstream of culvert

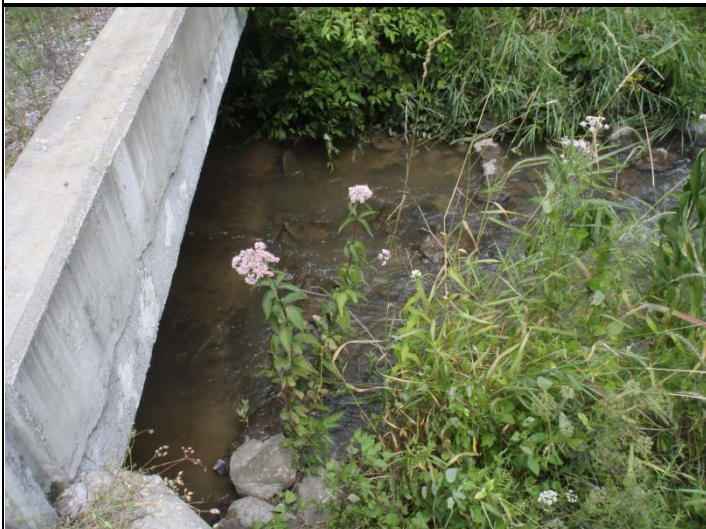
Photo 1. Upstream of bridge

Watershed:	Rock River													
Location:	St. Armand Rd, near intersection with Ballard Rd													
Problem Type:	Culvert/Bridge Issue													
Identification Source:	SGA, Rock River													
Ownership:	Local/Private													
Classification Level:	1													
Problem Description:	Bridge is constricting bankfull channel width.

Stream crossing under Ballard Rd (bridge shown) and then flows under St. Armand Rd before meeting Rock River. Bridge appears to be in good condition. No fish passage, drop in excess of one foot at outlet. Area surrounding bridge shows exposed ledge. Cows may have access to stream below the bridge, along St. Armand Rd.

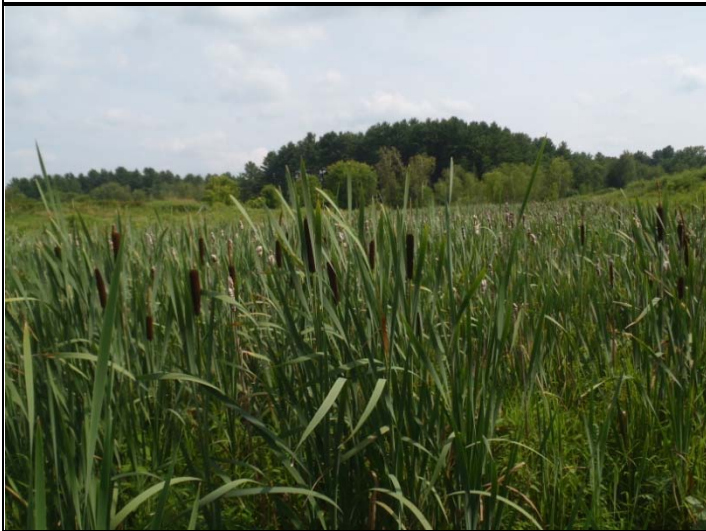
Photo 1. Wetland upstream of culvert

Problem Description:		
Culvert is constricting bankfull channel width.

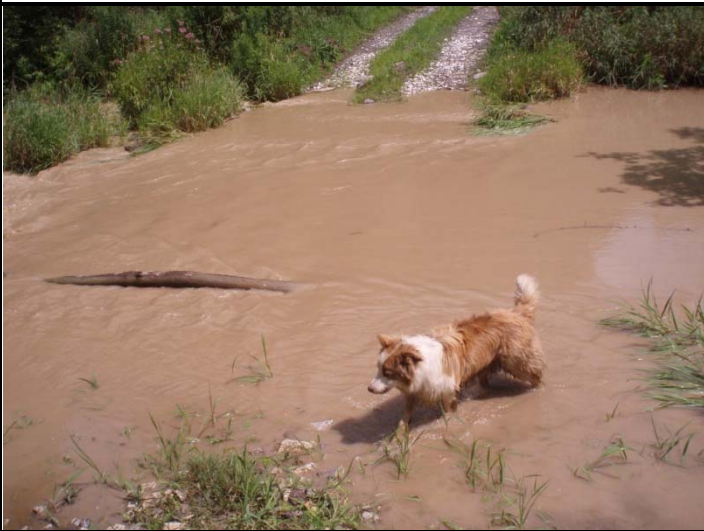
Photo 1. Farm road ford across Rock River

Watershed:	Rock River													
Location:	Rollo Rd, about 1.5 miles east of the intersection with Ballard Rd													
Problem Type:	Stream Crossing													
Identification Source:	SGA, Rock River													
Ownership:	Private													
Classification Level:	3													
Problem Description:														
Fords used as farm road crossing of Rock River; no bridges or culverts present.

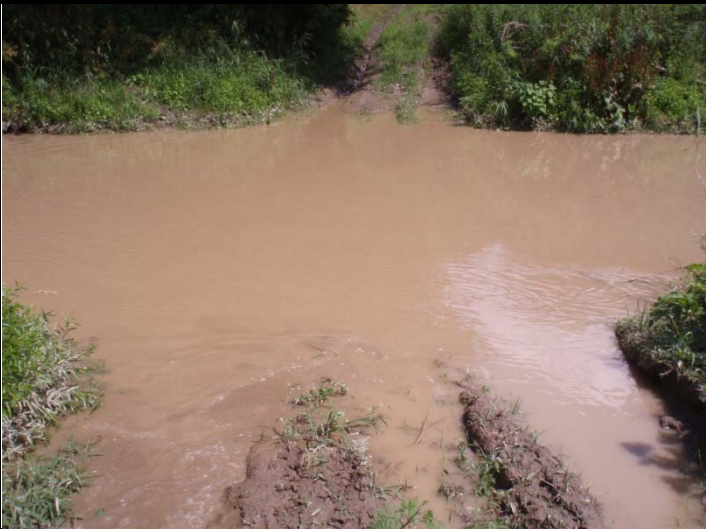
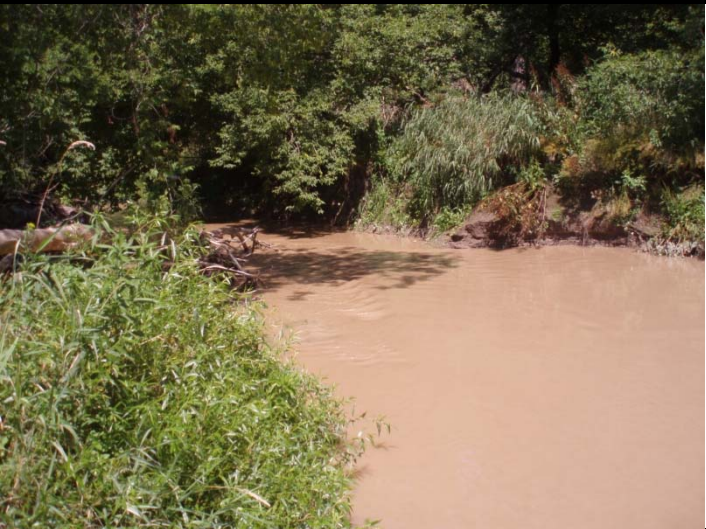
Photo 1. Farm road ford across Rock River	Photo 2. River downstream of ford

Description of Observed Conditions:
Major erosion along banks at farm crossing, and on unimproved access road down to the river. Obvious struggles to ford the Rock River evident. Entire farm area may be susceptible to erosion—steep banks, erosive soils. Have contacted AAFM about resources that might be available to improve the crossing.

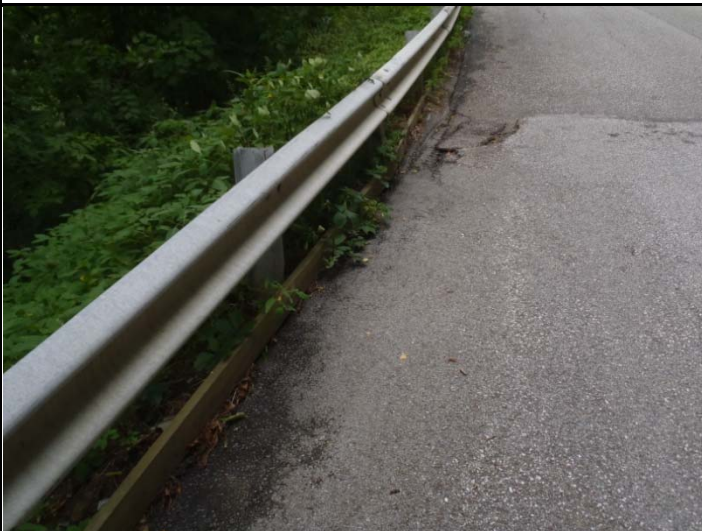
Photo 1. Erosion along roadside

Problem Description:		
Some gully erosion near the bridge over an unnamed tributary to the Missisquoi River.

Erosion in ditches along road, and major blowout at the end of guardrail were observed. Additional turnouts or other measures could be used to help reduce the volume and velocity of stormwater flows along Mill Hill.

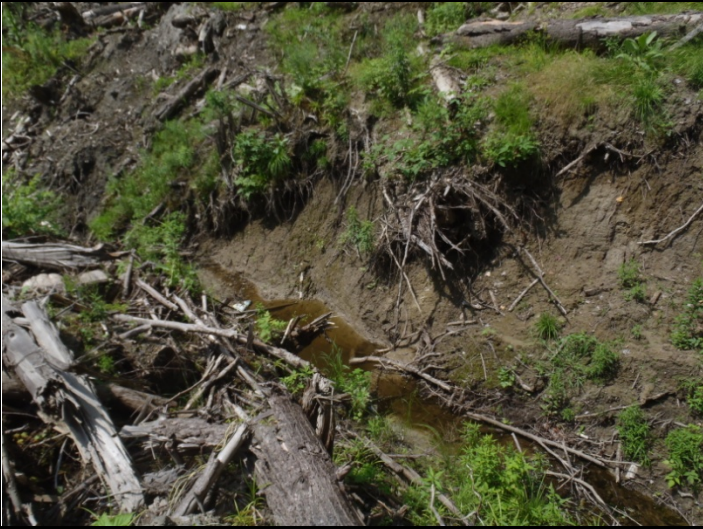
Photo 3. Channel dug by town to allow water flow

Flooding during Irene caused massive landslide; has been built back with stone and graded to approximately at 60 degree angle. Stream at bottom of hillside was plugged with sediment; the Town reports using an excavator to re-channelize the stream, but flow has been greatly restricted. Grass area near shed now has surface drain, flows down 18" corrugated plastic pipe to stream. Tile drain also installed—drains to 8" corrugated plastic pipe along bank. Water also flowing off parking area down SW bank, causing 8" gully erosion. (Additional photos included on the next page.)

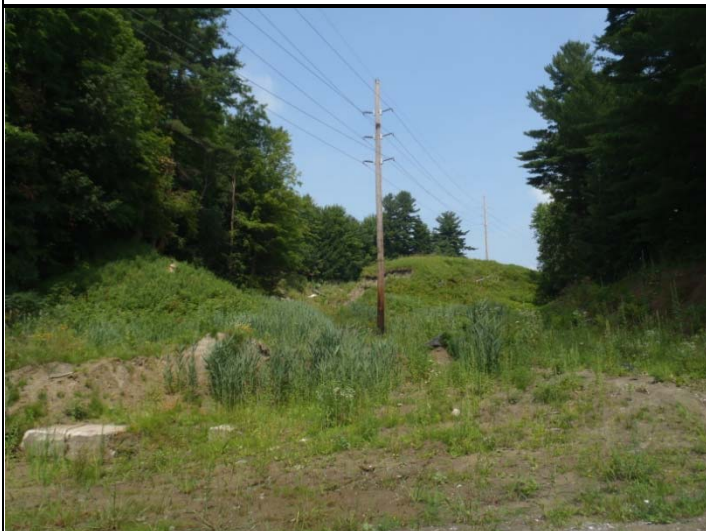
Photo 1. Landslide area from access road

Watershed:	Missisquoi River													
Location:	Route 207, about 1500' south of the junction with Route 78													
Problem Type:	Landslide													
Identification Source:	Town Feedback													
Ownership:	Private													
Classification Level:	1													
Problem Description:														
Landslide on the VELCO power line, north of Missisquoi, west of VT-207.

Massive landslide, caused by Irene, took down two utility poles. 25-50 feet of eroded banks above access road. Some evidence of dumping (e.g., tires and trash). No real source of flow upstream; some springs at toe of bank. Area north of landslide is the utility right-of-way (grass).

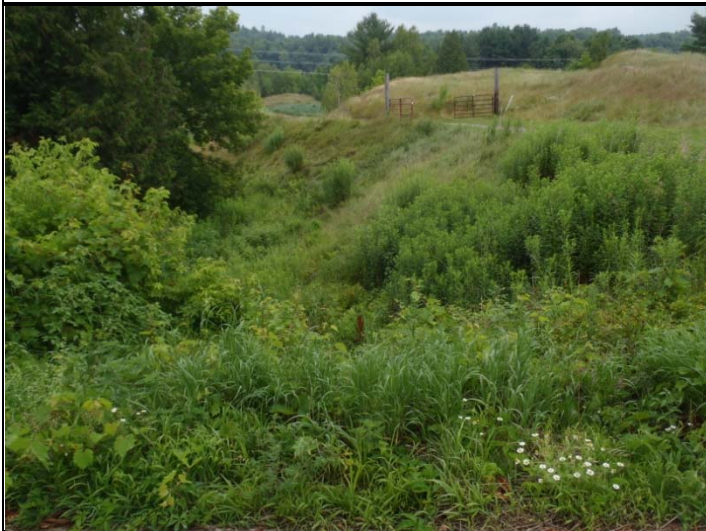
Photo 1. Landslide area from Brosseau Rd

Watershed:	Missisquoi River													
Location:	Whitetail Dr, near the intersection with Brosseau Rd													
Problem Type:	Local Drainage													
Identification Source:	Town Feedback													
Ownership:	Private													
Classification Level:	2b													
Problem Description:														
Erosion on Whitetail Dr. at Brosseau Rd.

Two separate farm ditches channel runoff to culvert upstream of road. Culvert is 18" corrugated metal, may be too small for heavy flows. Evidence of blowout east of culvert. Side of road rip-rapped and overgrown, some repairs may have been done already.

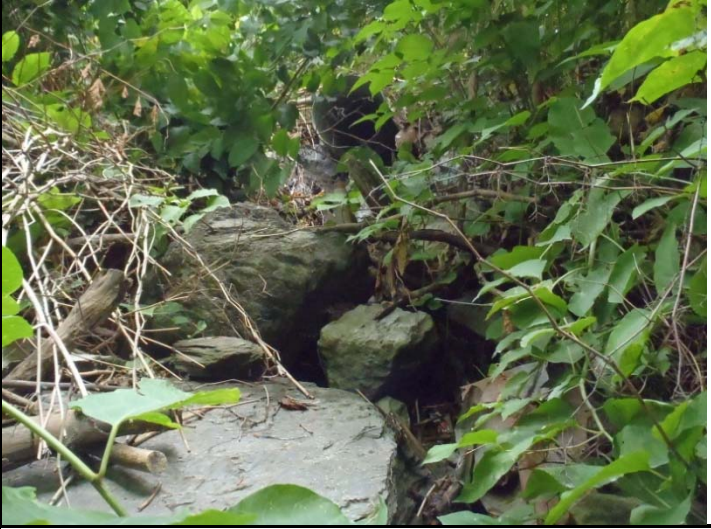
Photo 1. Outfall from under-road culvert	Photo 2. Looking back up at outfall

Watershed:	Missisquoi River													
Location:	Mill Hill Rd, at intersection with Lamkin St													
Problem Type:	BMP Retrofits													
Identification Source:	Missisquoi River Basin Urban Areas Stormwater Mapping Project													
Ownership:	Private													
Classification Level:	3													
Problem Description:	Investigate ravine for areas of active erosion.

Description of Observed Conditions:
 24" corrugated metal outfall at edge of the road; mapping suggests this pipe drains a significant portion of the village. Dripping flow. 18" abandoned pipe below. Rocks and trash also below outfall, down very steep bank. Evidence of erosion on embankment below outfall.

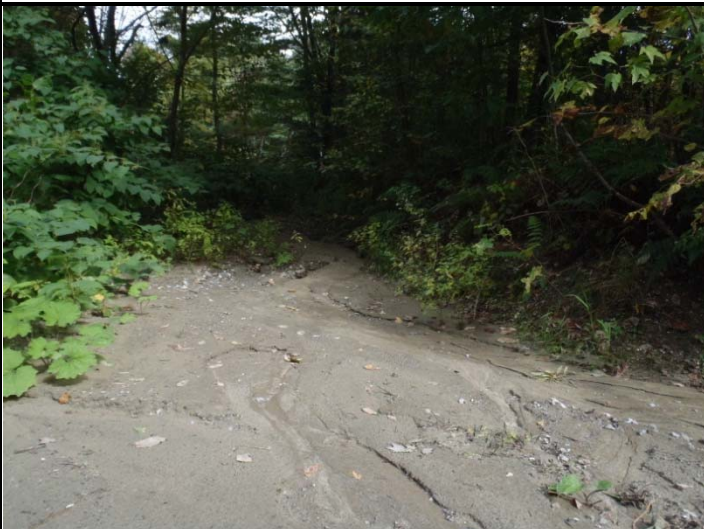
Photo 1. Overland flow near base of Pine Plains Rd

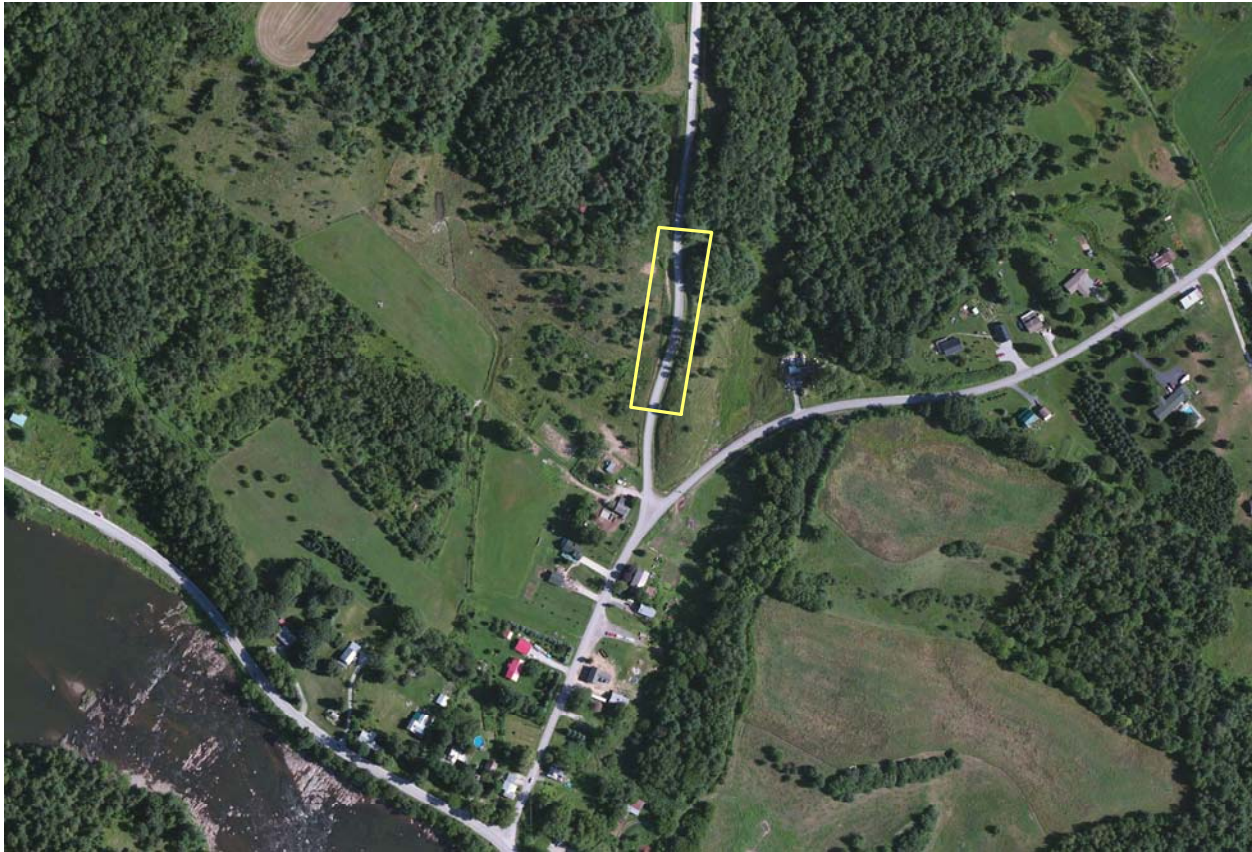
Figure 1. Area of eroding slopes highlighted in yellow.

Recent roadway improvement work along Durkee Road in Highgate Center has resulted in over-steepened banks causing erosion of sections of the ditch backslopes along both sides of the road. The section of road affected is fairly steep, and is located only about a third of a mile from the Missisquoi River. Approximately 300 feet of road side ditch is affected, with the backslope reaching a maximum approximate height of 10 ft (see Figure 2 and Figure 3).

The simplest solution would be to re-grade the backslopes to a maximum 3:1 slope and establishing vegetation. A drawback to this solution is the encroachment on private land when the slopes are partially flattened. Alternatively the backslopes could be re-graded to a maximum 2:1 slope and erosion control matting or a riprap blanket (stone armoring) installed. A third and even more intensive solution would be to install structures such retain walls. This approach would require engineering design and heavy construction work, but would minimize encroachment on private property.

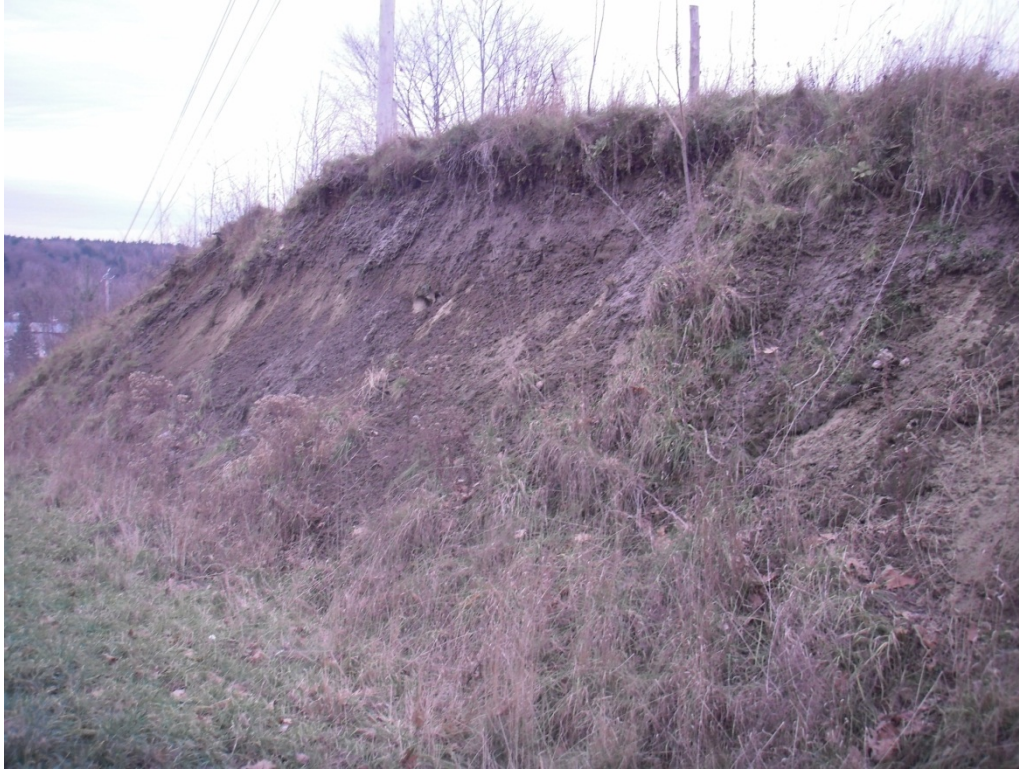
Figure 2. Oversteepened and eroding ditch backslope on west side of Durkee Rd. in Highgate Center.

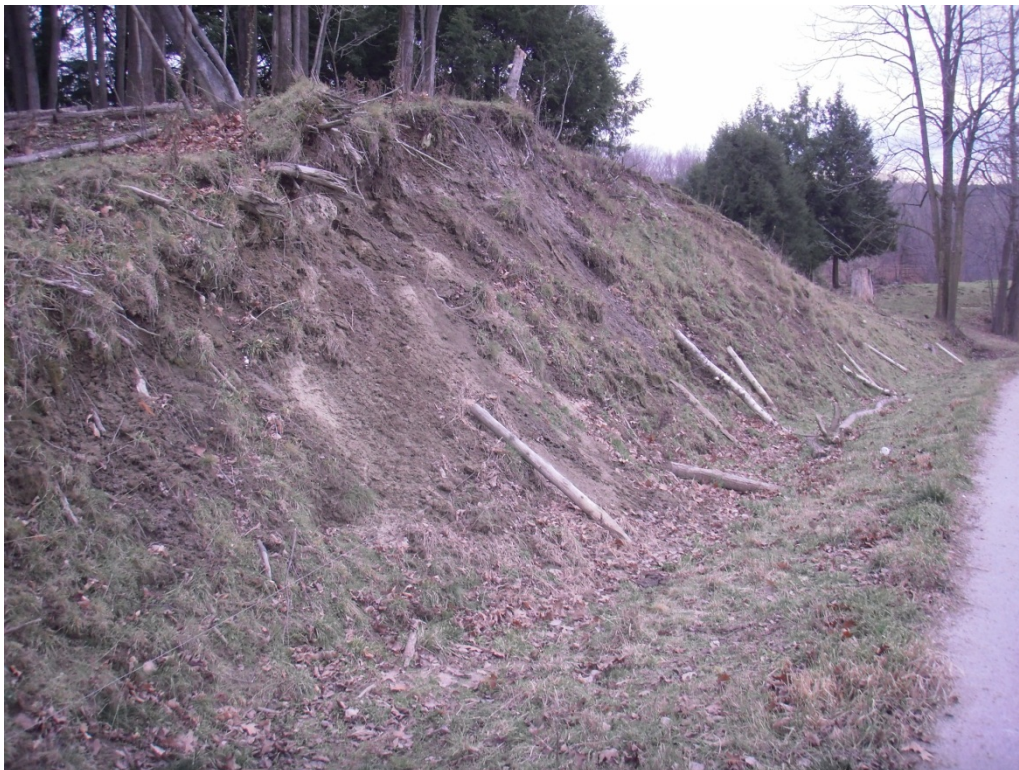
Figure 3. Eroding ditch backslope on the east side of Durkee Road in Highgate Center.

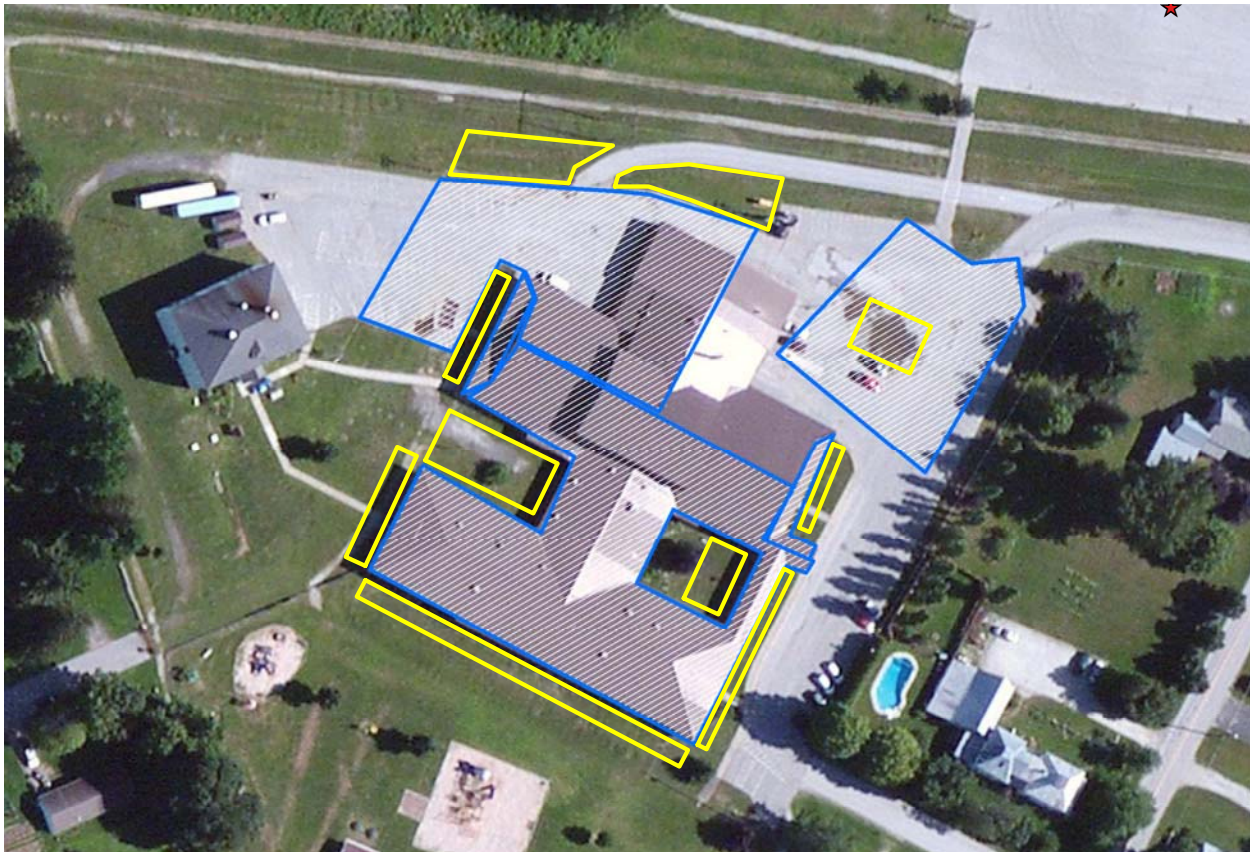
The Highgate Elementary School campus includes a large amount of impervious surface; 2.3 acres of roof top and asphalt parking area have been identified as treatable impervious areas. Figure 4 shows treatable impervious area (blue outline) and potential stormwater treatment practice (STP) locations (yellow outline). Roof runoff could be captured and treated in bioretention areas and rain gardens installed around below the drip-edge around the perimeter of the building and in the two center courtyards (Figures 5-7).

Figure 4. Highgate Elementary School. Treatable impervious surface is highlighted in blue and potential STP locations are shown in yellow.

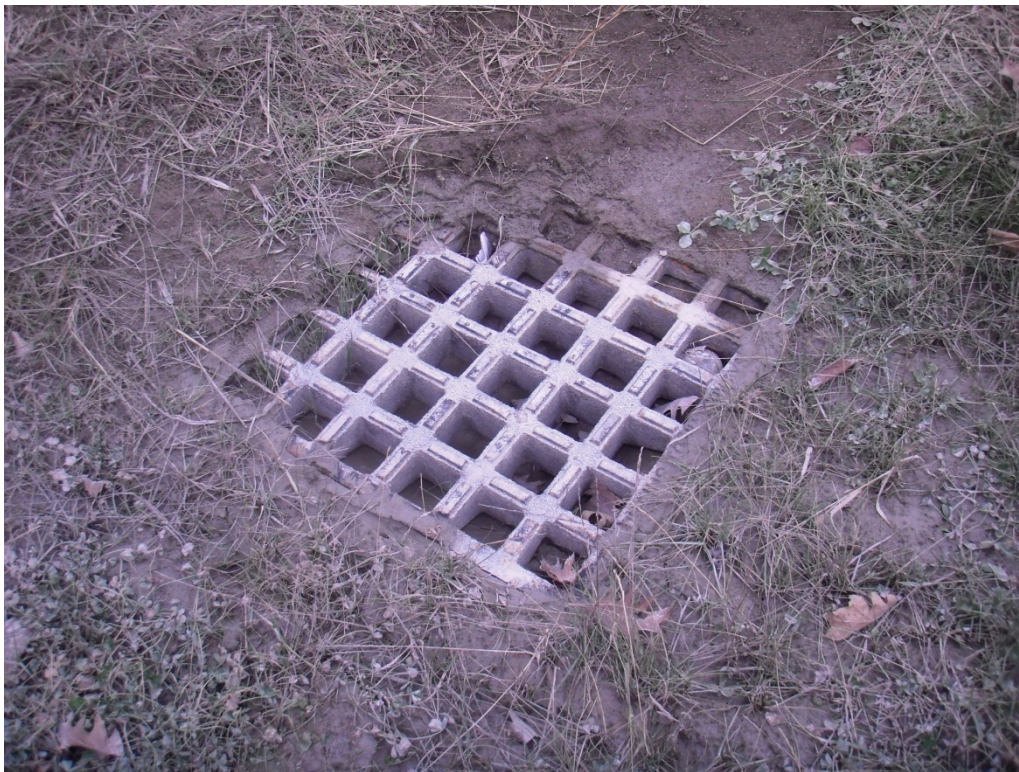
Figure 12. Sediment has completely filled catch basin at the Highgate town sand shed.

An infiltration-based STP could be constructed using the existing catch basin as an outlet. The STP could help keep sediment on-site reduce impacts to water quality and reduce the need to clean out the catch basin as often.

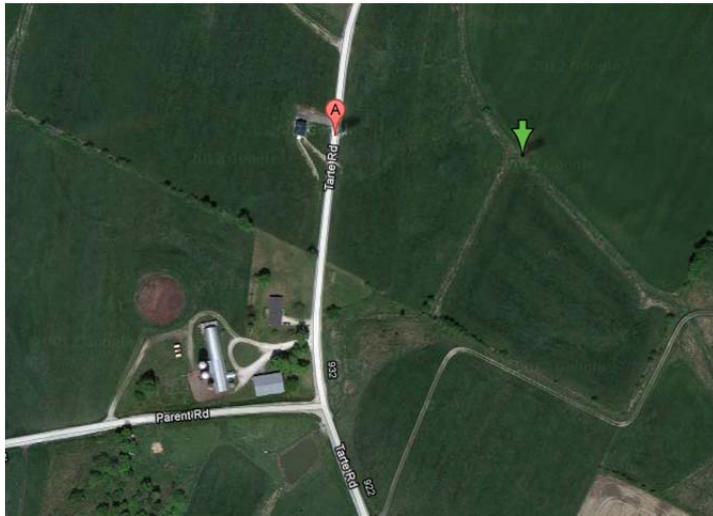
1.7.1 Tarte Rd, Crossing #1

Figure 20. Farm road crossing #1.
