STORMWATER MANAGEMENT PLAN FOR HIGHGATE

FINAL REPORT

Stone Project ID 112475-W

March 1, 2013

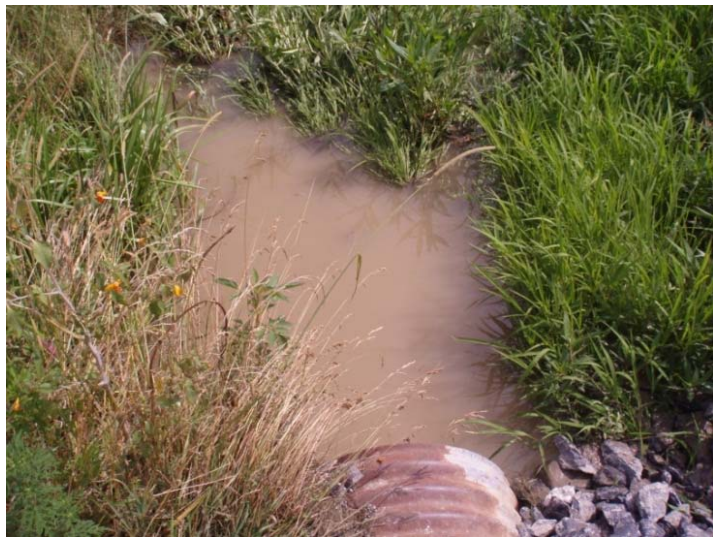
Figure 21. Scour pool at outfall from undersized culvert that carries unnamed Rock River tributary under farm road. Some rip rap has been placed by the landowner to address localized erosion around the culvert.

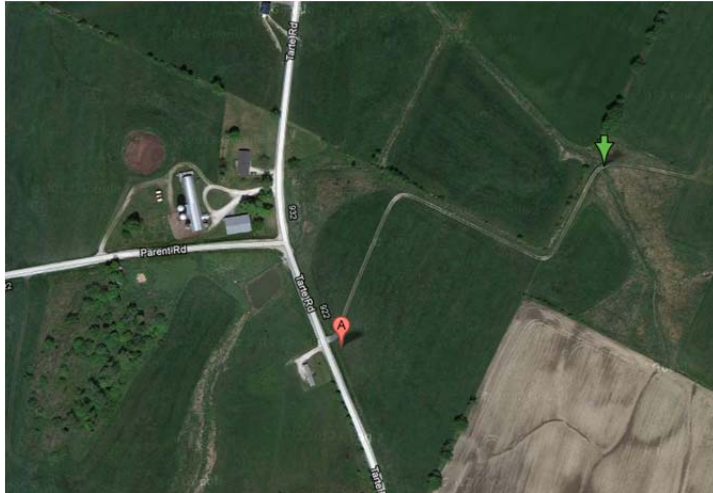
1.7.2 Tarte Rd, Farm Road Crossing #2

Figure 22. Farm road crossing #2.

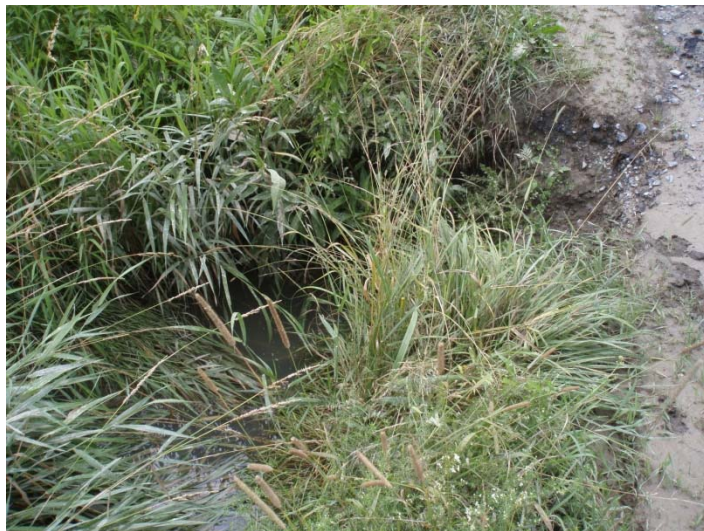
Figure 23. Undersized culvert under farm road. Erosion occurring from road surface as well as in scour pools at the upstream (shown) and downstream ends of the culvert.

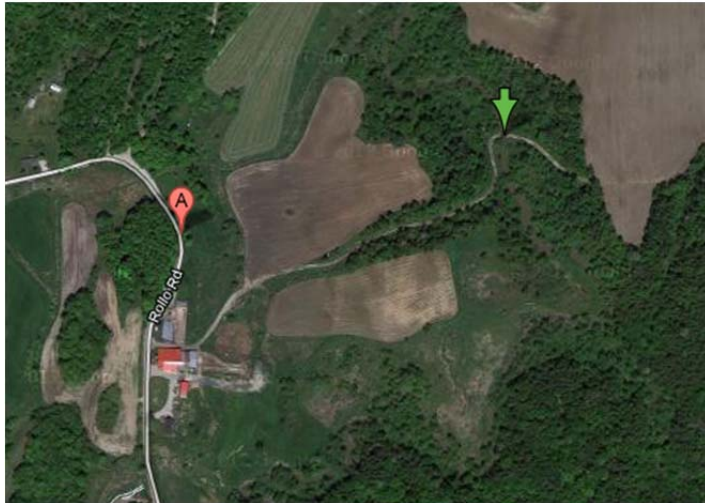
1.7.3 Rollo Rd, Farm Road Crossing #3

Figure 24. Farm road crossing #4.

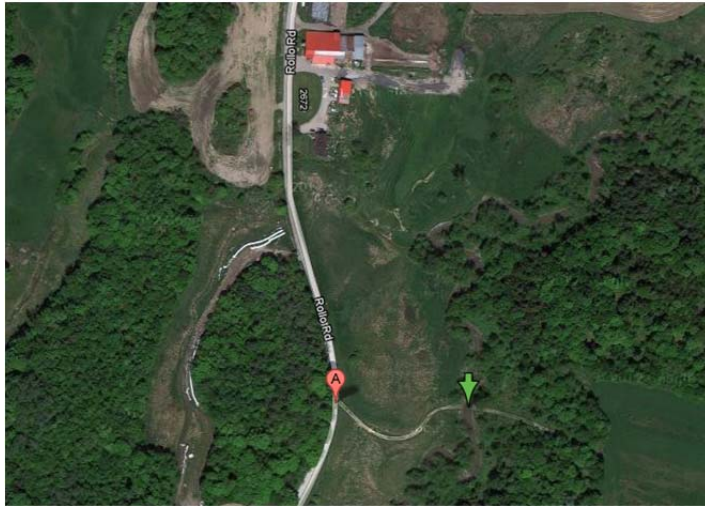
1.7.4 Rollo Rd, Farm Road Crossing #4

Figure 26. Farm road crossing #4.
