# Centerville Brook Corridor Plan

Hyde Park, Vermont

February 10, 2010

# Centerville Brook Corridor Plan Hyde Park, Vermont

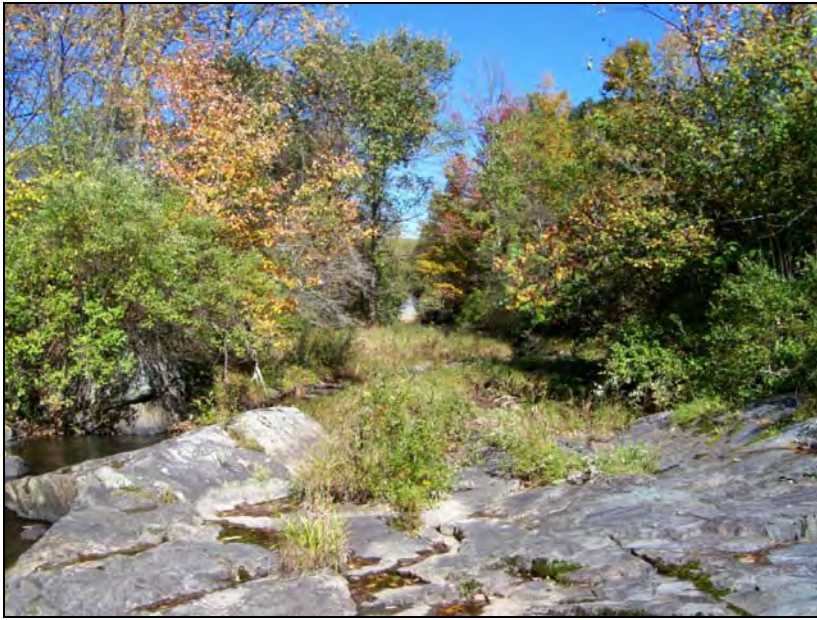
Centerville Brook segment R15.03 is a bedrock gorge between the Route 15 and Main Street crossings east of Hyde Park village. In accordance with ANR protocol, only a partial assessment was conducted on this reach.

**Centerville Brook segment R15.03 is a bedrock dominated channel.**

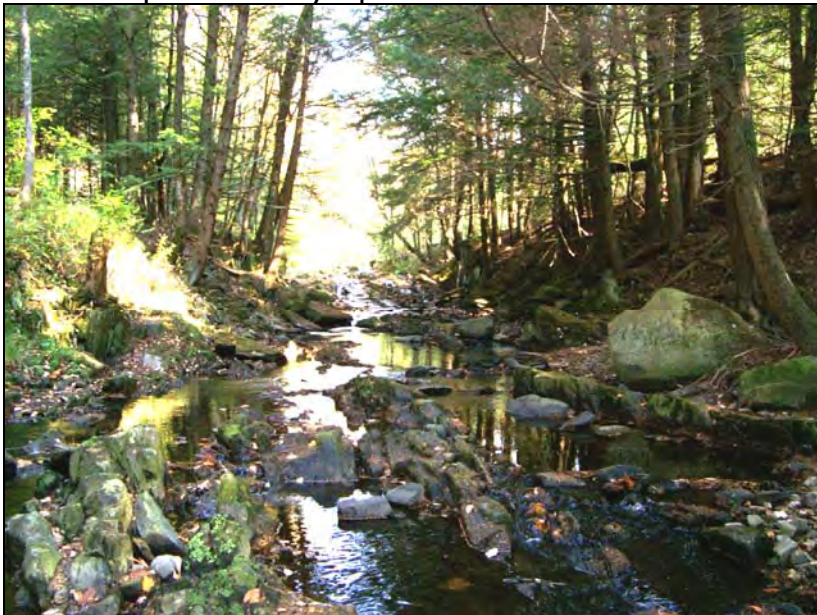
Centerville Brook segment R15.04-A is a bedrock dominated channel. In accordance with ANR protocol, only a partial assessment was conducted on this reach.

**Centerville Brook segment R15.04-A is a bedrock gorge.**

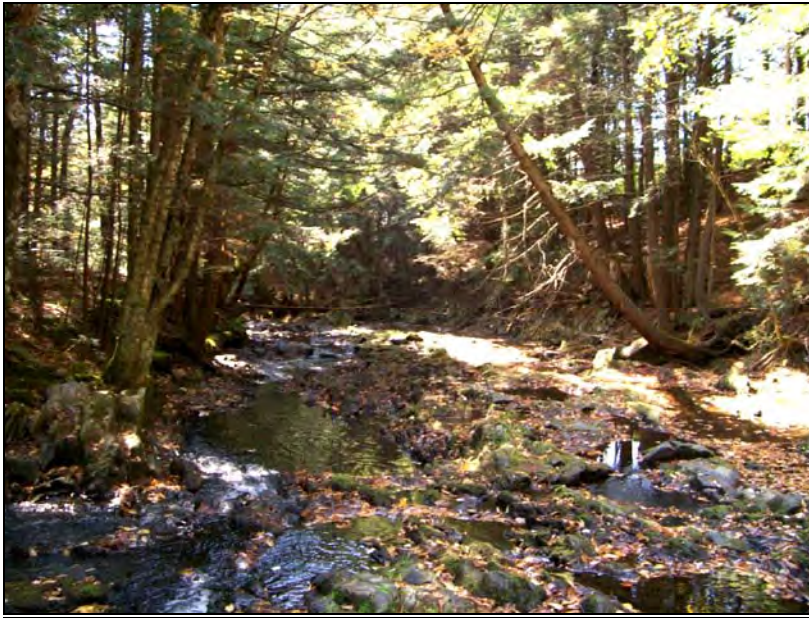
**Centerville Brook segment R15.04-C is a bedrock gorge.**

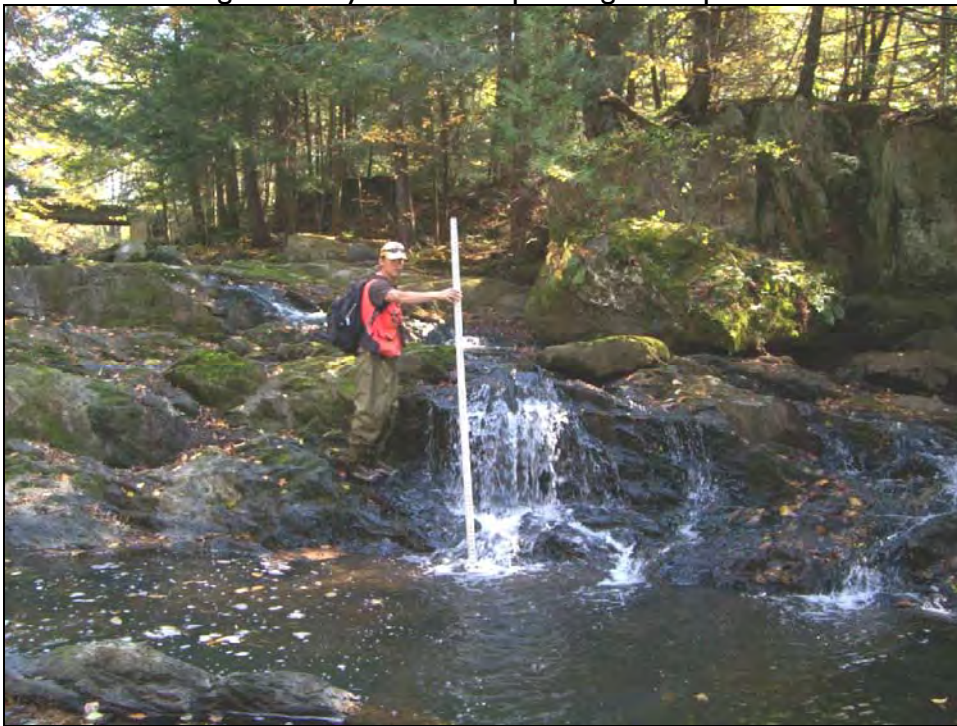
Centerville Brook R15.05-A begins just upstream from the private Pair Farm Road bridge where a very broad valley becomes confined and where the Centerville Brook encounters a bedrock dominated channel and a series of small waterfalls. Due to these waterfalls this segment only received a partial geomorphic assessment.

Segment R15.05-A is a bedrock dominated channel with several small waterfalls.

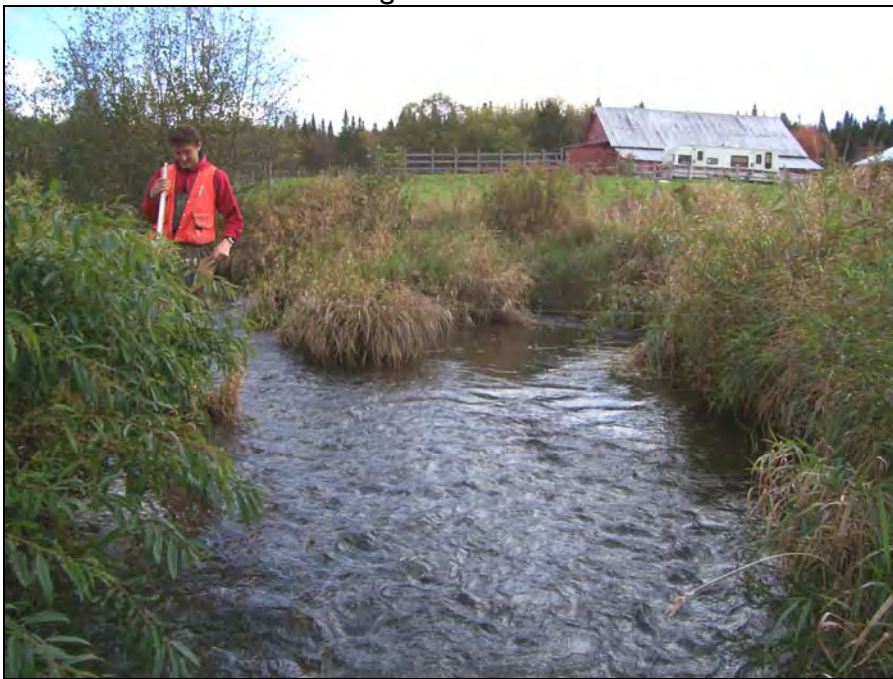
The channel in Segment R15.05-C is narrow and deep.

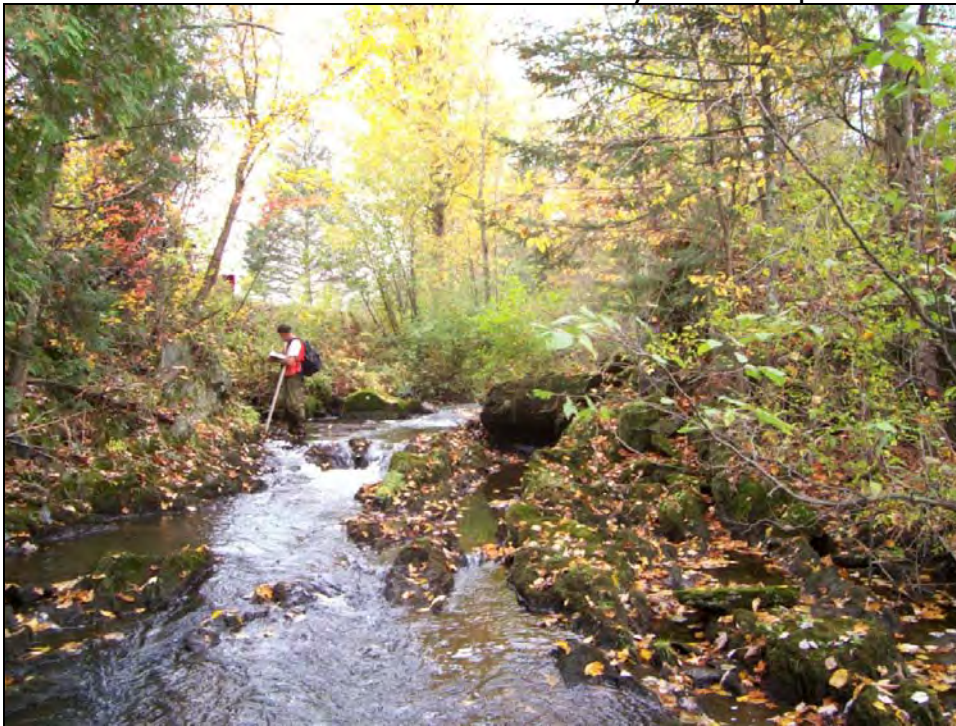
Centerville segment R15.05-D is a short (600 ft.) section of channel that begins where bedrock grade controls appear in the channel near the upper pastures of a dairy farm and ends at the culvert under Frost Road. The stream in this segment is controlled by bedrock on the bed and banks and therefore only received a partial Phase 2 assessment.

**Centerville Brook segment R15.05-D is controlled by bedrock on the bed and banks.**

#### **Replace bridge**

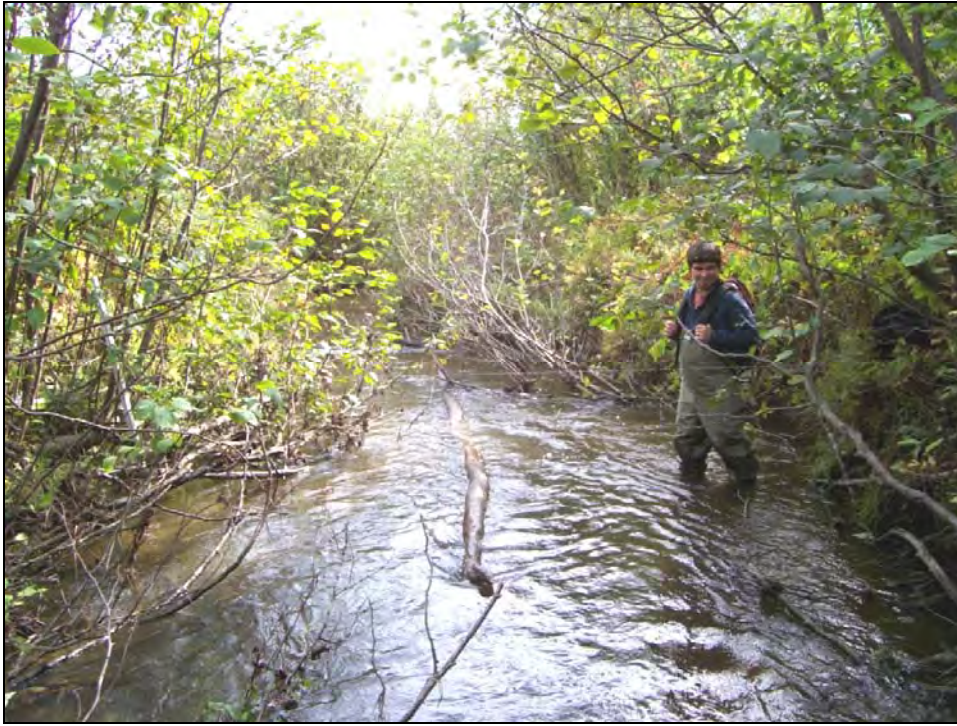
Centerville Brook segment R15.05-E begins at the confluence with a major tributary. The segment flows through a predominately undisturbed wetland area that is heavily vegetated with alder, willow, spruce, and fir. The channel through this segment is highly sinuous and has good floodplain access with abundant floodplain wetland noted. The stream is an “E” type channel that has been historically influenced by beavers (currently only the very upper portion of the segment is impounded). The channel did have evidence of some minor channel adjustment such as widening, aggradation, and planform. These observed adjustments are likely attributed to the highly dynamic nature (dam and avulsion, store and release) of beaver influenced channels.

**Segment R15.05-E is a heavily vegetated “E” type channel.**

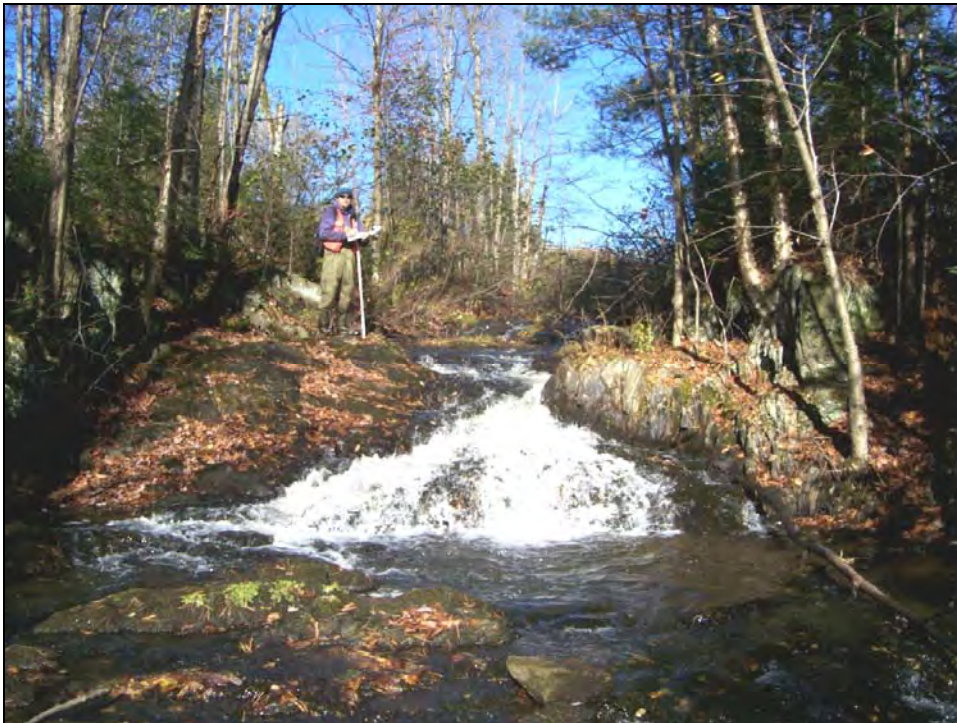
None of the culverts had sediment throughout the structure and were flagged as having reduced aquatic organism passage. The culvert crossing at Centerville Road in reach R1507-B is freefall with an outlet drop of 1 foot (see Figure 10). Using the VT Organism Passage Coarse Screen (Milone and MacBroom 2008) this culvert was flagged as no AOP for all aquatic organisms including adult salmonids. This structure is a high priority for replacement or retrofit.

Centerville Brook segment R15.07-B is a short section of channel that begins at the Centerville Road crossing and continues downstream through a series of bedrock waterfalls. Due to the extensive bedrock in the stream channel only a partial stream geomorphic assessment was conducted.

**Centerville Brook segment R15.07-B is dominated by bedrock grade controls.**

#### **Replace freefall culvert**
