Detecting and Eliminating Illicit Discharges to Improve Water Quality in the Lamoille River Basin

Final Report

Issued: January 31, 2014

Revised: July 11, 2014

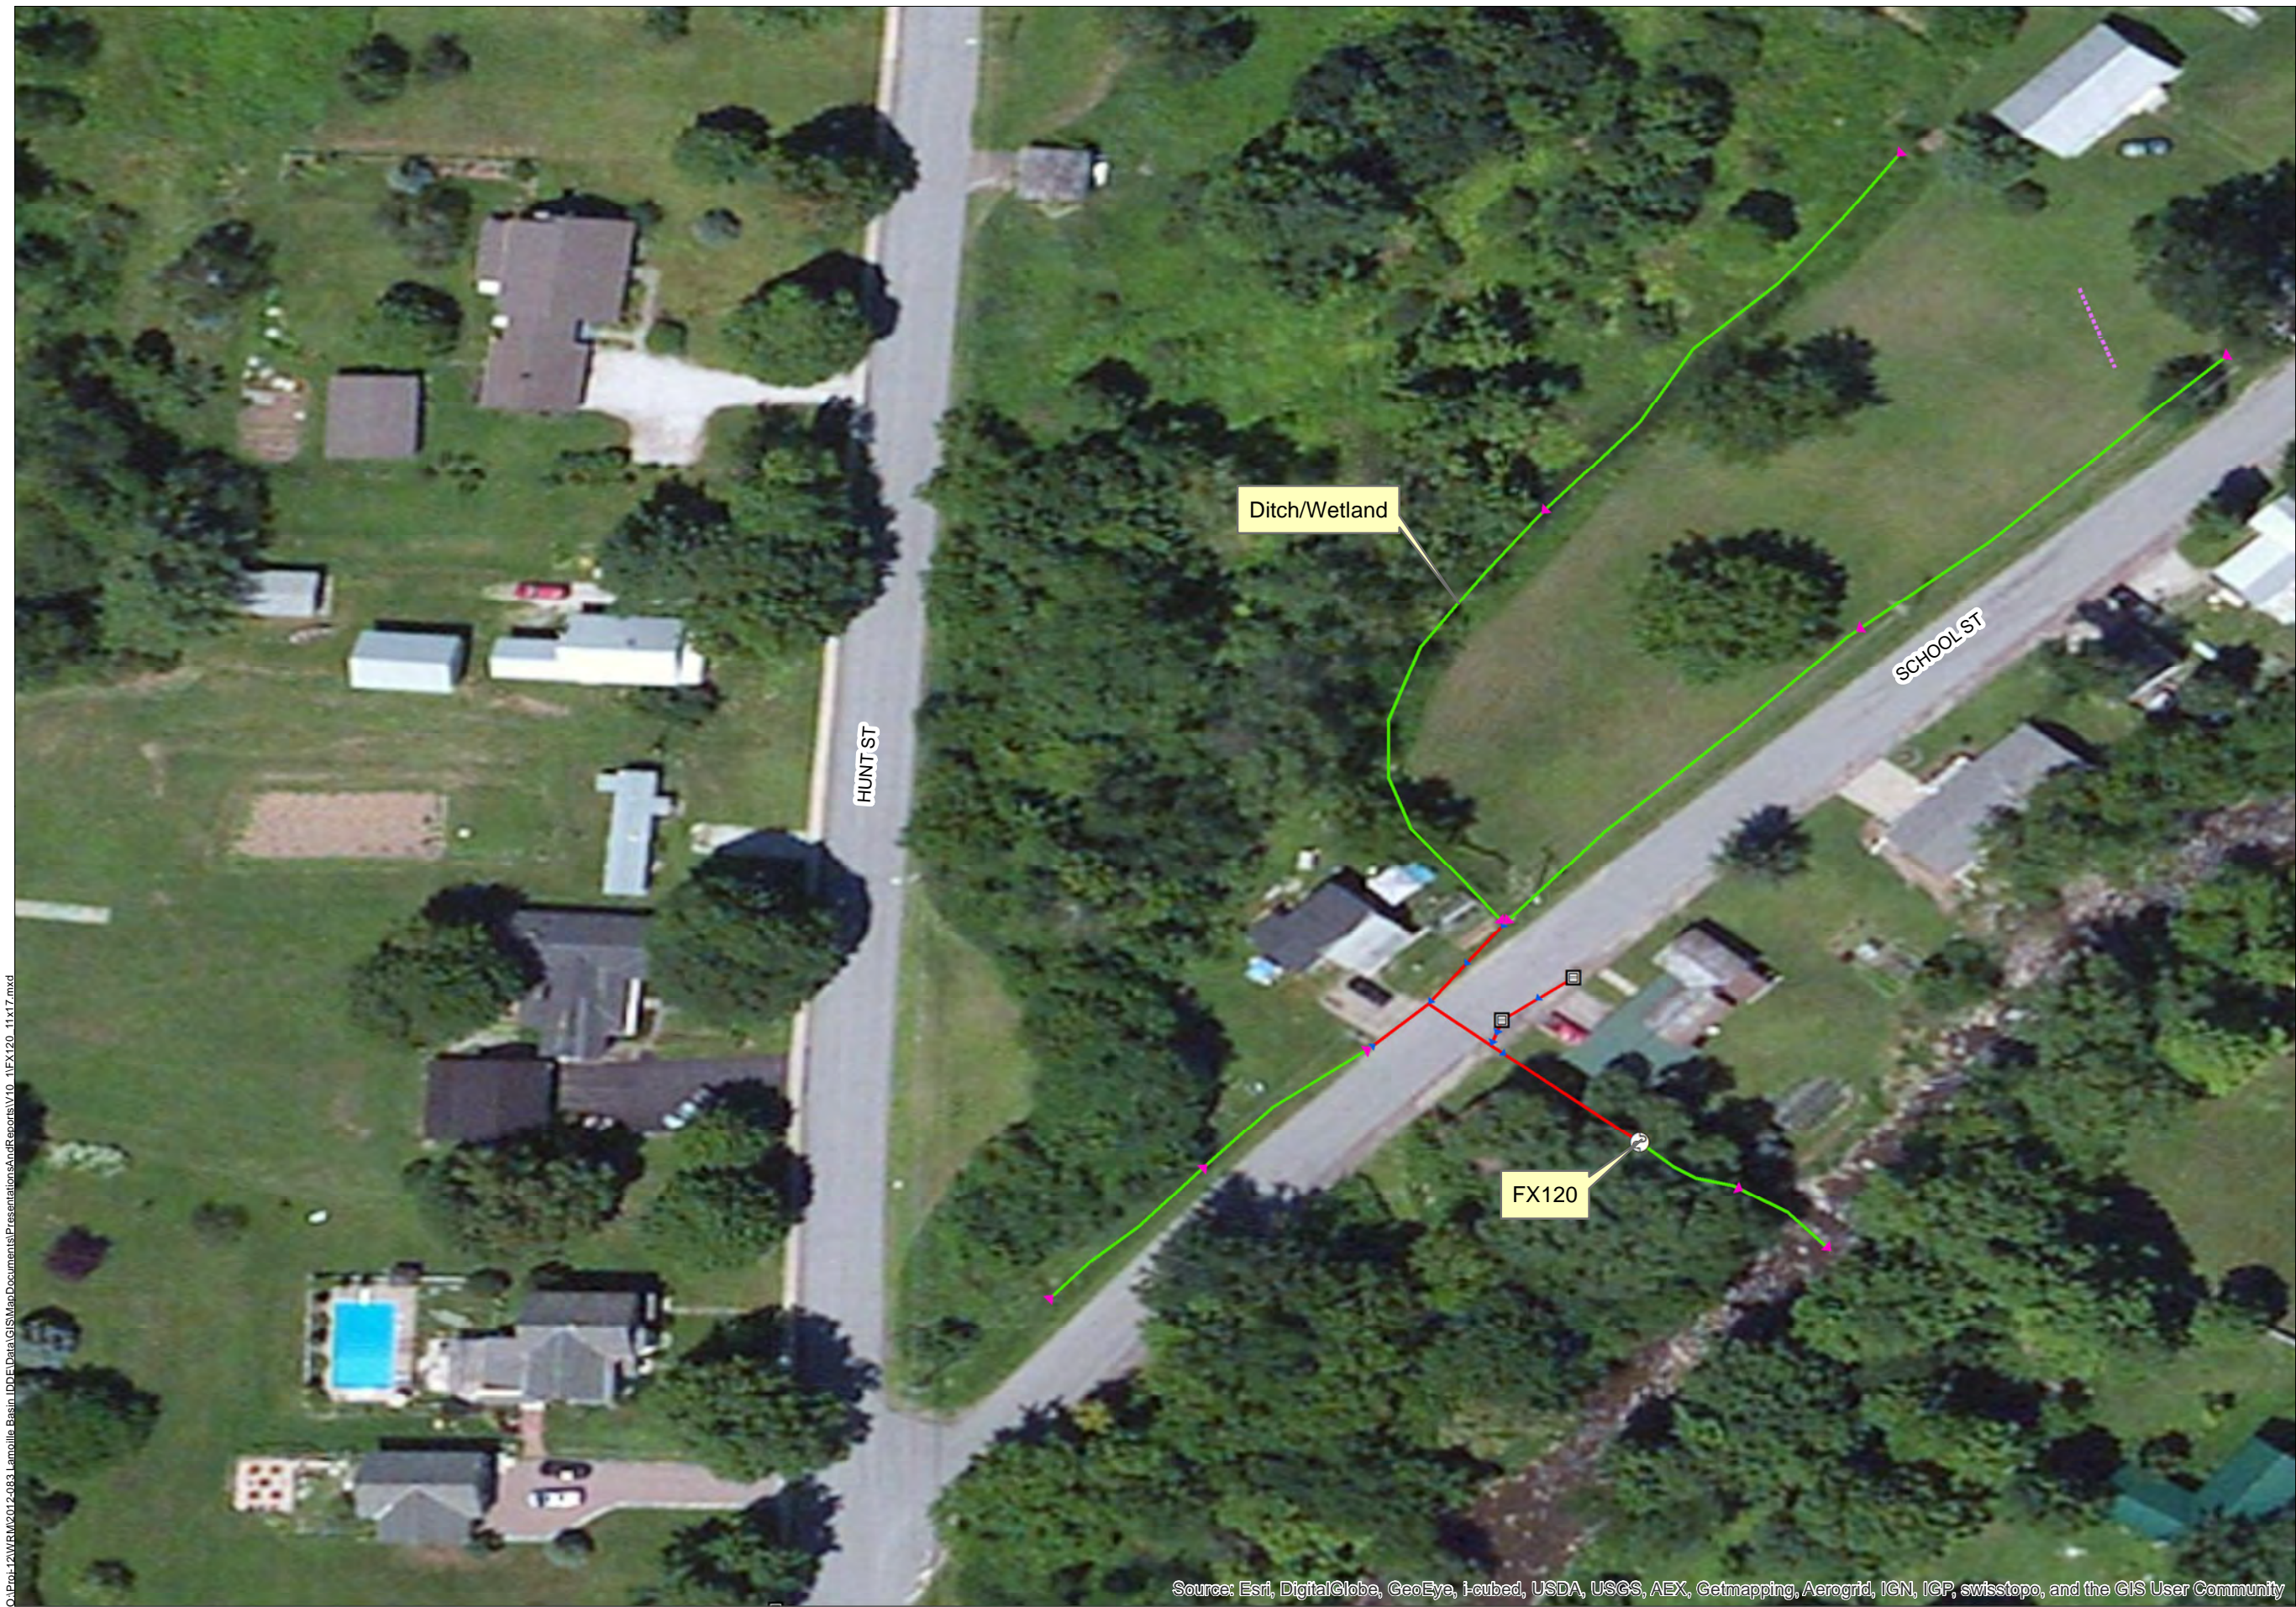
Map 3. System FX120
Lamoille River Basin IDDE
Fairfax, VT

The FX120 outfall is a 15-in. corrugated metal pipe. This system discharges on the southeast side of School Street (Appendix C, Map 3). The outfall pipe was dripping and had a musty odor and iron staining at the time of the initial assessment. Water quality data for this outfall are presented in Table 7. Moderate concentrations of ammonia (0.5-1.0 mg/L) were measured at the outfall on August 2 and 14; however, no ammonia was detected when the outfall was resampled on September 20, 2012. Low chlorine concentrations were measured on all three sampling dates. Due to detection of ammonia at the outfall, follow-up sampling was conducted on September 20, 2012 for total phosphorus and *E. coli* analysis. The flow rate was moderate (0.14 L/s) and the concentrations of total phosphorus (31.6 µg/L) and *E. coli* (74 MPN/100 mL) were low.

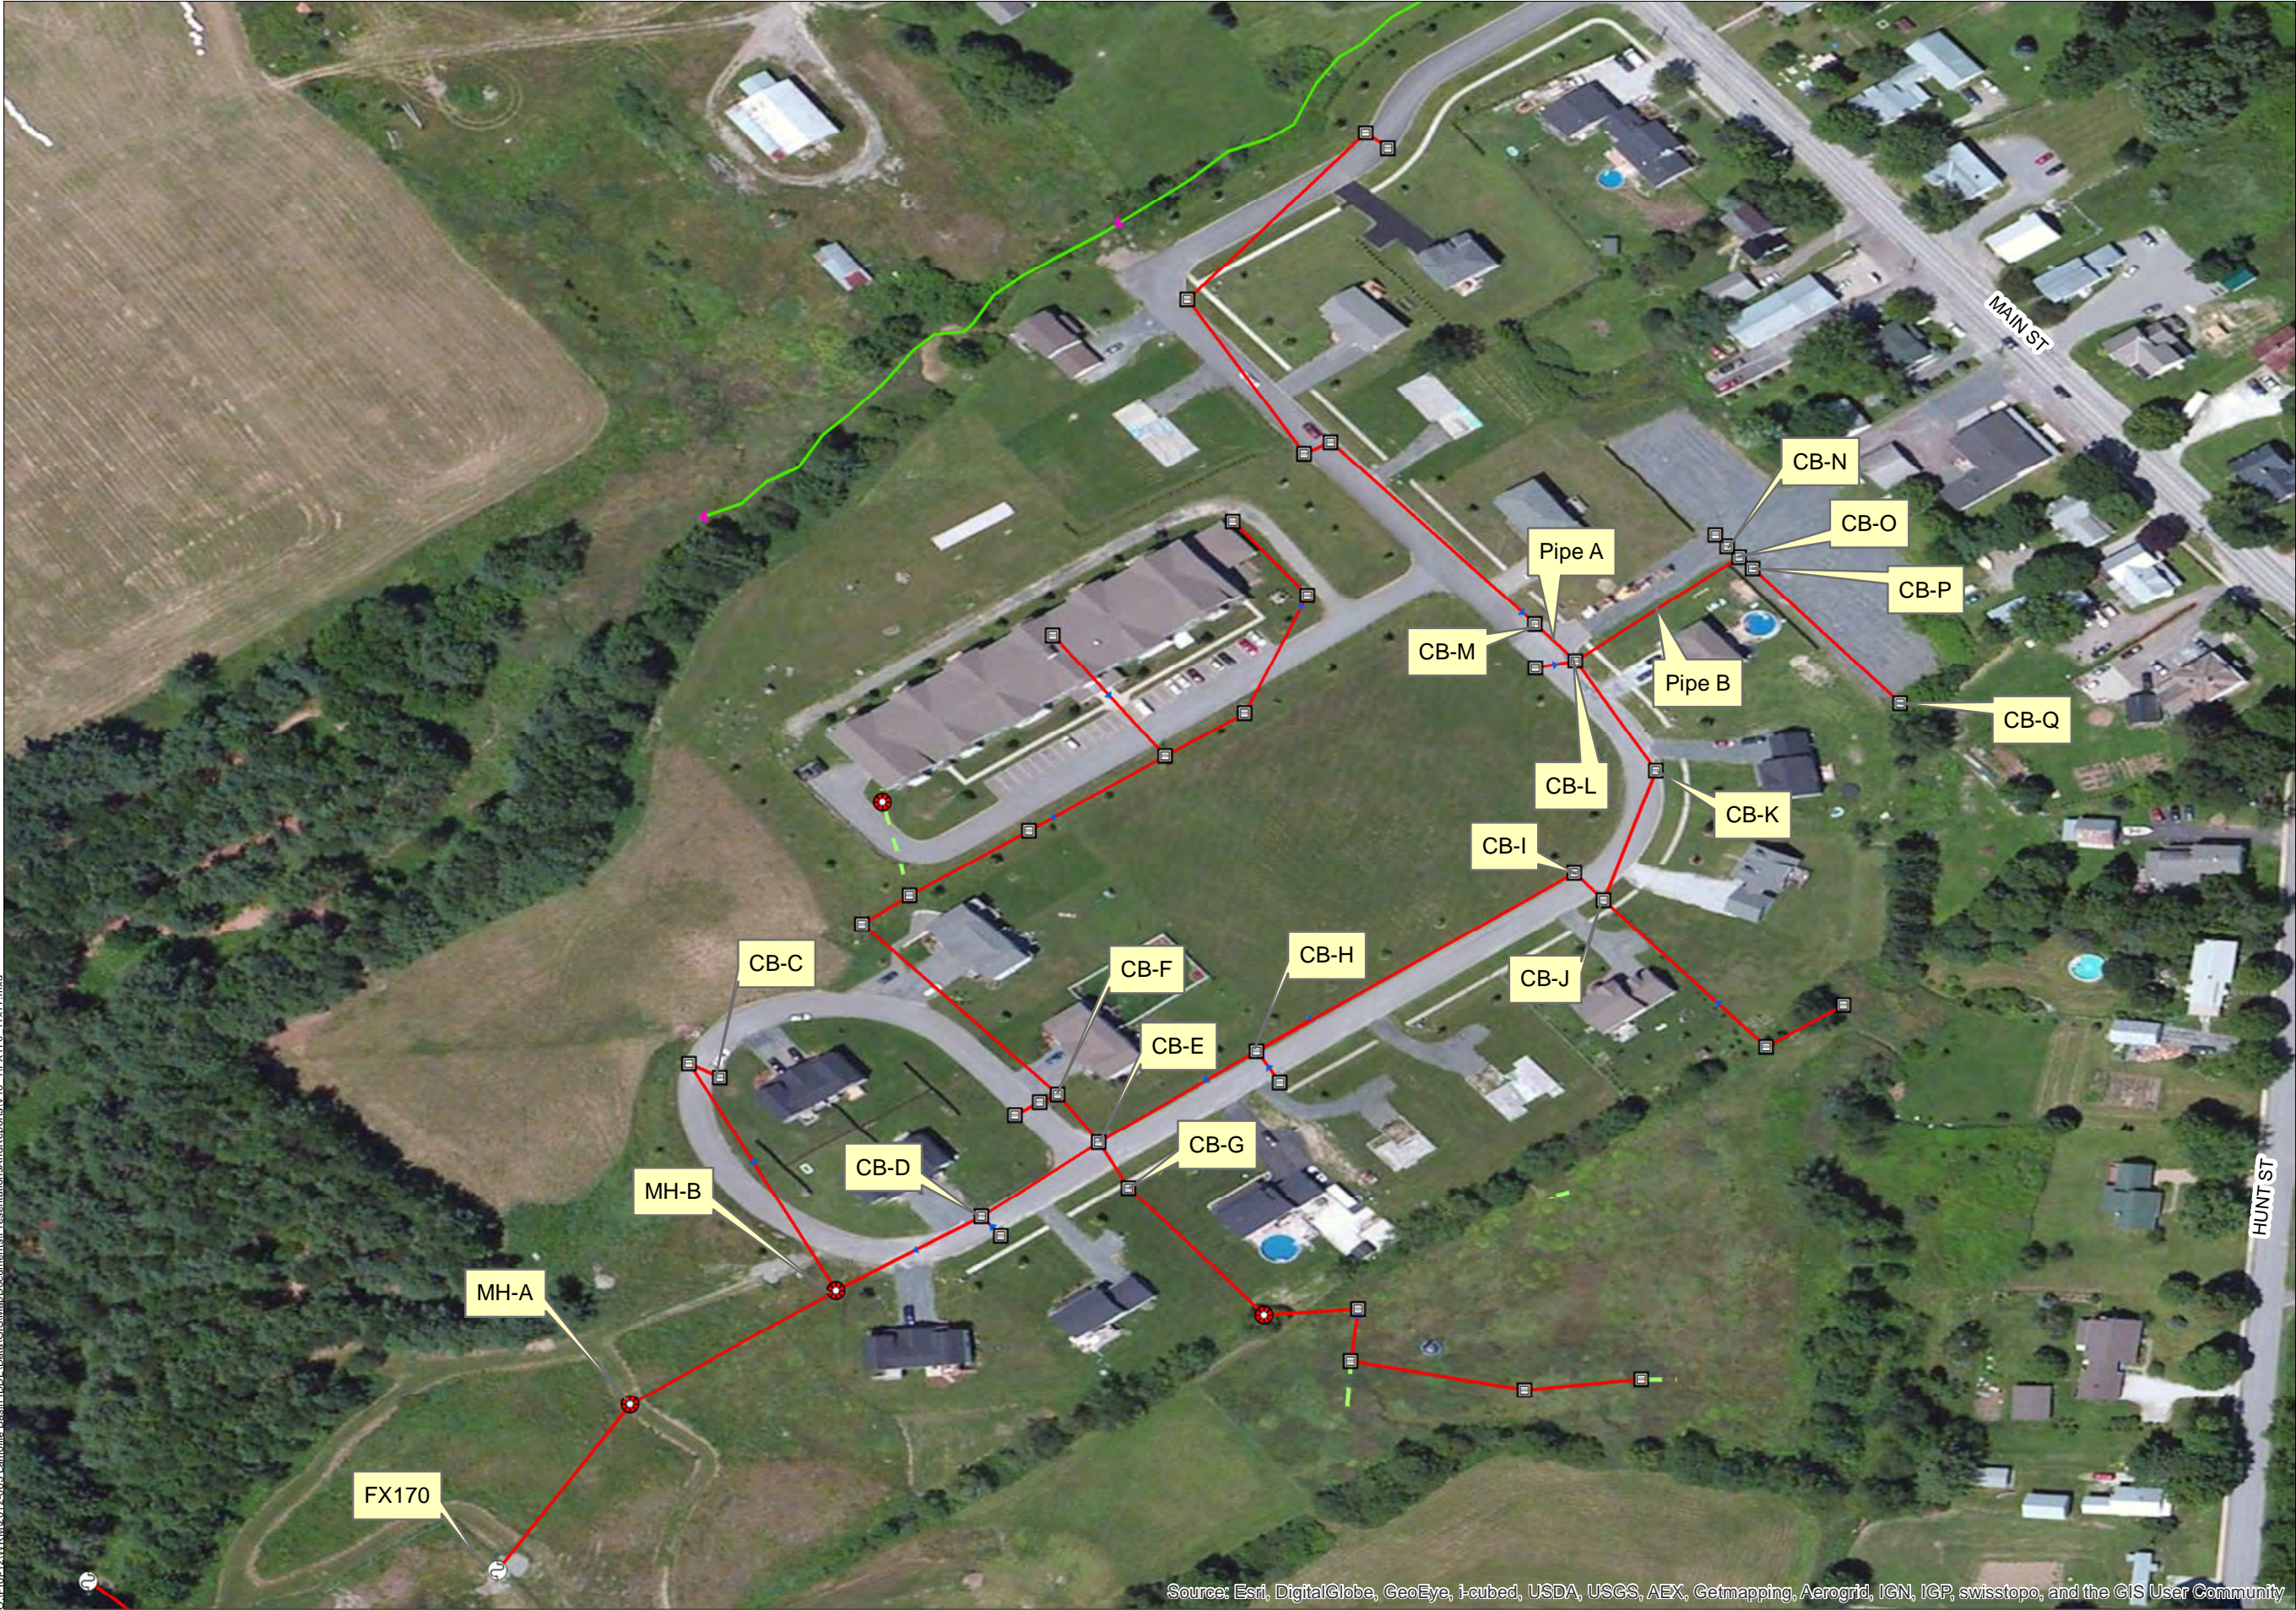
Map 4. System FX170
Lamoille River Basin IDDE
Fairfax, VT

On August 13, 2013, this system was visited with Randy Devine of the Town of Fairfax. We confirmed significant flows of chlorinated water entering catchbasin CB-L from both Pipe A and Pipe B. It is unclear whether the source is the municipally-owned water main or a privately owned lateral. **We have recommended that the Town perform leak detection on the municipal water line along Old Academy Street and on the line from Old Academy Street back to Main Street.**

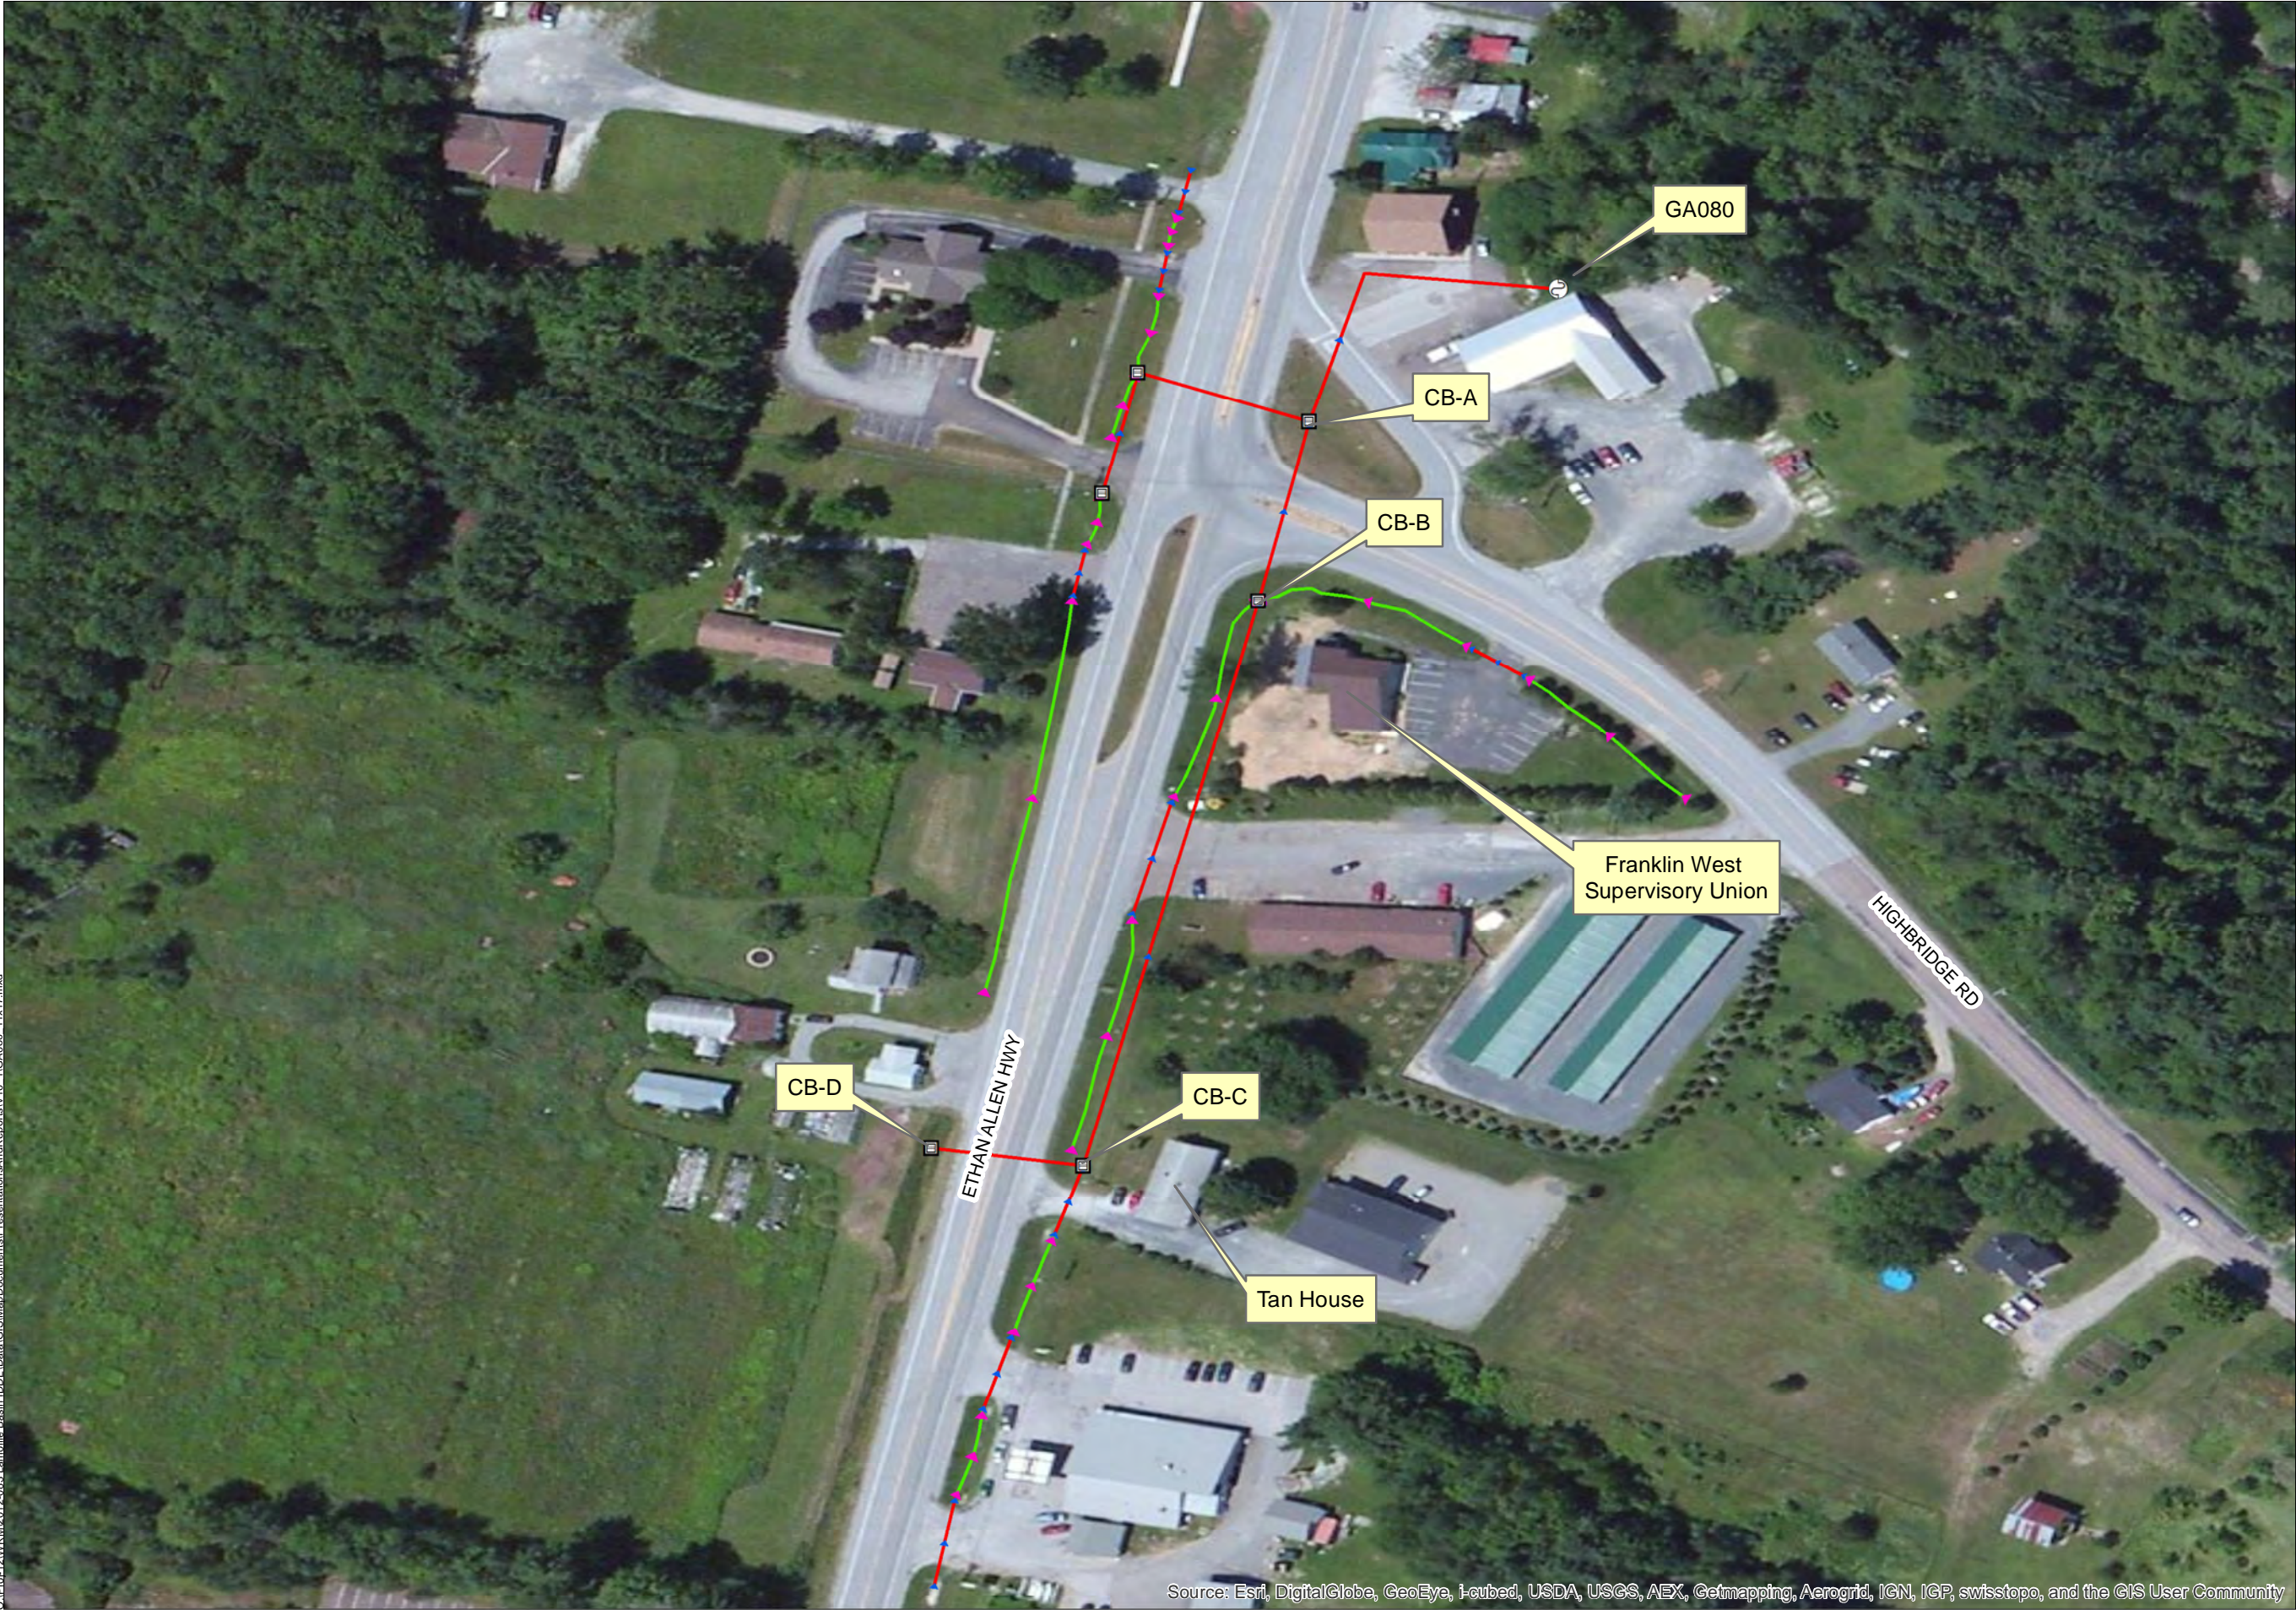
Map 5. System GA080
Lamoille River Basin IDDE
Georgia, VT

The GA080 outfall is an 18-in. corrugated black plastic pipe. This system drains a portion of Route 7 and discharges on the north side of Highbridge Road (104A) at its intersection with Route 7, behind an auto service station (Appendix C, Map 5). Water quality data for this outfall are presented in Table 9. On July 27, 2012 a petroleum odor was observed at the outfall; this may have resulted from fumes from the

service station. A distinct laundry odor was observed in the first three catchbasins up-pipe from the outfall. The odor was strongest in the second catchbasin up-pipe from the outfall, CB-B. Water in the sump of CB-B was opaque and blue-gray in color (Figure 2). Ammonia and MBAS detergents were detected at low concentrations at the outfall and optical brightener was detected at the outfall and in the first three up-pipe catchbasins.

August 23, 2013. Pads placed in CB-A, CB-B, and CB-C showed strong optical brightener fluorescence. Because no pipes enter CB-B and CB-C, we suspect the source of the laundry detergent is infiltration from the onsite wastewater treatment system at the tan ranch house located on Route 7 in front of the bike shop and kitchen store. A second possible source is infiltration from the newly constructed (2011) mound system at the Franklin West Supervisory Union building at 4497 Highbridge Road.

Given the presence of laundry detergent and the location of the tan house relative to the storm drain, we suspect that the onsite wastewater treatment system serving this property is not providing adequate wastewater treatment. The question becomes: what level of treatment constitutes failure? *E. coli* levels measured at the outfall were low; therefore the system may provide adequate pathogen removal. The phosphorus concentration was also low, suggesting that phosphorus removal in the leachfield soils may be adequate. We expect mobile constituents such as nitrogen, chloride, and optical brighteners to pass from onsite wastewater treatment systems to groundwater. This is not necessarily a problem. In our view, the strongest basis for finding that the system was not providing adequate wastewater treatment was the bluish-gray color observed in catchbasin CB-B on July 27, 2012 and the laundry odor repeatedly observed in CB-B and CB-C.

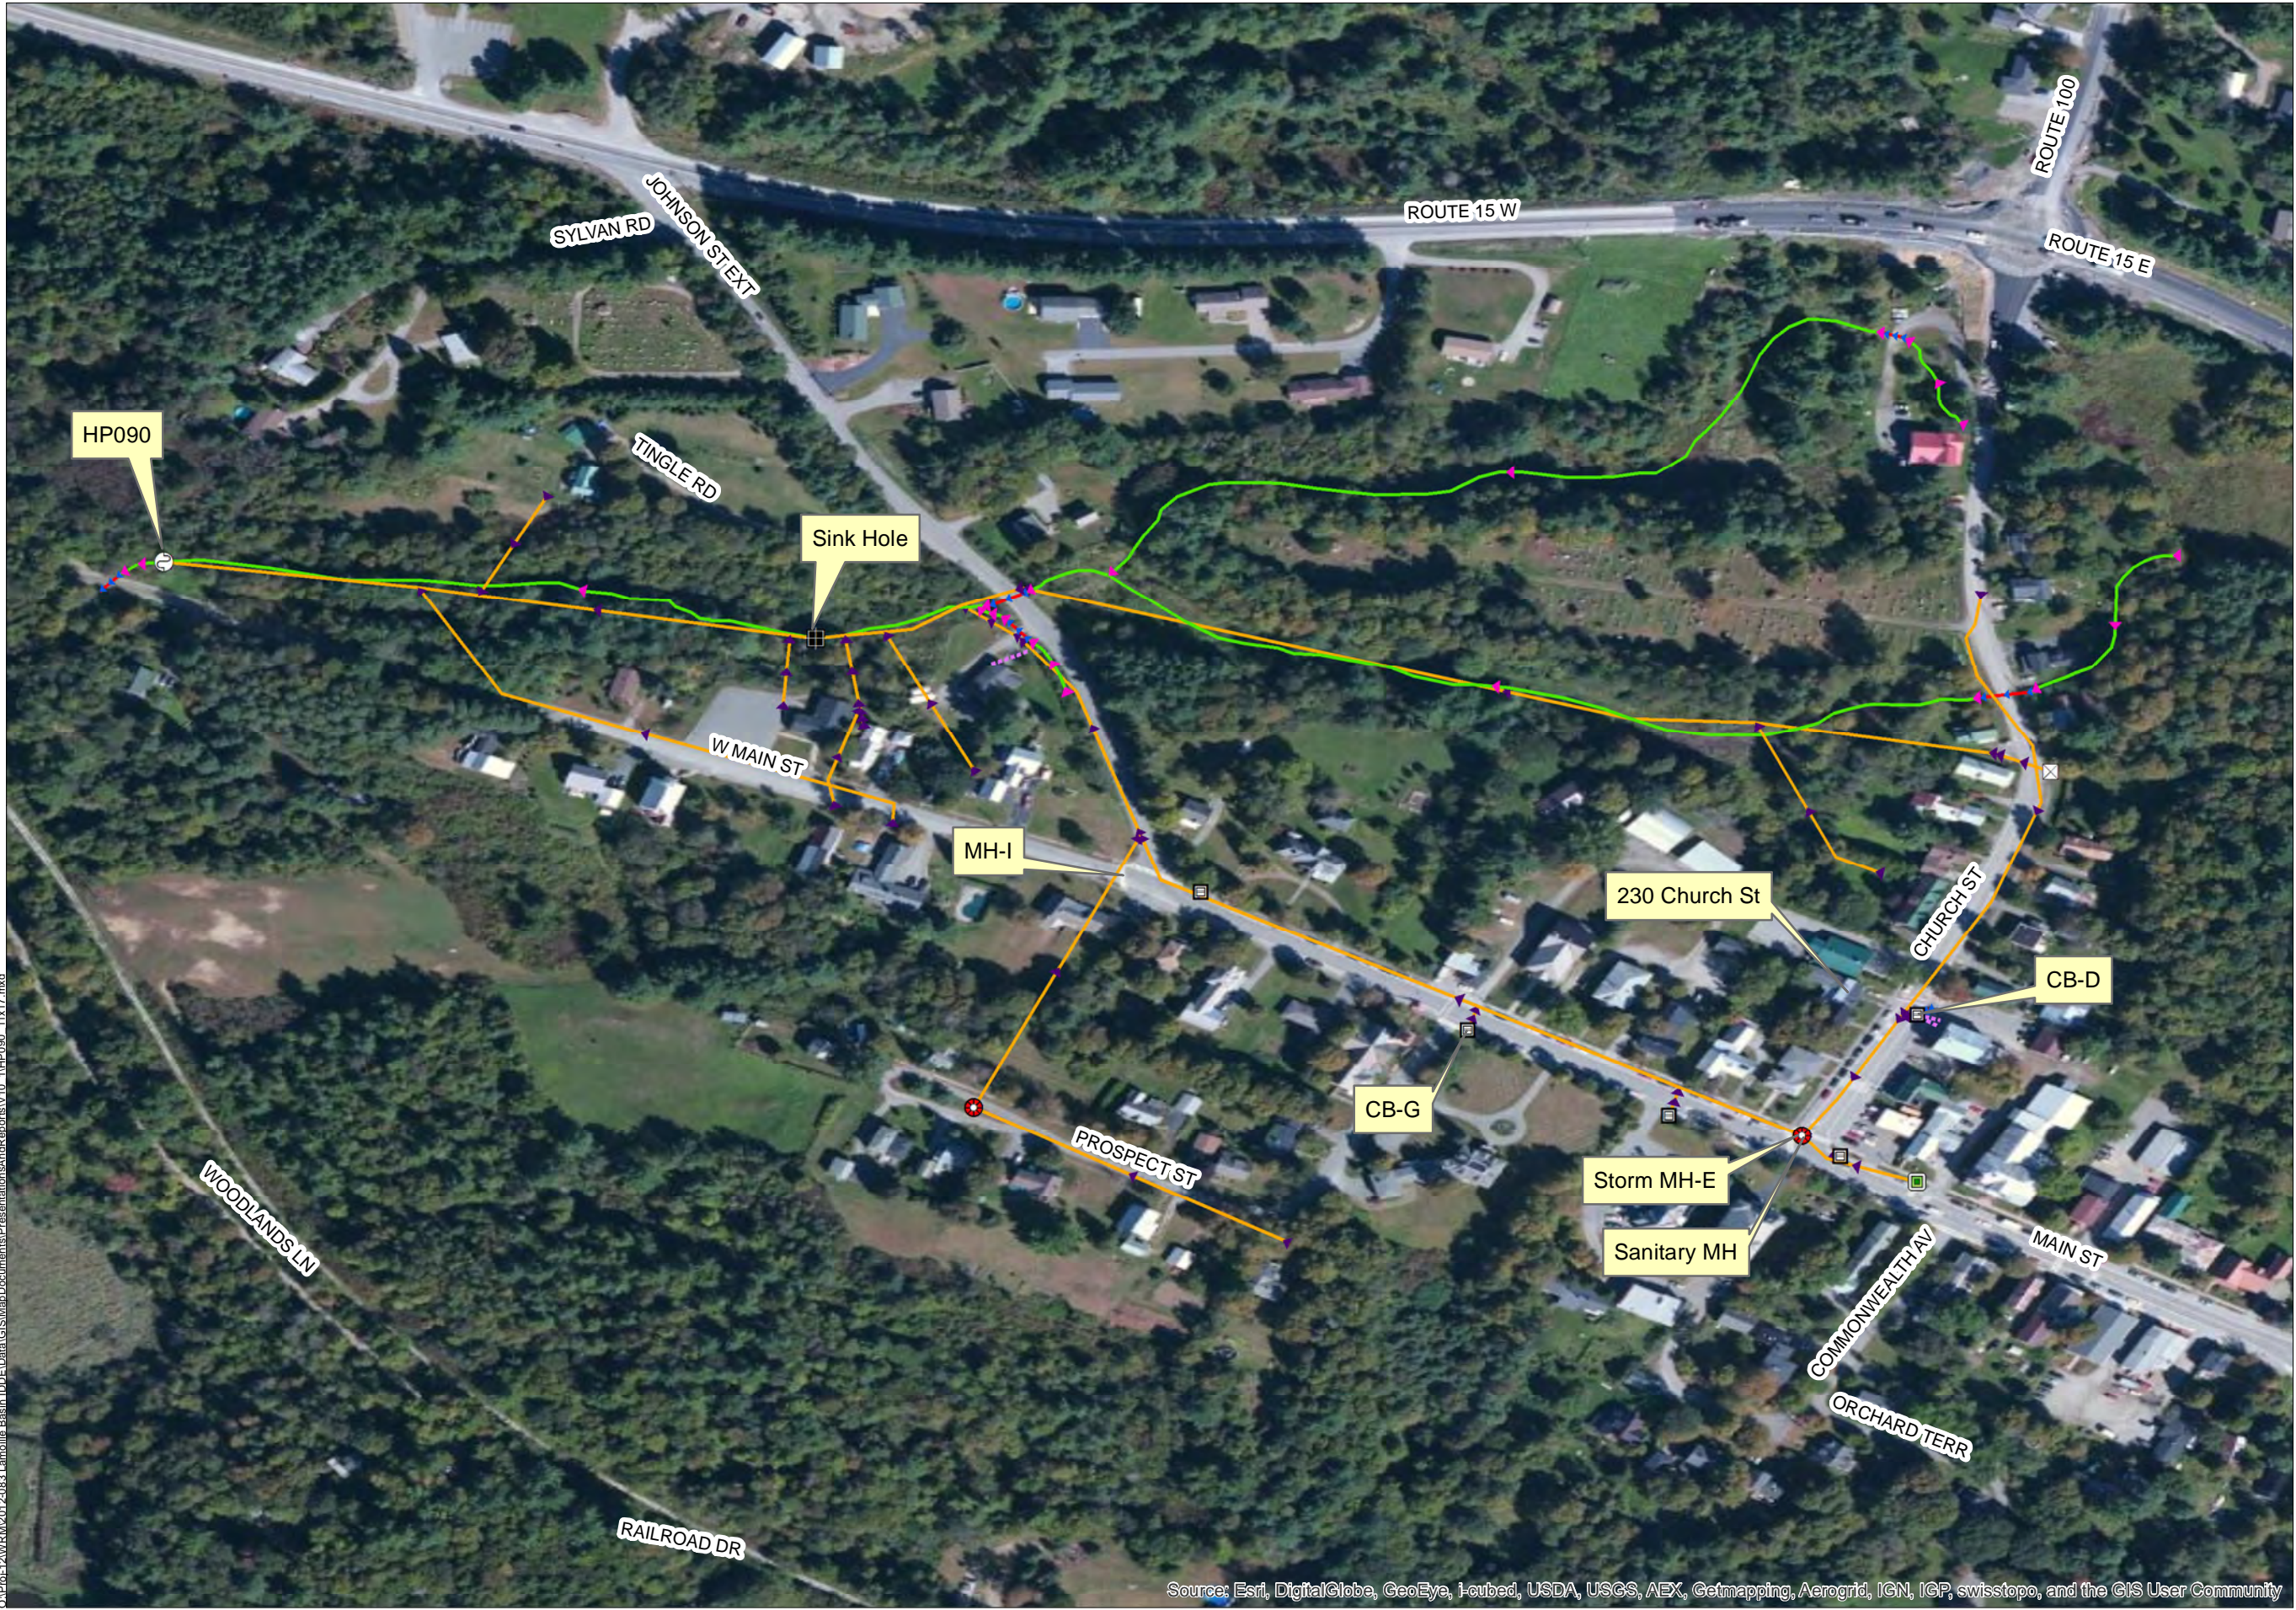
Map 14. System HP090
Lamaille River Basin IDDE
Hyde Park, VT

On November 13, 2012, we attempted to follow the path of the buried stormline up from the outfall. The vitrified clay line is broken in places, creating two sinkholes. The sinkhole pictured in Figure 4 had a wastewater odor and condoms were visible, indicating a wastewater source. Optical brightener monitoring pads were placed at the outfall, the sinkhole, CB-D, and MH-I. Optical brightener was

and Carol Robertson, the Village General Manager, to discuss the HP090 system. A site visit was made immediately following a rain storm and substantial flows were observed discharging from both the outfall and the sinkhole into the ephemeral stream running through the ravine. A wastewater odor was observed at both the outfall and the sinkhole. Because it was unclear what the broken pipe in the sinkhole was connected to, a plan was made to excavate the pipe to determine its connections and create access for sampling closer to Johnson Street Extension.

On October 31, 2013 excavation at the sinkholes quickly revealed that they were holes over breaks in the former combined sewer main. In the previously sampled sinkhole (closer to Johnson Street Extension), both ends of the broken vitrified clay line were exposed. Because the line was the main and not a broken lateral, attention shifted to finding the source of the contamination within the downtown area. All residences located on Main Street between Church Street and Johnson Street Extension were dye tested on October 31, 2013 and over the following weekend. In every case, dye was seen in the sanitary system and not the stormwater system (at MH-I).

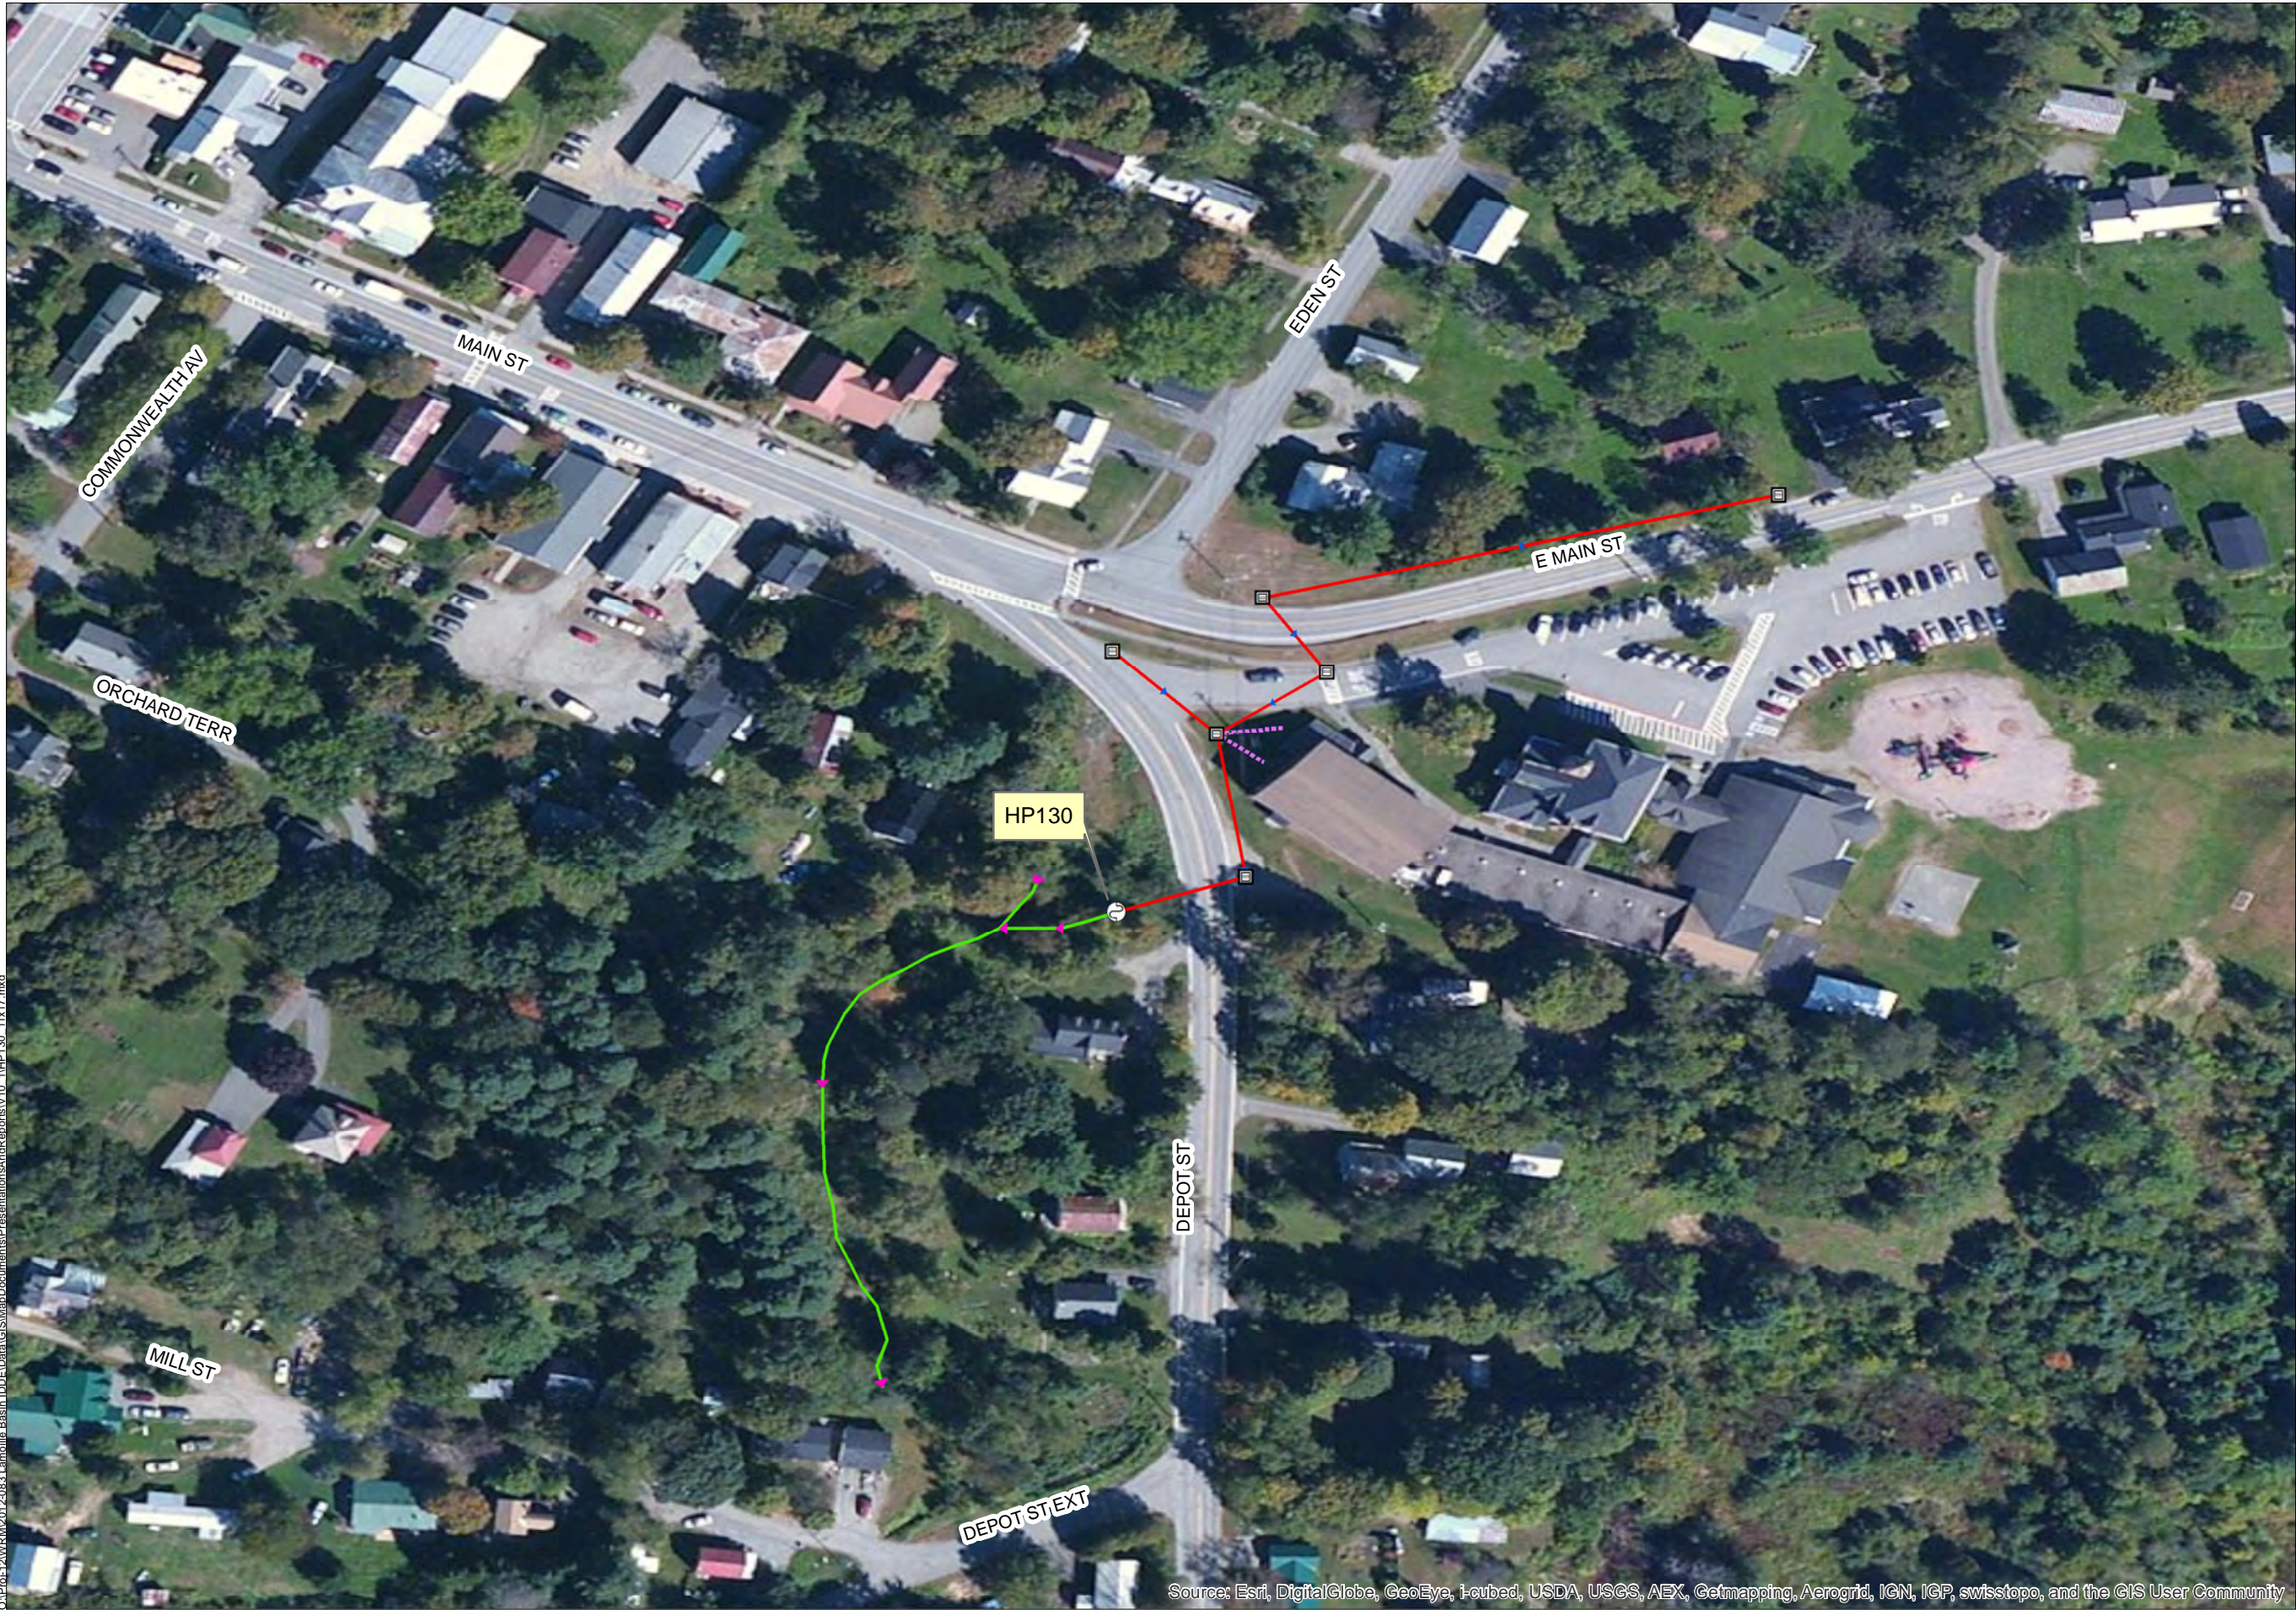
Map 15. System HP130
Lamoille River Basin IDDE
Hyde Park, VT

Although concentrations were low, MBAS was detected repeatedly at the outfall. It is possible there is a small wastewater or washwater leak infiltrating this system, possibly within the road base on Depot Street. However, no *E. coli* or optical brightener was detected, which suggests that any wastewater present has been partially renovated.

During the August 27, 2013 meeting with Ron Rodjenski and Carol Robertson, Mr. Rodjenski described plans to replace the sidewalk and stormwater drainage infrastructure in this area in 2014. The HP130 system will be replaced. **We concluded that if there is in fact an inappropriate discharge to this system, the problem would likely be eliminated in construction of the stormwater drainage system improvements.**
