Blanchard Brook, Montpelier, Vermont

Blanchard Brook in Montpelier has been found to be impaired by stormwater runoff quality as measured by the biology of the stream and is on the state's 303d list of impaired waterways. There are at least 12 significant discharges to the stream from the developed lands of Montpelier. The largest discharge to the stream is drainage area #127 which drains a large section of the central watershed. The recommended course of action for stormwater impacted streams is to install a treatment structure that controls both the water quality volume and the channel protection volume from these discharges near the outfall. A map showing the location of the discharges and a possible retrofit location is provided. A cost estimate (excluding land costs) is provided. Since this is a developed area modifying the existing wet ponds to manage these two volumes would be the least disruptive to the landowners. The landowners in drainage areas #121-122 will have to upgrade their discharges to the stream to meet 50% of the water quality volume from the properties although most of the runoff can be treated for sediment removal with drainage areas #3000b. This report also

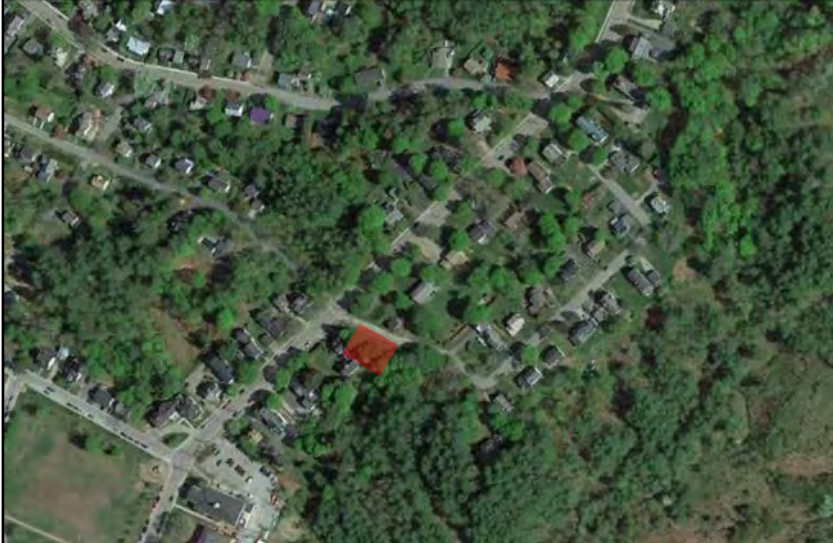
| Problem Area ID: BB-01 | Latitude: 44.256666 | Longitude: -72.563895 |

Description of Observed Conditions:
 Stormwater runoff from approximately 150' immediately east of College St. is turned out over a steep hillside and through an area where lawn waste is being composted. "Green Street" retrofitting could be used to better manage road runoff.

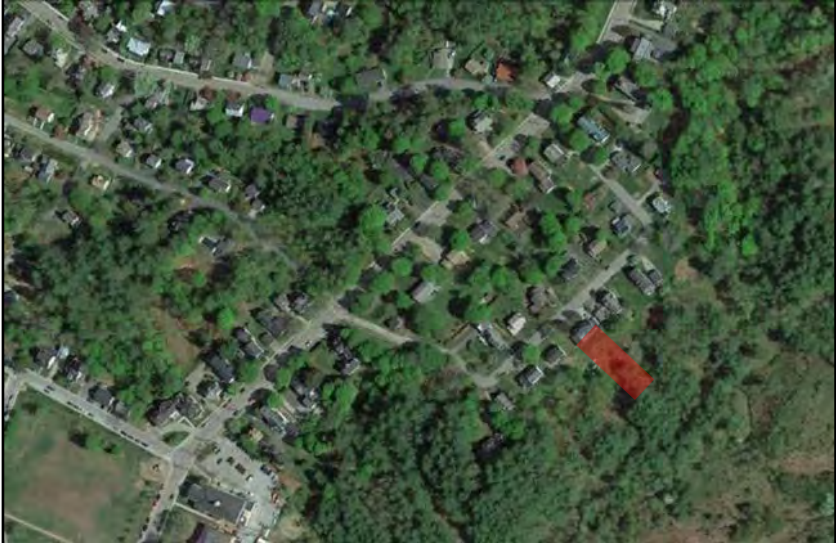
| Problem Area ID: BB-02 | Latitude: 44.256503 | Longitude: -72.561980 |

Description of Observed Conditions:
 City constructed a small splash pad/energy dissipation area approximately ¼ of the way down the slope in the backyard of #8 McKinley St as part of a CSO separation project. Homeowner indicated a willingness to consider improvements to the pond. Some erosion was visible below this structure.

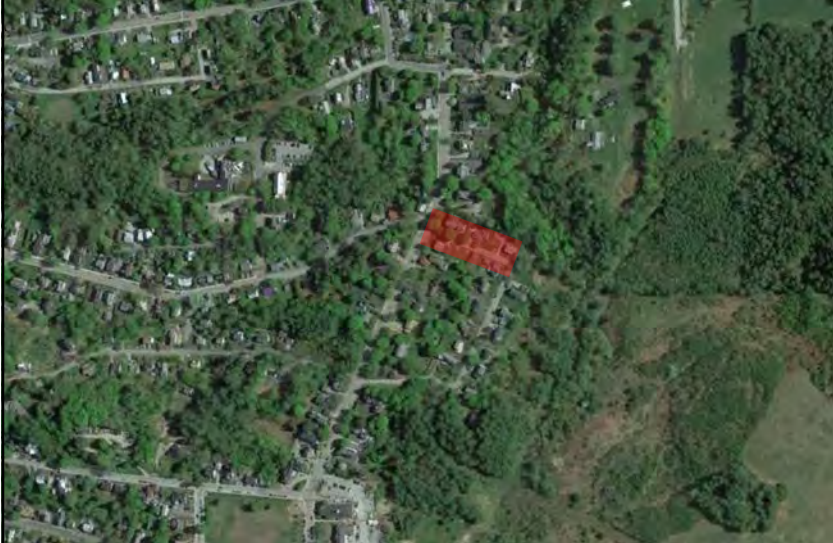
| Problem Area ID: BB-03 | Latitude: 44.257311 | Longitude: -72.561528 |

Description of Observed Conditions:
 Hinkley Street is wide, with no curbs separating the road edge from the adjoining green space. "Green Street" retrofit could be used to capture/treat runoff and add the benefit of traffic calming.

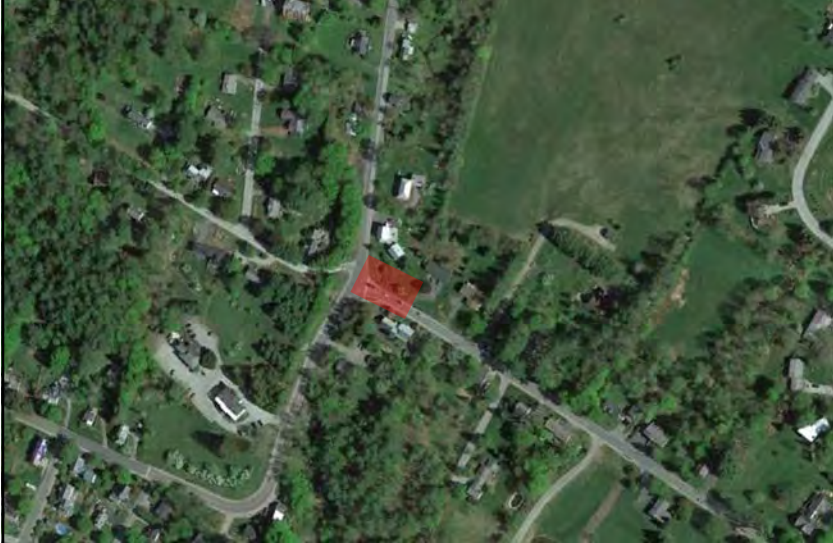
| Problem Area ID: BB-04 | Latitude: 44.262094 | Longitude: -72.558453 |

Description of Observed Conditions:
 Roadside drainage at the intersection of Towne Hill Rd and Main St is eroding. Drainage could be reshaped and stabilized to both reduce erosion and improve treatment.

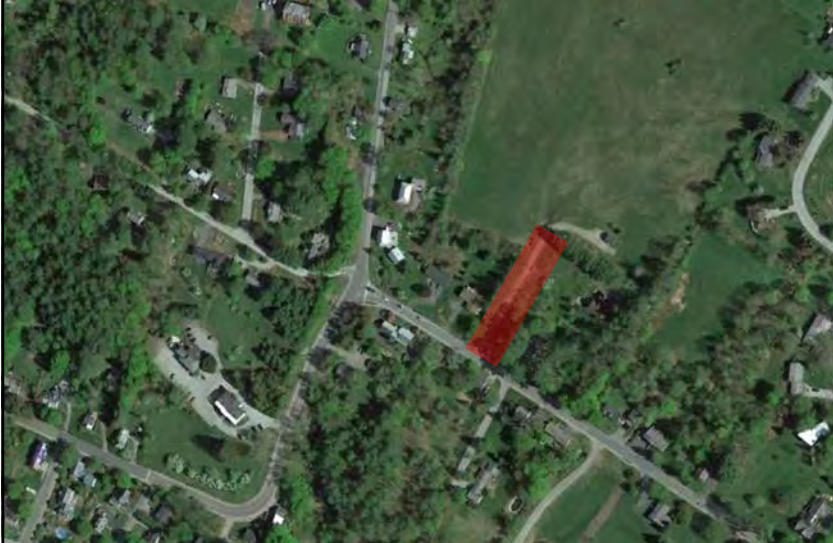
| Problem Area ID: BB-05 | Latitude: 44.261693 | Longitude: -72.557134 |

Description of Observed Conditions:
 Significant erosion of both the road surface and in the adjacent ditch was observed (Photo 1). A storm water treatment practice at the corner of Easy St and Towne Hill Rd could be effective in slowing and treating flow. The ditch itself should also be appropriately shaped and stabilized, and the road should be crowned.

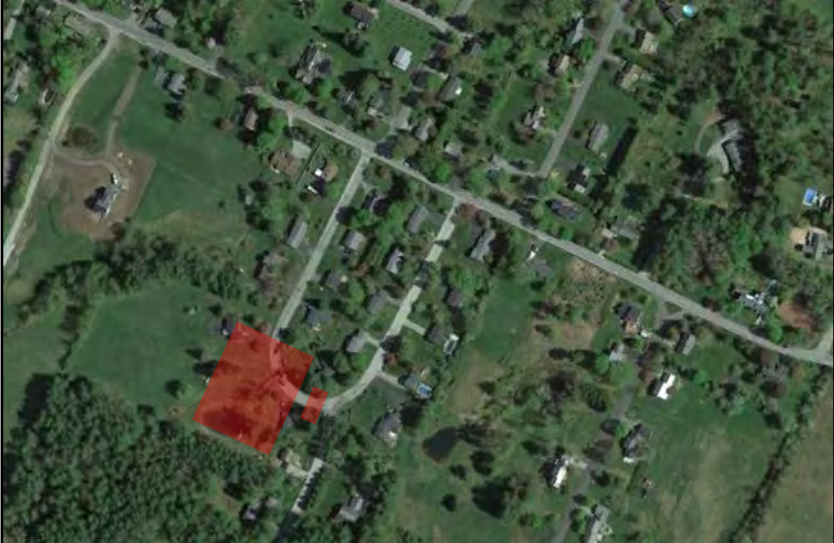
| Problem Area ID: BB-07 | Latitude: 44.258303 | Longitude: -72.554199 |

Description of Observed Conditions:
 Grandview Terrace was resurfaced during the summer of 2015. Concentrated flow along the edge of the shoulder has already started to erode the gravel and it is accumulating around the catch basins at the bottom of Grandview Terrace. The paved turnout was installed too high, making it ineffective for directing storm water. The shoulder at ~140 Grandview Terrace is in poor shape as well, and requires maintenance.

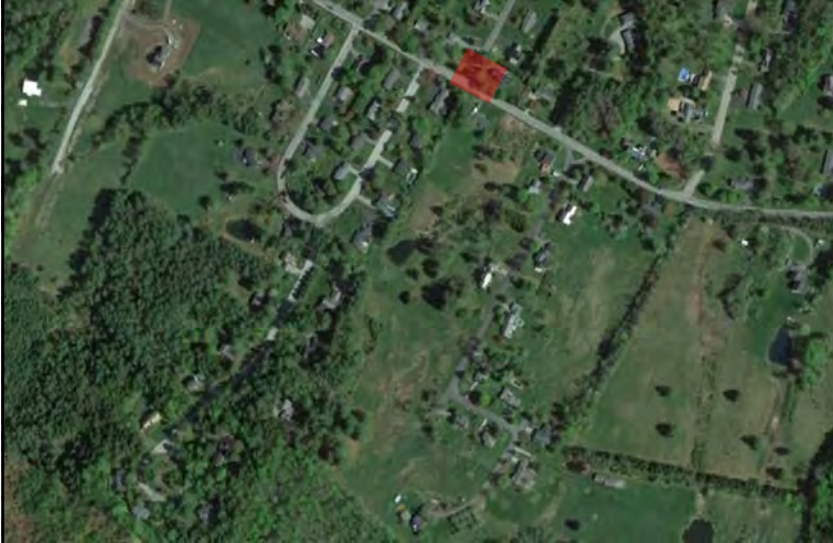
| Problem Area ID: BB-09 | Latitude: 44.259568 | Longitude: -72.551785 |

Description of Observed Conditions:
 “Green Street” or other retrofit within the ROW on Woodcrest Rd could be used to capture/treat runoff and add the benefit of traffic calming (Photo 1). On the opposite side of Woodcrest Rd a riser could be added to the catch basin to more effectively manage storm flows (Photo 2).

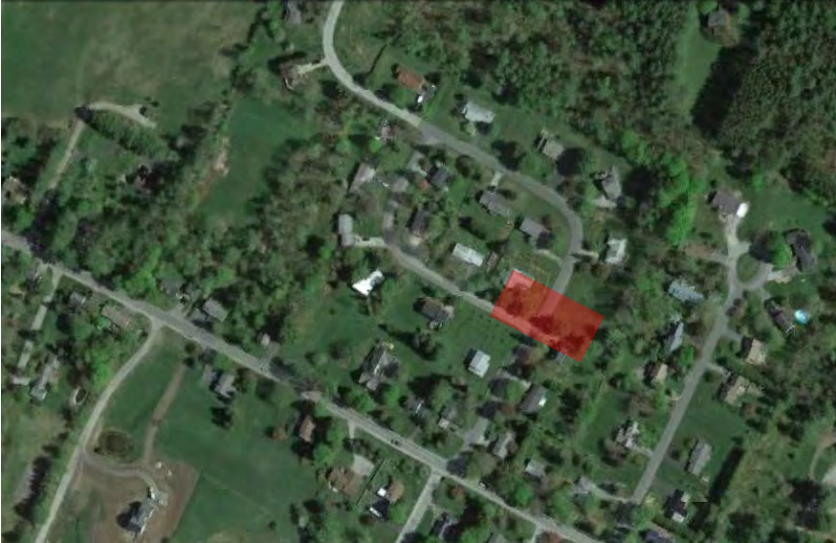
| Problem Area ID: BB-11 | Latitude: 44.260909 | Longitude: -72.552409 |

Description of Observed Conditions:
 The catch basin at the corner of Dover and Phillips could be raised. Stormwater storage/treatment could be provided in the green space as well (Photo 1). The ditch on the property across Dover Rd. could be reshaped and stabilized to reduce erosion (Photo 2).

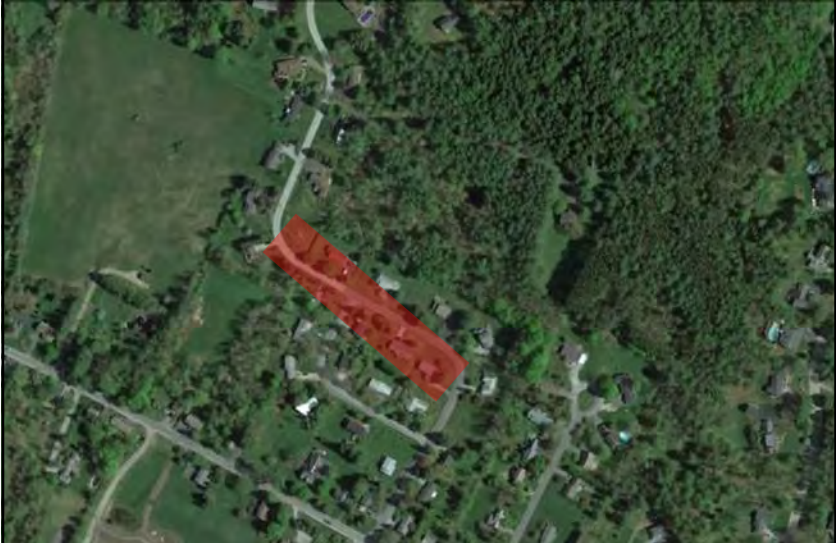
| Problem Area ID: BB-13 | Latitude: 44.262167 | Longitude: -72.553011 |

Description of Observed Conditions:
 Stream channel is currently unraveling below the road; this channel was partially stabilized following a 2008 storm event. Removing the curb on the east side of the street below 135 Phillips Road would allow for a grassed swale to manage stormwater runoff.
