# Ayers Brook Watershed Stormwater Management Plan

Towns of Randolph, Braintree, Brookfield

Completed by Two Rivers-Ottawaquechee Regional Commission

February 2016

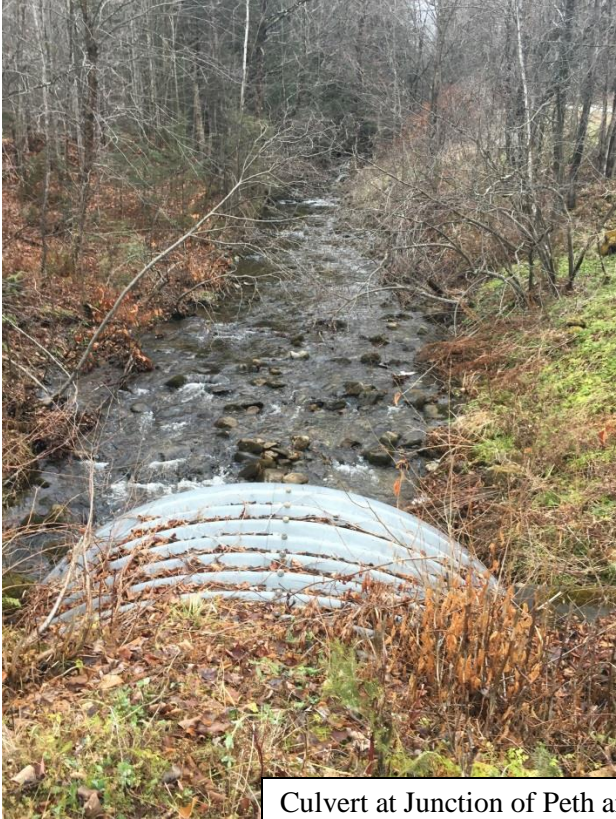
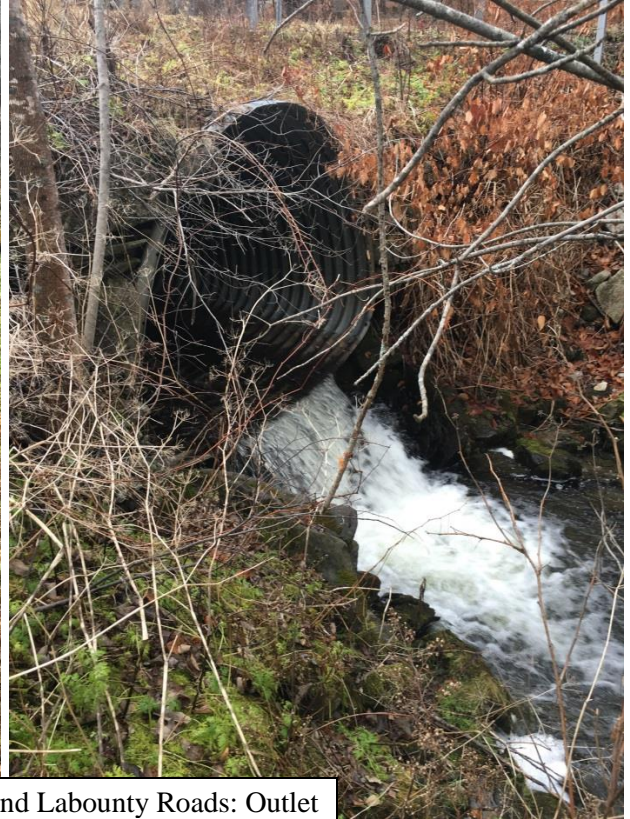
**Location and Description:** There is an undersized culvert at the junction of Peth Road and Labounty Road. The culvert is 9 feet high, 9 feet wide, and 52 feet long. The existing squashed culvert cannot appropriately handle the level of water that it currently experiences. It should be replaced with a bridge or arch to handle the hydraulic capacity of Spear Brook, a third order stream in the Ayers Brook Watershed. The outlet of this culvert is also perched, which prevents aquatic organism passage and leads to streambank and streambed scouring downstream.

Culvert at Junction of Peth and Labounty Roads: Outlet

**Recommended Treatment:** Upgrade this culvert to a bridge or arch. The width or span of this structure should be close to 22.16 feet according to bankfull width. Specific hydrologic studies may indicate that structure width may be bigger or smaller.

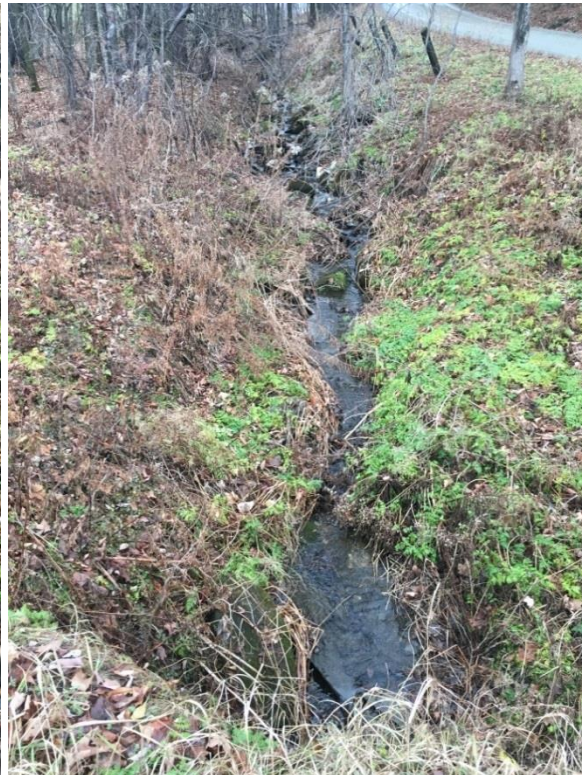
Culvert at the Junction of Peth and Brainstorm Roads: Inlet Stream

**Recommended Treatment:** Stone line inlet and outlet ditches. Upsize existing undersized culvert.

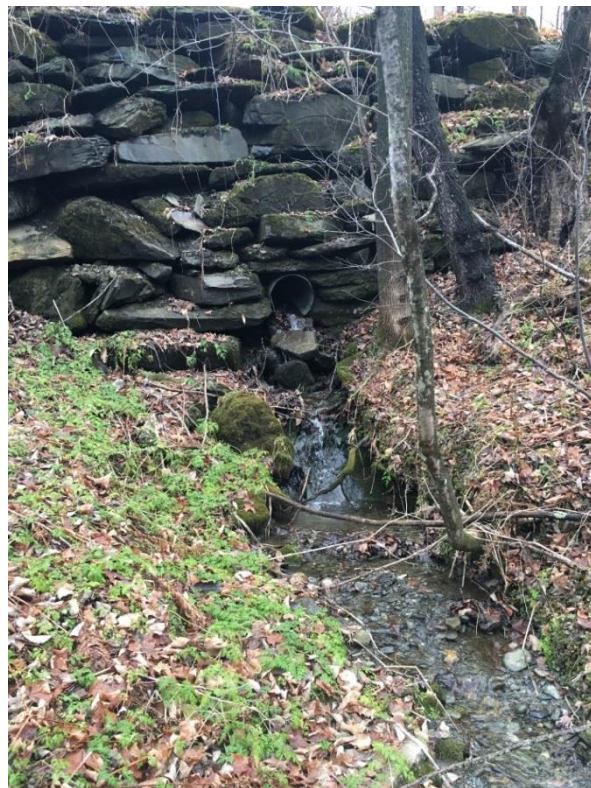
**Location and Description:** The 15 inch high, 15 inch wide, and 40 foot long culvert at this location is significantly undersized for the amount of water it witnesses. A rock wall at the outlet of this culvert poses a structural threat to the road if it were to collapse or fail. Sediment has accumulated at the inlet of this culvert. The outlet of this culvert is also perched, which prevents aquatic organism passage and leads to streambank and streambed scouring downstream.

Peth Road: Culvert Outlet and Rock Wall

**Recommended Treatment:** Upsize the culvert and stone-line the inlet and outlet ditches. The width or span of this structure should be close to 3.56 feet according to bankfull width. Specific hydrologic studies may indicate that structure width may be bigger or smaller.

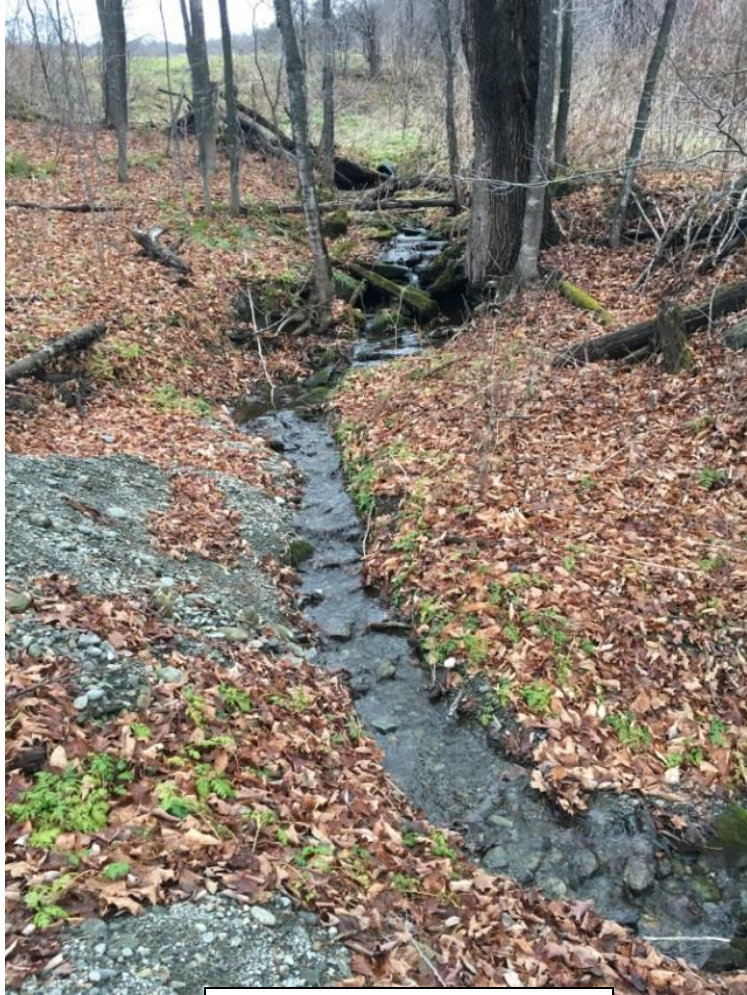
Peth Road: Inlet Stream

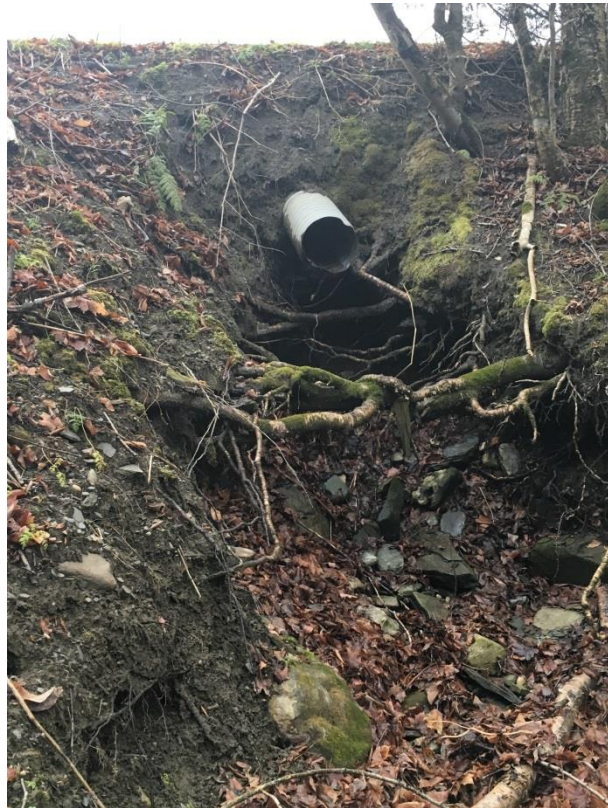
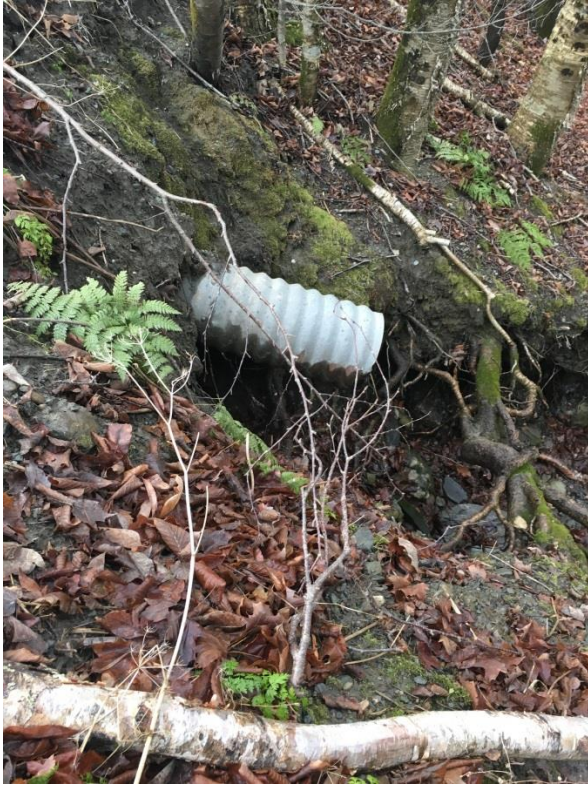
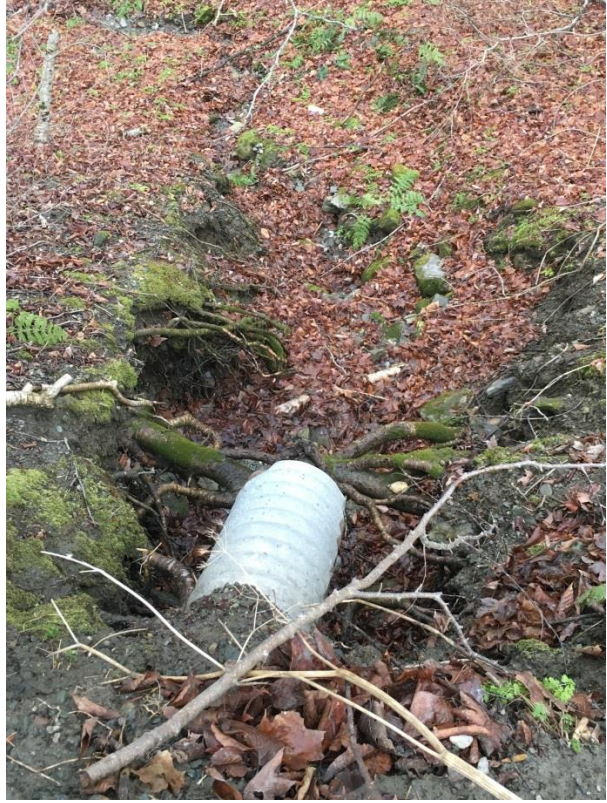
**Location and Description:** This 15 inch high, 15 inch wide, and 30 foot long steel culvert on Peth Road is in significant disrepair. The inlet has been damaged and is not properly ditched. The perched outlet has led to a severely eroded gully. Perched outlets also impede aquatic organism passage.

Peth Road: Culvert Outlet

**Recommended Treatment:** Stone-line the ditch inlet and outlet. Upsize the culvert to appropriately handle current levels of water. Repair eroded gully by fixing outlet bed with placed rock material.

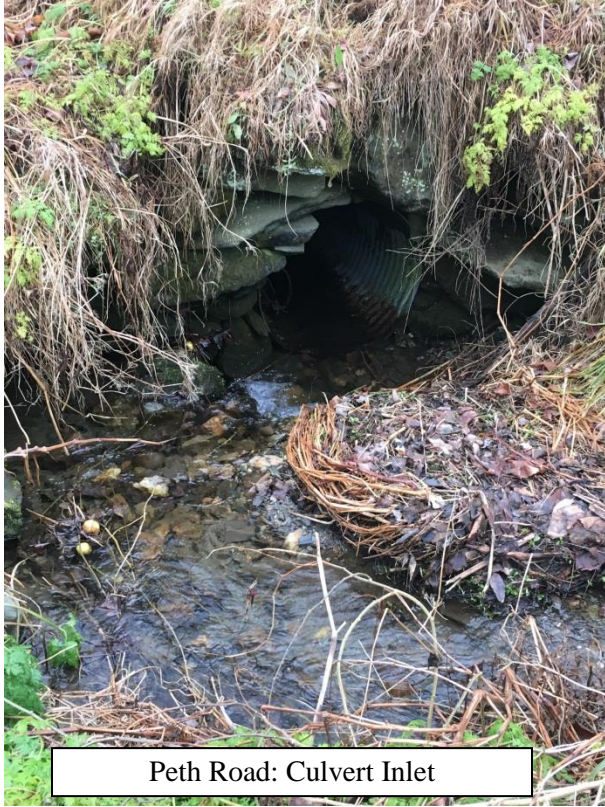
Peth Road: Culvert Inlet

**Recommended Treatment:** Upsize culvert to appropriately handle current levels of water. Stone line inlet and outlet ditches. .

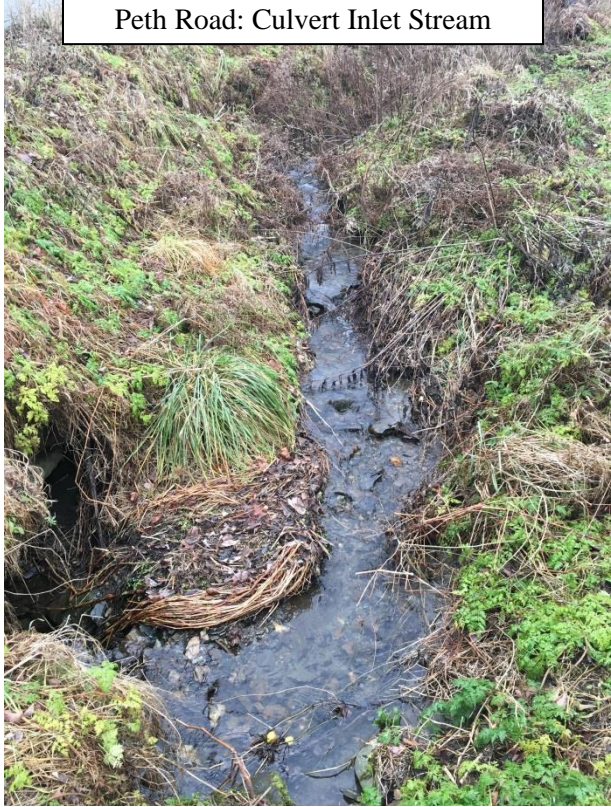
Peth Road: Culvert Inlet Stream

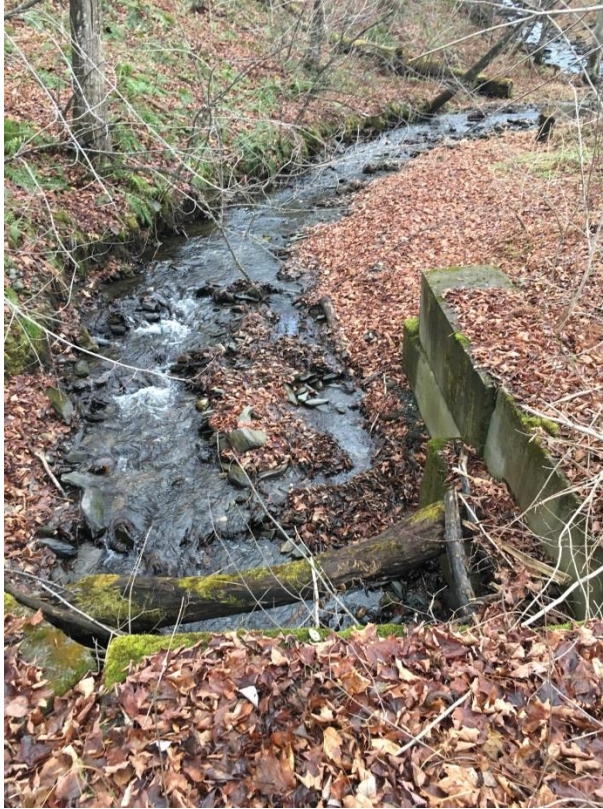
Brainstorm Road: Culvert Outflow

**Recommended Treatment:** Upgrade to a large pipe-arch or multi-plate pipe-arch. The width or span of this structure should be close to 11.5 feet according to bankfull width. Specific hydrologic studies may indicate that structure width may be bigger or smaller.

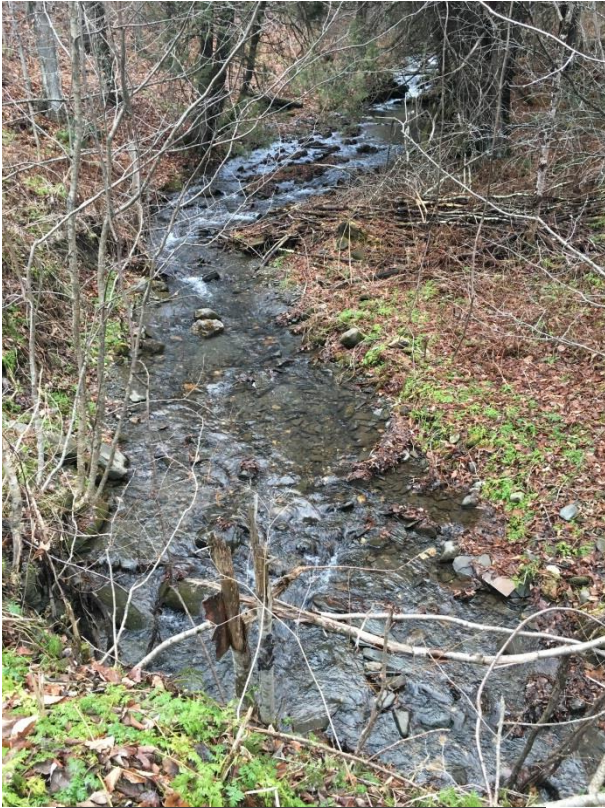
Farnsworth Brook Road Inlet Flow

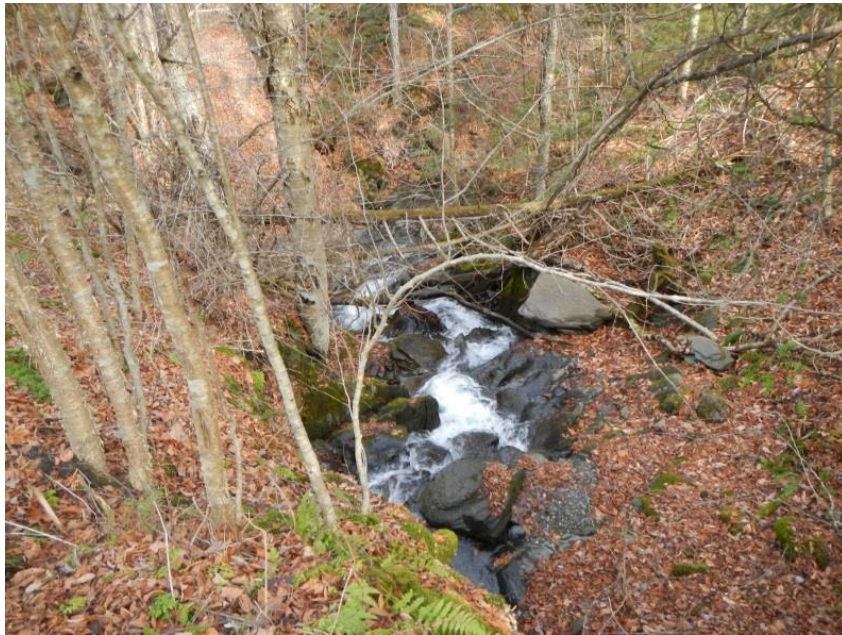
Farnsworth Brook Road Outlet Flow

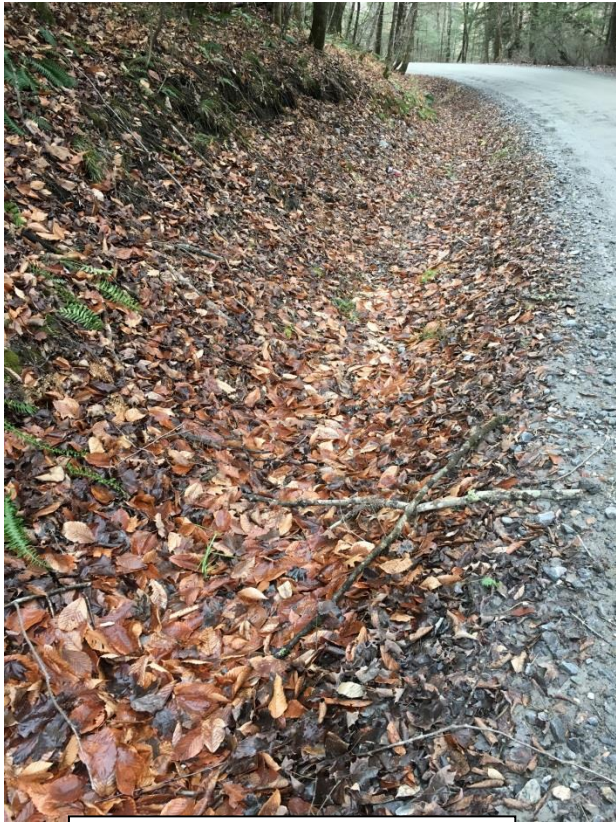
Erosion downhill of culvert inlet

**Recommended Treatment:** Stone-line ditches along the inlet and outlet to prevent further erosion. Install check dams. Upsize culvert to appropriately handle current water levels. Stabilize the eroded banks with mulching.

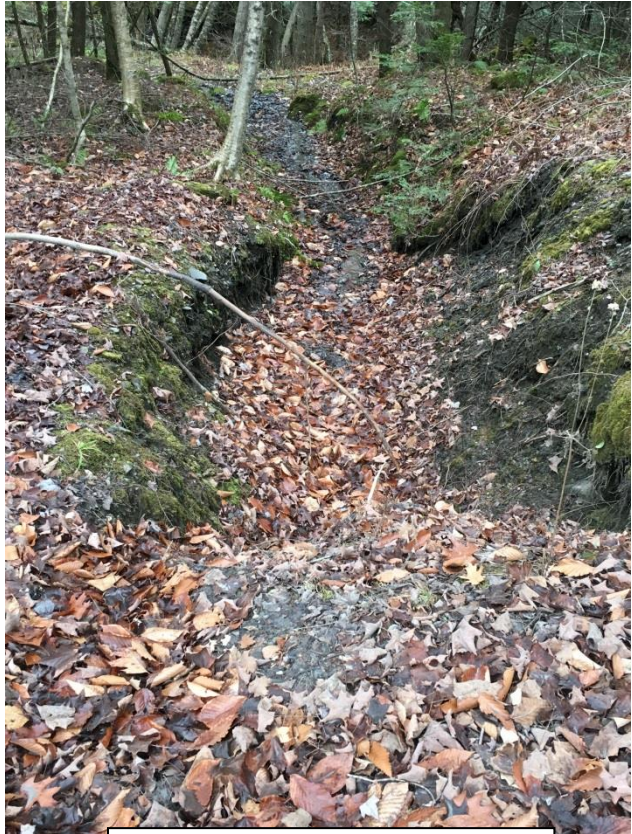
Erosion at culvert outlet

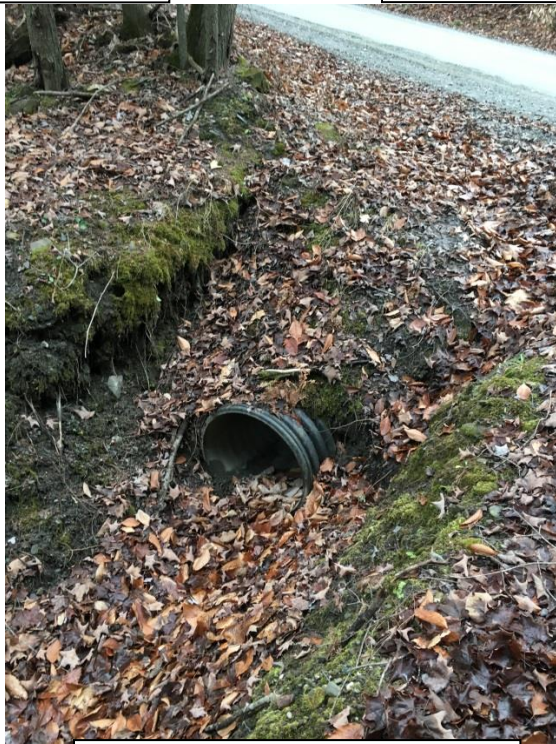
Culvert outlet

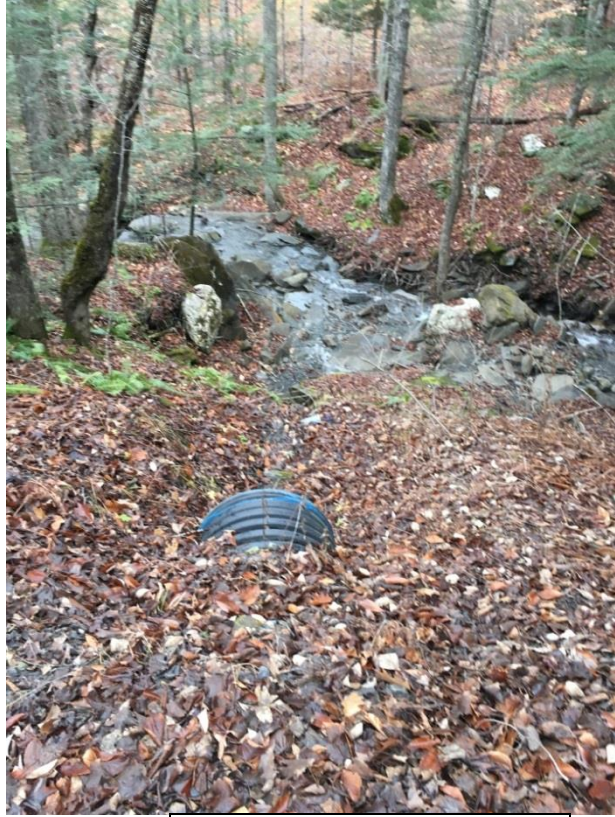
**Location and Description:** Project #13 is very close to #11 and #12. This 24 inch high, 24 inch wide, and 40 foot long plastic culvert has been overrun by the amount of water it experiences. High levels of erosion have occurred near the culvert inlet, including bedrock exposure. The culvert outlet discharges to the surface water that parallels the road and empties into Ayers Brook.

Culvert discharges to surface

**Recommended Treatment:** Stone-line ditches along the inlet and outlet to prevent further erosion. Stabilize the eroded banks with mulching. Upsize culvert to appropriately handle the current level of water.

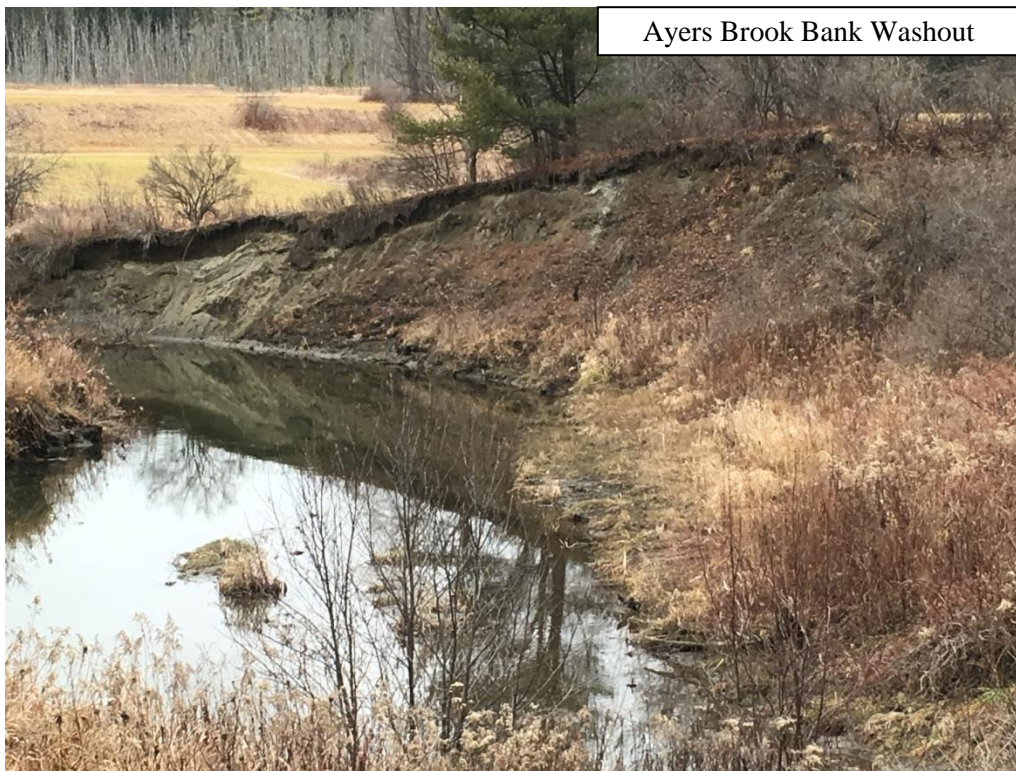
Farther north along Ayers Brook, north of Scenic Road on Route 12, is another section of extremely eroded and exposed streambank that is undergoing channel adjustment. A section of rip-rapped bank armament near this bank failure has pushed the erosive energy of Ayers Brook farther along in its stream channel path. Future encroachment of the river's flood hazard area should be avoided in order to allow the brook to meander and reestablish its flood storage capacity.

Rip-Rap Bank Armoring

**Recommended Treatment:** Plant riparian buffers to help stabilize the bank. Plantings should occur away from the near bank and outside bends where future erosion from lateral movement from Ayers Brook will continue. The Ayers Brook River Corridor Management Plan also identifies this area for a river corridor protection under CREP (Conservation Reserve Enhancement Program) or a similar conservation strategy.

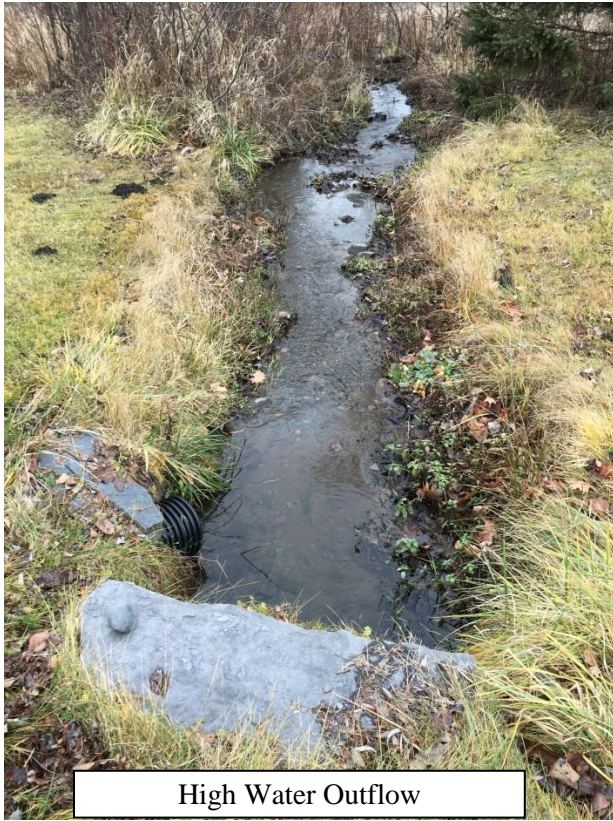
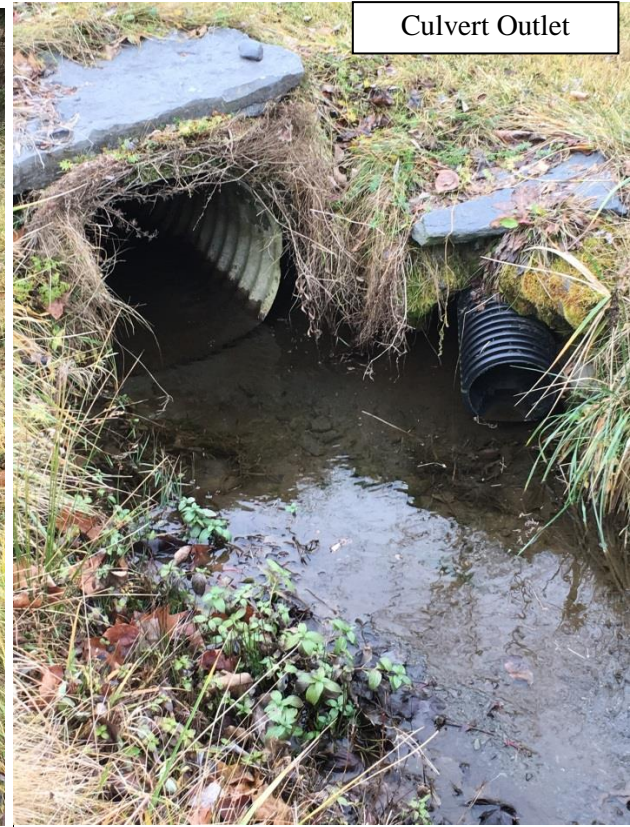
**Map Id:** 18

The second culvert is a 15 inch high, 15 inch wide, and 40 foot long steel culvert. Sediment is currently accumulating near the culvert inlet due to improper ditching.

Sediment Buildup near Inlet

Buried Inlet

**Recommended Treatment:** Properly ditch leading to the inlet of this culver, and stone-line the inlet ditch.

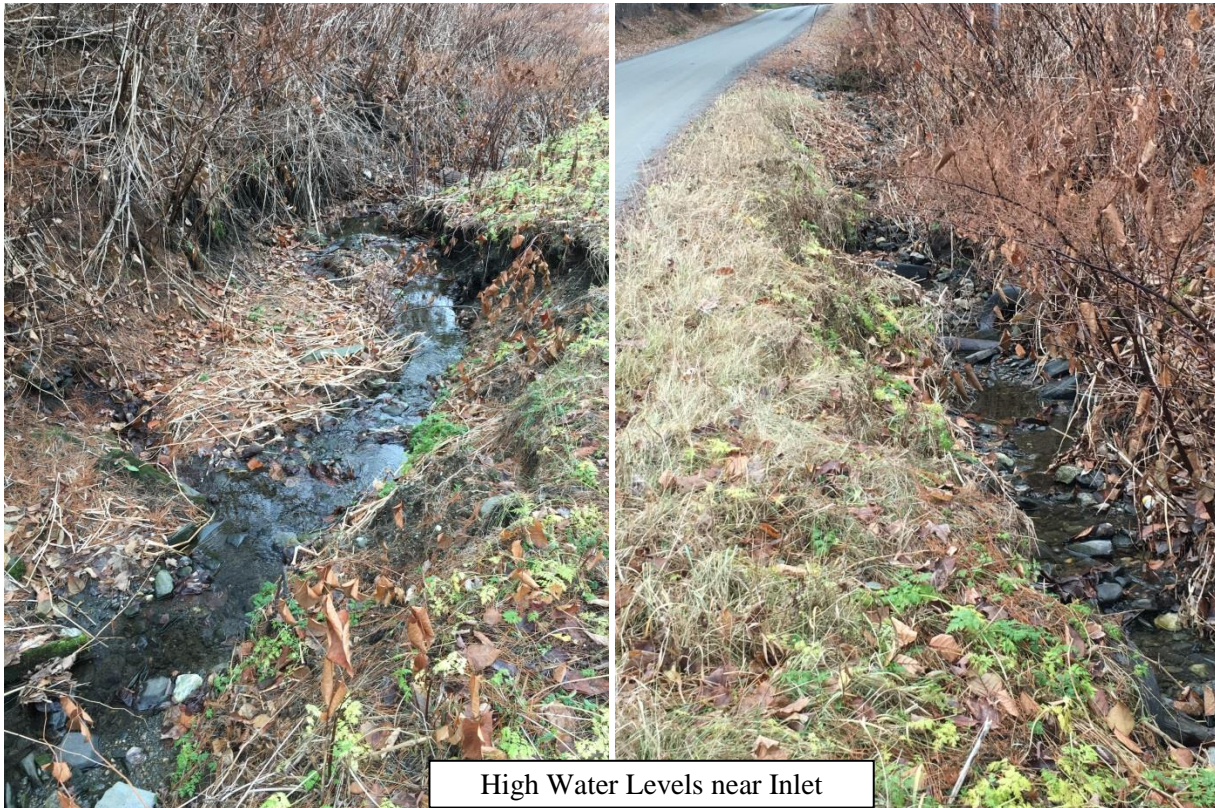
The plastic culvert at this location is 36 inches high, 36 inches wide, and 65 feet long. This site contains significant trash debris, including multiple tires in gullies along the side of the road. Significant water has caused a high level of erosion at the inlet, which has been increased by small drainage pipes contributing water at eroded sections. There is significant pooling of water at this culvert's outlet.

Eroded Section along Inlet

**Recommended Treatment:** Stone-line inlet and outlet ditches. Install check dams. Remove trash from inlet and outlet ditches.

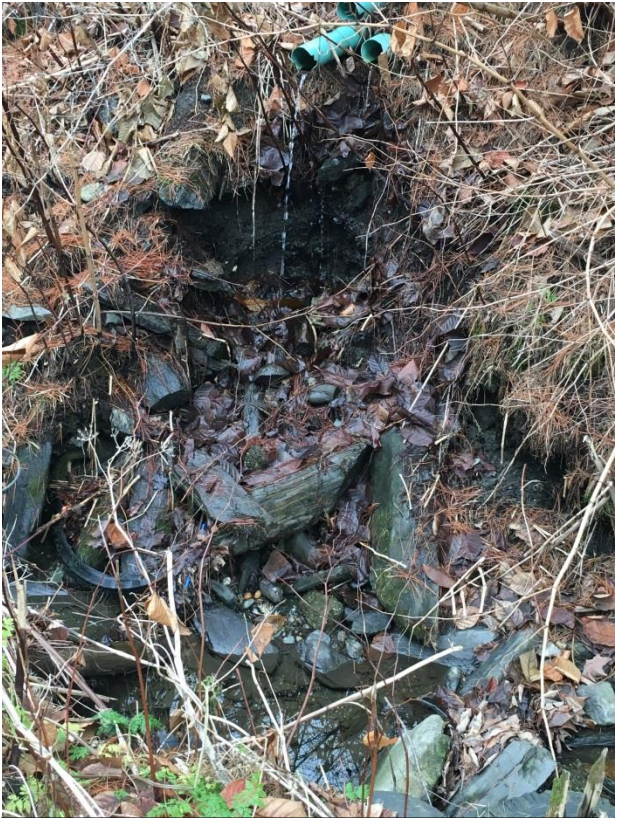
Small drainage sources causing erosion

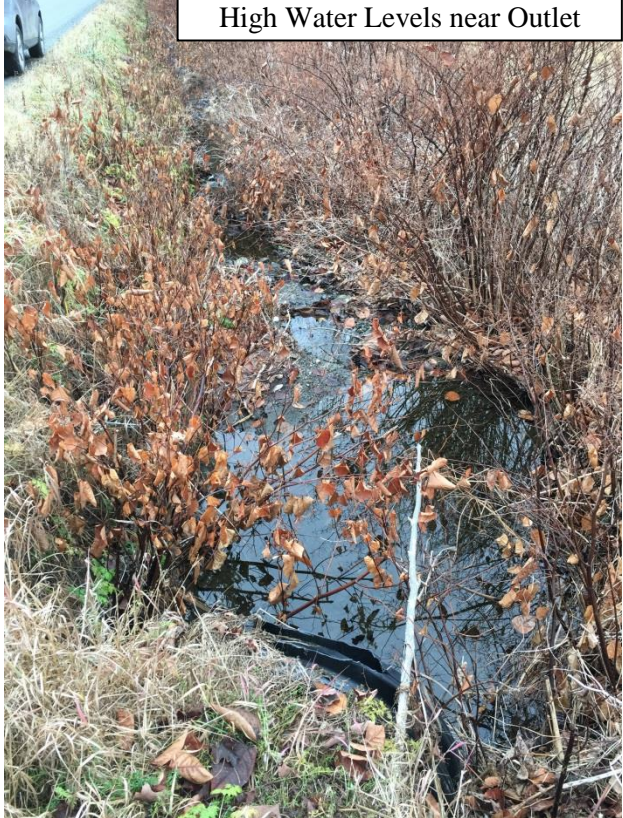
High Water Levels near Outlet

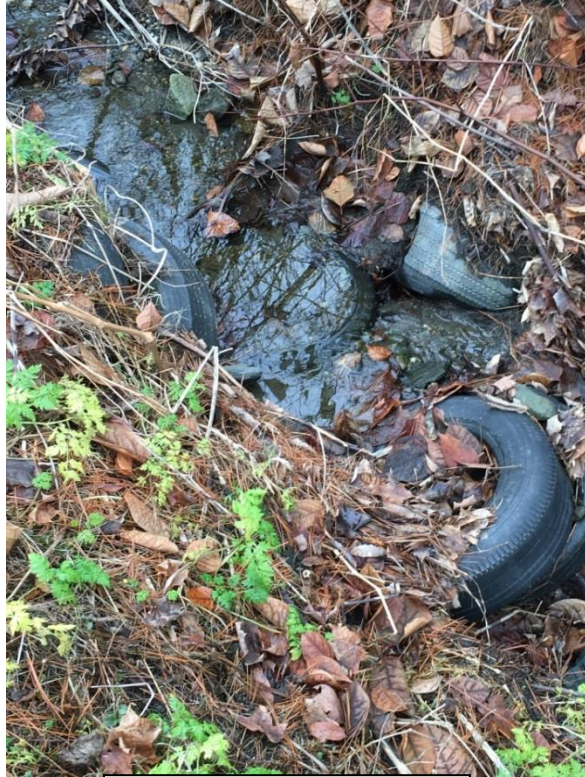
Tires in Inlet Ditch

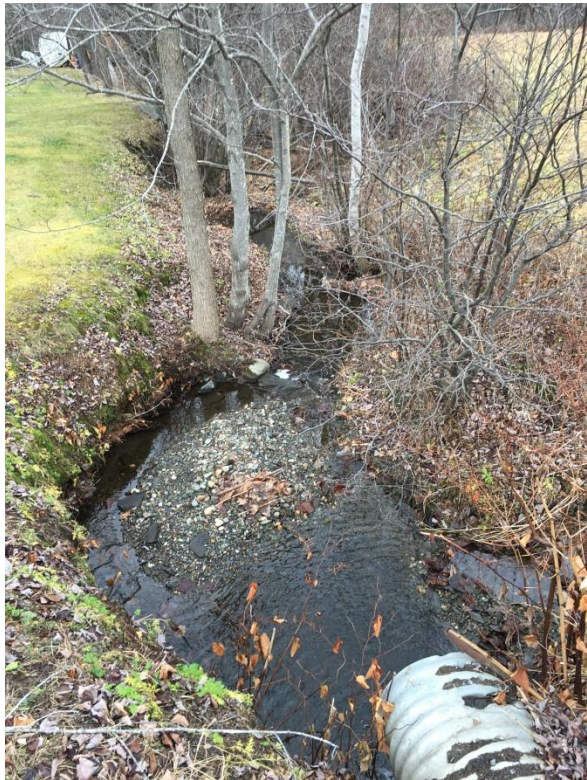
This 24 inch high, 24 inch wide, and 35 foot long steel culvert requires upgrading to appropriately handle the amount of water flow that it currently experiences. A high volume of water has pooled at the outlet. The top part outlet of the culvert is damaged, and the culvert outlet is perched, which prevents aquatic organism passage.

Outlet Flow

**Recommended Treatment:** Upsize culvert, including repairing broken portion of outlet. Stone-line outlet ditch. The width or span of this upsized culvert should be close to 3.82 feet according to bankfull width. Specific hydrologic studies may indicate that structure width may be bigger or smaller.

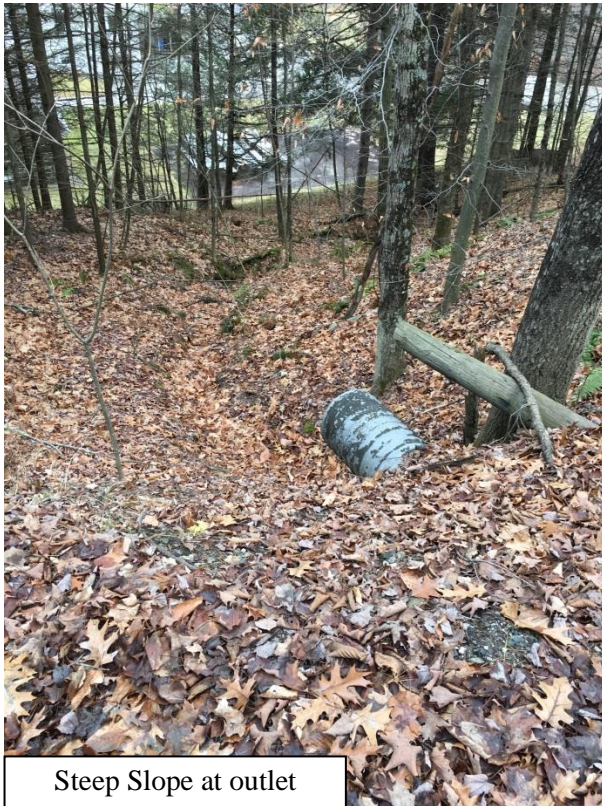
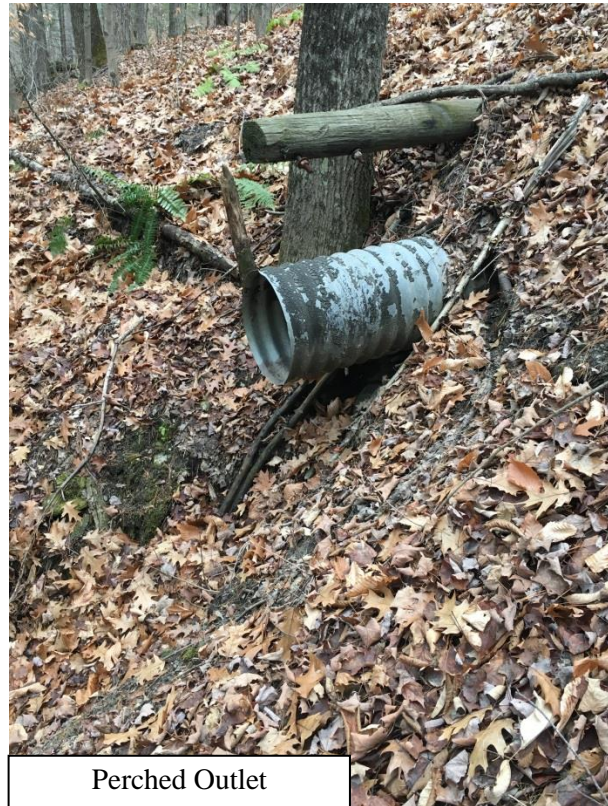
**Location and Description:** The most western priority project on Sunset Hill Road involves improvements to a 15 inch high, 15 inch wide, and 45 foot steel culvert. The culvert's inlet ditch could potentially erode with high levels of water. The outlet of this culvert is perched, which has eroded the steep slope surrounding it. Perched culverts also inhibit aquatic organism passage.

Ditch at Inlet

**Recommended Treatment:** Upsize culvert. Stone-line inlet and outlet ditches. Repair eroded gully by fixing outlet bed with placed rock material.
