APPENDIX D

Problem Area Summary Sheets (8½"x11")

Project: SW-1 **Problem Area Summary**

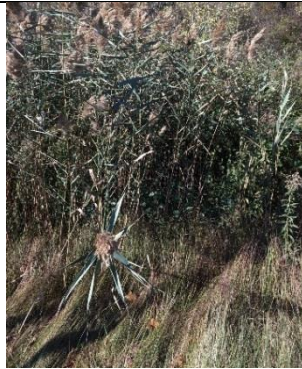
Site Description: This was identified as a possible retrofit opportunity in VTDEC stormwater infrastructure mapping (Subwatershed 28). Stormwater runoff from the west side Route 7A and the Bank of Bennington ATM drains through a stable grass ditch to an adjacent wetland. The WM. E. Dailey Inc. entrance and east side of Route 7A drains to existing stormwater infrastructure, along with the Paulin Inc. parking lot, to SW-1. There is minimal space for stormwater treatment at the SW-1 outfall.

Photo 1: Wetland and green space southeast of the ATM.

BMP Description: Explore this project in conjunction with SW-1. A portion of the drainage area from VT 7A and the WM. E. Dailey parking lot that enters stormwater infrastructure to the south, may be rerouted by installing a deep sump catch basin and underground infiltration or detention under the east shoulder, with an outlet to the wetland across the street. Stormwater treatment on the west side of the road may be improved through installation of a treatment feature, such as a gravel wetland.

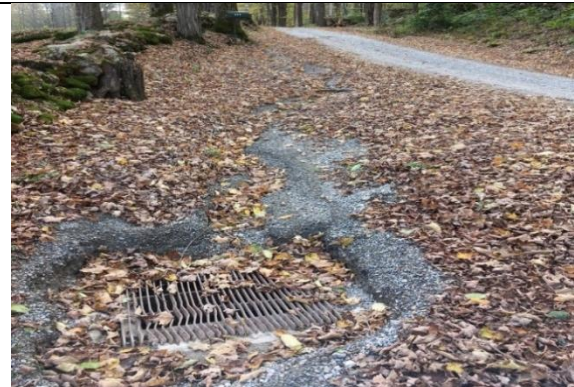
Site Description: Approximately 250 feet of road lacks ditches on both sides, causing erosion of the roadway. Gravel is deposited at the drop-inlet to a driveway culvert at #209 Jack Cross Road, which frequently clogs the culvert. The clogged culvert causes runoff to travel down the driveway toward the house. Stone walls on either side of the road may make it difficult to install ditches in some areas. This road segment ranked 13th (top 2%) in the water quality prioritization based on REI data.

Photo 2: Water flows down the roadway to a driveway culvert with a grated inlet that requires frequent unclogging.

BMP Description: Install stone-lined ditches on both sides of the road where possible. Grade the road to direct water to a new ditch on the southwest side of the road opposite the house as much as possible. Install a cross culvert at the bottom of the bend (the bottom of the steep slope).

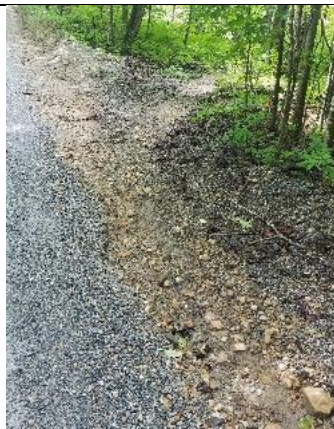
Site Description: A stretch of Cross Hill Road lacks adequate drainage for approximately 600 feet. Some runoff is directed to an unstable turnout. The downslope area south of the road is a good location to disperse runoff. Runoff from the north side of the road flows through an unstable ditch, which crosses to a ditch on the south side of the road that drains directly to a nearby stream. The area around the stream is low-lying and a frequent maintenance issue due to standing water and potholes. This area includes a road segment ranked 10th (top 2%) in the water quality prioritization based on REI data.

Photo 1: An unstable turnout on the south side of the road.

BMP Description: Install stone in northern ditches. Improve existing turnouts on the south side of the road and install a couple more up the hill to reduce the amount of runoff reaching this area. Install a cross culvert before the driveway of the proposed house to send flow into the forested area to the south.

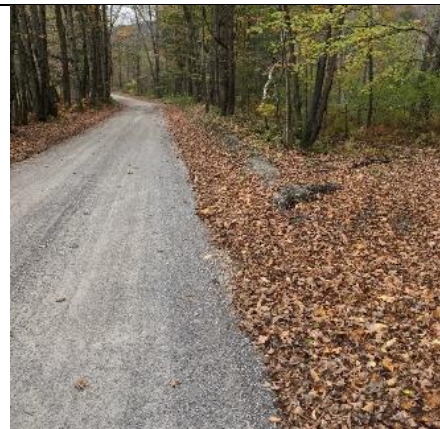
Photo 2: Section of Cross Hill Road without ditches or a stable turnout.

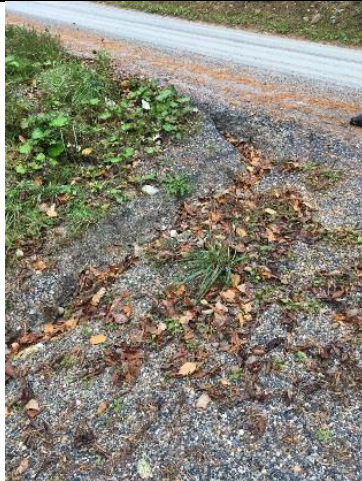
Site Description: Grader berms along approximately 250 feet of the northern side of Airport Road concentrate flow, causing severe erosion of the road and driveway that extends to the adjacent wetland. This road segment ranked 248th (top 46%) in the water quality prioritization based on REI data.

Photo 1: Erosion of the driveway due to concentrated flow from Airport Road.

BMP Description: Remove grader berms. Install a stone-lined turnout/conveyance before the driveway.

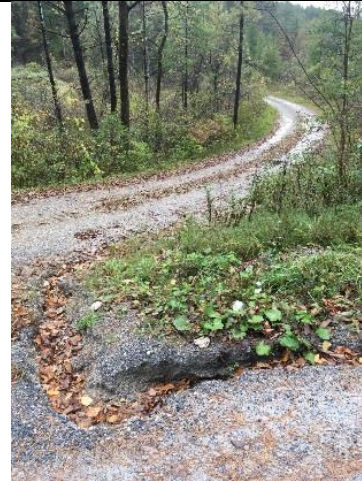
Photo 2: Erosion of Airport Road and the adjacent driveway.

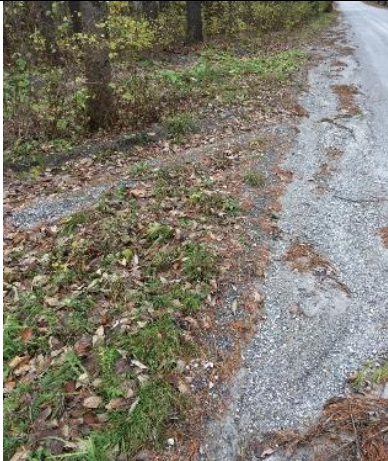
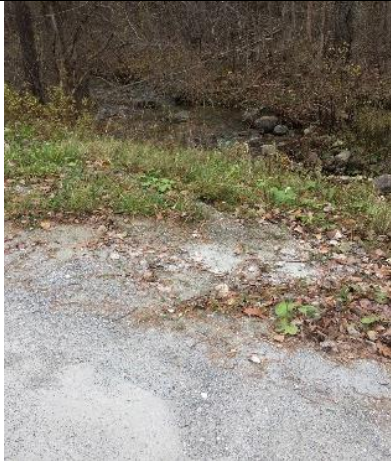
Location:	Trumbull Hill Road			
Latitude:	42.9711 N			
Longitude:	-73.1833 W			
Land Ownership:	Town			
<p>Site Description: An approximately 1,200-foot stretch of road lacks adequate drainage, causing the formation of a secondary ditch on the north side of the road that extends west to Paran Creek. Grader berms prevent drainage on the south side of the road, where runoff concentrates and drains via a poor conveyance to Paran Creek near the stream crossing. This area includes a road segment ranked 14th (top 3%) in the water quality prioritization based on REI data.</p>

<p>Photo 1: Runoff is eroding the roadway and bypassing an existing turnout on Trumbull Hill Road near the Oak Hill Road intersection.</p>		<p>Photo 2: Runoff on the south side of the road drains via a poor conveyance directly into Paran Creek.</p>

<p>BMP Description: Install turnouts on the south side of the road and on the north side of the road at the intersection with Oak Hill Road to enhance drainage. Install approximately 450' of ditch on the north side of the road with cross culverts east of each driveway and 400' of ditch on the south side of the road draining to a sediment trap in the forest.</p>				
WQ Benefits	Landowner Support and O&M	Cost and Constructability	Additional Benefits	Total Score (Priority)
11	3	2	1	17 (High)
<p>Additional Project Benefits Description: This project would address a chronic problem area for road maintenance.</p>				
<p>Project Comments: The project is assigned a high priority due to high sediment loads from erosion of the roadway and embankment that directly impacts Paran Creek. The project should not require any additional permitting. We estimate that total project costs may be between \$40,000 and \$60,000.</p>

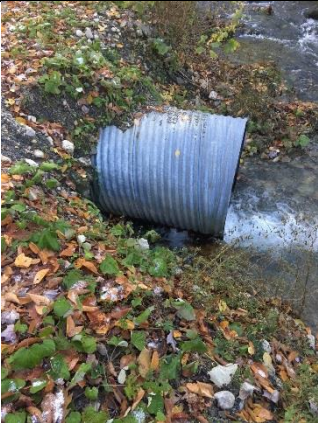
Location:	Shaftsbury Hollow Road			
Latitude:	43.0214 N			
Longitude:	-73.2355 W			
Land Ownership:	Town			
<p>Site Description: This road area has two poor conveyances to Little White Creek. One is located where Shaftsbury Hollow Road becomes Class 4 and is turned out toward the stream causing sediment to build up on the bank and enter the stream. The second is approximately 50 feet to the east where a culvert conveys a tributary under Shaftsbury Hollow Road. The culvert headers are severely eroded. This road segment ranked 4th (top 1%) in the water quality prioritization based on REI data.</p>

<p>Photo 1: Road runoff is contributing to erosion of the tributary culvert header.</p>		<p>Photo 2: Eroded conveyance to Little White Creek near the transition between Class 3 and Class 4 road on Shaftsbury Hollow Road.</p>

<p>BMP Description: Install a sediment trap between the Class 4 road and stream and stabilize the conveyance with stone. Stabilize the culvert headers with stone.</p>				
WQ Benefits	Landowner Support and O&M	Cost and Constructability	Additional Benefits	Total Score (Priority)
8	2	5	0	15 (Moderate)
<p>Additional Project Benefits Description: N/A</p>				
<p>Project Comments: The project is assigned a moderate priority due to the potential to reduce a sediment source to Little White Creek and the relatively low cost of the project. The project may require additional permitting for work in the river corridor and/or floodplain. We estimate that total project costs may be between \$2,000 and \$7,000.</p>

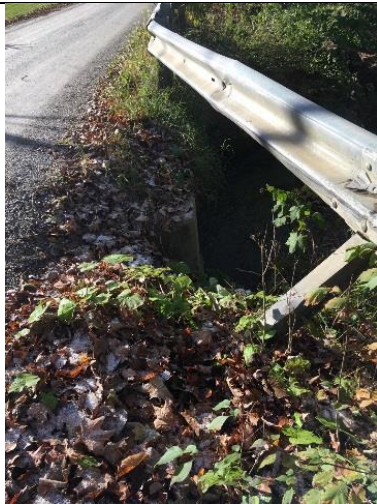
Site Description: Water runs down approximately 100' of road, entering Little White Creek at the culvert outlet and causing severe erosion of the header and roadway. This road segment ranked 209th (top 39%) in the water quality prioritization based on REI data.

Photo 1: Eroded embankment at the Little White Creek crossing.

BMP Description: Remove grader berm and deepen ditch so water can exit roadway before culvert. Stabilize conveyance with stone. Stabilize the road embankment as needed.

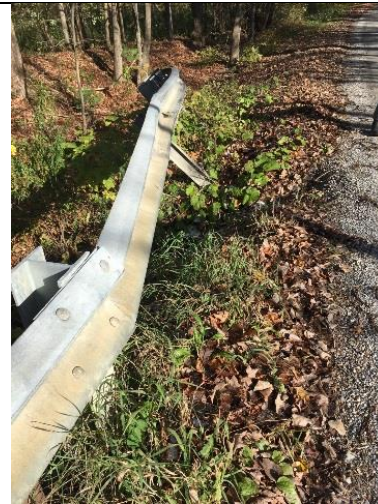
Photo 2: Runoff concentrates along Granger Hollow Road, eroding the area near the guardrail.

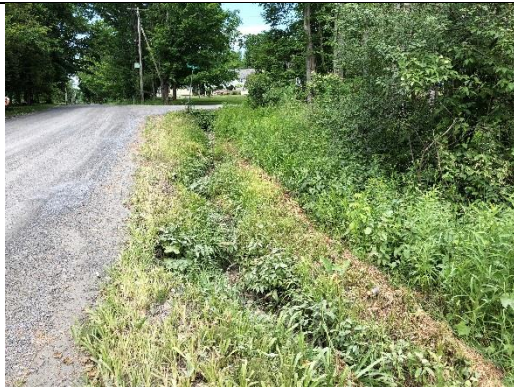
Site Description: Grader berms along approximately 600 feet of Glastenview Road are causing erosion of the roadway. Road gravel is accumulating in the ditch at the intersection with Daniels Road and the Daniels Road ditch is eroded for approximately 300 feet.

Photo 1: Eroded ditch along Daniels Road.

BMP Description: Remove grader berms. Install stone in eroded ditches as needed. Consider installing a sediment trap with a level spreader at the ditch outlet to settle out particulates and send sheet flow into the wetland.

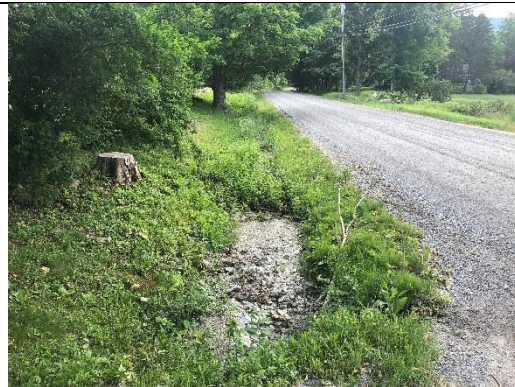
Photo 2: Eroded materials accumulating in the ditch at the intersection of Daniels Road and Glastenview Road.

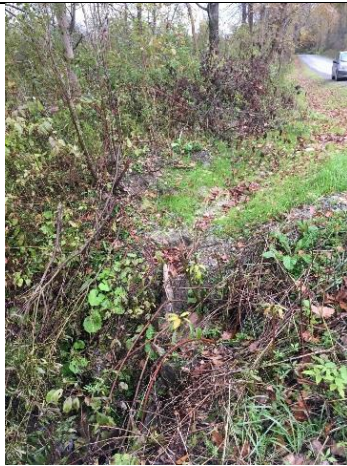
Site Description: Approximately 300' of eroding ditch extends directly to the stream via a poor conveyance. The stream culvert headers are unstable and eroding. This road segment ranked 37th (top 7%) in the water quality prioritization based on REI data.

Photo 1: Eroding ditch and conveyance.

BMP Description: Stabilize the culvert headers, conveyance, and ditch with stone.

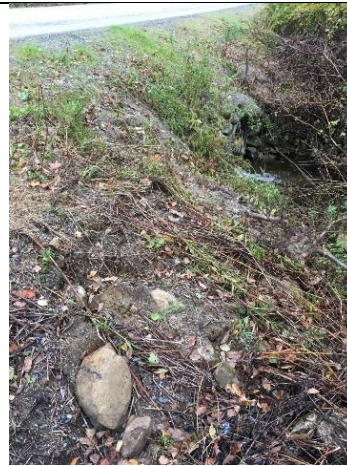
Photo 2: Eroding culvert header and conveyance at the stream crossing.

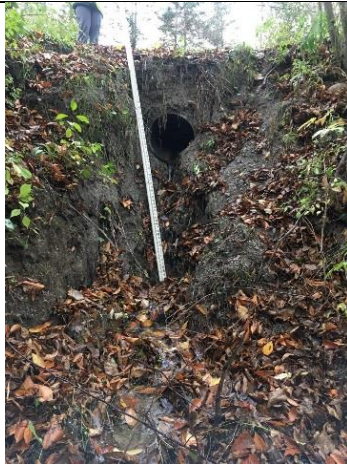
Site Description: This culvert has severe header and outlet erosion. This erosion continues for 85' to a nearby stream. This road segment ranked 16th (top 3%) in the water quality prioritization based on REI data.

Photo 1: Severe erosion at the culvert outlet.

BMP Description: Stabilize the culvert headers, outlet, and conveyance with stone. Consider installing check dams and a level spreader in the conveyance to slow and disperse flow.

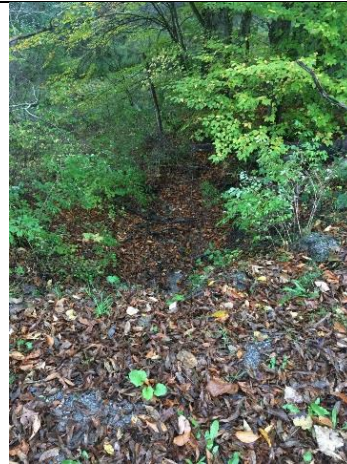
Photo 2: Eroded conveyance south of the road.

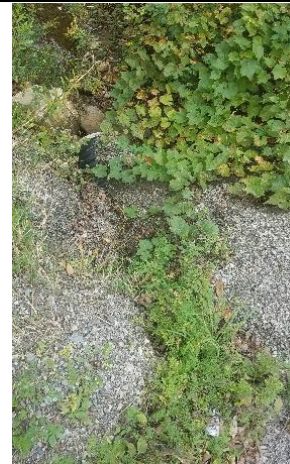
Site Description: The culvert outlet header is severely eroded. The erosion may cause undermining of the paved roadway and clogging of the drainage culvert. This road segment ranked 240th (top 45%) in the water quality prioritization based on REI data.

Photo 2: Erosion extends to the drainage culvert.

BMP Description: Stabilize the culvert header and road embankment with stone.

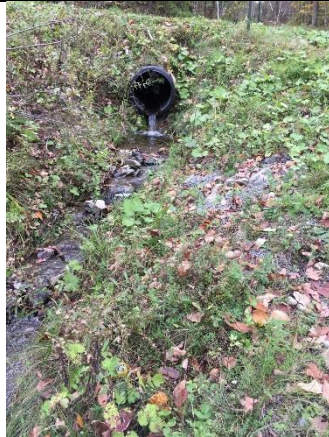
Site Description: The smooth HDPE culvert conveys a small channel with an approximately 16.5-acre drainage area. The capacity of the 18” culvert is estimated at 13 cfs, a flow that may be exceeded in the 10-year flood event. The culvert headers are eroding, with severe erosion of the road embankment around the culvert outlet.

Photo 1: Harrison Road culvert outlet.

BMP Description: Install a larger structure with stone headers. The recommended culvert size for an intermittent stream crossing of comparable drainage area is 24” in diameter. Based on HY-8 modeling, a 24” structure will pass the 25-year flood if the road elevation is raised 1 foot at the crossing. A 30” structure will pass the 25-year flood with no change in road elevation.

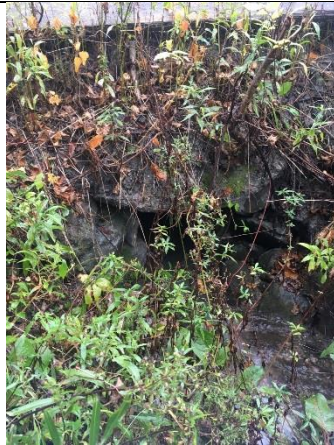
Site Description: The CMP conveys a small channel with an approximately 121-acre drainage area. The capacity of the 24” culvert is estimated at 31 cfs, a flow that may be exceeded in the 10-year flood event. The culvert headers are eroded as well as the channel downstream of the culvert.

Photo 1: East Road culvert inlet.

BMP Description: Install a larger structure with stone headers. The recommended culvert size for an intermittent stream crossing of comparable drainage area is 60” in diameter. Based on HY-8 modeling, a 60” structure will pass the 100-year flood.

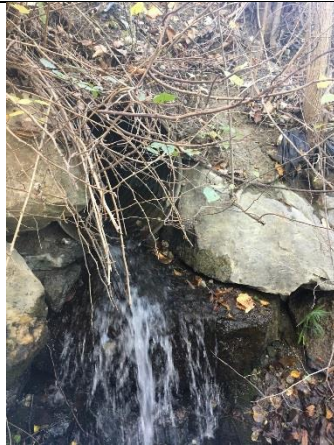
Site Description: The CMP conveys a small channel with an approximately 100-acre drainage area. The capacity of the 30" culvert is estimated at 47 cfs, a flow that may be exceeded in the 10-year flood event. The culvert headers are eroded as well as the road embankment and channel downstream of the culvert.

Photo 1: Murphy Hill Road culvert outlet.

BMP Description: Install a larger structure with stone headers. The recommended culvert size for an intermittent stream crossing of comparable drainage area is 48-60" in diameter. Based on HY-8 modeling, a 48" structure will pass the 25-year flood.

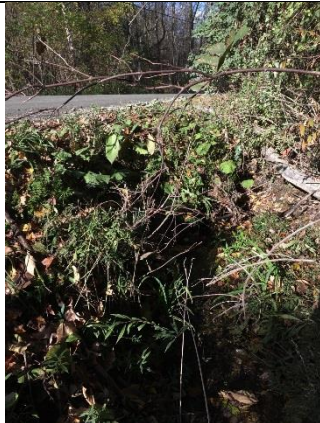
Site Description: The CMP conveys a channel with an approximately 68-acre drainage area. The capacity of the 24" culvert is estimated at 30 cfs, a flow that may be exceeded in the 10-year flood event. There is some erosion of the road embankment at the inlet and outlet.

Photo 1: Murphy Hill Road culvert inlet.

BMP Description: Install a larger structure with stone headers. The recommended culvert size for an intermittent stream crossing of comparable drainage area is 42-48" in diameter. Based on HY-8 modeling, a 42" structure will pass the 25-year flood.

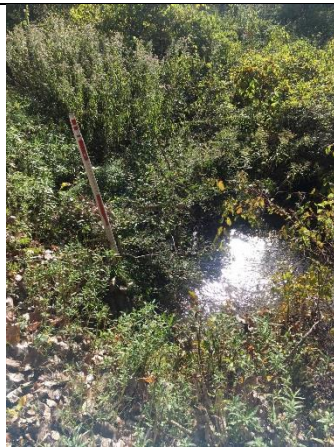
Photo 1:

Site Description: The CMP conveys a channel with an approximately 179-acre drainage area. The capacity of the 36" culvert is estimated at 30 cfs, a flow that may be exceeded in the 10-year flood event. There is some erosion of the road embankment at the inlet and outlet.

BMP Description: Install a larger structure with stone headers. The recommended culvert size for a stream crossing of comparable drainage area is over 66" in diameter. Based on HY-8 modeling, a 72" round or 84" by 60" elliptical structure will pass the 25-year flood.
