STORMWATER MANAGEMENT PLAN FOR SHELDON

FINAL REPORT

Stone Project ID 12-145

January 24, 2014

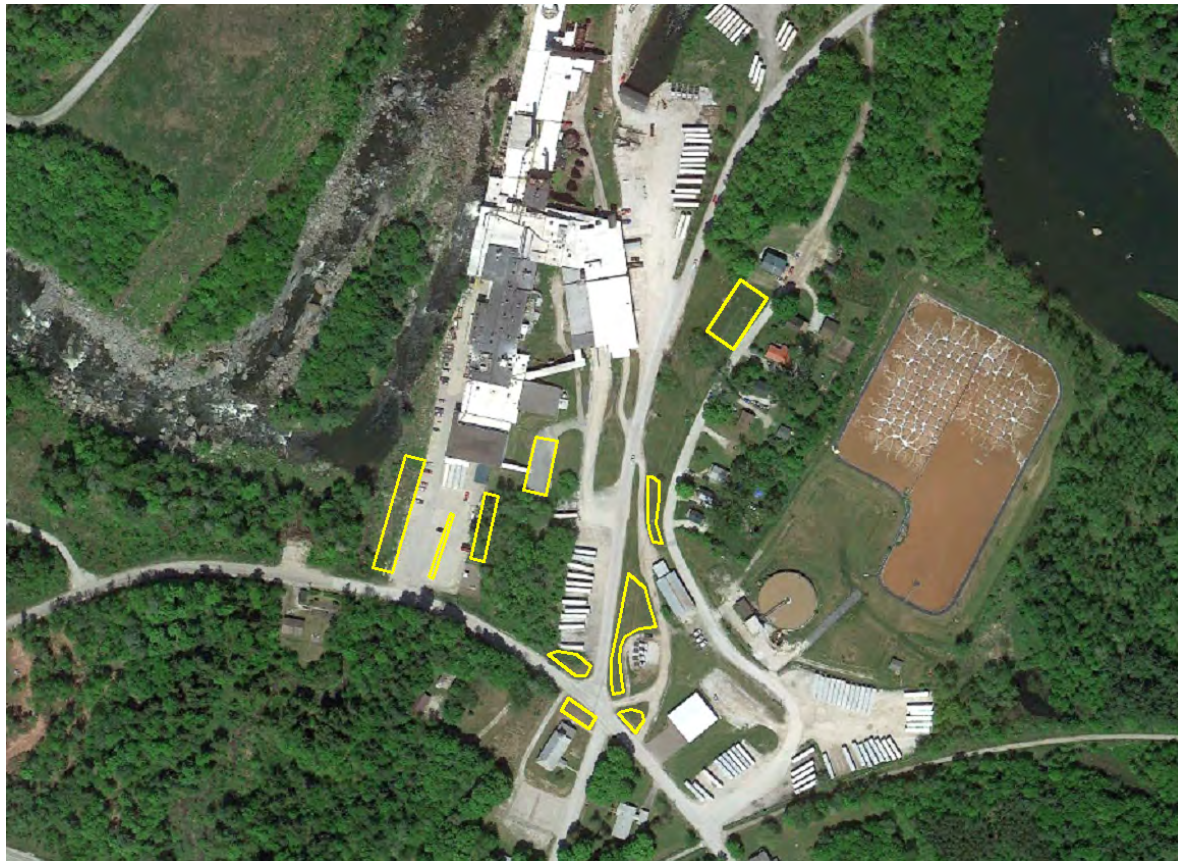
Soils in the Sheldon Springs area around the RockTenn facility appear to be well-drained sandy loams, but are very rocky. The topography is terraced and quite steep in many areas. The impervious surfaces in the area are expansive and include several large, gravel parking areas. Stormwater impacts could be greatly reduced by grading gravel surfaces in a manner to direct drainage towards stormwater treatment practices and/or paving them. Pervious pavement in select areas may also be an option to reduce stormwater runoff.

Figure 1. Several stormwater treatment opportunities (highlighted) exist in Sheldon Springs near the RockTenn facility.

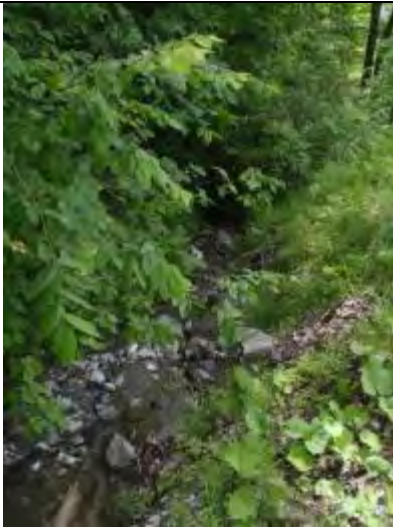
Photo 4. Sediment deposited in ditch

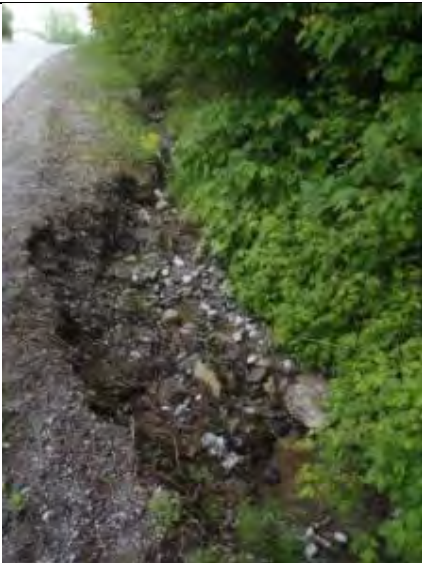
Photo 6 Ditch bank collapse and sediment deposit

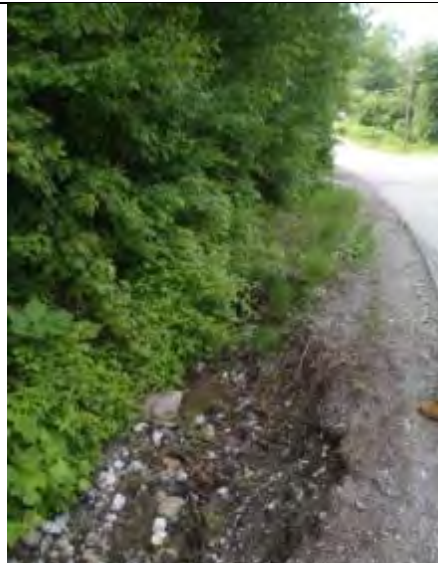
Photo 7. Ditch erosion

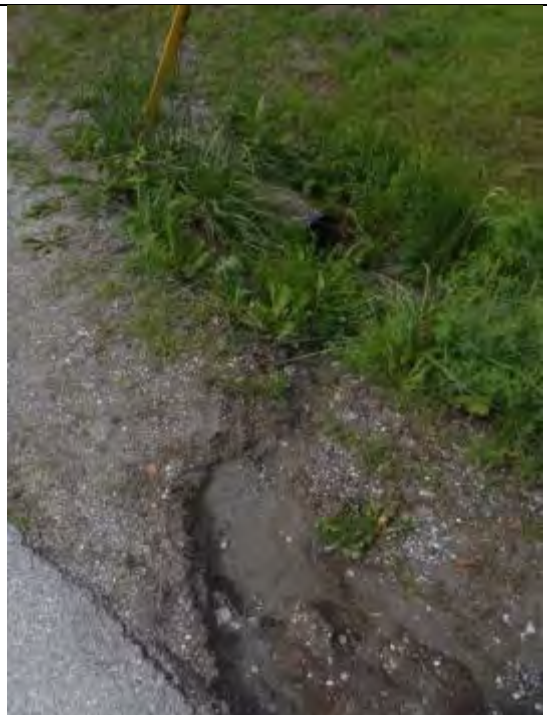
Photo 15. Catch basin filled with sediment

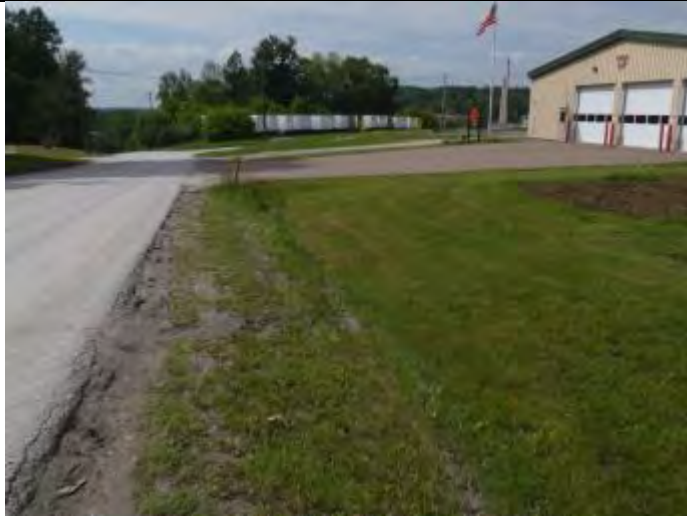
Photo 17. Shoulder erosion

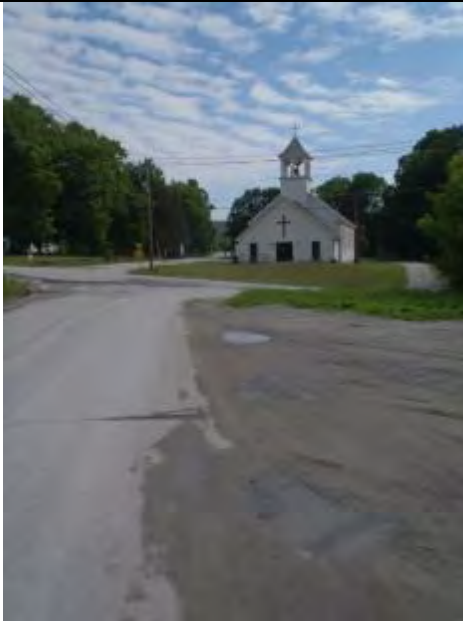
Photo 19 Sediment from lot deposited on road surface

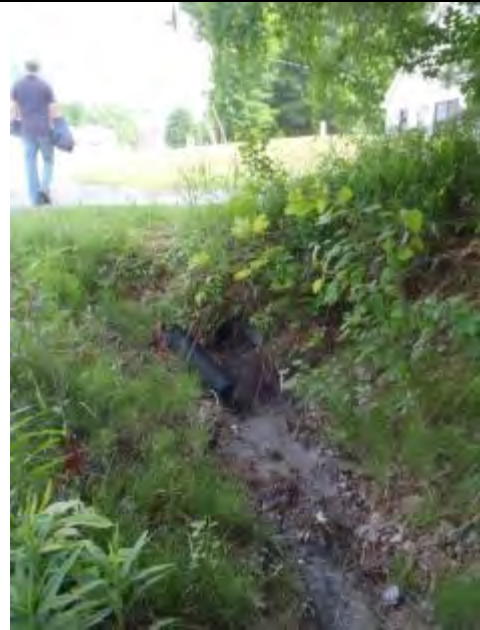
Photo 20. Sediment deposited at a culvert outfall

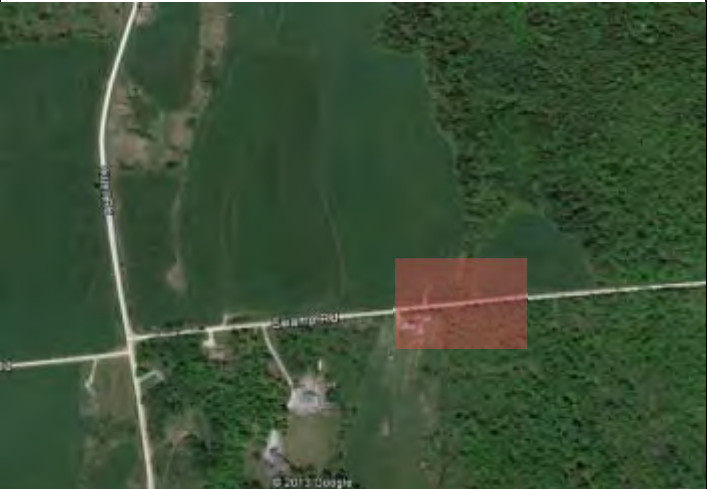
Problem Area ID: GB-1	Latitude: 44°52'49"N	Longitude: 72°52'31"W
Watershed: Goodsell Brook

A culvert that conveys Goodsell Brook under Swamp Road is too short for the current width of the road. The resulting over-steepened slope, coupled with unmanaged stormwater runoff from the road surface, has created unstable conditions at both the inlet and outlet of the culvert. Generally, vegetated slopes should be limited to 2:1 (horizontal to vertical) to maintain stable conditions. Erosion of this slope will likely soon lead to deteriorating road conditions. In addition, the existing culvert pipe is undersized (approximately one-half bankfull width), and a large scour pool has formed on the downstream side of the culvert. The location of the culvert is indicated in Figure 3.

Given the deteriorating condition of the culvert and surrounding banks, it is a good candidate for replacement. The replacement culvert should be long enough to accommodate 2:1 (H:V) slopes at the inlet and outlet, and sized such that it matches the stream's bankfull width, and so that 1/6th of the culvert can be buried at bankfull stream width to provide a natural bottom.

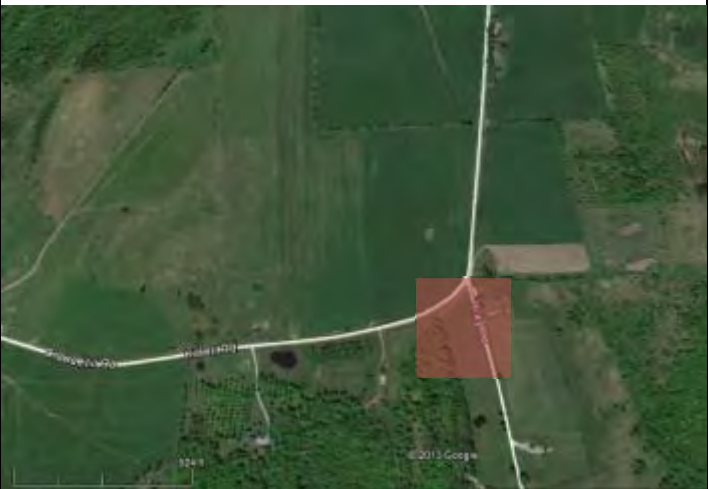
Problem Area ID: GB-2	Latitude: 44°52'11"N	Longitude: 72°52'23"W
Watershed: <u>Goodsell Brook</u> Location: <u>Route 105, 0.5 miles west of Rt. 236 Junction</u> Problem Type: <u>Erosion</u> Identification Source: <u>SWMP Assessment</u> Ownership: <u>Private</u> Classification: <u>3</u>

Description of Observed Conditions:
 Ditch is actively eroding. A large sediment deposit was observed near culvert inlet. Large pile of gravel placed at intersection adjacent to stream.

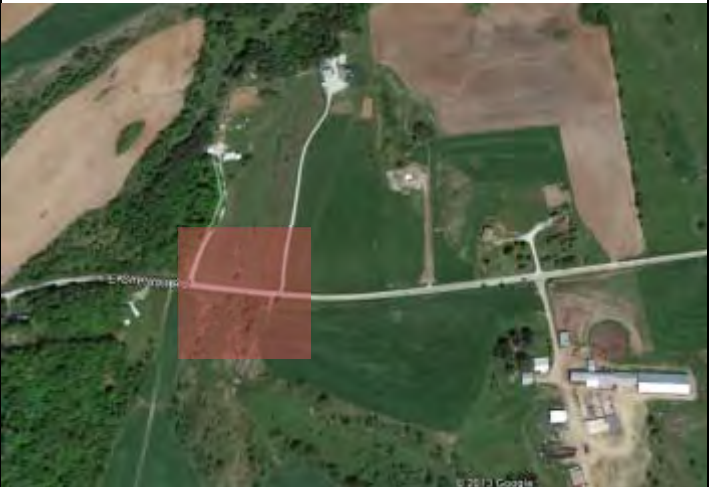
Problem Area ID: MR-11	Latitude: 44°53'50"N	Longitude: 72°53'45"W
Watershed: Missisquoi River Location: E. Sheldon Road, 1.0 miles West of Kittell Rd. Problem Type: Erosion Identification Source: SWMP Assessment Ownership: Private Classification: 3

Description of Observed Conditions:
 Active bank erosion observed. Beaver dams in area were removed several years ago and the area now serves as pasture to 13-14 animals. Bank above culvert is beginning to collapse. Spoke with farmer who owns the property with his father. He was very informative and interested in making improvements; opportunity has been shared with staff at Vermont Agency of Agriculture for follow-up.

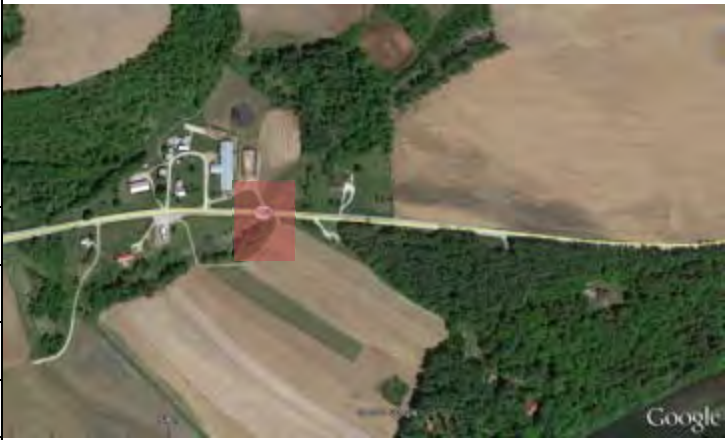
Problem Area ID: MR-12	Latitude: 44°54'38"N	Longitude: 72°53'14"W
Watershed: Missisquoi River Location: Rt. 105, 100 yards east of fruit stand at farm driveway Problem Type: Drainage Identification Source: SWMP Assessment Ownership: Local Classification: 3

Description of Observed Conditions:
 Asphalt road surface has started to collapse into ditch. Large sediment deposit in ditch.

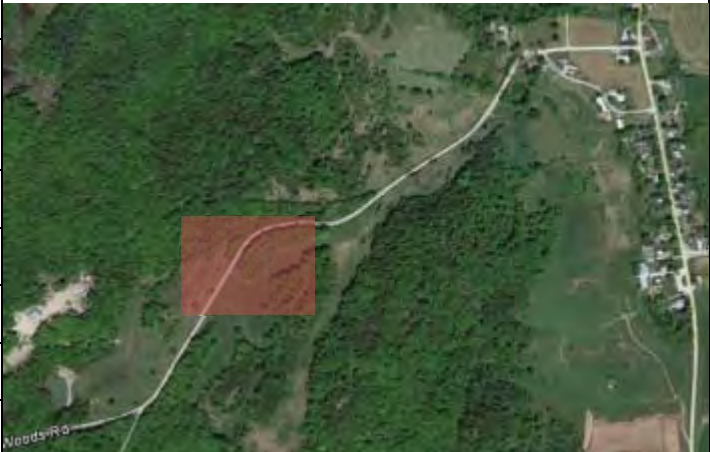
Problem Area ID: BC-3	Latitude: 44°52'52"N	Longitude: 72°57'27"W
Watershed: <u>Black Creek</u> Location: <u>Sheldon Woods Road near junction with Johnson Road</u> Problem Type: <u>Erosion</u> Identification Source: <u>Town Feedback</u> Ownership: <u>Local</u> Classification: <u>2</u>

Description of Observed Conditions:
 Shoulder erosion in some places. Observed sediment deposits in roadside grass swale.

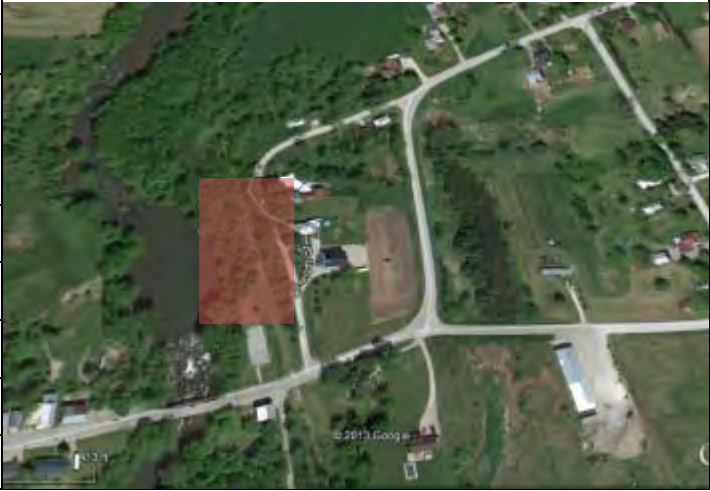
Problem Area ID: BC-5	Latitude: 44°52'58"N	Longitude: 72°56'32"W
Watershed: Black Creek

Church Street is a narrow paved road serving three buildings, with a paved parking lot along the east side of a church and a steep bank leading down the rail trail to the west. The culvert that drains a large portion of this area is crushed and clogged with debris. The culvert outlets onto the steep bank, approximately 150 feet from the Black Creek. Due to the condition of the culvert, most of the runoff from the area appears to run over the road, and is eroding the top of the bank. The guard-posts along the top of the bank have begun to fall over the edge.

While there is not enough space in this narrow section of road to provide adequate ditching, there is an opportunity to install a bioretention practice at the church. Such a practice could capture, slow, and treat the runoff from a significant portion of the area's impervious surface. Since the existing culvert is crushed and clogged, it should be replaced with one that meets current standards.

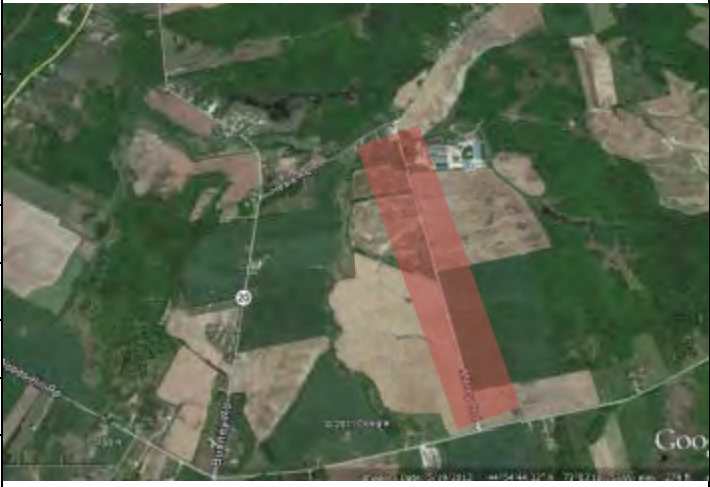
Problem Area ID: HB-1	Latitude: 44°54'00"N	Longitude: 73°01'44"W
Watershed: Hungerford Brook Location: Morey Road south of Heald Road junction Problem Type: Infrastructure Identification Source: Town Feedback Ownership: Local Classification: 3

The section of Morey Road between Woodshill Road and Heald Road has four culverts (Figure 8) that are too short for the current width of the road, resulting in unstable conditions at both the inlets and outlets. Erosion of the over-steepened slopes surrounding the culvert by stormwater runoff from the road surface will lead to deteriorating road shoulder conditions in the near- to medium-term. A replacement culvert should be long enough to accommodate vegetated slopes which are at least 2:1 (H:V) to maintain stable conditions. Another option may be to construct headwalls at the inlets and outlets of each culvert in order to stabilize and protect the banks from further erosion.

Description of Observed Conditions:
 Road edge is beginning to collapse into the stream above some culverts along Morey Rd. Culverts appear to be too short, at least as compared to current road width.
