STORMWATER MANAGEMENT PLAN FOR ST. ALBANS TOWN

FINAL REPORT

Stone Project ID 14-053

March 25, 2015

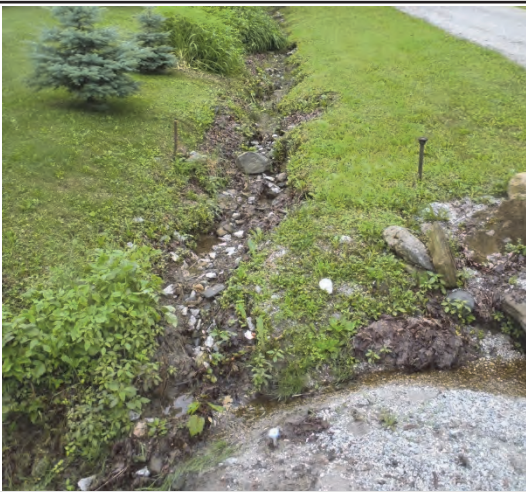
Ditch carrying stormwater runoff from private road is actively eroding, and the culvert under La Cresta Dr. is completely plugged with sediment. The Town indicated that the area of active erosion extends further to the west, between Howard Estates and Ashton Drive.

Photo 1. Actively eroding ditch.

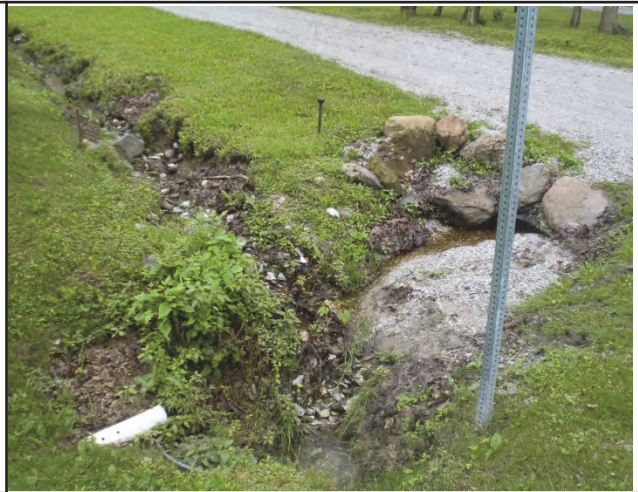
Photo 2. Plugged culvert

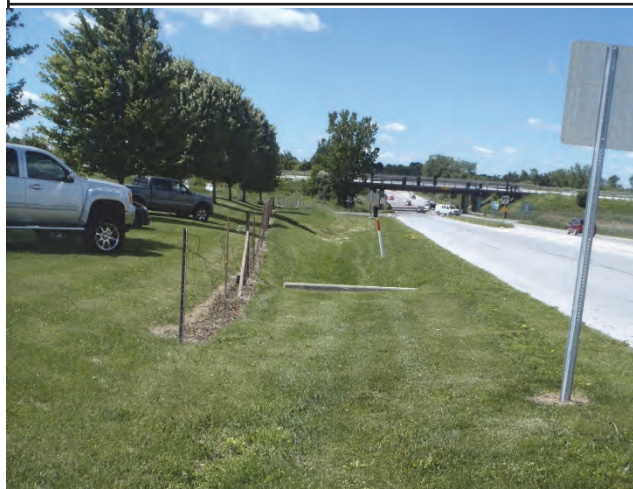
Grassed swale in front of Handy Chevrolet receives stormwater runoff from parts of the I-89 off-ramp, Route 207 and Paquette Dr.

Photo 1. Looking south along Route 207 toward I-89.

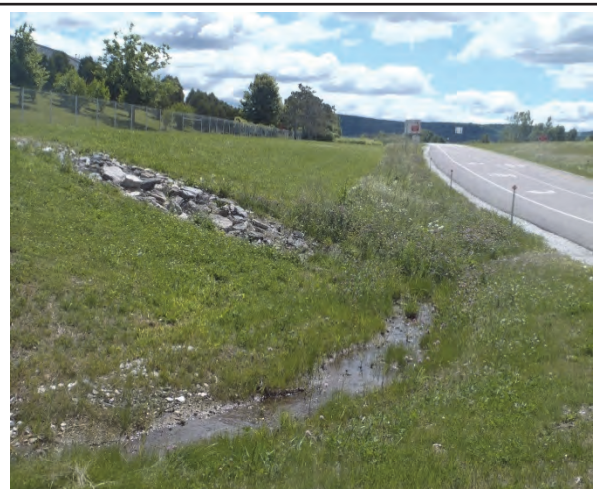
Photo 2. Intersection of Route 207 and I-89 off ramp

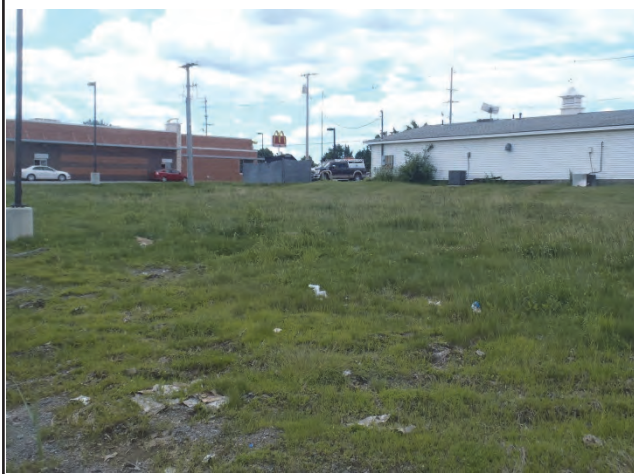
Green space between Key Bank and McDonald's appears well-suited for stormwater retrofit, including existing curb cuts.

Photo 1. Existing green space between McDonald's and Key Bank.

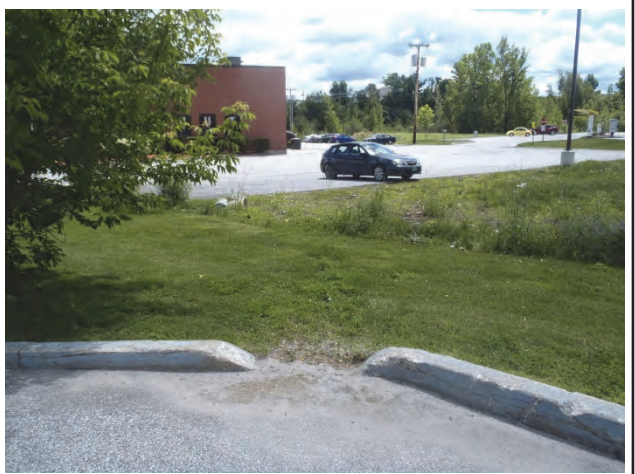
Photo 2. Existing curb-cut along back edge of Key Bank parking lot.

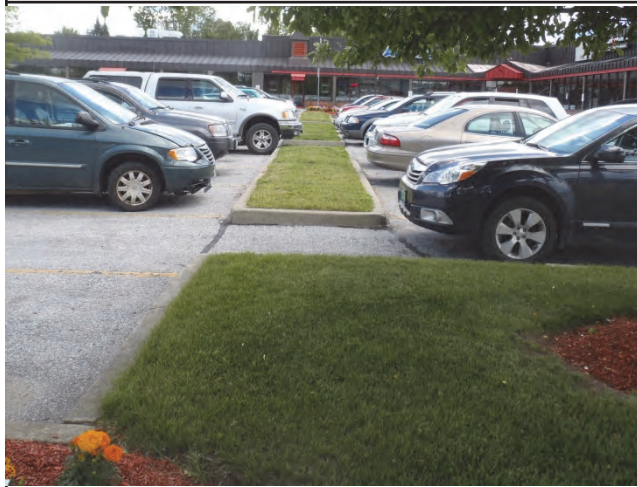
Numerous elevated vegetated islands within Highgate Commons parking lot could be retrofitted to become stormwater management depressions.

Photo 1. Islands at the south end of the parking lot.

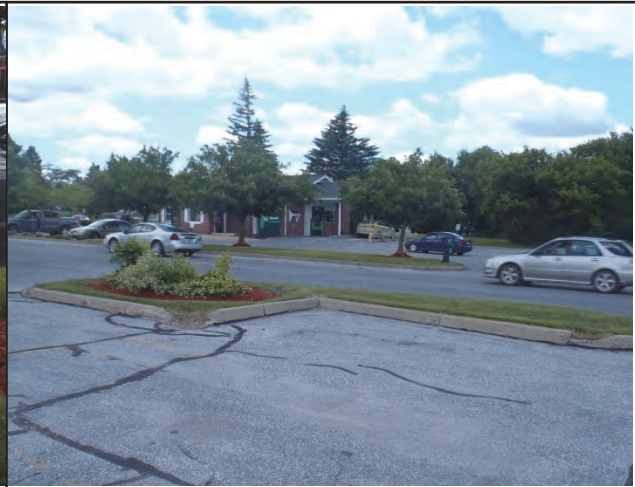
Photo 2. Example of island used to separate parking areas from travel lanes.

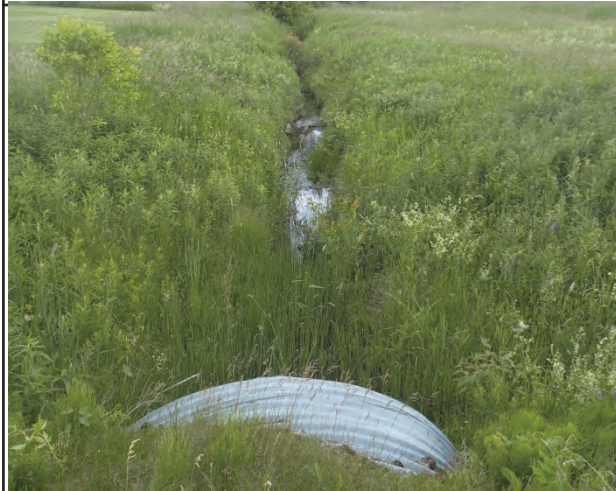
There are numerous opportunities to improve stormwater management in Franklin Park West. Unnamed tributary to Stevens Brook passes through the park and there is little woody vegetation in the buffer, where a buffer is provided. The area has wide grass roadside swales that could be retrofitted to further slow and treat stormwater runoff. The Town cleaned ~1.5 feet of sediment from this culvert in 2012.

Photo 1. Unnamed tributary to Stevens Brook flowing through Franklin Park West

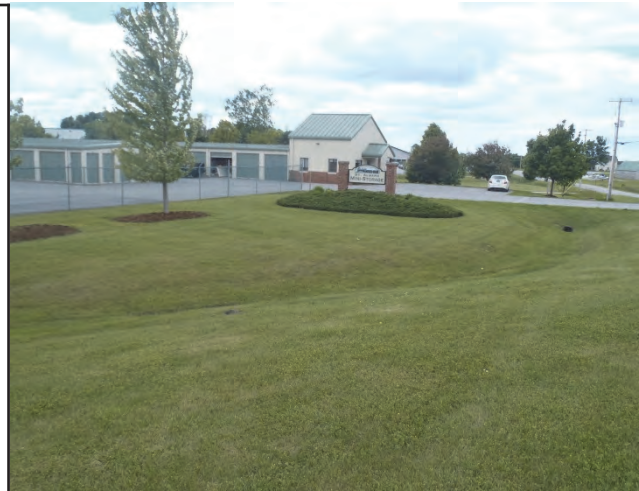
Photo 2. Example of wide grass swales present throughout Franklin Park West.

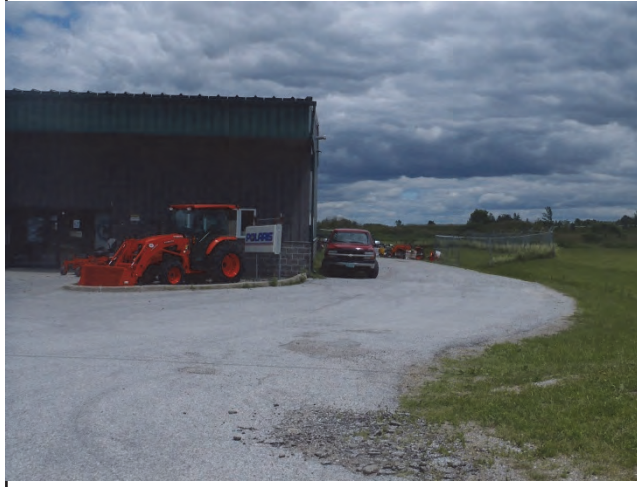
There are numerous opportunities to improve stormwater management in Franklin Park West. In general, the area has wide grass roadside swales, with some areas of erosion (see Photo 2, below). In addition, roof runoff within the Park appears largely unmanaged. Friends of Northern Lake Champlain applied for funding to improve stormwater management at Champlain Valley Equipment in late 2014.

Photo 1. Downspout at Champlain Valley Equipment discharging directly onto parking lot

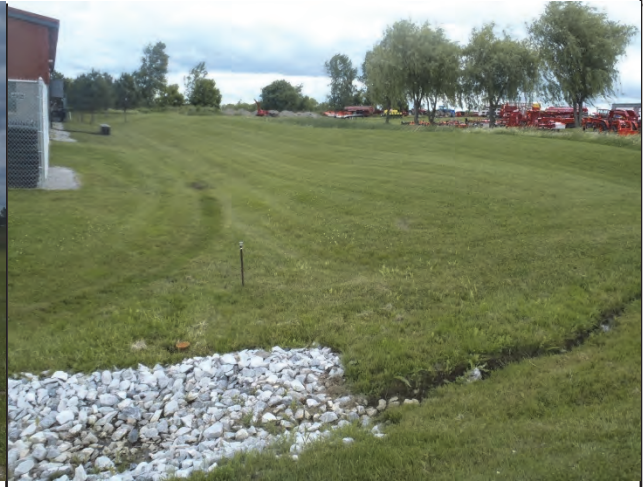
Photo 2. Eroding swale near F.W. Webb

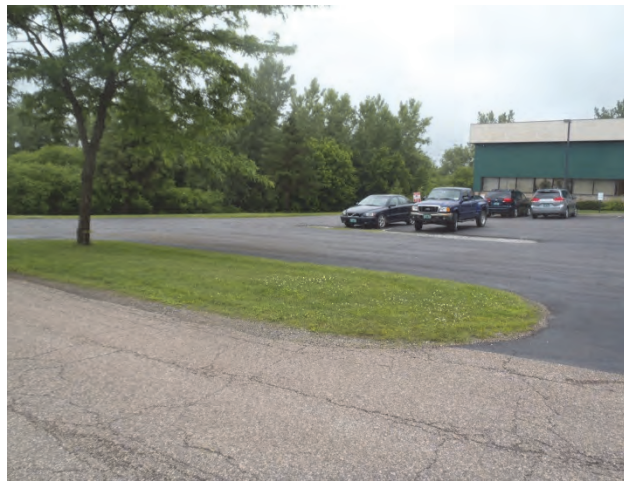
Green space and unpaved area within *Catamount Research and Development* parking lot present retrofit opportunities.

Photo 1. Possible green space for stormwater management

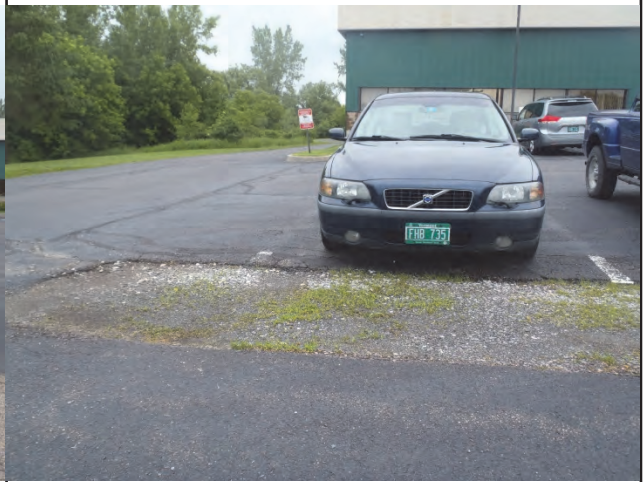
Photo 2. Unpaved area within parking lot.

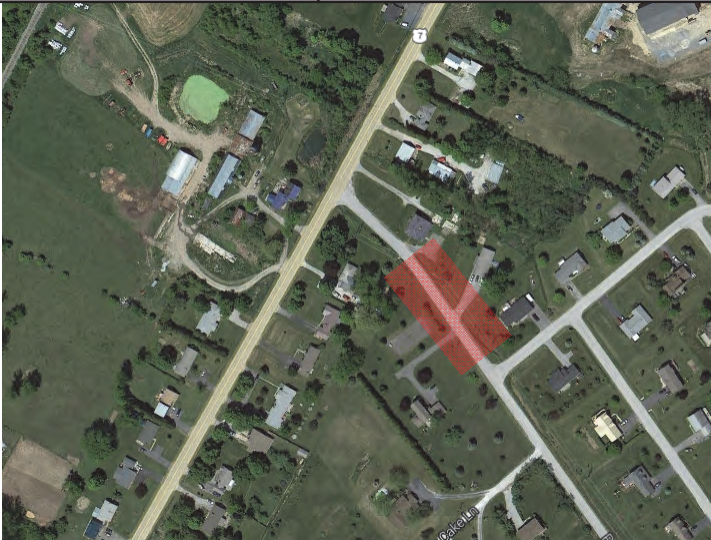
Problem Area ID: RB-03	Latitude: 44.789803°	Longitude: -73.097988°
Watershed: Rugg Brook

Description of Observed Conditions:
 A series of eroding roadside ditches are carrying runoff along Prospect Hill Rd., before turning northwest toward Harborview Estates.

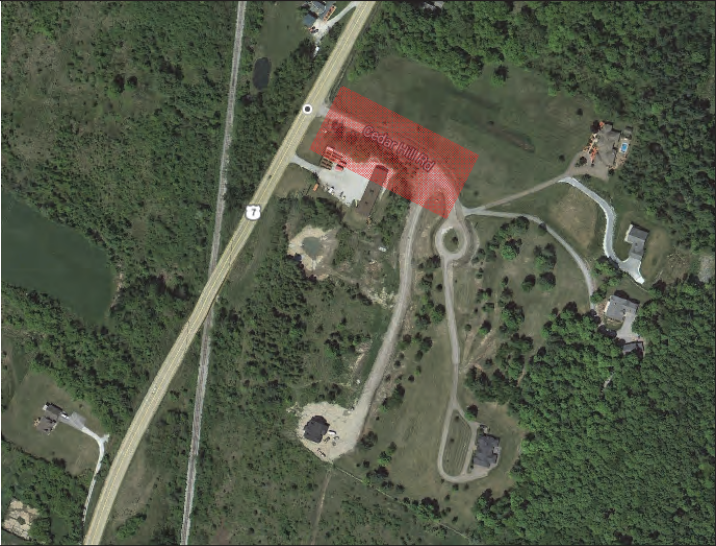
Problem Area ID: RB-04	Latitude: 44.783151°	Longitude: -73.101744°
Watershed: _____ Rugg Brook _____

Active erosion in the ditch along Cedar Hill Rd., from Charbonneau Dr. down to Route 7. Culvert headers poorly installed and actively being eroded around.

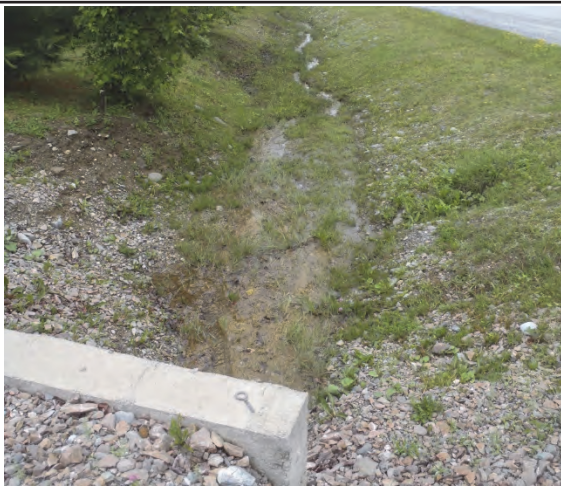
Photo 1. Erosion around culvert header.

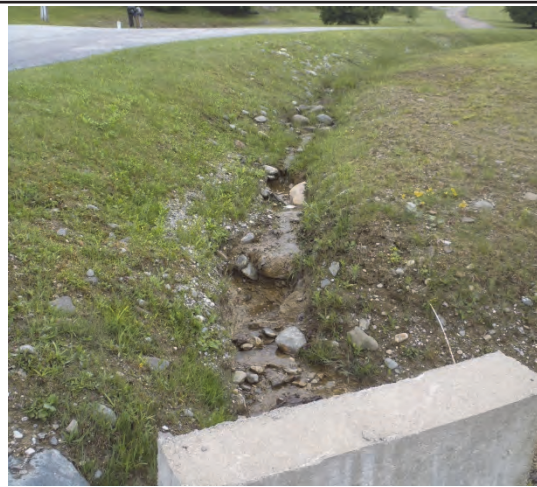
Photo 2. Erosion upstream of culvert header.

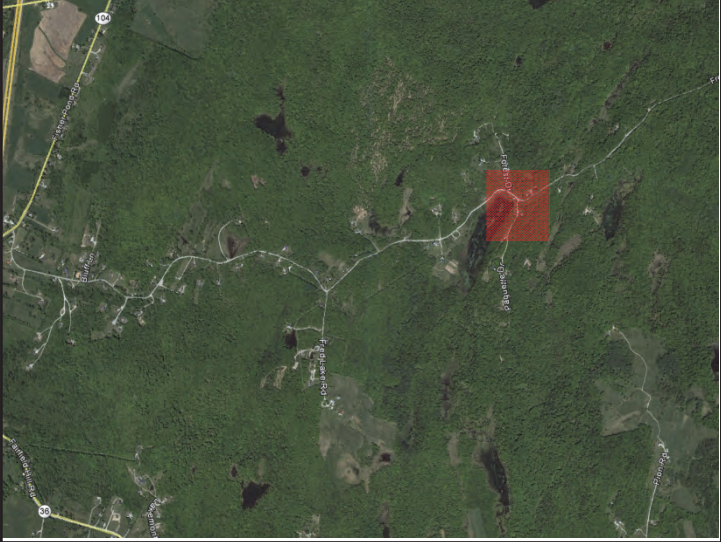
Problem Area ID: DC-01	Latitude: 44.812944°	Longitude: -73.040234°
Watershed: _____ Dead Creek _____

Description of Observed Conditions:
Culvert is perched and downstream banks are eroding.

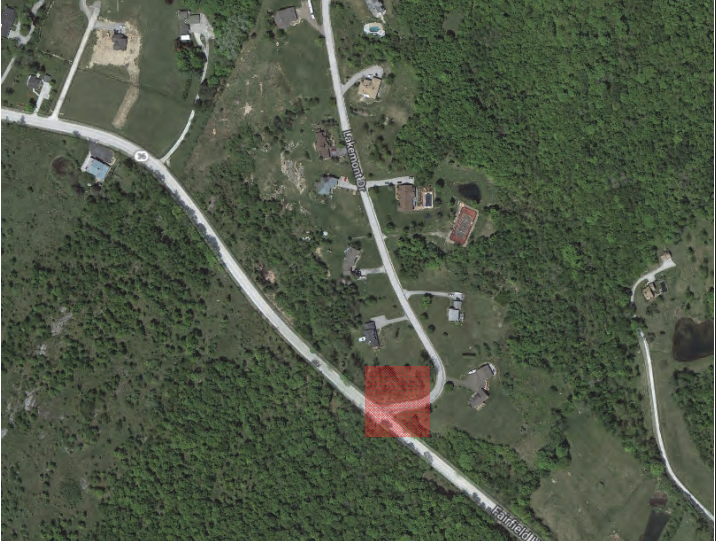
Problem Area ID: DC-02	Latitude: 44.794885°	Longitude: -73.048592°
Watershed: <hr/> Dead Creek

Description of Observed Conditions:
 Culvert is perched and downstream banks are eroding.

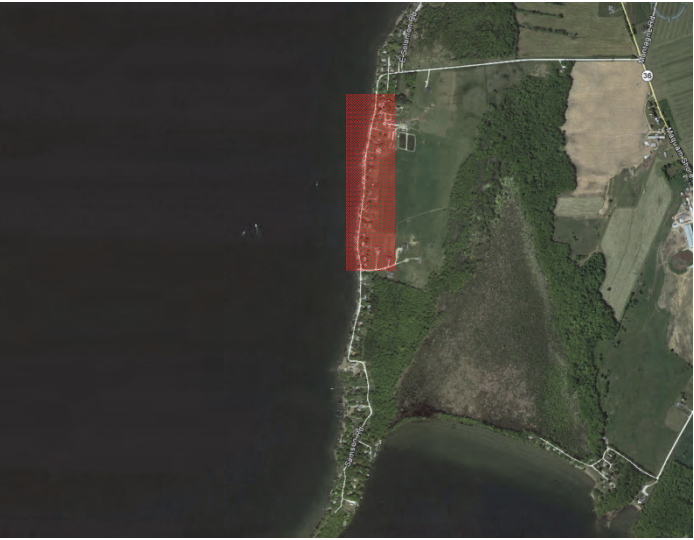
Problem Area ID: LC-01	Latitude: 44.82298825	Longitude: -73.1893853
Watershed: _____ Lake Champlain _____

Four culverts along Samson Road were identified in the culvert inventory as “critical.” It appears that the culverts have been replaced recently with catch basins that outlet to the lake. Some erosion was observed around the catch basin located 120 ft north of Waters Edge Dr. Some bank erosion was observed around the outlet located 720 feet north of Waters Edge Dr. The remaining two catch basins and outlets appear to be in good condition.

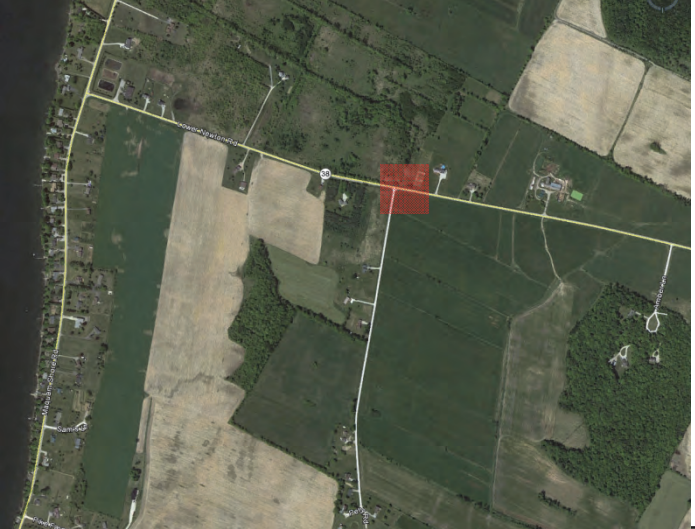
Problem Area ID: LC-02	Latitude: 44.859291°	Longitude: -73.170685°
Watershed: Lake Champlain

Description of Observed Conditions:
 The culvert under Perry Road appears to have recently been replaced. The ditch upstream from the culvert is narrow and V-shaped and is beginning to incise.

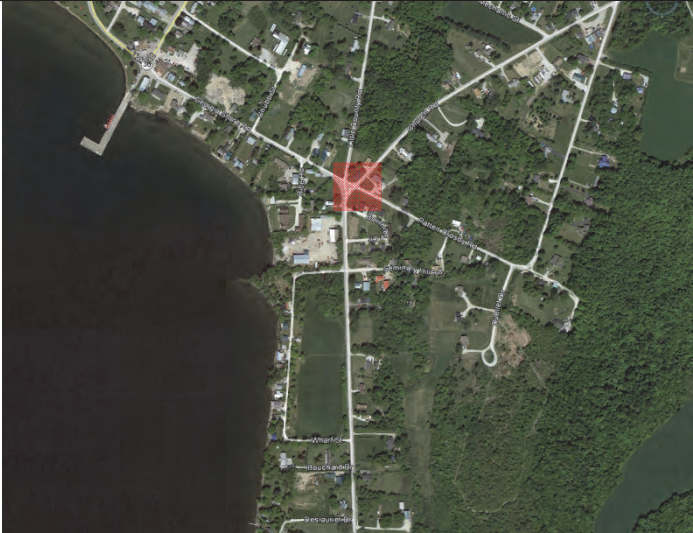
Problem Area ID: SAB-01	Latitude: 44.805582°	Longitude: -73.134757°
Watershed: <div style="border-bottom: 1px solid black; padding: 2px 0;">St. Albans Bay</div>

Description of Observed Conditions:
 The culvert beneath Patten Crosby Rd. appears to have recently been replaced. A discontinuous culvert section from Church St. is misaligned and may cause future erosion problems due to the confined nature of the area and nearby utilities.

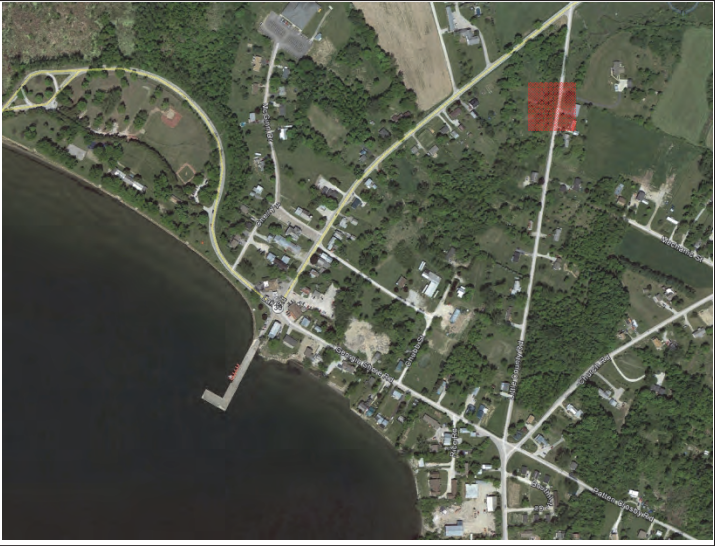
Problem Area ID: SAB-03	Latitude: 44.810947°	Longitude: -73.133882°
Watershed: <hr style="border: 0; border-top: 1px solid black; margin: 2px 0;"/> St. Albans Bay

Description of Observed Conditions:
 Stream banks upstream from culvert are unstable for several hundred feet. As a result, the culvert is misaligned with the stream. The bank above the culvert inlet and outlet is steep. The culvert outlet is perched, but a concrete splash pad has limited erosion.

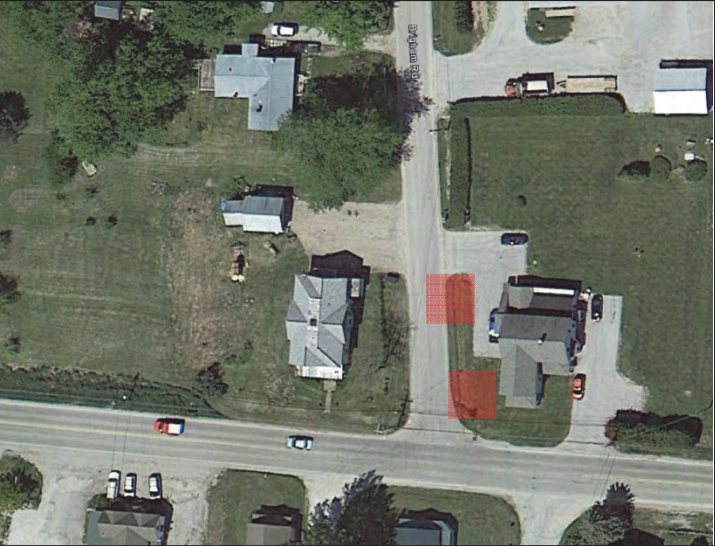
Problem Area ID: SAB-04	Latitude: 44.812159°	Longitude: -73.107130°
Watershed: <hr/> St. Albans Bay

Description of Observed Conditions:
 Two locations where culvert sections are discontinuous, resulting in scour holes approximately 4 ft. deep. The area around this location is largely impervious.

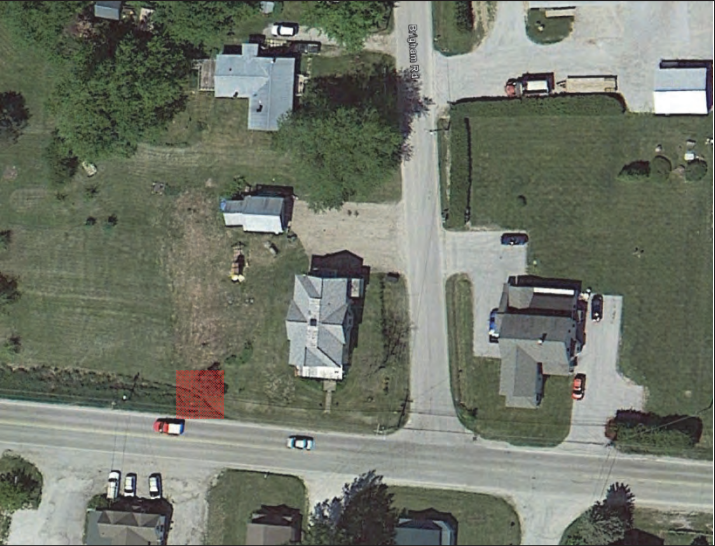
Problem Area ID: SAB-05	Latitude: 44.812159°	Longitude: -73.107130°
Watershed: St. Albans Bay

Description of Observed Conditions:
Erosion at the outlet of a culvert. Outlet is only 2 feet from the edge of pavement (Lake Rd.), and pavement is beginning to fail.

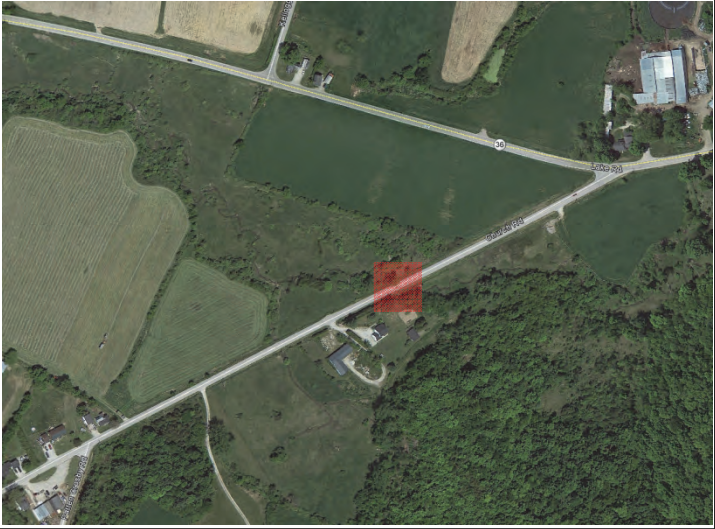
Problem Area ID: SAB-06	Latitude: 44.810003°	Longitude: -73.124885°
Watershed: _____ St. Albans Bay _____

Description of Observed Conditions:
Banks near inlet are eroding where stream turns 90-degrees to enter the culvert. There is a large scour pool at the outlet. Nearby utilities may be at risk as banks continue to erode.

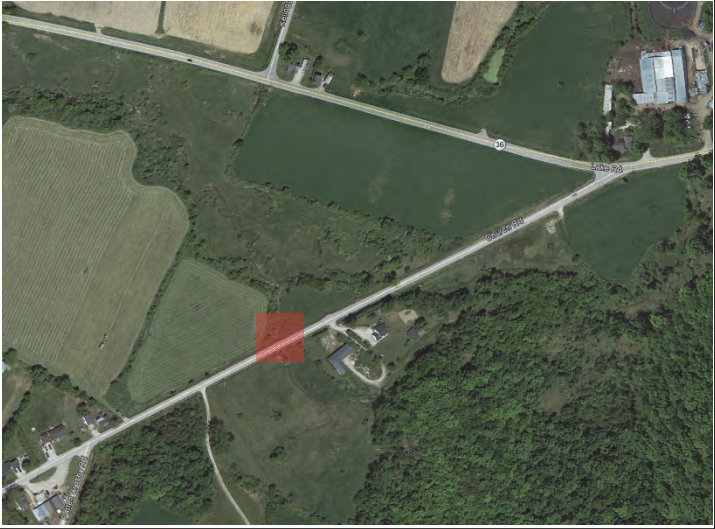
Problem Area ID: SAB-07	Latitude: 44.805582°	Longitude: -73.134757°
Watershed: St. Albans Bay

Description of Observed Conditions:
 A large catchment drains to this undersized culvert. The culvert outlet is perched and the banks nearby are eroding.

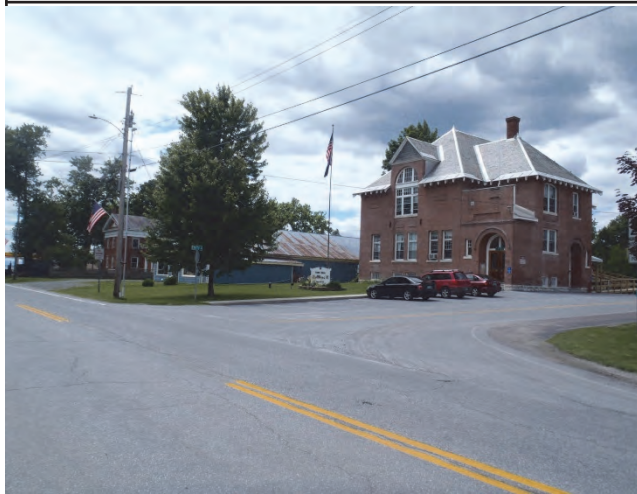
Stormwater runoff from Town Hall currently flows out to Lake Rd., and across the edge of the gravel parking lot before dropping into a nearby catch basin. It appears that the front lawn of Town Hall could be retrofitted to improve stormwater management.

Photo 1. St Albans Town Hall, and lawn

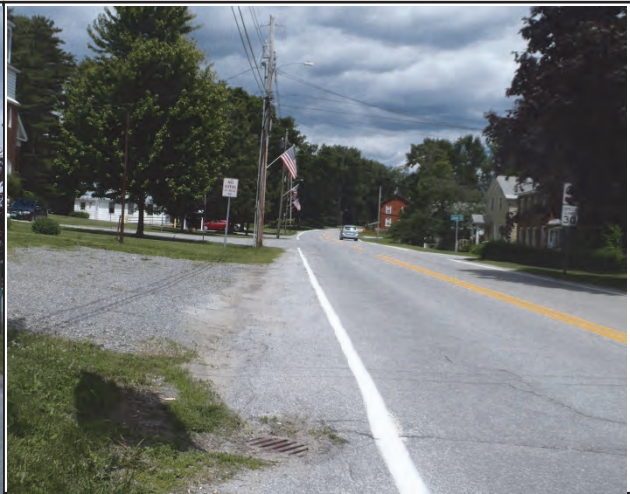
Photo 2. Catch basin that receives runoff from Town Hall
