Stormwater Master Plan Town of St. Johnsbury, Vermont

15-215

Stormwater Master Plan

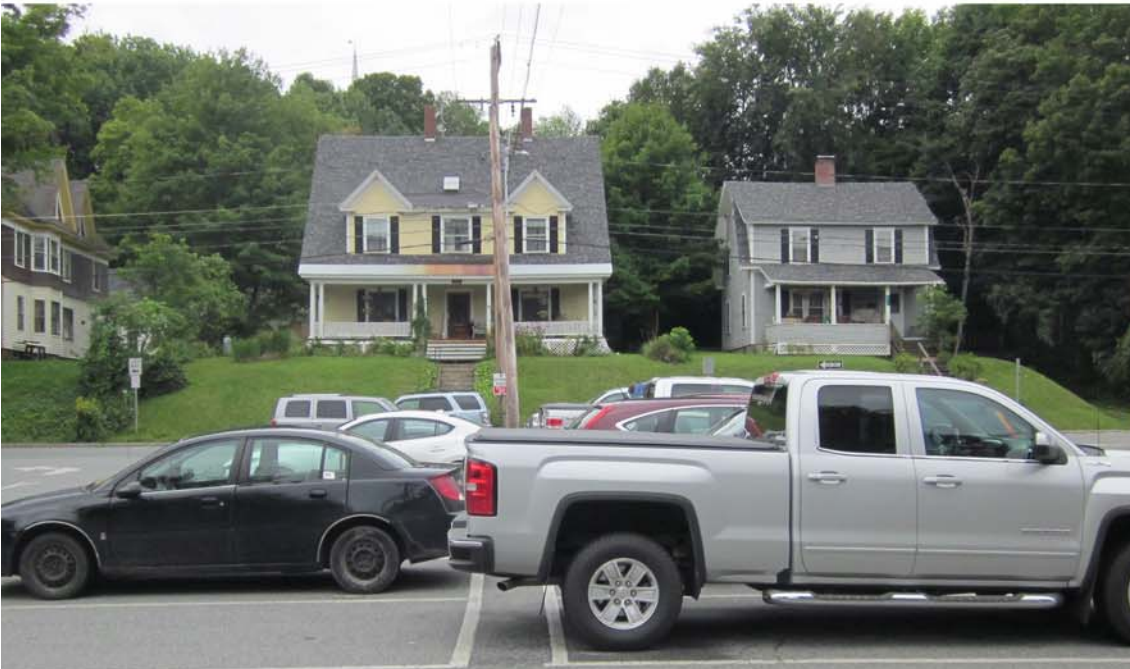
Existing Condition

The existing municipal parking lot at Pearl Street.

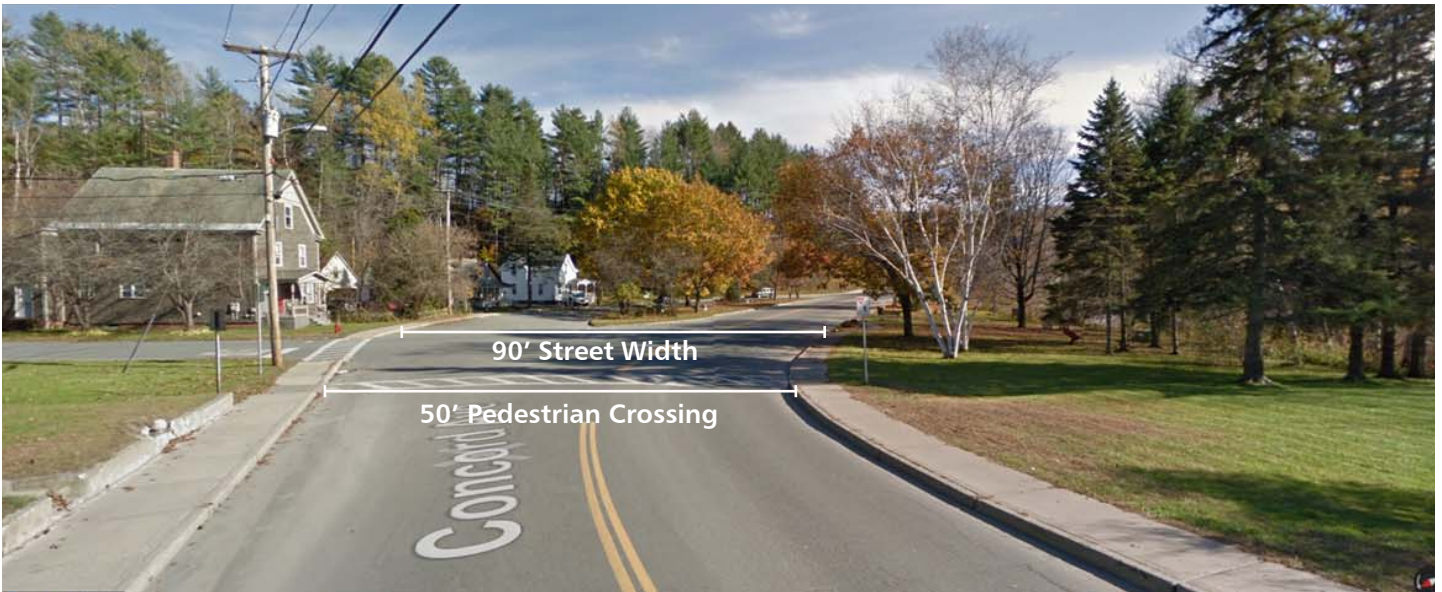
Existing Condition

The excessive paving at Concord Avenue, Old Concord Avenue and Gilman Avenue. The pedestrian crossing is 50' wide and the street is 90' wide just west of the residential square.

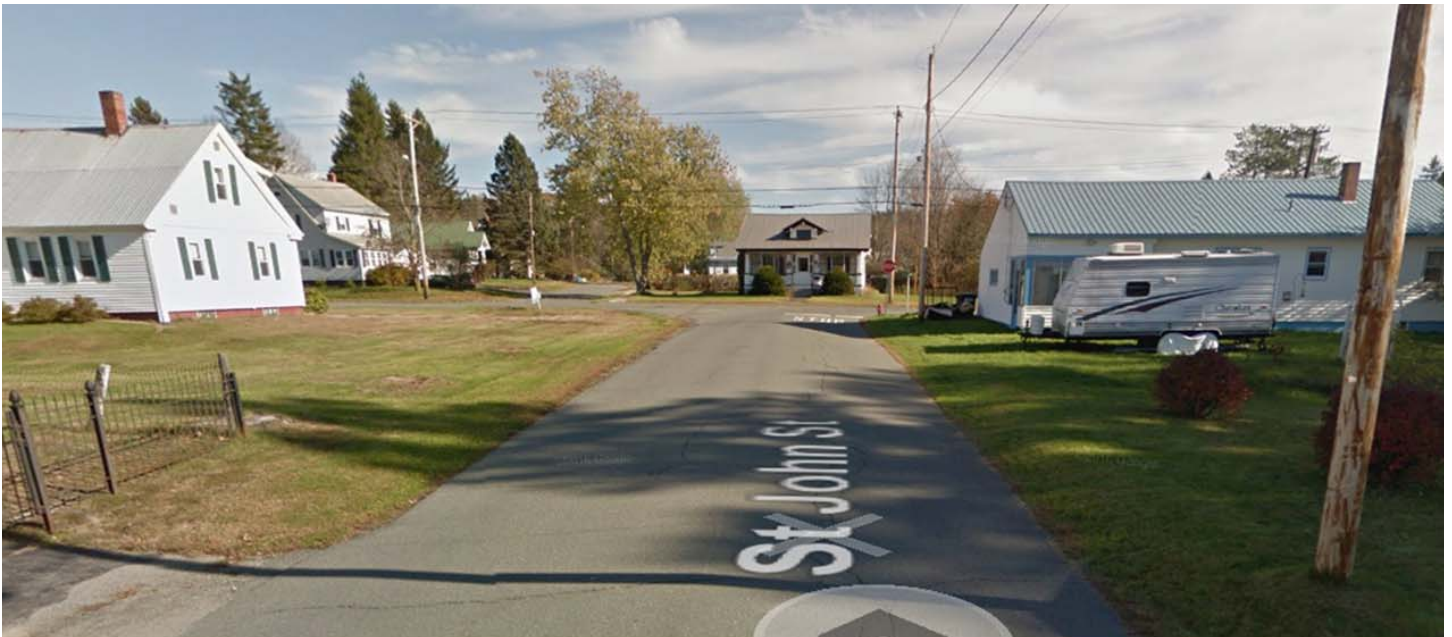
Existing Condition - St. John Street

Above, existing conditions on St. John Street near the intersection with Pleasant Street.

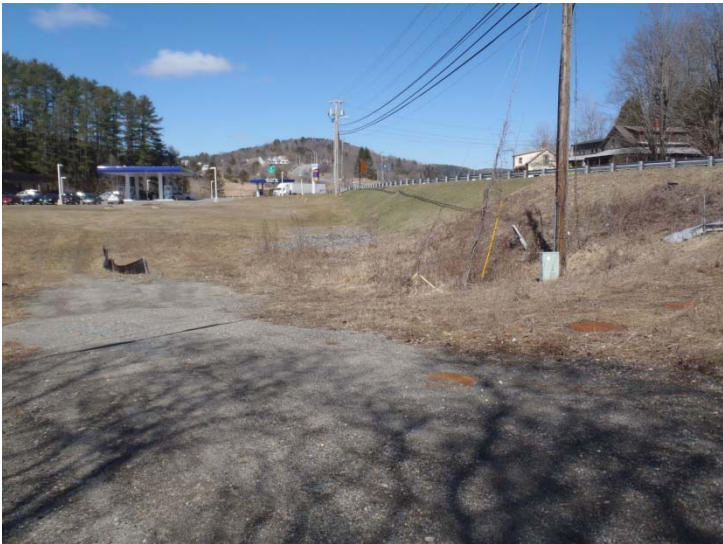
Potential to capture and treat a portion of the runoff from sewershed bounded by Cliff St to the west, Summer St to the east and Mt Pleasant St to the north in the existing green space to the south of Route 2 and west of High St. A “best fit” solution for this site has been designed and the project is moving to construction.

Photo 1. Potential retrofit location

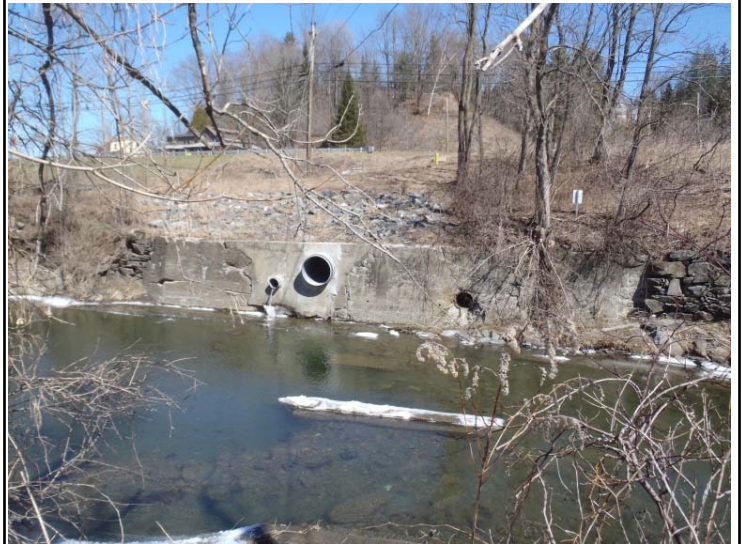
Photo 2. Existing outfalls to the Sleepers River

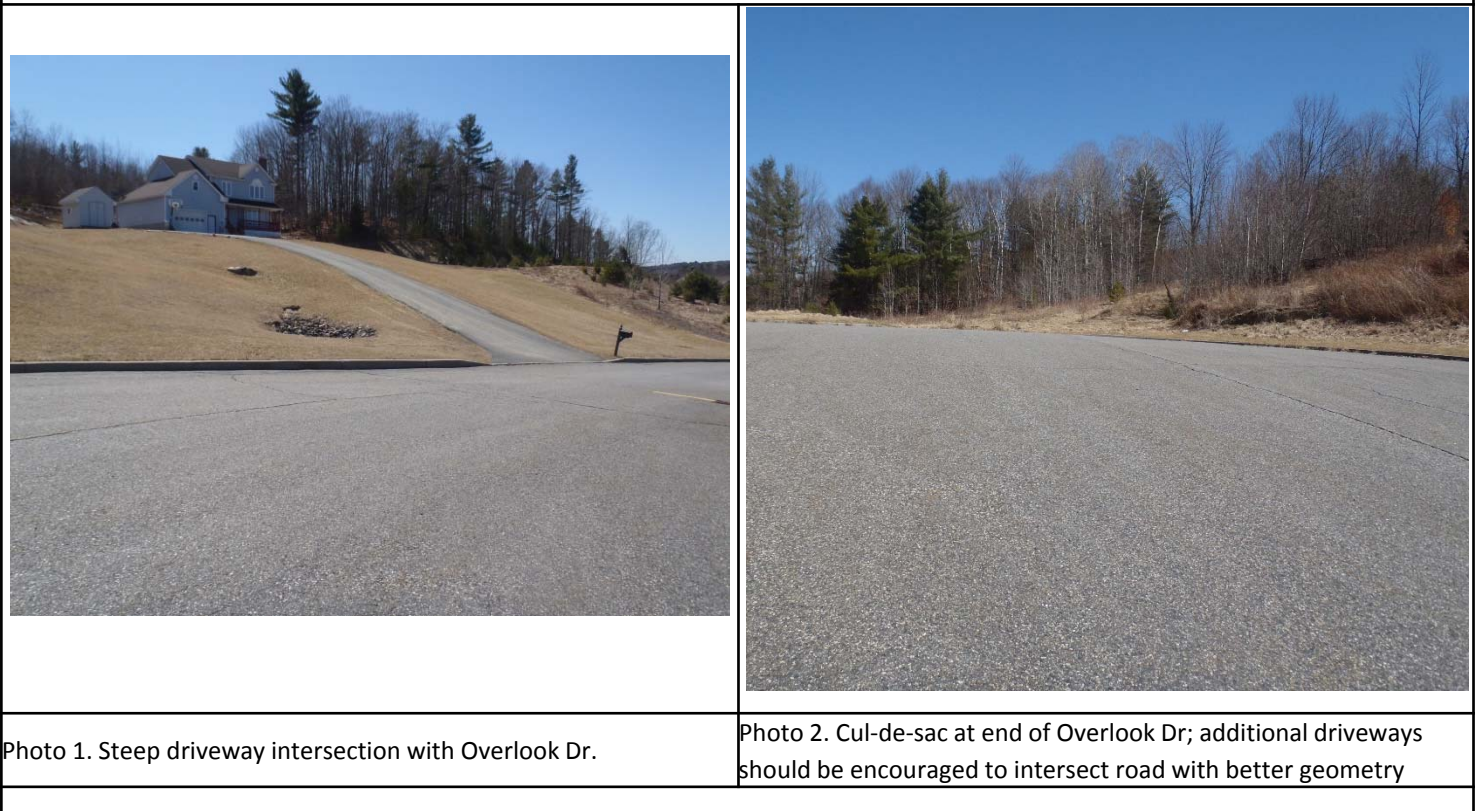
Description of Observed Conditions:
 Driveways along Overlook Dr generally intersect the road surface at a steep angle and little or no apron resulting in significant gravel being carried into the road and ultimately the storm sewer system. Undeveloped lots remain around the cul-de-sac and could be encouraged to implement better driveway design.

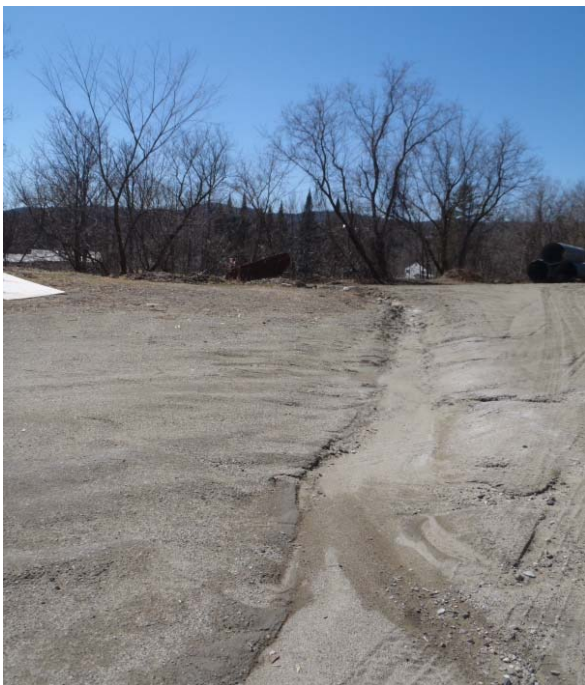
Sand storage pile at the Town Garage is experiencing “creep” and has slumped over the jersey barriers intended to prevent material from eroding into a nearby drainage swale; both stormwater outlets from the facility show evidence of significant sediment transport and active erosion.

Photo 1. Gully erosion through Town Garage maintenance yard

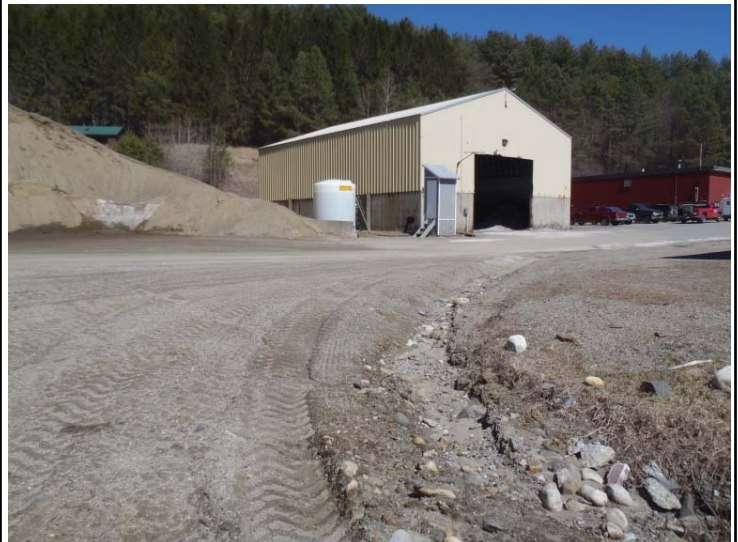
Photo 2. Visible “creep” of the sand storage pile

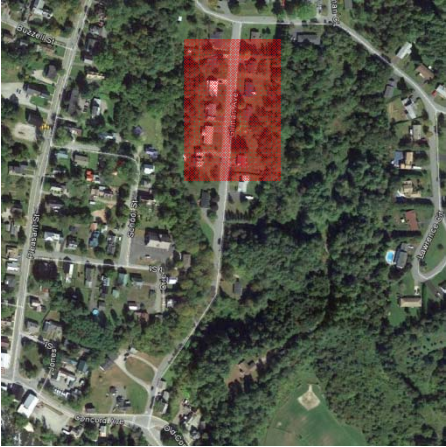
Description of Observed Conditions:
 Bring overly-wide section of road back to standard width, establishing a grassed channel with check dams, as needed, on both sides of the road to convey stormwater runoff.

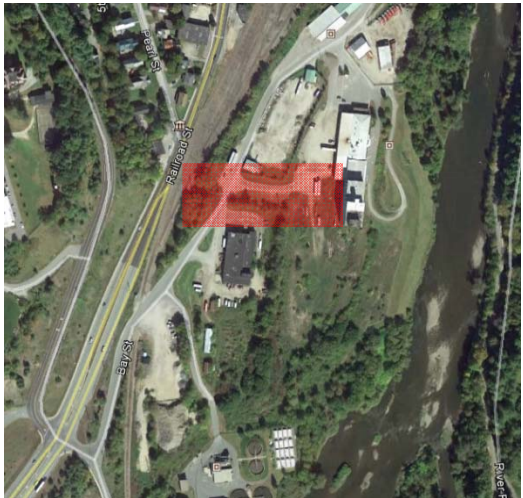
Problem Area ID: PR-03	Latitude: 44.244437	Longitude: -72.005892
Watershed: <hr style="border: 0; border-top: 1px solid black; margin: 2px 0;"/> Passumpsic River

Description of Observed Conditions:
 Heavy sediment load was observed in the swale immediately to the north of 659 Bay St. The swale receives stormwater runoff from the west side of Bay St through a cross-culvert, but the origin of the stormwater is unknown as the infrastructure in this location has not been mapped.

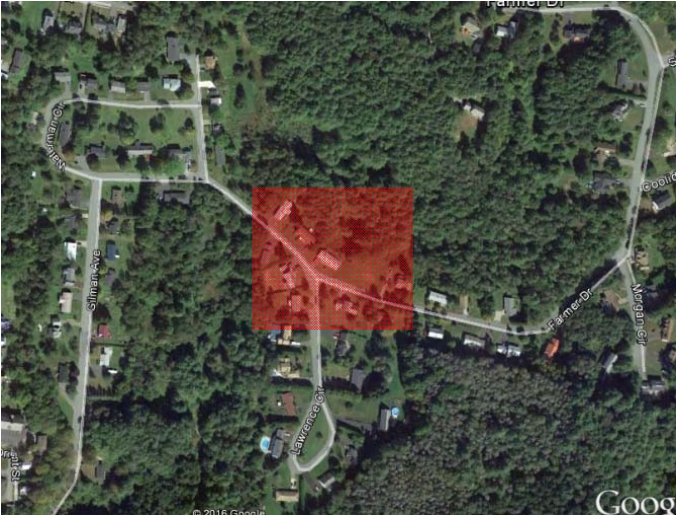
Problem Area ID: PR-04	Latitude: 44.254521	Longitude: -72.002911
Watershed: <hr style="border: 0; border-top: 1px solid black; margin: 2px 0;"/> Passumpsic River

Description of Observed Conditions:
 There is an undersized culvert ~30 feet below grade; embankments of road crossing are unstable and show evidence of gully erosion slumping. Although it is unlikely to be possible to replace this culvert as part of a stormwater master plan, there are opportunities to better manage stormwater runoff from adjacent residential areas.

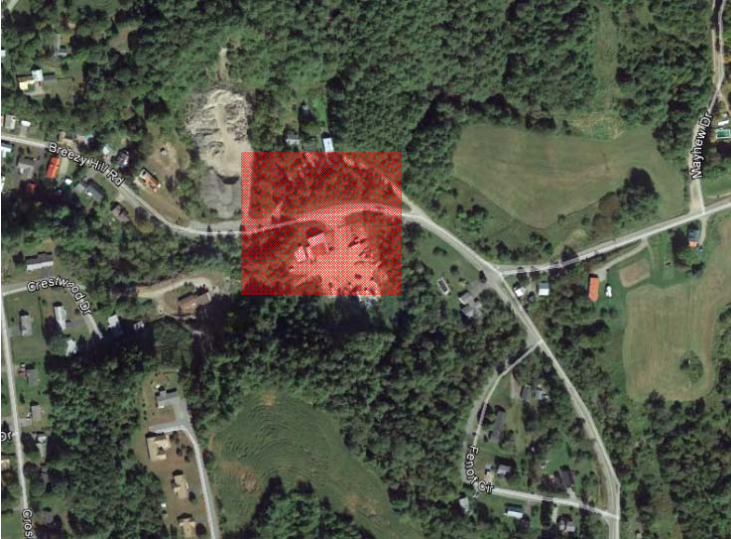
Problem Area ID: PR-05	Latitude: 44.271720	Longitude: -72.003495
Watershed: <hr style="border: 0; border-top: 1px solid black; margin: 2px 0;"/> Passumpsic River

Description of Observed Conditions:
 Unmanaged stormwater runoff from roadway concentrates where Breezy Hill Rd crosses Roberts Brook (Passumpsic River tributary) and is causing gully erosion and general embankment instability.

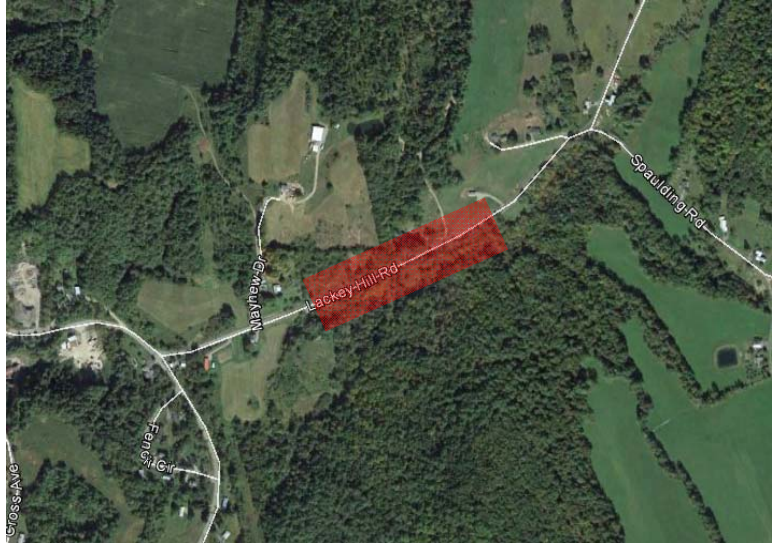
Problem Area ID: PR-06	Latitude: 44.271817	Longitude: -72.001880
Watershed: <hr style="border: 0; border-top: 1px solid black; margin: 2px 0;"/> Passumpsic River

Description of Observed Conditions:
 Unstable ditches, turnouts and cross-culverts are resulting in significant erosion and visibly more turbid water in Roberts Brook between Spaulding Rd and Breezey Hill Rd. Opportunity to bring overly-wide section of road back to standard width and establish properly shaped ditches, with stone-lining and check dams as needed.

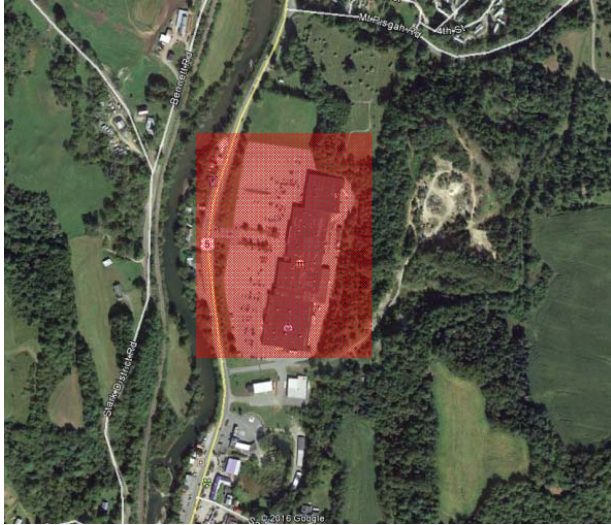
Problem Area ID: PR-07	Latitude: 44.273805	Longitude: -72.004960
Watershed: <hr/> Passumpsic River

Description of Observed Conditions:
 Site includes more than 10 acres of unmanaged impervious surface. Existing islands within the parking lot could be retrofit as bioretention areas. Opportunities exist for treatment in the green spaces to the west and north of the parking lot. There may also be opportunities to reconfigure/depave certain areas without interfering with existing uses, including CDL training.

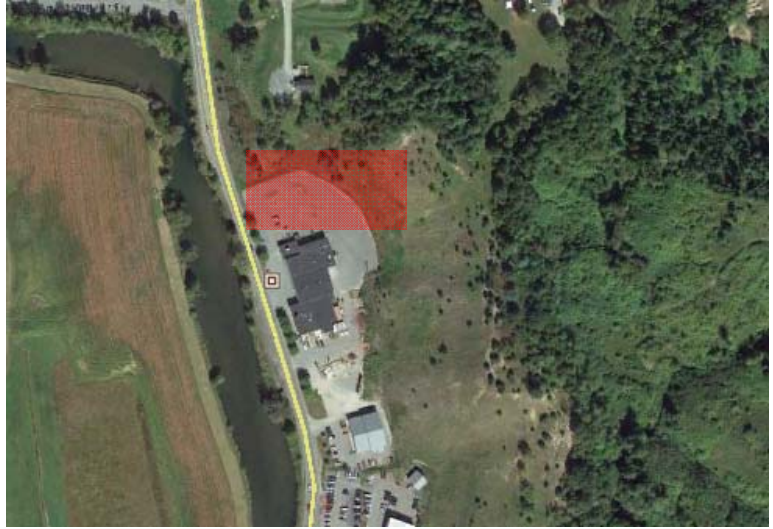
Problem Area ID: PR-09	Latitude: 44.262991	Longitude: -72.005191
Watershed: <hr style="border: 0; border-top: 1px solid black; margin: 2px 0;"/> Passumpsic River

Description of Observed Conditions:
 Retrofit existing green spaces in the parking lot by recessing them and regrading the lot to drain to these areas; swale along the northside of the parking lot could be retrofit as a bioswale to provide enhanced stormwater treatment

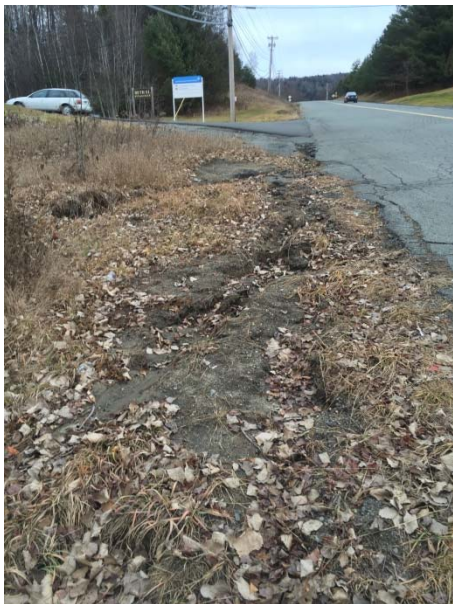
There are a number of small stormwater practices which appear to be designed to treat runoff from buildings and parking facilities along Sherman Dr., several of which appear unmaintained and potentially undersized, and are discharging onto a steep slope without energy dissipation. There are retrofit opportunities to use existing green spaces in the parking lots by recessing them and regrading to drain to these areas; swale along the north-side of the parking lot could be retrofit as a bioswale to provide enhanced stormwater treatment. Other parts of the campus are covered under an existing stormwater discharge permit (5099-9015).

Photo 1: Erosion along the road shoulder

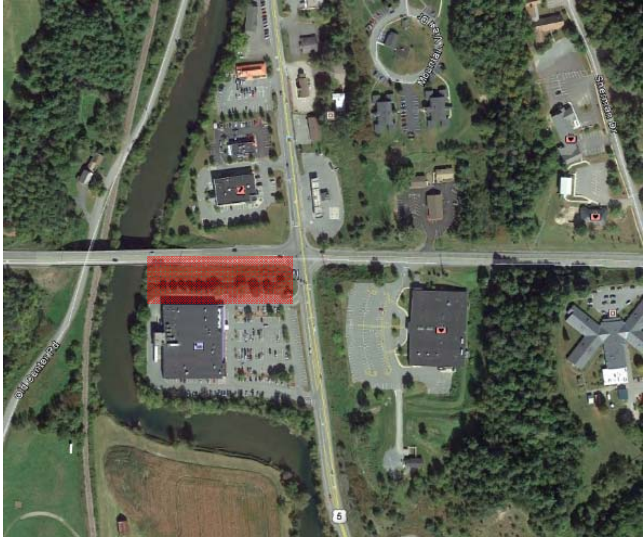
Problem Area ID: PR-11	Latitude 44.264338	Longitude: -72.005582
Watershed: <hr/> Passumpsic River

Description of Observed Conditions:
 Existing swale along the south-side of Hospital Dr (adjacent to the Price Chopper shows evidence of high flows and sediment transport. Swale could be retrofitted to improve stormwater management.

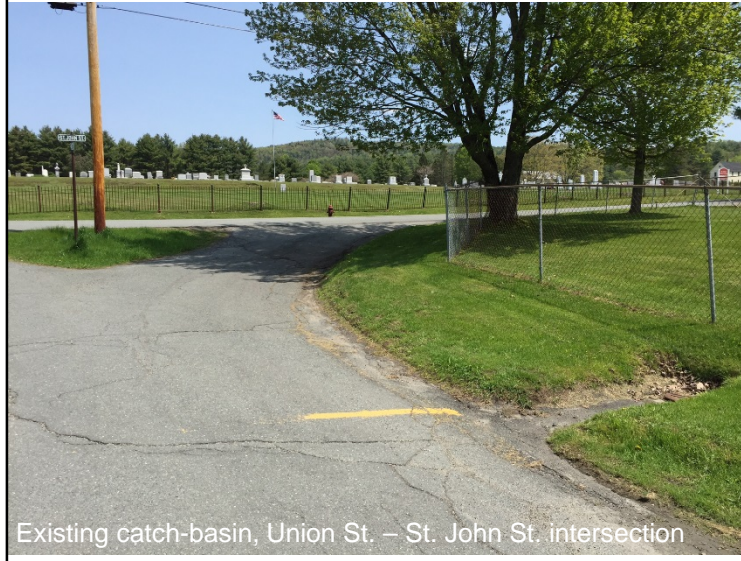
Existing catch-basin, Union St. – St. John St. intersection

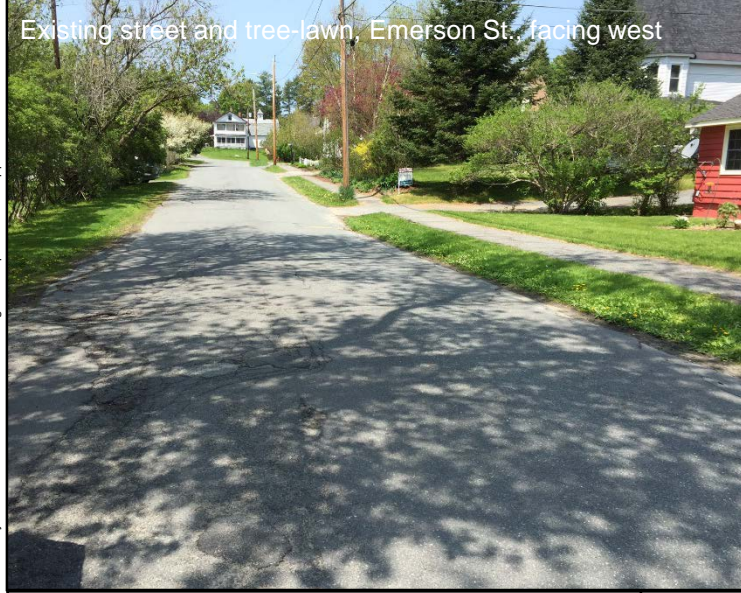
Existing street and tree-lawn, Emerson St. facing west
