June 29, 1989

Final Expanded Site Inspection Report
Lemieux Truck Dump/Mountain View Auto Restoration
Lyndonville, Vermont

TDD No. F1-8702-02
Reference No. \$375VT10E1
CERCLIS No. VTD108866278/
VTD981204159

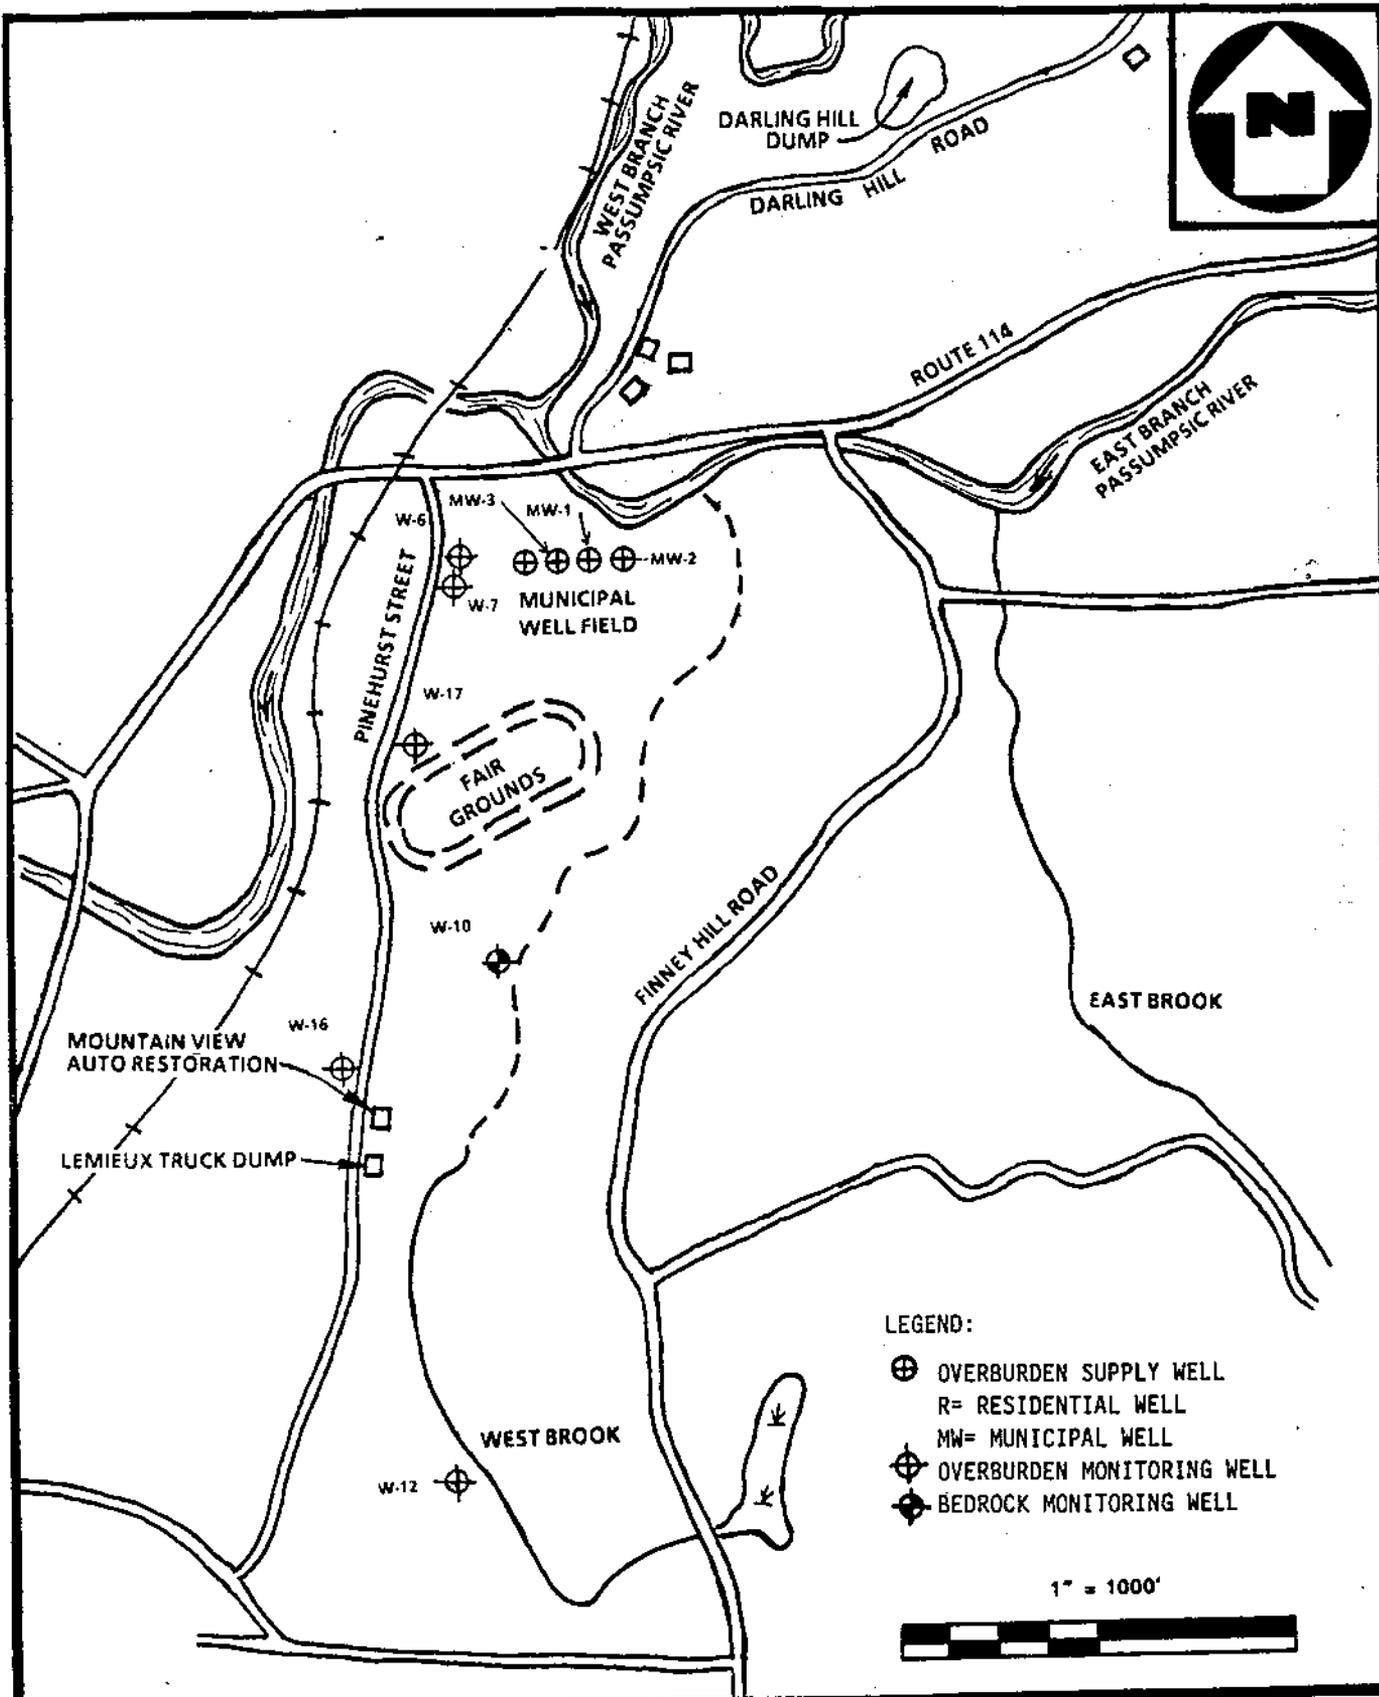
FIGURE 4

PHASE III SAMPLE LOCATIONS, JUNE 1987

collected from West Brook immediately downslope and downstream of the facilities. The sample from location SD-07 was collected from the East Branch Passumpsic River, immediately downstream of where West Brook joins it (Figure 4).
