Re: Bank of Vermont/Gleason Site, Route 103, Rockingham, Vermont

GLEASON SITE INVESTIGATION

PHASE II HYDROGEOLOGIC INVESTIGATION

GLEASON SITE; ROCKINGHAM-VT

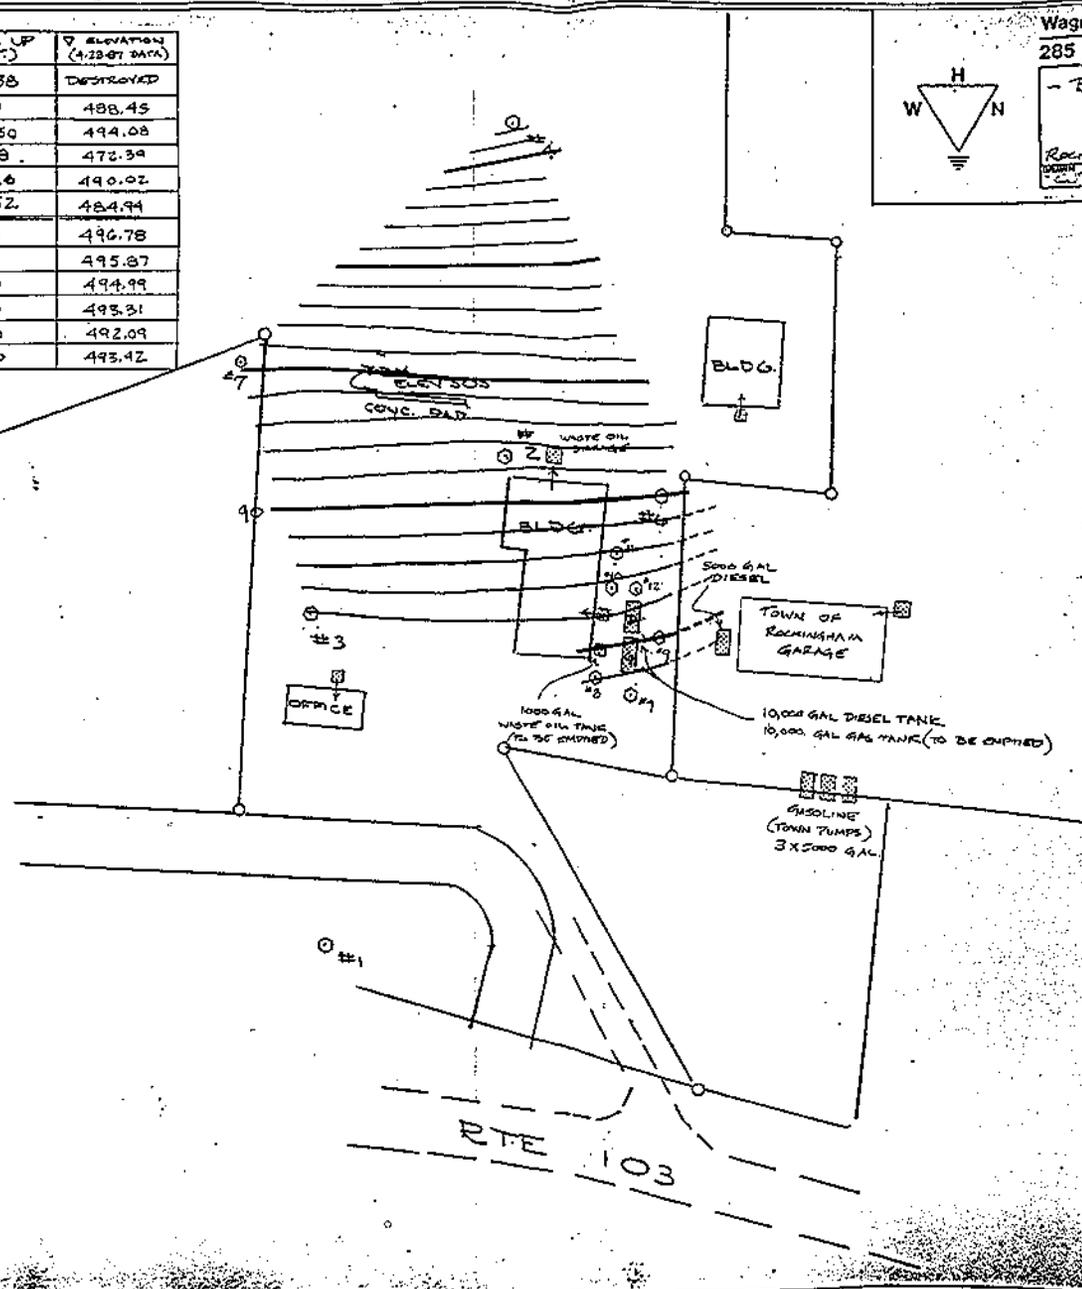
Wagner, Heindel, and Noyes, Inc. Consulting Engineers
 285 North St., Burlington, Vermont 05401 802-658-0820
 - BANK OF VERMONT FLORENCE
 MONITOR WELL LOCATIONS
 WILKINSON
 ROCKINGHAM
 DATE 7/30/87
 DRAWN BY [signature] CHECKED BY [signature] DATE 7/21/87

- Notes
- MONITORING WELLS #1 - 6 - INSTALLLED ON 4/19/86 BY ADAMS ENGINEERS
 - MONITORING WELLS #7 - #12 - INSTALLLED ON 2/17/87 BY ADAMS ENGINEERS
 - WELL #5 DESTROYED BY TOWN VEHICLE
 - ALL WELL LOCATIONS & ELEVATIONS SURVEYED BY SOUTHERN VERMONT ENG. 7/06 AND 8/87

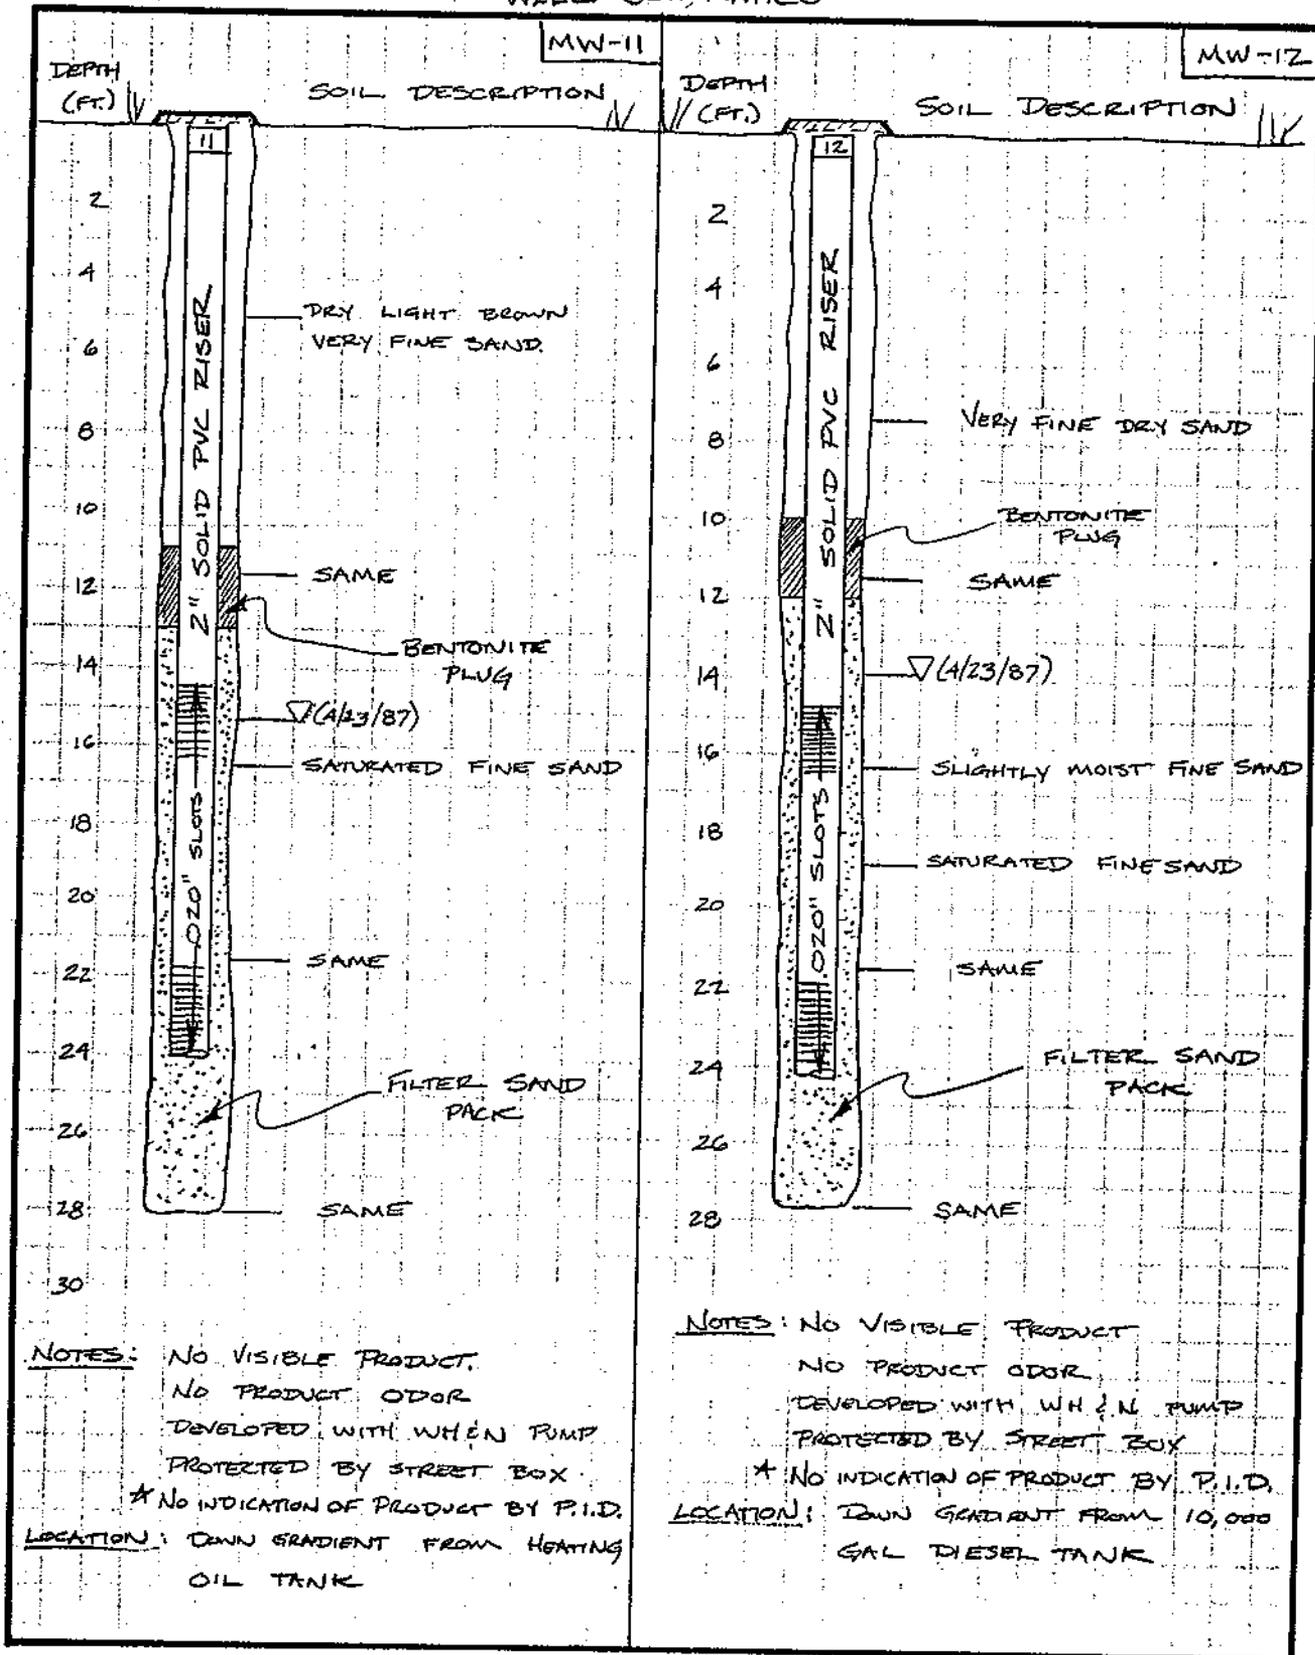
WELL SCHEMATICS

NOTES: NO VISIBLE PRODUCT.
NO PRODUCT ODOR.
DEVELOPED WITH W.H. & N. PUMP.
PROTECTED BY STREET BOX.
* NO INDICATION OF PRODUCT BY P.I.D.

LOCATION: DOWN GRADIENT FROM HEATING OIL TANK
