**MANCHESTER MOTORS**  
**Manchester, Vermont**

**EXPANDED PHASE II ENVIRONMENTAL SITE ASSESSMENT**  
**AUGUST 1992**

**August 25, 1992**

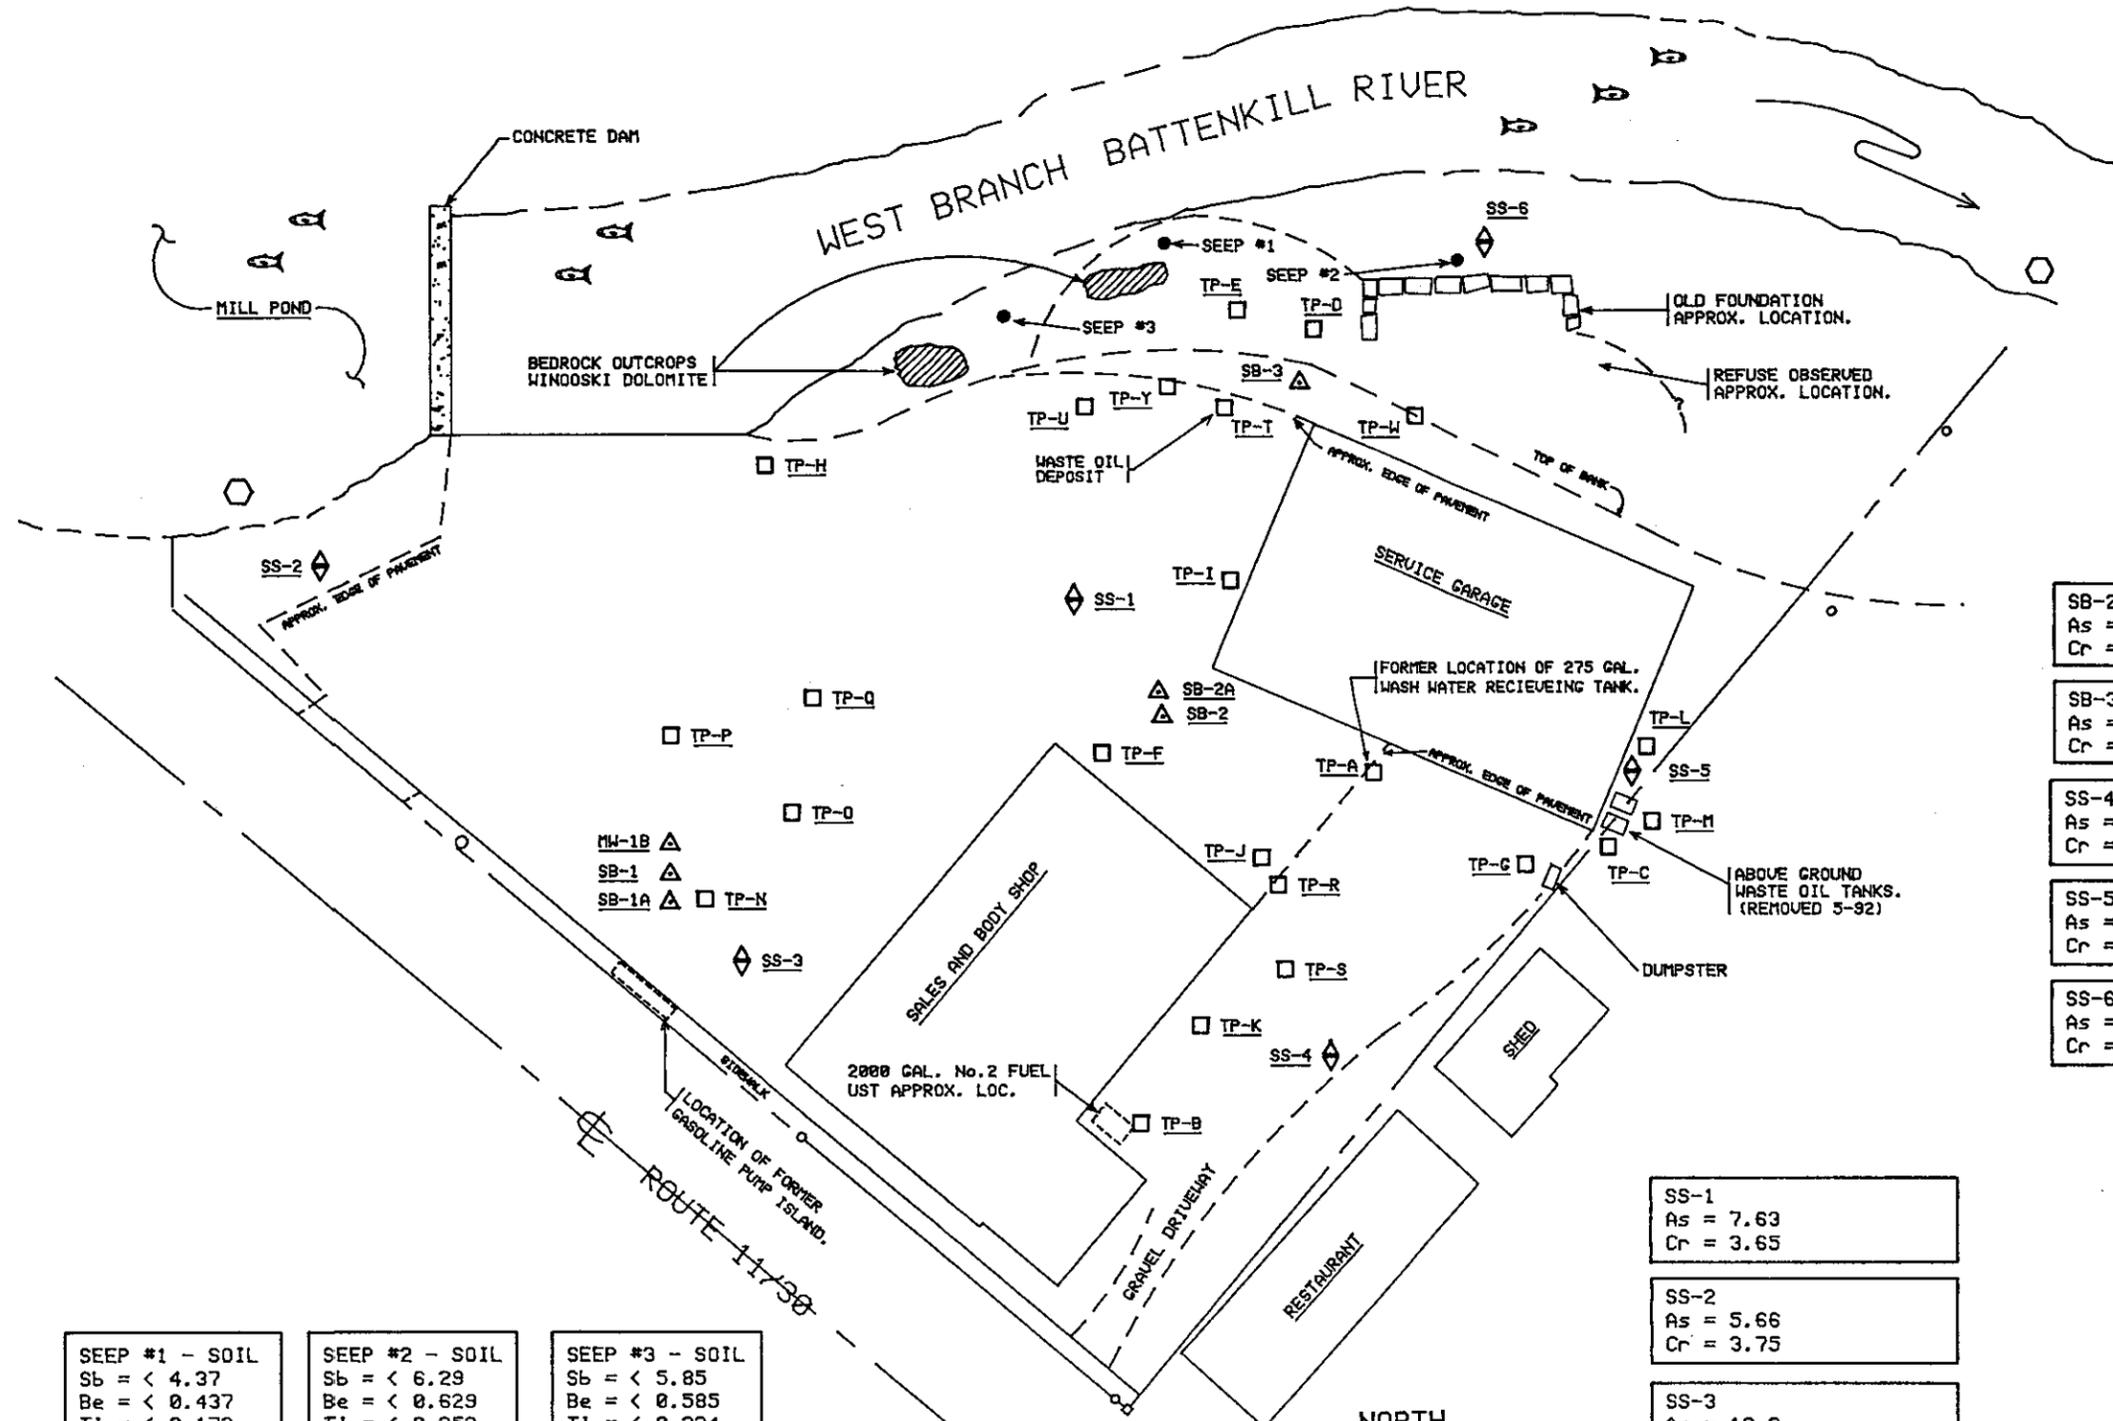
SB-2 (4.5-6.5 FT. BGS)
As = 6.74
Cr = 13.5

SB-3 (5-7 FT. BGS)
As = 4.72
Cr = 7.75

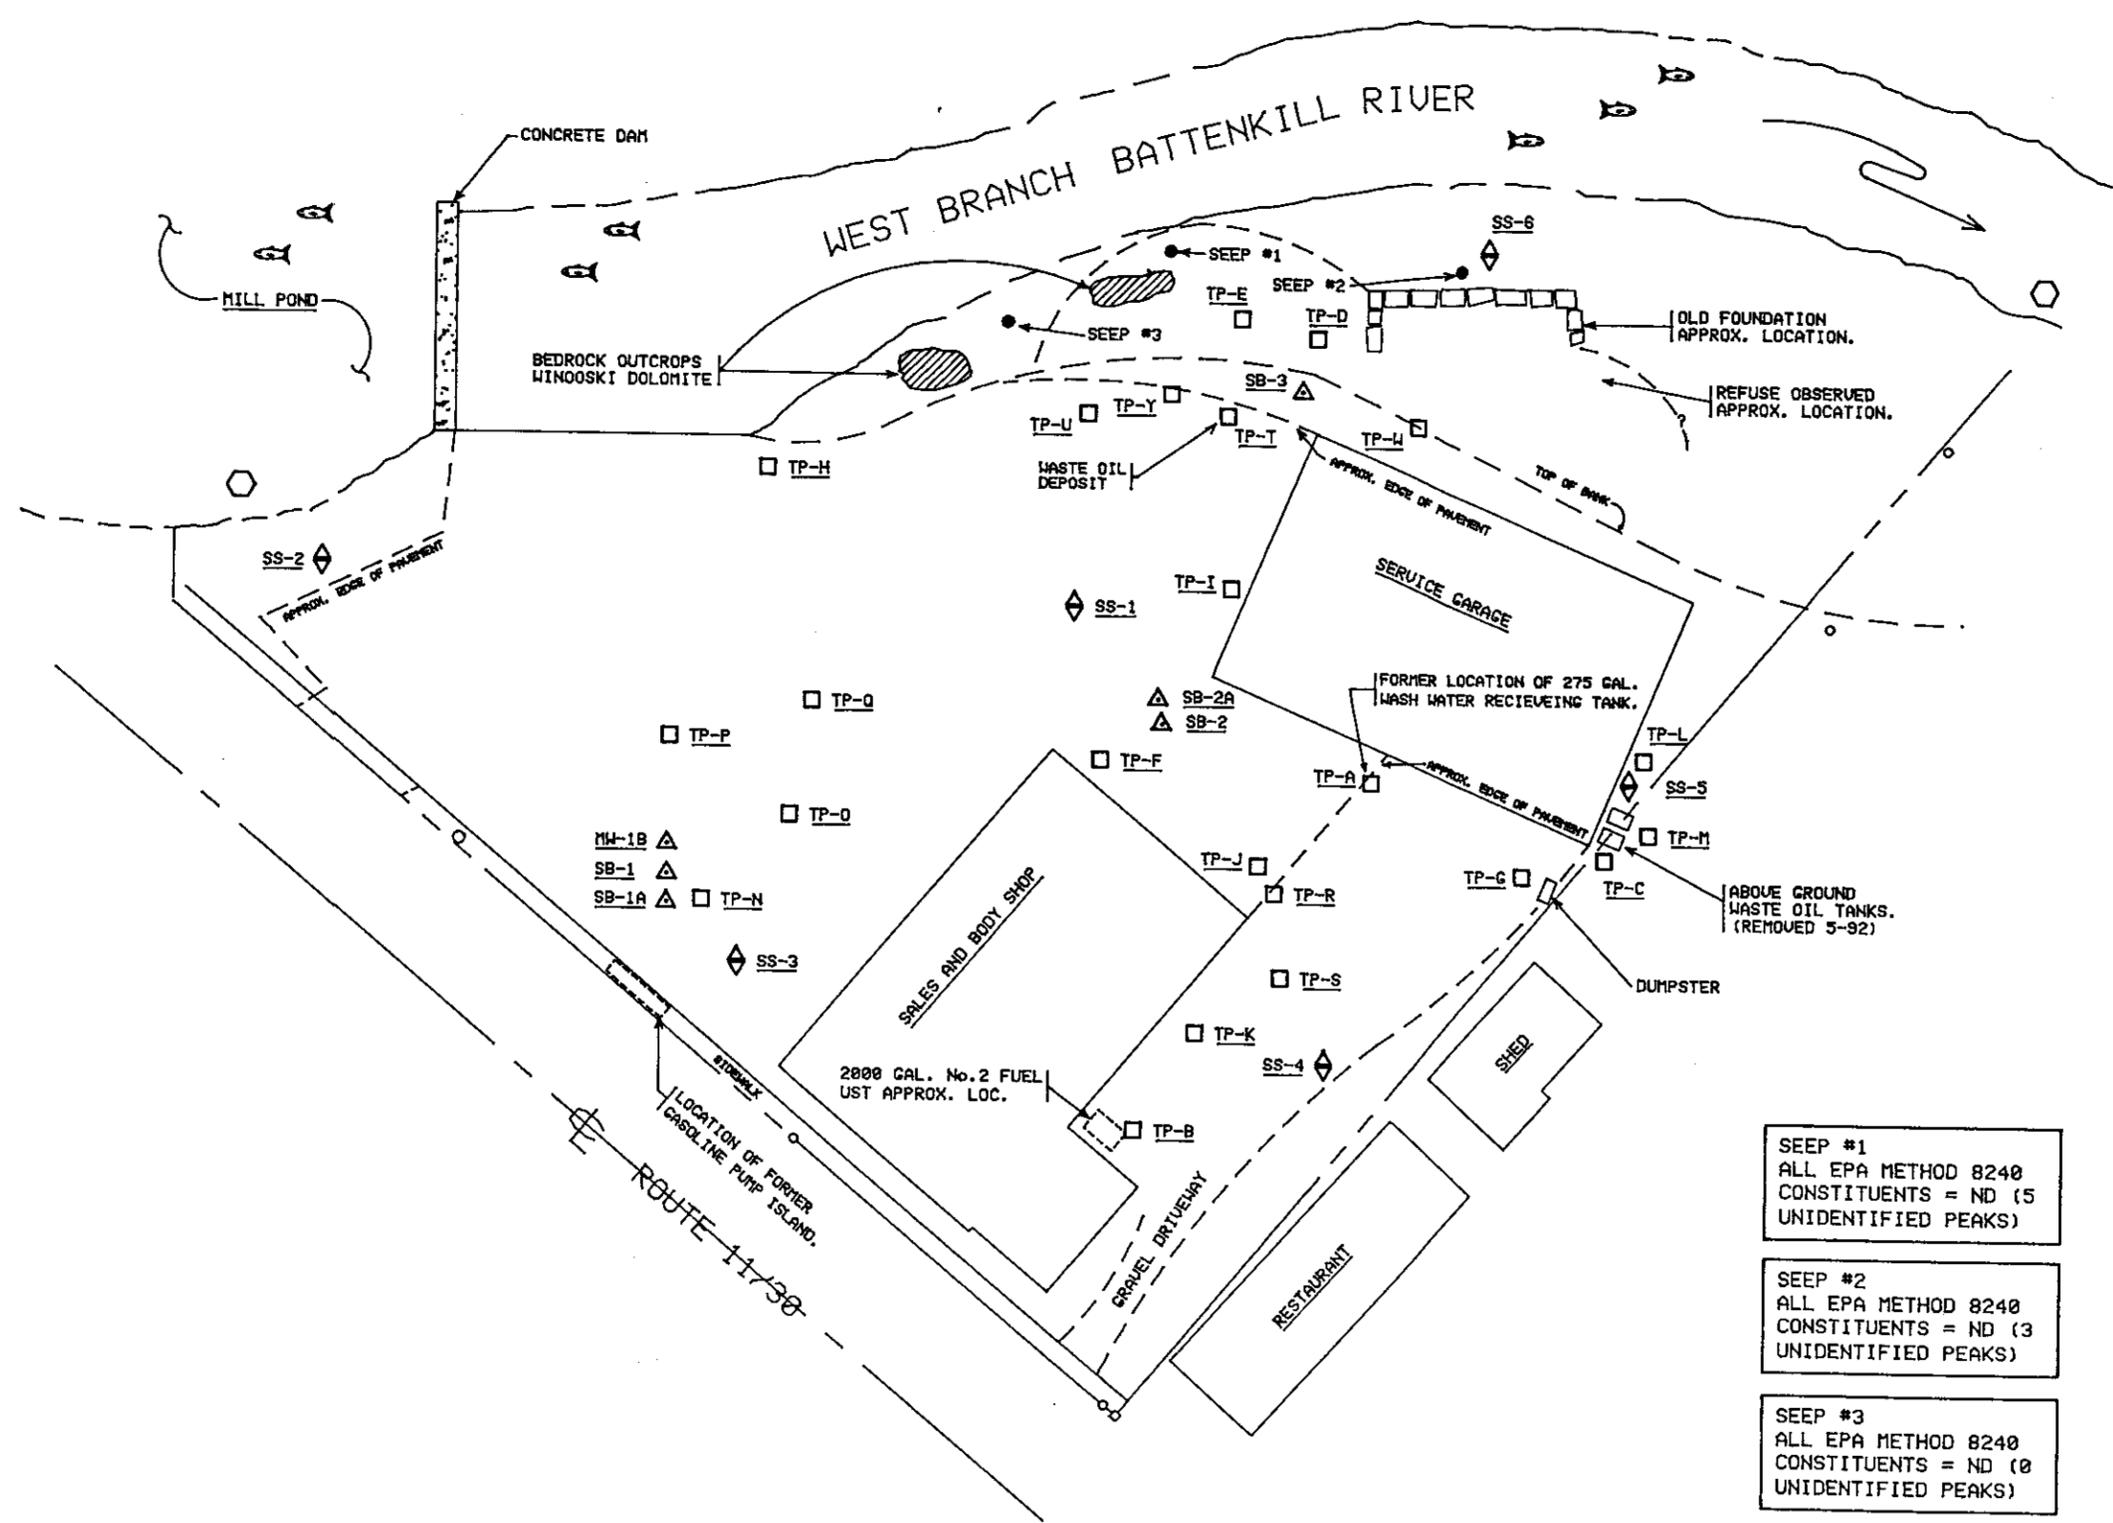
SB-1: 4-6 FT. BGS  
ETHYL BENZENE 57.0  
TOLUENE TBO  
TOTAL XYLENES 347 (10 UNIDENTIFIED PEAKS)

SB-3: 5-7 FT. BGS  
TOTAL XYLENES 62.0 (0 UNIDENTIFIED PEAKS)

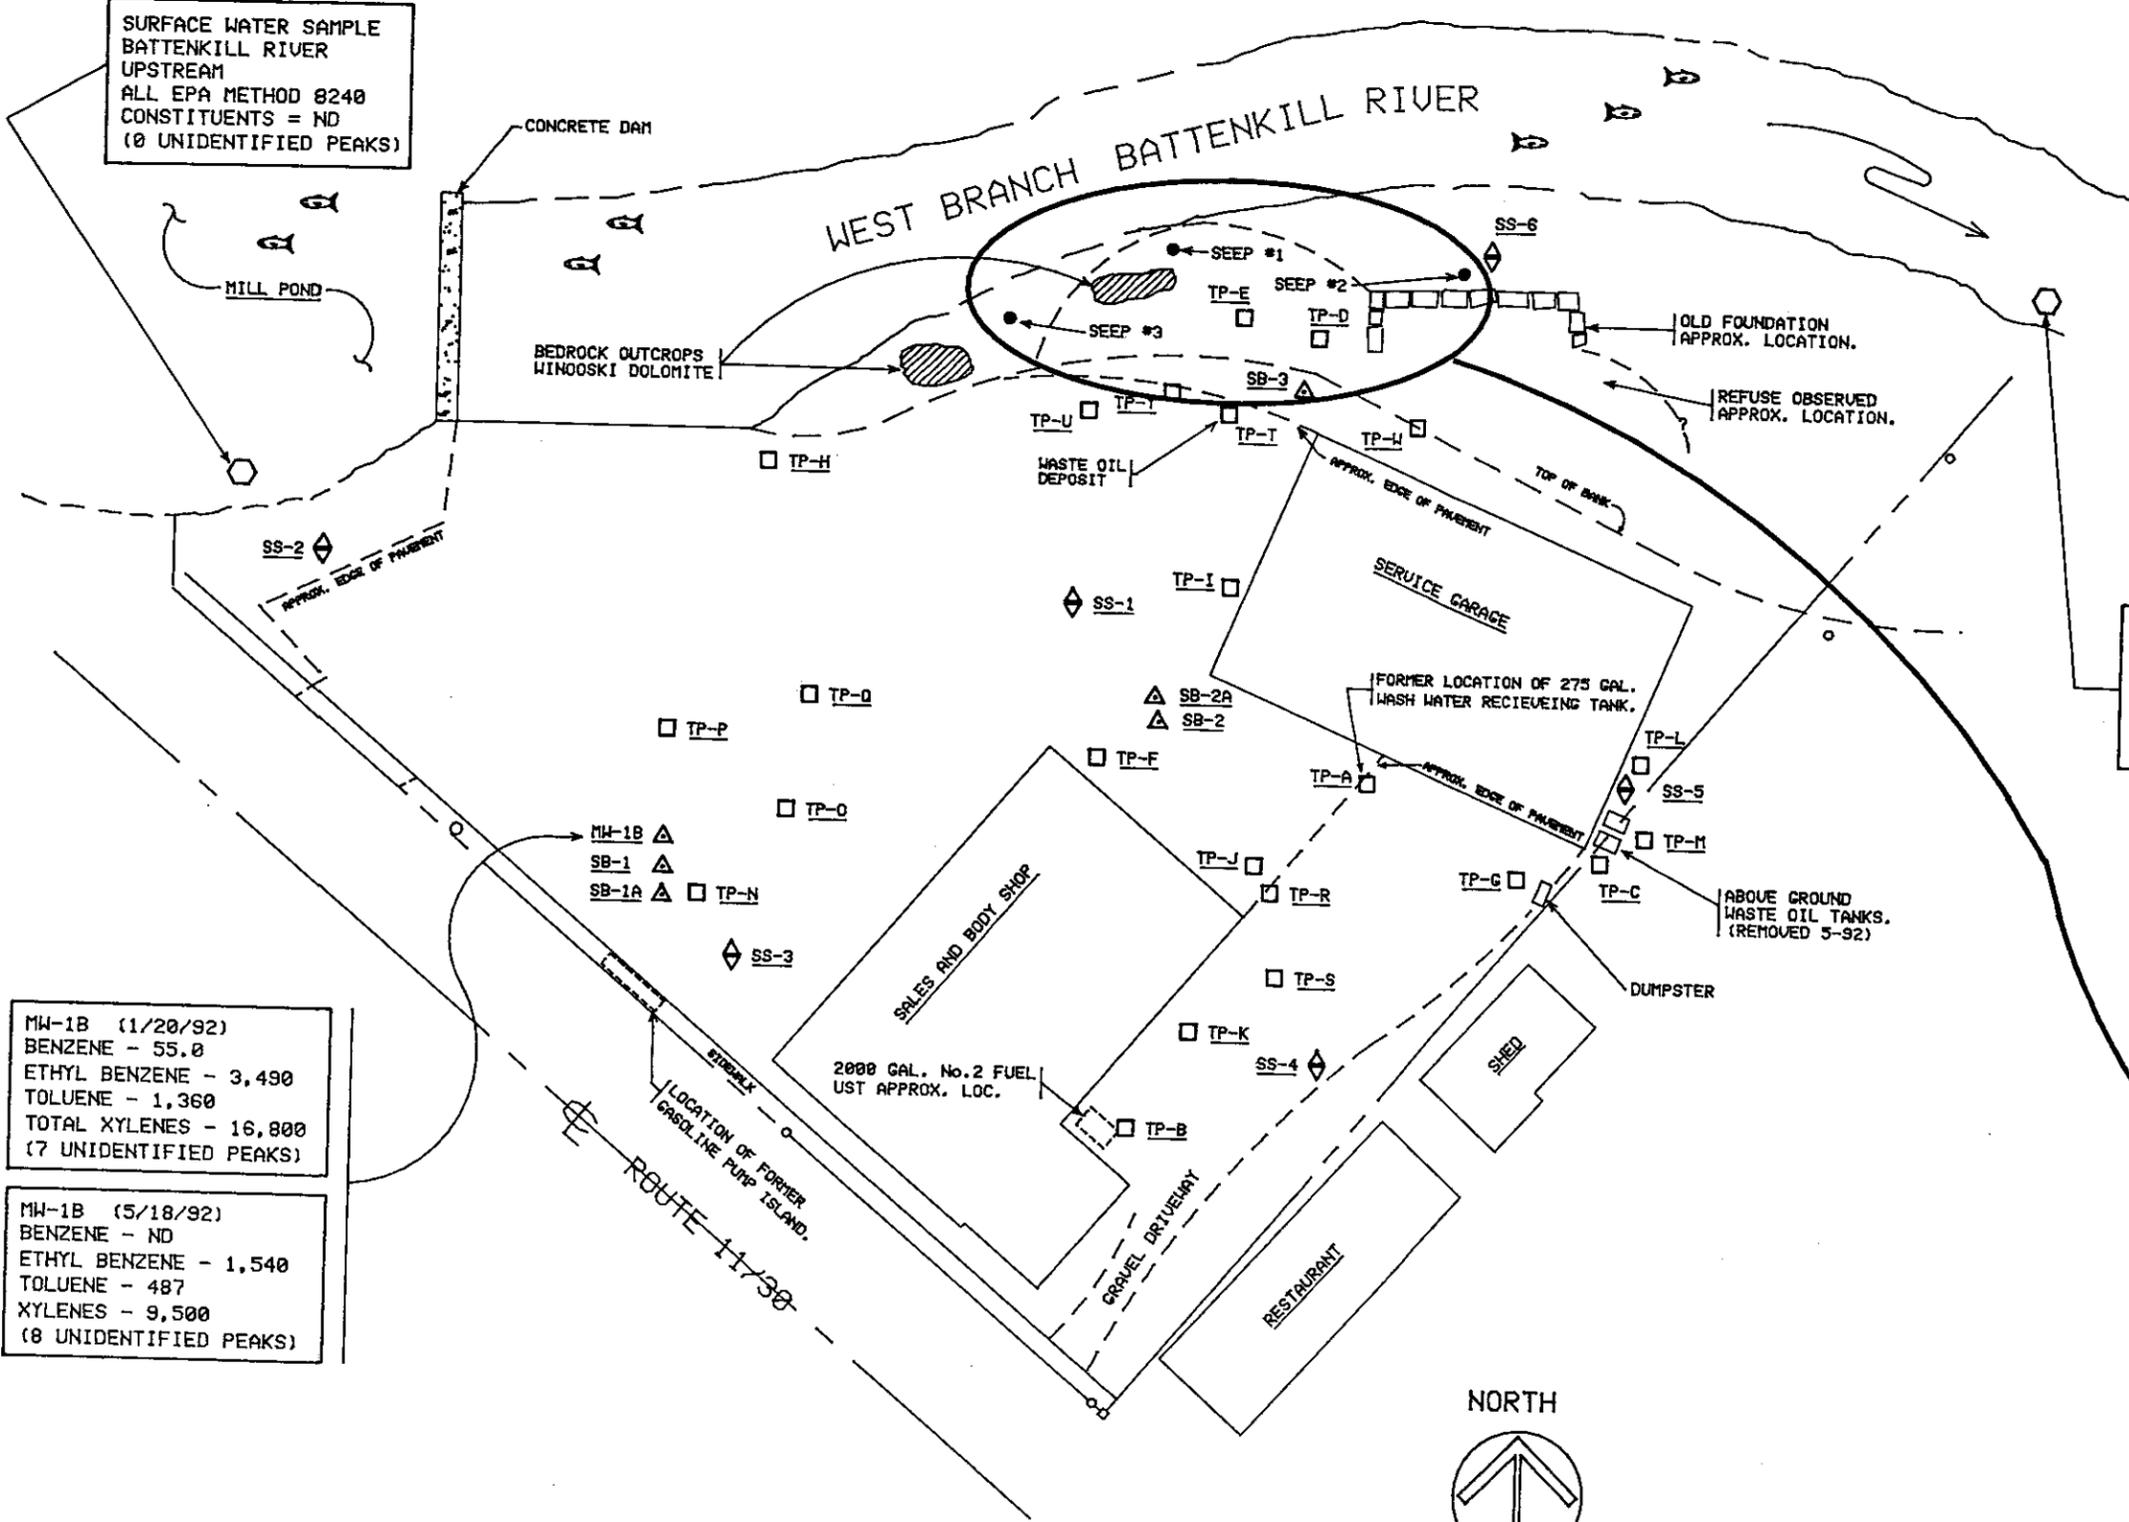
SURFACE WATER SAMPLE  
BATTENKILL RIVER  
DOWNSTREAM  
ALL EPA METHOD 8240  
CONSTITUENTS = ND  
(0 UNIDENTIFIED PEAKS)

SURFACE WATER SAMPLE  
BATTENKILL RIVER  
UPSTREAM  
ALL EPA METHOD 8240  
CONSTITUENTS = ND  
(0 UNIDENTIFIED PEAKS)

MW-1B (1/20/92)  
BENZENE - 55.0  
ETHYL BENZENE - 3,490  
TOLUENE - 1,360  
TOTAL XYLENES - 16,800  
(7 UNIDENTIFIED PEAKS)

MW-1B (5/18/92)  
BENZENE - ND  
ETHYL BENZENE - 1,540  
TOLUENE - 487  
XYLENES - 9,500  
(8 UNIDENTIFIED PEAKS)

- 4. Dufresne-Henry recommends a repeat sample of groundwater in monitoring well MW-1B. This is a reasonable request. We will perform repeat sampling and analysis of this well when we complete our other field work at the site.

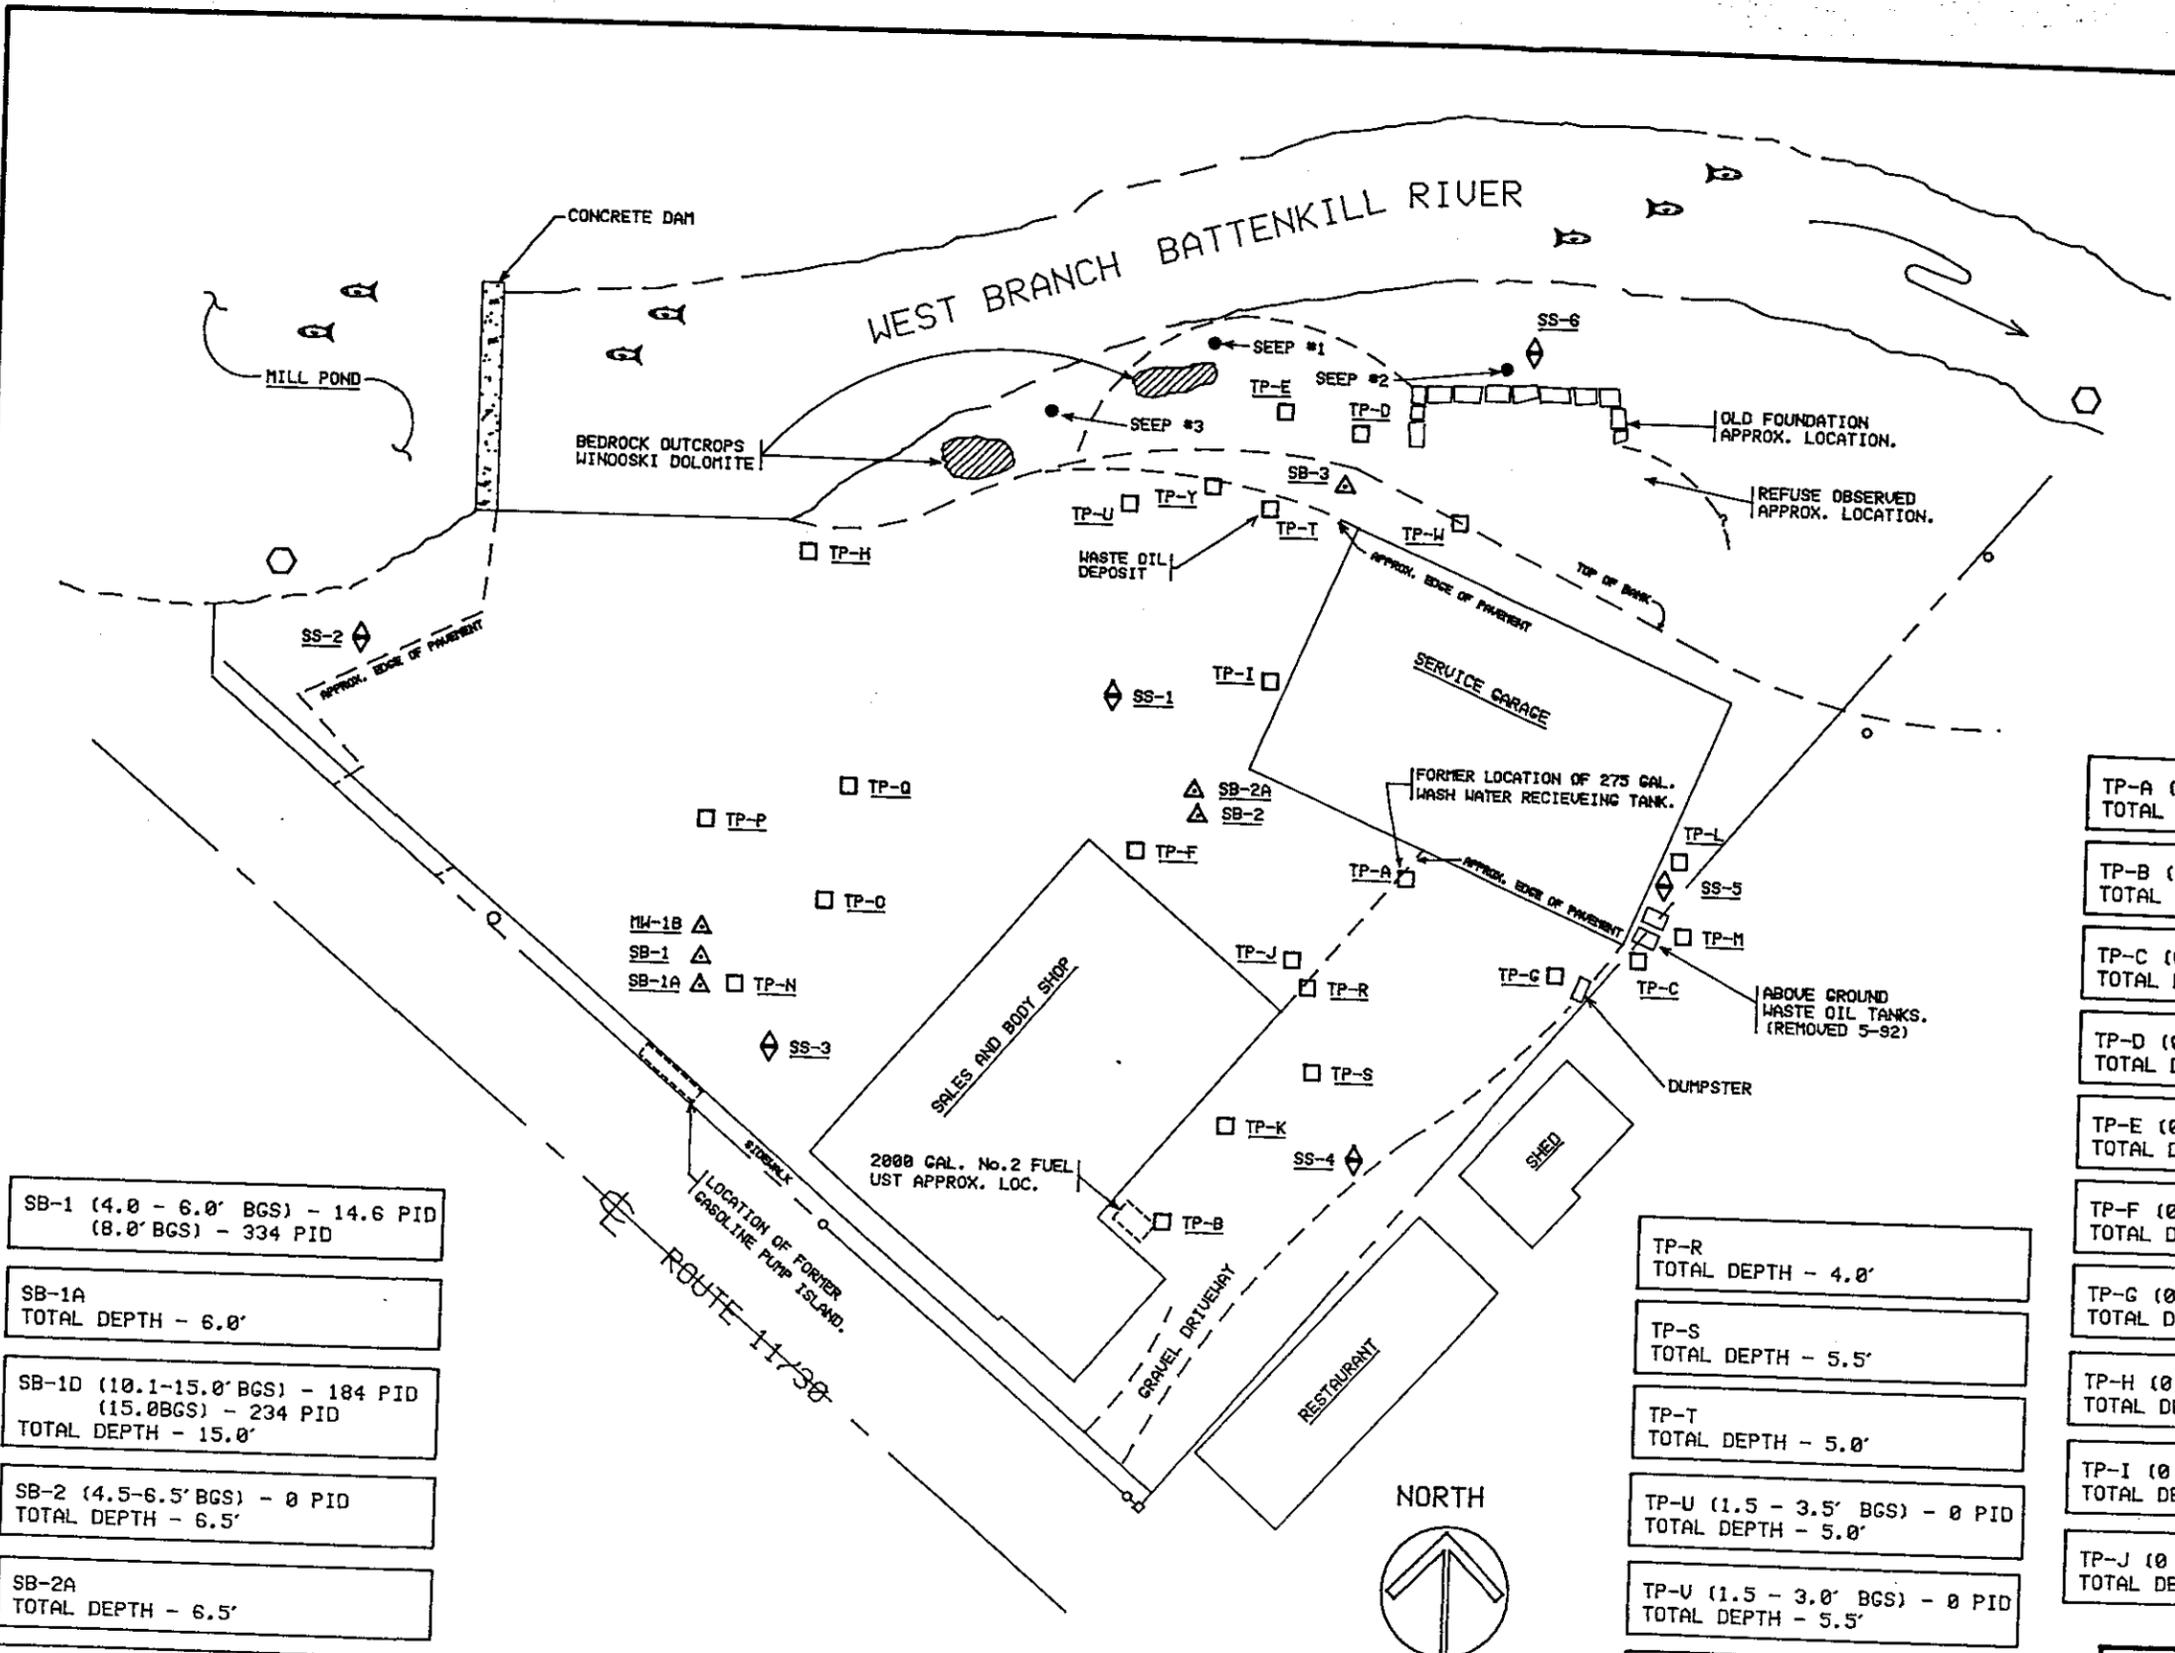
TP-A (0 - 7.0' BGS) - 0 PID TOTAL DEPTH - 7.0'
TP-B (0 - 6.5' BGS) - 0 PID TOTAL DEPTH - 6.5'
TP-C (0 - 4.0' BGS) - 0 PID TOTAL DEPTH - 4.0'
TP-D (0 - 8.0' BGS) - 0 PID TOTAL DEPTH - 8.0'
TP-E (0 - 6.0' BGS) - 0 PID TOTAL DEPTH - 6.0'
TP-F (0 - 2.0' BGS) - 7.8 PID TOTAL DEPTH - 6.0'
TP-G (0 - 7.5' BGS) - 0 PID TOTAL DEPTH - 7.5'
TP-H (0 - 2.0' BGS) - 64 PID TOTAL DEPTH - 2.0'
TP-I (0 - 2.0' BGS) - 0 PID TOTAL DEPTH - 2.0'
TP-J (0 - 2.0' BGS) - 0 PID TOTAL DEPTH - 2.0'
TP-K (0 - 2.0' BGS) - 0 PID TOTAL DEPTH - 2.0'
TP-L (0 - 1.8' BGS) - 1.2 PID TOTAL DEPTH - 1.8'
TP-M (0 - 0.6' BGS) - 25.1 PID (0.6' - 2.0' BGS) - 25.1 PID (3.3' BGS) - 0.7 PID TOTAL DEPTH - 3.5'
TP-N (4.0' BGS) - 3.4 PID TOTAL DEPTH - 6.3'
TP-O (3.8' BGS) - 3.7 PID TOTAL DEPTH - 3.8'
TP-R TOTAL DEPTH - 4.0'
TP-S TOTAL DEPTH - 5.5'
TP-T TOTAL DEPTH - 5.0'
TP-U (1.5 - 3.5' BGS) - 0 PID TOTAL DEPTH - 5.0'
TP-V (1.5 - 3.0' BGS) - 0 PID TOTAL DEPTH - 5.5'

TP-W (5.0 - 8.5' BGS) - 0 PID TOTAL DEPTH - 8.5'
