**REPORT ON THE
INVESTIGATION OF SUSPECTED SUBSURFACE
PETROLEUM CONTAMINATION**

**Fairdale Farms
Bennington, Vermont**

**VTDEC SITE #93-1544
GRIFFIN PROJECT #1944481**

SEPTEMBER 1994

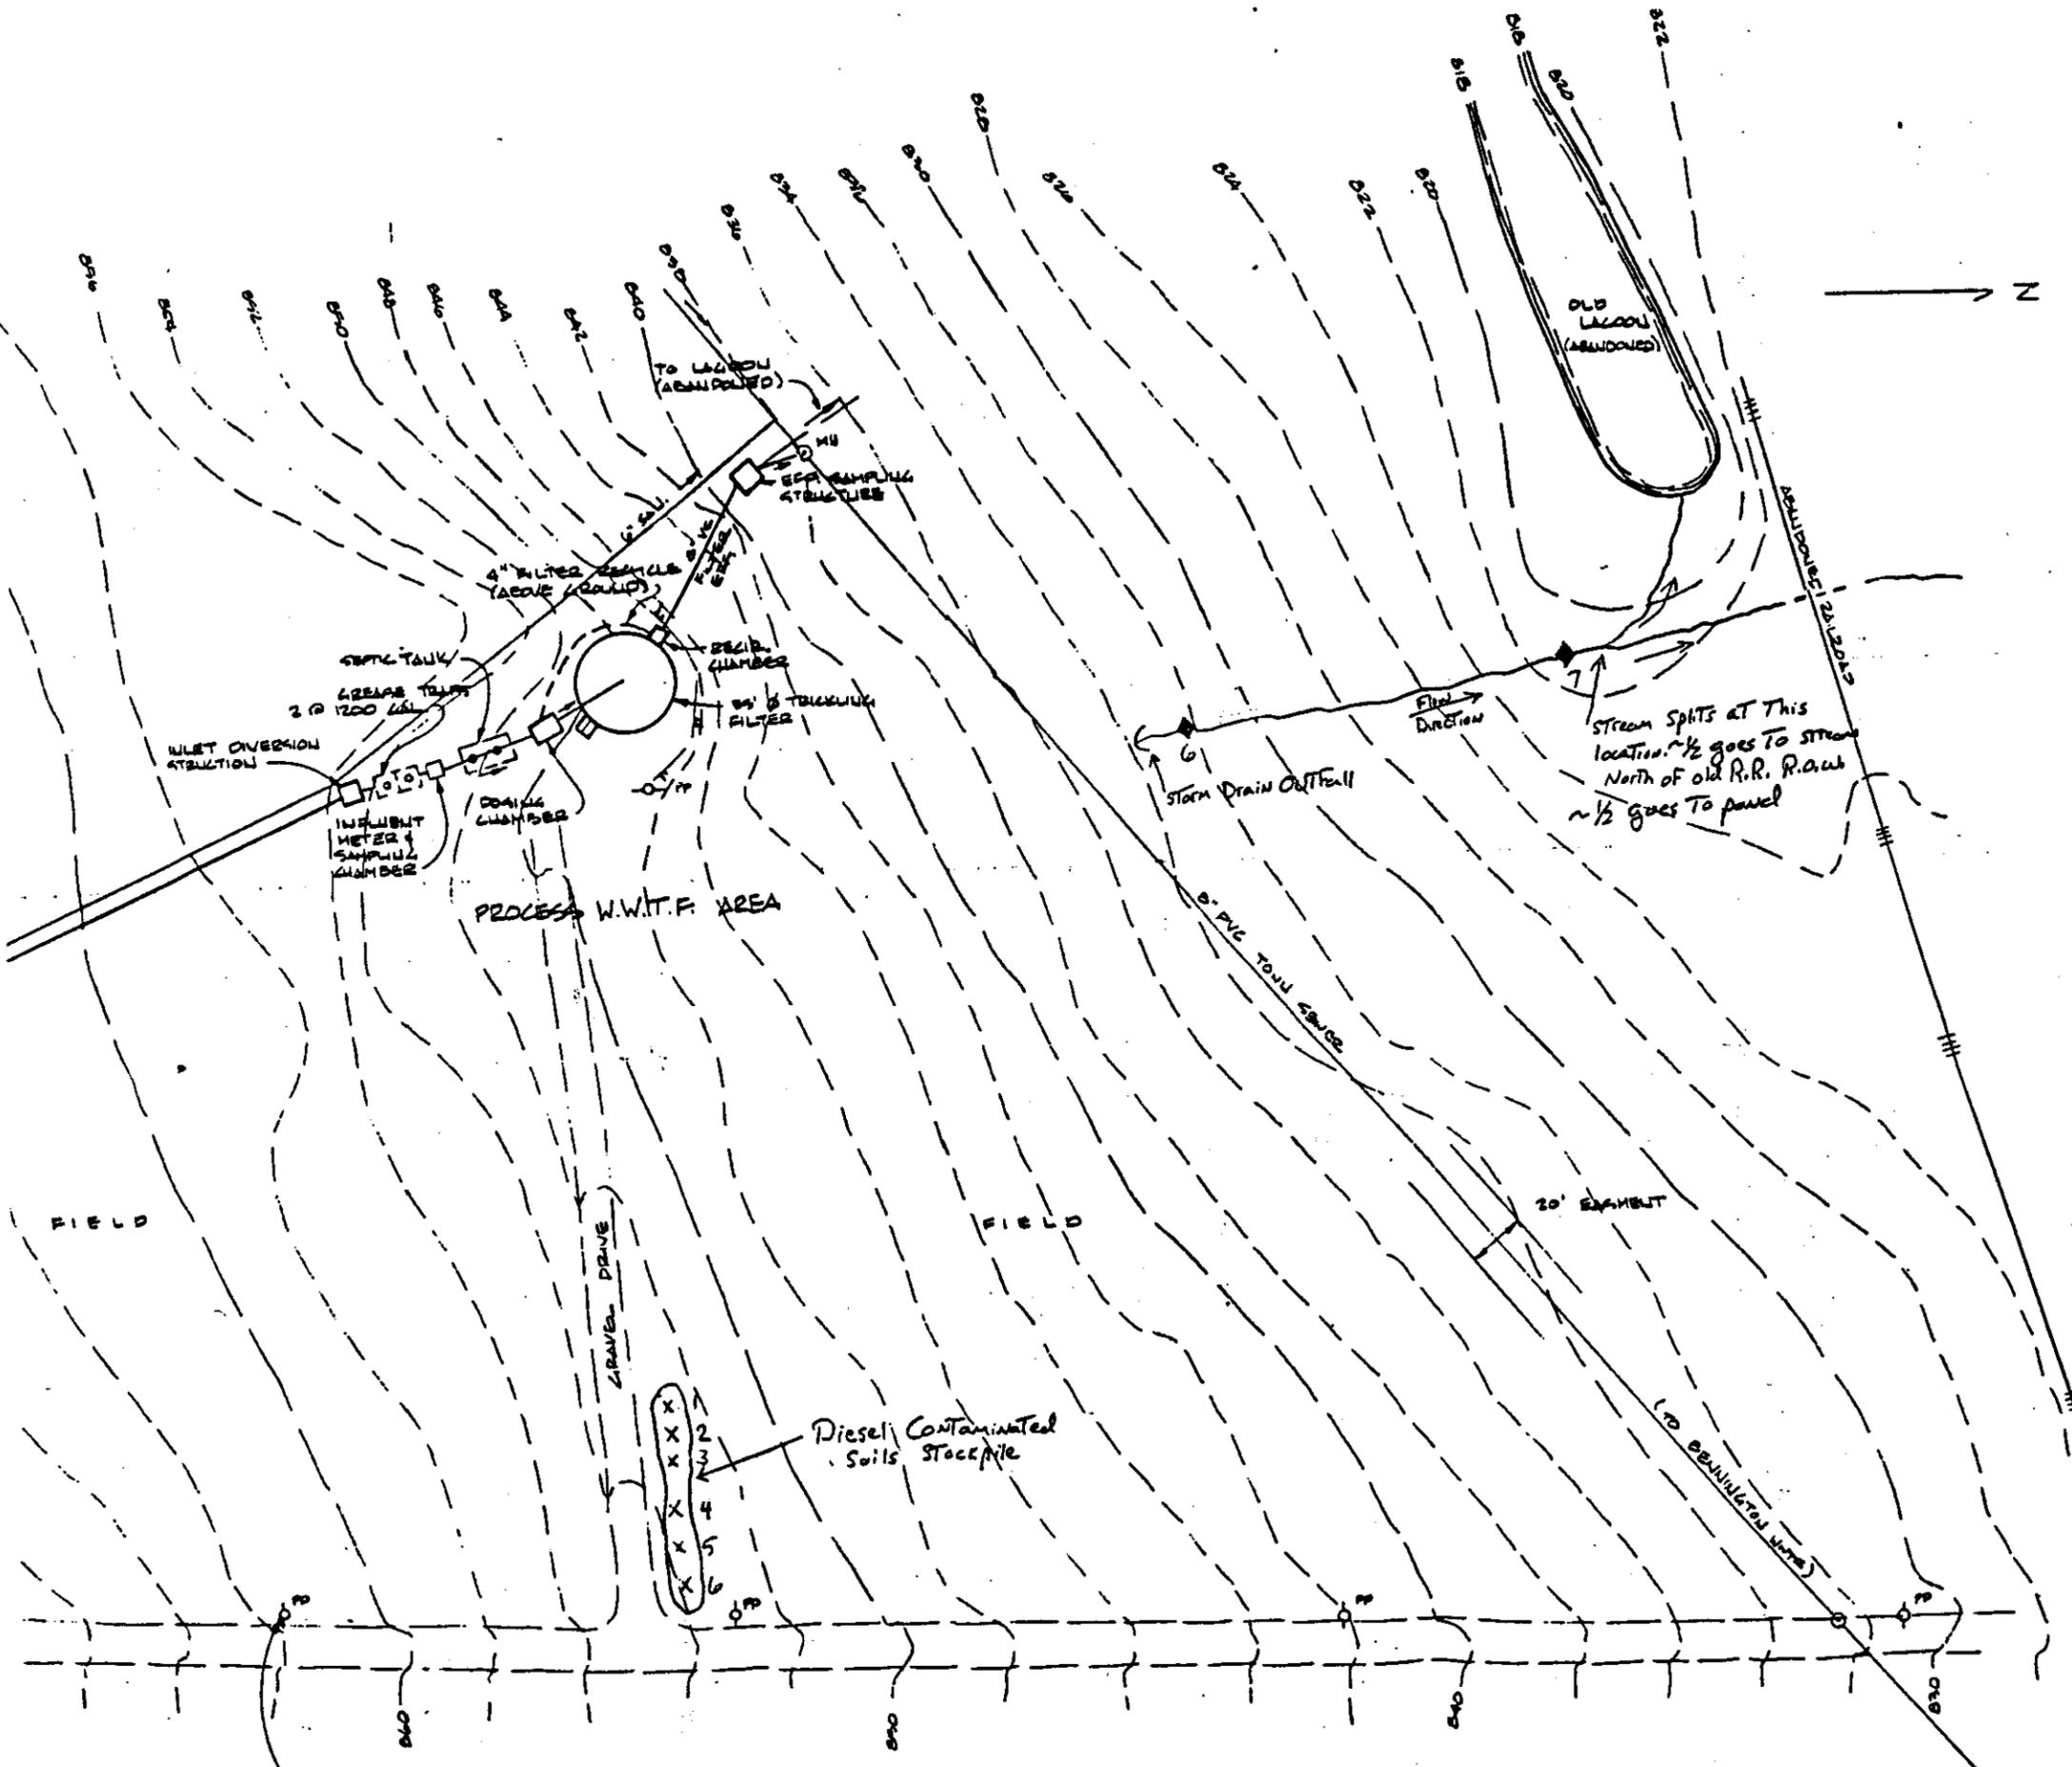
SITE MAP
Sheet 2 of 2
Fairdale Farms, Bennington, VT

The drainage swale and the small stream which reportedly received runoff of diesel associated with the November 26, 1993 overflow of the AST were screened for VOCs with an HNu™ Model PI-101 PID on June 13, 1994. Very low to negligible flow was observed in the drainage swale; water was dripping from the culvert into the swale approximately 165 feet northwest of the AST. A biological sheen was observed on the standing water present in a 0.5-ft to 1-ft wide channel in the swale. A low flow of water (less than 0.5 gallon per minute - visual estimate) was observed in the storm runoff swale flowing southerly to its confluence with the drainage swale on the eastern edge of the access road to the wastewater treatment plant and stockpiled soils. To screen VOCs in the drainage swale, runoff swale, and stream, small test pits were excavated using a clean hand shovel along the bottom and sides of the channels, and the exposed soils and seeping ground water were screened with the PID. In addition, at certain of these same sample locations, the air above standing or flowing water was screened for VOCs with a PID. The table below indicated the stream and swale screening results. Screening locations 1, 2, and 3 were along the drainage swale; locations 4 and 5 were positioned along the storm runoff swale upstream of its confluence with the drainage swale (see Site Map: Sheet 1 of 2 in Appendix A). Screening locations 6 and 7 were located along the stream formed by emergence of storm runoff waters from the underground culvert at a location midway between the Process Wastewater Treatment facility and the Old Lagoon (see Site Map: Sheet 2 of 2).

Screening Location	VOCs in Soils (ppm)	Observations
1 channel bottom - soils/water	20	0.5 inch dark petroleum-stained soils
1 channel edge - soils	18	0.5 inch dark petroleum-stained soils
1 mid channel - above water	0	No petroleum sheen
2 channel bottom - soils/water	13	1 inch dark petroleum-stained soils
2 north channel edge - soils	1	0.5 inch dark petroleum-stained soils
2 mid channel - above water	0	No petroleum sheen

Screening Location	VOCs in Soils (ppm)	Observations
3 channel bottom - soils/water	2	1 inch dark petroleum-stained soils
3 north channel edge - soils	1	1 inch dark petroleum-stained soils
3 mid channel - above water	0	Slight petroleum sheen
4 channel bottom - soils/water	0	No staining, no sheen
5 channel bottom - soils/water	0	No staining, no sheen
6 channel bottom - soils/water	0.5	Slight surface soil staining
7 channel bottom - soils/water	0.5	Slight surface soil staining
