Neshobe River in Rutland County Corridor Plan

**Brandon, Vermont
September 12, 2011**

Prepared by:
Bear Creek Environmental, LLC
297 East Bear Swamp Road
Middlesex, Vermont 05602

Prepared for:
The Rutland Natural Resources Conservation District
170 Main Street
Rutland, VT

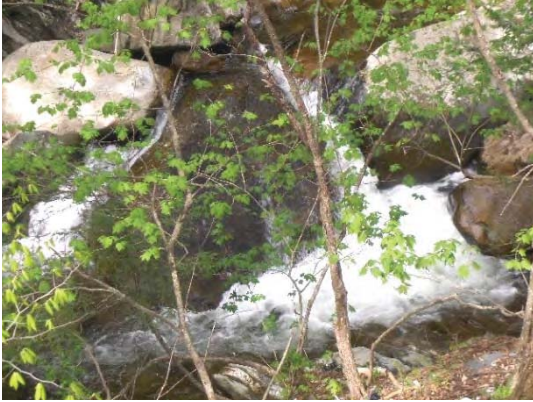
**Figure 3.2. Narrowly confined channel
(BCE, 5/7/2010)**

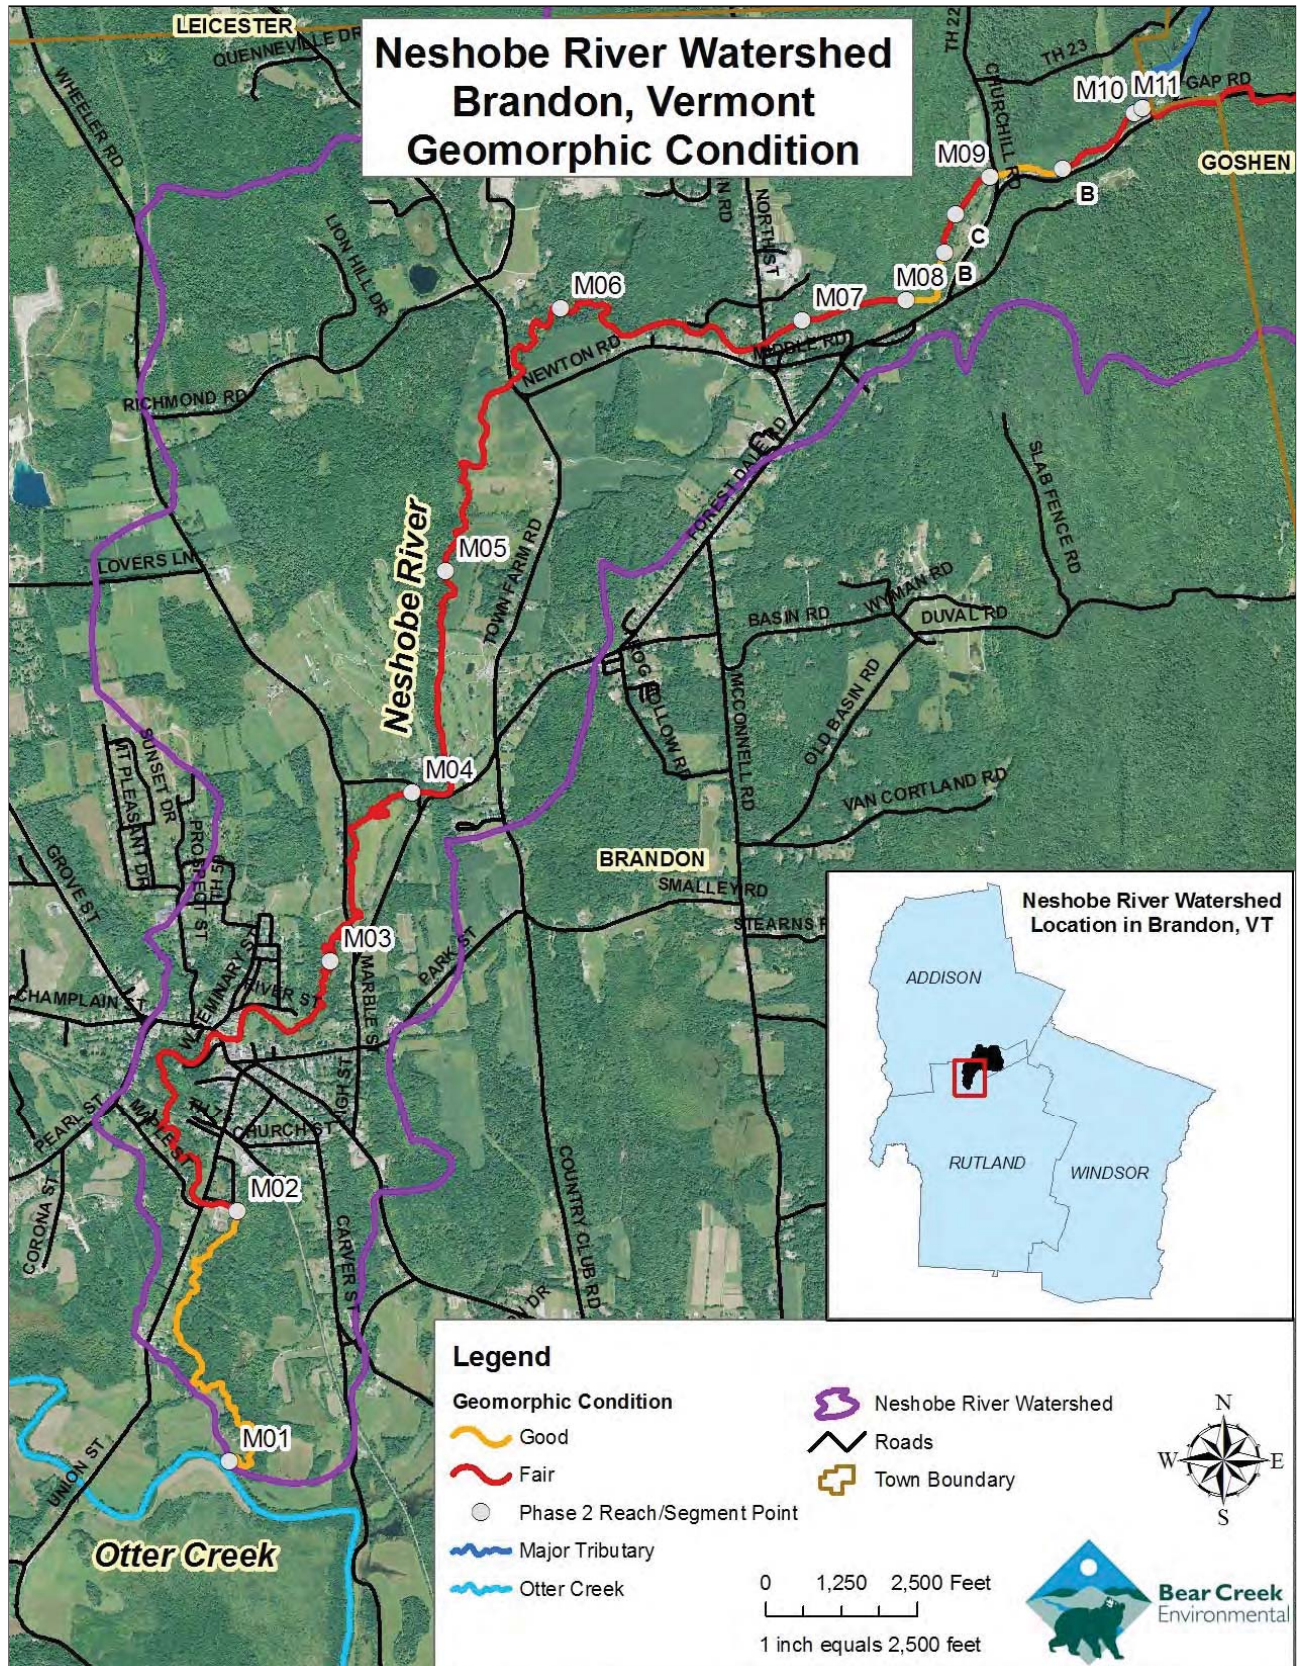
The existing geomorphic condition is depicted in Figure 5.2. Geomorphic condition is determined based on the degree (if any) of channel degradation, aggradation, widening and planform adjustment. Except for three reaches/segments, the assessed segments and reaches in the Neshobe River watershed in Brandon were found to be in “fair” geomorphic condition. The other three assessed reaches were in “good” geomorphic condition. Many of the reaches studied in the Neshobe River watershed are undergoing a channel evolution process in response to large scale changes in its sediment, slope, and/or discharge associated with the human influences on the watershed. Table 3 below summarizes the channel evolution of each study reach and the primary adjustment processes that are occurring.

Figure 5.2. Phase 2 Geomorphic Condition of the Neshobe River Watershed

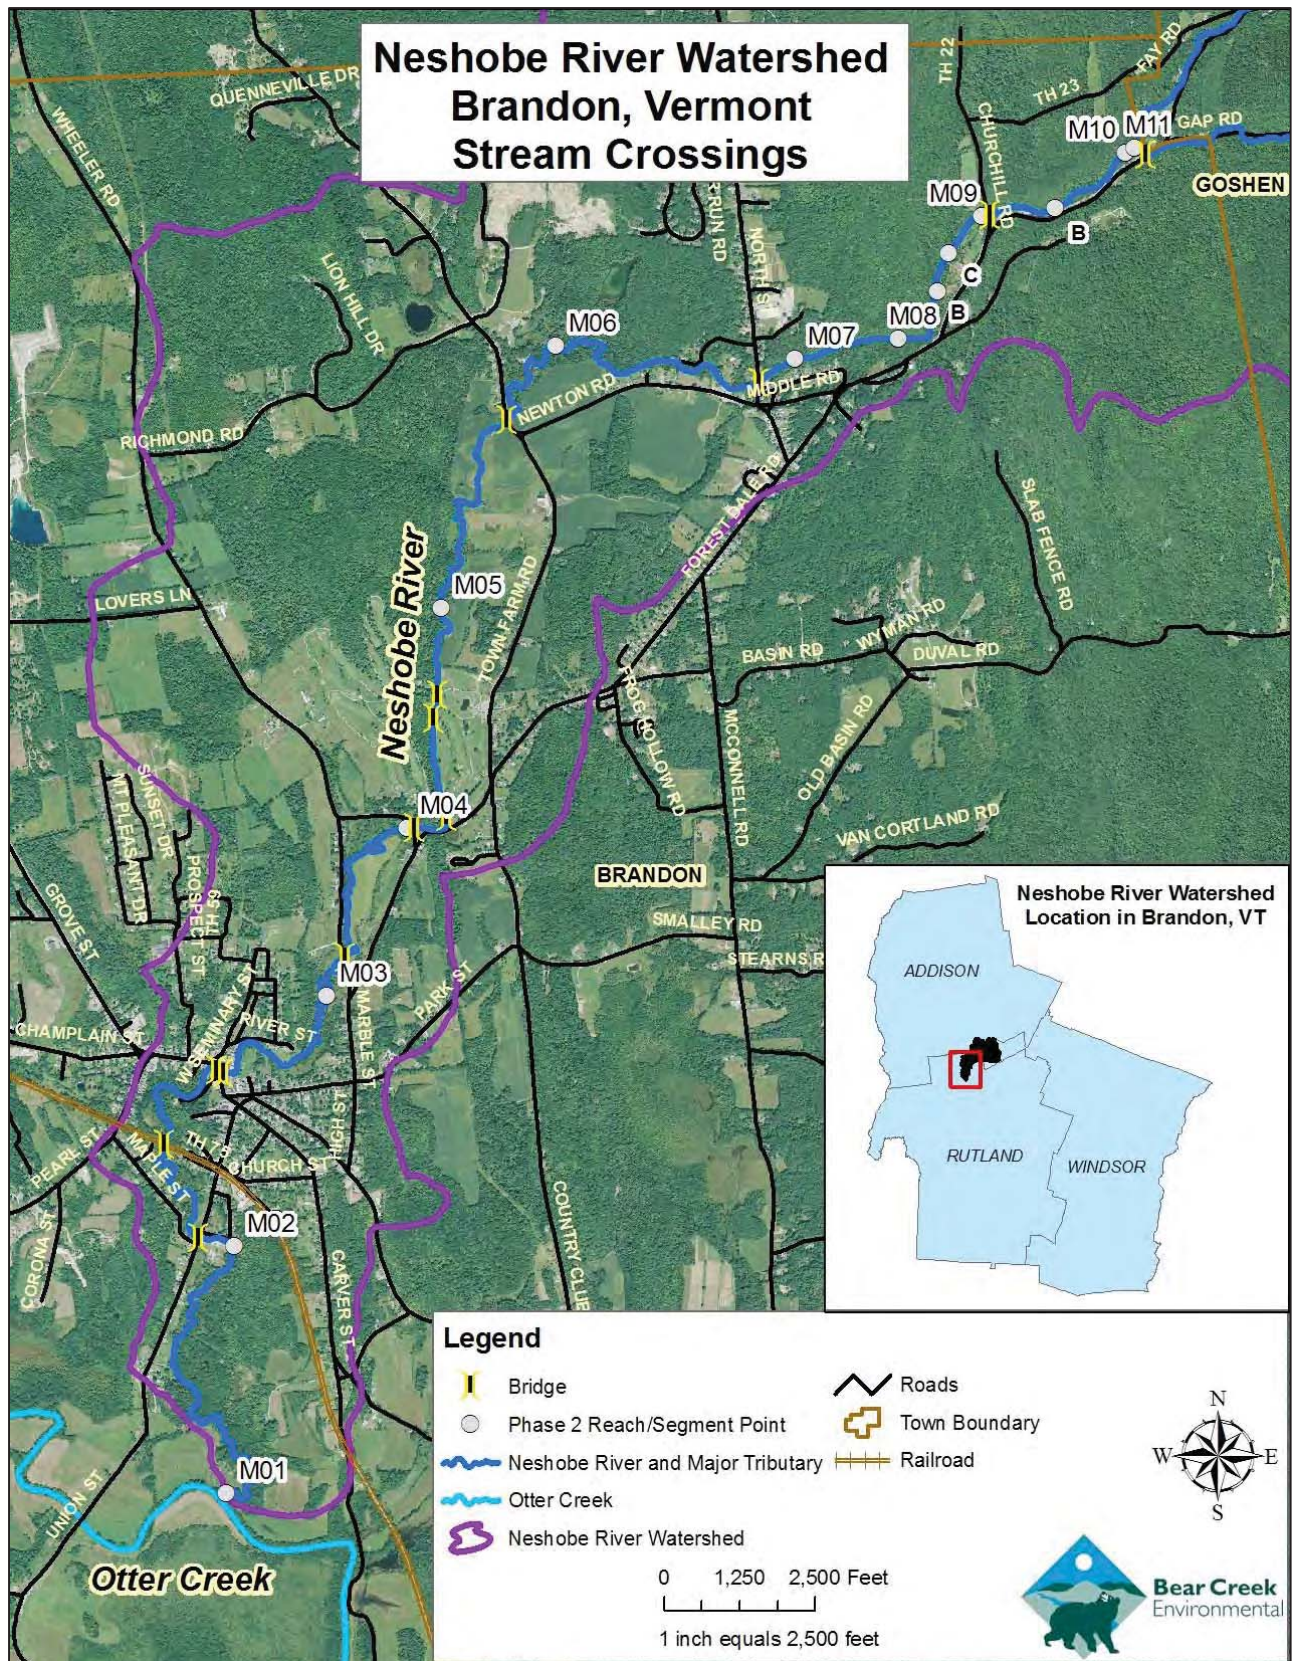
There are a total of 13 bridge crossings on the Neshobe River in Brandon (Figure 5.4). Eight of these stream crossings are on public roads and one in Reach M02 is at a railroad crossing. A bridge and culvert assessment using the VANR protocol was conducted of the Stone Mill Dam Road Bridge by Round River Design. The geomorphic compatibility and AOP screening tools, photographs and Phase 2 constriction notes were used to prioritize structures for replacement/retrofit. A list of resources for towns regarding funding, planning and design for replacement and retrofit of stream crossings is available on the Vermont River Management and the Vermont Department of Fish and Wildlife’s web sites: http://www.vtwaterquality.org/rivers/htm/rv_EducationalResources.htm <http://www.vtfishandwildlife.com/library.cfm?libbase =Reports and Documents>).

The spans and clearance of all the structures were re-measured by Shannon Pytlik and Ethan Swift on May 11, 2011. The Wheeler Road Bridge was noted to have undermined abutments and there is a concern that the structure may be undersized. Keith Arlund stated in a recent select board meeting on March 14, 2011 that “the town had been advised in 2009 that the cement abutments were not in good shape...” This Wheeler Street structure has been given a high priority for replacement based on the abutments being undermined and the low percent bankfull width relative to the reference channel width. Additional field work is recommended to provide a measured bankfull width to adequately design the span of the bridge for replacement.

Figure 5.4. Stream Crossings within the Neshobe River Watershed

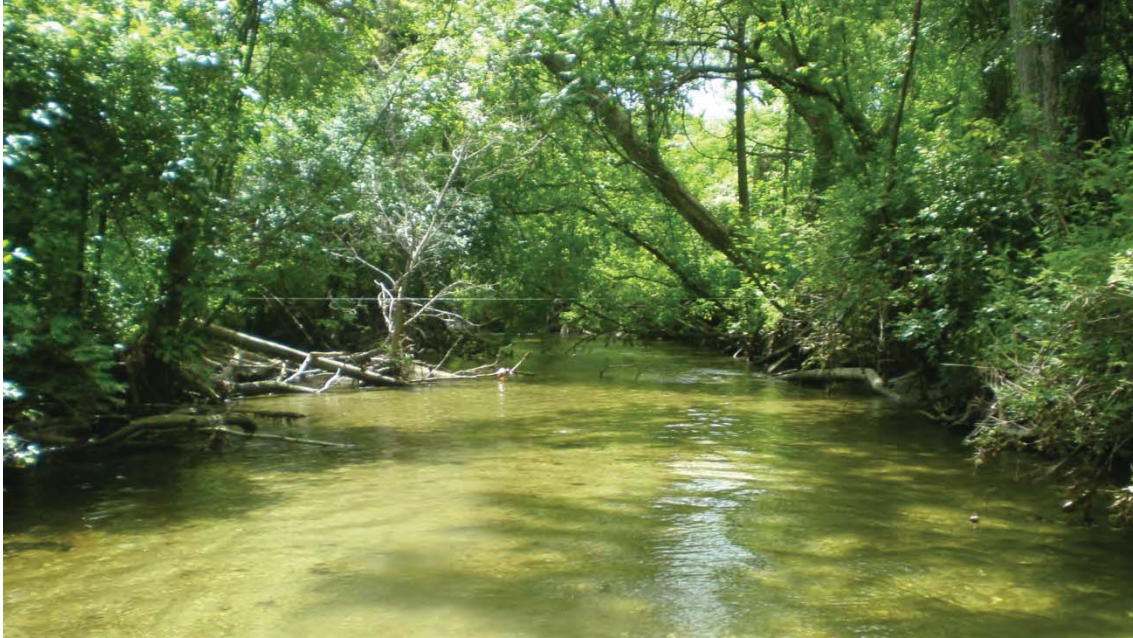
Reach M01 begins at the mouth of the Neshobe and continues until just below the Union Street crossing. It is a sand dominated "E" type lowland stream with numerous oxbows within the floodplain (Figure 7.1). The dominant bedform is dune-ripple. Towards the lower end of the reach, there are abundant wetlands. The incision and width to depth ratios have remained low most likely due to the increased sediment input from upstream in the watershed. Since this reach has excellent floodplain access, it is an important sediment attenuation reach.

Figure 7.1. Sand dominated “E” channel in Reach M01 (Round River Design, 6/24/09)

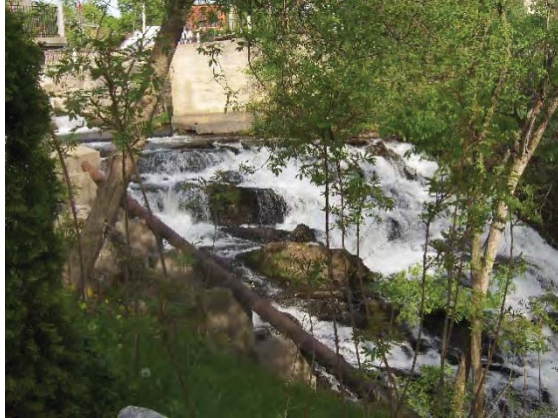
Reach M02 is 1.7 miles long and contains numerous grade controls including a dam (Figure 7.2), a weir, bedrock grade controls, and a waterfall. Downstream of the waterfall in downtown Brandon, the channel slope decreases and the valley opens up. The channel is slightly incised in Reach M02, but there is still adequate floodplain access except for a few locations. Reach M02 is a sand dominated “E” channel with riffle-pool as its dominant bedform. There is a berm in this reach approximately 300 feet long located just downstream of the Center Street crossing. There are four bridges that cross the Neshobe River in Reach M02 (Union Street, Route 7, Footpath, and a Railroad crossing). None of the bridges have a high priority for replacement at this time.

Figure 7.2. Dam and waterfall in downtown Brandon on Reach M02 (BCE, 5/7/2010)

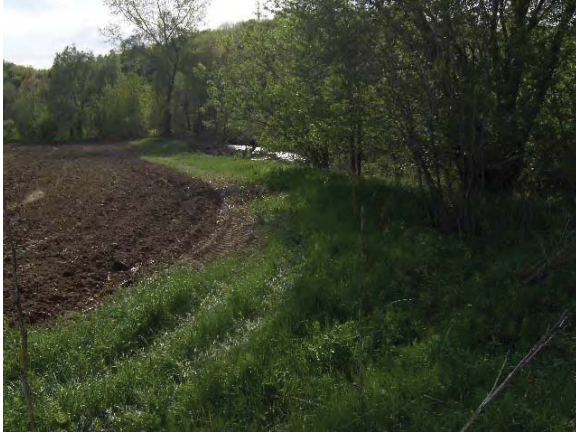
Reach M05 is 1.2 miles long and flows through agricultural land with crop as the dominant land use on both sides of the river corridor (Figure 7.7). Gravel is the dominant substrate in this “E” channel that contains mostly riffle-pool bedforms. The dominant buffer width on both sides is 26-50 feet and approximately 30 percent of the length has a buffer width less than 25 feet in width (Figure 7.8).

Figure 7.7. Agricultural field within corridor of Neshobe River in Reach M05 (BCE, 5/7/10)

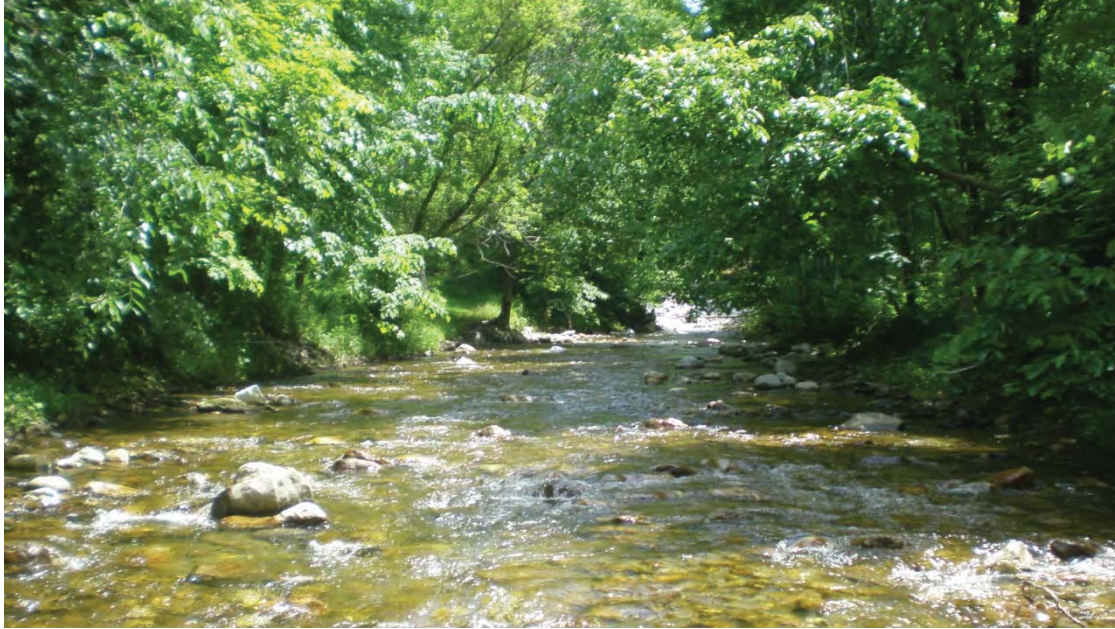
Reach M06 is approximately one mile long and begins about ½ mile upstream of the Town Farm Road Bridge and continues until 700 feet upstream of the North Street Bridge. The channel has been extensively straightened and bermed (50 percent of the reach length) for development and the placement of Newton Road. It is in this reach that the stream type changes from “E” to a gravel dominated “C” channel (Figure 7.9). There is one stream crossing at North Street Bridge where the structure has caused both downstream and upstream deposition.

Figure 7.9 Gravel dominated “C” channel of Reach M06 (Round River Design, 6/17/09)

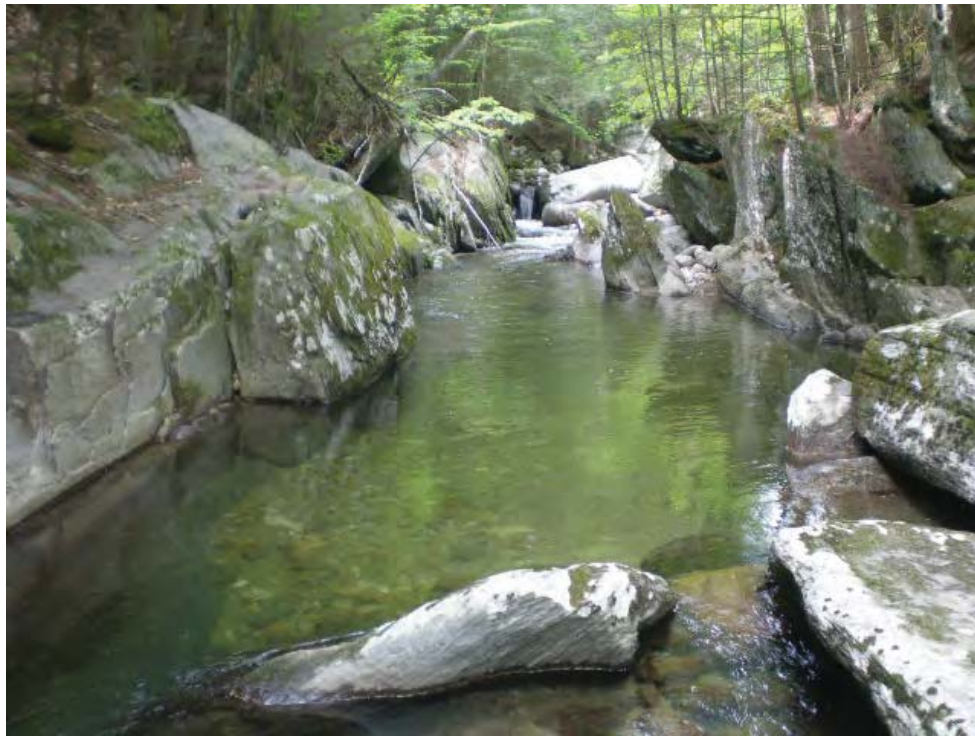
Reach M08 was divided into three segments based on differences in valley widths. The downstream segment, M08-A is narrowly confined and contains many bedrock grade controls and bedrock along the banks preventing incision and widening (Figure 7.13). The bedrock along the banks is acting as a channel constriction as well. From field observations of old terraces, it appears that there was significant historic aggradation that has since been worn down to bedrock, but the channel has not incised from reference (Round River Design, 2009). The stream type is a cobble dominated “B” channel in a step-pool system. Since it has not incised, the channel is in stage F-I of the channel evolution model. The segment begins where the channel becomes narrowly confined and continues for approximately 1,300 feet until the valley opens up. A berm that begins in upper section of Reach M07, continues into Segment M08-A for 300 feet.

Figure 7.13. Bedrock on banks and grade controls in Segment M08-A (Round River Design, 6/8/09)

The RGA and the RHA were both scored as “good”. The geomorphic condition is due to the stability of the channel through the presence of bedrock and lack of incision. High quality pools and a well vegetated riparian zone contributed to the “good” habitat condition in segment M08-A.

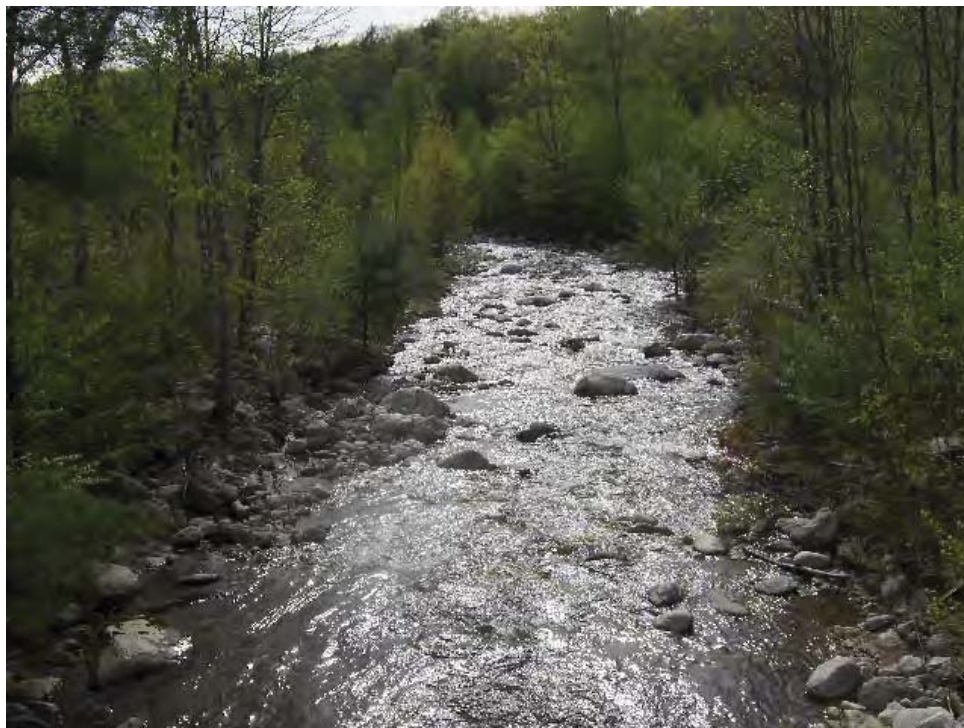
Segment M08-B begins where the valley gets wide and slope decreases again and continues for approximately 700 feet until the confluence with Hollow Brook. The segment has been straightened along the entire length (Figure 7.14), which has led to channel incision through historic sediments that were most likely here from either post glaciation or 1800s land clearing. This historic incision has led to aggradation, widening and planform adjustment as the channel builds a new floodplain. The channel is in stage F-IV since there is a juvenile floodplain. The RGA scored in the “fair” range. The stream type is “Cb” and dominated by gravel and planebed bedform. The banks and buffers are well vegetated with trees and the riparian corridor is dominated by shrubs/saplings and forested land. The RHA scored “good” as a result of high quality pools and stable and well vegetated banks and riparian corridor.

Figure 7.14. Straightened channel in Segment M08-B with well vegetated banks and buffers (BCE, 5/7/10)

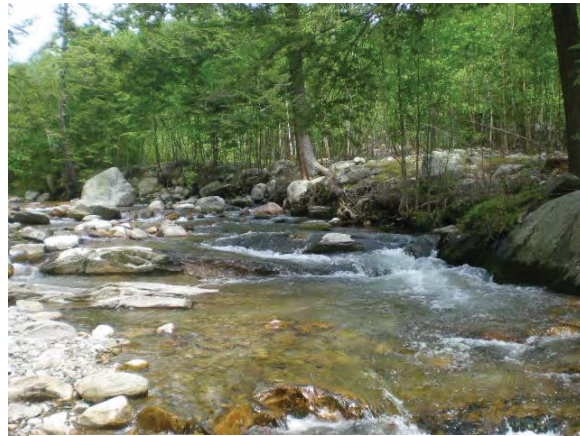
Figure 7.16. Step-pool features in Segment M08-C (Round River Design, 6/8/09)

The RHA scored “good” in Segment M08-C due to nice pools and high quality stream banks. However, the RGA scored “fair” as a result of moderate incision and subsequent aggradation, widening and planform adjustment. Five flood chutes and one island are evidence of the planform adjustment.

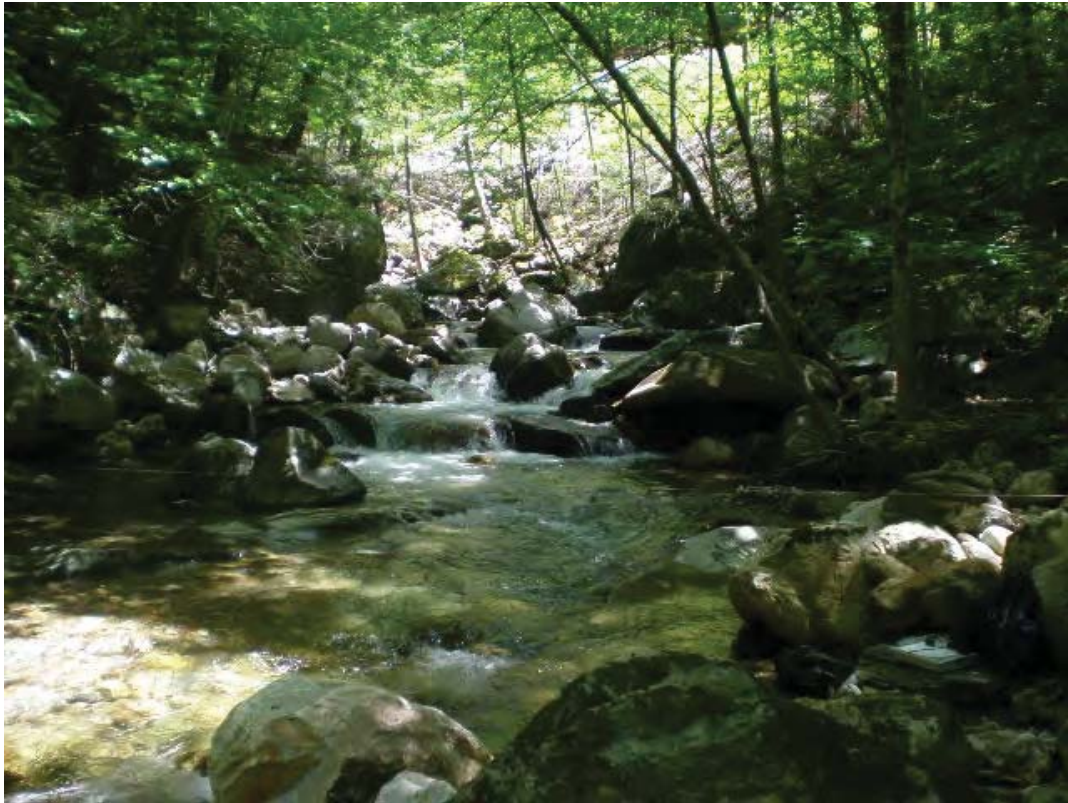
Segment M09-A has not incised most likely due to the resistant bedrock. The stream type is a cobble dominated “B” stream in a step-pool system (Figure 7.17). The channel evolution stage is F-I since there has been no degradation. Both the RHA and RGA scored “good”. Pools and well vegetated banks and buffers contributed to the “good” habitat condition. The lack of incision and planform adjustment has led to the “good” geomorphic condition.

Figure 7.17. Typical channel of Segment M09-A (Round River Design, 6/8/09)

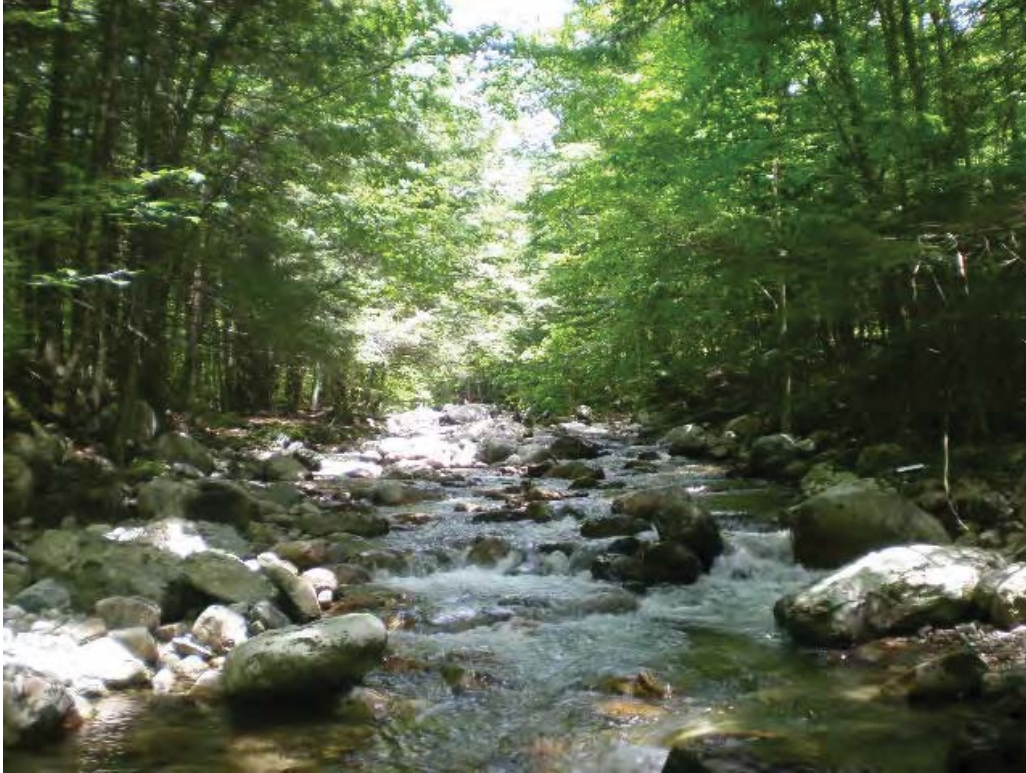
Segment M09-B has a higher width to depth ratio than downstream segments/reaches. There is one bedrock grade control and five bedrock constrictions. A mass failure (70’ wide x 30’ high) on the northern bank is contributing sediment to the channel. The northern buffer is in great condition with a well forested buffer greater than 100 feet in width. The southern buffer is predominantly 51-100 feet wide and the subdominant width is greater than 100 feet.

Figure 7.18. Typical channel of Segment M09-B (Round River Design, 6/8/09)

The RHA scored “good” as a result of pool variability and substrate and well vegetated banks and riparian zones. However, the RGA scored “fair” due to incision, resulting in a stream type departure and extensive widening. The channel is in stage F-III of the channel evolution model since it has gone through incision and is currently widening and undergoing planform adjustment.

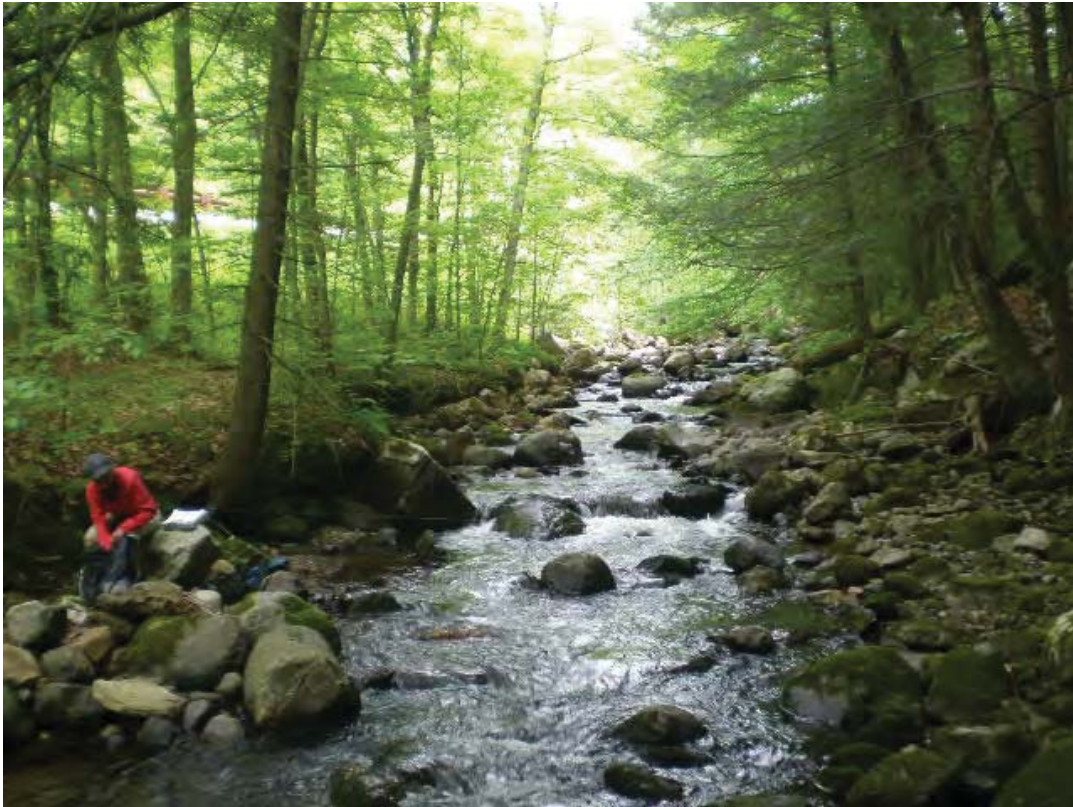
The stream type in Reach MII is a cobble dominated “Ba” with a step-pool bedform (Figure 7.19). Near bank and buffer vegetation on both sides is comprised predominantly of deciduous trees and coniferous trees are subdominant. The RHA scored “good” while the RGA scored “fair” in Reach MII. Although the riparian zone on the northern side is narrow, others factors such as bank vegetation and good pool quality contributed to the “good” habitat condition. The “fair” RGA score was mostly due to the moderate historic incision (ratio of 1.41). Aggradation, widening, and planform adjustment scored in the good range.

**Figure 7.19. Step-pool “B” channel
of Reach MII along Gap Road
(Round River Design, 6/5/09)**
