Crosby Brook Watershed Stream Corridor Restoration Plan

June 1, 2009

Fitzgerald Environmental Associates, LLC. 316 River Road

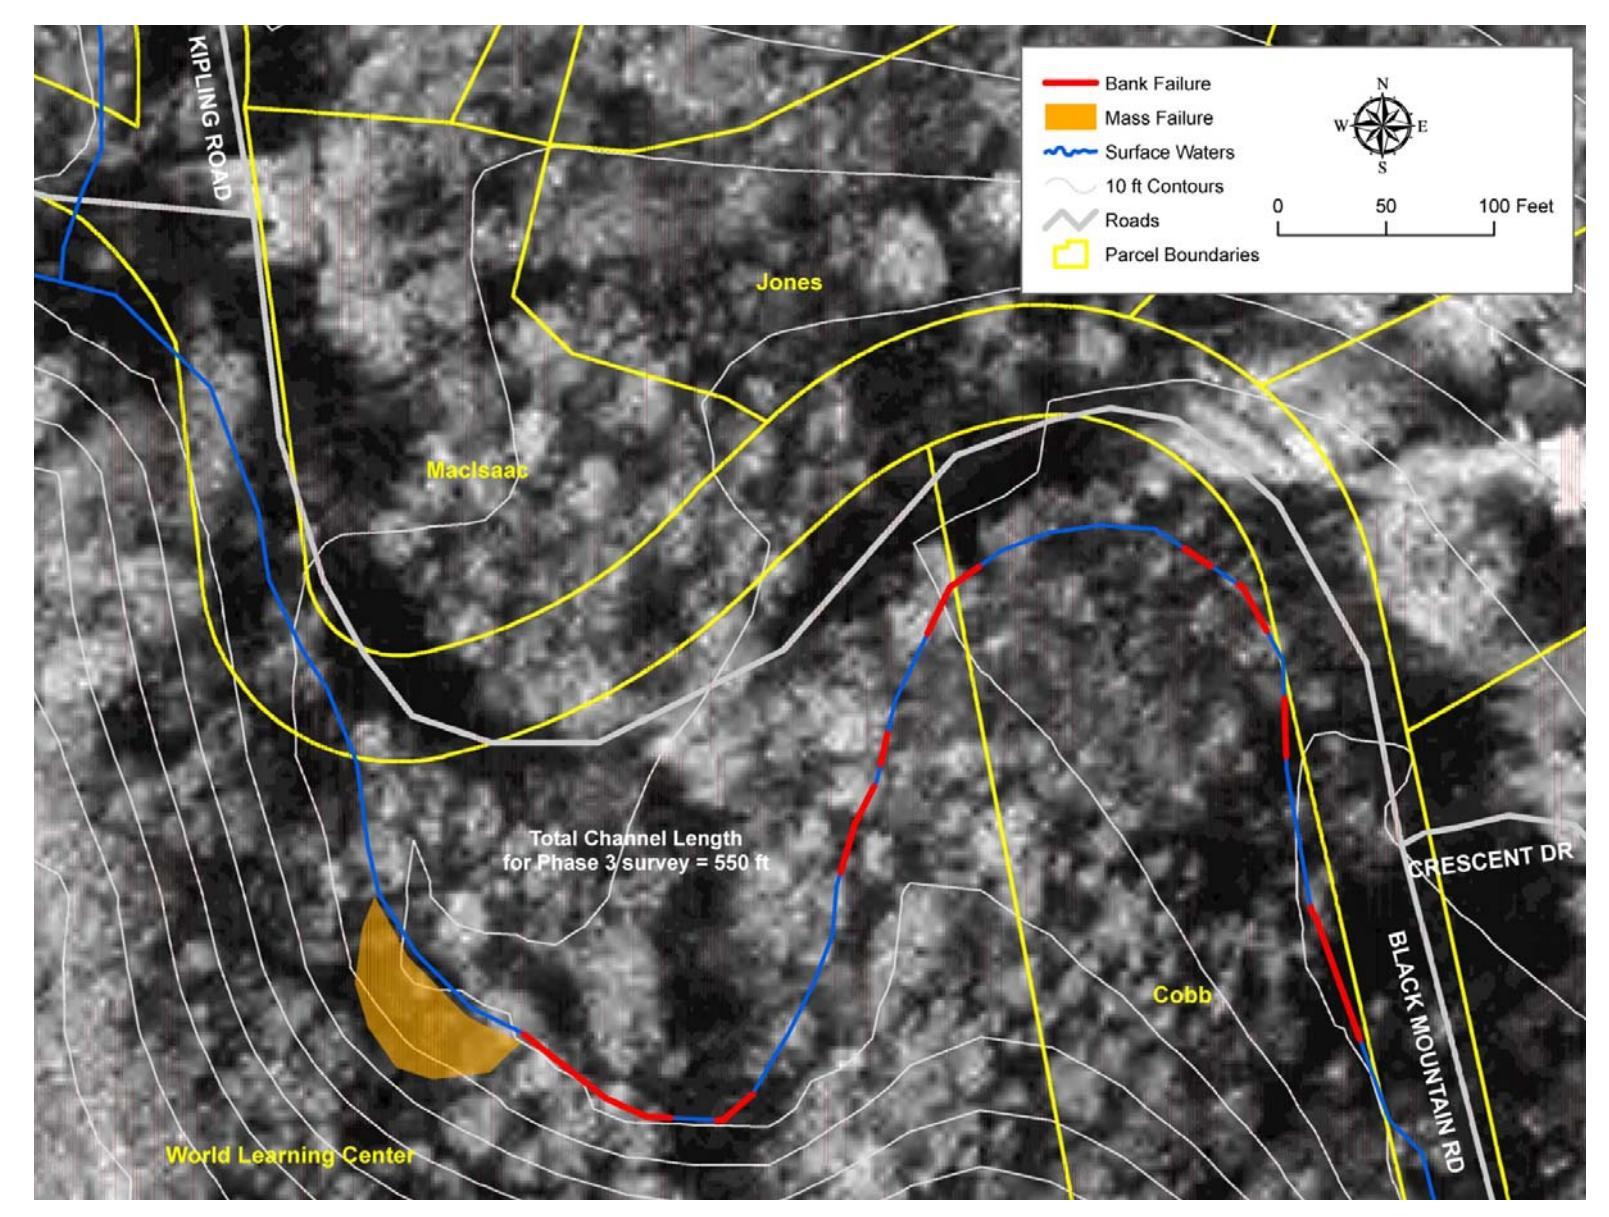
Figure 14. Site location map.

This segment was delineated to capture the short, unconfined section of channel associated with the large mass failure along Black Mountain Road (Figure 13). It is found from the sharp bend in the channel along Black Mountain Road up to 200 feet south of the intersection with Kipling Road (Figure 14). The segment is 0.2 miles long (1,000 feet), and the field measured channel slope was 2.2%. One nickpoint was noted in the lower reach that may have caused a disconnect between the channel and floodplain in the lower segment. Two channel cross sections were measured to better understand the variability in channel incision within the segment. One cross section in the lower segment below the nickpoint revealed an incised channel morphology (IR = 1.9), while another above the nickpoint indicated only minor incision (IR = 1.1). The incised section of the segment represents a majority (approximately 70%), and has likely been exacerbating the increased supply of sediment to lower reaches from the mass failure and other bank failures.

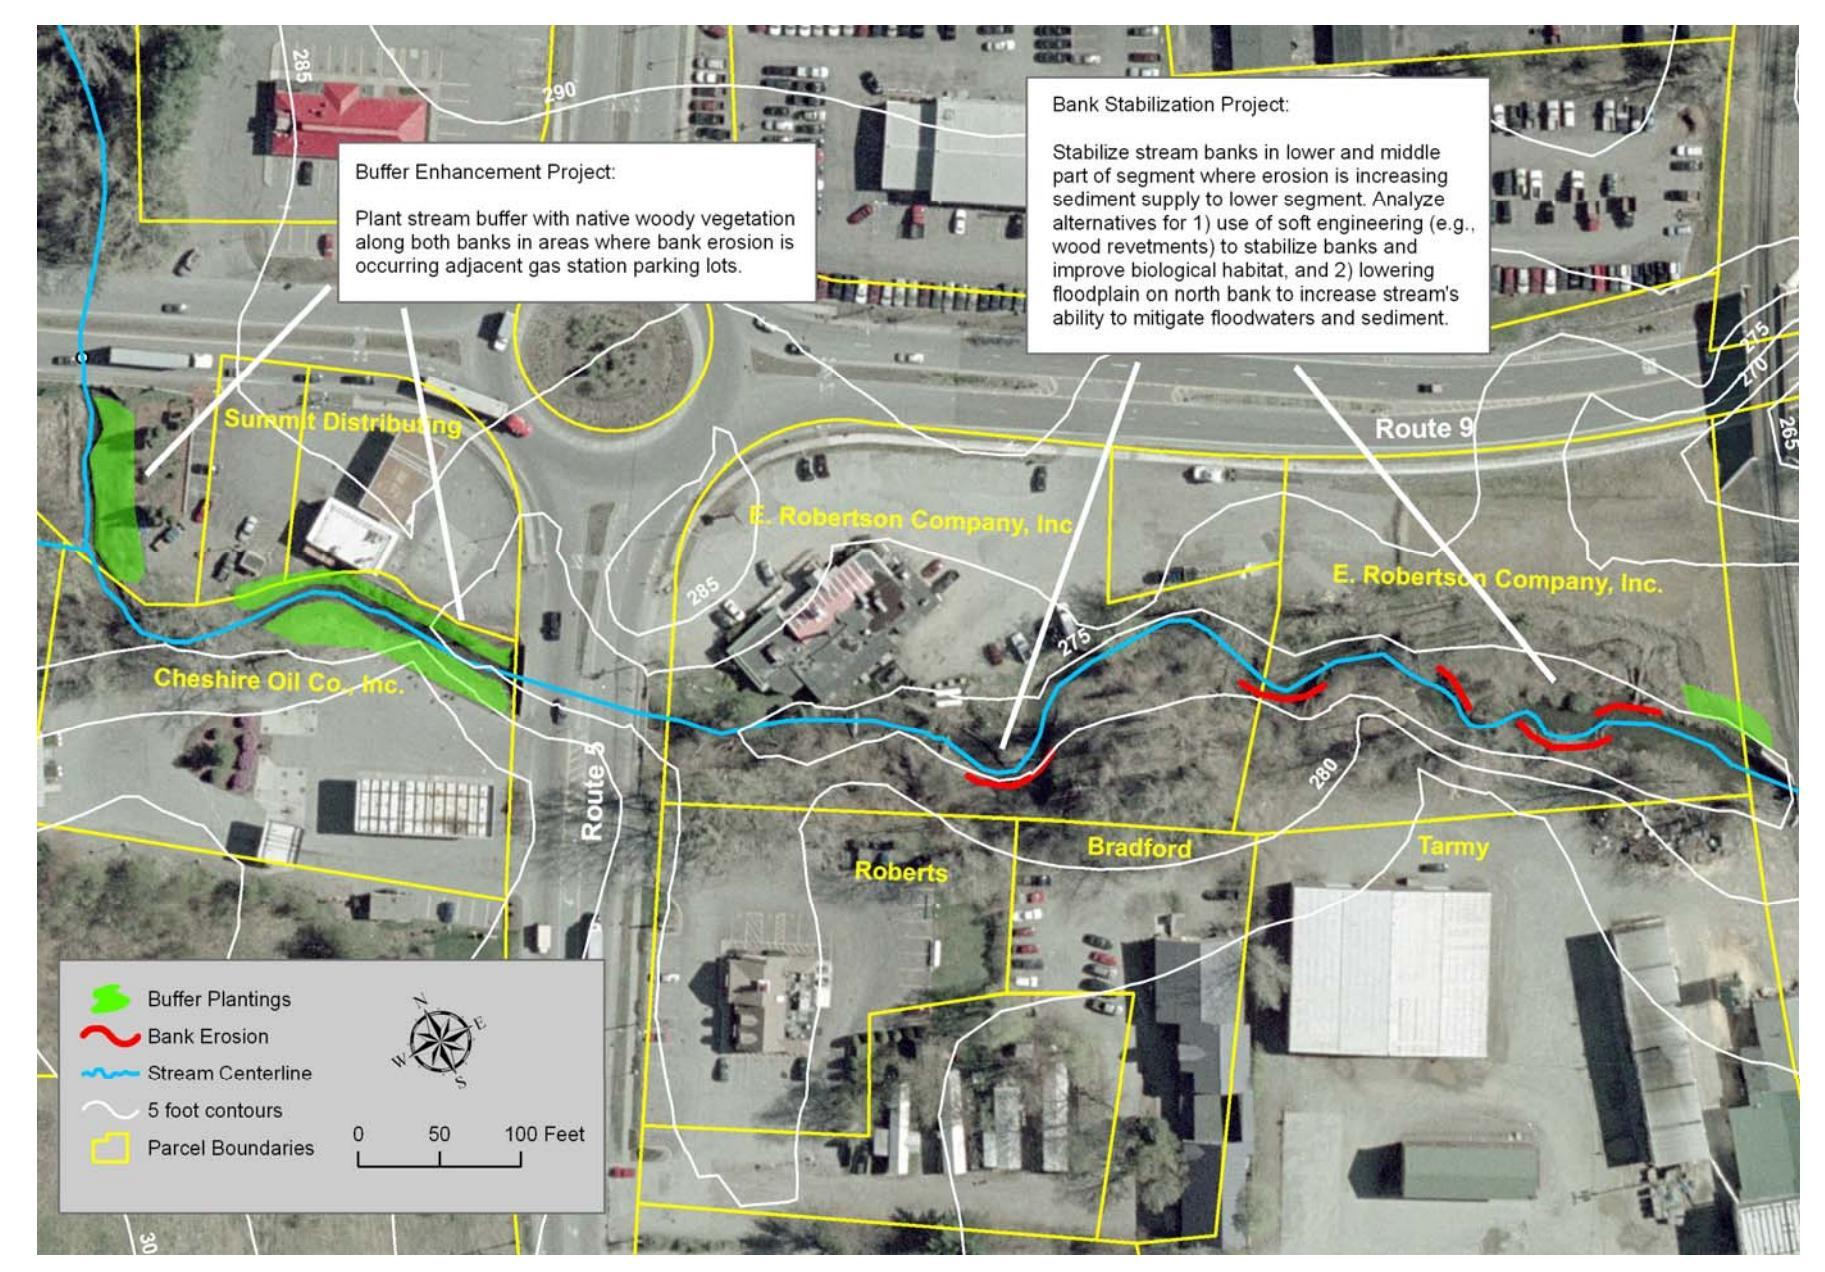
Figure 19. Project location and approach.

Segment M01-B is found from a break in slope near the railroad tracks up to the confluence with the South Branch at the Exit 3 ramp (see Figure 19). The segment is approximately 1,500 feet long and has an overall channel slope of approximately 0.5%. Under reference conditions we would expect this segment to be found in a broad, alluvial valley. Gravel stream channels in this setting and watershed zone typically have a meandering profile with riffle-pool bed features. However, encroachments on the channel from the railroad, Route 9, and commercial development have reduced the available floodplain area. As a result, the channel is found in an altered (semi-confined) valley setting with a lower than expected entrenchment ratio (ER = 2.8). Due to the diminished floodplain access, greater stream power is concentrated in the channel and has led to incision and numerous bank failures. Large failures were noted along the south bank of the segment, some reaching heights of 12 feet (Figure 18).

The bed is dominated by sand (49%), with lesser amounts of fine gravel (27%) and silts (13%). A very high degree of fine sedimentation was observed throughout segment, which is likely leading to impacts on the biotic habitat. Due to the change in valley morphology and the moderate to high channel incision noted throughout, the segment is moderately unstable with a high degree of vertical and lateral adjustment processes (RGA condition "Fair", CEM stage II). The increase in fine sediments and limited buffer and corridor protection resulted in a decreased habitat score (RHA condition "Fair"). The large woody debris (LWD) density for this reach was well below the average for Crosby Brook reaches (47 pieces/mile).

Due to the active nature of the channel and slope adjustments, a bank restoration approach with floodplain re-grading should be considered for this site. Conceptual designs used from other stream stabilization projects have been compiled below to illustrate the range of techniques available for this site. In addition, a typical channel cross-section from the Phase 2 surveys illustrates the degree of channel incision, and how floodplain re-grading could increase floodplain function.

The failures along the south bank are caused by channel adjustments and a lack of structure and vegetative protection in the fill soils. Compared to the Black Mountain Road failure site, there is a greater amount of space to work within at these failure sites beyond the banks; therefore a wider range of stabilization techniques can be considered. A soft engineering approach using natural materials in combination with some rock armoring could be applicable. In addition, the steep banks of the fill soils could be peeled back, with the final bank profile taking on a moderated slope that would allow planted vegetation to become established. Examples of combinations of rock riprap with wood and/or tree revetments are provided below (Figure 21) from the Federal Interagency Stream Restoration Working Group's publication on Stream Corridor Restoration (FISRG, 2001).

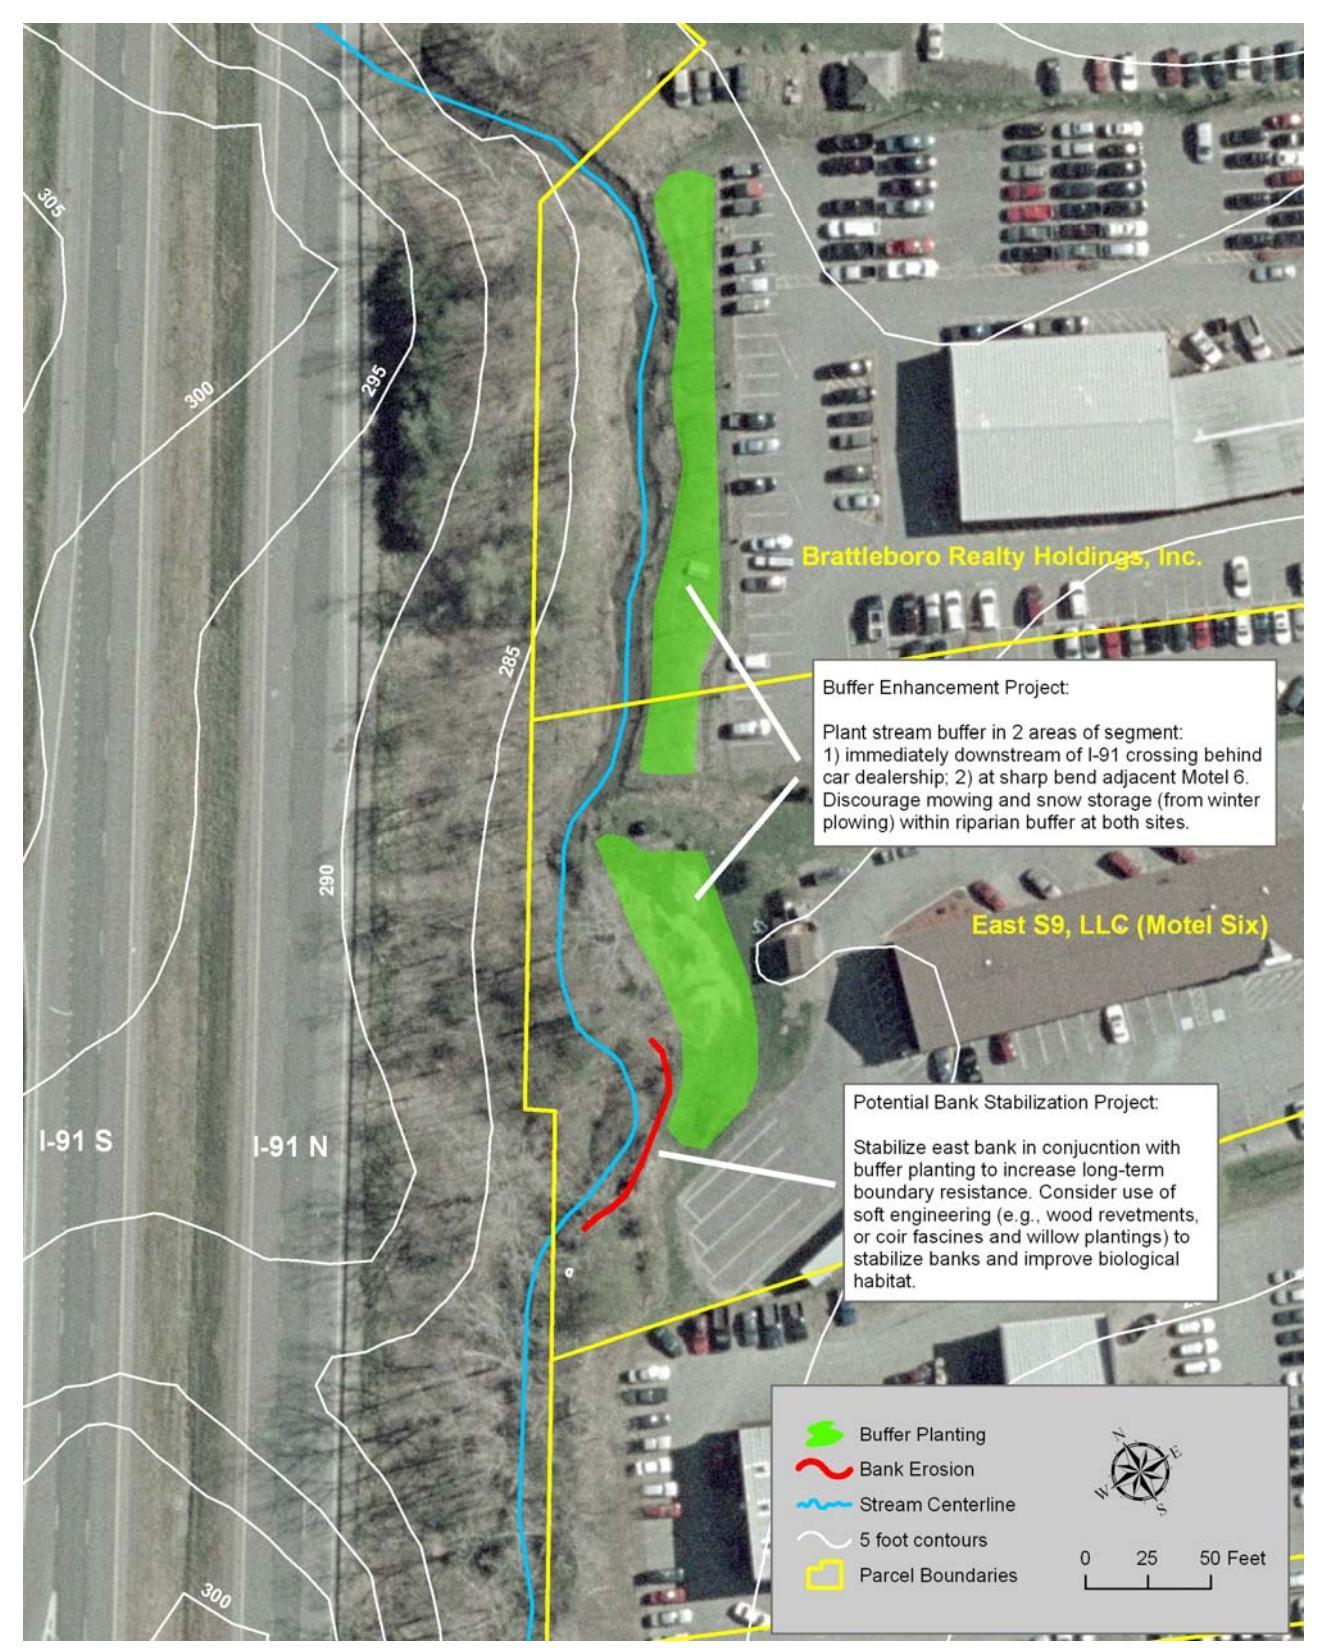
Figure 24. Site location and strategy map.

Due to the departure in valley and channel morphology and the high channel incision, the segment is considered extremely sensitive to further human impacts (RGA condition "Poor", CEM stage II). There is very limited habitat diversity due to extensive straightening, increase in fine sediments, and limited buffer and corridor protection (RHA condition "Poor"). VTDEC sampling data indicate that the fish and macroinvertebrate communities have been highly impacted, supporting fair to poor conditions. The LWD density for this reach was the lowest for any of the main stem reaches (30 pieces/mile).

Figure 24 shows the two areas where the buffer planting is recommended. Combined, these areas cover approximately 8,400 square feet (0.2 acres). NRCS buffer planting guidelines (NRCS-VT, 2009) for planting density would result in a total of 60 trees for this site (300 stems/acre). Given the highly impacted urban setting, a higher density planting plan that includes a combination of trees and shrubs would aid in the reestablishment of a healthy buffer in a shorter time frame. A higher density of 675 stems per acre (8 feet spacing on center) is recommended. The estimated cost range below includes materials and labor. The project costs could be further lowered if the VYCC or other volunteers were to help in the planting effort. Given the presence of beavers in the area, stem protectors are recommended for the tree plantings.
