HOOSIC RIVER

Phase 2 Stream Geomorphic Assessment

Pownal, VT

FINAL REPORT

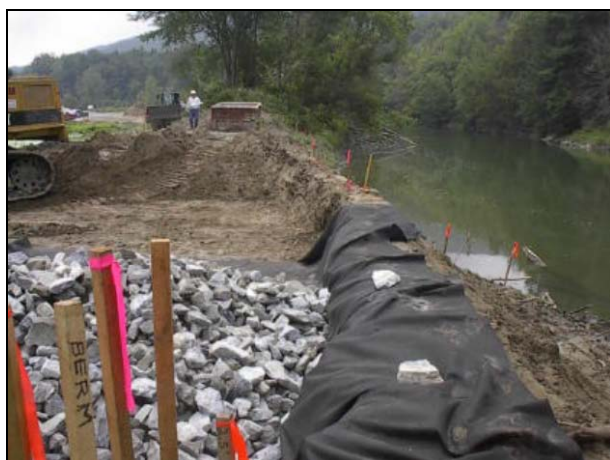
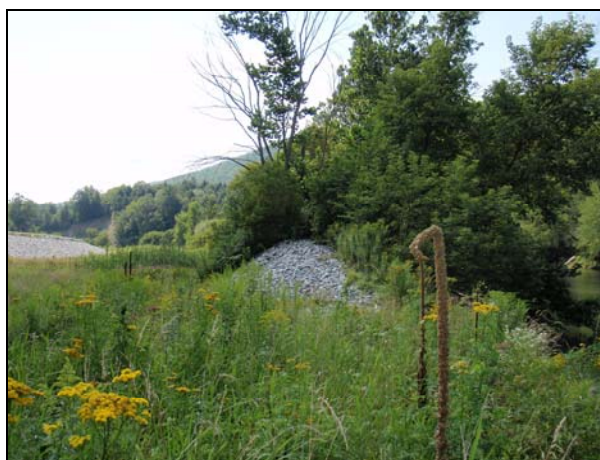
Northern end of berm at the site of former lagoon area, looking south. Left: lowering of the berm and placement of rip-rap for drainage during remediation in 2004 (from Metcalf & Eddy, 2005). Right: revegetation observed during Phase 2 assessment.

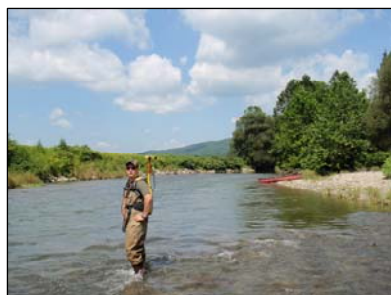
Reach M01 is the lower-most reach in the assessment area. It flows for approximately 1 ¼ miles from the downstream end of an agricultural field below the wastewater treatment facility to the Route 346 bridge at the Vermont-New York border. The left corridor is entirely forested while the right corridor is mostly agricultural, with some forested areas and shrubby buffer zones. The natural valley is very broad, but human modifications have reduced it to narrow width. The modified valley wall is defined on the left by the natural mountain slope, which is usually continuous with the bank, and on the right by the railroad, which is continuous with the bank for about 1,000 feet. In the section of railroad encroachment and for another 1,000 feet downstream along an agricultural field (totaling almost 30% of the reach length), the right bank is rip-rapped and has buffers less than 25 feet. An island and several floodchutes are also present in this reach.

M01 has a reference type of C4 but has degraded to a B4c. At the cross-section, the river is moderately entrenched (ER = 1.6) with a high width-to-depth ratio (36). Using the agricultural field on river-right as the recently abandoned floodplain (RAF) yields an incision ratio (IR) of 2.1. The reach received a rapid habitat assessment (RHA) score of 'good' and a rapid geomorphic assessment (RGA) score of 'fair'. It has experienced historic degradation and widening and is now forming a new floodplain through aggradation, as evidenced by many depositional features. Planform is also adjusting, as evidenced by

flood chutes, transverse bars, & erosion. Therefore, the reach was determined to be in Stage IV of the channel evolution model (CEM). Due to the stream type departure (STD) from C to B, the stream sensitivity is very high.

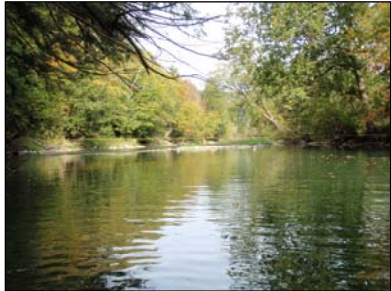
Reach M02 is the shortest reach, flowing for just over half a mile from the upper end of the wastewater treatment facility (WWTF) to the end of an agricultural field below it. The left corridor has some sparse residential development at the upper end of the reach, but is primarily forested, while the right corridor is mostly occupied by the open land of the WWTF (Photo 87), with some agricultural land at the downstream end. The naturally very broad valley is confined to narrow width by human encroachments, defined on the left by the natural mountainside slope usually continuous with the bank, and on the right by the railroad. A berm runs almost the entire length of the WWTF property on the right (over 2,200 feet). Portions of this berm were excavated and redesigned during the Superfund clean-up and redevelopment of the former tannery lagoon complex where the WWTF now sits (see Section 1.3). Between the end of the berm and the start of the agricultural field (approximately 170 feet), the buffer is less than 25 feet (Photo 100) and the bank is covered in a reinforcing carpet-like material (Photos 102 and 103). Across from the berm near the upper end of the reach, there is a substantial mass failure approximately 50 feet high where the mountainside is actively eroding (Photos 88 through 90).

Reach M02 has a reference type of C4 but berming and degradation have resulted in a departure to type F4. It is entrenched ($ER = 1.3$), with a moderate W/D ratio (22). The IR based on the RAF of the WWTF land is 1.0, but the presence of the berm yields a human-elevated IR of 2.2. The reach received an RHA rating of 'good' and an RGA rating of 'fair'. It has experienced historic degradation and floodplain build-up when it was bermed and is now attempting to widen as evidenced by the mass failure, but is confined by a steep valley wall with some bedrock sections and the berm. It was determined to be in stage III of the CEM. Due to the STD from C to F, the stream sensitivity is extreme.

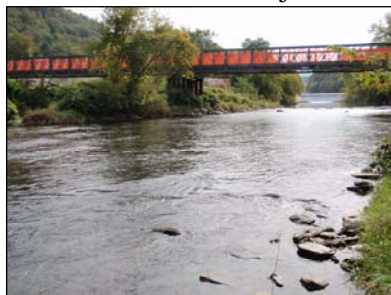
Near the center of the segment, Dean Road crosses the river. The former bridge, built in 1939, was abandoned over 20 years ago (Martinez et. al, 2005). A temporary bridge approximately 100 feet downstream (pictured above) has facilitated river crossings since then. During the Phase 2 field assessment (summer and fall of 2008), the old bridge was demolished and construction began on a new

bridge to take its place. By the end of September, the abutments and pier were in place but the deck had not yet been constructed.

Segment M03-A has a reference type of C3, but floodplain build-up and historic degradation have resulted in a departure to type B3c. In the lower half of the segment where the cross-section was taken, the river is moderately entrenched (ER = 2.1) with a moderate width/depth ratio (32). The upper half of the segment (below the dam) is more entrenched with a lower width/depth ratio, but the river was too deep in that area to safely and accurately perform a cross-section. Using the terrace on the left bank as the RAF yielded an IR of 1.8. Again, the upper half of the segment would likely have yielded a higher IR due to the presence of a high bank on both sides. The segment received an RHA rating of 'good' and an RGA rating of 'fair.' It has experienced historic degradation and floodplain build-up, has become overwidened (particularly in the lower section where it is not constrained by bedrock and foundations), and is now developing new depositional features through aggradation. It was determined to be in Stage IV of the CEM, and the stream sensitivity is high.

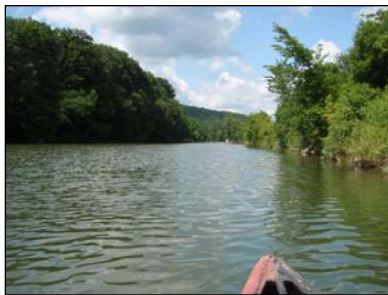
Segment M03-B is the upstream portion of Reach M03 described above. It encompasses the majority of the impounded area upstream of the Pownal Dam. In accordance with Phase 2 protocols, this segment was not assessed because it is impounded and is too deep to allow for cross-section measurements. However, its channel dimensions and characteristics are very similar to those of Segment M04-B described below. Reach M03 has a naturally broad valley and a reference stream type of C. This segment is encroached by both the railroad and Route 346, which run within one bankfull width of the river in the right corridor for the majority of its length. Along the railroad, the right bank is rip-rapped and has a buffer less than 25 feet. The left corridor contains an open water/wetland complex.

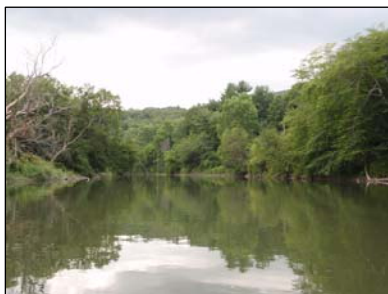
Reach M04 flows for approximately 1 ¾ miles from just upstream of the Mack plant on river-right to the impoundment above Pownal Dam. Segment M04-A is a short (1,500-foot) section at the lower end of the reach that is still somewhat impounded by the dam. It is relatively flat, deep, and slow-moving, similar to the impoundment downstream. The naturally very broad valley is split almost in half (to narrow width) by the presence of the railroad in the right corridor. The steep mountainside natural valley wall on the left is mostly continuous with the bank, while the right corridor consists primarily of a wetland area with two small ponds. The segment is largely featureless.

Segment M04-A is classified as its reference stream type of C, but its reference substrate type of cobble has been almost entirely replaced by sand, with some silt and detritus. It is relatively unentrenched (ER = 3.7), with a moderate width/depth ratio (29). Using the right bank as the RAF yields an IR of 1.4. Although habitat condition in this segment would be considered poor for its reference high gradient stream type, a low gradient RHA form was used to facilitate management toward equilibrium in the current condition, as it is unlikely that the Pownal Dam would be removed. This yielded an RHA rating of 'good,' while the RGA rating remained 'poor.' This segment has experienced significant historic aggradation due to sediment settling out above the dam and has essentially become a featureless plane bed with little evidence of adjustment, except for the ongoing aggradation. Therefore, it was determined to be in Stage IV of the CEM and the stream sensitivity is very high.

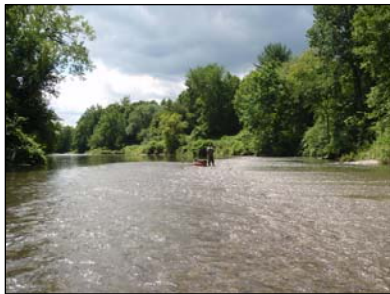
Segment M04-B occupies the majority (almost 1.5 miles) of Reach M04. The most sinuous of the reaches, it meanders across its broad valley, defined on the left by the natural mountainside and on the right by the railroad. These two features alternately become continuous with the bank for short stretches between meanders. When the valley wall is continuous with the bank on one side of the river, the opposite floodplain area primarily consists of agricultural fields. In some areas the buffer between the river and fields is adequate, while others have buffers less than 25 feet. Other land uses of note include the forest on the left and a short section of industrial development on the right at the Mack plant near the top of the reach. Small areas of erosion are present throughout the reach, and where the right bank is encroached by the railroad it is armored with rip-rap. Several floodchutes and depositional features are also present.

Segment M04-B is still a reference stream type of C, but the dominant substrate size has decreased from cobble to gravel. It is unentrenched (ER = 5.9), with a moderate width/depth ratio (23). Using the agricultural field on the left as the RAF yields an IR of 1.2. The segment received an RHA rating of 'good' and an RGA rating of 'fair.' It has experienced historic degradation and is now narrowing to form a new floodplain through aggradation and development of bar features. Planform is also adjusting, as evidenced by several transverse bars/rifles, floodchutes, and erosion. It was determined to be in Stage IV of the CEM, and the stream sensitivity is very high.

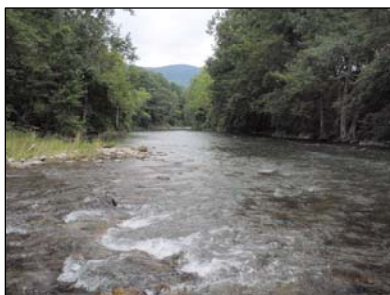
Reach M05 is the longest reach in the assessment area at just over 2 miles. It flows from the upstream extent of the Green Mountain Park (former racetrack) property to just above the Mack plant property. Its naturally very broad valley has been reduced to broad width by the railroad on the right. The natural mountainside valley wall on the left is sometimes continuous with the bank and usually within one bankfull width of the river. The left corridor is mostly forested, with some scattered agricultural and residential development areas, particularly near the crossing of Main Street. The right corridor is similarly developed in this region, but a dominant feature is the 144-acre Green Mountain Park occupying almost half of the reach length at the upper end. This site of the former racetrack includes an extensive paved lot with access roads, a large spectator stand, the racetrack itself (which encircles around a pond), and an area of former stable buildings which have been demolished. The relatively flat lot is accessed when the river is at floodprone height (equal to two times the maximum bankfull depth).

Although lateral channel migration in reach M05 is restricted by development, it was found to be still in its reference condition of C3 at the cross-section. It is possible that the low slope of this reach has alleviated some of the degradation typically seen in similarly encroached streams. Furthermore, the former racetrack lot appears to be currently serving as a floodplain for the river, whereas if the lot were developed with valuable infrastructure, the river would likely be prevented from accessing this floodplain via bank armoring, berming, etc. This would certainly lead to further degradation of the reach, effectively pushing it backwards in the CEM.

Reach M05 is only slightly entrenched (ER = 3.7), with a low width/depth ratio (21), and an IR of 1.7 based on an RAF of the former racetrack lot. It received an RHA rating of 'good' and an RGA rating of 'fair.' The reach has experienced historic degradation, has developed new bar features through aggradation, and appears to be approaching relative stability near the end of Stage IV of the CEM. The stream sensitivity is high.

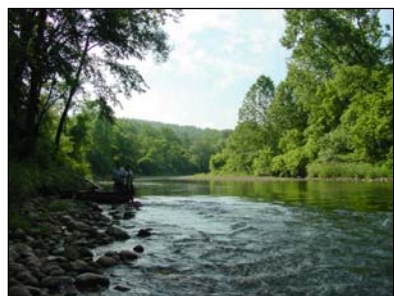
Reach M06 flows for just over a mile from the Massachusetts-Vermont border to the upstream extent of the Green Mountain Park (former racetrack) property. Its naturally broad valley is only slightly confined by the railroad and Route 7 on the right, but the valley type remains broad. The left corridor predominantly consists of two large agricultural fields, separated by a section of forest where the bank is continuous with its natural mountainside valley wall. When the river is not near the railroad (which occurs for almost 70% of the reach), the right corridor is lightly forested with a network of dirt roads and ATV trails. The right bank is often relatively high with areas of erosion

(Photos 6 and 15). The left bank is usually somewhat lower with less erosion, except in the case of the high, eroding terrace adjacent to the lower agricultural field for over 700 feet (Photos 19 through 23). Here, the nearly vertical bank is over 30 feet high and actively eroding away at what little vegetation is left in the less than 25-foot buffer between the river and the field. The right (opposite) bank is closely encroached by the railroad and is rip-rapped just upstream (Photo 18) and downstream of the erosion site. A large floodchute is also present opposite this eroding bank (between the rip-rap sections), and another can be found just upstream on the left.

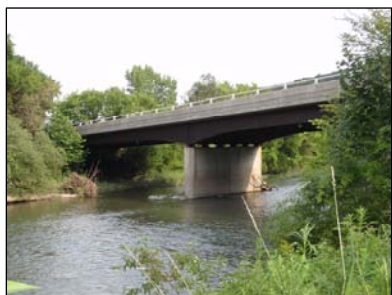
The Route 346 Bridge is located in Reach M01 at the downstream extent of the assessment area, where Route 346 crosses the Vermont border into New York. The largest of the three bridges, it has a span of 219 feet, a deck width of 39 feet, and a clearance of 24 feet. The span is 134% wider than the measured channel width of 164 at the bridge. The structure is primarily concrete with steel girders and reinforcements. Small side and mid-channel bars are present upstream and downstream of the bridge. The left bank is rip-rapped for about 150 feet under the bridge and extending up and downstream. The bank armoring and structure seem to be in good condition, and little evidence of erosion or scour was observed. The railroad crosses the river approximately 600 feet downstream. Additional views of the Route 346 Bridge can be seen in Photos 121 through 127 of Appendix E.

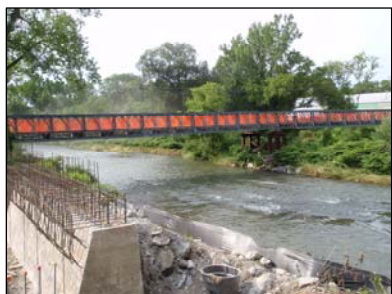
The Dean Road crossing is located in Segment M03-A, approximately 800 feet downstream of the Pownal Dam. The former Dean Road Bridge, built in 1939, was abandoned over 20 years ago (Martinez et. al, 2005). A temporary bridge approximately 100 feet downstream (pictured above) has facilitated river crossings since then. During the Phase 2 field assessment (summer and fall of 2008), the old bridge was demolished and construction began on a new bridge to take its place. By the end of September, the abutments (in foreground above) and pier were in place but the deck had not yet been constructed. Dimensions for the new bridge were obtained from plans provided by the construction workers. The temporary bridge was not assessed. The new Dean Road Bridge will have a span of 260 feet, a deck width of 30 feet, and a clearance of 16 feet. The span will be 160% of the channel width, which was measured to be 163 feet. It will be of concrete construction with steel girders and reinforcements. Already, a significant mid-channel bar greater than half of bankfull elevation is present upstream and downstream of the bridge site. Rip-rap is present on the left bank under both the temporary bridge and new bridge site (pictured above). Additional views of the temporary bridge and new bridge construction can be seen in Photos 73 through 79.

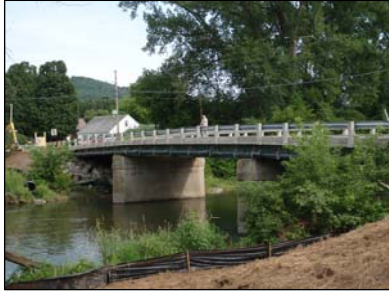
The Main Street Bridge is located toward the end of Reach M05. With a span of 178 feet, a deck width of 24 feet, and a clearance of 14 feet, it is the smallest of the three bridges. The span is 123% of the 145-foot-wide channel. Structure material is concrete with steel girders and reinforcements. Both banks are rip-rapped under the bridge, and a large mid-channel bar greater than half of bankfull height is present upstream (photo 34). At the time of the assessment, construction for a new town wastewater collection system was in progress. A new drainage pipe had been installed on the right bank just below the bridge (Photo 41), and both banks had been re-graded, freshly rip-

rapped (under the bridge), and re-planted. Additional views of the bridge can be seen in Photos 36 through 42.

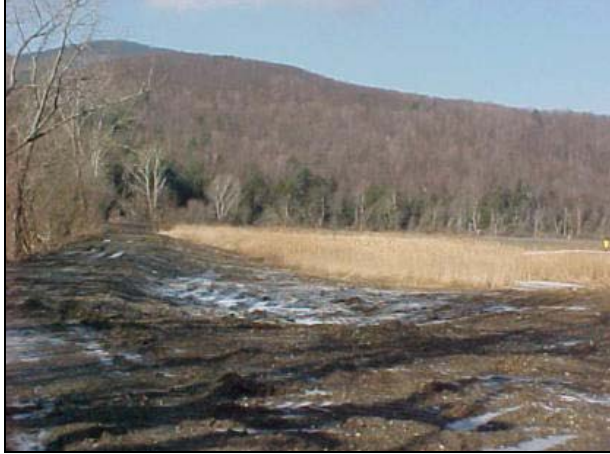
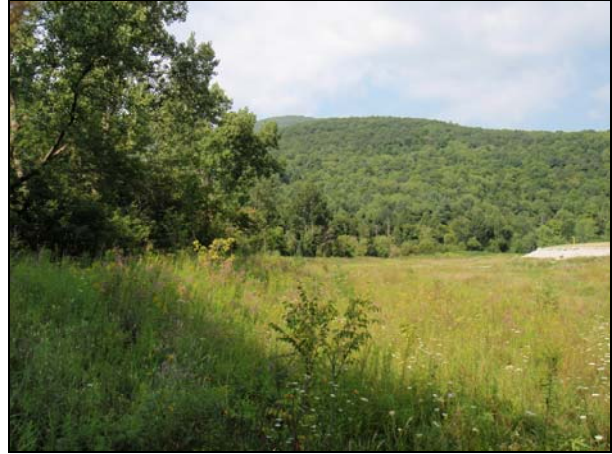
However, this former floodplain area is particularly sensitive due to the remediation of historic hazardous wastes from the tannery (see photographs on the following page), so berm removal or offset may not be feasible here.

Lagoon area prior to remediation in March 2004 on left (Metcalf and Eddy, 2005) and after remediation during the Phase 2 assessment in August 2008 on right. (The Hoosic River is out of view on the left.)

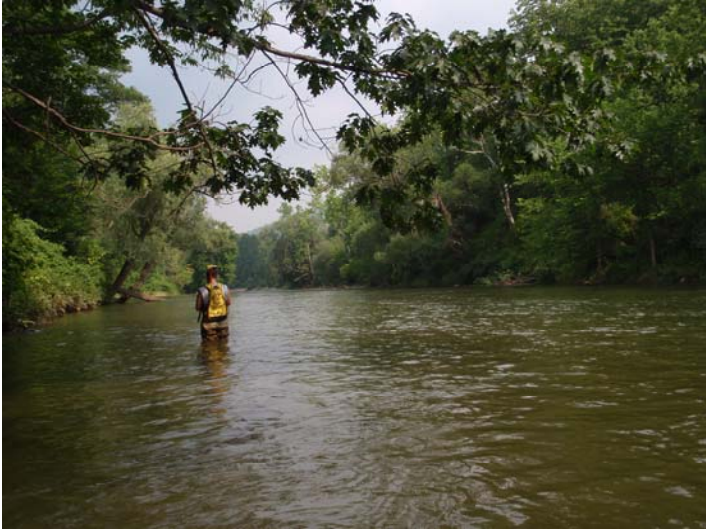
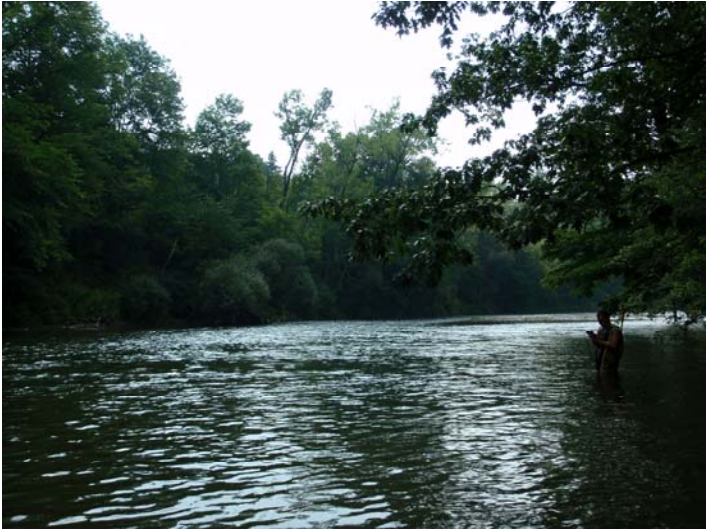
Segment ID: M06	Photo #: 1	Date: 7/31/08	View: DS	Segment ID: M06	Photo #: 2	Date: 7/31/08	View: US
Description: Top of reach M06				Description: Bottom of reach M07

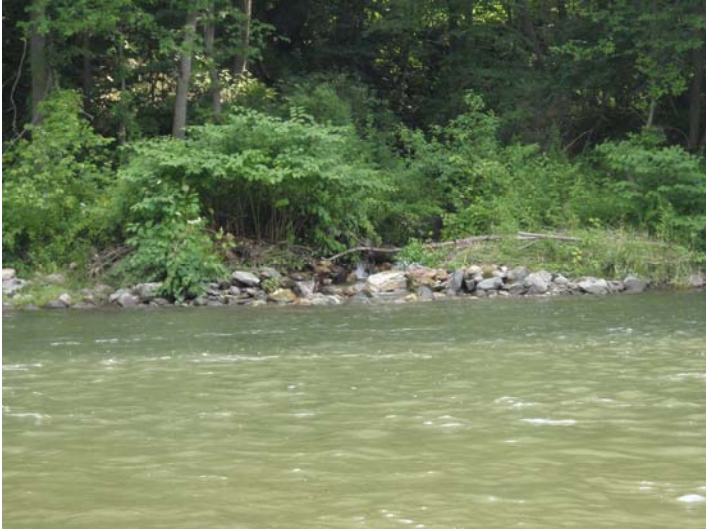
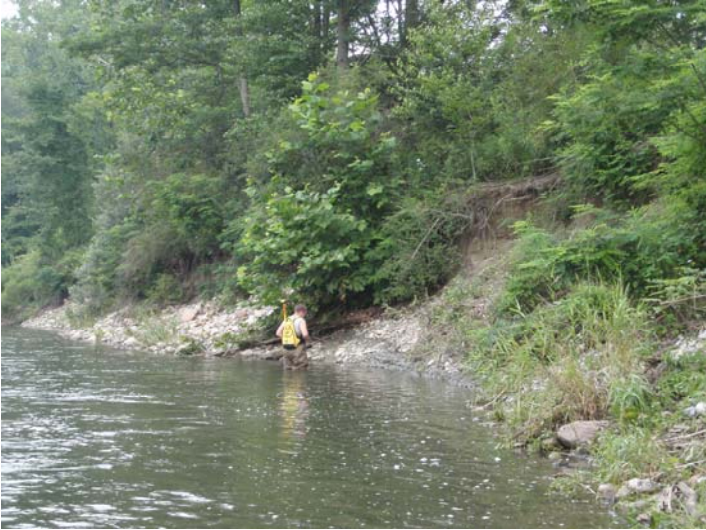
Segment ID: M06	Photo #: 3	Date: 7/31/08	View: RB	Segment ID: M06	Photo #: 4	Date: 7/31/08	View: DS RB
Description: Tributary entrance at M06/M07 reach break				Description: 9' erosion along RB below reach break

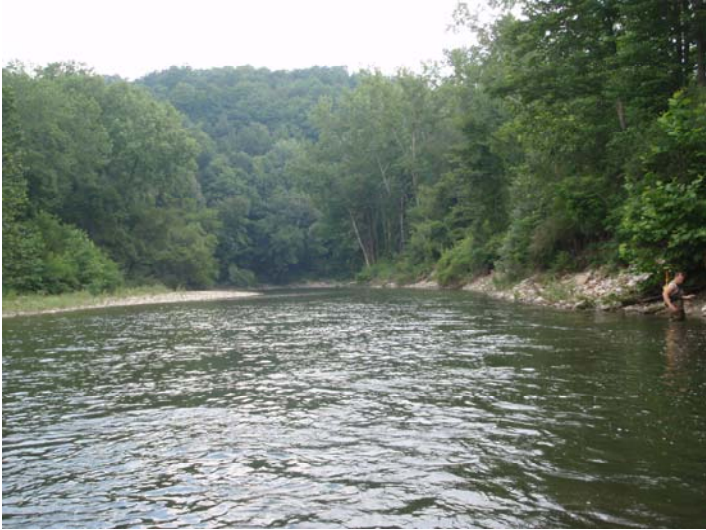
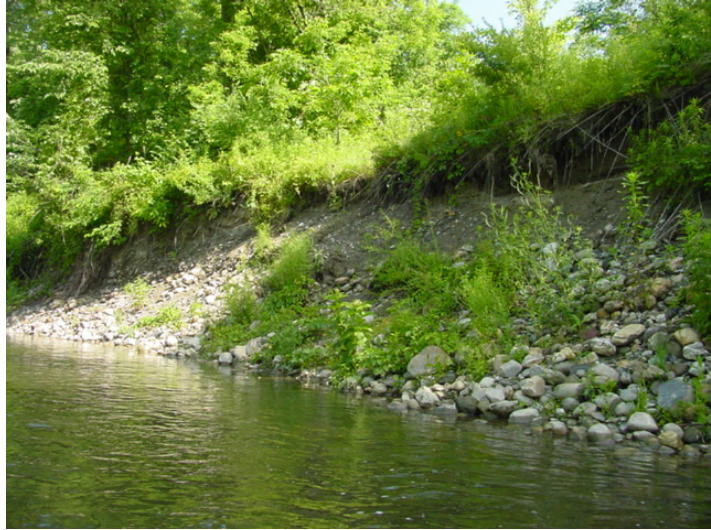
Segment ID: M06	Photo #: 5	Date: 7/31/08	View: DS	Segment ID: M06	Photo #: 6	Date: 9/25/08	View: DS RB
Description: Side bar on L, erosion on R				Description: RB erosion DS of reach break

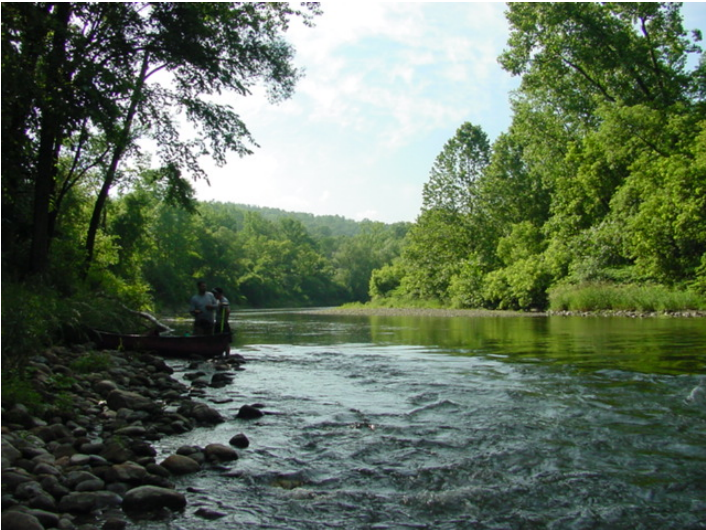
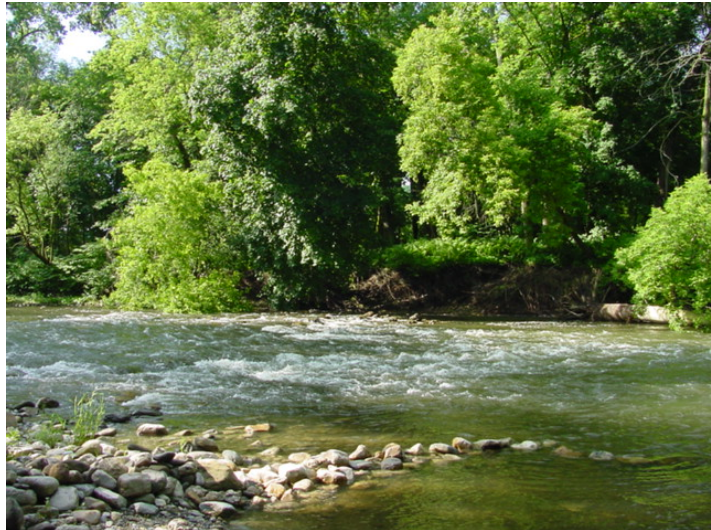
Segment ID: M06	Photo #: 7	Date: 6/25/08	View: US	Segment ID: M06	Photo #: 8	Date: 6/25/08	View: LB
Description: US from sharp bend				Description: Across channel at sharp bend (RL erosion, riffle, manmade jetty)

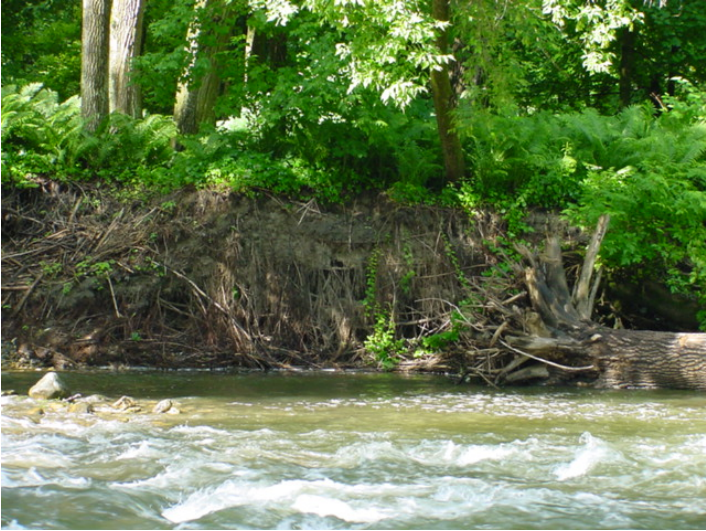
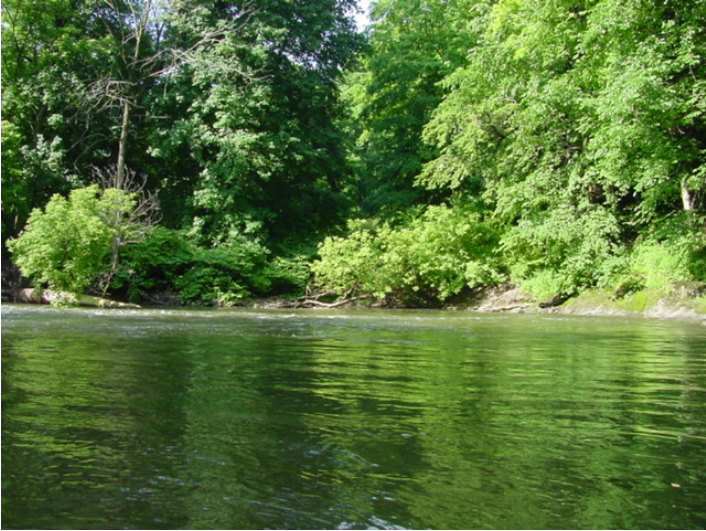
Segment ID: M06	Photo #: 9	Date: 6/25/08	View: LB	Segment ID: M06	Photo #: 10	Date: 6/25/08	View: LB
Description: Close-up of erosion at sharp bend above trib				Description: Trib entrance & pool below sharp bend

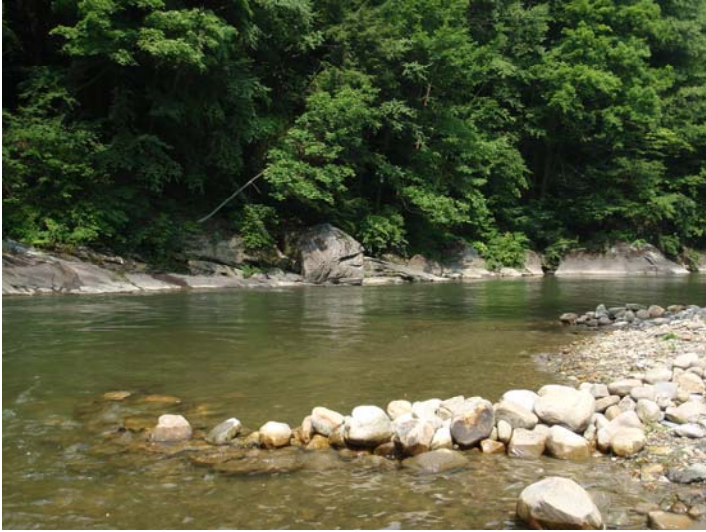
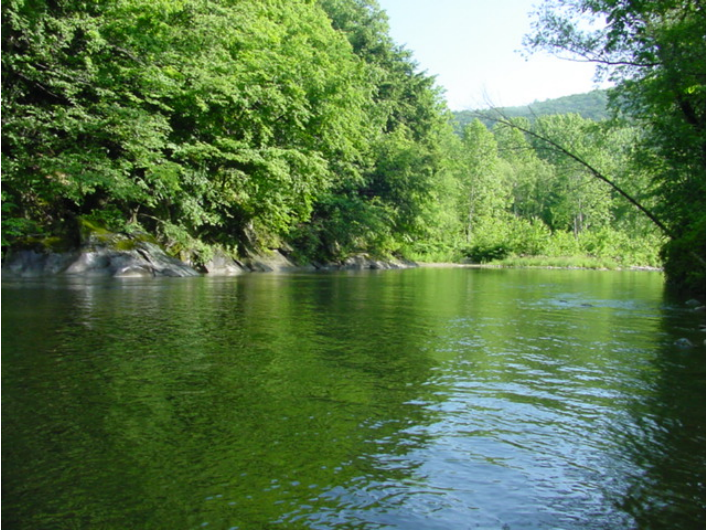
Segment ID: M06	Photo #: 11	Date: 7/31/08	View: DS	Segment ID: M06	Photo #: 12	Date: 6/25/08	View: DS
Description: Bedrock LB below sharp bend (manmade jetty in foreground)				Description: DS from sharp bend (start of RL floodchute in background)

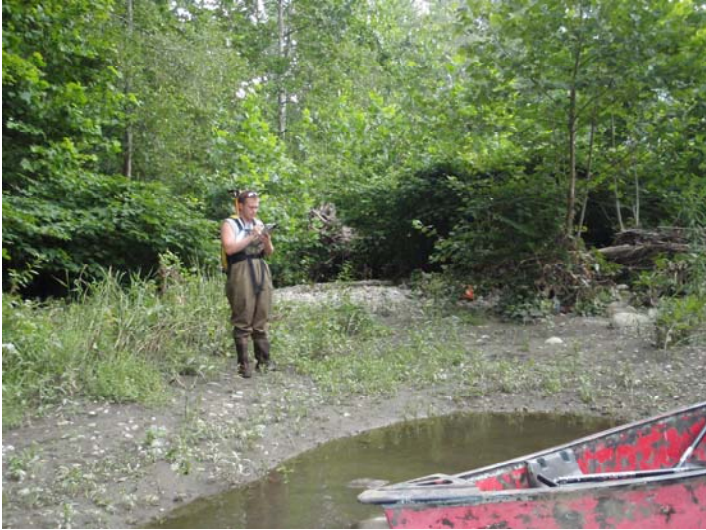
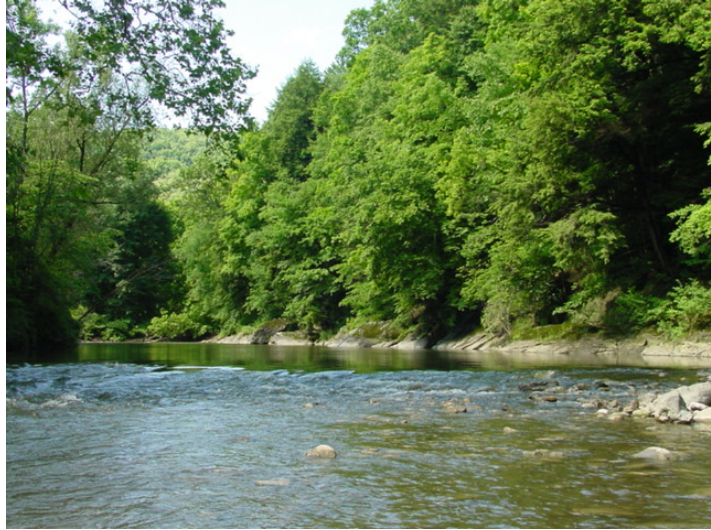
Segment ID: M06	Photo #: 13	Date: 7/31/08	View: DS LB	Segment ID: M06	Photo #: 14	Date: 6/25/08	View: US
Description: Top of RL flood chute				Description: US from head of floodchute toward sharp bend

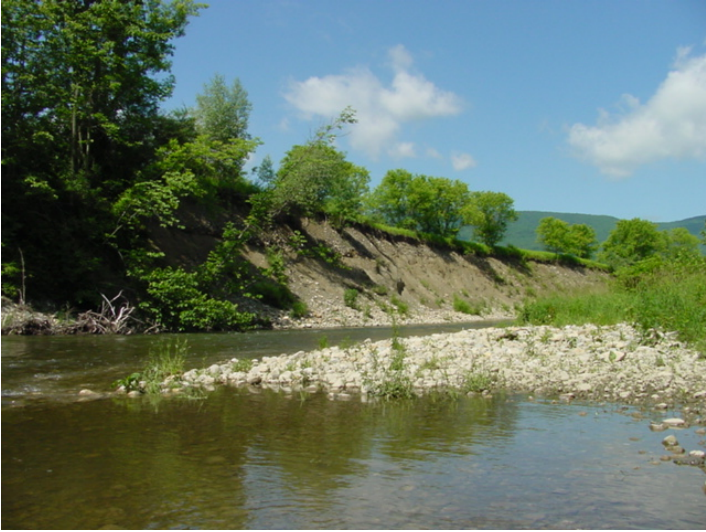
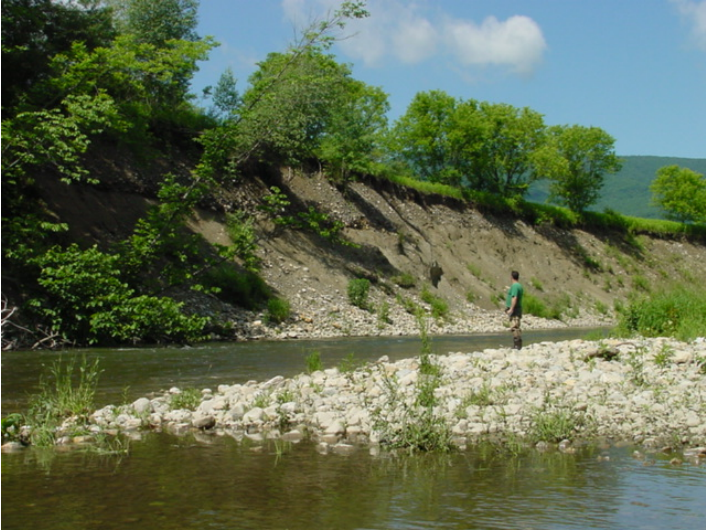
Segment ID: M06	Photo #: 19	Date: 6/25/08	View: DS	Segment ID: M06	Photo #: 20	Date: 6/25/08	View: DS
Description: 30' eroding terrace (island in foreground)				Description: 30' eroding terrace (island in foreground)

One protective technique that would help prevent further bank erosion, which can lead to bank armoring and degradation, is to plant stream buffer vegetation to help stabilize the banks. Target areas should include locations where the buffer is currently less than 25 feet, such as the eroding high terrace in Reach M06 (pictured at left), as well other areas along the river where adjacent land use has limited the extent of natural riparian buffers (primarily along agricultural fields and railroad embankments). In locations such as the eroding high terrace in Reach M06, dynamic-process conservation areas, or erosion easements, may be a better alternative than large investments such as vegetative plantings due to the tendency of the bank to erode in this area and the agricultural land use. Natural regeneration can be a cost effective way to restore the vegetation on the banks.

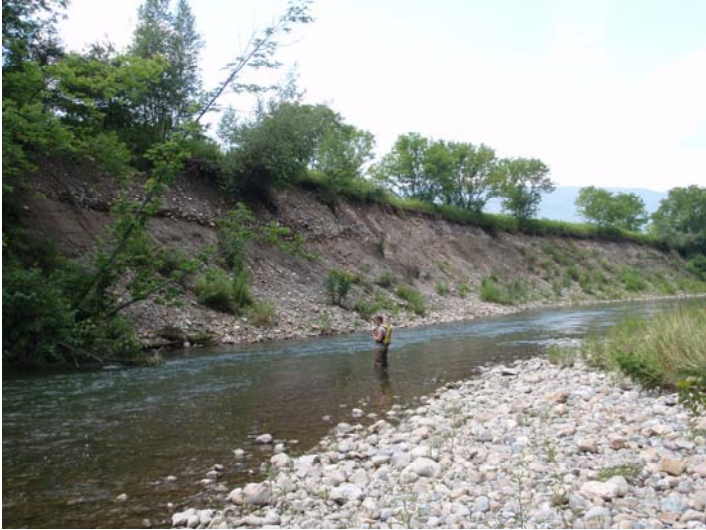
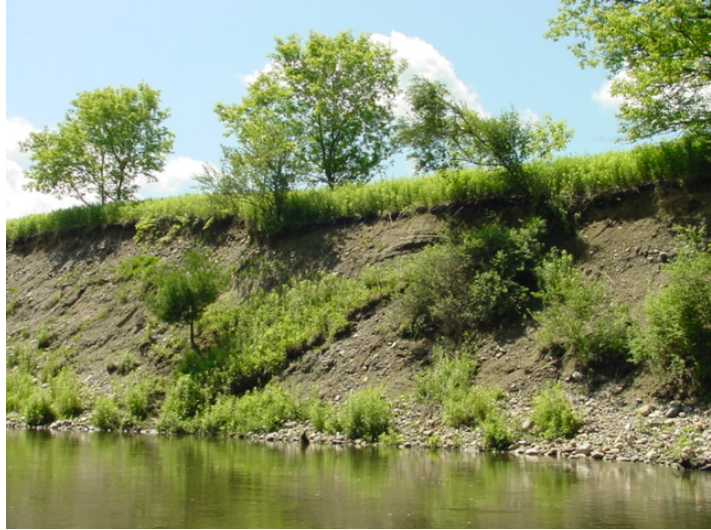
Segment ID: M06	Photo #: 21	Date: 7/31/08	View: DS	Segment ID: M06	Photo #: 22	Date: 6/25/08	View: LB
Description: 30' eroding terrace (island in foreground)				Description: 30' eroding terrace

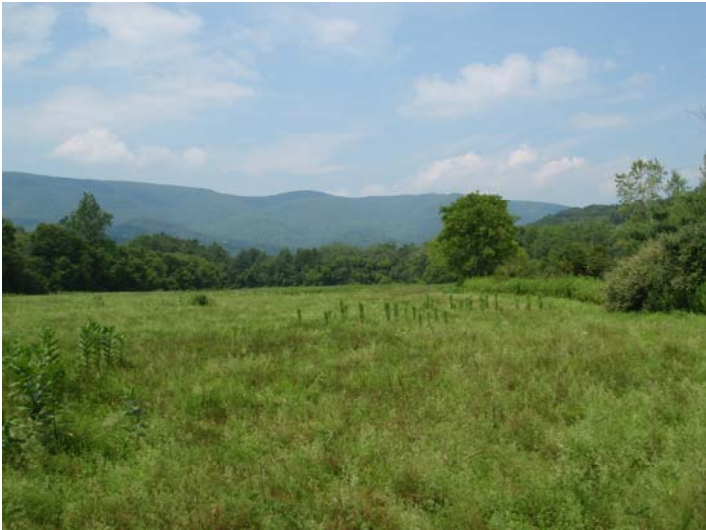
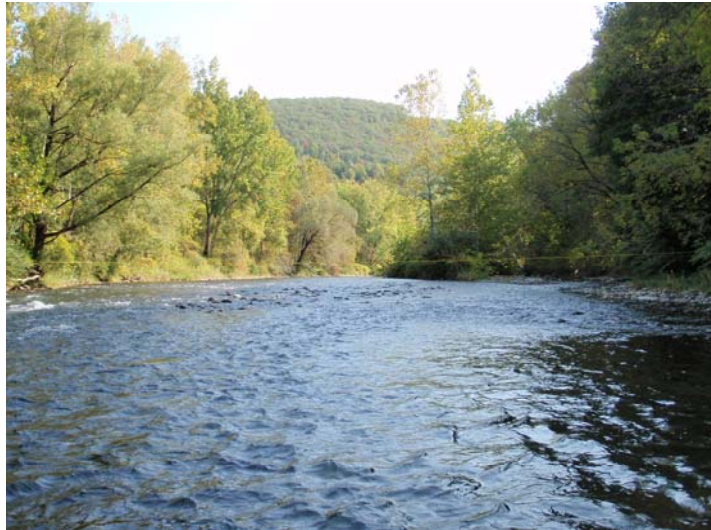
Segment ID: M06	Photo #: 23	Date: 7/31/08	View: DS LB	Segment ID: M06	Photo #: 24	Date: 9/24/08	View: US
Description: Field above high terrace on LB				Description: M06 x-section (note tape line)

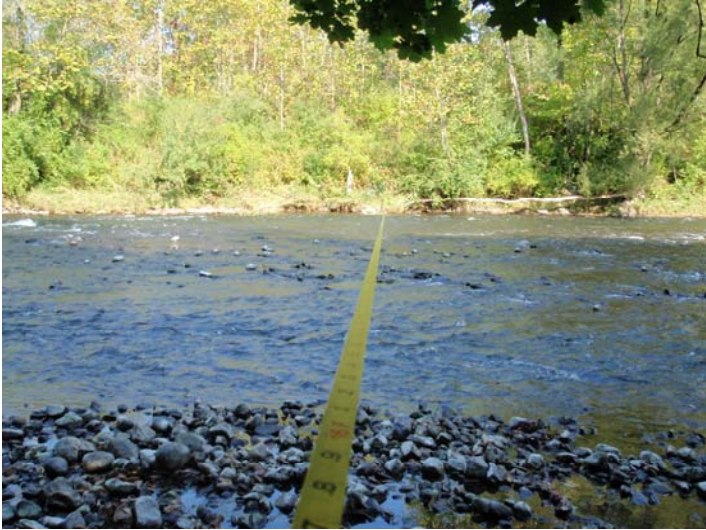
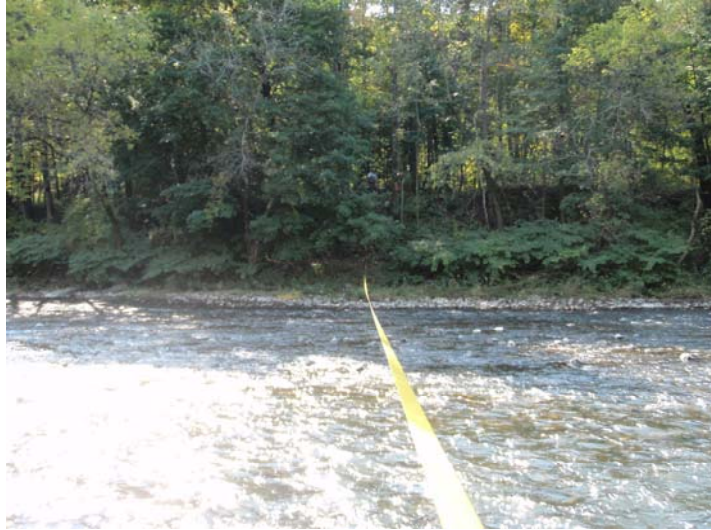
Segment ID: M06	Photo #: 25	Date: 9/24/08	View: RB	Segment ID: M06	Photo #: 26	Date: 9/24/08	View: LB
Description: M06 x-section				Description: M06 x-section

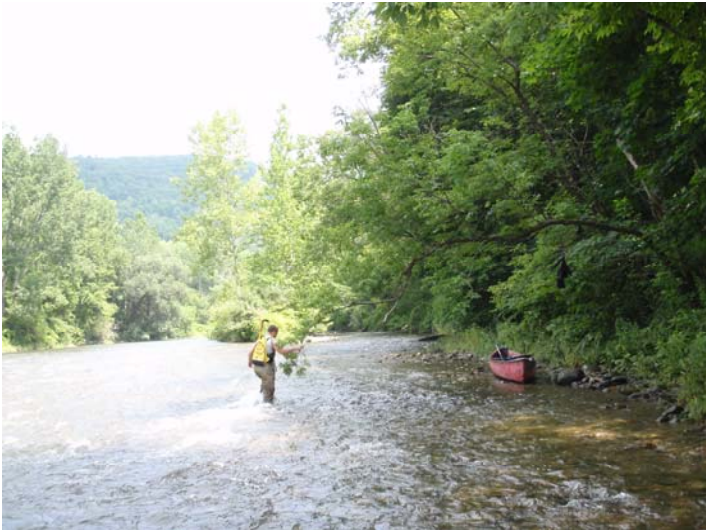
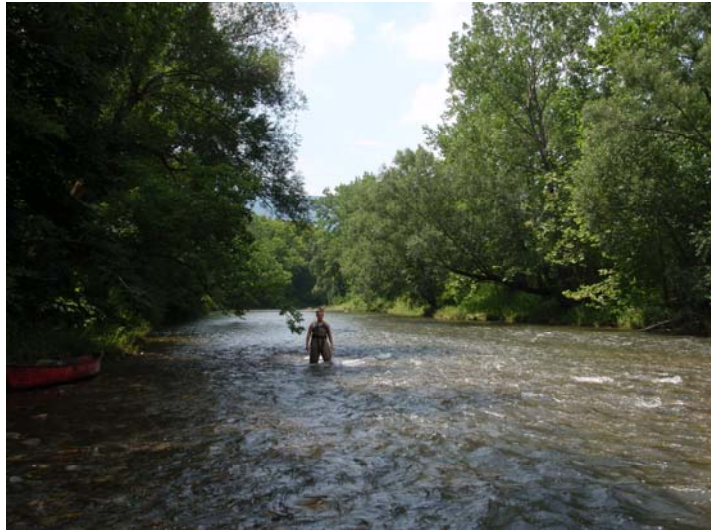
Segment ID: M06	Photo #: 27	Date: 7/31/08	View: US	Segment ID: M05	Photo #: 28	Date: 7/31/08	View: DS
Description: Bottom of reach M06				Description: Top of reach M05

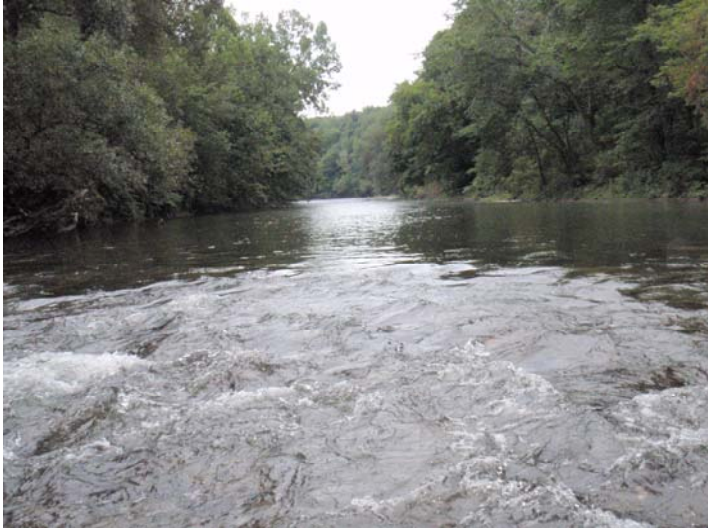
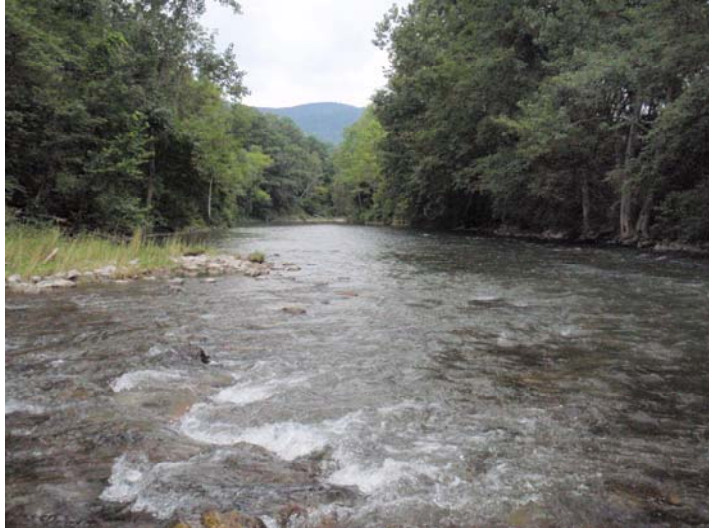
Segment ID: M05	Photo #: 29	Date: 8/18/08	View: US	Segment ID: M05	Photo #: 30	Date: 8/18/08	View: DS
Description: US from M05 x-section				Description: DS from M05 x-section

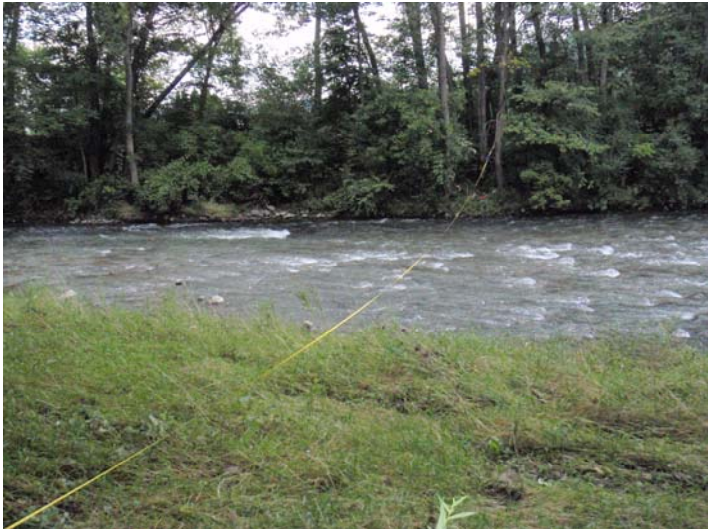
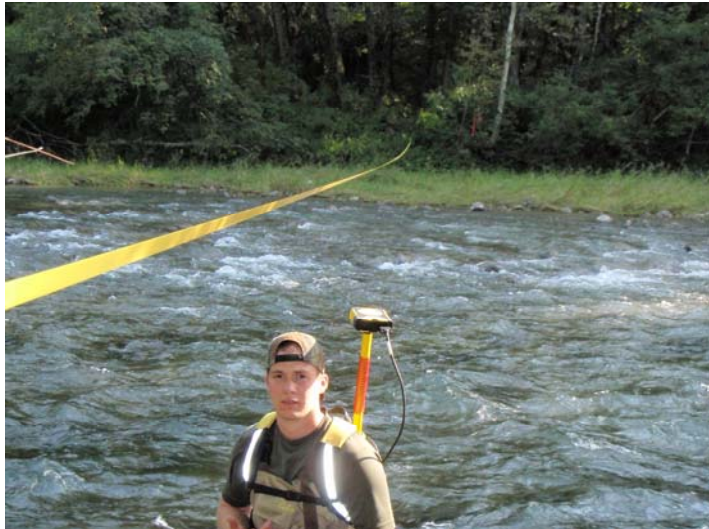
Segment ID: M05	Photo #: 31	Date: 8/18/08	View: RB	Segment ID: M05	Photo #: 32	Date: 8/18/08	View: LB
Description: M05 x-section				Description: M05 x-section

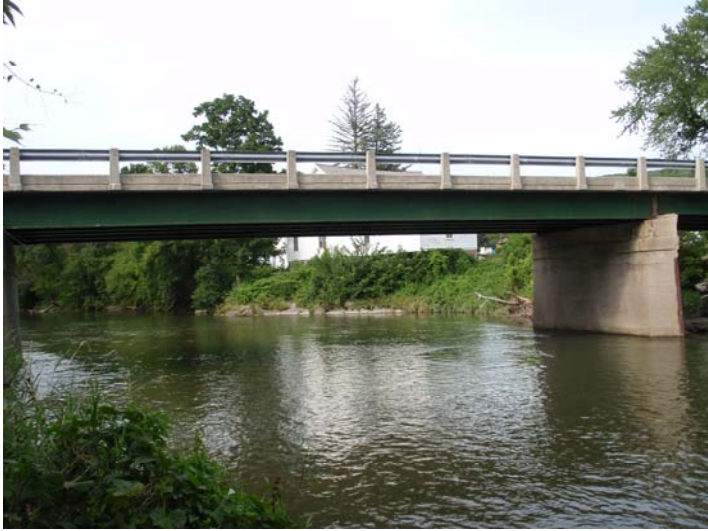
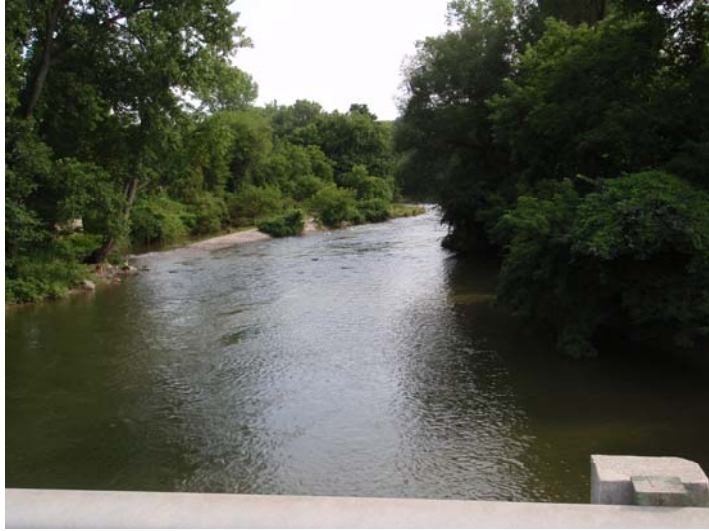
Segment ID: M05	Photo #: 37	Date: 7/30/08	View: DS RB	Segment ID: M05	Photo #: 38	Date: 7/30/08	View: US
Description: Main St. Bridge inlet (residential development in background)				Description: US from Main Street Bridge (diagonal bar in background)

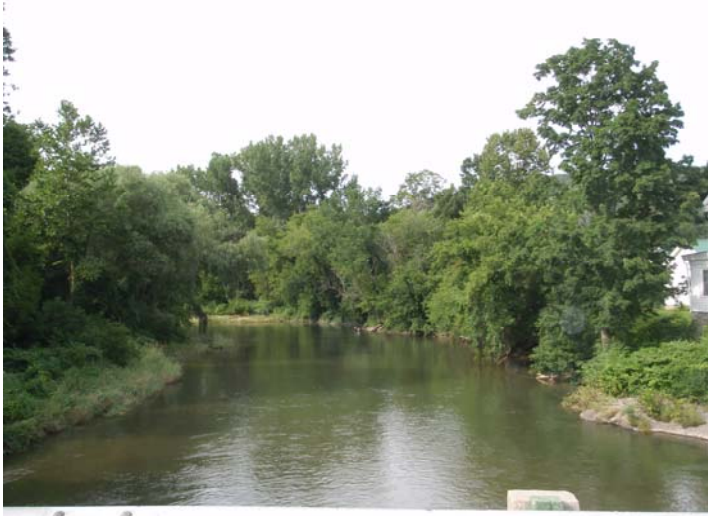
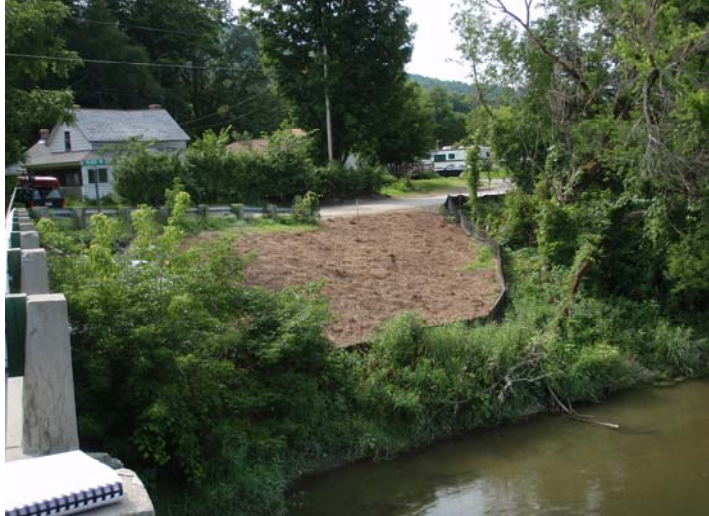
Segment ID: M05	Photo #: 39	Date: 7/30/08	View: DS	Segment ID: M05	Photo #: 40	Date: 7/30/08	View: DS LB
Description: DS from Main Street Bridge				Description: DS LB re-vegetation area at Main Street Bridge

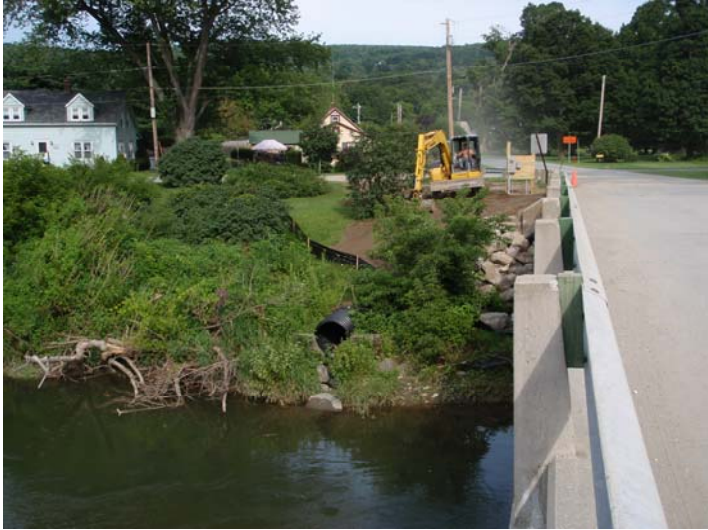
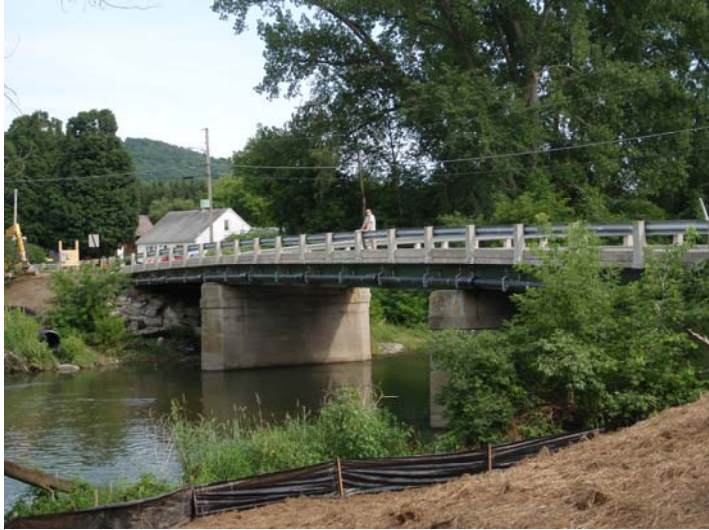
Segment ID: M05	Photo #: 41	Date: 7/30/08	View: DS RB	Segment ID: M05	Photo #: 42	Date: 7/30/08	View: US RB
Description: DS RB new drainage pipe at Main Street Bridge				Description: Outlet of Main Street Bridge (re-vegetation area in foreground)

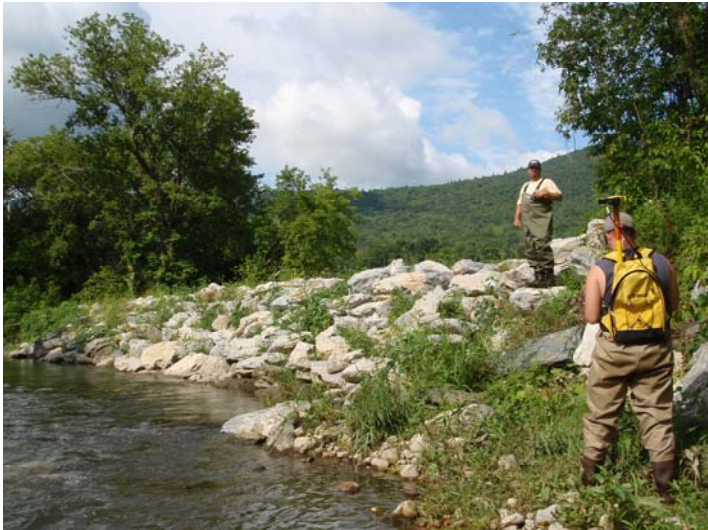
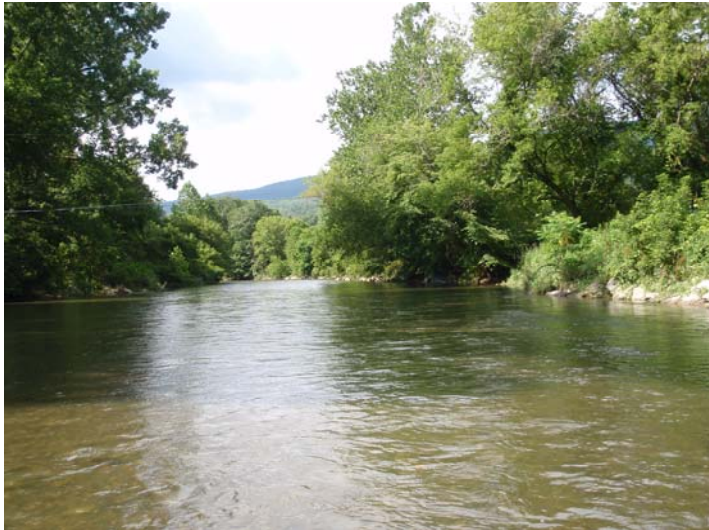
Segment ID: M05	Photo #: 43	Date: 8/1/08	View: US LB	Segment ID: M05	Photo #: 44	Date: 8/1/08	View: US
Description: LB heavy rip-rap at reach break				Description: Bottom of reach M05

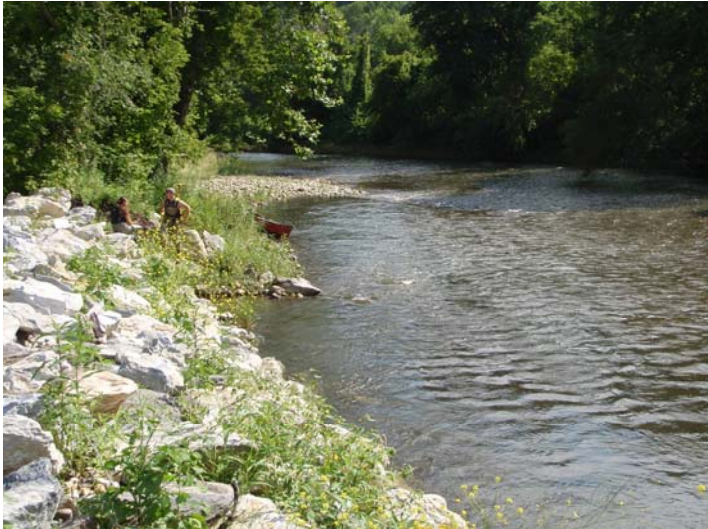
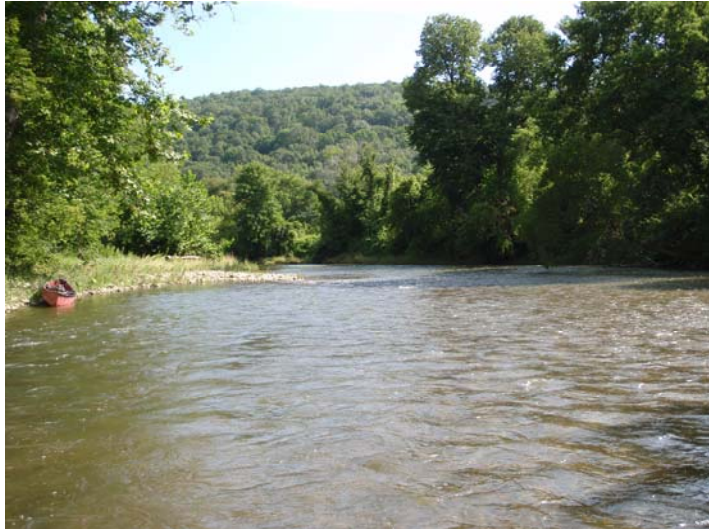
Segment ID: M04-B	Photo #: 45	Date: 8/1/08	View: DS	Segment ID: M04-B	Photo #: 46	Date: 8/1/08	View: DS
Description: LB rip-rap at reach break and sedimentation downstream				Description: Top of reach M04 (sedimentation on L)
