HOOSIC RIVER

Phase 2 Stream Geomorphic Assessment

Pownal, VT

FINAL REPORT

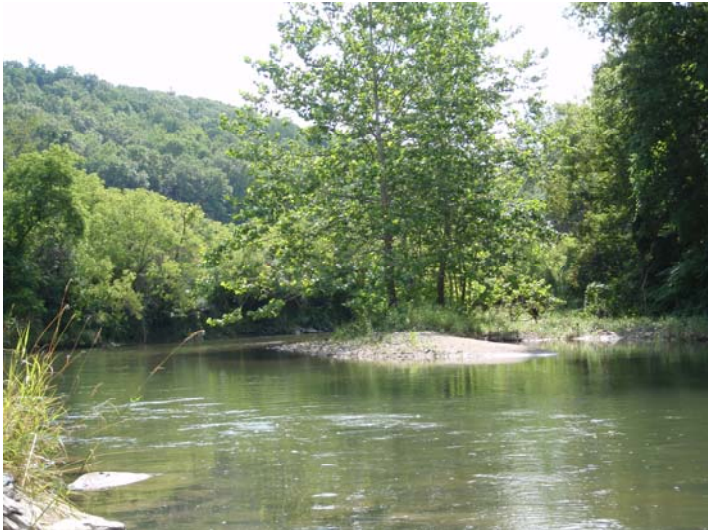
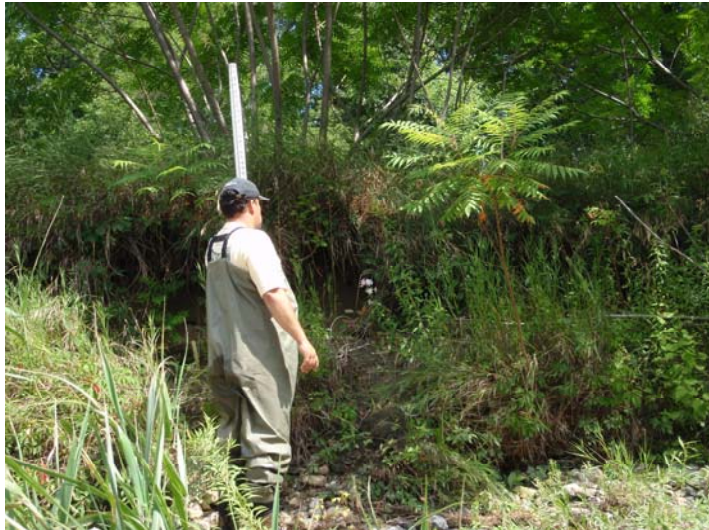
Segment ID: M04-B	Photo #: 47	Date: 8/1/08	View: US	Segment ID: M04-B	Photo #: 48	Date: 8/1/08	View: RB
Description: Bottom of vegetated PB; flood chute outlet on R				Description: 6' RB erosion across from flood chute outlet in photo 47

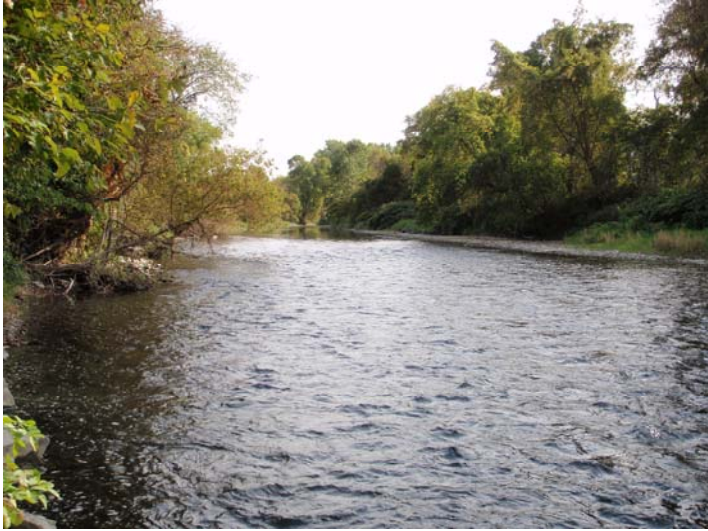
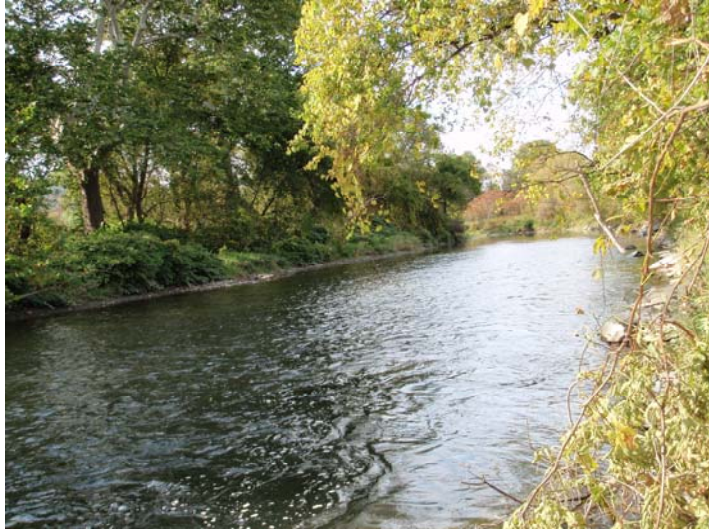
Segment ID: M04-B	Photo #: 49	Date: 9/25/08	View: US	Segment ID: M04-B	Photo #: 50	Date: 9/25/08	View: DS
Description: From M04B x-section				Description: From M04B x-section

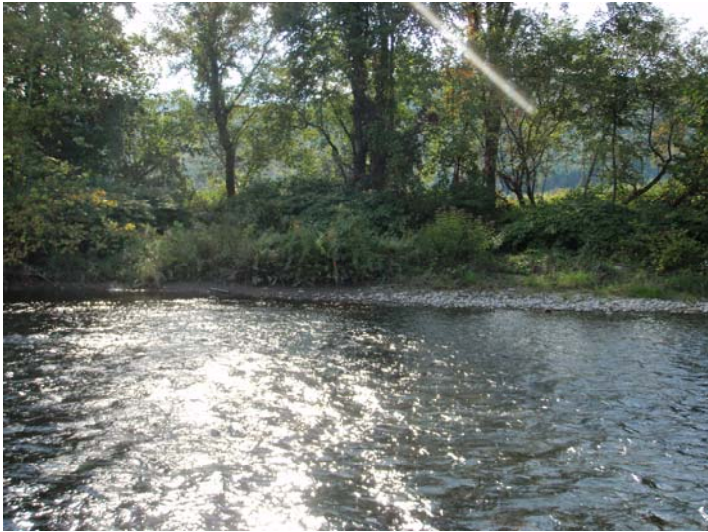
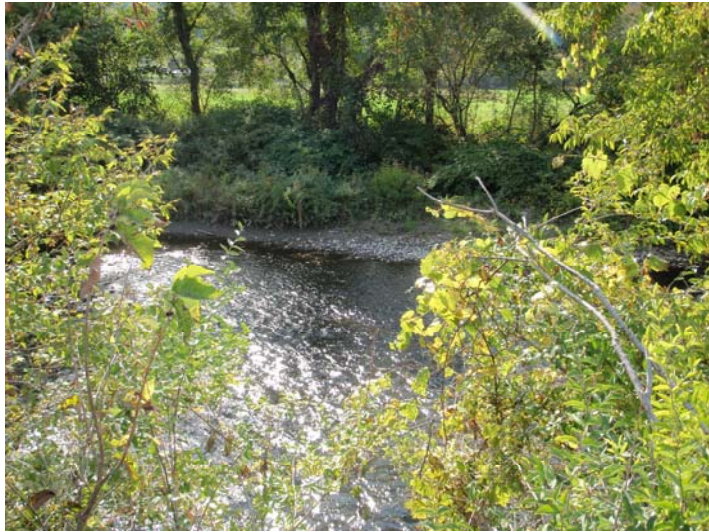
Segment ID: M04-B	Photo #: 51	Date: 9/25/08	View: LB	Segment ID: M04-B	Photo #: 52	Date: 9/25/08	View: LB
Description: M04B x-section from bottom of RB				Description: M04B x-section from top of RB (ag field in background)

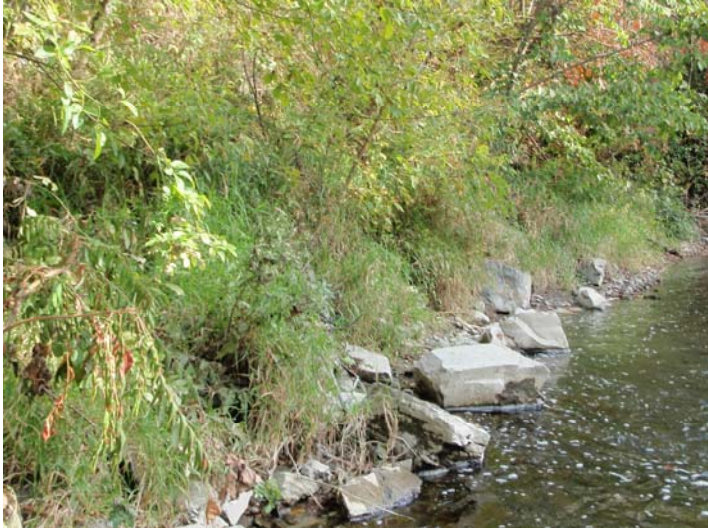
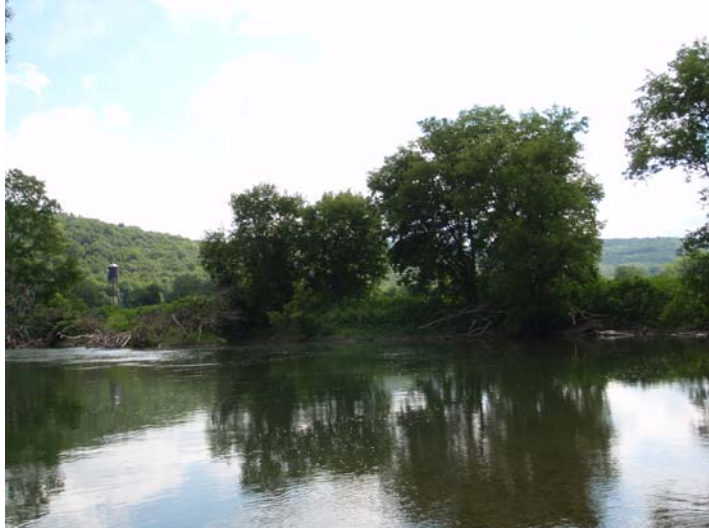
Segment ID: M04-B	Photo #: 53	Date: 9/25/08	View: US RB	Segment ID: M04-B	Photo #: 54	Date: 8/1/08	View: US LB
Description: Right bank near M04B x-section				Description: Buffer <25' US of sharp bend

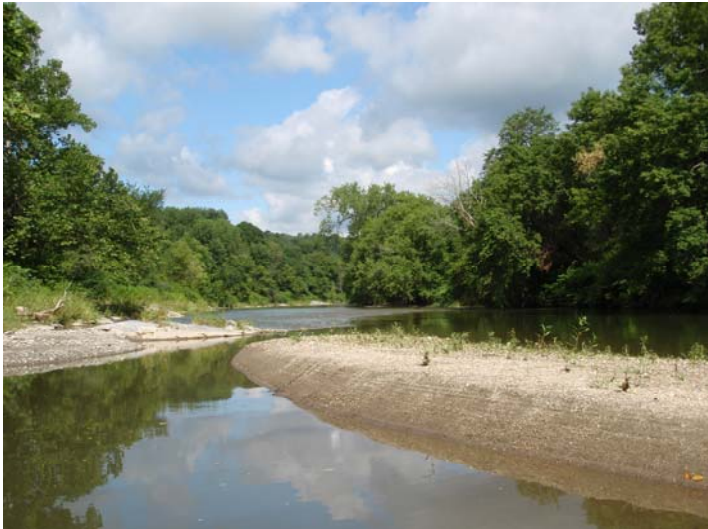
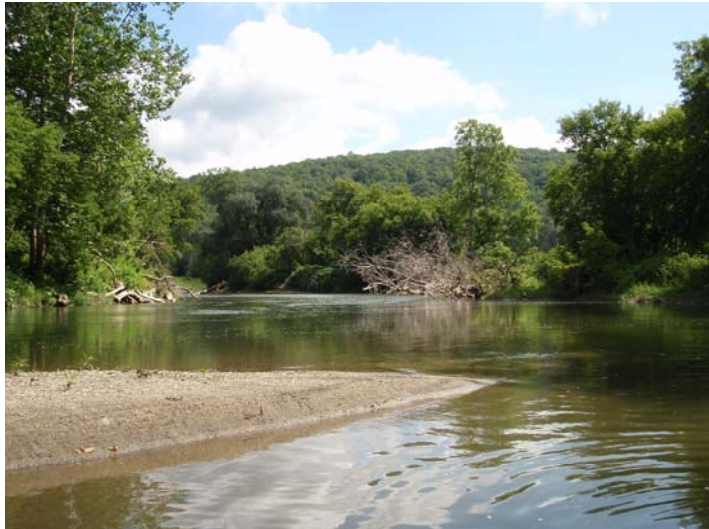
Segment ID: M04-B	Photo #: 55	Date: 8/1/08	View: DS	Segment ID: M04-B	Photo #: 56	Date: 8/1/08	View: US
Description: Bedrock (L) and deposition (foreground) at sharp bend				Description: US from sharp bend (deposition in foreground)

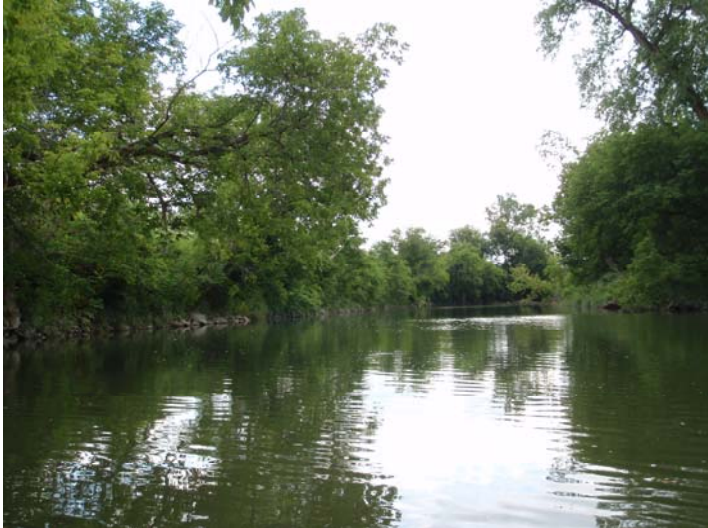
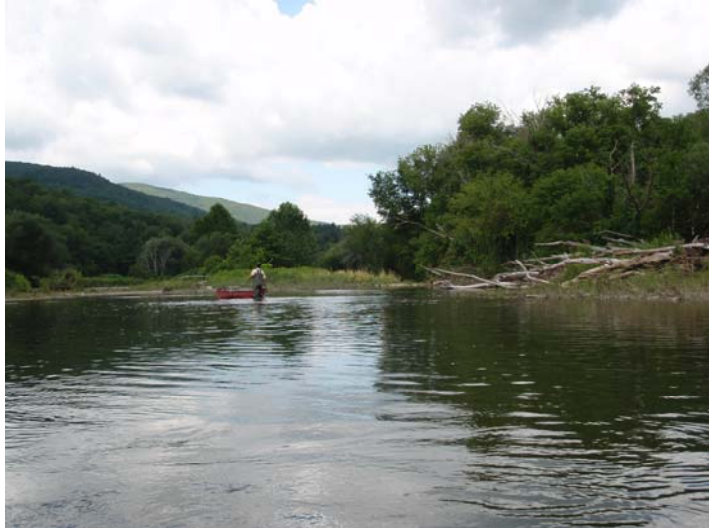
Segment ID: M04-B	Photo #: 61	Date: 8/1/08	View: US	Segment ID: M04-B	Photo #: 62	Date: 8/1/08	View: DS
Description: US from island showing buffer <25' & rip-rap along railroad				Description: Top of island

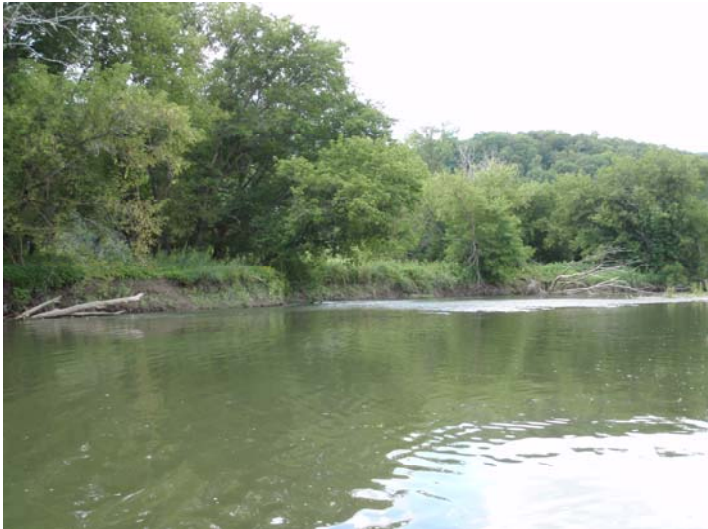
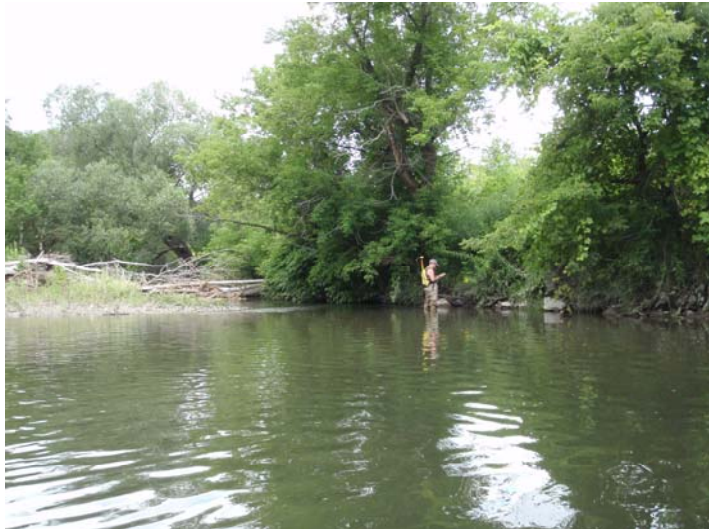
Segment ID: M04-B	Photo #: 63	Date: 8/1/08	View: DS LB	Segment ID: M04-B	Photo #: 64	Date: 8/1/08	View: DS RB
Description: Erosion on LB across from island				Description: End of buffer <25', top of island/RR channel

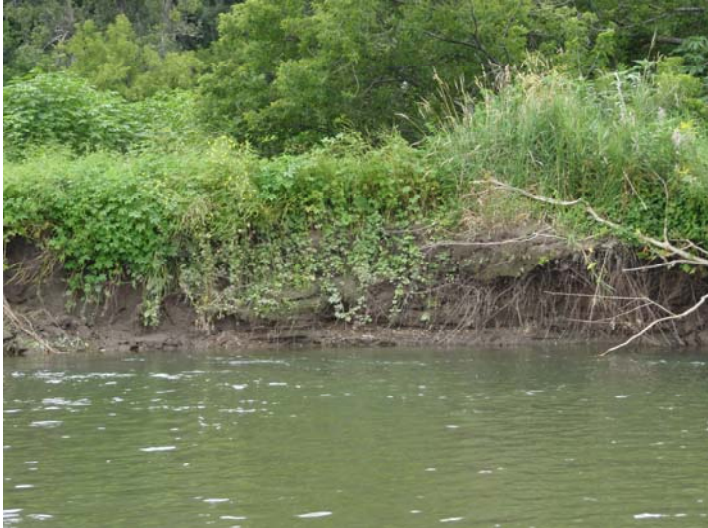
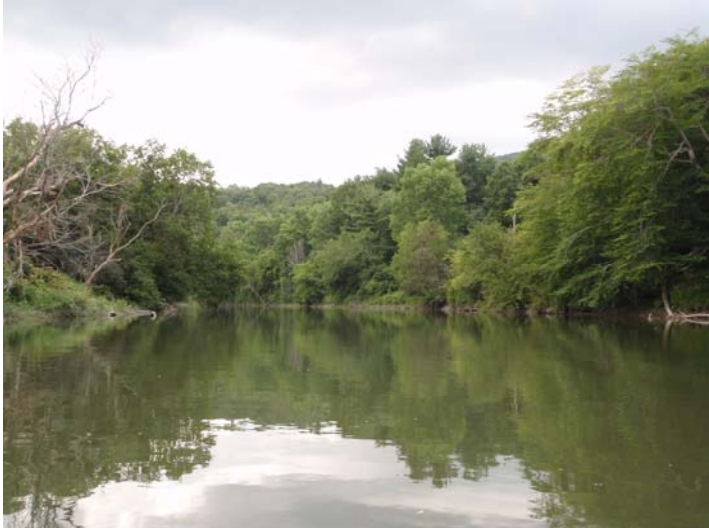
Segment ID: M04-B	Photo #: 65	Date: 8/1/08	View: LB	Segment ID: M04-A	Photo #: 66	Date: 8/1/08	View: US
Description: Second erosion site near DS end of island				Description: Bottom of reach M04 (start of M04-B just past bend)

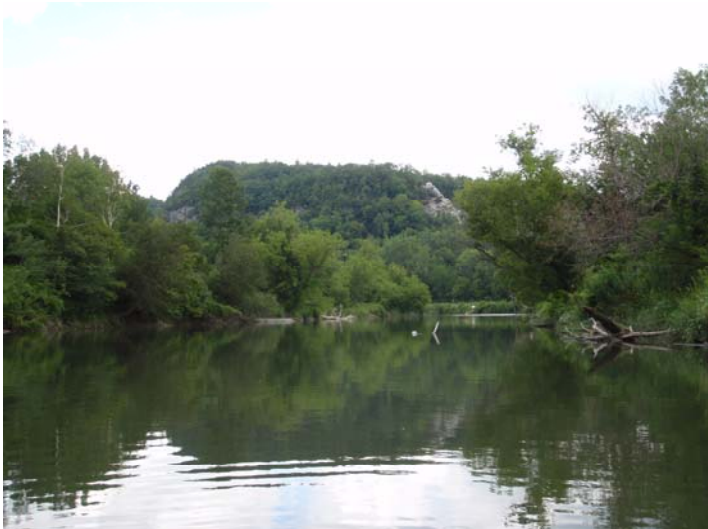
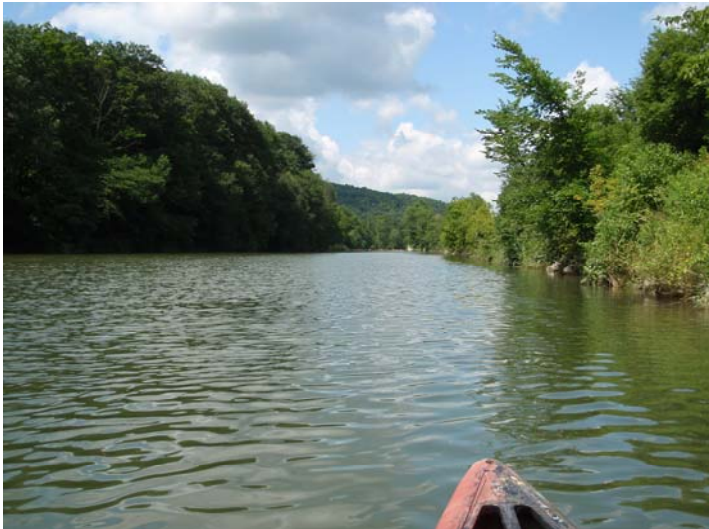
Segment ID: M03-B	Photo #: 67	Date: 8/1/08	View: DS	Segment ID: M03-B	Photo #: 68	Date: 8/1/08	View: DS
Description: Top of reach M03				Description: Towards dam

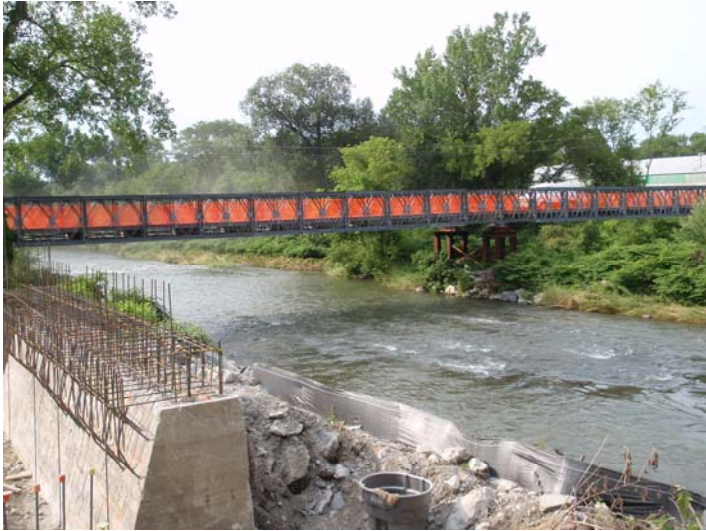
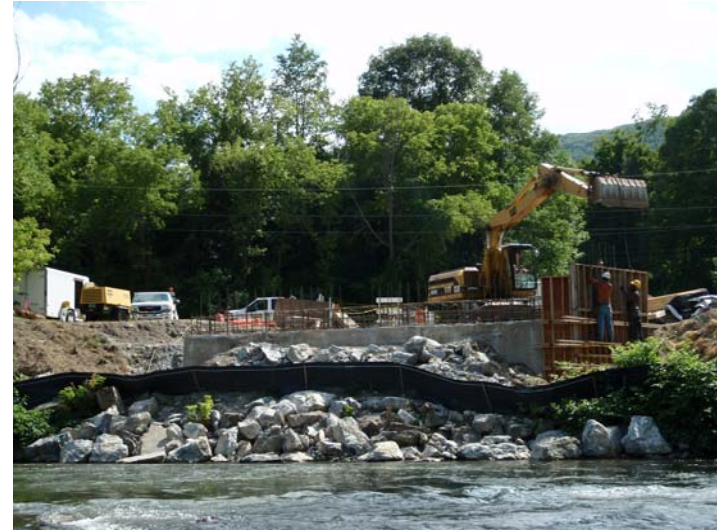
The Dean Road crossing is located in Segment M03-A, approximately 800 feet downstream of the Pownal Dam. The former Dean Road Bridge, built in 1939, was abandoned over 20 years ago (Martinez et. al, 2005). A temporary bridge approximately 100 feet downstream (pictured above) has facilitated river crossings since then. During the Phase 2 field assessment (summer and fall of 2008), the old bridge was demolished and construction began on a new bridge to take its place. By the end of September, the abutments (in foreground above) and pier were in place but the deck had not yet been constructed. Dimensions for the new bridge were obtained from plans provided by the construction workers. The temporary bridge was not assessed. The new Dean Road Bridge will have a span of 260 feet, a deck width of 30 feet, and a clearance of 16 feet. The span will be 160% of the channel width, which was measured to be 163 feet. It will be of concrete construction with steel girders and reinforcements. Already, a significant mid-channel bar greater than half of bankfull elevation is present upstream and downstream of the bridge site. Rip-rap is present on the left bank under both the temporary bridge and new bridge site (pictured above). Additional views of the temporary bridge and new bridge construction can be seen in Photos 73 through 79.

Segment ID: M03-A	Photo #: 73	Date: 7/30/08	View: DS RB	Segment ID: M03-A	Photo #: 74	Date: 8/1/08	View: LB
Description: From new bridge abutment towards temp bridge & islands				Description: New bridge construction on LB

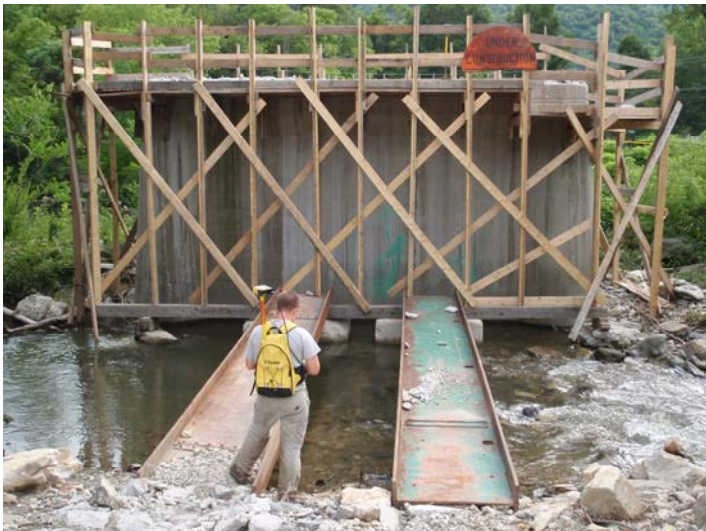
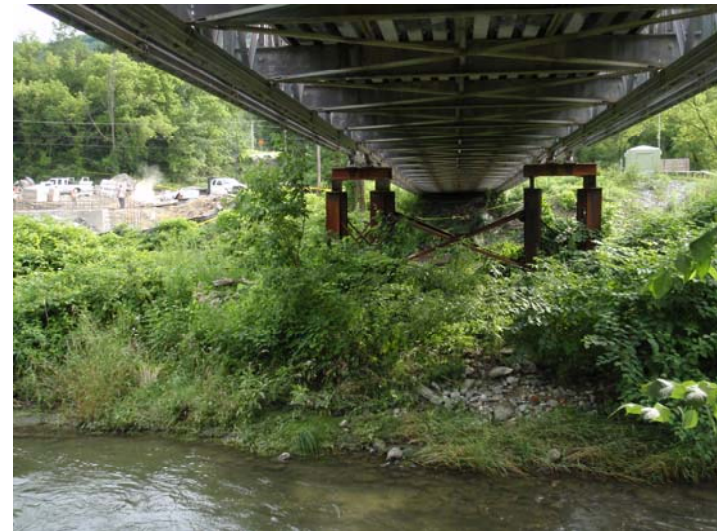
Segment ID: M03-A	Photo #: 77	Date: 7/30/08	View: US	Segment ID: M03-A	Photo #: 78	Date: 9/25/08	View: RB
Description: From temp bridge towards dam (new bridge construction on L)				Description: X-section (from LB looking over main channel to island & RB)

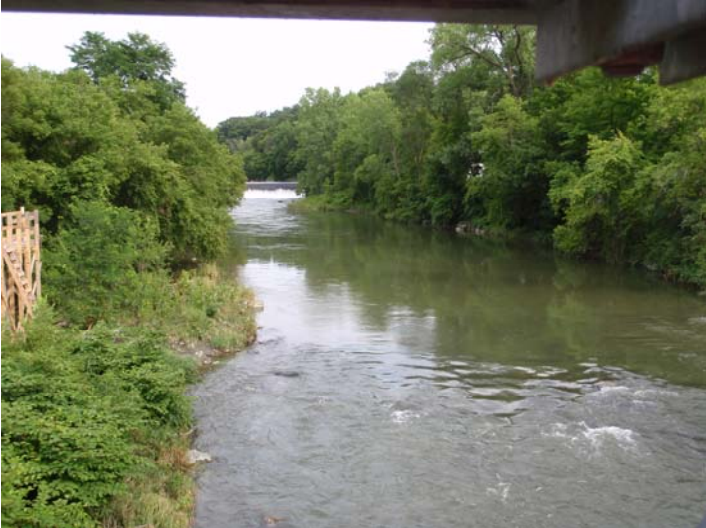
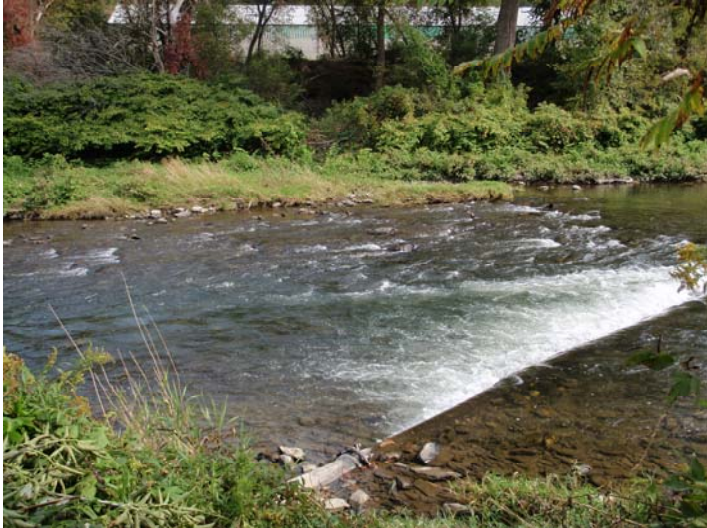
Segment ID: M03-A	Photo #: 79	Date: 9/25/08	View: US	Segment ID: M03-A	Photo #: 80	Date: 9/25/08	View: DS
Description: US from x-section LB toward temp bridge, new pier, & dam				Description: DS from x-section LB (island on R)

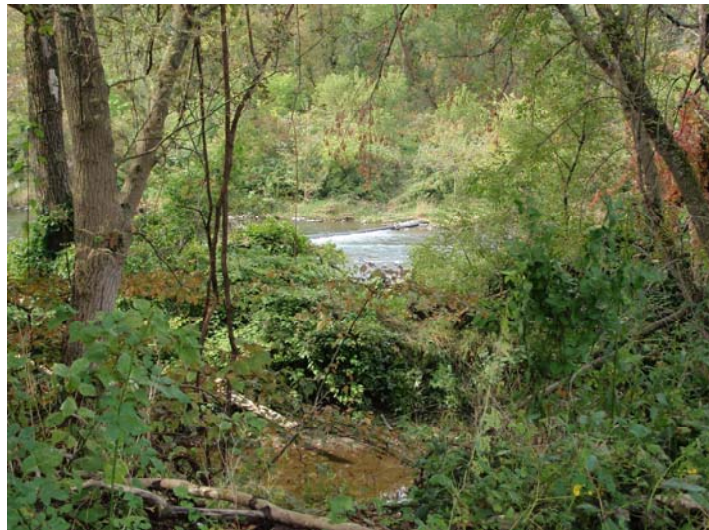
Segment ID: M03-A	Photo #: 81	Date: 8/1/08	View: LB	Segment ID: M03-A	Photo #: 82	Date: 9/25/08	View: LB
Description: Looking towards LB at x-section site; note exposed pipe				Description: X-section from top of RB looking over island; R chan. not visible

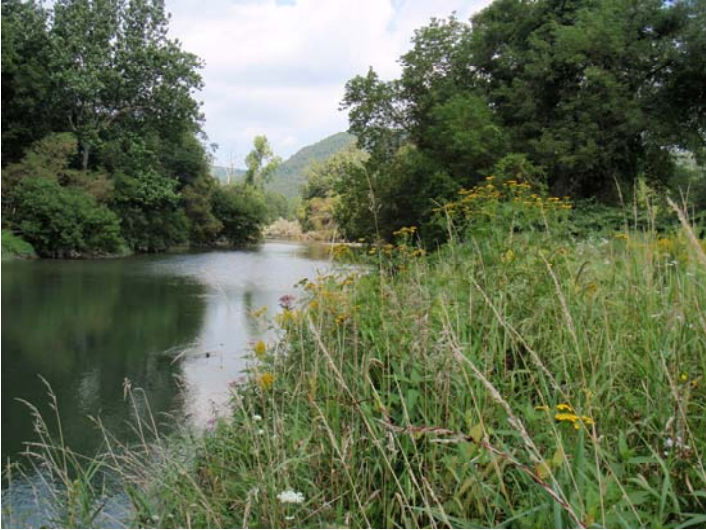
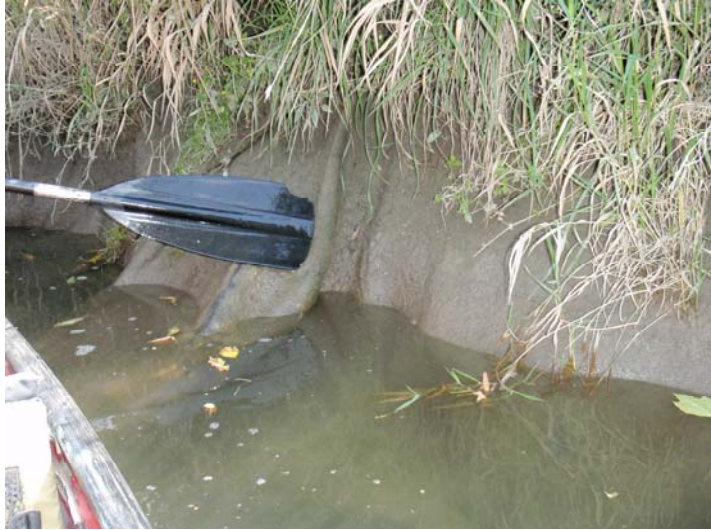
Segment ID: M02	Photo #: 101	Date: 8/18/08	View: DS RB	Segment ID: M02	Photo #: 102	Date: 8/18/08	View: RB
Description: Buffer <25' section below WWTF berm				Description: Carpet-like material on bank below buffer <25' section

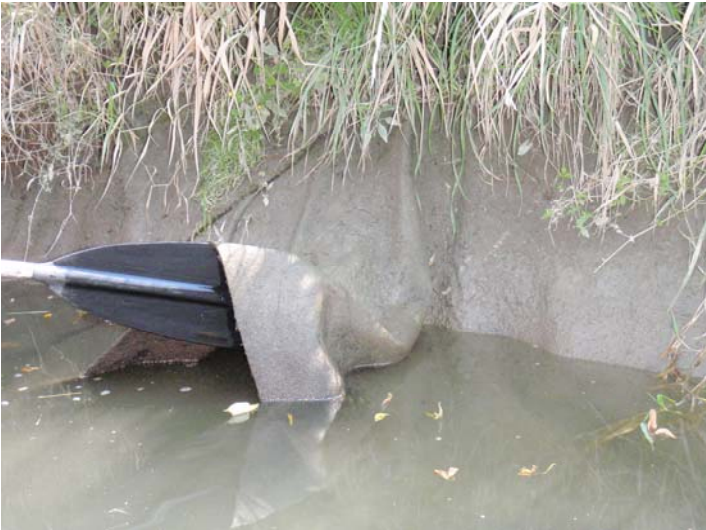
Segment ID: M02	Photo #: 103	Date: 8/18/08	View: RB	Segment ID: M02	Photo #: 104	Date: 8/18/08	View: US
Description: Carpet-like material on bank below buffer <25' section				Description: Bottom of reach M02

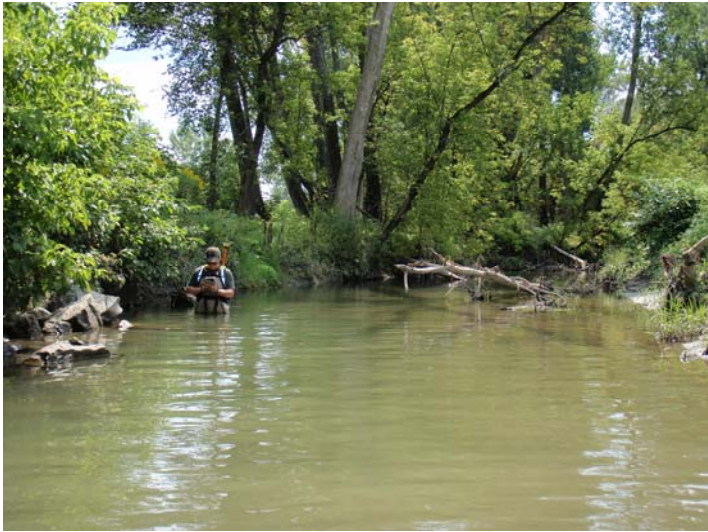
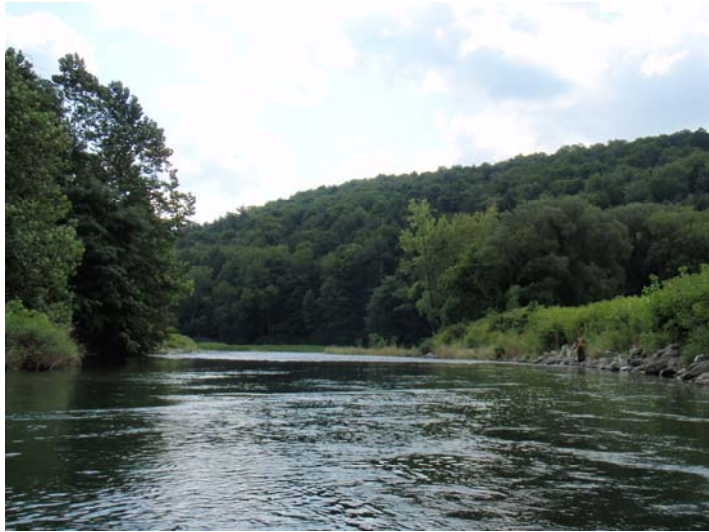
Segment ID: M01	Photo #: 107	Date: 8/18/08	View: US RB	Segment ID: M01	Photo #: 108	Date: 8/18/08	View: DS
Description: DS end of island/start of rip-rap				Description: Looking toward sharp bend (buffer <25'/rip-rap on R)

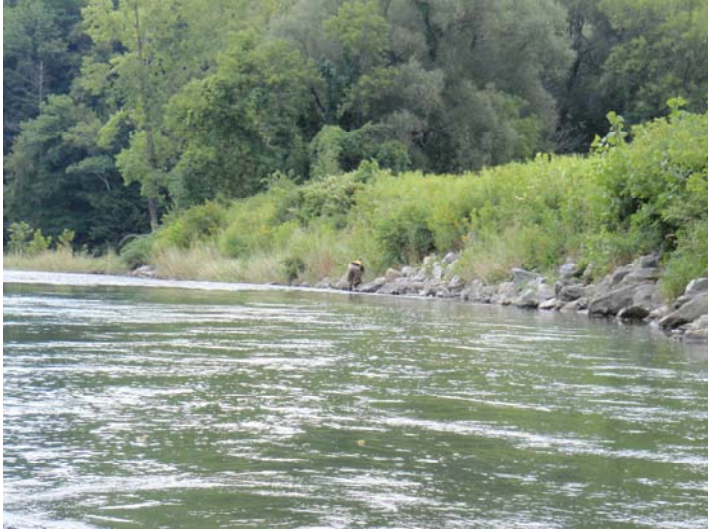
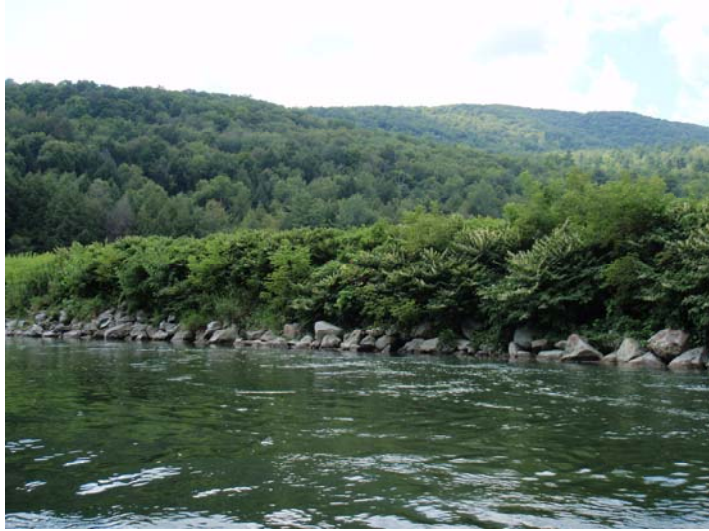
Segment ID: M01	Photo #: 109	Date: 8/18/08	View: DS RB	Segment ID: M01	Photo #: 110	Date: 8/18/08	View: RB
Description: Buffer <25'/rip-rap on RB just above bend				Description: Buffer <25'/rip-rap on RB just above bend (note invasives)

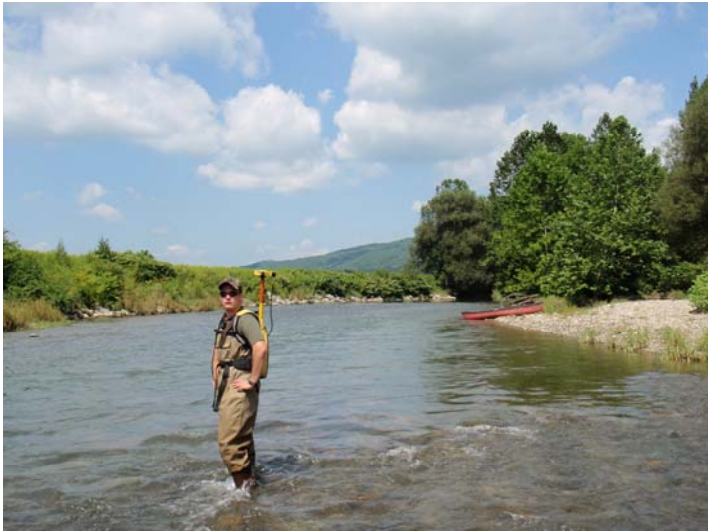
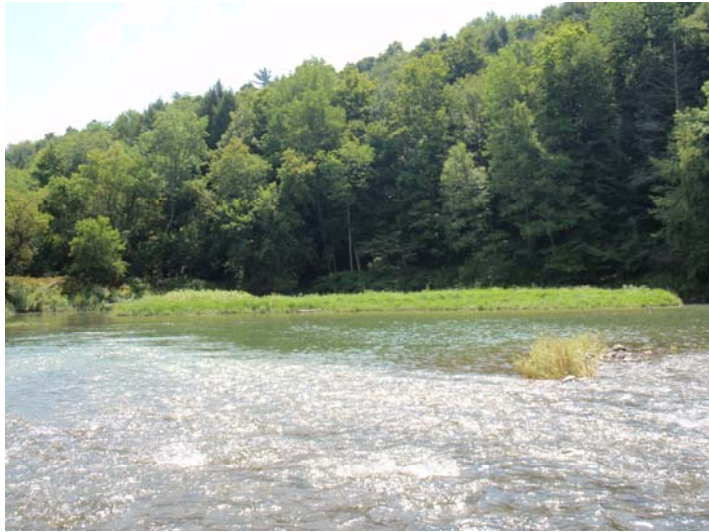
Segment ID: M01	Photo #: 111	Date: 8/18/08	View: US	Segment ID: M01	Photo #: 112	Date: 8/18/08	View: DS
Description: Just US of sharp bend				Description: Toward sharp bend and area of sedimentation

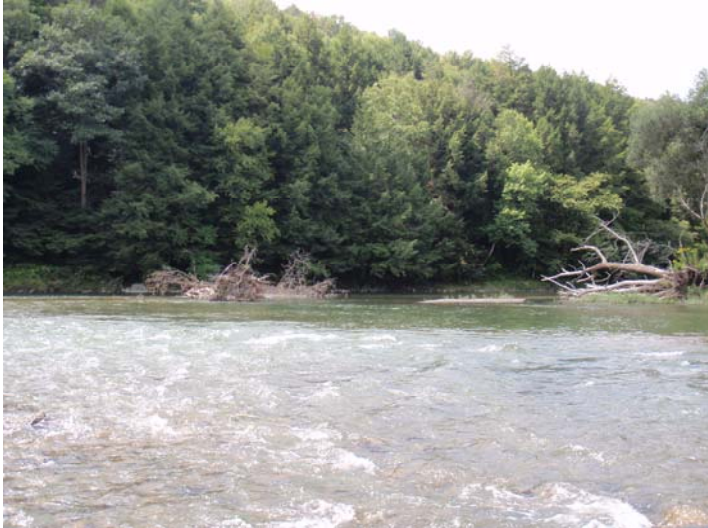
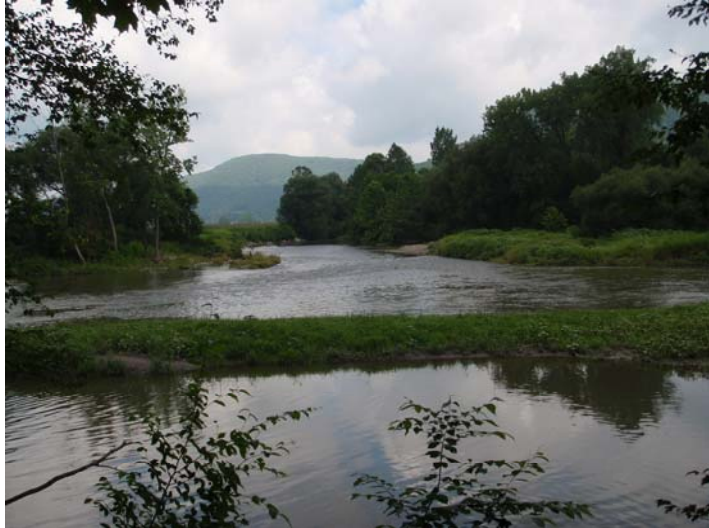
Segment ID: M01	Photo #: 113	Date: 8/18/08	View:	Segment ID: M01	Photo #: 114	Date: 7/29/08	View: US
Description: DS of sharp bend				Description: From LB at sharp bend (sedimentation in foreground)

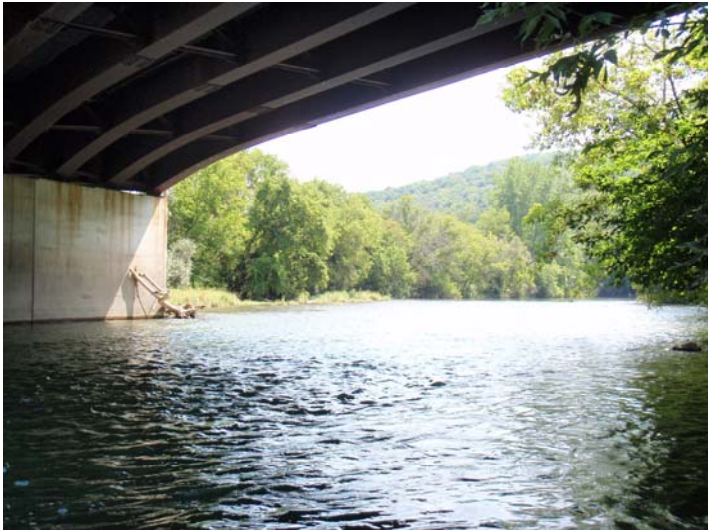
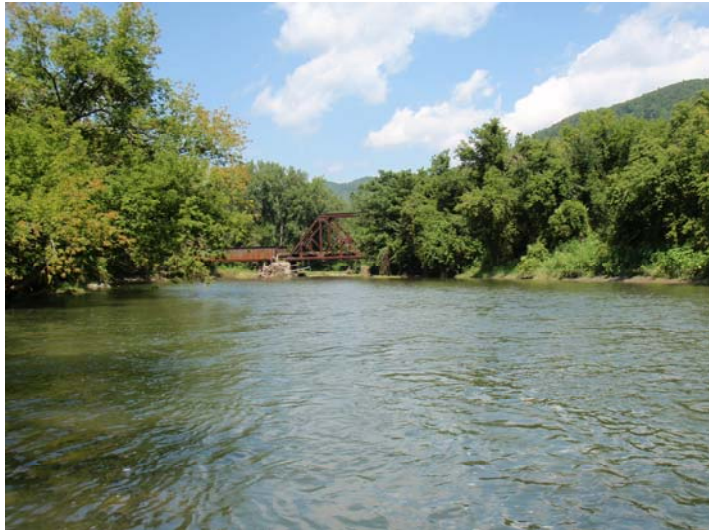
Segment ID: M01	Photo #: 125	Date: 6/25/08	View: US	Segment ID: M01	Photo #: 126	Date: 6/25/08	View: DS
Description: US from deck of Route 346 bridge				Description: DS from deck of Route 346 bridge (railroad bridge in background)

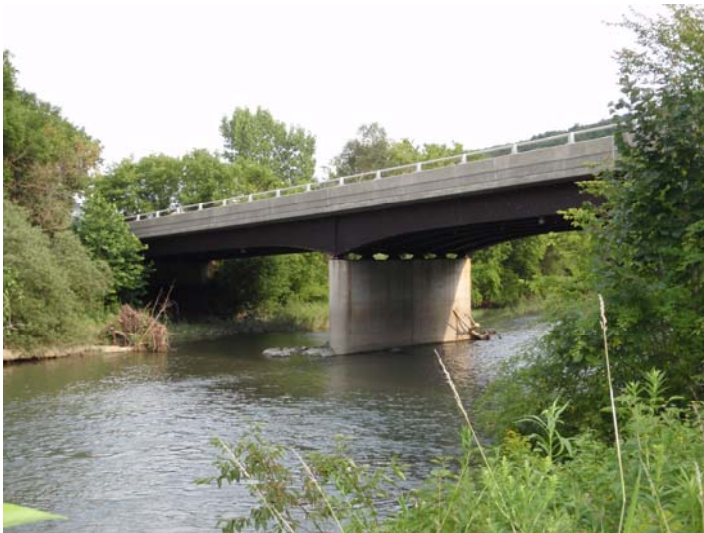
Segment ID: M01	Photo #: 127	Date: 7/30/08	View: US RB
Description: Outlet of Route 346 bridge
