Ompompanoosuc River Corridor Plan

West Fairlee to Thetford, Vermont
April 28, 2011

Bear Creek Environmental, LLC
297 East Bear Swamp Road
Middlesex, Vermont 05602

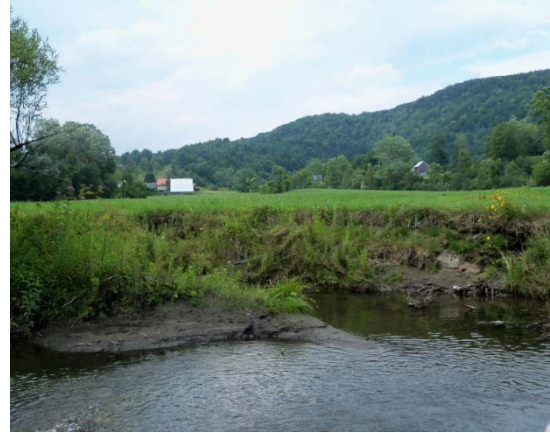
The lack of a high quality riparian buffer is one factor contributing to the “fair” habitat condition of R19-A. Approximately 80 percent of the east bank has buffer widths of less than 25 feet (Figure 4.13). The east bank has a riparian corridor that is primarily hay fields. The west bank has a dominant buffer width of greater than 100 feet and a sub-dominant buffer width of 51-100 feet. Forest is the primary land use in the western river corridor. Not surprisingly, 65 percent of the east bank has bank erosion compared with 25 percent of the west bank.

Figure 4.13 Lack of buffer along hay field

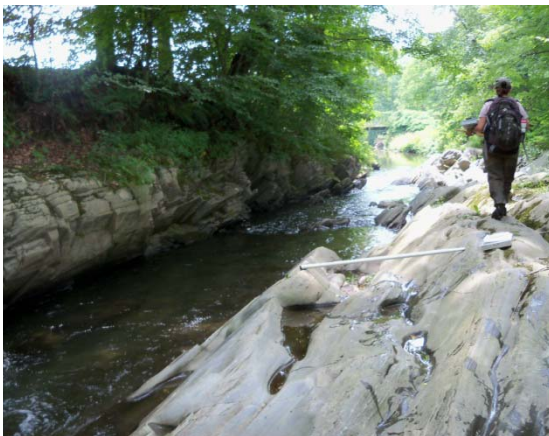
Segment R19-B is about a mile in length and contains five areas with ledge that are providing a natural grade control for the channel (Figure 4.14). The Geer dam, a man made grade control, was originally built to generate hydroelectric power (Figure 4.15). According to DEC records, the dam is no longer in service. The dam is holding back sediment, and is a barrier to aquatic organism passage. The dam has a total height of 6.7 feet, and it was 3.6 feet from the water surface to the top of the dam at the time of the Phase 2 assessment on July 28, 2010.

Figure 4.14 Ledge grade control above Geer dam

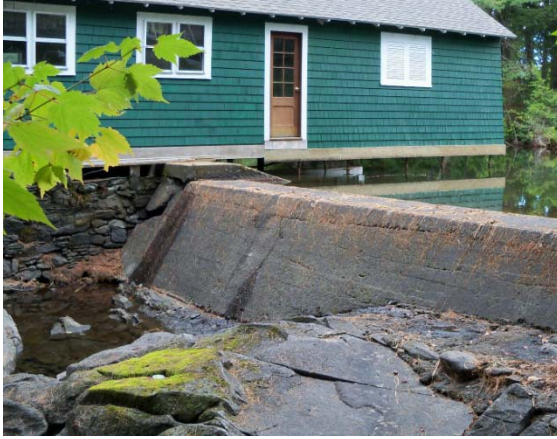
The habitat condition for RI6T2.02 is at the high end of the “fair” range. Woody debris cover was outstanding, with logs and debris jams creating cover (Figure 4.27). Coarse particulate organic material (CPOM), which is an important source of food and cover for aquatic insects, was present both in the margins and channel. There is a high percentage of silt (30%) making the substrate less suitable for the colonization by water quality sensitive species and for trout reproduction. Connectivity of habitat scored low, because of the man-made obstruction (Lake Fairlee Dam). The dam is fourteen feet in height and is creating a system obstruction for movement of fish and other aquatic species (Figures 4.28 and 4.29).

Figure 4.28 Lake Fairlee Dam from downstream

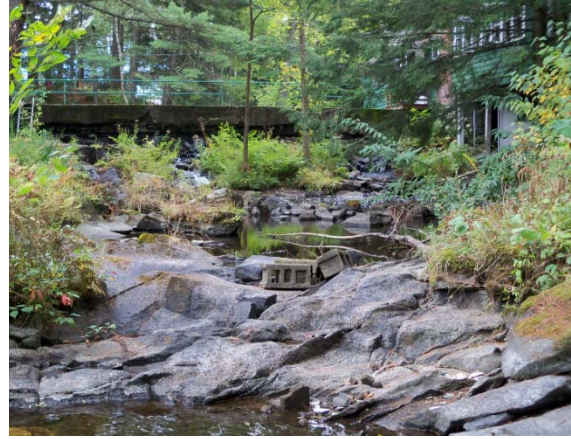
Figure 4.29 Looking upstream at natural ledge & Dam

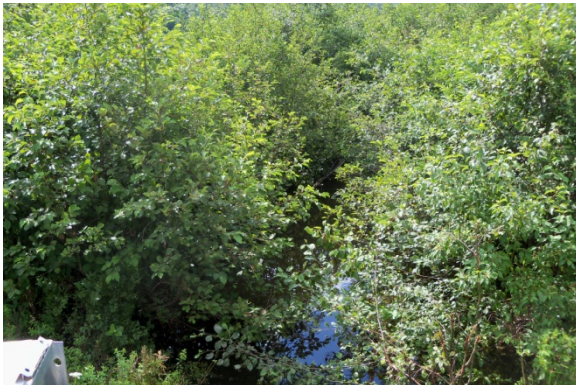
RI6T2.04-A is a wetland from upstream of Lake Fairlee to above the Route 244 crossing (Figure 4.30). The upper end of the segment, below King Hill Road, had a defined channel (Figure 4.31), but access to the stream was not possible because of lack of landowner permission for access. The entire length of the segment from Lake Fairlee to King Hill Road is about 1,760 feet. The dominant buffer width on each side is greater than 100 feet; however, there are areas with buffers less than 100 feet in the vicinity of the road crossing.

Figure 4.30 Wetland below Route 244 crossing

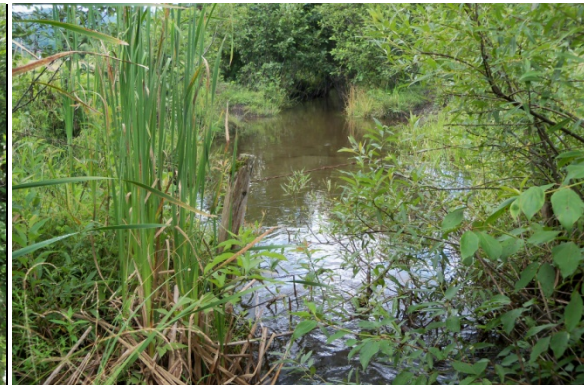
Figure 4.31 Below Kings Hill Road in RI6T2.04

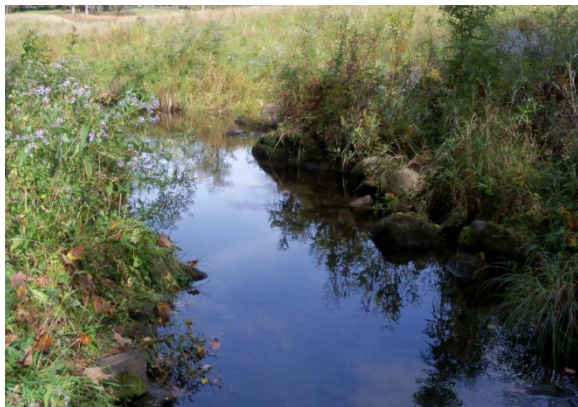
A full Phase 2 assessment of the most upstream portion of R16T2.05 (segment E) could not be completed because of lack of landowner permission. Segment E is about 1,500 feet in length. Riprap is evident along both sides of the channel at the downstream end; the lower 230 feet of the segment has been straightened (Figure 4.40). The upper 550 feet of the segment has also been straightened, and what appears to be an old mill building is located along the east bank in the most upstream part of the segment (Figure 4.41). The channel in most of this segment flows through a horse pasture with nearly 75 percent of the channel length having buffers less than 25 feet in width.

Figure 4.40 Straightened channel in R16T2.05-E

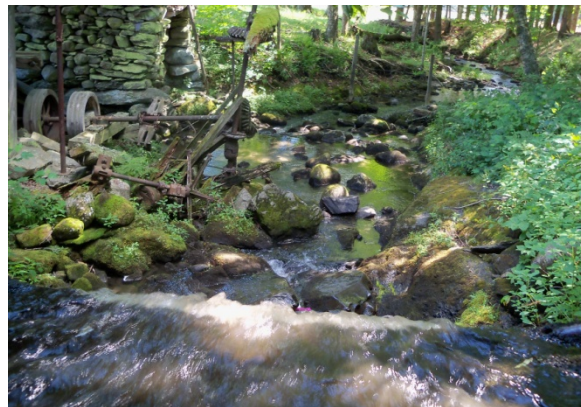
Figure 4.41 Old mill building on east bank

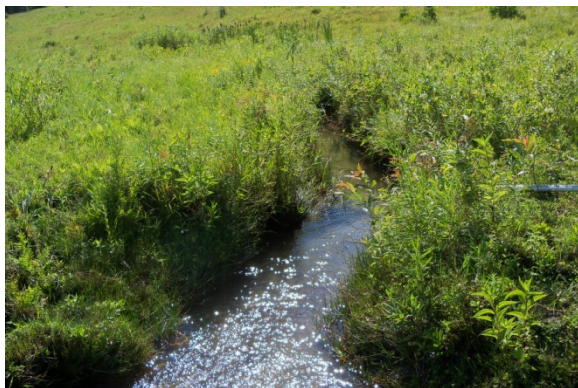
The most downstream segment, R16T2.06-A, starts at Marsh Hill Road and goes upstream about one-half mile through a horse pasture with buffers less than 25 feet along the entire length (Figure 4.42). This segment likely was a wetland historically that has been altered for agricultural use. The dominant bedform is riffle-pool, although there are some areas with plane bed features that lack defined pools. The dominant bed substrate is gravel. Silt and clay are cohesive bank material on the lower bank, while the upper bank is non-cohesive and consists primarily of sand. The channel has a reference and existing stream type of “E”, but lacks the high sinuosity that is typical of this type of channel. The channel currently has a straightened planform either due to active head cuts (Figure 4.43) or historic and present channel management practices, such as straightening and armoring or dredging. Six active head cuts were mapped during the Phase 2 assessment, which is a sign of active incision. The overall geomorphic condition is at the low end of the “fair” range. In addition to having extreme active incision through the presence of numerous head cuts, the channel is actively widening due to lack of floodplain access. There is bank erosion along 60 percent of both banks. Horses are adding to the bank erosion, by causing localized disturbance at animal fords (Figures 4.44 and 4.45).

Figure 4.42 Low sinuosity in segment R16T2.06-A

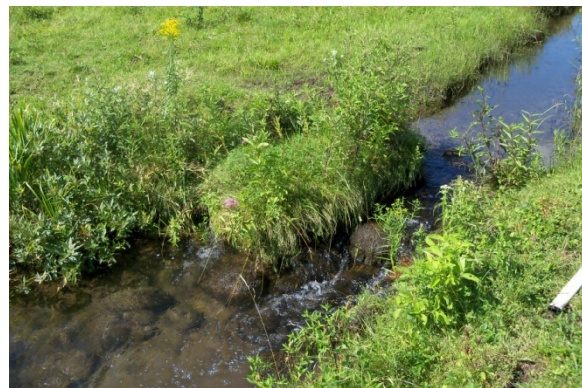
Figure 4.43 Head cut or knickpoint

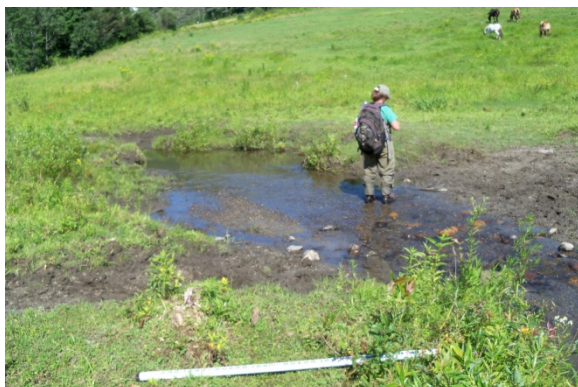
Figure 4.44 Disturbed soil at animal ford

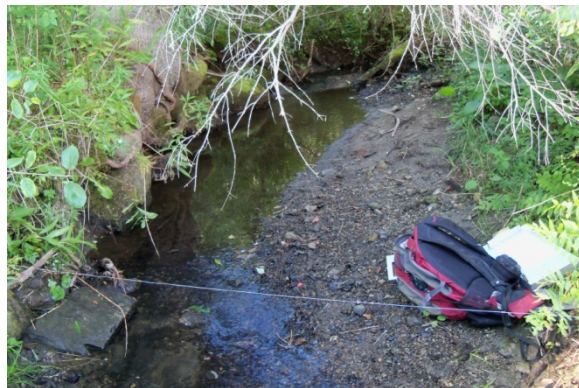
Wetlands are extensive in the riparian buffer and corridor (Figure 4.46). The high quality buffers are contributing to the habitat condition of "good", although the habitat score was at the low end of the range. The dominant buffer width on each side of the channel is 100 feet, and there is less than 200 feet of channel length with buffers less than 25 feet on the east bank. The subdominant buffer width on the west bank is 26-50 feet. All of the habitat parameters were rated in the good category with the exception of Channel Morphology. Channel morphology was rated fair because of the channel straightening (Figure 4.47) and the limited floodplain access.

Figure 4.47 Channel straightening and bank armoring

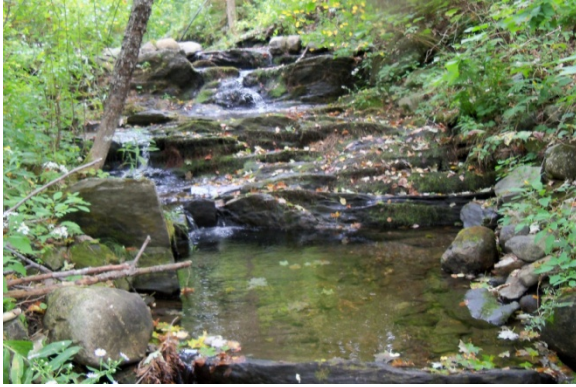
Figure 4.48 Waterfall in R16T2.06-C

The habitat condition of R16T2.06-C is also “good”, although the score is at the low end of the range. All of habitat parameters scored in the good category with the exception of connectivity. The waterfall and the Godfrey Road culvert are likely an obstruction for some aquatic species. The Godfrey Road culvert is discussed in further detail in sections 4.5 and 6.2. In general, the water depth in segment C is shallow. There are frequent pools, but none of the pools exceeded two feet in depth at the time of the assessment.

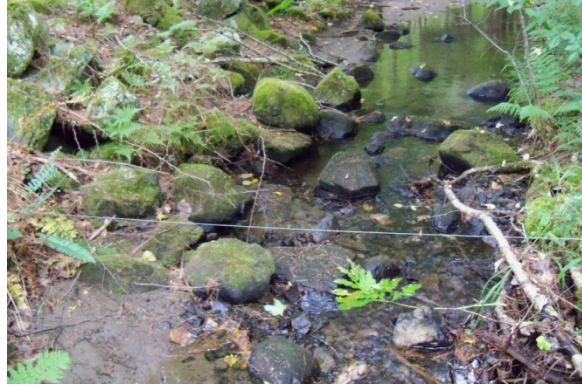
Segment R16T2.06-C starts at the pedestrian bridge, located just downstream of the Godfrey Road crossing, and continues upstream just under one-half mile to a wetland. The geomorphic and habitat setting of segment C is much different than the "E" channels in segments A and B. There are multiple grade controls in R16T2.06-C, including three areas of ledge and a waterfall below Godfrey Road that is shown in Figure 4.48. The valley is still very broad. A cross section measured in the middle of the reach indicates the channel is not incised. Figure 4.49 shows the channel at the cross section location in segment C. Both the existing and reference stream type is "C". The channel is in the first stage of the channel evolution model (F-I or stable). The geomorphic condition is "good".

Figure 4.49 Typical channel in R16T2.06-C

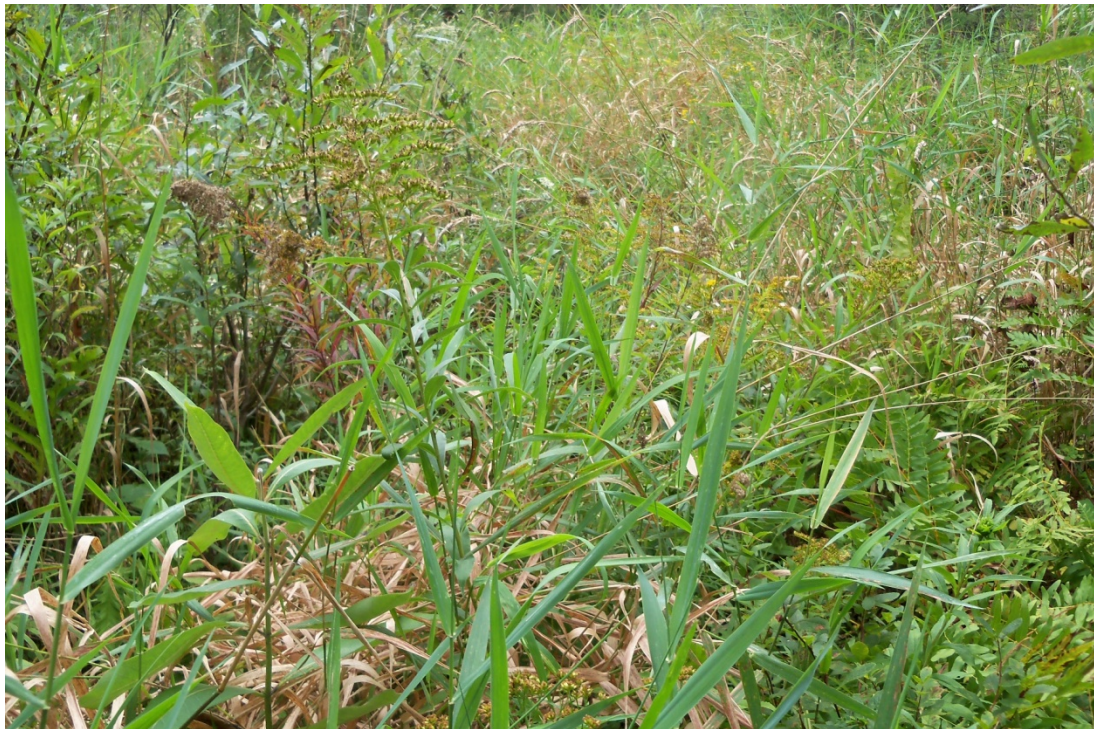
A full Phase 2 assessment of R16T2.06-D, the most upstream segment of Blood Brook, could not be completed because the channel is small and in a wetland setting (Figure 4.50). The valley is very wide and the buffers are expansive.

Figure 4.50 Wetland in segment R16T2.06-D

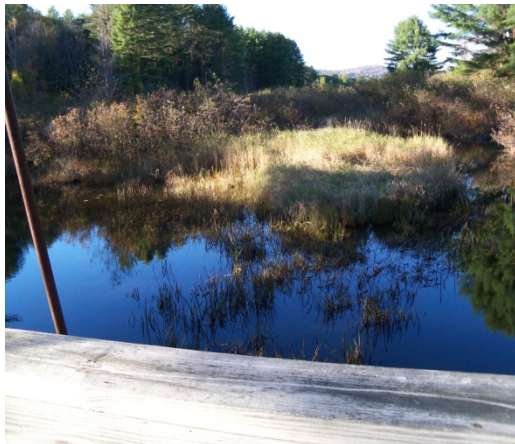
Figure 4.51 Wetland upstream of Lake Fairlee

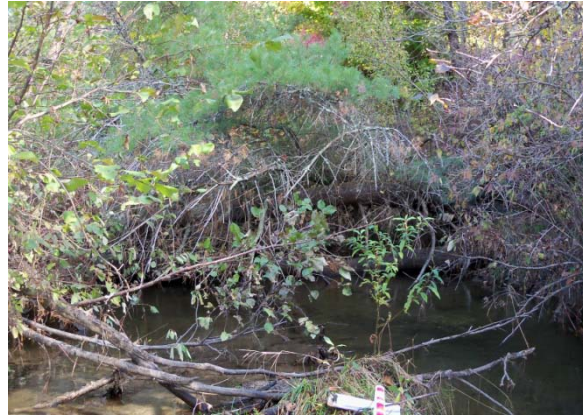
Figure 4.54 Large woody debris cover

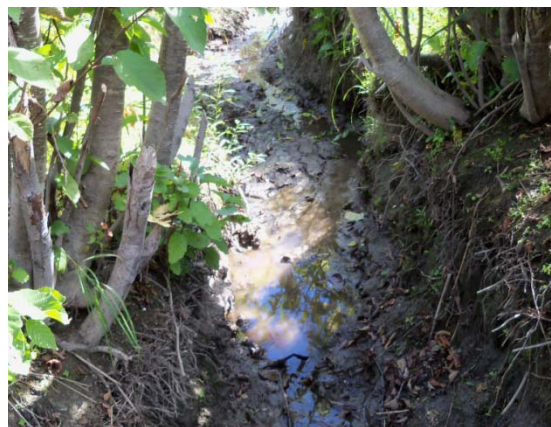
Figure 4.57 Incised drainage swale

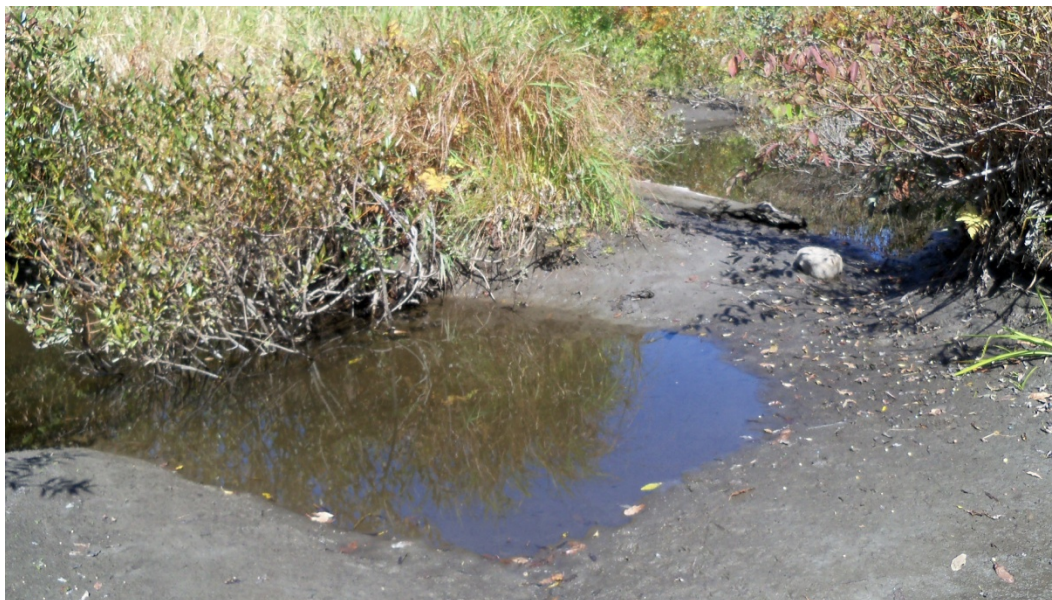
The active geomorphic processes occurring in R16T2.03S1.02-A is also impacting habitat. The overall habitat condition is “fair”. There are few stable undercut banks, most likely due to the extreme bank erosion and the lack of large woody vegetation along the near bank. Woody debris cover is in the fair category due to lack of large woody debris. Most of the woody material is small, and coarse particulate material is in good supply and is present in the channel and along the margins. About one-third of the reach has buffers less than 25 feet in width. Hay fields are the dominant corridor land use on the east side of the channel, while wetland is dominant in the buffer on the west side. The subdominant land use on the west side is pasture. Wetlands in the corridor on the west side are providing out of channel refuge areas (such as the shown in Figure 4.60) that provide safety for aquatic species during high flow events.

Figure 4.60 High flow refuge area in wetland

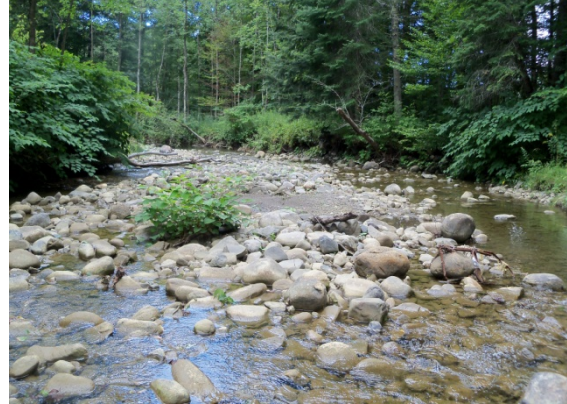
Despite the active geomorphic adjustment, the habitat scored at the high end of the “fair” range. The habitat parameter Scour and Deposition Features was mixed in terms of scoring. Scour (pool habitat) was ranked high, while deposition (bars) was ranked low. The frequency and diversity of pool sizes are providing excellent deep water habitat cover for fish. Boulders and large woody debris in the pools are contributing to pool cover (Figure 4.64). Large depositional features, such as mid channel bars, are present in the channel (Figure 4.65). Fine deposition in the channel may clog the voids between cobbles and coarse gravel, thereby impairing spawning habitat for trout, shelter for young trout, and habitat for aquatic insects. The dominant buffer width is greater than 100 feet on both sides, and trees on the near bank are providing organic material that is an important source of food for aquatic insects and other aquatic species. There are numerous undercut banks with suitable water depths to provide bank cover for fish (4.66).

Figure 4.65 Large depositional features reduce habitat

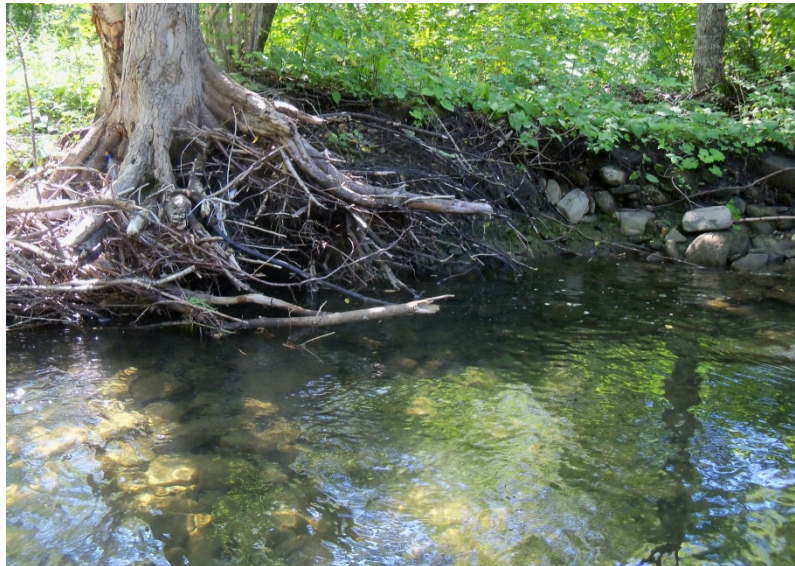
Figure 4.66 Tree root is providing a stable undercut bank

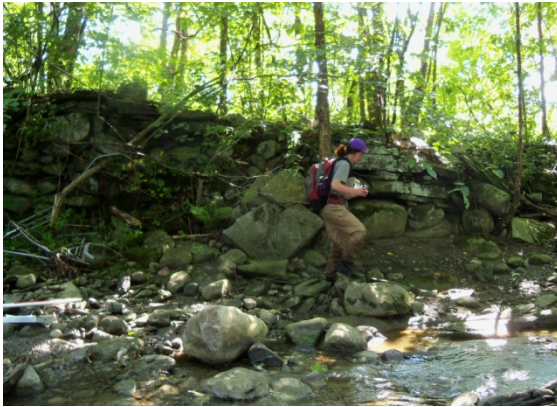
Figure 4.67 Rock wall or old abutment on east bank

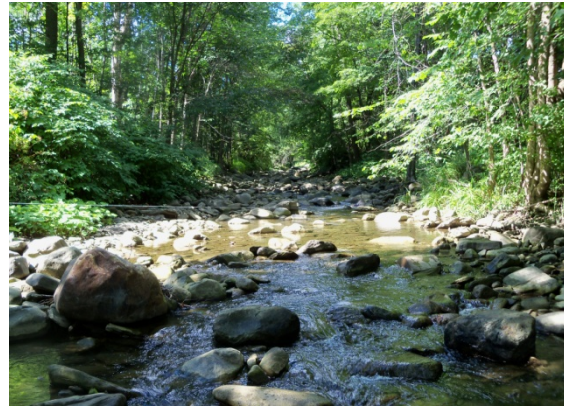
Segment B on the lowest reach of Schoolhouse Brook begins just downstream of the Route 113 crossing and continues upstream 625 feet. The segment has been extensively straightened and there is large rock or hard bank armoring present along 245 feet of the west bank and 155 feet of the east bank. There is some evidence of berms along the east bank that are likely from windrowing. The channel was likely dredged following a major flood event and the material was placed along the east bank to protect adjacent yards and buildings off of Route 113. The channel is encroached upon by Back Street on the west bank. A rock wall or old abutment is also located on the east bank (Figure 4.67). Back Street sits high above the channel, and it is possible that there was some placement of fill on the west bank that is associated with the residential development. The channel has incised resulting in a stream type departure from a reference “C” channel to a “B” channel with reduced floodplain. The geomorphic condition is “fair”. The channel is in the incised stage of the channel evolution model, and appears to be locked in place by large boulders along the bank toe and berms. There are very few depositional features in segment B; the channel has become a sediment transport reach because of the straightened planform (Figure 4.68). There are two channel spanning ledge grade control areas that guard against future channel incision.

Figure 4.68 Straightened platform

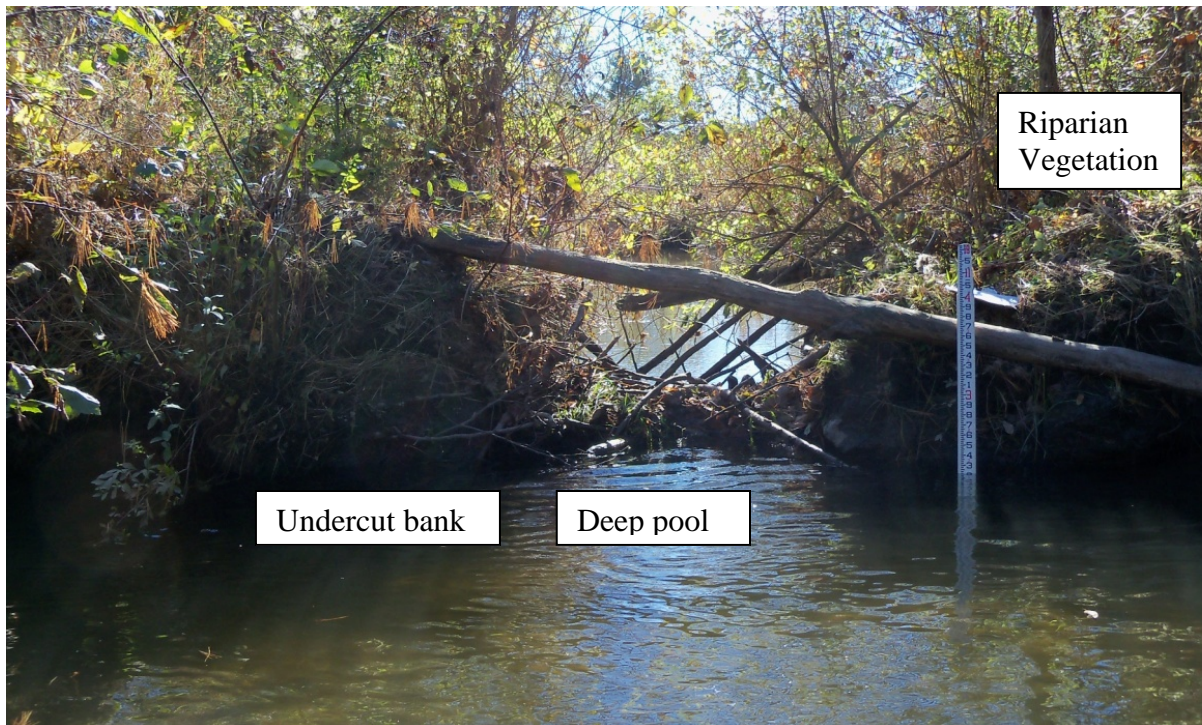
Figure 4.72. Segment RI6T2.03SI.01-B on Middle Brook had high quality habitat including excellent woody debris cover, deep pools, undercut banks, and trees in the buffer.

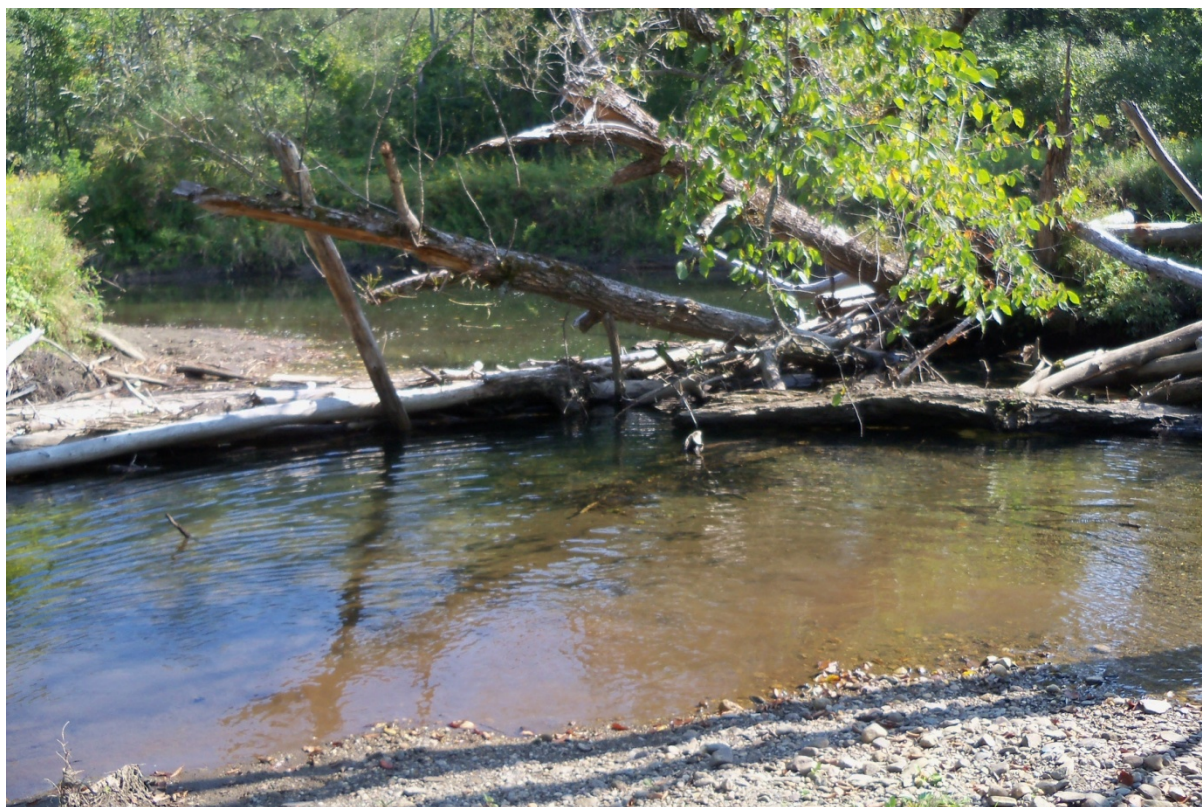
Figure 4.73. Large woody debris creating cover in Reach 17

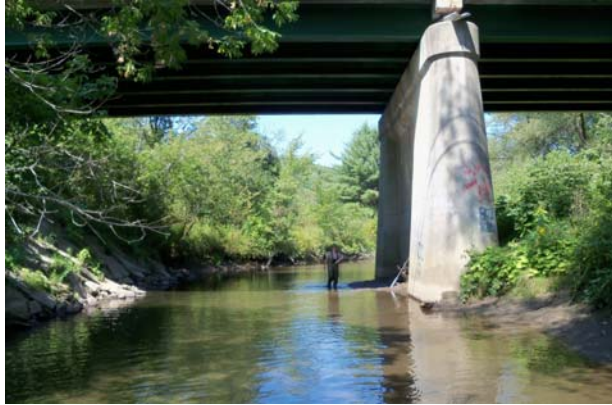
The Route 244 Bridge in R17 of the main stem has a span that is 148 percent of the bankfull channel width; however, a center pier is causing alignment problems and sediment accumulation on the east side of the channel (Figure 4.75). This aggradation is reducing the effective width to pass sediment and water during a bankfull event. The bridge is not likely to be replaced in the near future because of its size (span is 81 feet). The Route 244 Bridge has been assigned a priority of moderate rather than NR (not recommended at this time) to acknowledge this issue; it is recommended that geomorphic compatibility be considered if the bridge were to be replaced in the future.

Figure 4.75. Center pier of Route 244 Bridge

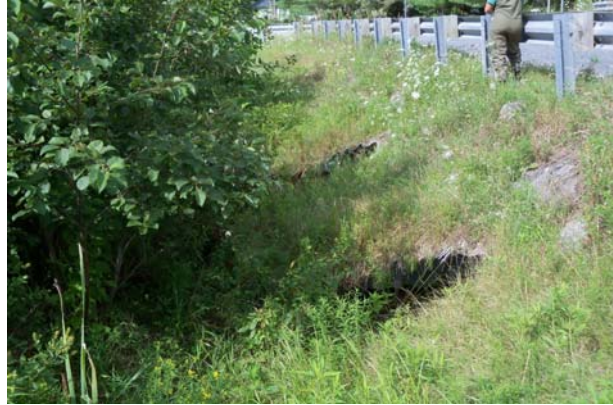
The Route 244 crossing on Blood Brook consists of three small culverts ranging between 6 and 6.5 feet in width (Figure 4.76). The culvert bottoms are steel corrugated pipe; the pipes do not have a natural stream bed with sediment and are reducing aquatic organism passage. For this reason the Route 244 crossing was assigned a moderate priority for replacement.

Figure 4.76. Three culverts at Route 244 Crossing
