**Brewster River Phase 1 & 2
Stream Geomorphic Assessment Summary
March 15, 2013**

Fitzgerald Environmental Associates, LLC.
18 Severance Green, Suite 203
Colchester, VT 05446

Lamoille County Planning Commission
PO Box 1637
52 Portland Street, Second Floor
Morrisville, VT 05661

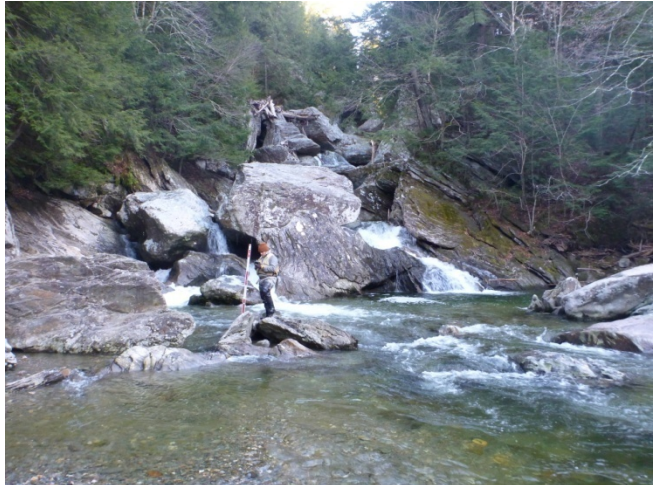
Figure 9: Brewster River Gorge in M04

Most of the reaches found along the mainstem of the Lower Brewster River are C-type streams under reference conditions, with the exception of Reaches M02, M03, M04, M08, M13 and M14. M02-M04 are found in a confined valley setting with gorges and numerous grade controls where the Brewster River descends through an area with shallow underlying bedrock (Hazens Notch schist formation). Moving upslope, the reaches of the Upper Brewster River begin to enter confined valley settings at Reach M16. The upper Brewster River is dominated by sediment transport streams of A and B types. The tributary reaches generally follow the similar pattern of unconfined C-type reaches in the lower reaches transitioning to confined A and B-type in the headwaters.

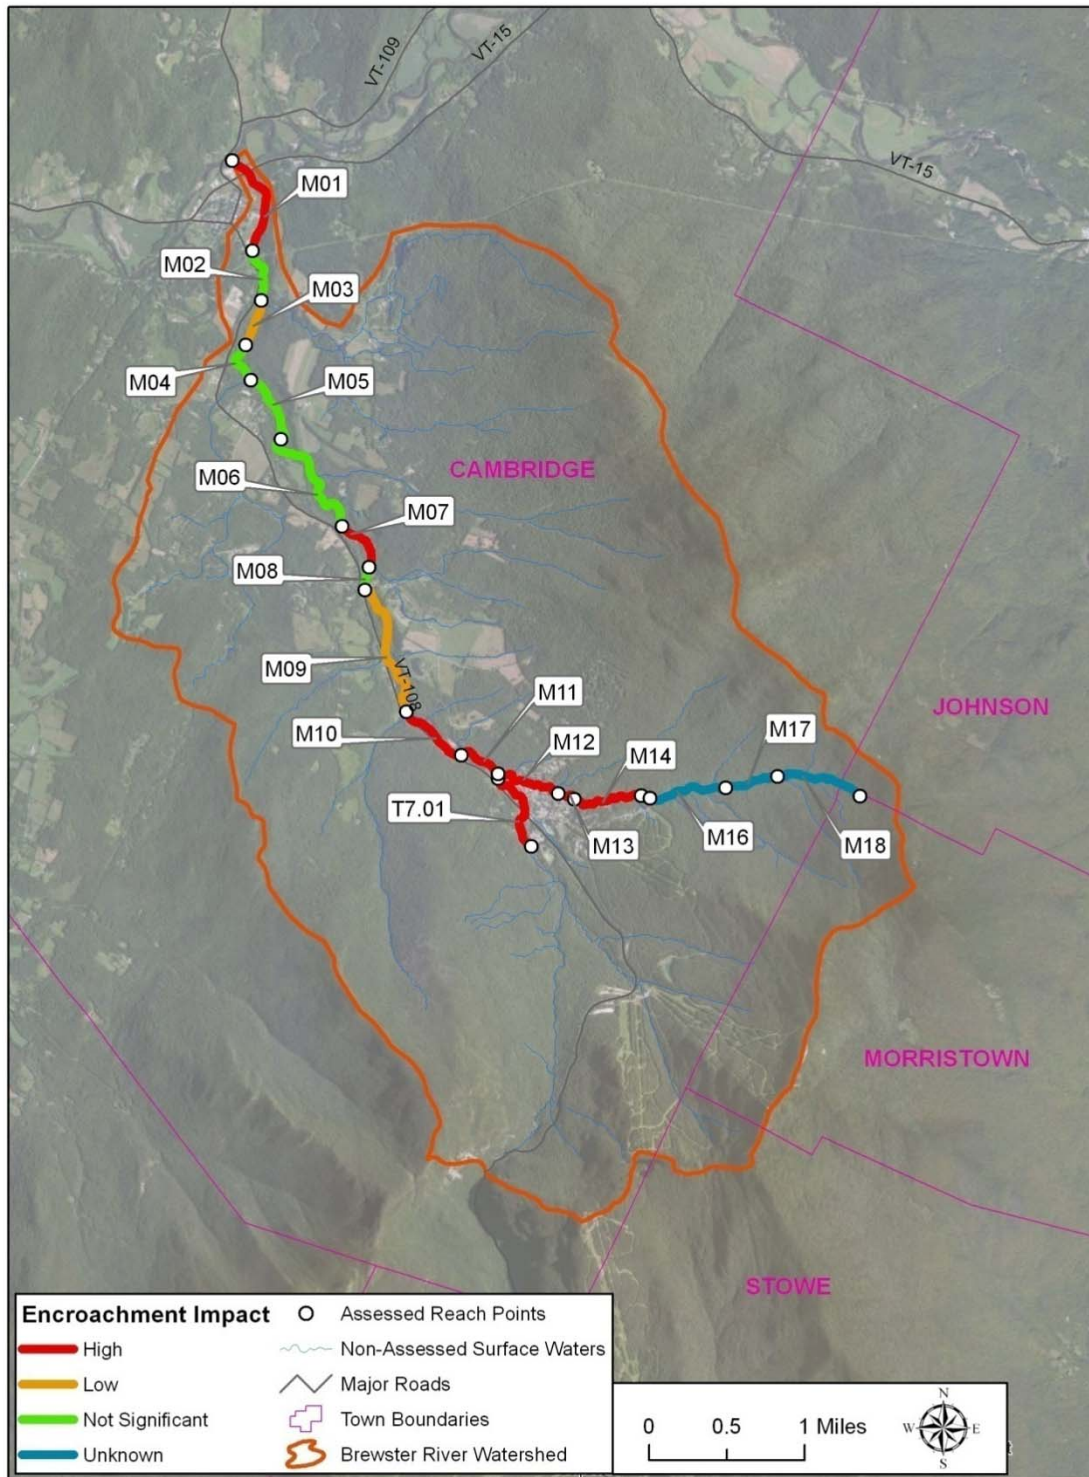
Figure 13: Impacts from corridor encroachments in the Brewster River watershed

Following the Phase 1 protocol, any berms, roads, driveways, railroads and/or improved paths found within the stream corridor were indexed using the FIT. These areas were identified using 2011 Bing aerial imagery, and were confirmed and/or refined during the field observations. Figure 13 depicts the reaches where encroachment has significantly impacted the stream corridor, with ratings based on the percentage of the reach length that was impacted as indicated in Table 10. Impacts classified as "High" from corridor encroachment were found in reaches M01, M07, M10-M14 and T7.01. Impacts classified as "Low" were found in reaches M03 and M09.

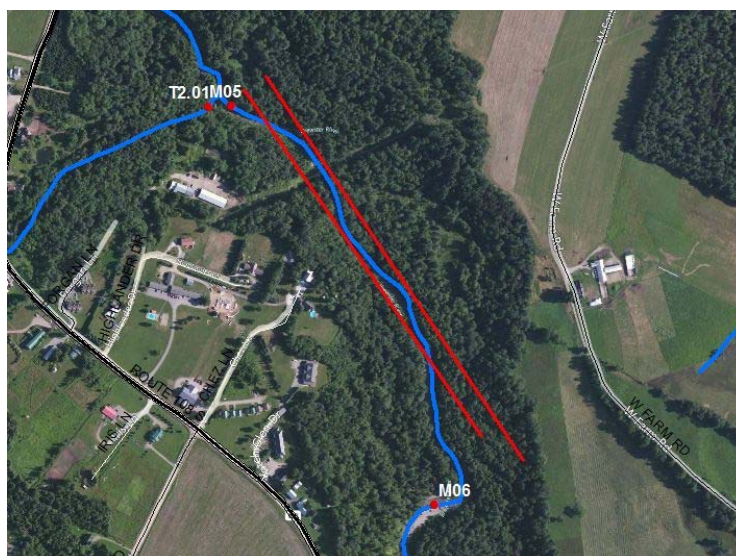
Figure 16: Meander geometry assessment on Reach M05

For reaches characterized within unconfined valley settings (C-type channels), meander geometry was reviewed following the Phase 1 protocols. Four of the 18 reaches had meandering profiles suitable for assessment of meander width and wavelength. Shapefiles were developed to indicate the areas where meander width and wavelength was measured (Figure 16). Where the meander wavelengths and widths fell outside of the range of expected values relative to the predicted channel width, impact ratings of high or low were assigned according to the degree of departure (VTDEC, 2009). Four of the assessed reaches had impacts for meander width and/or meander wavelength (Table 11).

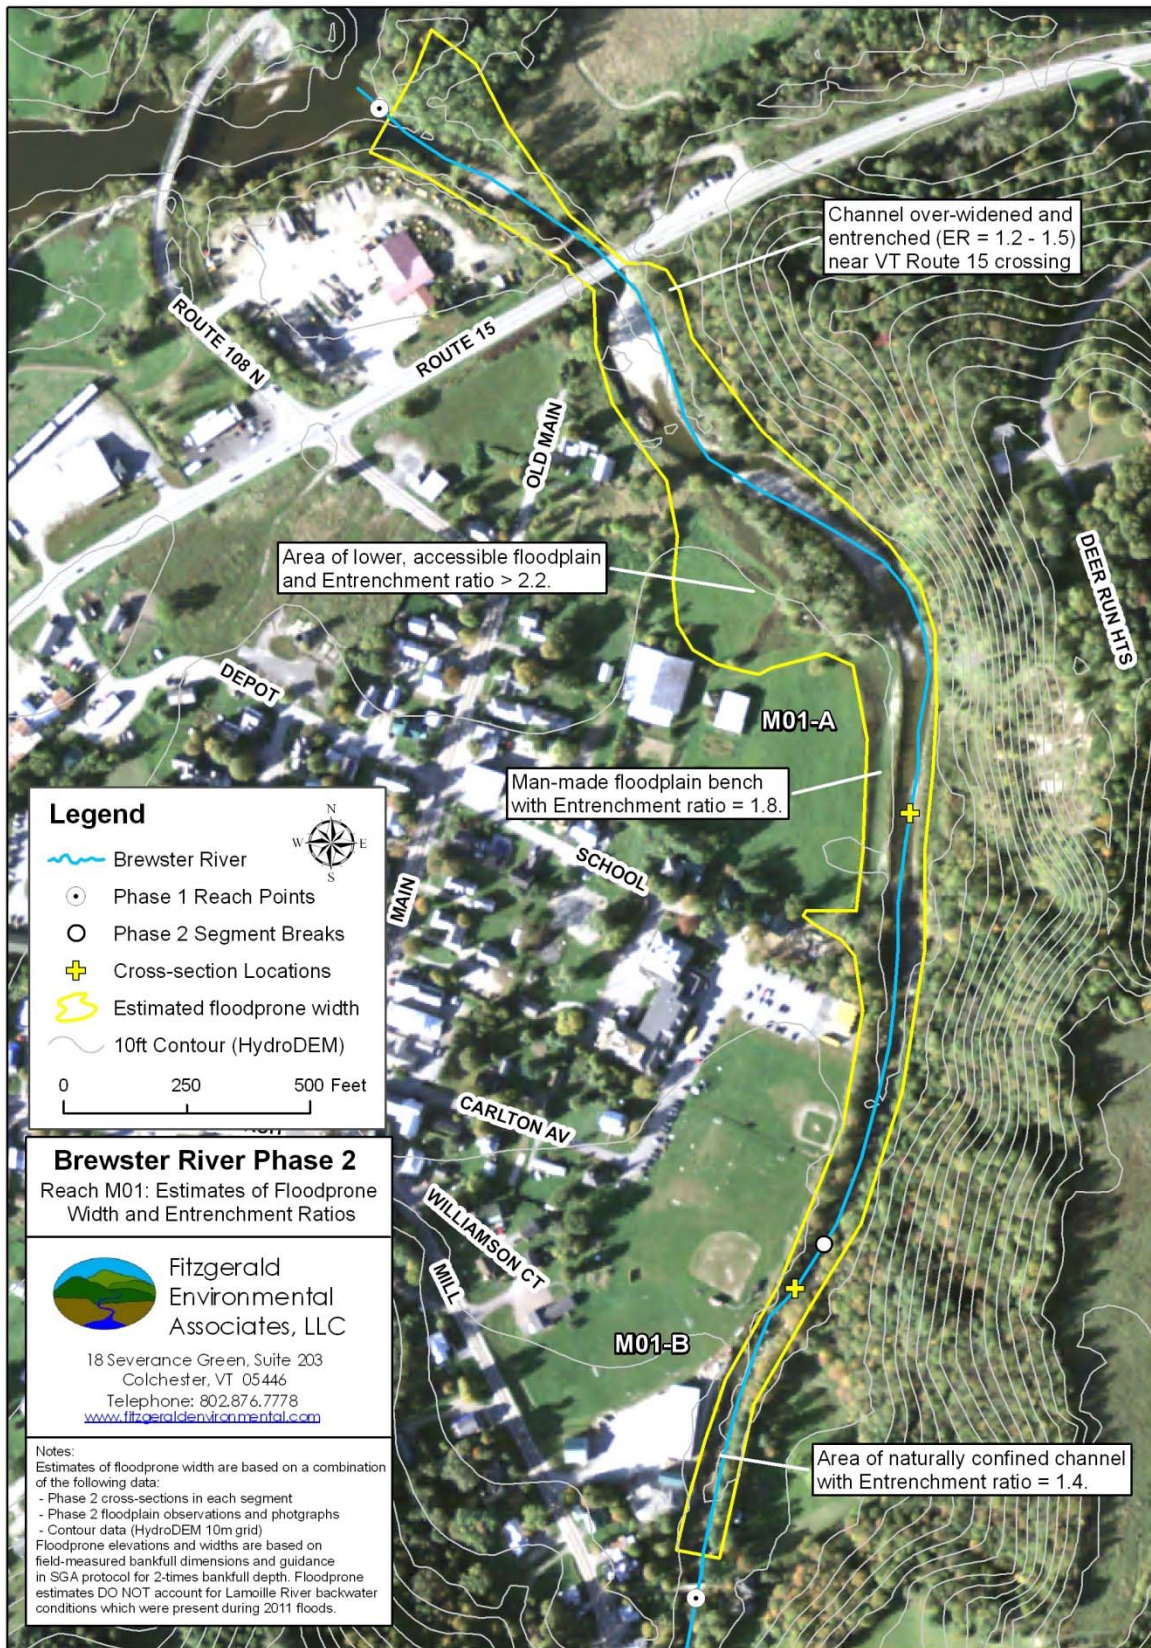
Figure 23: Variation in floodprone width in Reach M01.

Floodplain access and entrenchment ratio varies considerably throughout Reach M01, and in particular M01-A (Figure 21). However, actual flood hydraulics are affected by the backwater from the Lamoille. The SGA protocol for determining floodprone width based on bankfull dimensions was followed, but this approach does not account for backwater effects in large events for tributaries approaching the confluence of a larger river. On average, the entrenchment ratio is in the B-type range for this reach, which as noted above, is a departure from the C-type by reference.

Stage III of the F channel evolution model was selected to characterize current channel morphology, as widening is seen as the dominant process. Overall the channel was unstable and entrenched with a RGA score of "Fair". Habitat was rated as fair due to moderate woody debris and pool habitat features as well as good connectivity and hydrologic characteristics.

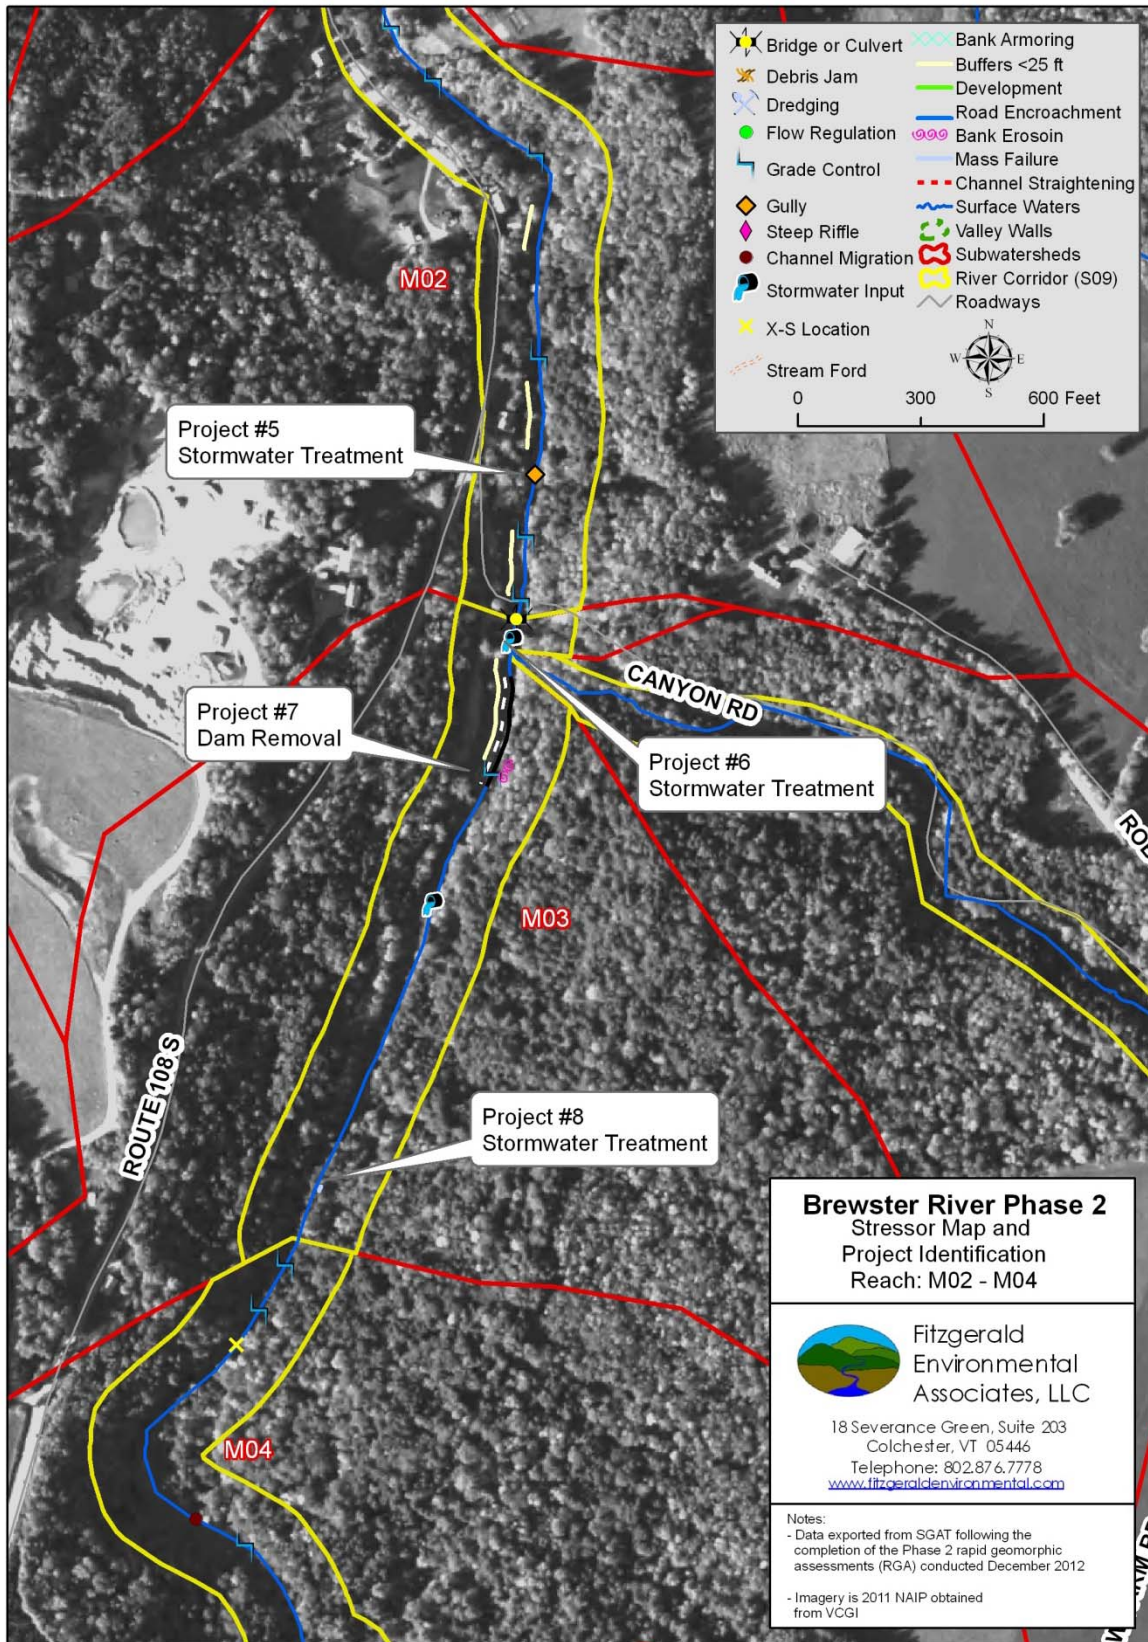
Figure 31: Reaches M02-M04 stressor map and project identification

#7 Swimming area dam Reach M03 44.63556 N 72.82558 W	Active Restoration Dam Removal	A channel spanning ~6' tall dam that was constructed for a swimming hole is causing sediment deposition upstream and interrupting sediment transport. Biologically the dam is a barrier to aquatic organism passage and may increase water temperature.	Remove dam and restore historic Brewster River channel. Needs further investigation with local officials as to history and use of structure, and impact on downstream sediment transport.	Moderate	High	Improve habitat connectivity. Potential restoration of natural hydrologic and sediment regimes.	Potentially high costs for study and implementation of dam removal projects.	LCPC; Village of Jeffersonville; Town of Cambridge; VTDEC; VTFWD

#8 Brewster Gorge hiking trail erosion Reach M03 44.63283 N 72.82721 W	Active Restoration Stormwater Treatment	Bank erosion and potential for small mass failure due to concentrated runoff from waterbars on hiking trail.	Stabilize upper bank near runoff source; Add stone armor and/or weirs to slope along runoff pathway to reduce erosion.	Low	Moderate	Reduced sediment and pollutant loading	Low to moderate costs for design and installation of BMPs.	LCPC; Village of Jeffersonville; Town of Cambridge; VTDEC; VYCC

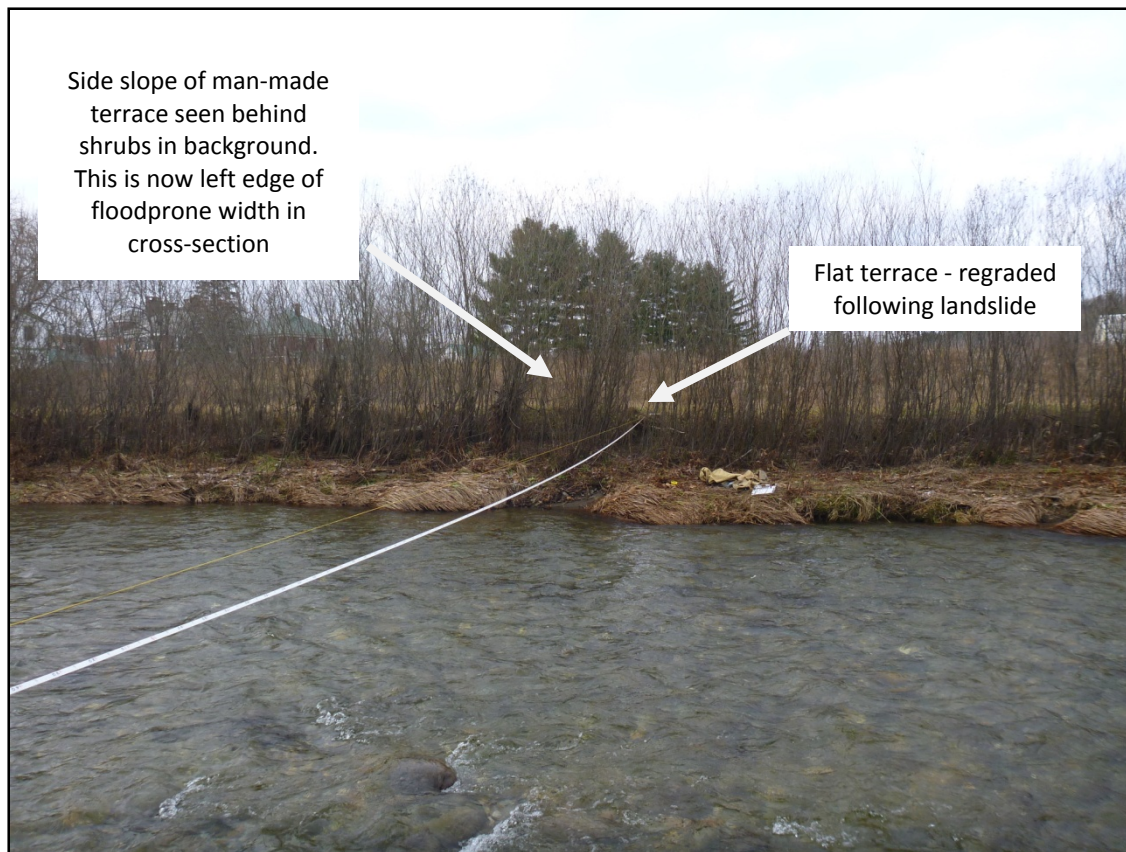
- Step 1.3 – Berm - In cross-section there is a berm noted as the left valley wall. There is none in the FIT. Should there be? Confirm if berm should be noted and/or provide more explanation in XS as to what berm is referencing. This would also update Phase 1 step 6.1.
We have removed this note re: “berm” from the XS excel sheet, and replaced it with “side slope of a man-made terrace”. See photograph below indicating different features shown on cross-section.

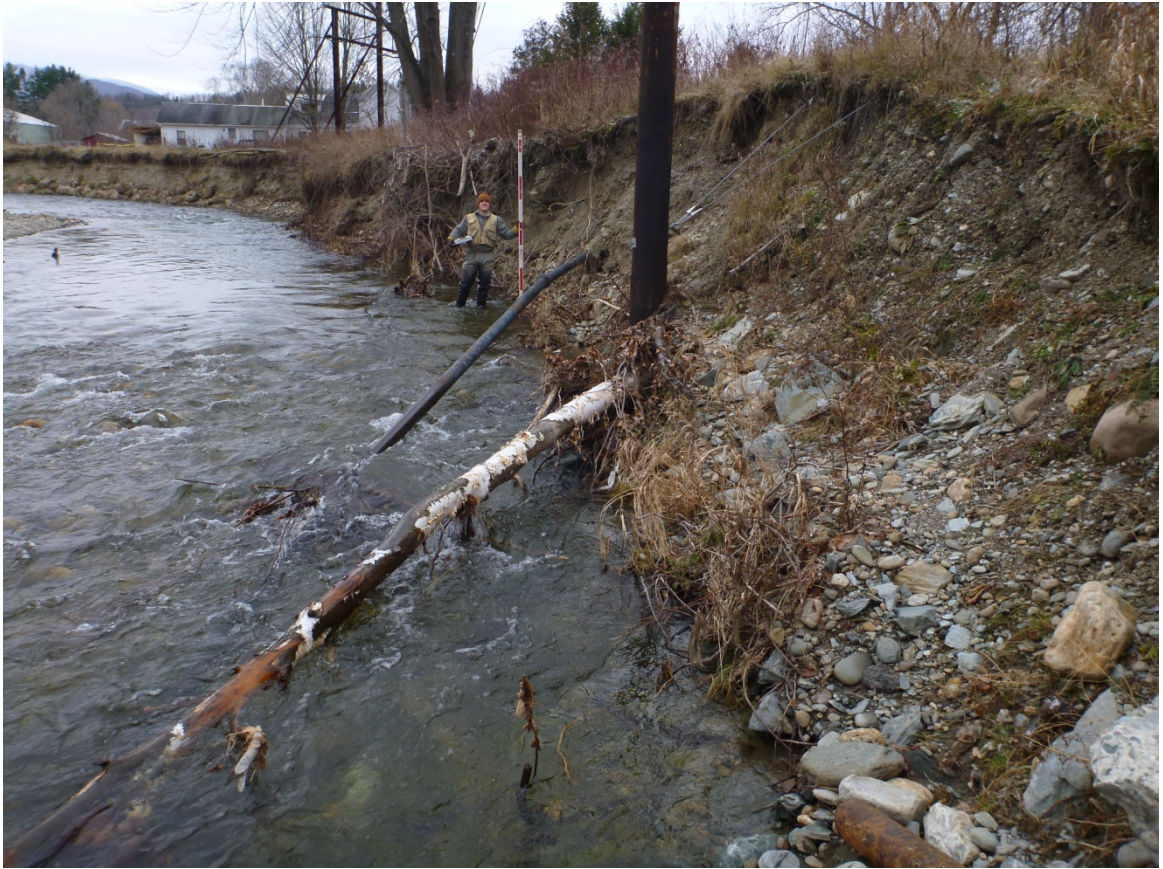
We have taken a second look at this segment in more detail, including the channel geometry throughout the whole segment. We agree with you that we should consider this segment a B-type (departure from C) based on the entrenchment ratio. Portions of the lower segment around Rt 15 are widened and incised enough that, in the absence of backwater from the Lamoille (which is not a realistic scenario), the entrenchment ratio would be lower than 1.4 due to the depth available relative to a likely maximum bankfull depth of 3.5. See photograph below with stadia rod. The left banks were between 7-8ft tall at this bend where the bar has formed, therefore the 2-times max depth would result in an entrenchment ratio of close to 1 as the channel is like a rectangular weir.

As you know, trying to type tributary streams at confluences is challenging due to tailwater effects, etc. We have noted in report with a map those areas with more F-type geometry and those with departed B-type geometry.
