From: Joseph Guzelak <jguzelak@ENPRO.COM>
Sent: Thursday, February 05, 2015 5:12 PM
To: 'dmorin@luhs18.org'
Cc: Moran, Matt
Subject: WMD616-2014 Hanley residence spill report
Attachments: spill report summary.pdf

RE: Residential fuel oil spill: WMD616-2014

On December 17, 2014 you contacted ENPRO Services, Inc. to respond to a heating oil release from an outside 275 gallon above ground storage tank (AST) at your residence. The following is a summary of observations, actions and sampling results related to clean up efforts.

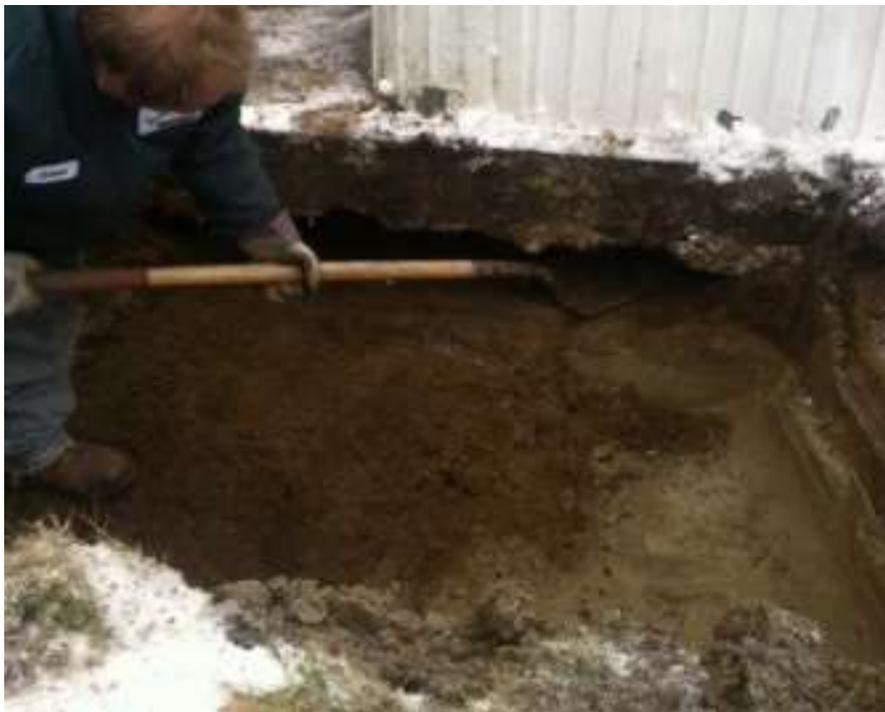
Corroding copper supply line running under mobile home

ENPRO Services, Inc. recommends that no further action is warranted in regards to this release at this location. However, as can be seen in the last photo, the supply line is corroding and it is recommended that it be replaced.
