STORMWATER MANAGEMENT PLAN FOR FAIRFIELD

FINAL REPORT

Stone Project ID 12-145

January 23, 2014

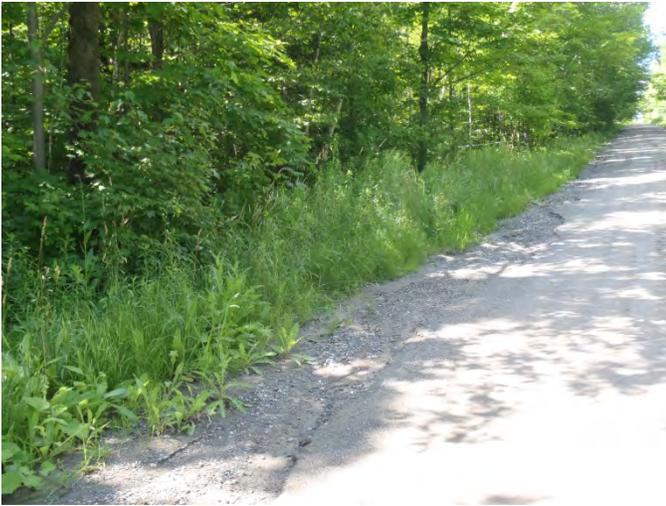
Figure 4. Berm at road edge prevents runoff from leaving road surface.

- Crowning the roadway so water does not remain on the road surface. For roadways that are not super-elevated, this generally means a 2-4% (1/4” - 1/2” per ft) crown for gravel roads and a 1-2% (1/8” - 1/4” per ft) crown for paved roads to promote sheeting of water.
- Avoiding creation of a ridge or berm between the crown and the ditch when grading gravel roadways. Any berm along the roadway shoulder that prevents the proper sheeting of water should be removed.
- Roadways should have at least a 15-inch thick processed gravel subbase, with the top 3 inches (minimum) as crushed gravel.

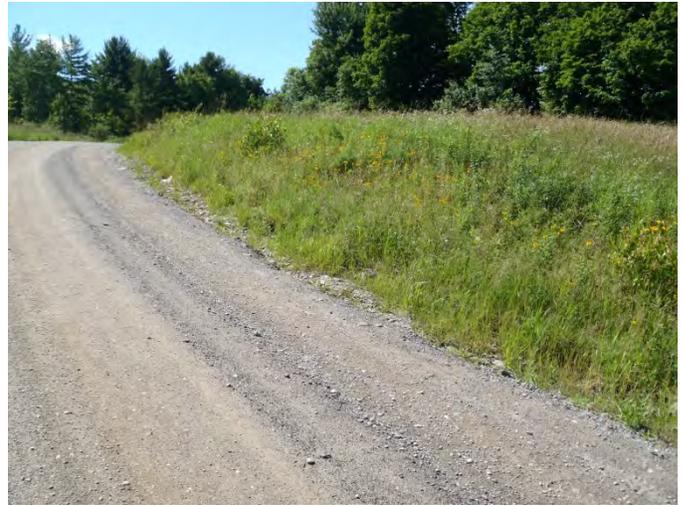
Figure 4. Formation of “secondary swale” on road surface.

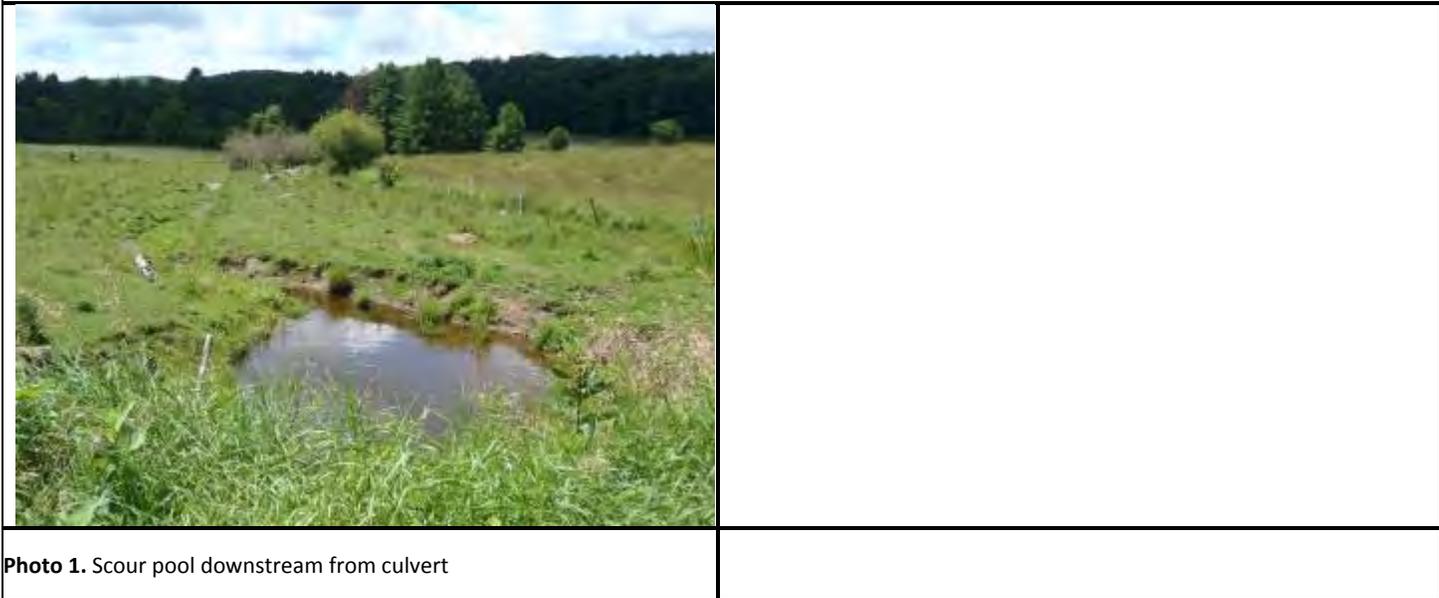
Description of Observed Conditions:
 Stream bank erosion downstream of TH 32.
 Undersized culvert leading to scour pool and bank erosion downstream.

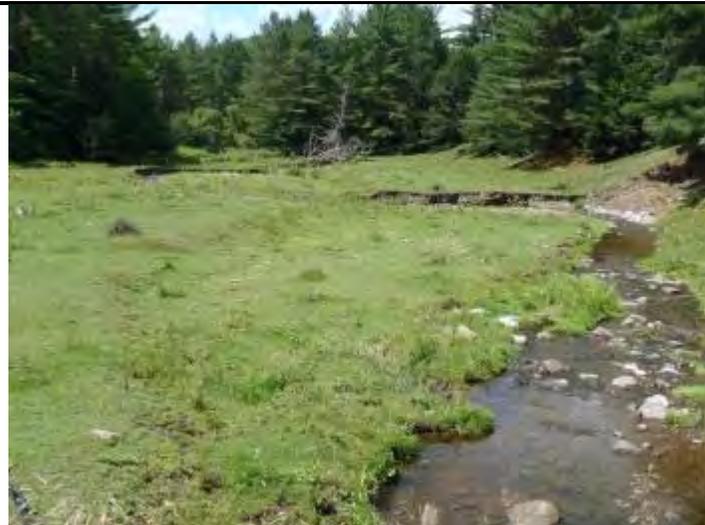
Culvert is undersized contributing to downstream erosion. Animals have access to stream. Outlet is perched 8-10"

Photo 1. Downstream bank erosion

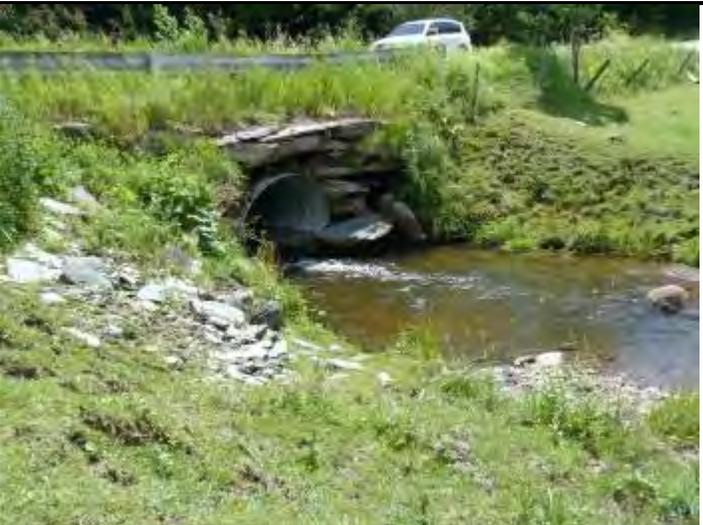
Photo 2. Culvert outlet, perched 8"

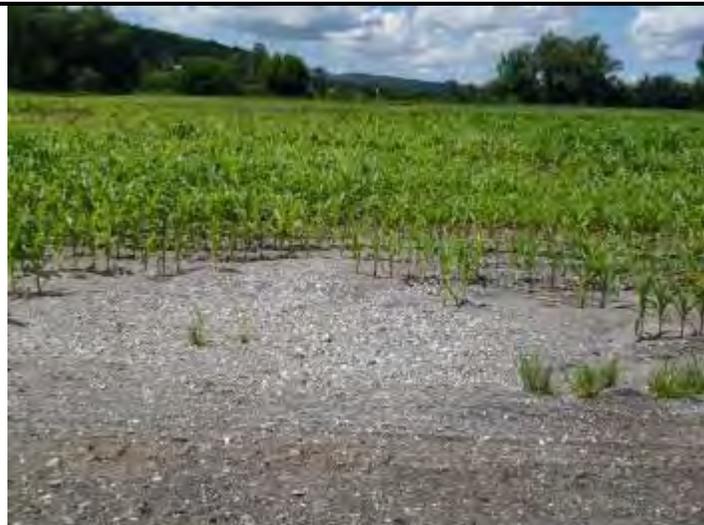
Undersized bridge causing bank erosion up and downstream. Road had recently been graded and no evidence of the stream overtopping the road was readily apparent. There were however a few large sediment deposits along the roadside and in the adjacent field. No sediment appeared to reach the creek.

Photo 1. Gravel from road deposited in adjacent field

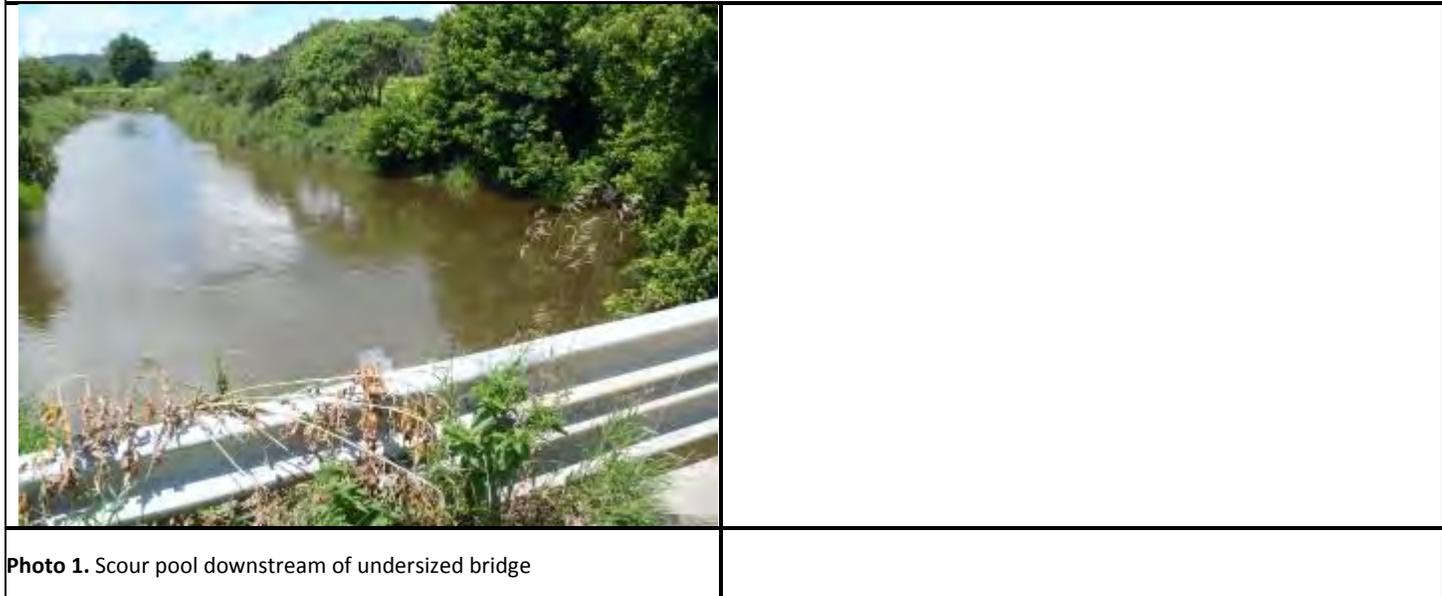
Description of Observed Conditions:
 Private bridge 1,000 ft downstream of Ryan Road shows evidence of scour and may be undersized.

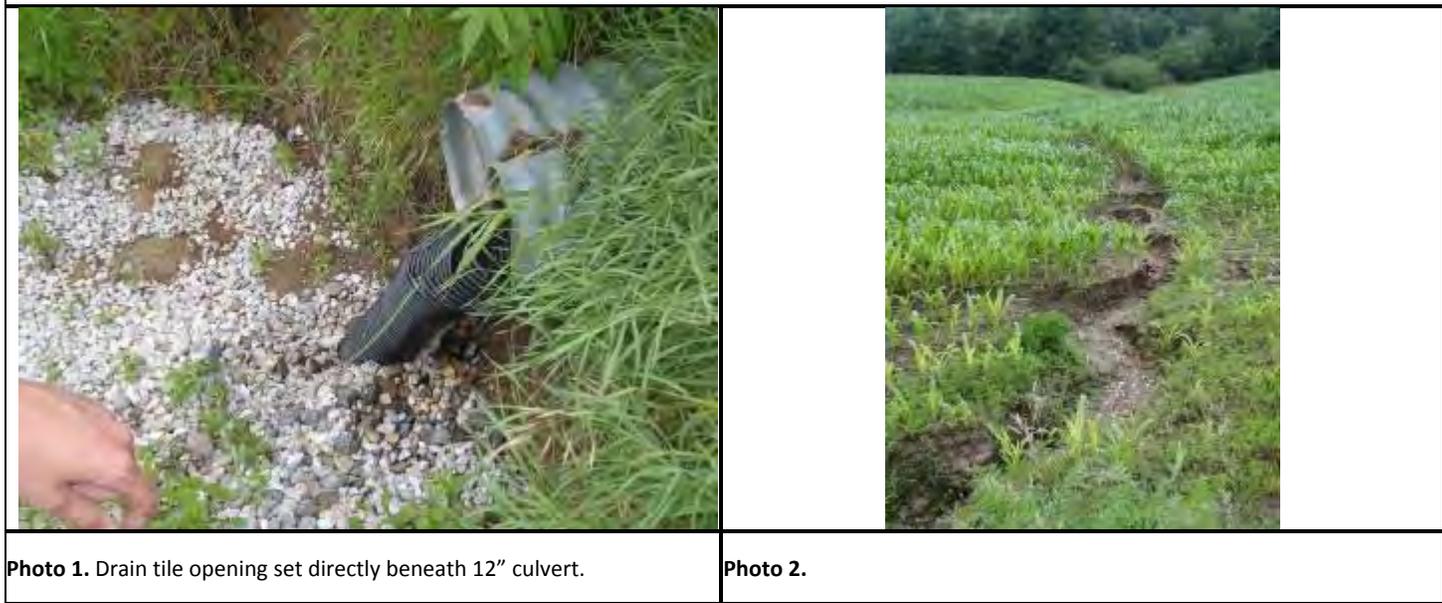
Description of Observed Conditions:
 Crop field has been tilled, but flow path is heavily eroded

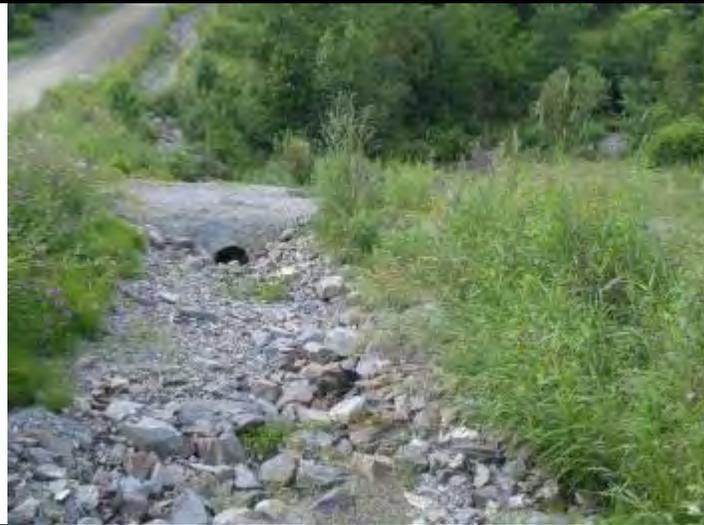
Stone-lined ditch with check-dams appears to have recently been installed and functioning properly. Bridge is properly sized, but water flowing beneath is very turbid with no apparent source. Future investigation is needed to determine source of turbid water.

Photo 1. Recently installed stone

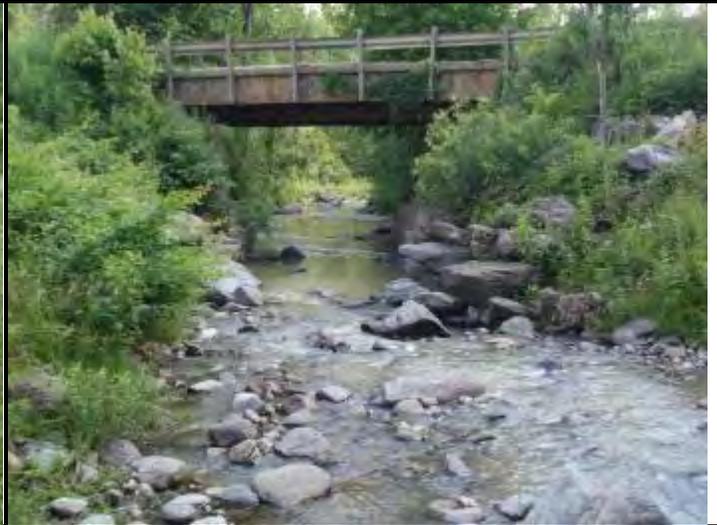
Photo 2. Visibly turbid water

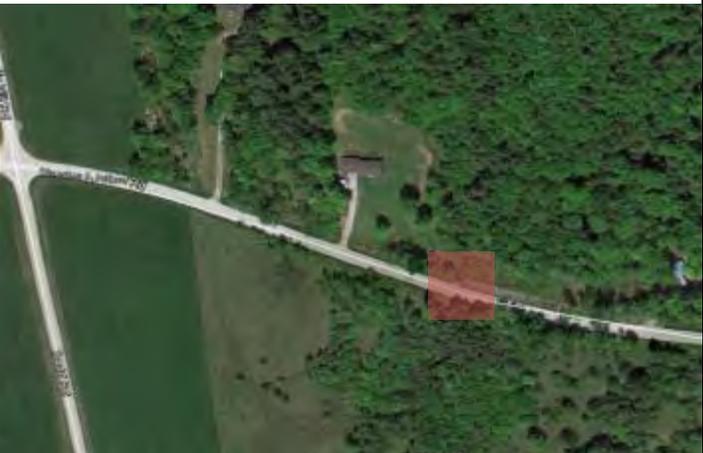
Appears to be recent culvert repair. Road shoulder above culvert at both the inlet and outlet is uncompacted gravel, which is slumping into the stream. There is a large sediment deposit in the stream directly downstream from the crossing. Further erosion of shoulder may result in damage to the roadway.

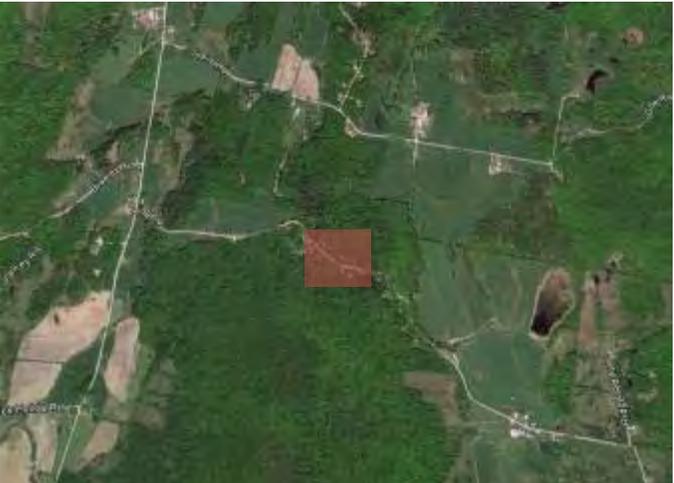
Problem Area ID: FR-2	Latitude: 44°46'16"N	Longitude: 73° 56'28"W
Watershed: <u>Fairfield River</u> Location: <u>Ridge Road east of Fairfield River crossing</u> Problem Type: <u>Erosion</u> Identification Source: <u>Town Feedback</u> Ownership: <u>Local</u> Classification: <u>3</u>

Description of Observed Conditions:
 Roadside ditch erosion, needs stone lining.
 Ditch is incising and banks are slumping.

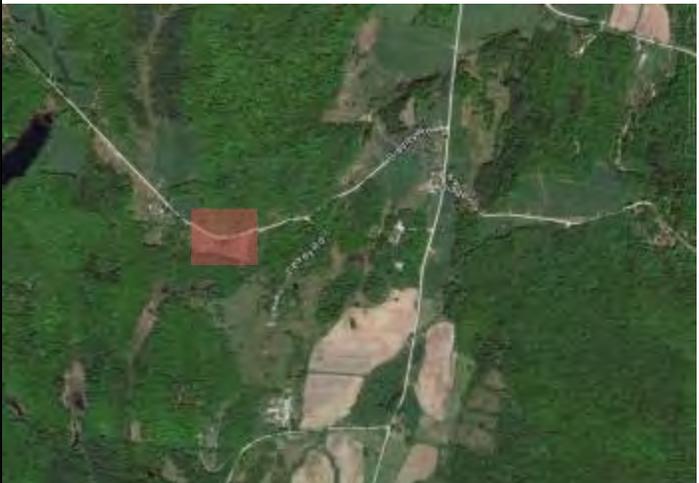
Problem Area ID: FR-4	Latitude: 44°46'19"N	Longitude: 73°58'07"W
Watershed: <u>Fairfield River</u> Location: <u>Bradley Road west of Pelkey Road junction</u> Problem Type: <u>Erosion</u> Identification Source: <u>Town Feedback</u> Ownership: <u>Local</u> Classification: <u>3</u>

Description of Observed Conditions:
 Road edge erosion, needs stone lining.

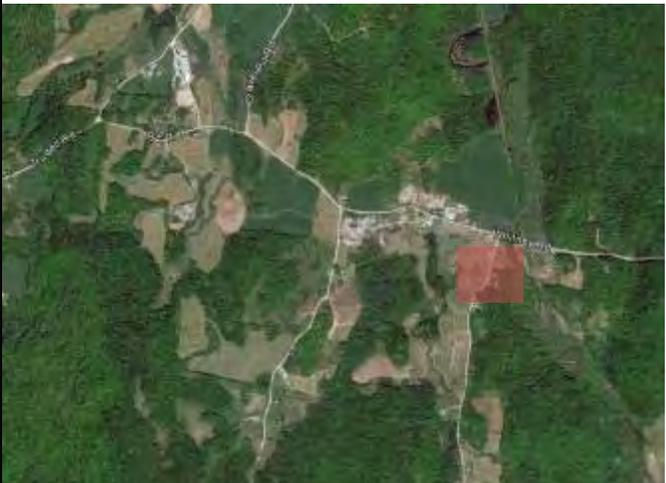
Description of Observed Conditions:
 Stream bank erosion downstream of 9' culvert.
 Animals have access to stream.

Photo 1. Failing streambank in active pasture

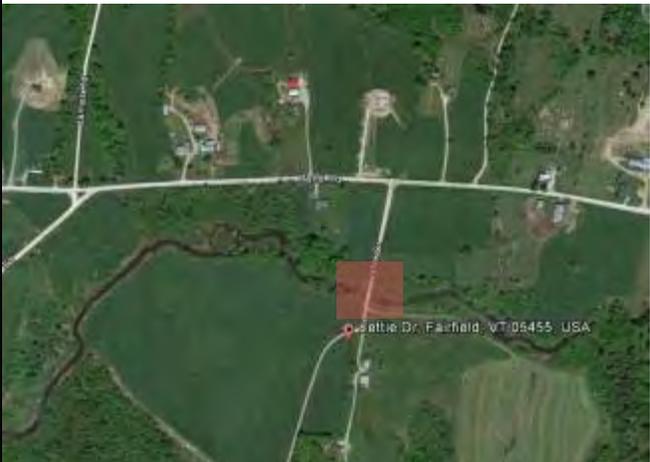
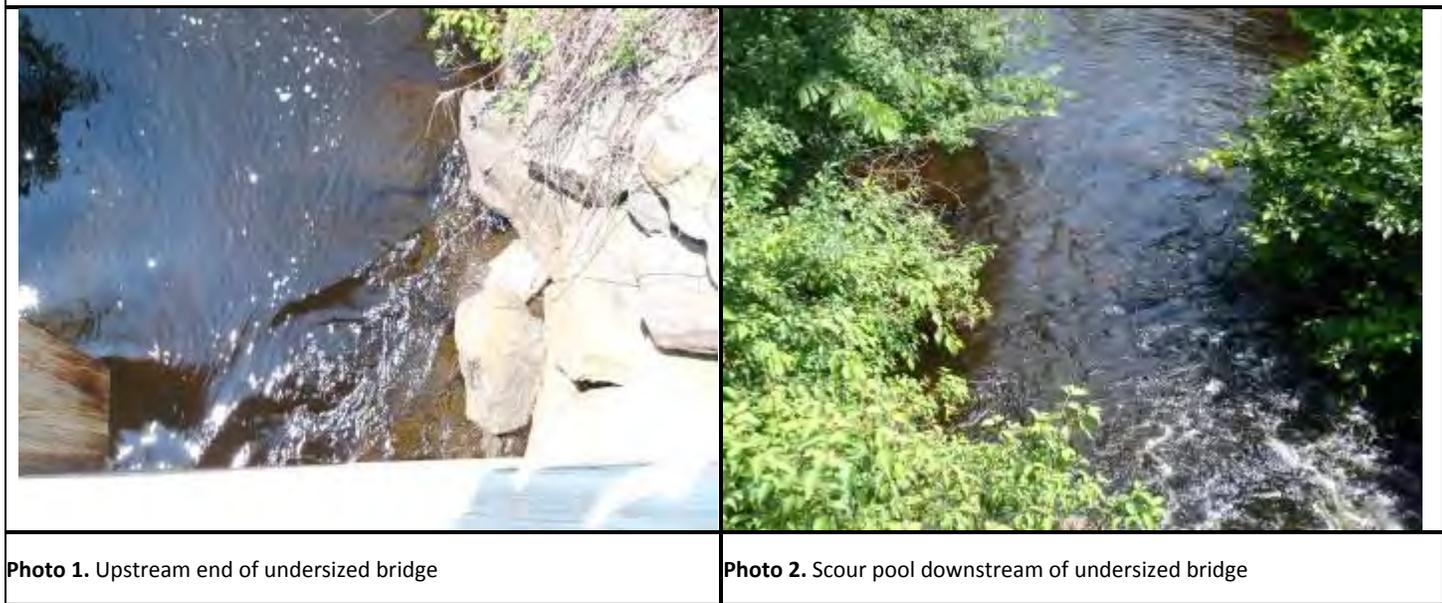
Problem Area ID: DC-1	Latitude: 44°51'11"N	Longitude: 72°57'43"W
Watershed: Dead Creek <hr/> Location: Jettie Road by Dead Creek crossing. <hr/> Problem Type: Infrastructure <hr/> Identification Source: Geomorphic Assessment <hr/> Ownership: Local <hr/> Classification: 2

Description of Observed Conditions:
 Undersized bridge.
 Bridge is 1/2 bank full width.
