Stormwater Master Plan City of Montpelier, Vermont

15-097

Stormwater Master Plan

City of Montpelier, Vermont

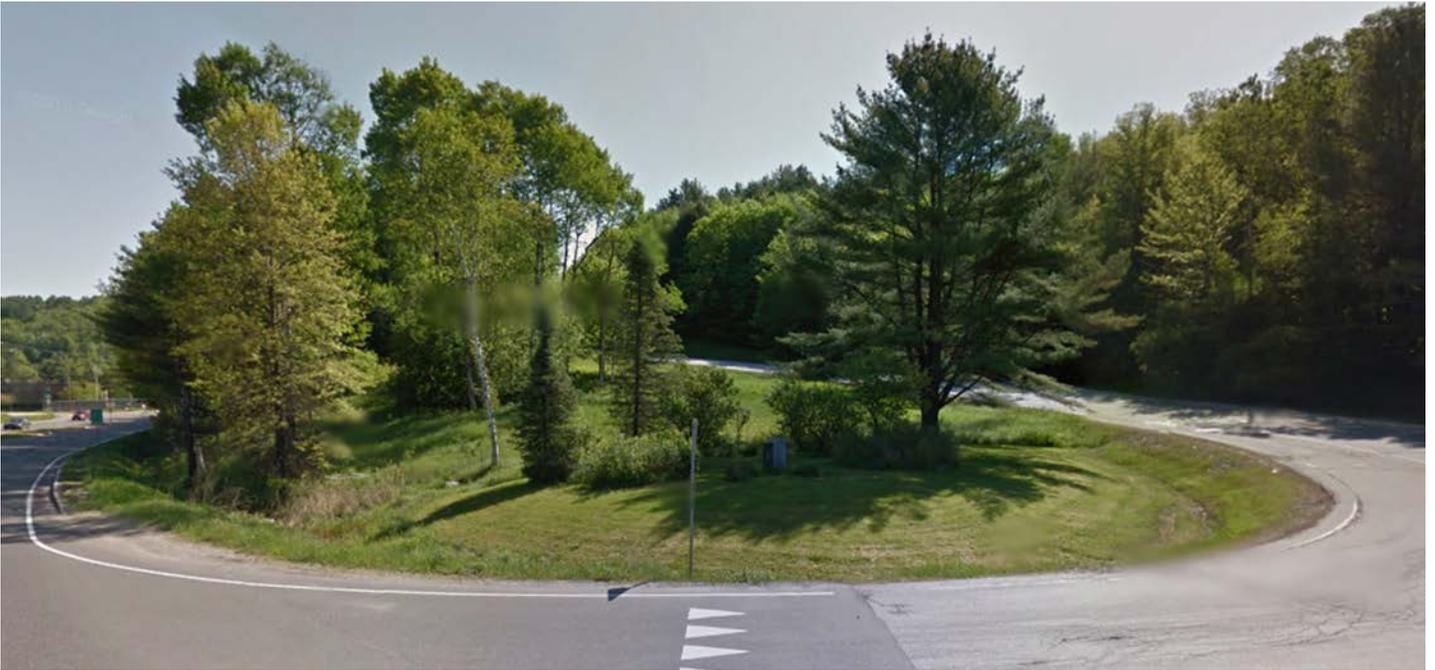
Existing Condition

Currently stormwater from National Life Drive sheet flows into the landscaped area at National Life and Memorial Drive where it flows along a grassed swale and enters a piped drainage system and it is conveyed to the river and discharged via a culvert under Memorial Drive.

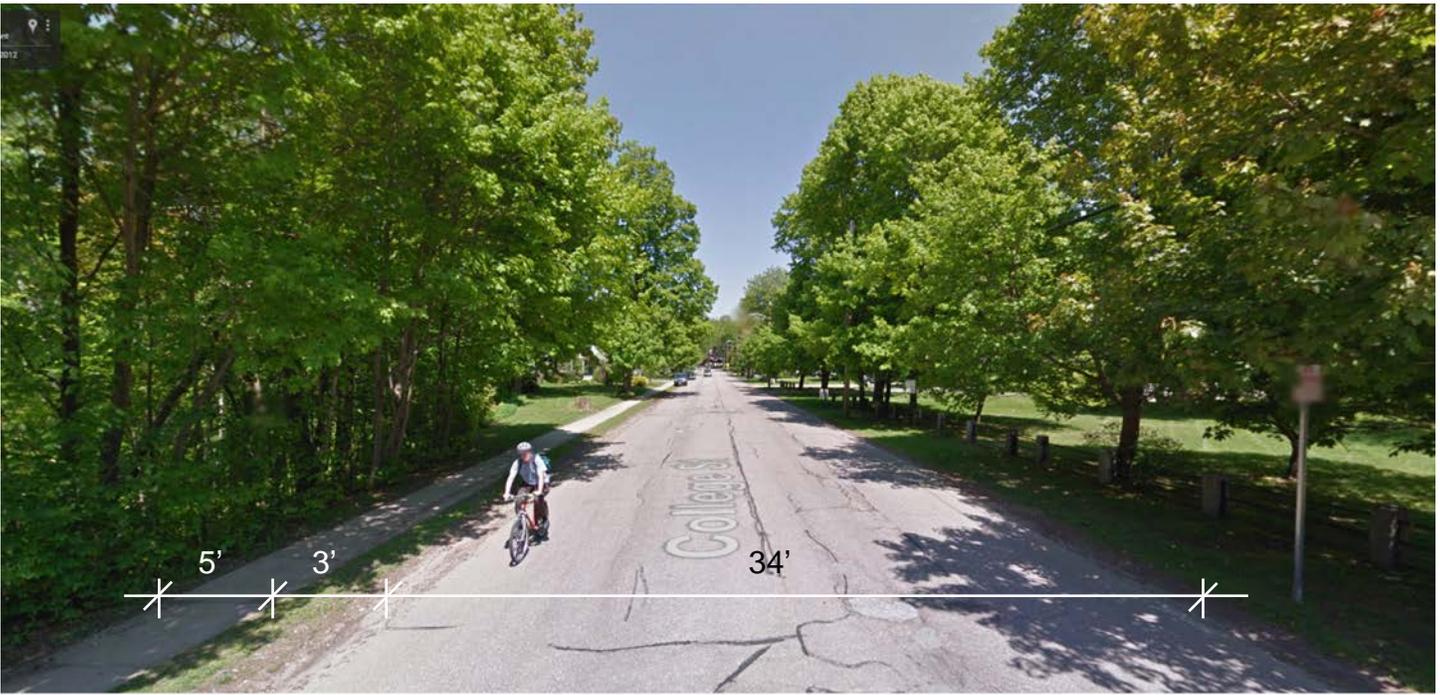
Existing Condition

Currently there is excess paved width in College Street which can be converted to landscaped stormwater swales. The existing street section includes a five foot sidewalk, a grass strip approximately three feet in width, and a 34-foot roadway. This street is designated as a 'share-the-road' street in the bicycle and pedestrian master plan.

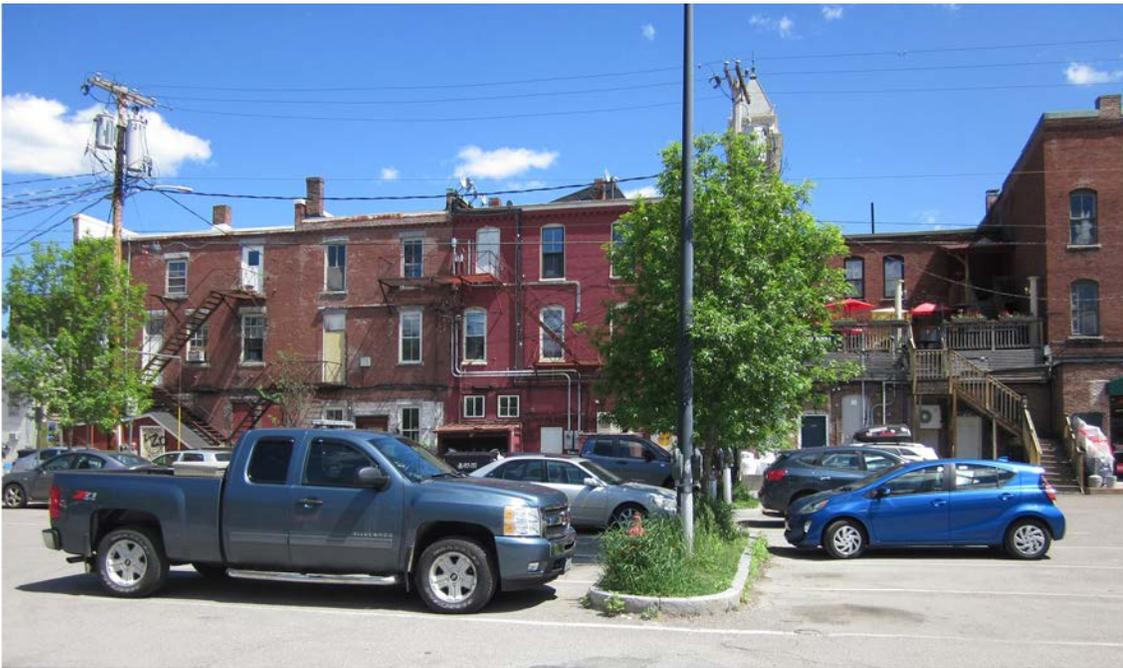
Existing Condition. The existing parking lot behind Main Street is a large paved area that drains into the North Branch of the Winooski River.

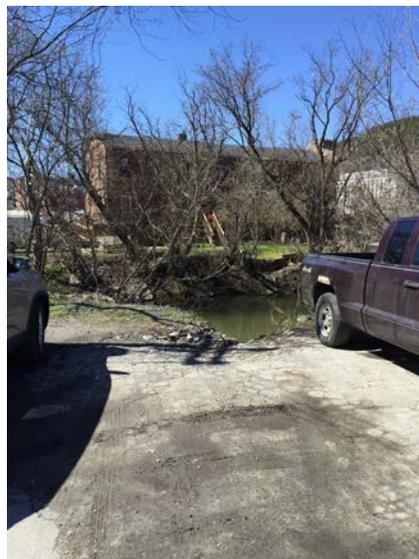
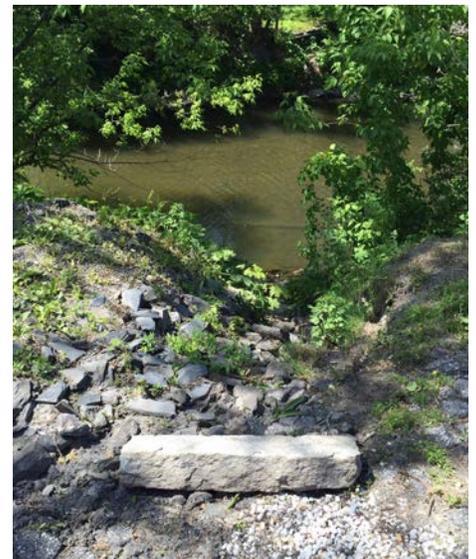
Existing Condition. The existing parking lot behind Main Street at the river’s edge. The parking lot drains into the river and there is significant erosion at the low spot where the water drains into the river (see photos below).

Stormwater flows into the river from a low point in the parking area causing bank erosion and water quality problems.

Pervious Paving and Stormwater Planters. Paving beneath the parking stalls can be replaced with pervious pavers. The edge of the parking area can be curbed to prevent stormwater flow into the river. The parking space at the low point of the lot where water drainage is eroding the bank can be converted to a stormwater planter that collects and infiltrates stormwater.

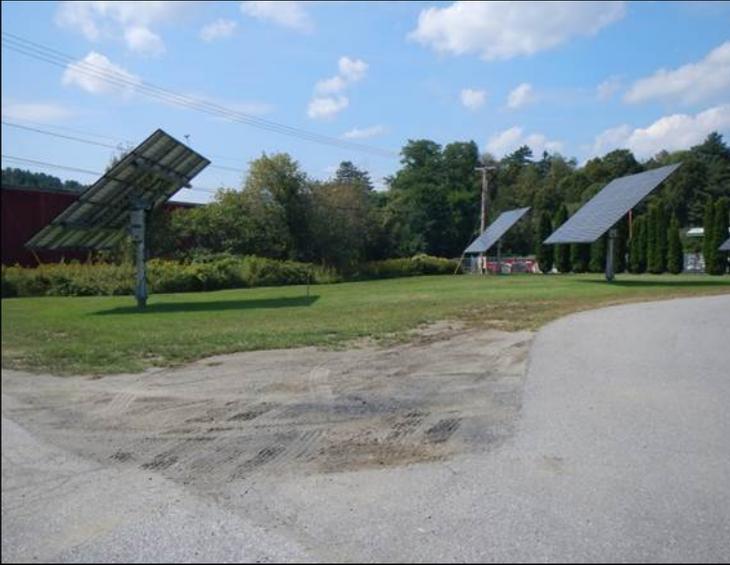
Photo 1. Solar panel installation that could be modified to incorporate stormwater management	Photo 2. Catch basin that could be plated over (1 of 2)

Description of Observed Conditions:
 The two catch basins (including the one pictured in Photo 2, below) could be capped, and rainwater should be redirected in the circular green space or the lawn area where the solar panels are installed.

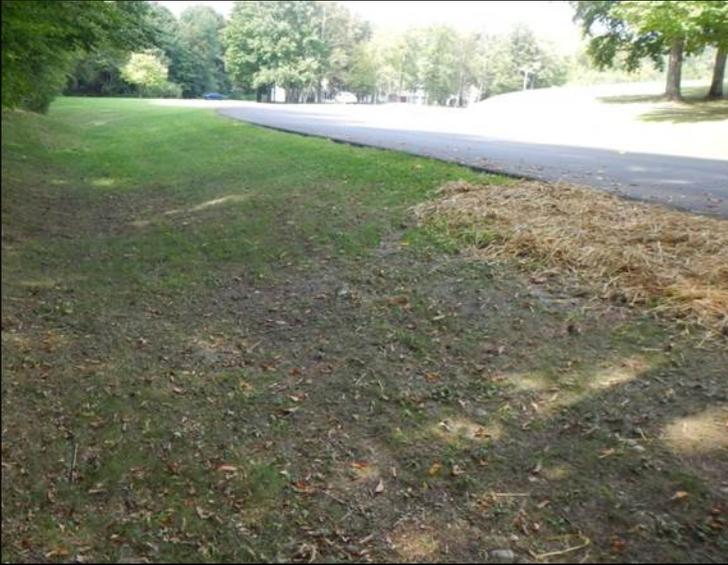
Photo 1. Berm would be constructed on low area behind location indicated by the arrow.

Description of Observed Conditions:
 Open green space on the right side (driving uphill) of National Life Drive. There is an existing, subsurface storage pipe system in this green space that was installed by National Life as part of their permit that will need to be considered. Capping the catch basin in Photo 2 and constructing a berm at location indicated in Photo 1 to turn water out into the swale could be effective. Pipe running downhill from the catch basin in Photo 2 is not deep; there may be an opportunity to “daylight” additional stormwater into the swale. Depending on the drainage area, the swale may need to be reinforced and/or require check dams.

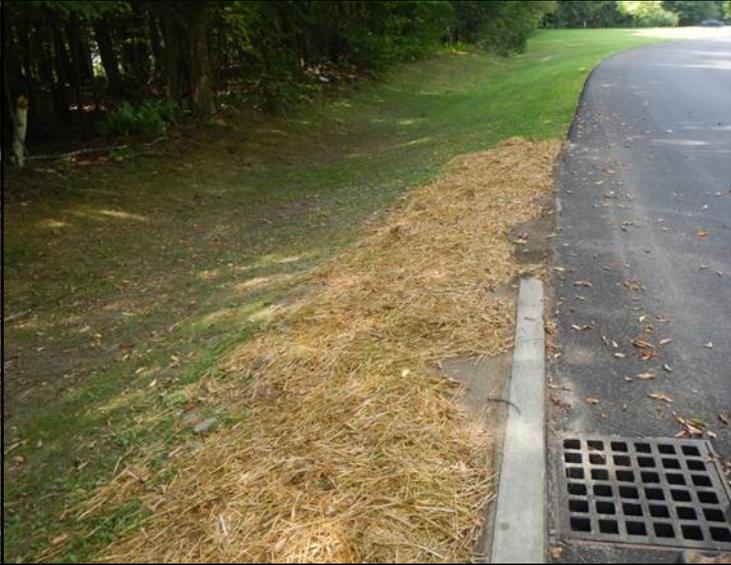
Photo 2. Catch basin uphill of green space

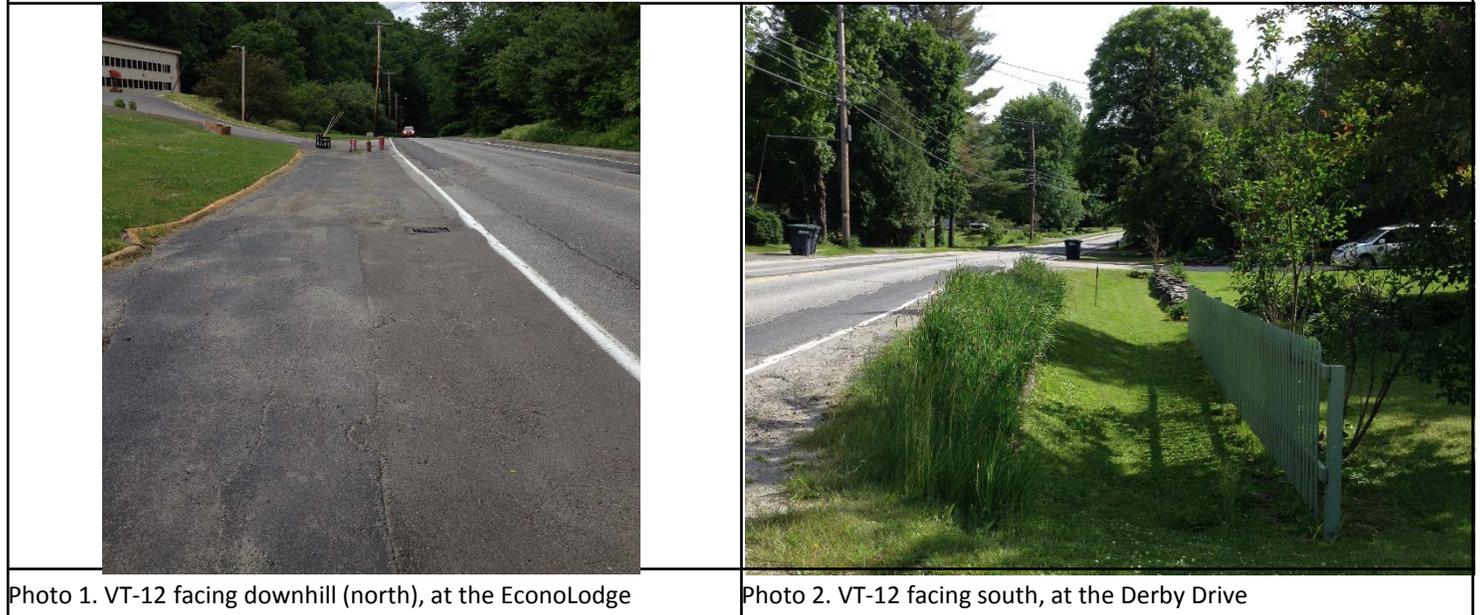
There is green space along the west side of Vermont 12, both north and south of Derby Drive, that could be suitable for stormwater management. This includes “depaving” the overly-wide shoulder in front of the Econo Lodge. The City has indicated that this section of roadway is scheduled for paving in 2017.

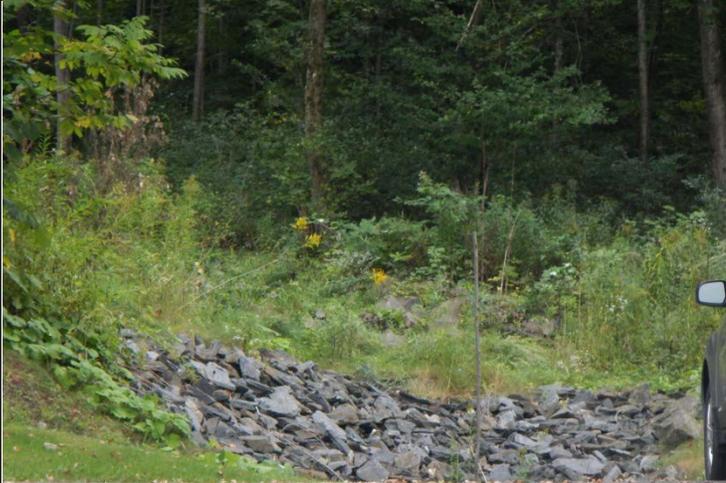
Description of Observed Conditions:
 Drainage at the top of the street has been stabilized with riprap (Photo 1). In addition, there is a concrete manhole with small inlets at its base and an overflow inlet located out-of-site in this photo beyond the rip-rap. No ditches along the sides of the steep street but little erosion was visible along the permanent edge. The City has plans to construct a small retention basin with an outlet control structure on Isabel Circle, which is at the top of this drainage area.

Photo 1. Rock pile constructed in the yard of the topmost house in the line of flow

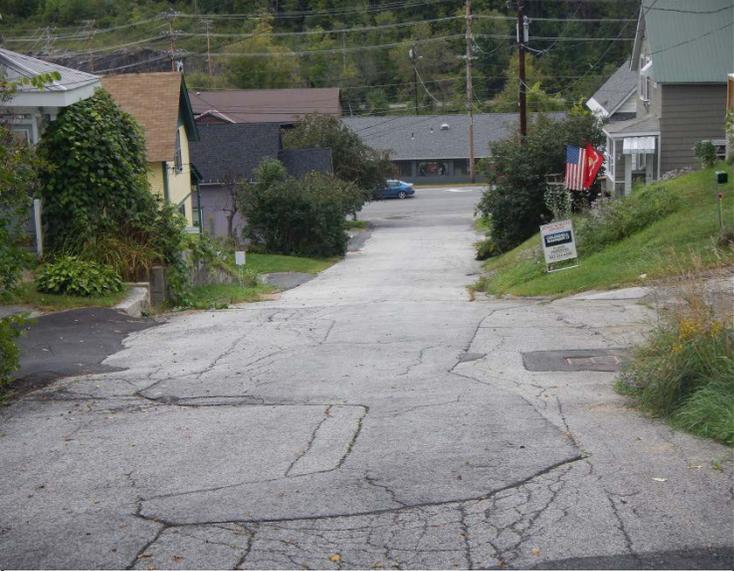
Photo 2. View down the steep street

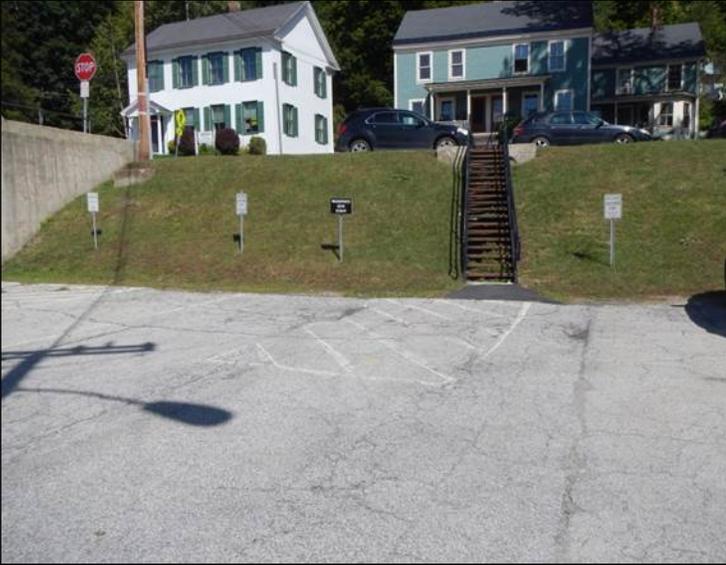
Description of Observed Conditions:
 Potential for a small, linear bioretention at toe of green space to capture/infiltrate a portion of parking lot runoff. Site also received excess runoff from the State House during large/intense wet weather events through a weir/manhole by the Pavilion Office Building. Site is somewhat constrained due to the steep slope of the available green space. When lot is resurfaced, consideration should be given to the use of a porous pavement.

Photo 1. Proposed green space around staircase

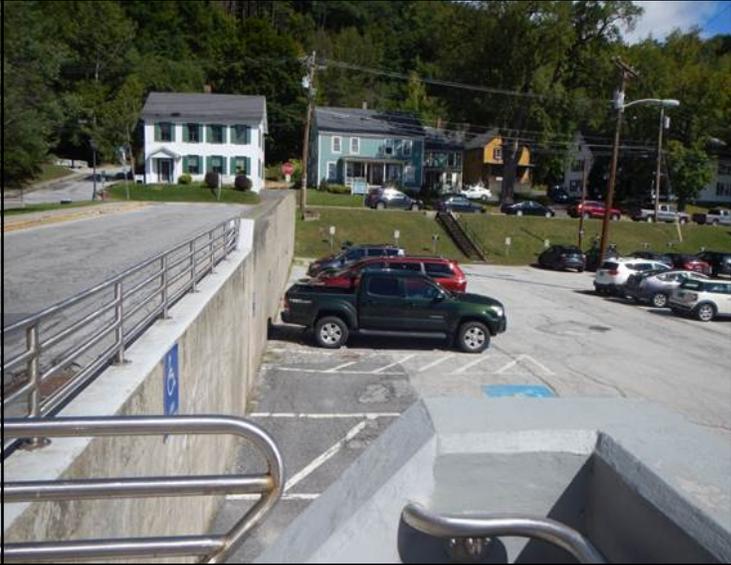
Photo 2. Gov. Davis Ave parking lot

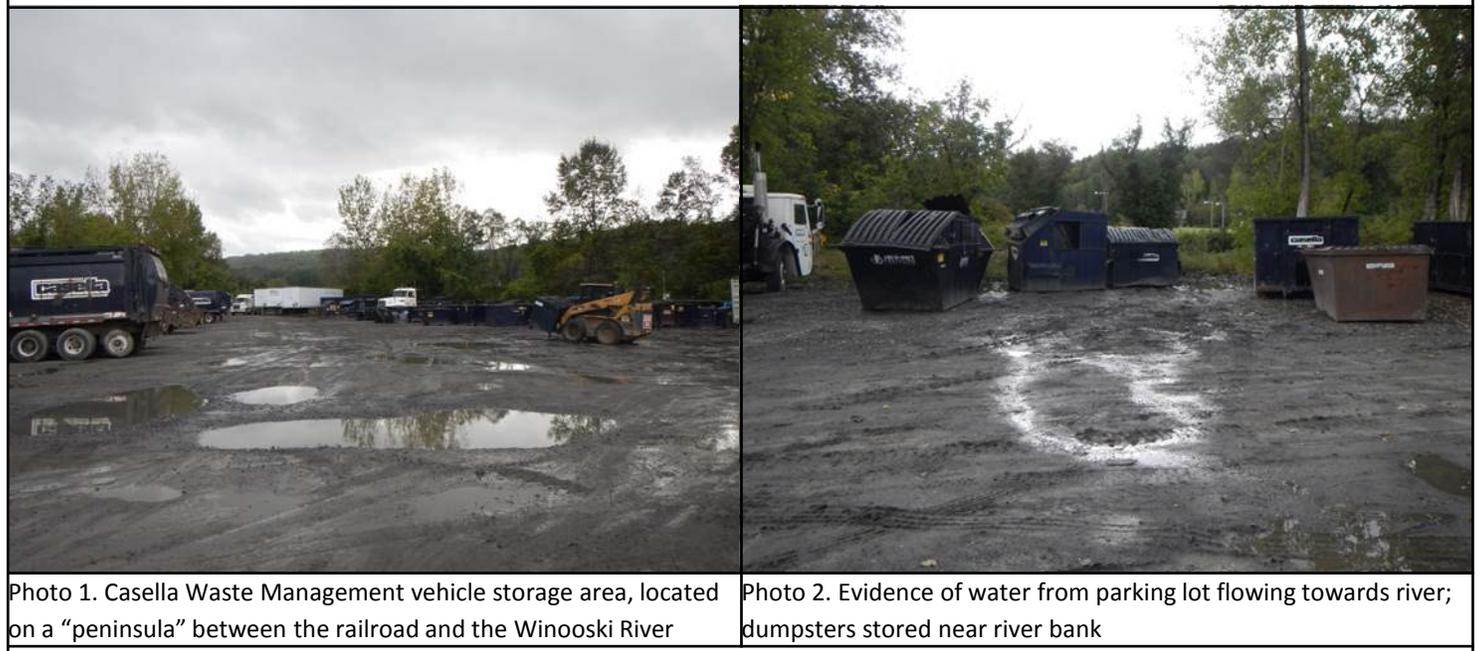
Description of Observed Conditions:
 Permitted facility (#4790). Standing water from rain the day before remained on the gravel machinery parking area (Photo 1). In the image, the river is to the left. There is a vegetated berm-like structure preventing flow into the river along most of that side of the parking lot, but one flat section allows flow into the river (Photo 2). A strip of gravel and grass along the right side of the lot (relative to Photo 1) was under standing water. A Casella Waste Systems employee stated there is one catch basin draining the paved lot at the front of the property.

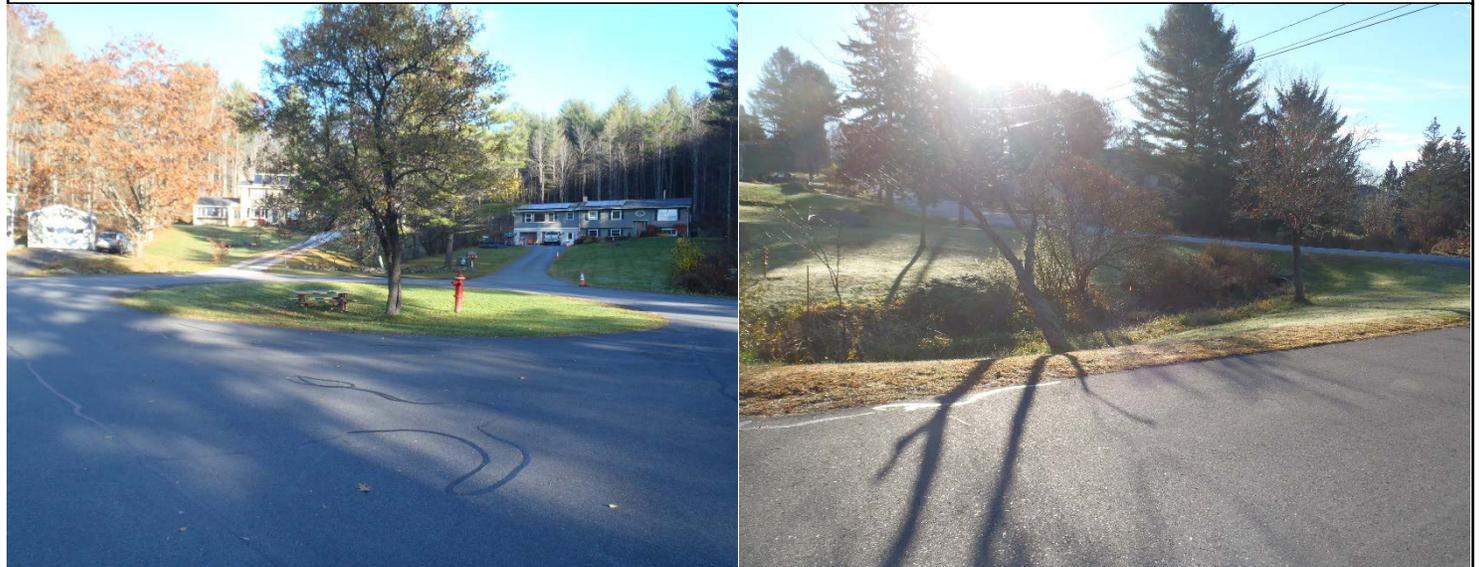
Description of Observed Conditions:
 There are a number of drainage features that all intersect in the vicinity of Dunpatrick Circle. Water from this area ultimately becomes part of a more significant surface water feature along the west side of Terrace Street.

Photo 1. Cul-de-sac presents potential retrofit opportunity. Photo 2. Existing natural areas along Dunpatrick Circle could potentially be used to better manage stormwater.

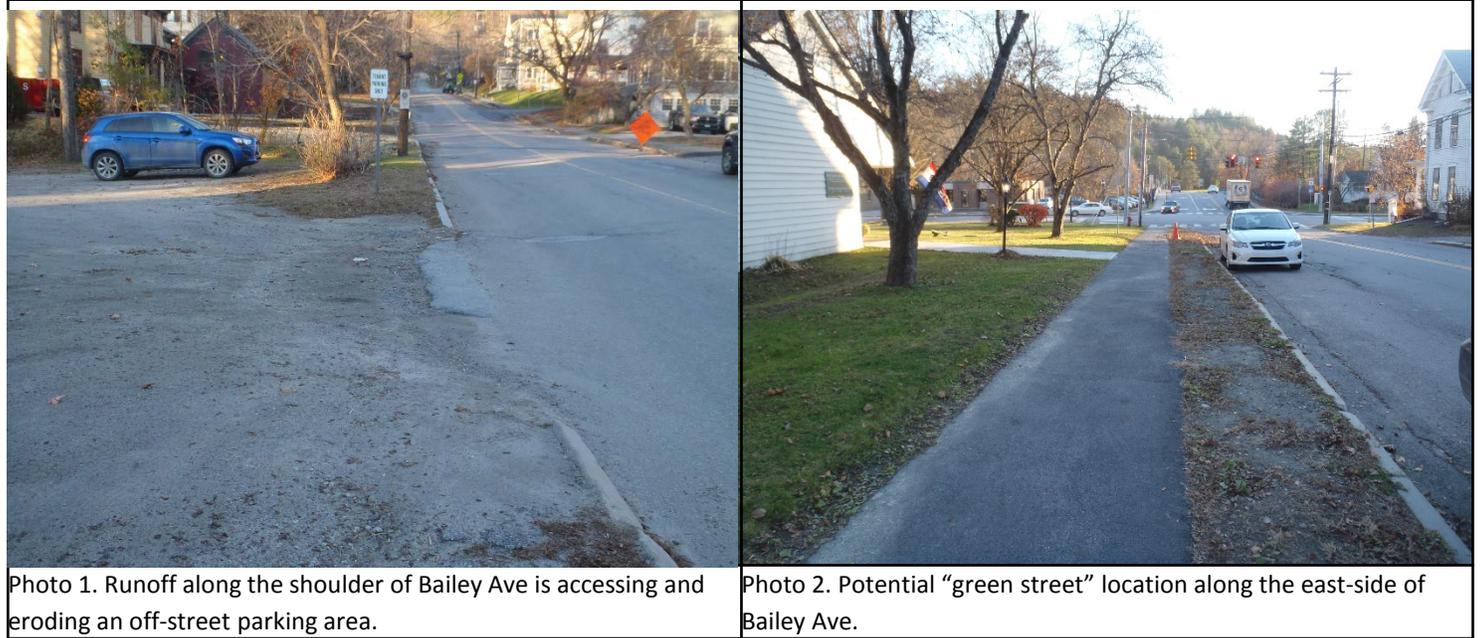
Description of Observed Conditions:
 Significant stormwater runoff along the shoulders of Bailey Ave accesses and erodes off-street parking areas; there is a need to comprehensively address stormwater runoff along this block.

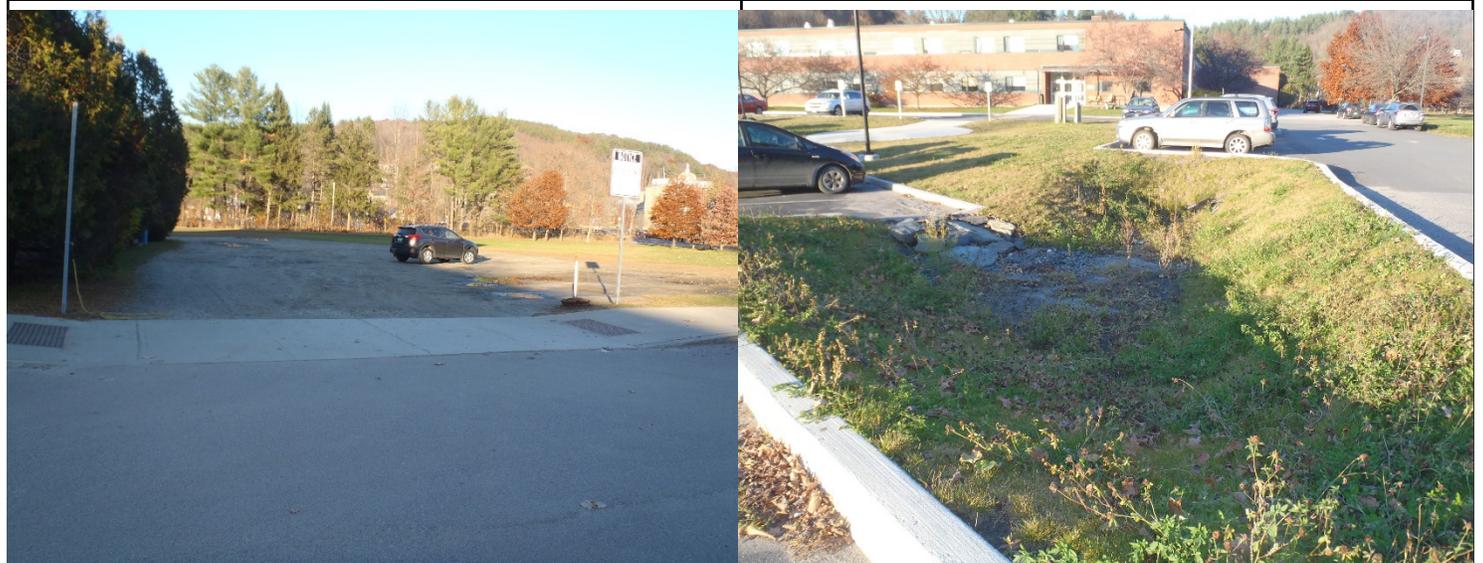
Description of Observed Conditions:
 There are a number of opportunities for improved stormwater management on the Montpelier High School campus. These include: addressing sediment transport from the overflow parking area in front of the school (Photo 1), retrofitting the green space in the traffic loop in front of the school to accept stormwater runoff, and improving stormwater management measures designed to capture runoff from the back parking lot which show evidence of short circuiting (Photo 2).

Photo 1. Overflow parking area Photo 2. Existing stormwater management in back parking lot

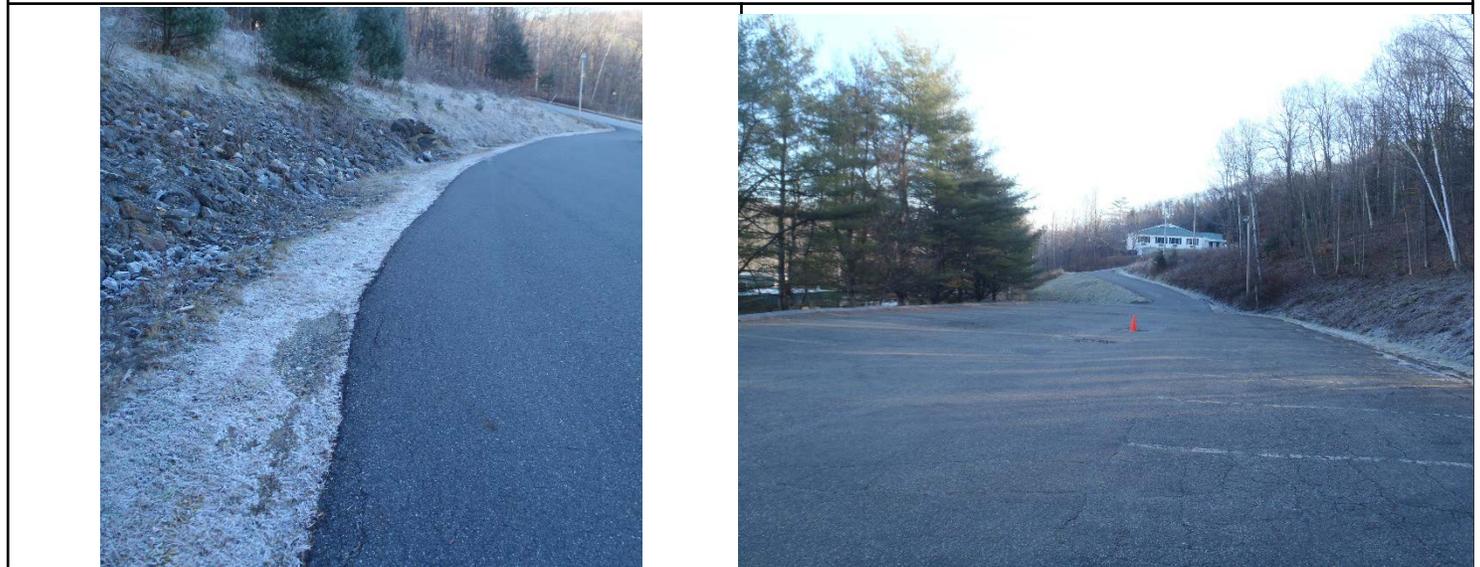
Description of Observed Conditions:
 The are significant areas of unmanaged impervious surface, mainly parking areas, associated with both of these facilities that could benefits from improved stormwater management. In addition, these lots have been reported to receive significant “run-on” from uphill residential development. There is an existing drainage swale along the north edge of these parking areas that could be improved to better manage stormwater; there are also opportunities to better manage stormwater runoff in the upper watershed.

Photo 1. Drainage swale along north edge of VT NEA parking area Photo 2. Parking area at Leahy Press

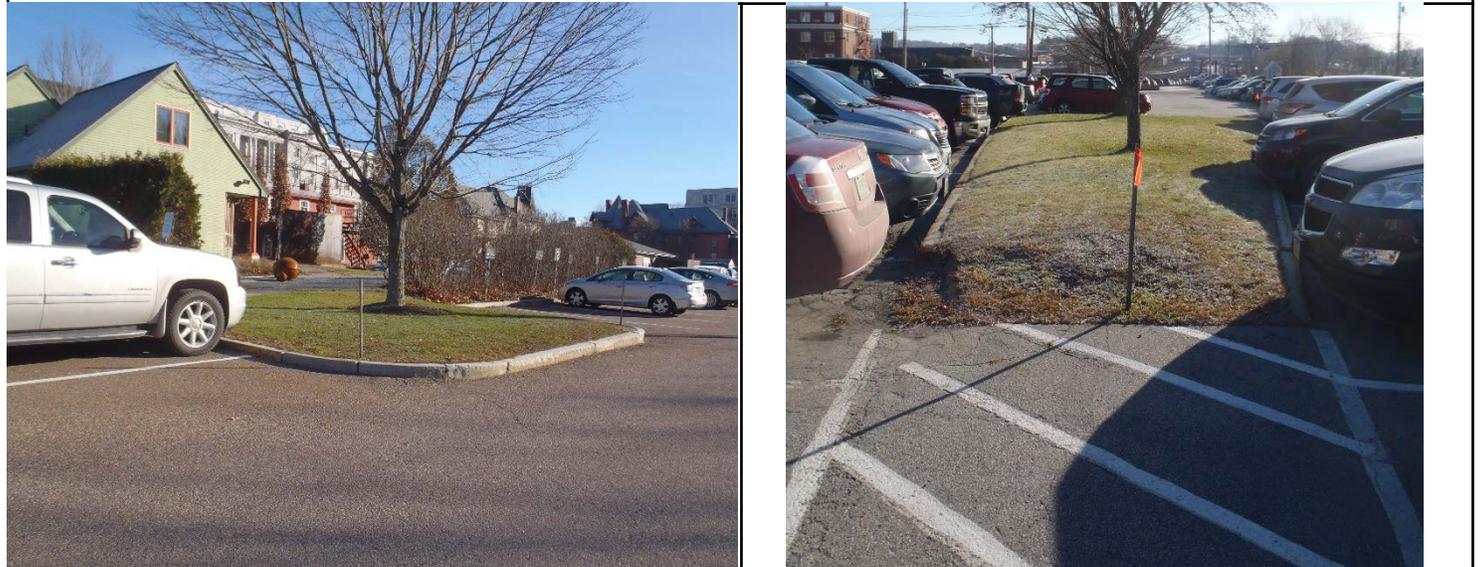
Description of Observed Conditions:
 Small islands of green space within the existing state-operated parking areas between State St and the Winooski River could be retrofitted to provide stormwater management for a portion of the surrounding impervious surface.

Photo 1. Green space behind Visitor Center Photo 2. Green space in lot behind 116 State St

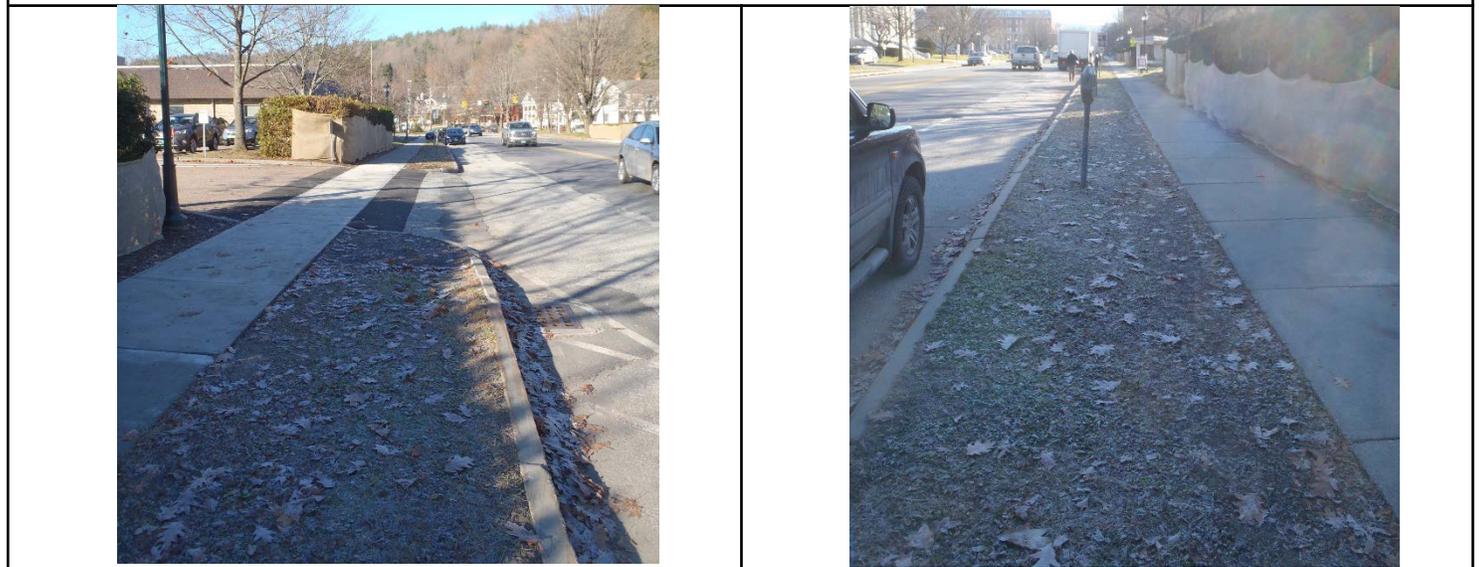
Description of Observed Conditions:
 There is existing green space along the south-side of State St that could be retrofit using a “Green Street” style approach to improve stormwater management for road (and sidewalk) related runoff.

Photo 1. Green space, looking west along State St.	Photo 2. Green space, looking east along State St.
--	--

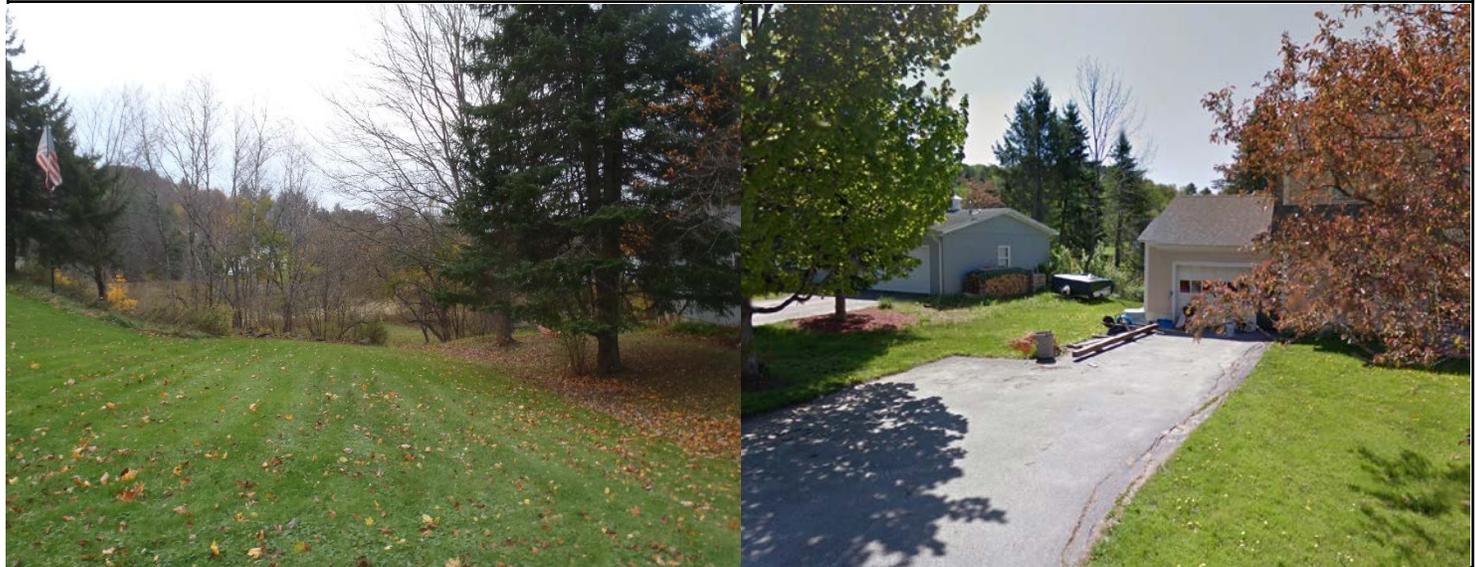
Description of Observed Conditions:
 There is a large open area behind 11 Dairy Lane that could be retrofitted to provide treatment for the Greenfield Terrace neighborhood.

Photo 1. Looking south from east of 11 Dairy Ln

Photo 2. Looking south from west of 11 Dairy Ln

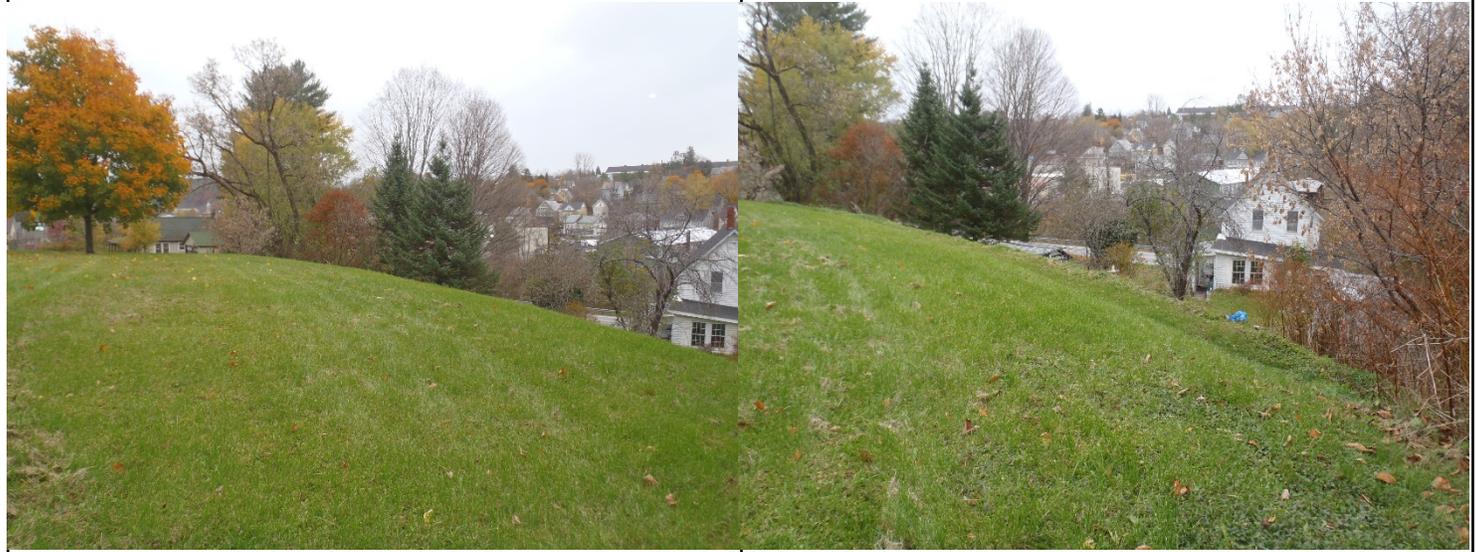
Description of Observed Conditions:
 There is a large open area across from 169 Berlin St that could be retrofitted to provide treatment for the Berlin St. – Cedar Hill – Wilson St. neighborhood. Flat areas of site are somewhat limited with site dropping off quickly and steeply to the northeast which may limit treatment options.

Photo 1. Looking northwest across open area. Photo 2. looking northeast across open area.

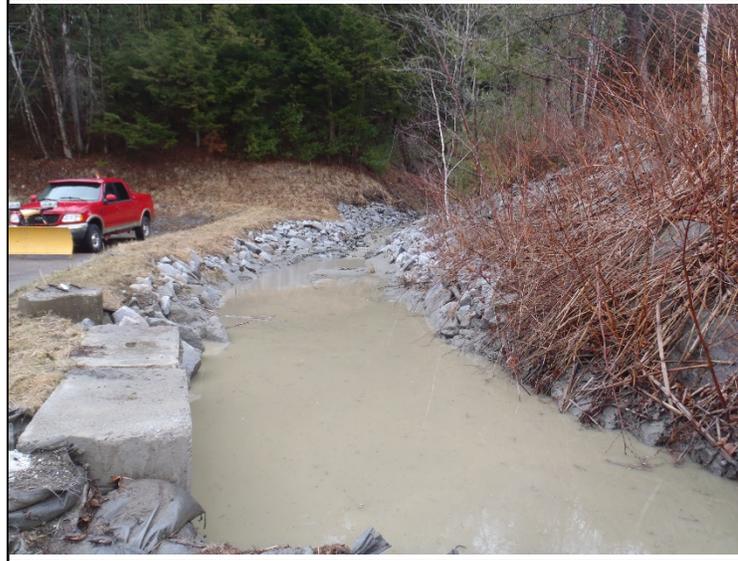
Description of Observed Conditions:
 Undersized culvert on Crossway Saab property captures intermittent stream and conveys under Route 302 through the Cody Chevrolet property to Stevens Branch. Significant sediment deposits at culvert outlet, likely attributable to actively eroding channel above Crossway Saab. In addition, there is significant headcutting due to overland flow behind Cody Chevrolet which contributes to the sediment load being delivered to Stevens Branch.

Photo 1. Stone channel conveying sediment-laden water to undersized culvert; culvert was plugged with debris when photo was taken.

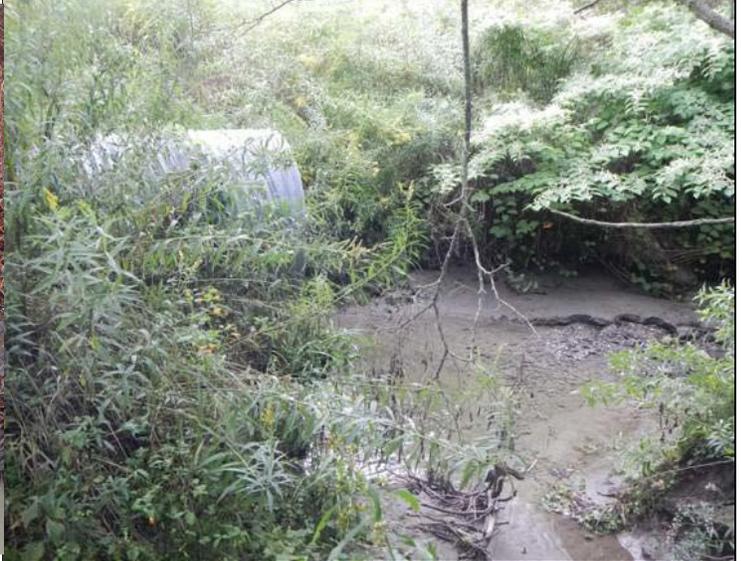
Photo 2. Culvert outlet pool behind Cody Chevrolet Note eroded banks.

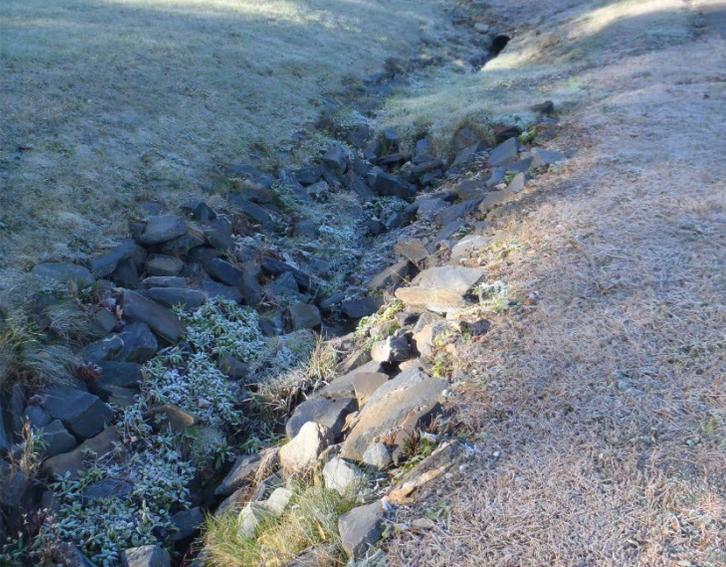
Description of Observed Conditions:
 The drainage ditch along the southside of Moonlight Terrace appears to receive a high sediment load. The ditch has previously been stabilized with rip rap and two check dams, but additional check dams are likely needed given the road slope.

Photo 1. Looking west along Moonlight Terr away from the Barre-Montpelier Rd.

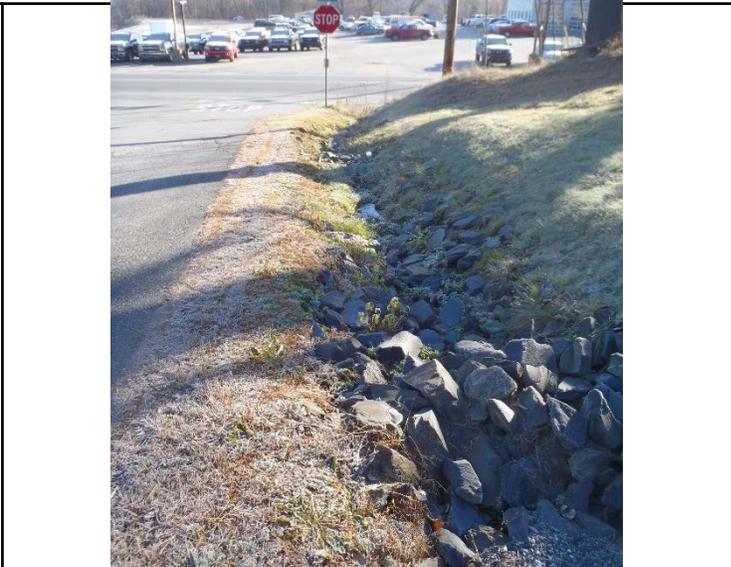
Photo 2. Looking east along Moonlight Terr

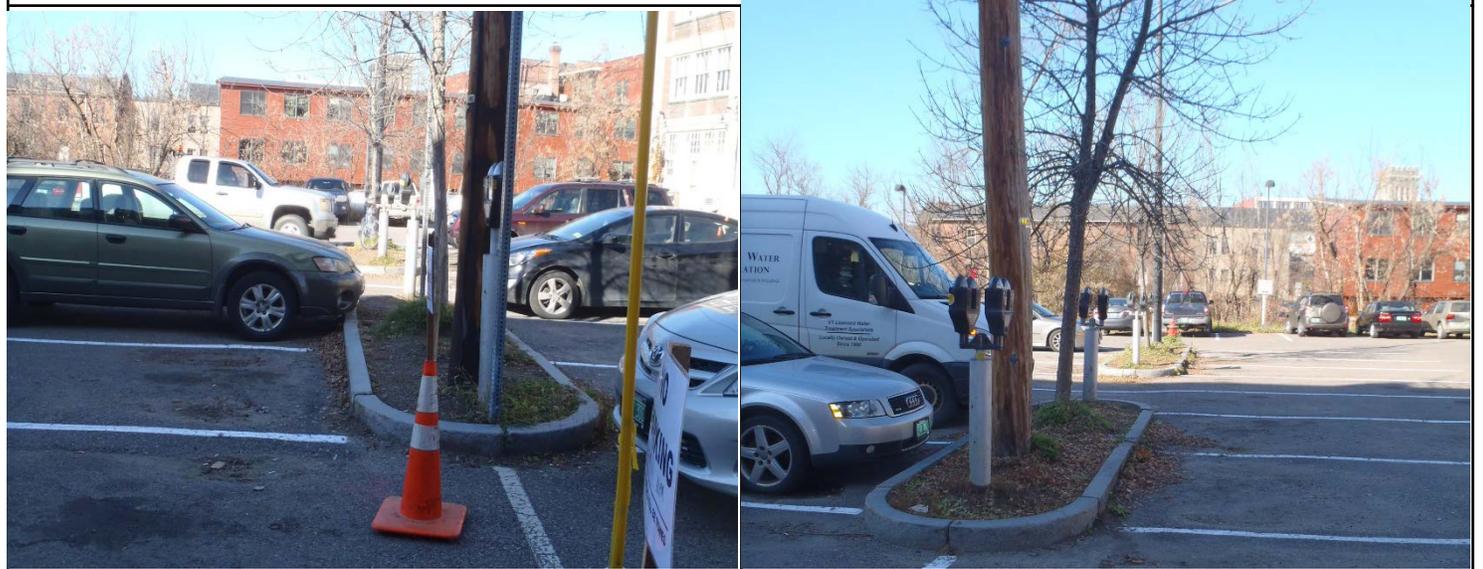
Description of Observed Conditions:
Expand/improve existing islands in parking lot for storm water capture and treatment prior to discharge to the Winooski River.

Photo 1. Islands in parking lot could be reconfigured to promote stormwater management.

Photo 2. More islands.

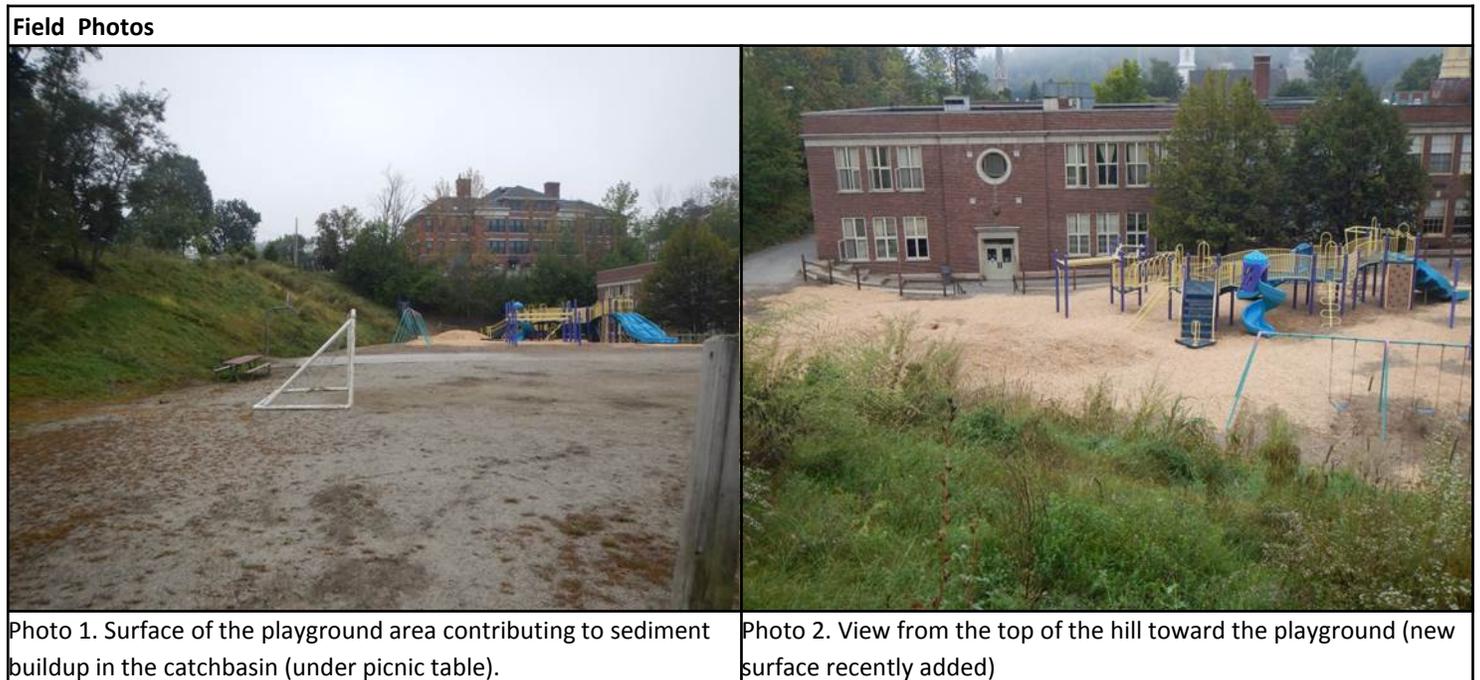
Description of Observed Conditions:
 Due to its landscape position, Union Elementary School receives considerable run-on from south and east. There are a number of catch basins on the school property that are partially or fully located within the school's outdoor recreation areas, and thus collect a considerable amount of wood chips used to treat these areas. The school is actively fundraising to make improvements to these recreation areas, and hopes to incorporate improved stormwater management efforts into the overall renovation.

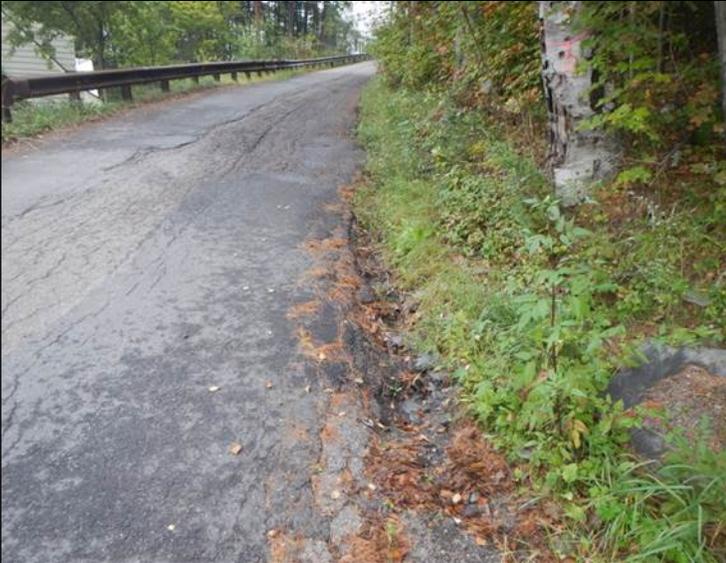
Description of Observed Conditions:
 Marvin Street is steep and narrow, making the construction and maintenance of appropriate roadside drainage difficult (particularly along the section between Hubbard and Bingham Streets) (Photo 1). Potential opportunity for bioretention at the corner of Marvin and Bingham (Photo 2), though this site is on private property.

Photo 1. Erosion on roadside requiring ditch maintenance	Photo 2. Potential bioretention location at the corner of Marvin and Bingham Streets

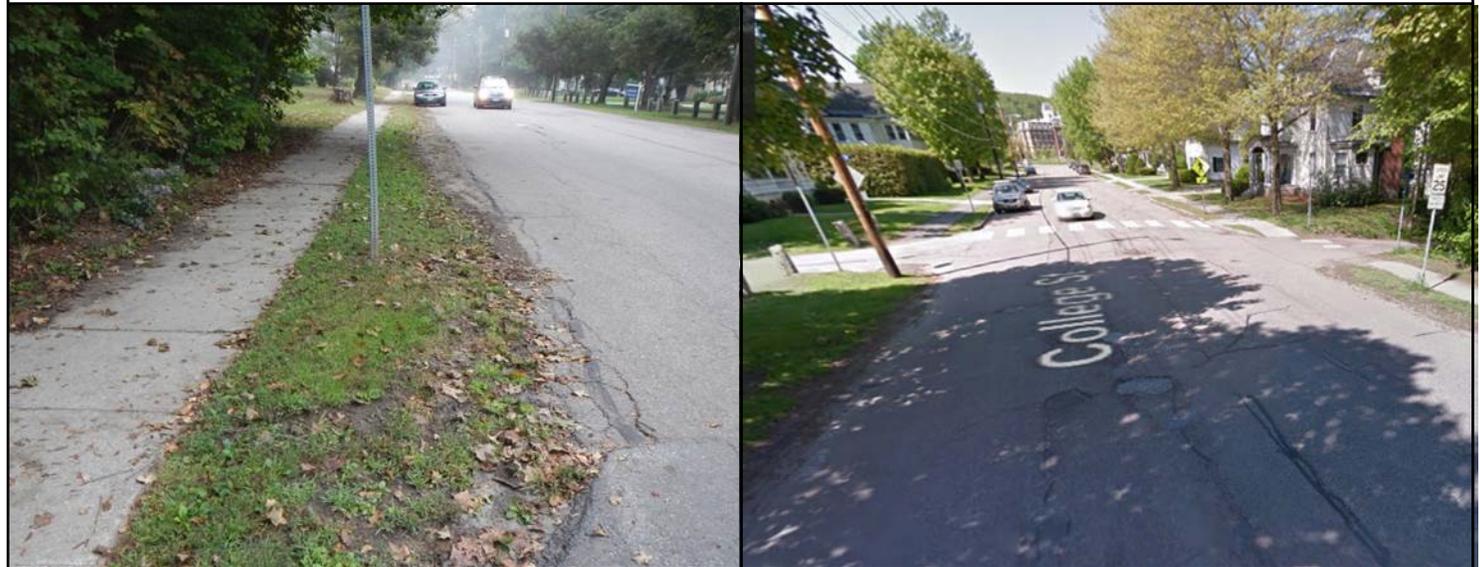
Description of Observed Conditions:
 College Street is wide, with no curbs separating the road edge from the adjoining green space. "Green Street" retrofit could be used to capture/treat runoff and add the benefit of traffic calming.

Photo 1. Corner of Marvin and College. Traffic moves fast on College St.

Photo 2. Facing the opposite direction as Photo 1. (Photo from Google Maps)
