Stormwater Master Plan City of Montpelier, Vermont

15-097

Stormwater Master Plan

City of Montpelier, Vermont

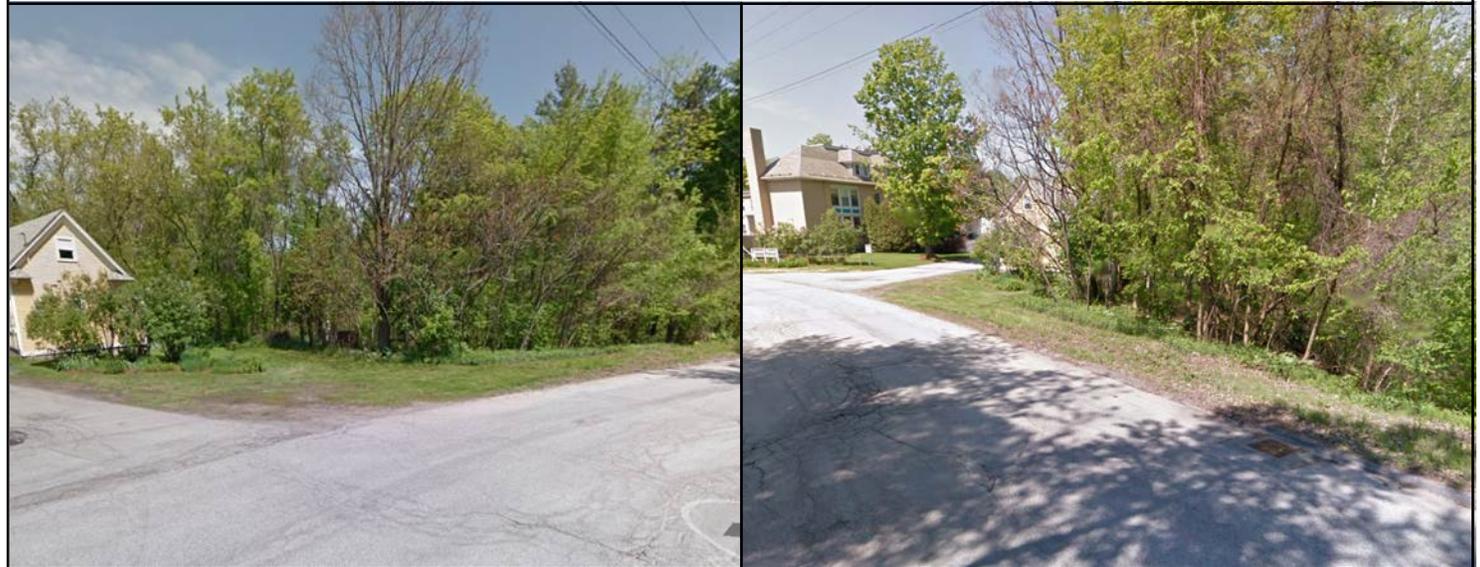
Description of Observed Conditions:
 A bioretention or other treatment could be installed on the green corner at the turn-in to Heaton Woods (Photo 1). Catch basin on Woodrow Ave could be capped and stormwater diverted into the treatment area.

Photo 1. Location of potential bioretention area. Image from Google Maps.

Photo 2. View of the proposed rain garden location showing the catch basin to be capped

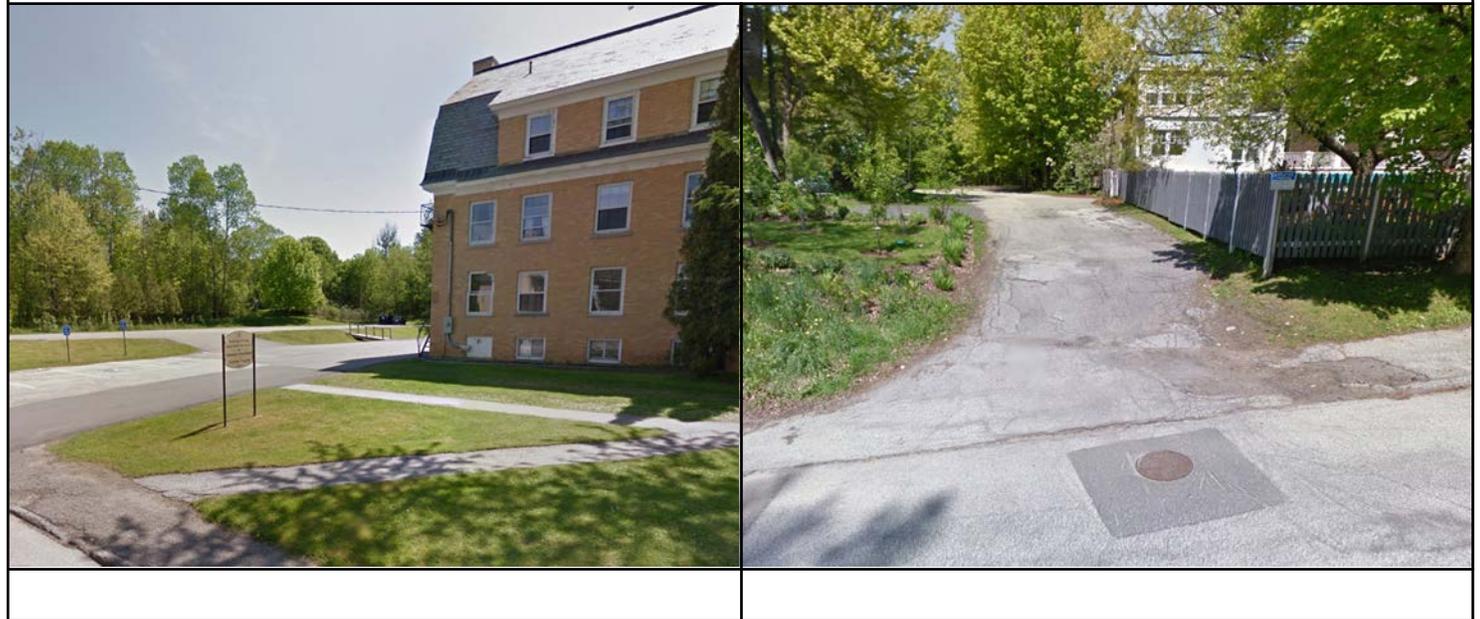
Description of Observed Conditions:
 This facility contains a significant amount of unmanaged impervious surface. There is green space in front of the building along Heaton St. that could be retrofit to manage runoff from the parking lot.

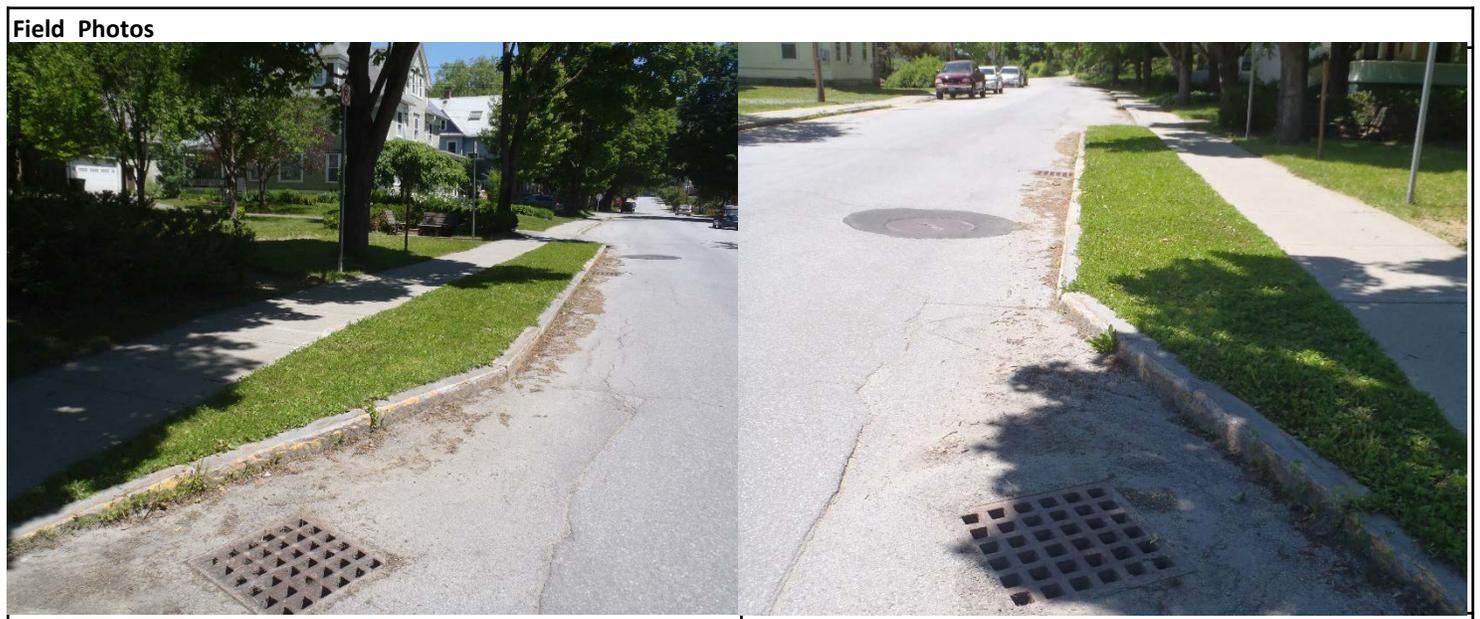
Description of Observed Conditions:
 The City previously installed a bump-out in front of a small, neighborhood park to promote better line-of-sight. The area could be recessed to also accept storm flows from Summer St.

Photo 1. Looking northeast along Summer St Photo 2. Looking to the southwest along Summer St

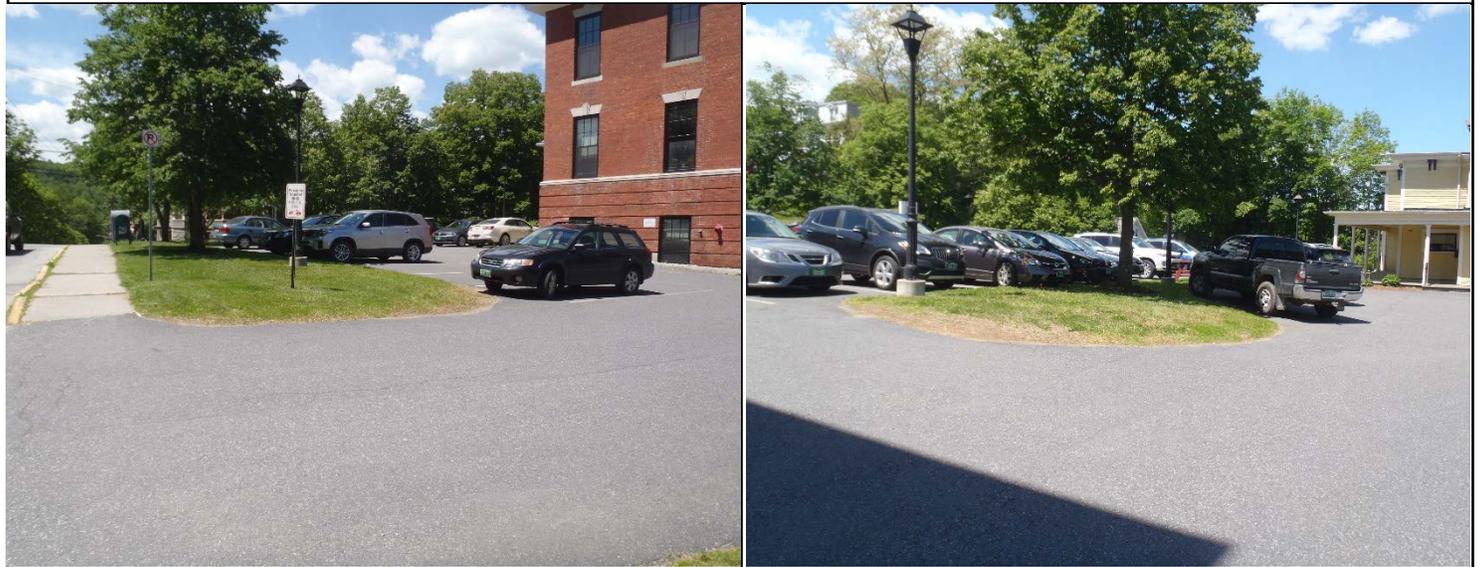
Description of Observed Conditions:
 Runoff from the parking lot and building roof at 54 East State St are currently unmanaged, and the catch basins serving this site are connected to the City's combined sewer system.

Photo 1. Existing green space along southern boundary of 54 East State St.

Photo 2. Existing parking lot island at 54 East State St

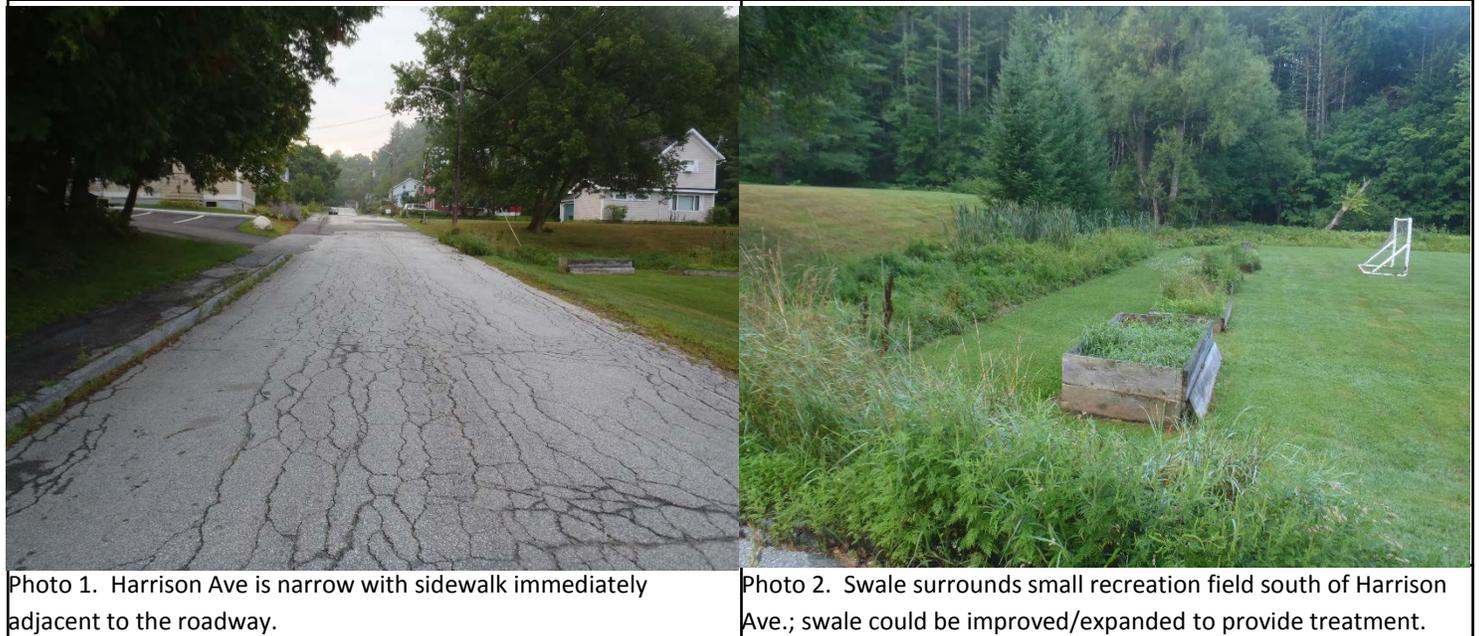
Description of Observed Conditions:
 The City has indicated that water main replacement and road paving is planned for Harrison Ave in 2018, which provides an opportunity to consider stormwater management solutions for this neighborhood. There is an existing recreation field in the south west corner of this neighborhood, surrounded by a swale that could provide an opportunity for enhanced treatment.

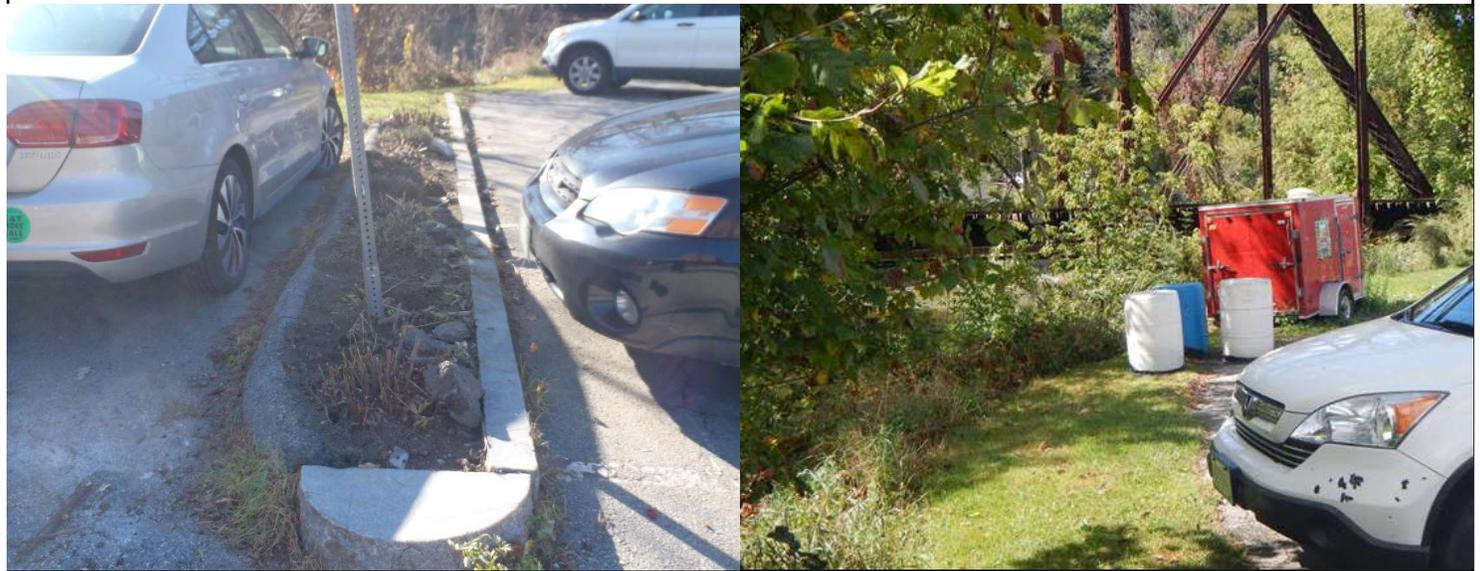
Description of Observed Conditions:
 Potential retrofit in southeast corner of lot to capture/treat runoff from parking lot prior to discharge into the Winooski. There may be opportunities to reconfigure parking in lot to the west to create bioretention islands in the lot.

Photo 1. Small, existing island that could be reconfigured to except stormwater runoff

Photo 2. Strip of downward-sloping green space looking toward railway bridge

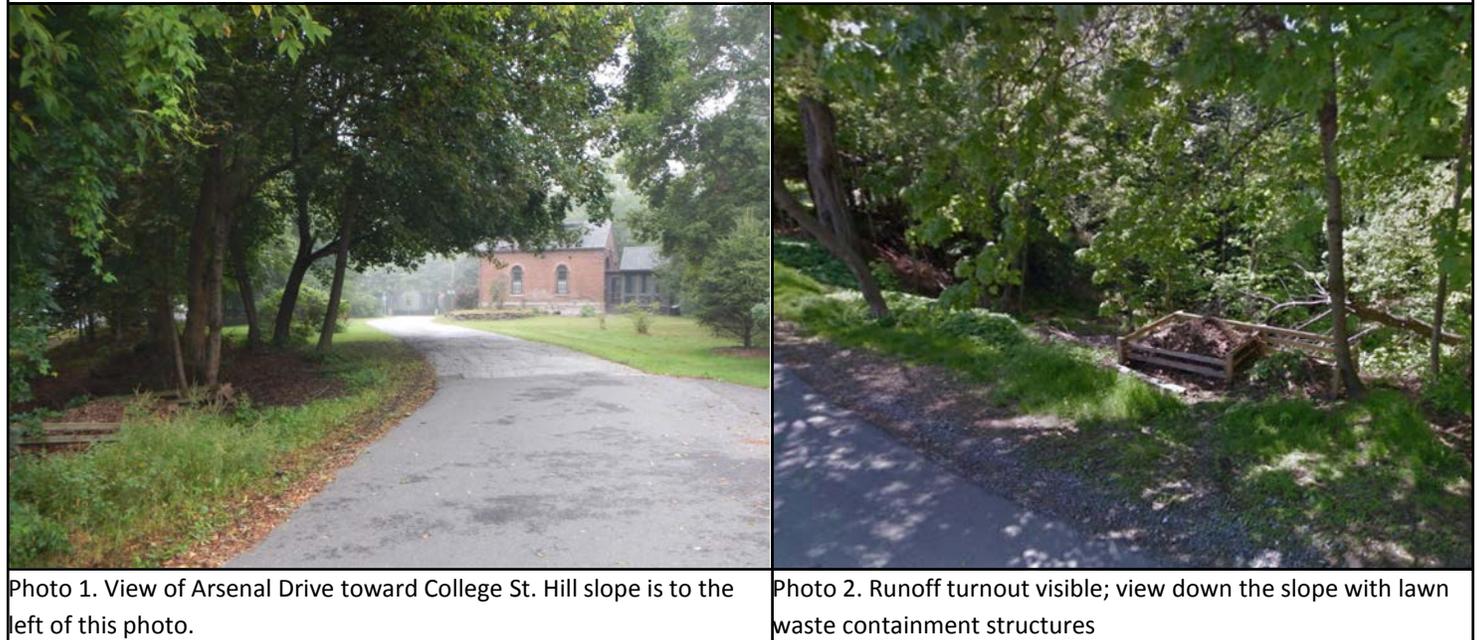
Description of Observed Conditions:
 Stormwater runoff from approximately 150' immediately east of College St. is turned out over a steep hillside and through an area where lawn waste is being composted. "Green Street" retrofitting could be used to better manage road runoff.

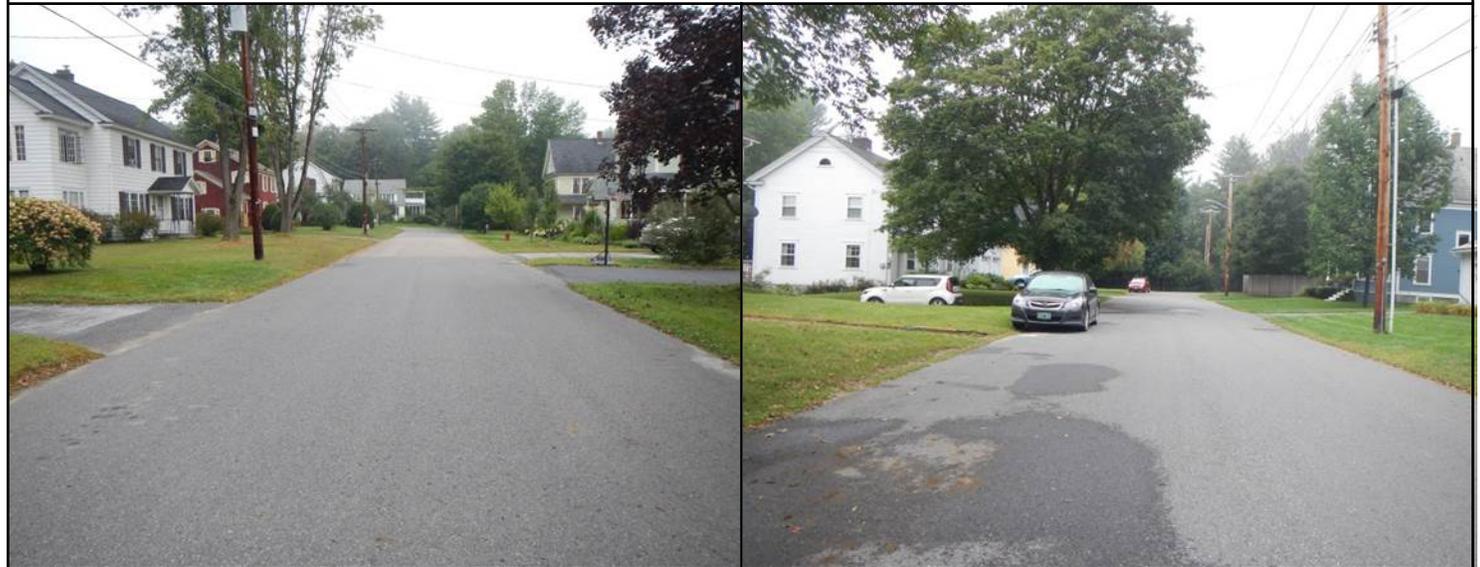
Photo 1.

Description of Observed Conditions:
 Hinkley Street is wide, with no curbs separating the road edge from the adjoining green space. "Green Street" retrofit could be used to capture/treat runoff and add the benefit of traffic calming.

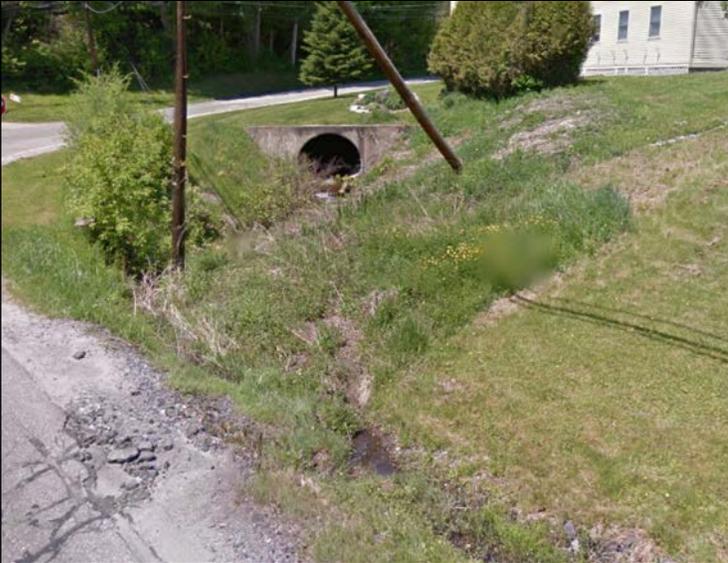
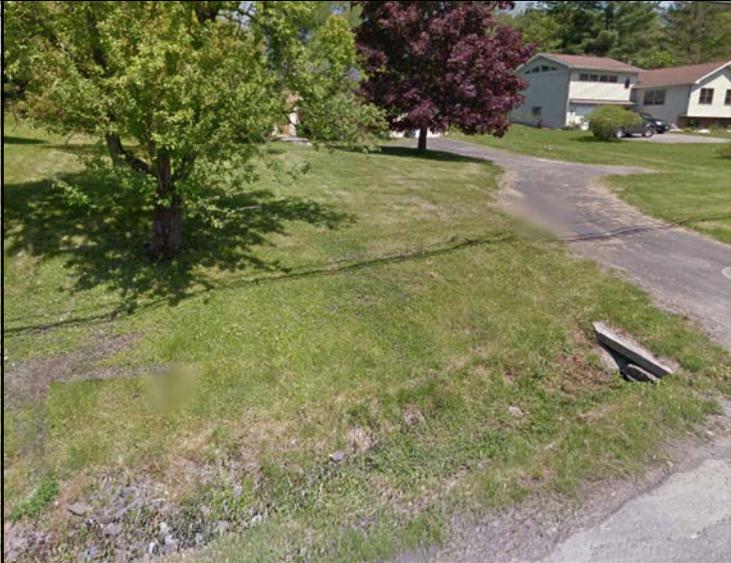
Description of Observed Conditions:
 Roadside drainage at the intersection of Towne Hill Rd and Main St is eroding. Drainage could be reshaped and stabilized to both reduce erosion and improve treatment.

Photo 1. Ditch running into creek.	Photo 2. More permanent vegetation should be planted in this ditch.

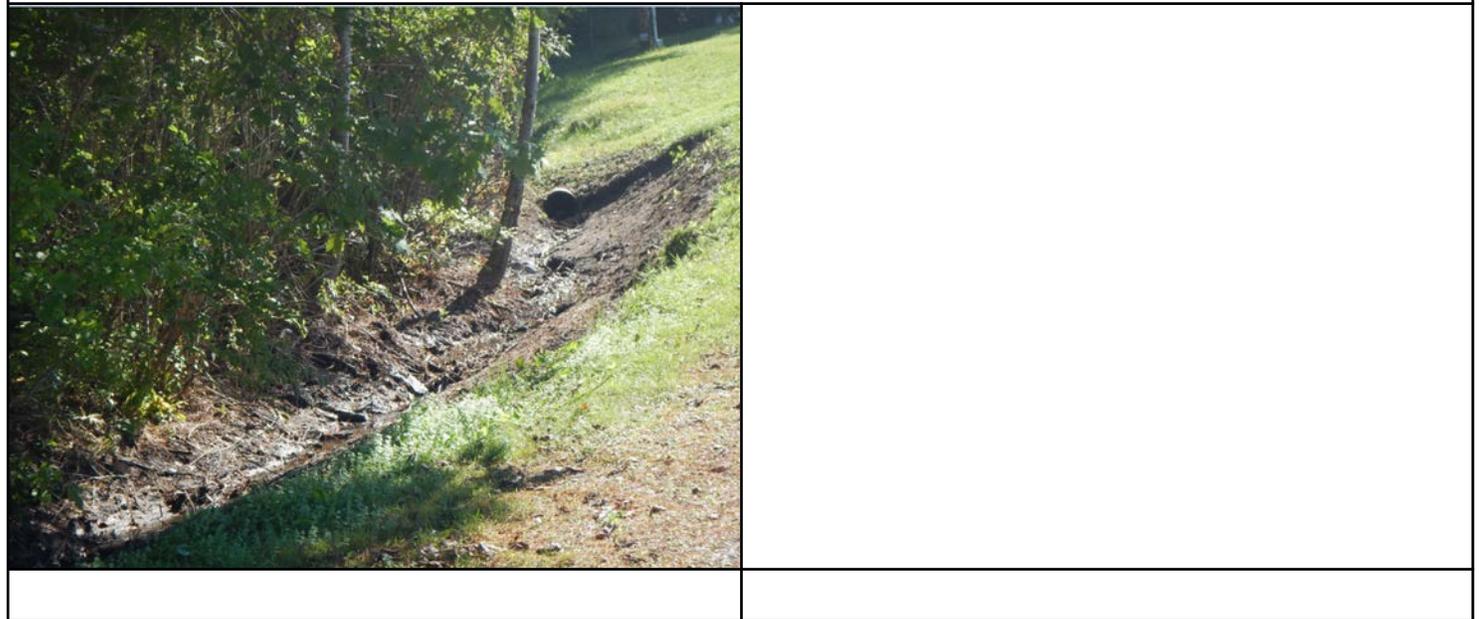
Description of Observed Conditions:
 Drainage at 28 Spring Hollow Road has recently been maintained, but was not stabilized. The V-shape and oversteepened banks of the drainage ditch will also need to be addressed.

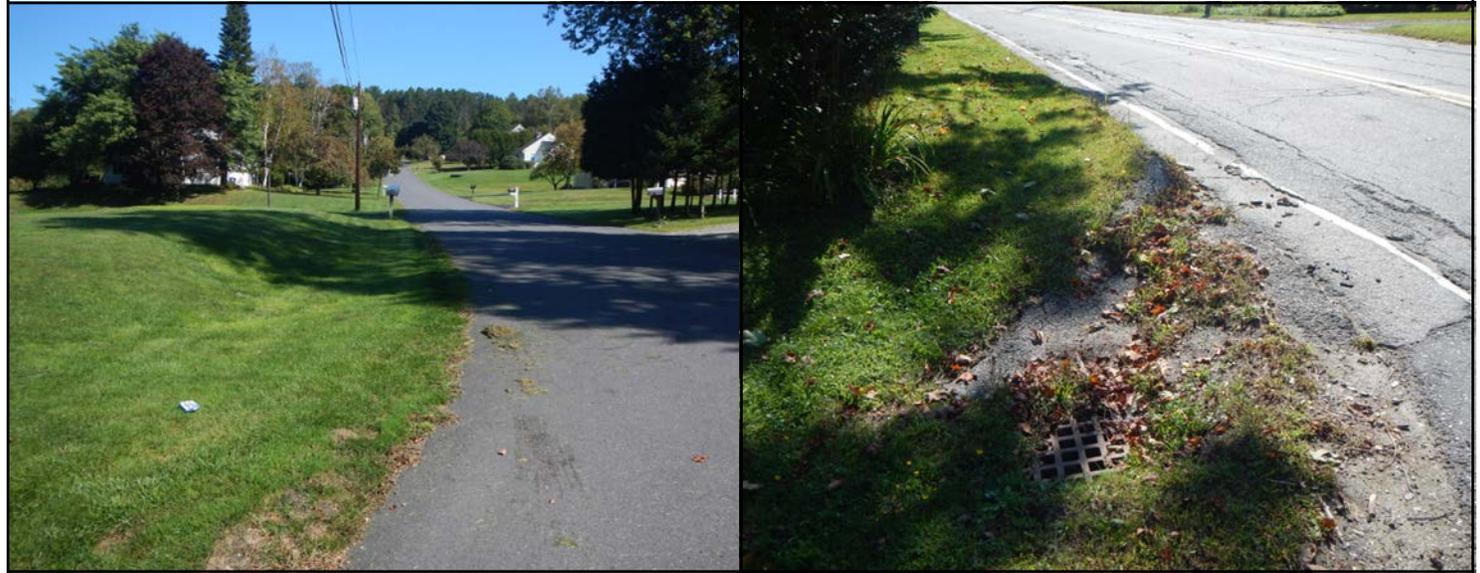
Description of Observed Conditions:
 "Green Street" or other retrofit within the ROW on Woodcrest Rd could be used to capture/treat runoff and add the benefit of traffic calming (Photo 1). On the opposite side of Woodcrest Rd a riser could be added to the catch basin to more effectively manage storm flows (Photo 2).

Photo 1. Potential rain garden site at the corner of Woodcrest and Towne Hill Rds.

Photo 2. Catch basin that needs to be fitted with a riser.

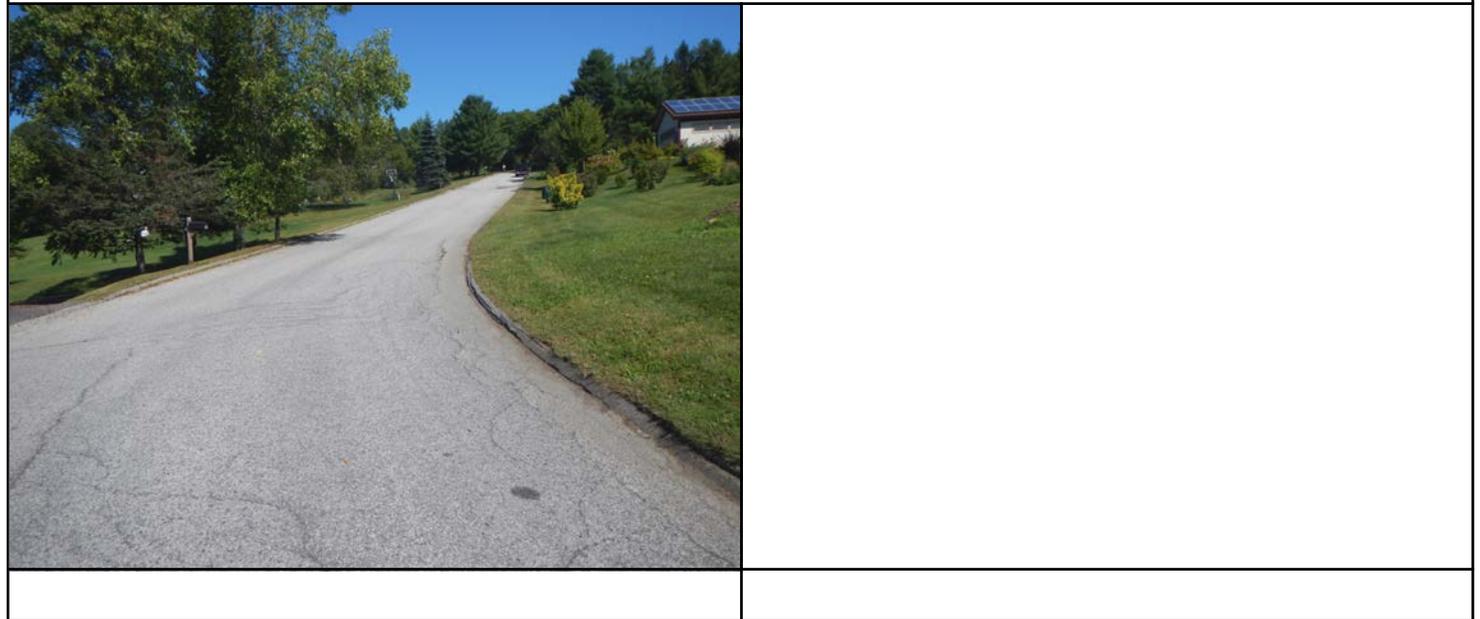
Description of Observed Conditions:
 Stream channel is currently unraveling below the road; this channel was partially stabilized following a 2008 storm event. Removing the curb on the east side of the street below 135 Phillips Road would allow for a grassed swale to manage stormwater runoff.

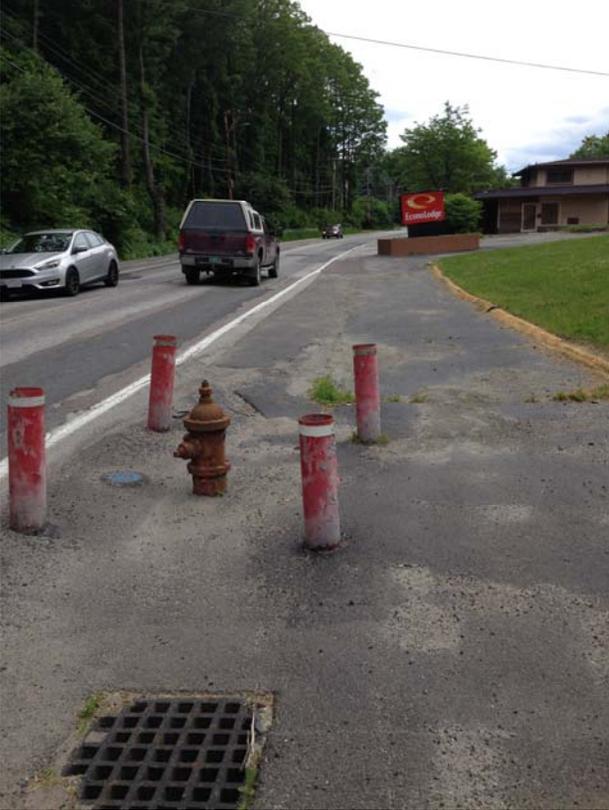
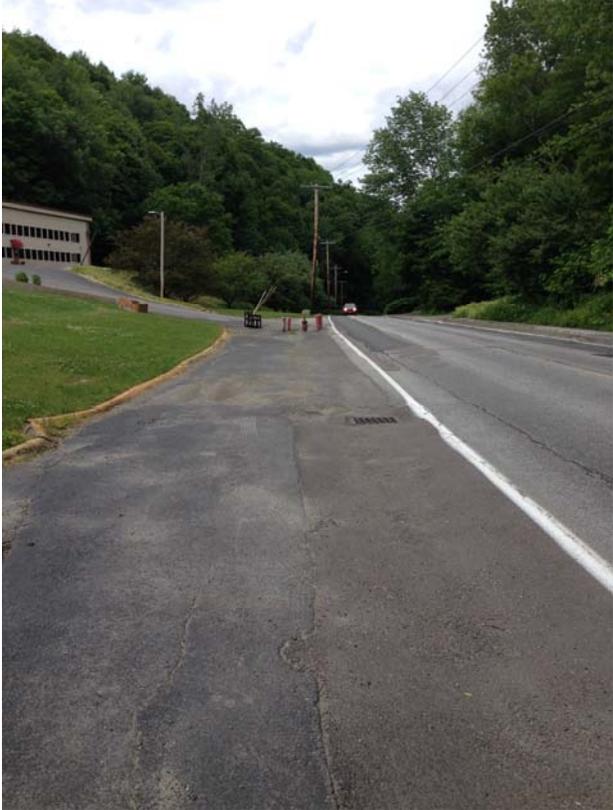
The western side of Northfield St. near the Econolodge, from roughly in front of the abandoned restaurant building to the catchbasin at the main entrance to the motel, currently drains to the catch-basin at the northeast corner of a curbed lawn island in front of the new motel building. The curbed lawn area appears to end at the City’s right-of-way, which is entirely paved between the lawn and VT Route 12. This paved area could instead be made into a stormwater swale (similar to the College Street Stormwater Swale concept), with an underdrain tying back into the storm drainage system at the northern end of the facility. The success of this concept depends largely on potential conflicts with other underground infrastructure, particularly the water system.

Area 1, potential stormwater swale treatment area, looking south (left) and north (right).

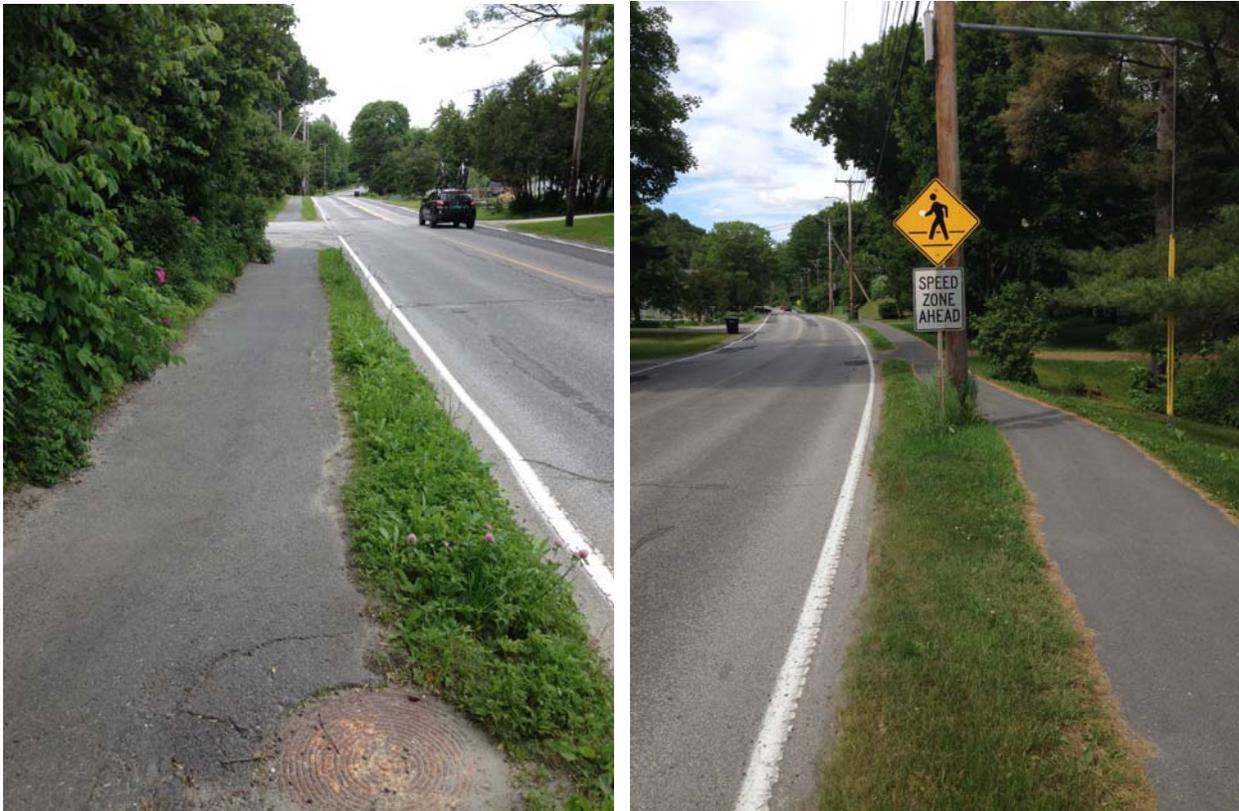
Along the eastern side of Northfield Street, between the northern and southern intersections with Colonial Drive, is a substantial opportunity to retrofit the existing three-foot-wide green strip between the pavement edge and the sidewalk into a stormwater swale. This concept would also be similar to the College Street Stormwater Swale concept, but with a narrower width to fit within the existing green strip (more like Stormwater Planters concept from the Heney-Jacobs Parking Lot opportunity sheet). The roadway in this area is not curbed, and catch basins on this side of the road already tie to the stormline on the west side, so underdrains in the retrofit stormwater swales could be tied back into the existing closed drainage system without disturbing the existing infrastructure.

Area 2, potential stormwater swale treatment area, looking south (left) and north (right).

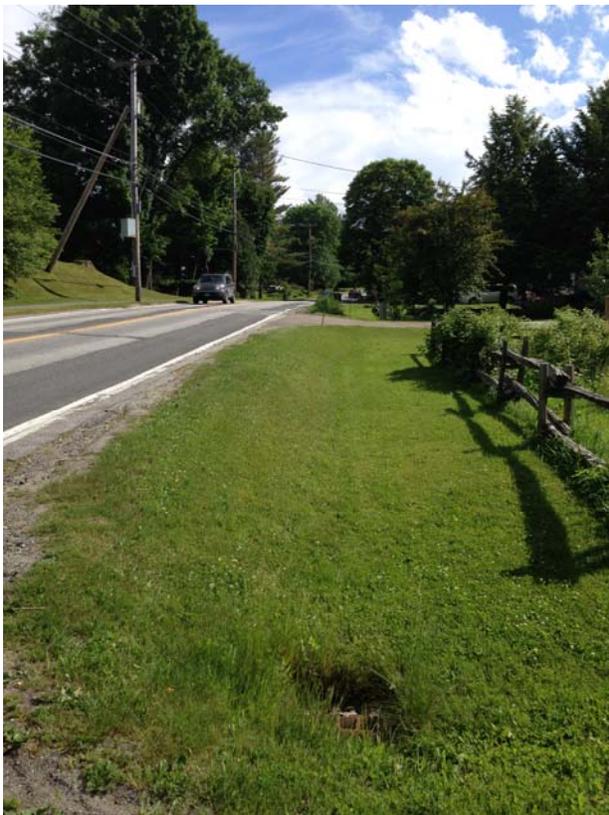
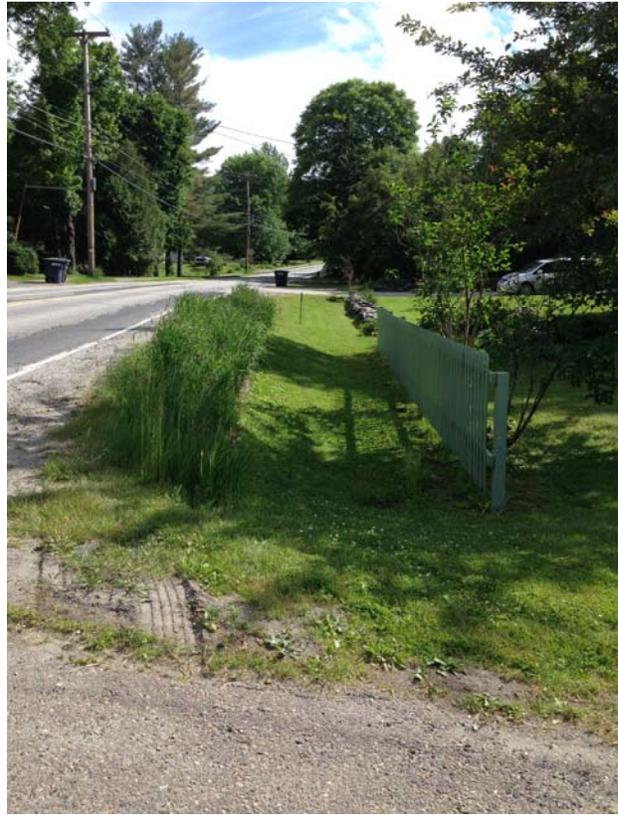
Along the west side of Northfield Street across from Area 2, there is an opportunity to retrofit existing grass swales into stormwater swales, particularly in front of the four houses south of the Lutheran Church. This concept would also be similar to the College Street Stormwater Swale concept, but modified as necessary to fit within the existing right-of-way. Based on parcel mapping, the right-of-way appears to be very constrained on this side of the road as compared to Area 2, and so this opportunity may require negotiation with the abutting landowners beyond what would be reasonable within the anticipated timeline for the roadway reconstruction project. At minimum, however, care should be taken to maintain sheetflow from the roadway into the grass swales, to minimize short-circuiting of runoff flowing down the road shoulder and directly to catch-basins rather than traveling into the grass swales.

Area 3, potential stormwater swale treatment area, looking south.

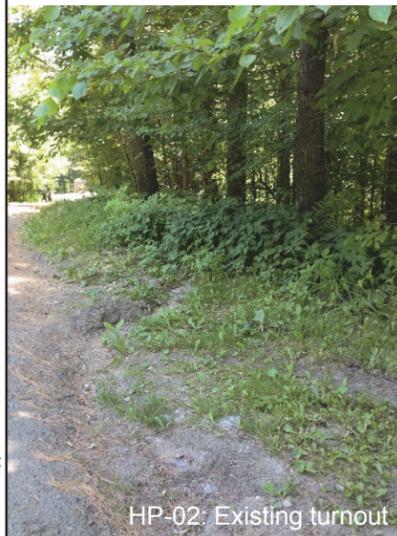
HP-02: Existing turnout

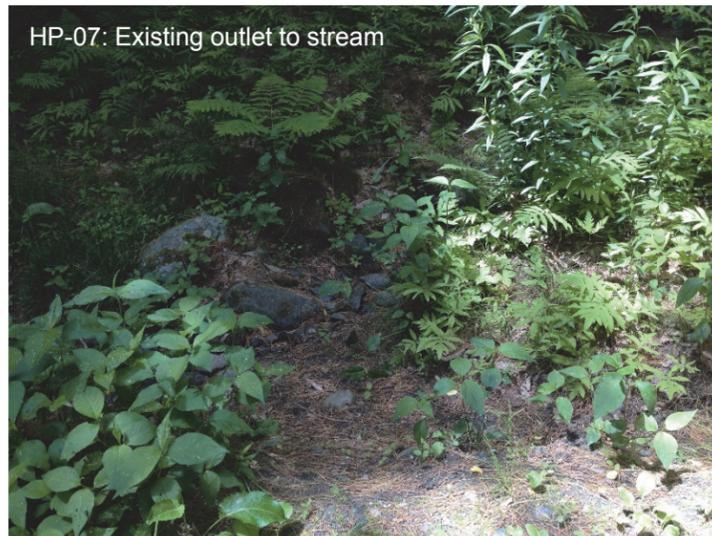
HP-07: Existing outlet to stream

- HP-15: REPAIR CULVERT ENDWALL PER TYPICAL DETAIL. INSTALL ROCK APRON AT DOWN-SLOPE END OF CULVERT, USING DIMENSIONS FROM HP-07.

Item	Quantity	Unit
Rock Apron (HP-07 and HP-15, per outlet)		
#4 riprap, placed	5	CY
Stone-Lined Ditch (HP-08)		
Excavation	39	CY
#4 riprap, placed	26	CY

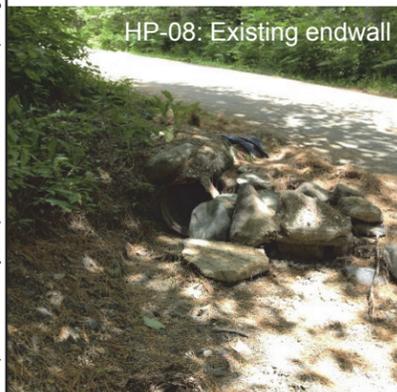
HP-08: Existing endwall

- HP-08: REPAIR CULVERT ENDWALL PER HEADER TYPICAL DETAIL. RESHAPE AND STONE LINE DITCH ON UPSLOPE SIDE OF CULVERT. STONE LINED DITCH VOLUMES:
 - EXCAVATION: 3' DEEP, 2' BOTTOM WIDTH, 2:1 SIDES.

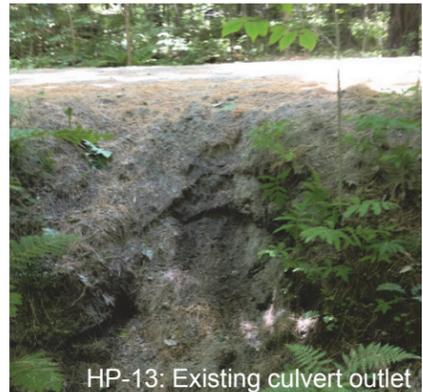
HP-13: Existing culvert outlet

- 1 FT DEPTH X 14 FT WIDTH = 14 CF/LF X 50 LF = 700 CF = 26 CY
- HP-13: LOCATE AND CLEAN OUT DOWN-SLOPE END OF CULVERT. REPAIR CULVERT ENDWALL (OR INSTALL ENDWALL) PER TYPICAL DETAIL. SEE SHEET 1 FOR PLUNGE POOL DESIGN DETAILS.

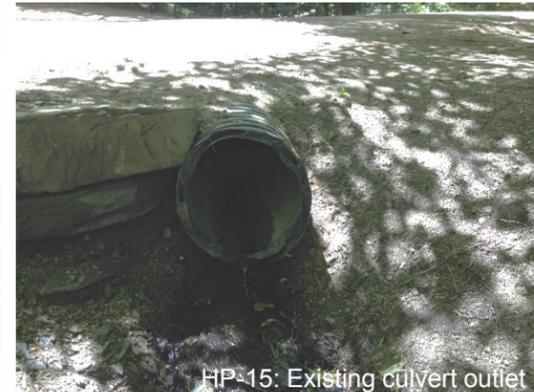
HP-15: Existing culvert outlet

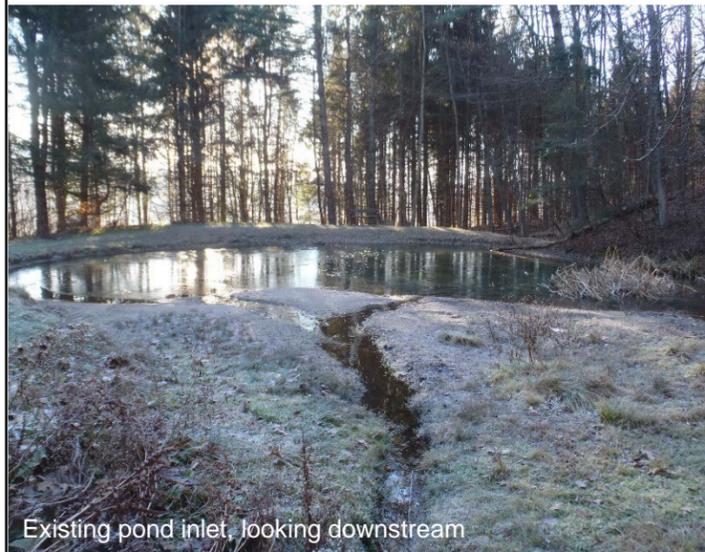
Existing pond inlet, looking downstream

- DESIGN IMPROVEMENTS TO THE EXISTING POND RECOMMENDED AS FOLLOWS:
 - EXCAVATE SEDIMENT ACCUMULATION TO RESTORE POND GEOMETRY. CONSIDER EXTENDING POND FOOTPRINT SLIGHTLY TO THE NORTHWEST/INLET END TO INCREASE AVAILABLE AREA FOR SEDIMENT STORAGE.

- CONSTRUCT SEDIMENT FOREBAY AT EXISTING POND INLET. THE FOREBAY SHOULD BE SIZED TO CONTAIN AT LEAST 10% OF THE WQV (OR ~1,000 CU. FT.). THE FOREBAY OUTLET SHOULD BE DESIGNED WITH NON-EROSIVE CONDITIONS AND PLACED TO MAXIMIZE THE FLOW PATH OF WATER THROUGH THE FOREBAY.

- LINING THE BOTTOM OF THE FOREBAY WITH RECYCLED GRANITE CURBING IS RECOMMENDED TO FACILITATE CLEANOUT. ENSURE THAT VEHICLE ACCESS CAN BE MAINTAINED TO THE FOREBAY FOR EASE OF MAINTENANCE.

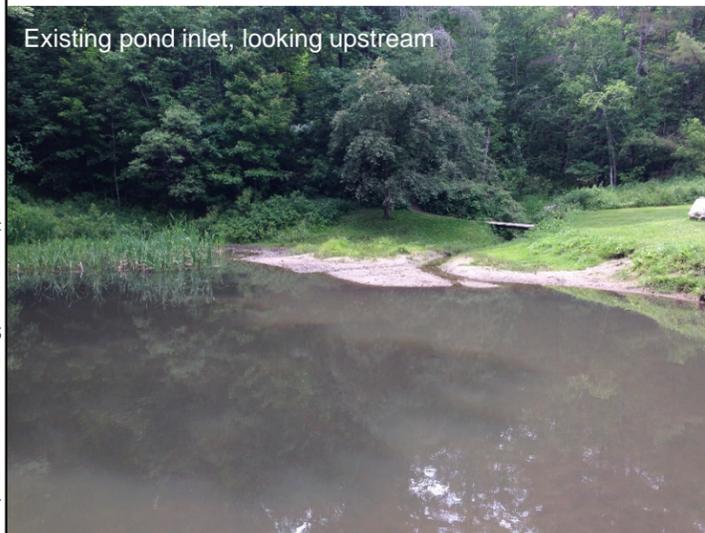
Existing pond inlet, looking upstream

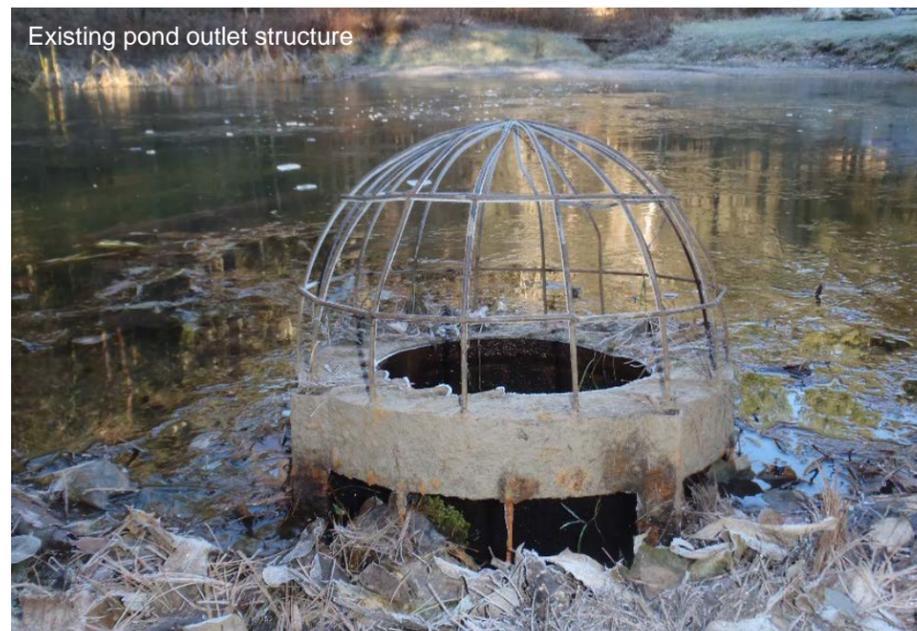
Existing pond outlet structure

- THE EXISTING POND OUTLET STRUCTURE RETURNS STORM FLOWS TO THE CLOSED DRAINAGE SYSTEM. THERE IS NO SEPARATE EMERGENCY SPILLWAY OR STABLE OUTFALL. THIS DESIGN CONCEPT DOES NOT ENVISION THE CONSTRUCTION OF NEW OUTFALLS OR EMERGENCY SPILLWAYS SUCH AS THOSE SHOWN IN THE SCHEMATIC.
- THE AREA AND GEOMETRY AVAILABLE FOR IMPROVEMENTS TO THE EXISTING POND WILL LIMIT THE POSSIBILITIES FOR EXTENDED DETENTION OF STORM FLOWS GREATER THAN THE WATER QUALITY VOLUME. WHILE THE SCHEMATIC SHOWS THE FULL RANGE OF POSSIBILITIES FOR EXTENDED DETENTION, DETAINING THESE VOLUMES IS NOT LIKELY TO BE FEASIBLE.

- REPLACE THE EXISTING POND OUTLET STRUCTURE. IF POND VOLUME IS SUFFICIENT, CONSIDER INSTALLING A RISER WITH MULTIPLE OUTLET LEVELS TO RETAIN A PERMANENT POOL AND SOME AMOUNT OF EXTENDED-DETENTION STORAGE FOR LARGER STORMS, WHILE RETAINING A PROTECTED, OPEN RISER TOP FOR RETURN OF LARGER STORM FLOWS TO THE CITY'S CLOSED DRAINAGE SYSTEM.

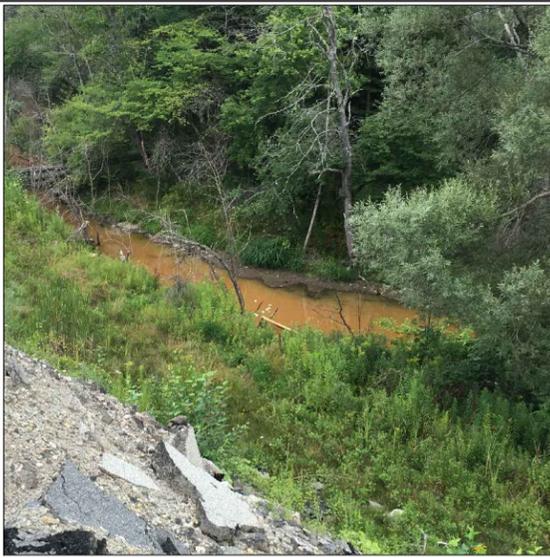
- FR-01: THE STREAM EXITING THE SITE HAS TAKEN ON A RUST COLOR. IT SHOULD BE INVESTIGATED FURTHER TO DETERMINE THE CAUSE OF THE DISCOLORATION. IT IS LIKELY THAT THE BRIDGE TRUSS AT FR-02 IS A CONTRIBUTING FACTOR.

FR-01: STAINING IN THE STREAM

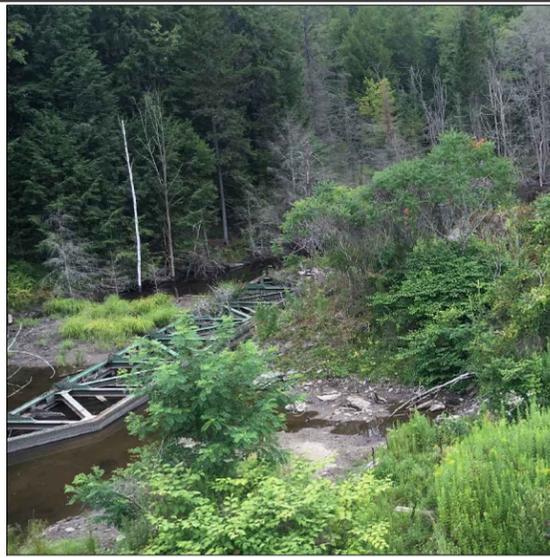
FR-02: BRIDGE TRUSS IN STANDING WATER

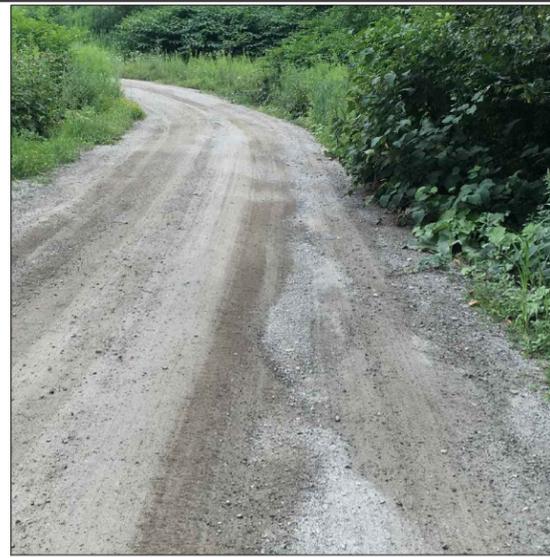
FR-03/04: DITCHING/SEDIMENT BASIN OPPORTUNITY

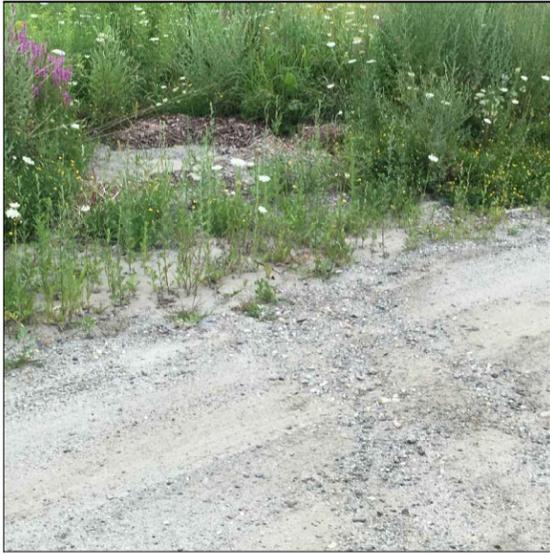
FR-05: DITCHING/WATER BAR/TURNOUT AND SETTLING BASIN OPPORTUNITIES

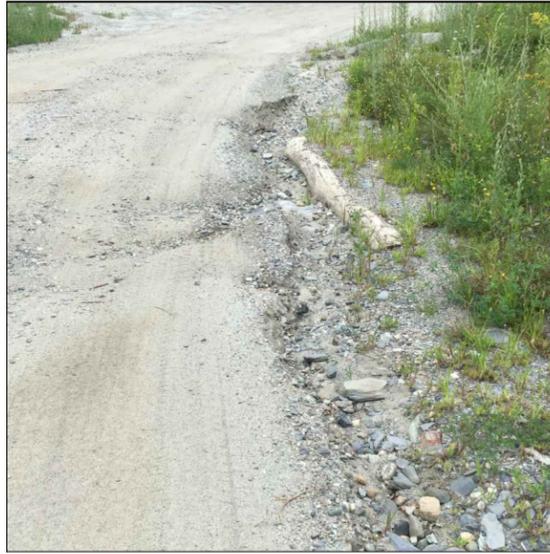
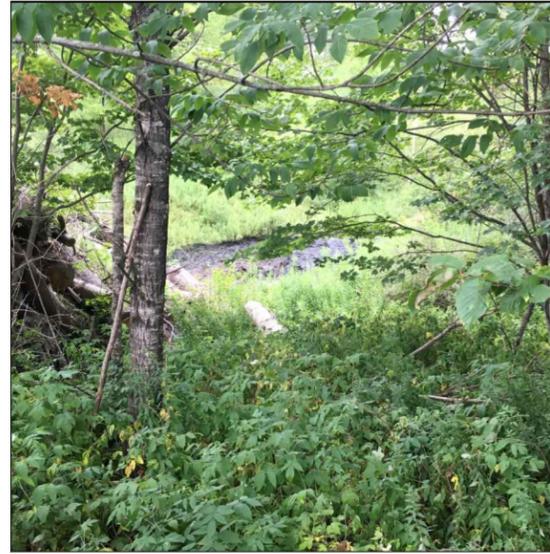
FR-06: VACUUM TRUCK DUMPING SITE

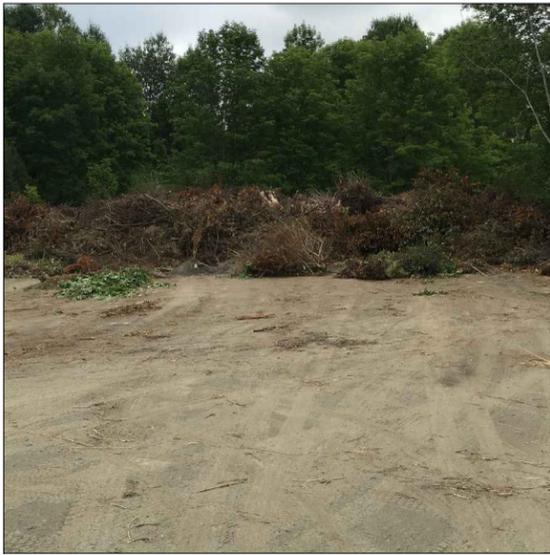
FR-07: ORGANIC MATERIAL DUMPING SITE

- FR-07: ALL ORGANIC MATTER SHOULD BE STORED IN A SINGLE LOCATION. THE LOCATION SHOULD HAVE A THREE-SIDED FENCED-IN AREA THAT CAN OPERATE AS A HOLDING STRUCTURE. IF BUILT OUT OF WOODEN SLATS. THIS AREA CAN OPERATE AS A LARGE COMPOSTING FACILITY. 2-3' SHOULD BE EXCAVATED WITHIN THE ENCLOSURE TO HELP RETAIN AND SLOW RUNOFF FROM THE DECOMPOSING ORGANIC MATTER.

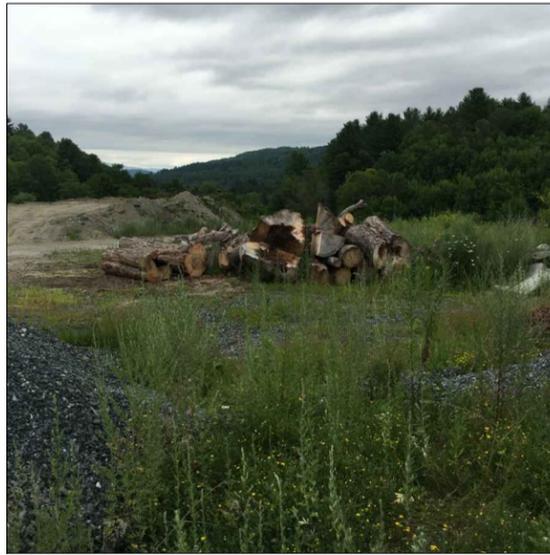
FR-07: ORGANIC MATERIAL DUMPING SITE

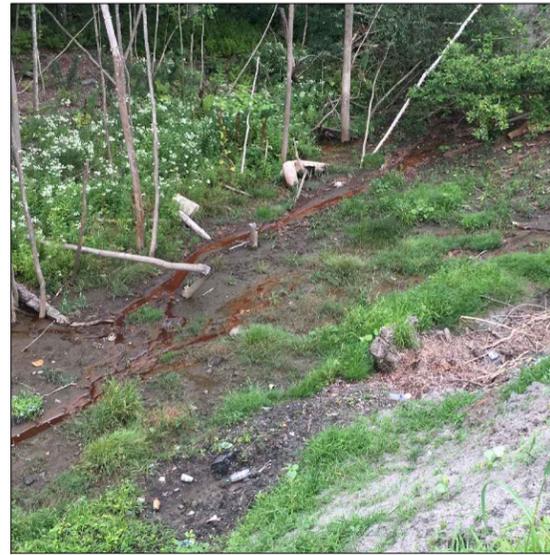
- FR-08: EMBANKMENTS ACROSS THE SITE HAVE BEGUN TO SLUMP. THE TOE SHOULD BE STABILIZED IN ACCORDANCE TO THE VEGETATED STONE OR GABION WALL DETAILS. SILT FENCE SHOULD BE PLACED BEYOND THE TOE TO HELP PROTECT AGAINST ANY FURTHER SLUMPING. AT THE TOP OF THE EMBANKMENT, FENCING OR BALLARDS SHOULD BE INSTALLED TO DETER INDIVIDUALS FROM DRIVING OR PARKING TOO CLOSE TO THE EDGE. THIS WILL ALSO RESTRICT DUMPING OVER THE EMBANKMENT TO RETAIN THE EXISTING DRAINAGE AREAS AT THE TOE.

FR-08: STABILIZE BANK

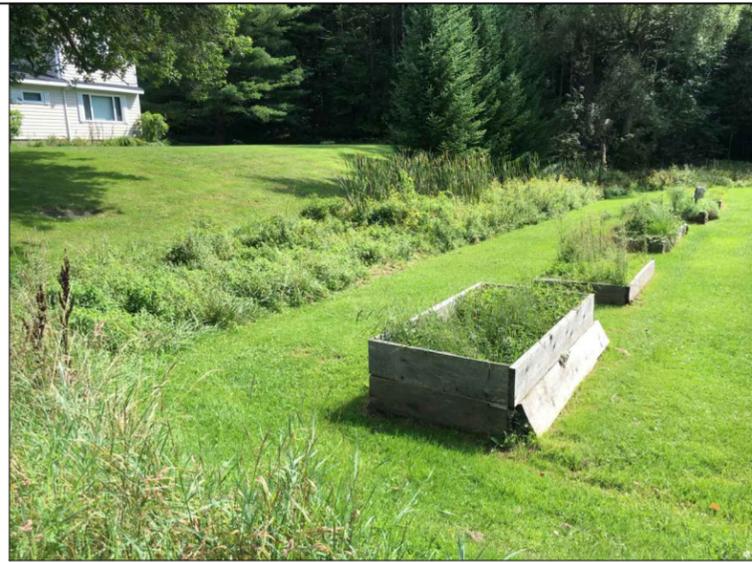
HA-03: BEGINNING OF EXISTING DRAINAGE SWALE

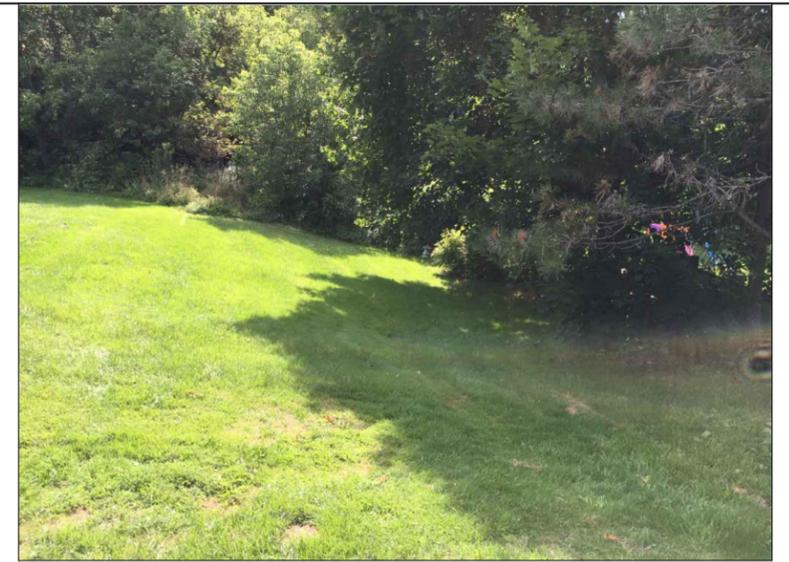
HA-07: EXISTING LOW POINT, CONSTRUCT SEDIMENT TRAP
