Stormwater Master Plan City of Montpelier, Vermont

15-097

Stormwater Master Plan

City of Montpelier, Vermont

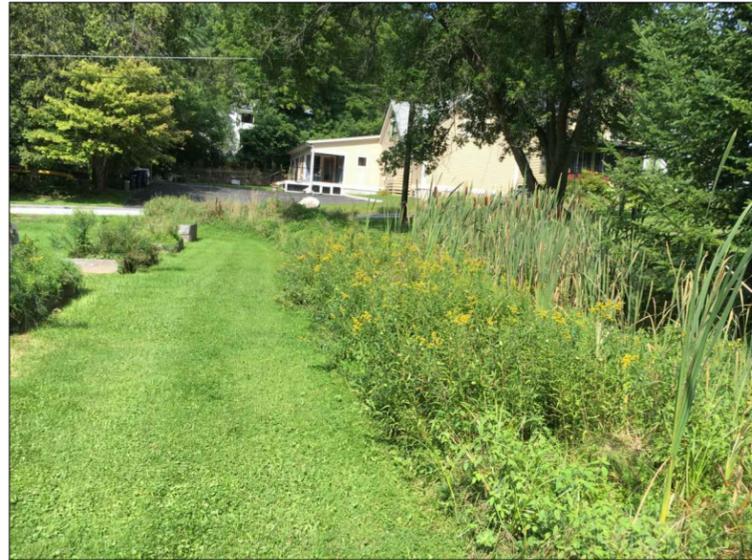
HA-03: LOOKING NORTH UP THE EXISTING DRAINAGE SWALE

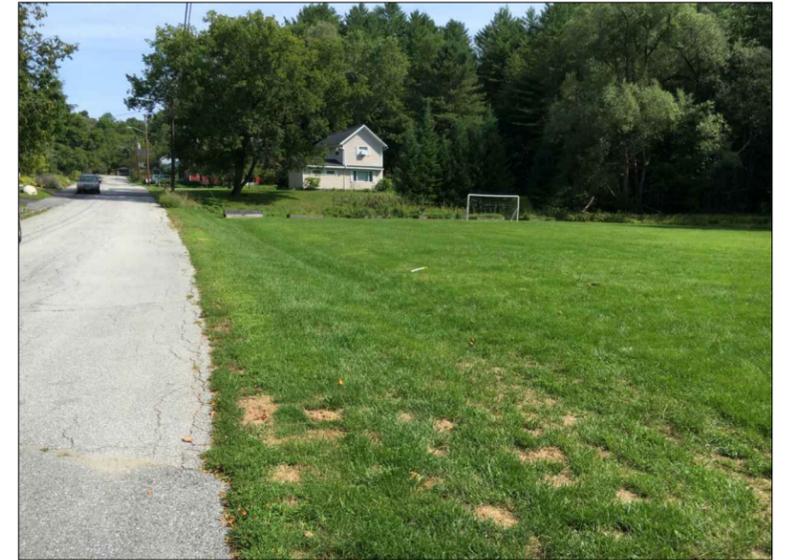
HA-05: ESTABLISH A GRASS SWALE ALONG THE EDGE OF ROAD

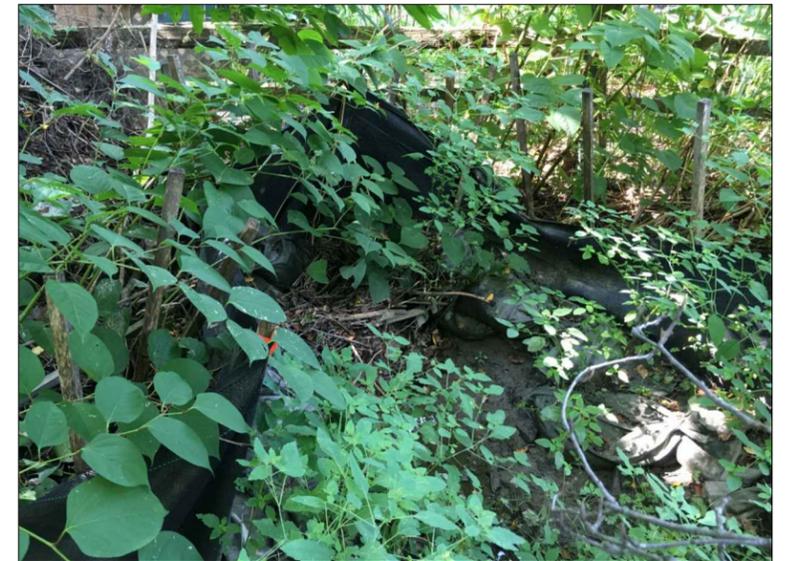
HA-08: UNKNOWN COLLECTION / OUTLET STRUCTURE IN SWALE

- HA-08: DETERMINE OUTFALL LOCATION AND REPLACE WITH A HORIZONTAL ORIFICE AND TRASH RACK.
