Bennington IDDE
 Outfall Code: BTN-9

Bennington Outfalls

WATERSHED
CONSULTING ASSOCIATES, LLC
 430 Shelburne Road
 Burlington, VT
 watershedca.com
 802.497.2367

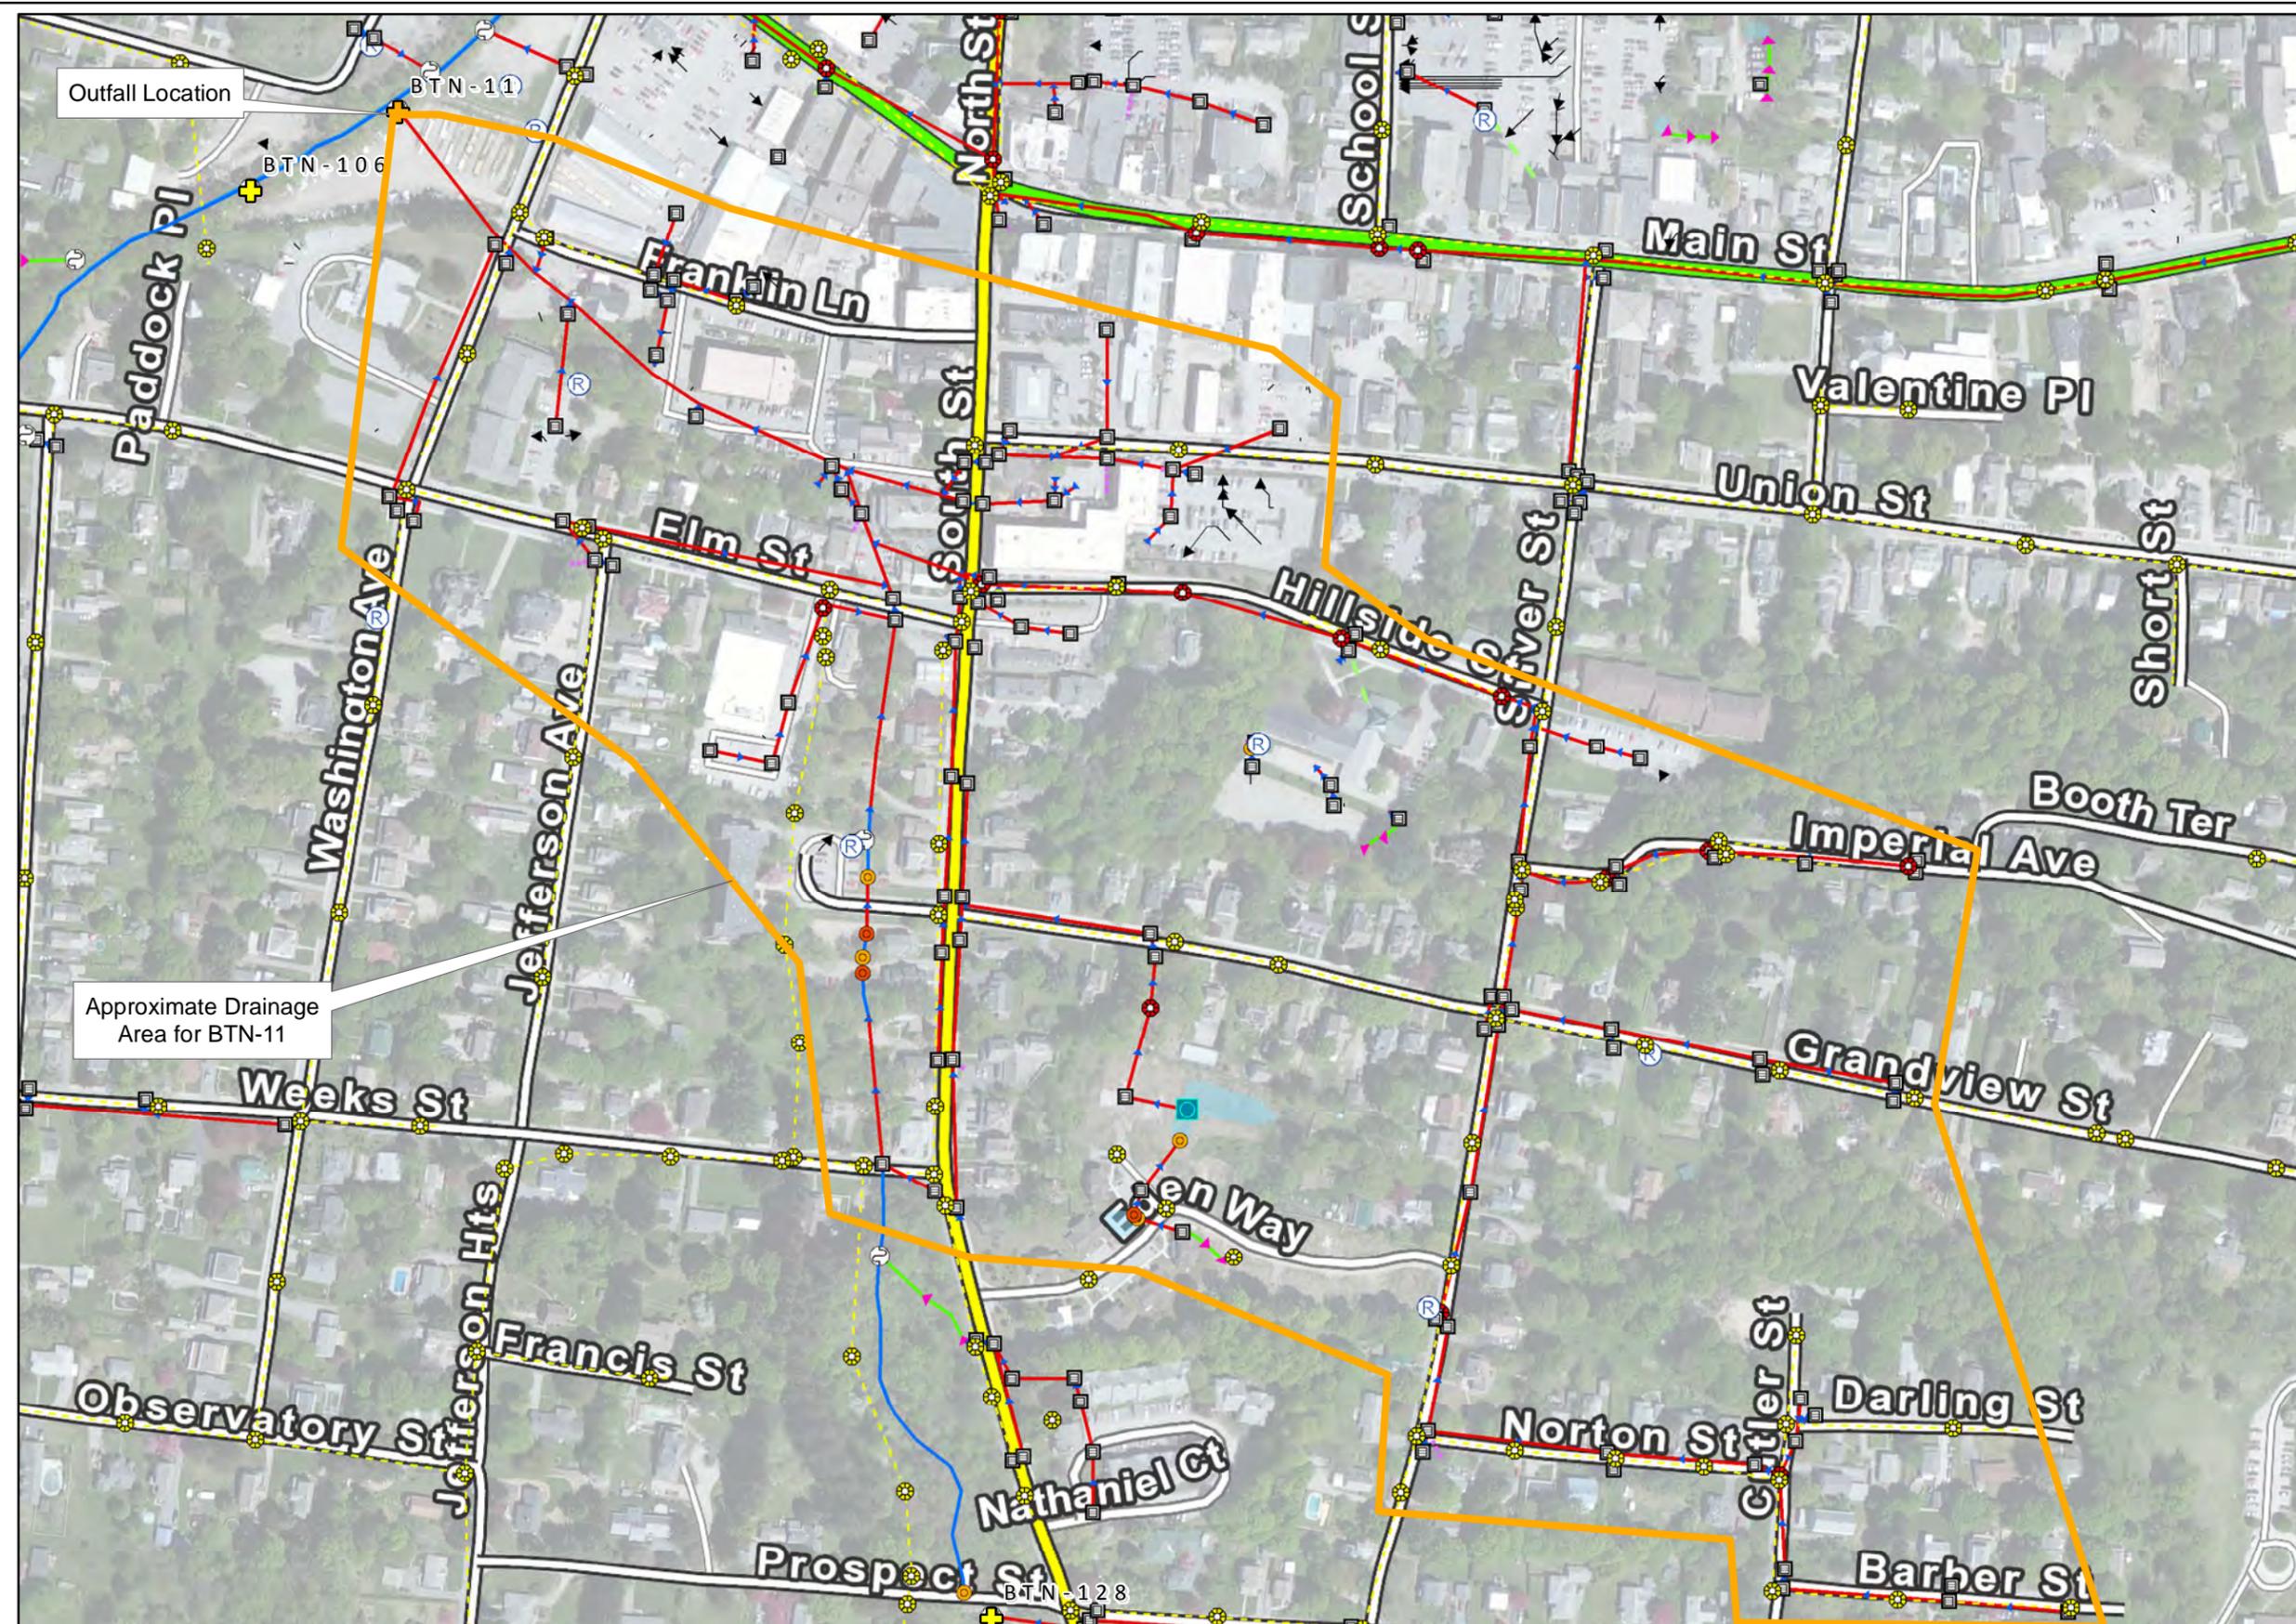
Bennington IDDE
 Outfall Code: BTN-11

Investigated connection with Town of Bennington on 9-22-15.
Pipe not broken - no connections to SW pipe.

Suspect that results here related to street / neighborhood washoff.
Televised pipes - no connections.

Pooled water in CB sump. Sampled from sump for lab analysis. Found high detergent and bacteria 9-3-15.
Televised pipes 9-22-15. No suspect connections found.
Do not suspect chronic illicit discharge.

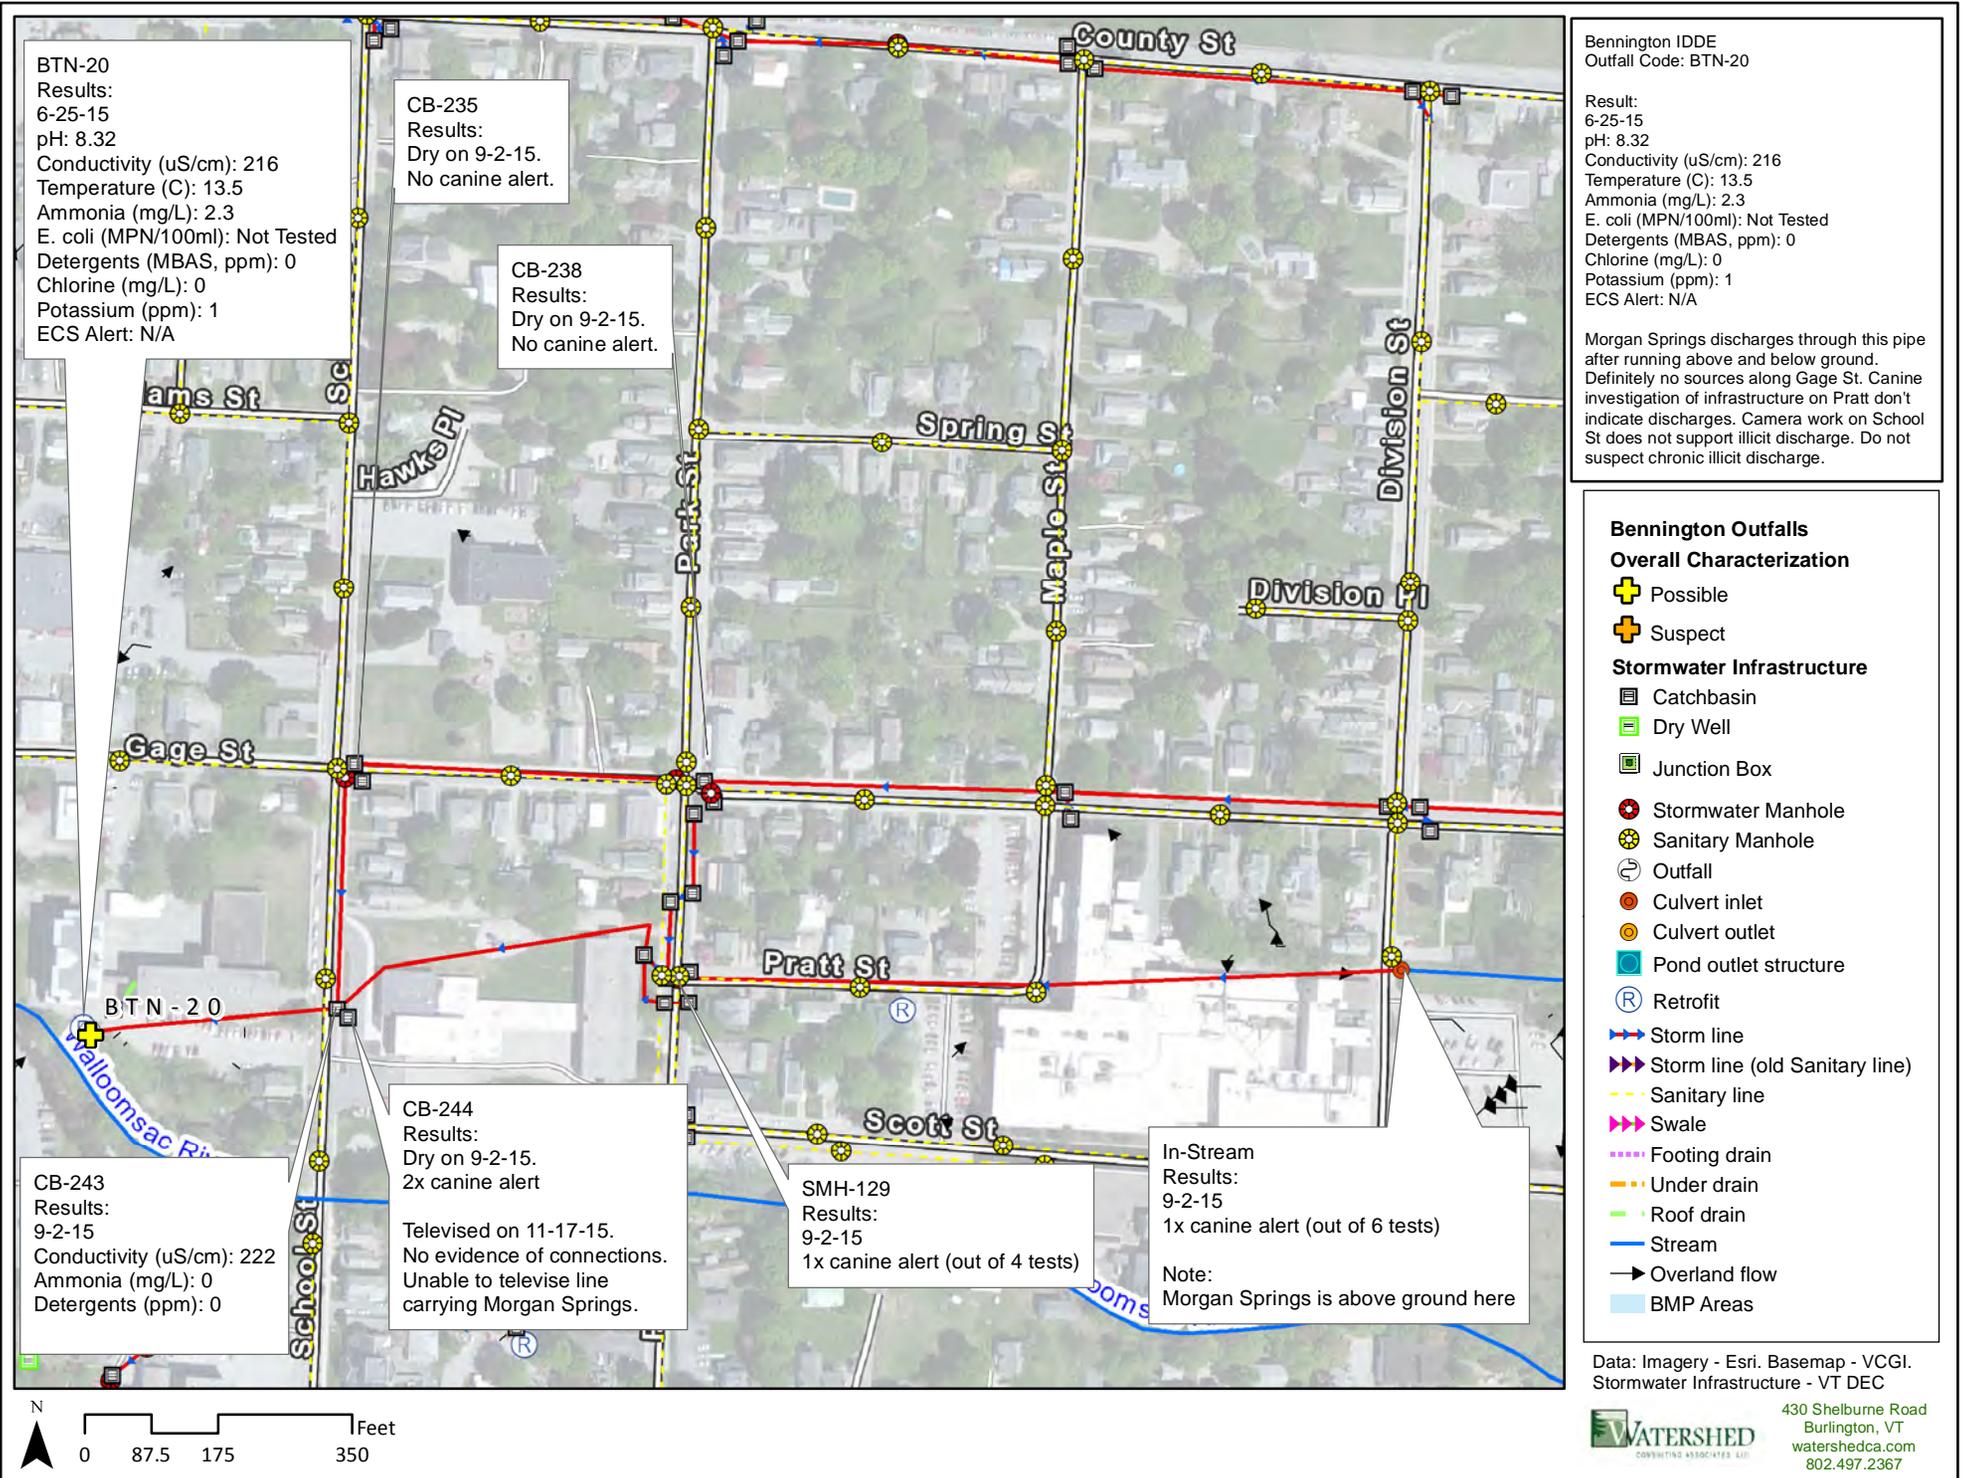
BTN-20
 Results:
 6-25-15
 pH: 8.32
 Conductivity (uS/cm): 216
 Temperature (C): 13.5
 Ammonia (mg/L): 2.3
 E. coli (MPN/100ml): Not Tested
 Detergents (MBAS, ppm): 0
 Chlorine (mg/L): 0
 Potassium (ppm): 1
 ECS Alert: N/A

CB-235
 Results:
 Dry on 9-2-15.
 No canine alert.

Initial visit on 7-2-15. 0.39" rain in past 24 hours. On return visit on 9-1-15 - no flow. Placed OB pad on 9-4-15 - no florescence. Reddish stains and sheen likely iron-philic bacteria - sheen breaks into chunks. Suspect this is underdrain pipe outlet from Rescue Squad parking lot.

Initial visit on 7-2-15. 0.39" rain in past 24 hours. On return visit on 9-1-15 - no flow. Reddish stains and sheen near pipe due to outflow from BTN NEW 202. Don't suspect chronic illicit discharge.

Flow initially observed on 7-2-15 likely due to rain in past 24 hours. No flow on 9-1-15. Water quality results not strongly indicative of illicit discharge.

CBs dry on 9-3-15. No canine alert.

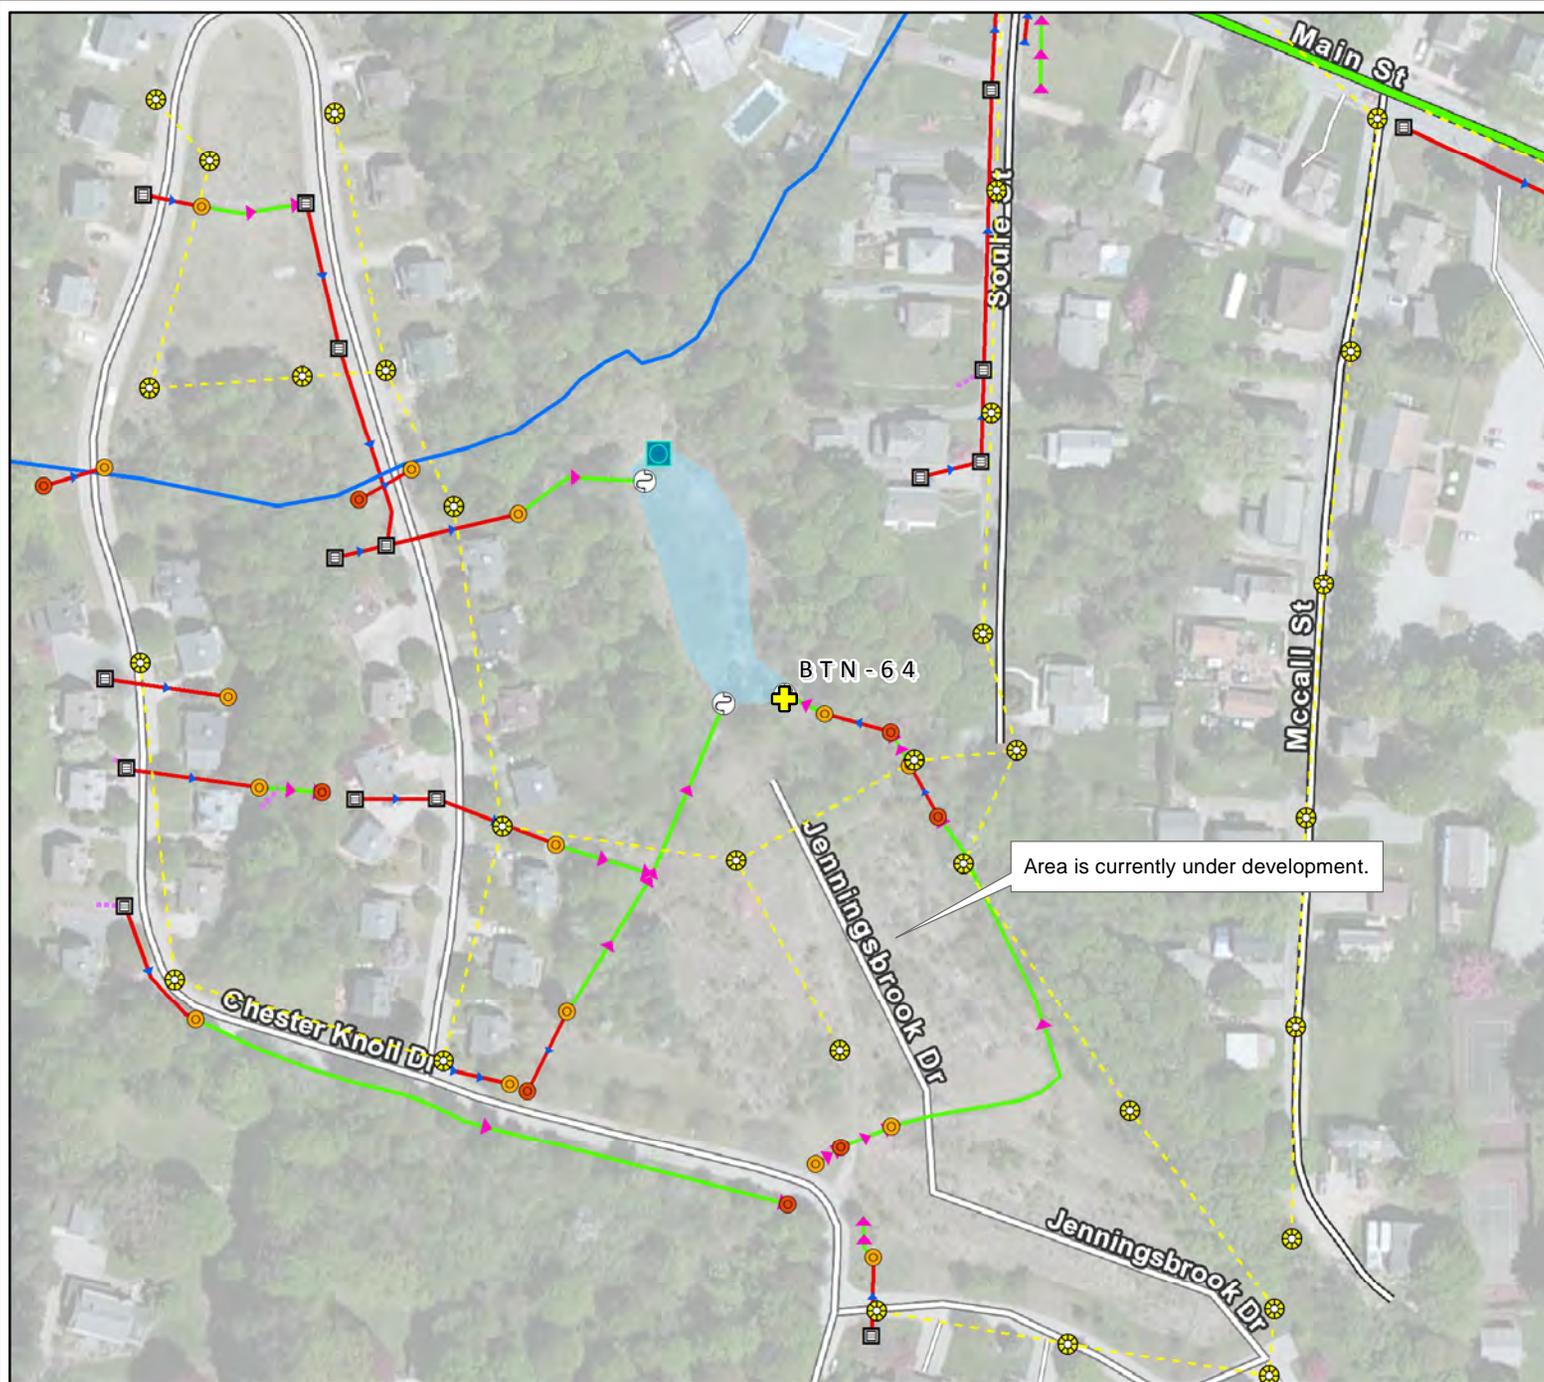
Bennington IDDE
 Outfall Code: BTN-64

Results:
 7-2-15
 pH: 7.6
 Conductivity (uS/cm): 885
 Temperature (C): 11.5
 Ammonia (mg/L): 0.19
 E. coli (MPN/100ml): Not Tested
 Detergents (MBAS, ppm): Not Tested
 Chlorine (mg/L): Not Tested
 Potassium (ppm): Not Tested
 ECS Alert: N/A

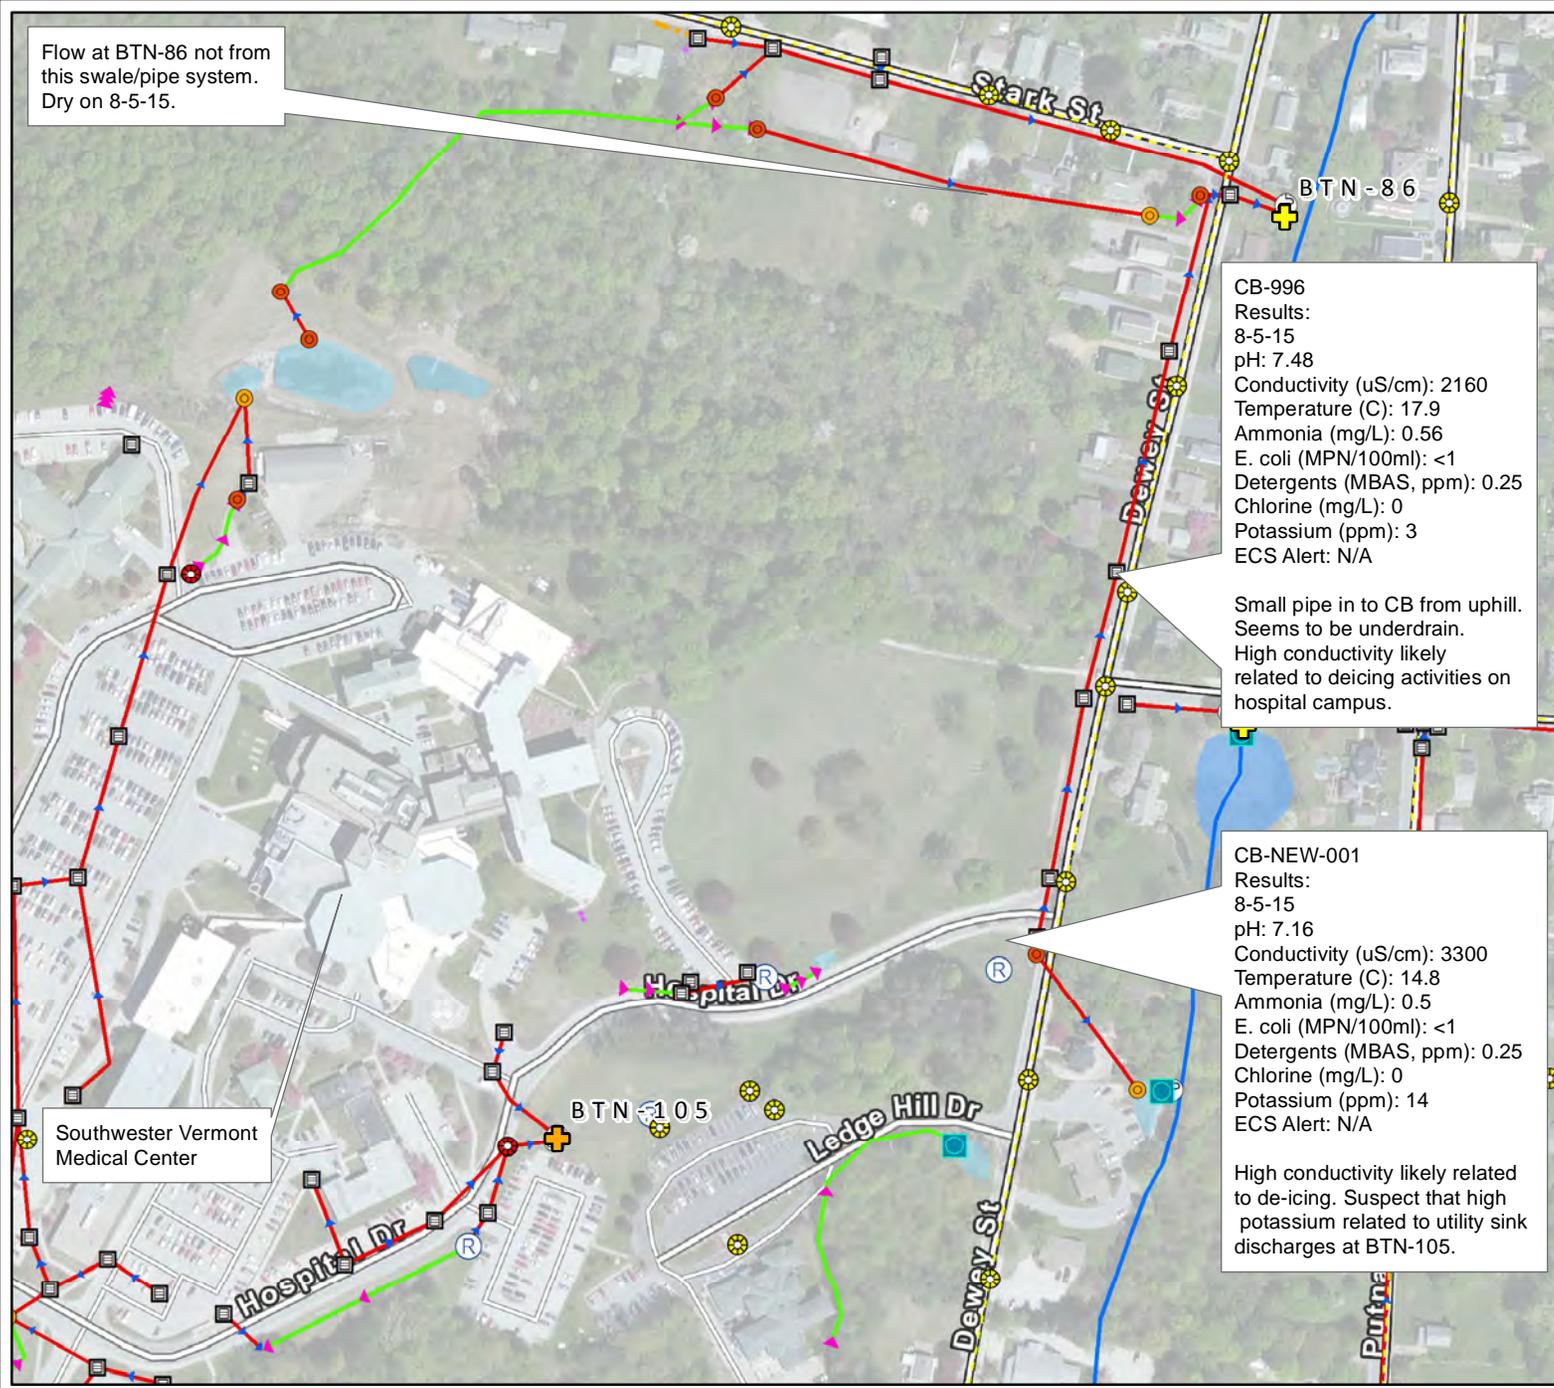
Flow at BTN-86 not from this swale/pipe system. Dry on 8-5-15.

CB-996
 Results:
 8-5-15
 pH: 7.48
 Conductivity (uS/cm): 2160
 Temperature (C): 17.9
 Ammonia (mg/L): 0.56
 E. coli (MPN/100ml): <1
 Detergents (MBAS, ppm): 0.25
 Chlorine (mg/L): 0
 Potassium (ppm): 3
 ECS Alert: N/A

Initial testing on 6-25-15. Follow-up on 8-5-15 found trickle flows in two upstream CBs. Don't suspect sanitary discharge. Likely conductivity results related to deicing activities on hospital. Outflow from BTN-105 may affect BTN-86.

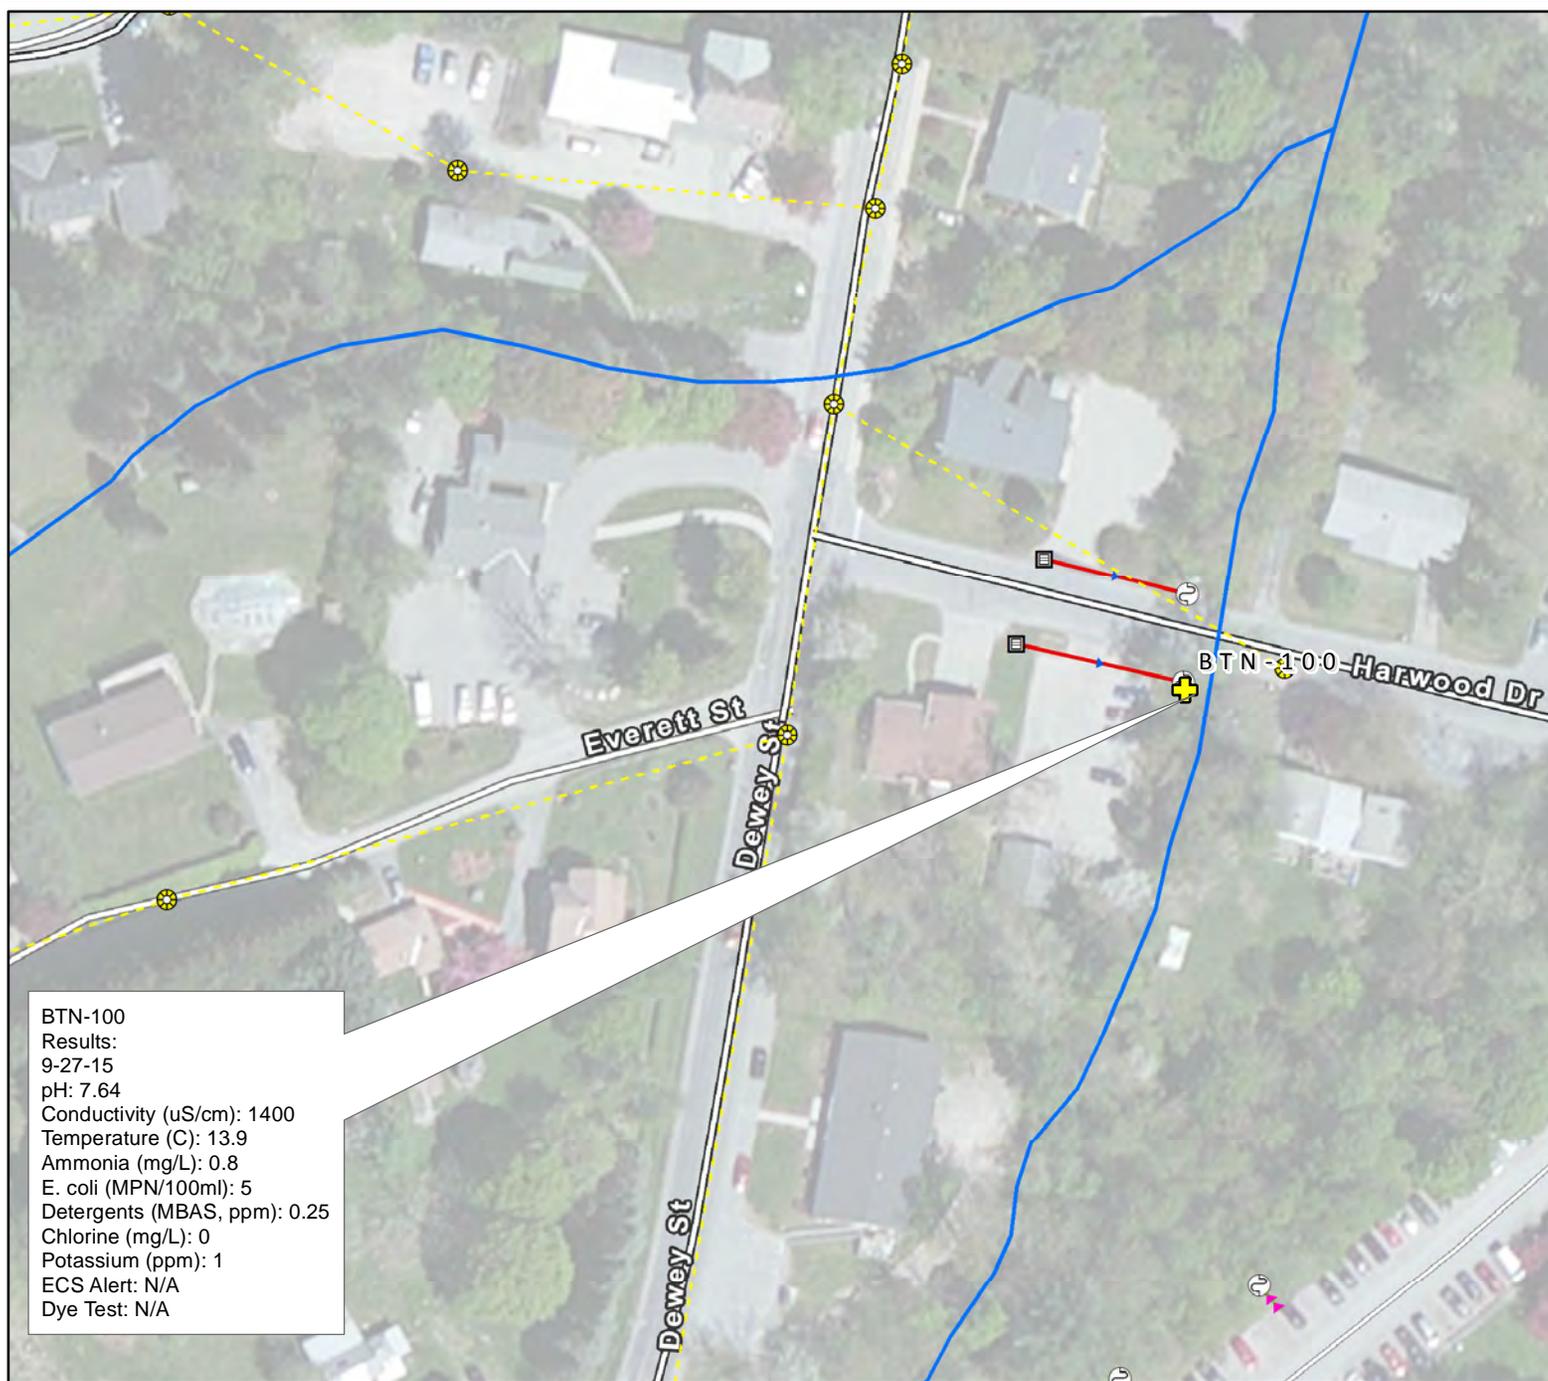
Bennington IDDE
 Outfall Code: BTN-100

Results:
 6-24-15
 pH: 7.38
 Conductivity (uS/cm): 1520
 Temperature (C): 18.5
 Ammonia (mg/L): 0.44
 E. coli (MPN/100ml): Not Tested
 Detergents (MBAS, ppm): 0.15
 Chlorine (mg/L): 0
 Potassium (ppm): 1
 ECS Alert: N/A

Noticed issue on 7-2-15. On return visit on 9-4-15, water was somewhat cleaner - not as turbid. On follow-up visit on 9-22-15, spoke with Willy Hall, facilities manager. Pointed out issue - he followed up and found an improperly connected paint sink. Issued fixed on 10-13-15.

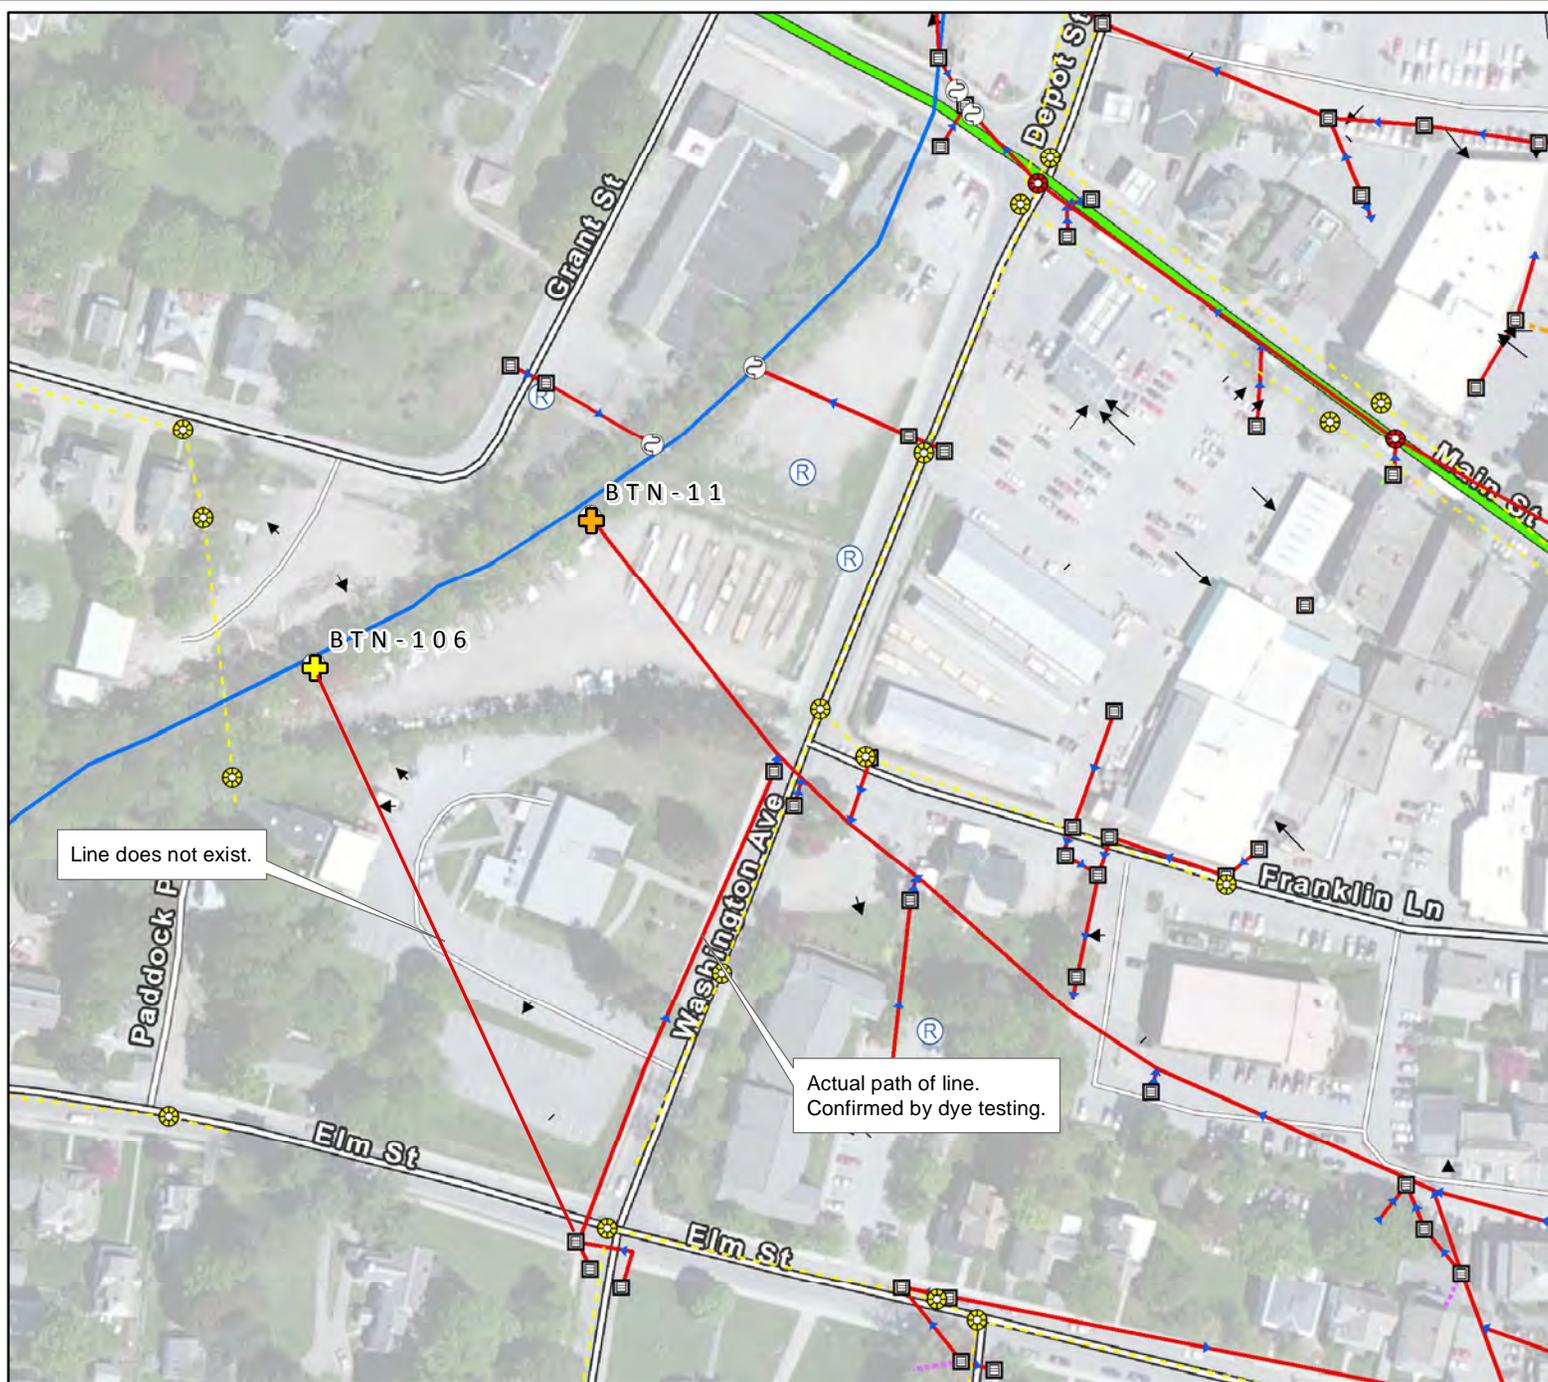
Bennington IDDE
 Outfall Code: BTN-106

Result:
 6-25-15
 Dry - no tests conducted.

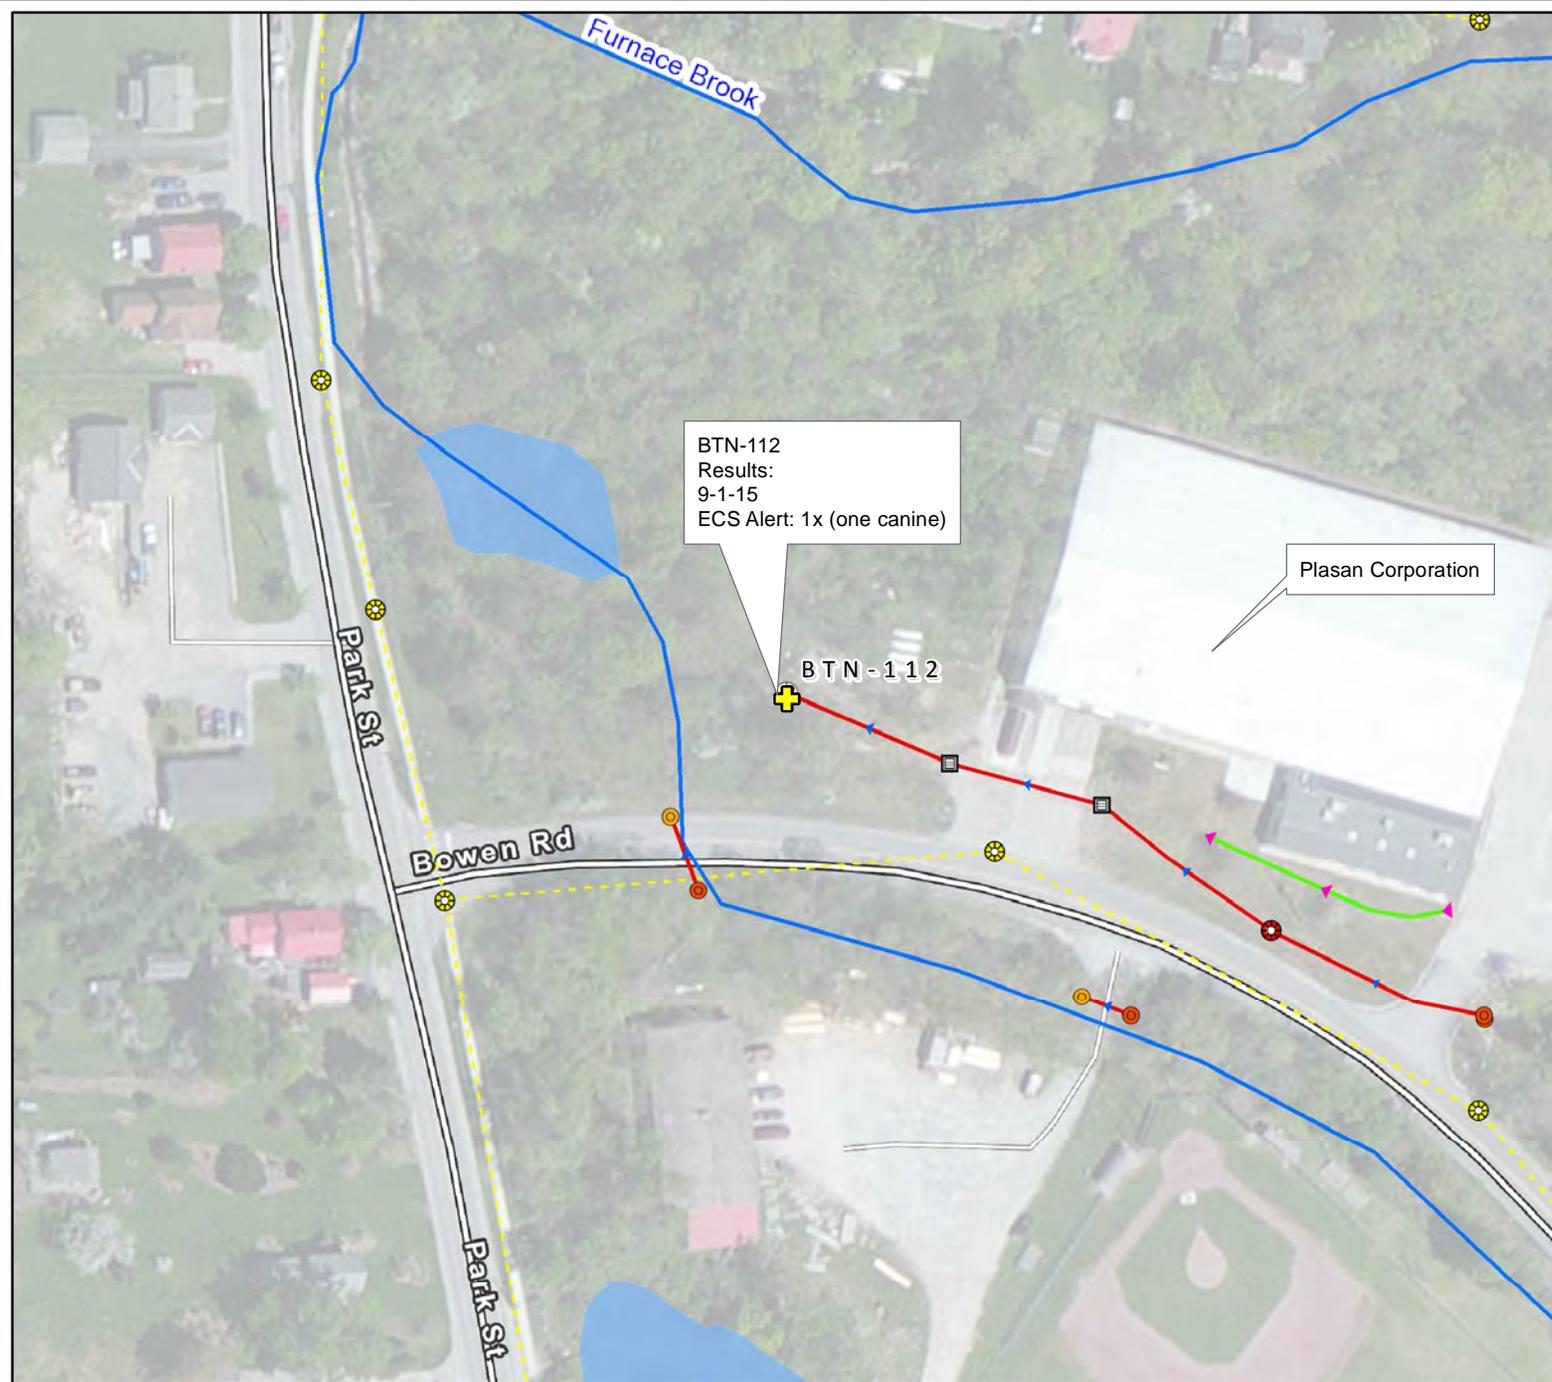
BTN-112
 Results:
 9-1-15
 ECS Alert: 1x (one canine)

Initial visit on 6-5-15. Brownish stains noted. Follow-up on 9-1-15 to sample for ECS - flow still consistent. Final follow-up on 9-27-15. Flow clearly from a small stream flowing through this area. Do not suspect chronic illicit discharge.

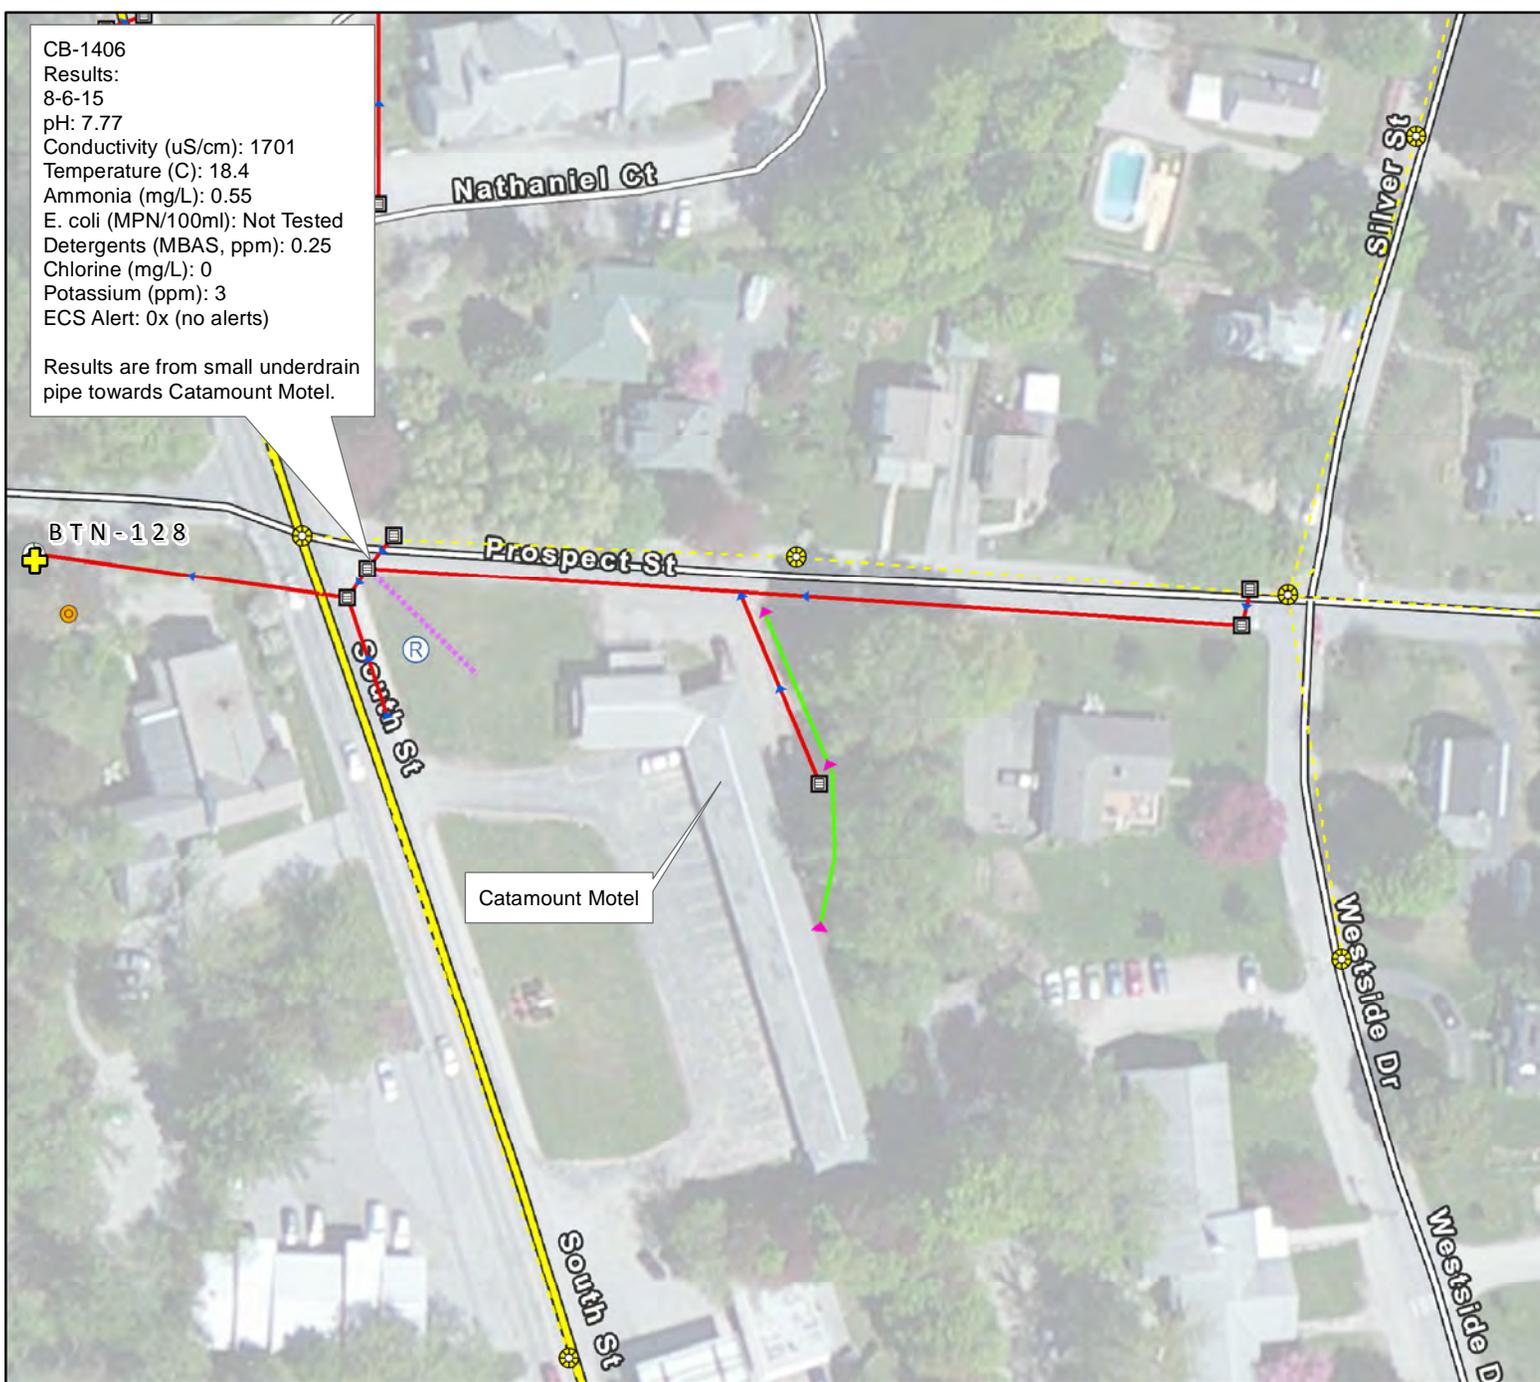
Opened this sanitary manhole - observed similar water in pipe as found at outfall (color, odor)

Town of Bennington found sag in sanitary pipe had broken into stormwater pipe. Slip-lined 1000' of pipe to eliminate issue in early August, 2015.

Found very high ammonia on 6-12-15. Returned on 7-27-15 to obtain e. coli and phosphorus sample. Suspect illicit discharge at that time - opened sanitary manhole and saw similar water. Called Town of Bennington - they fixed the issue by slip-lining 1000' of pipe.

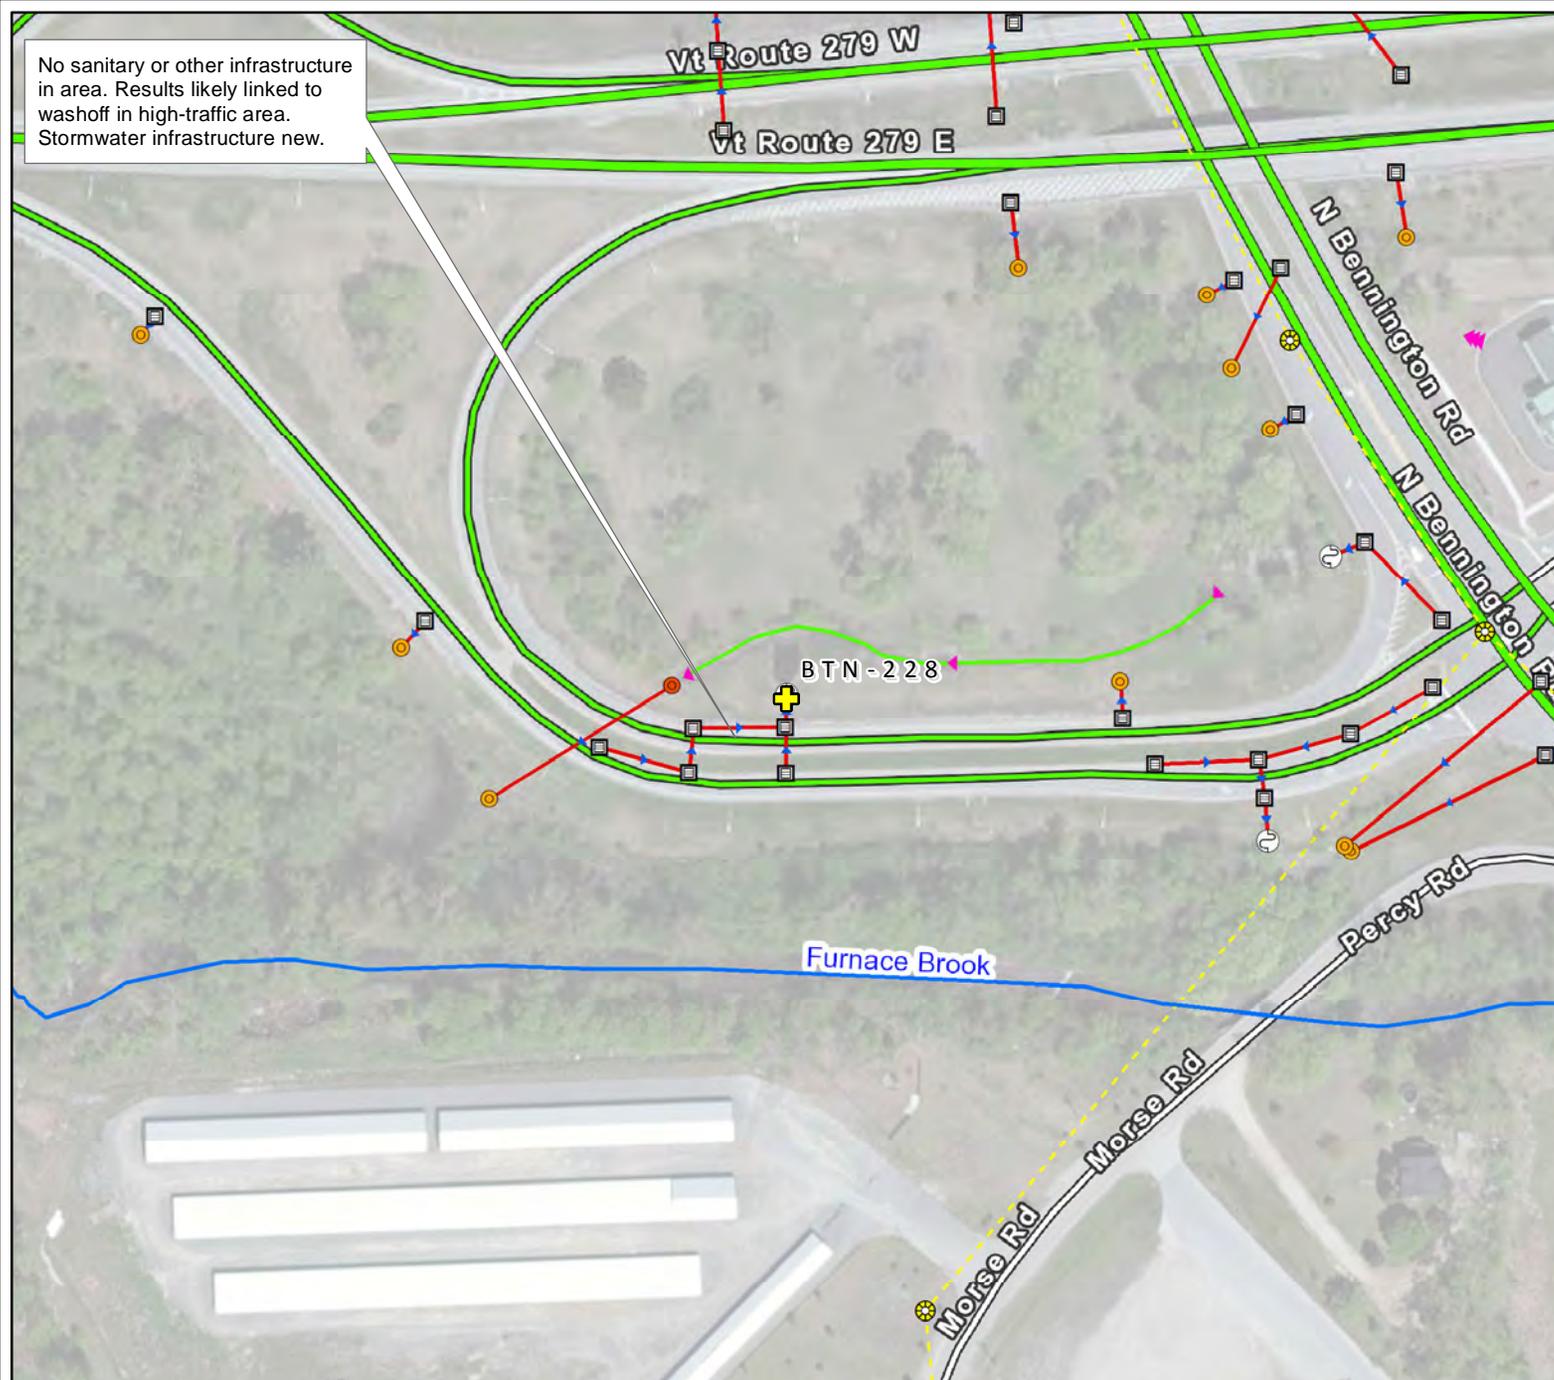
Bennington IDDE
 Outfall Code: BTN-228

No sanitary or other infrastructure in area. Results likely linked to washoff in high-traffic area. Stormwater infrastructure new.
