Bennington IDDE
 Outfall Code: BTN-9

Bennington Outfalls

WATERSHED
CONSULTING ASSOCIATES, LLC
 430 Shelburne Road
 Burlington, VT
 watershedca.com
 802.497.2367

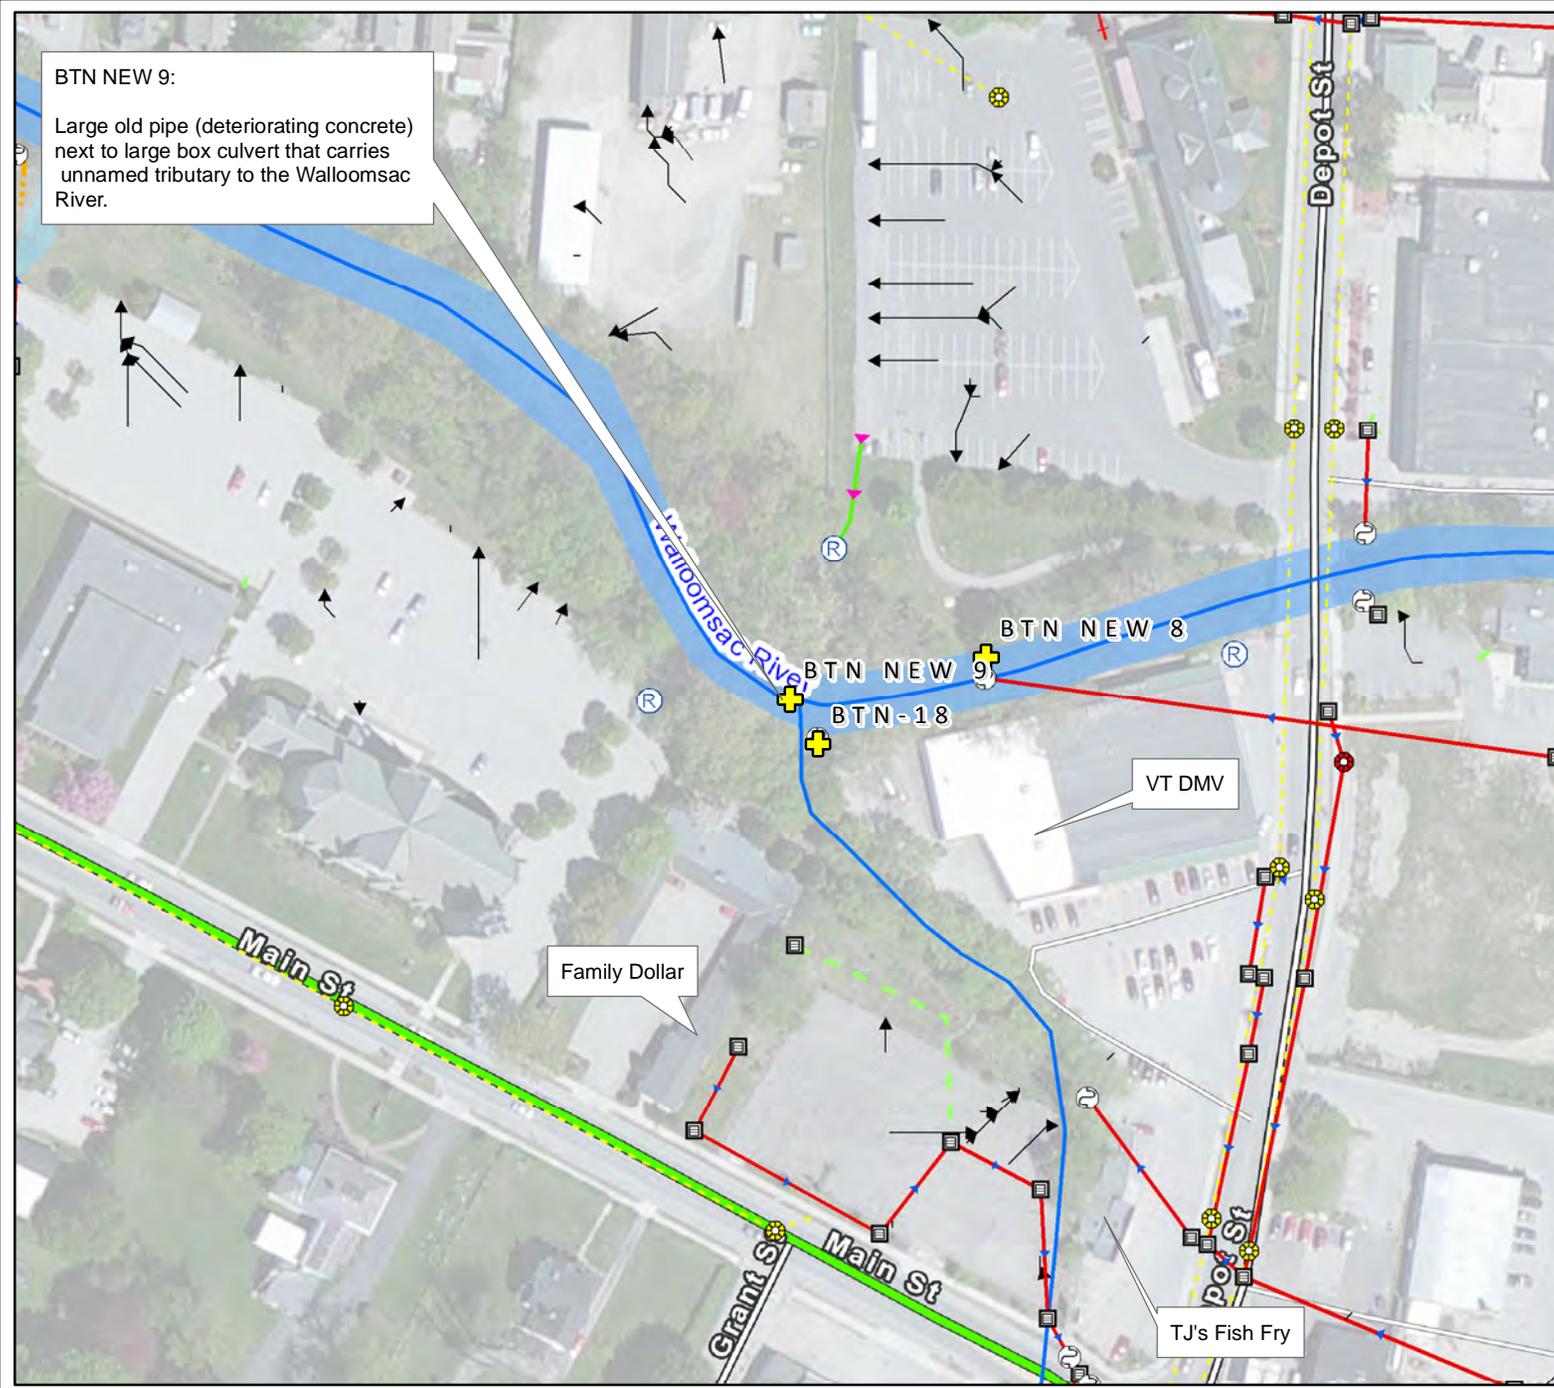
Bennington IDDE
 Outfall Code: BTN-NEW-9

BTN NEW 9:
 Large old pipe (deteriorating concrete) next to large box culvert that carries unnamed tributary to the Walloomsac River.

Results:
 6-24-15
 pH: 7.49
 Conductivity (uS/cm): >2400
 Temperature (C): 7.49
 Ammonia (mg/L): 0.14
 E. coli (MPN/100ml): Not Tested
 Detergents (MBAS, ppm): 0.25
 Chlorine (mg/L): 0
 Potassium (ppm): 0
 ECS Alert: N/A
 OB Test: Negative

Initial visit on 6-24-15 - 0.48" rain in past 24 hours. Observed intermittent flow - like pumped flow. Returned on 9-27-15. Observed sump pump arrangement in basement of business. Sampled pool of sump for lab. Results consistent. Don't suspect chronic illicit discharge.

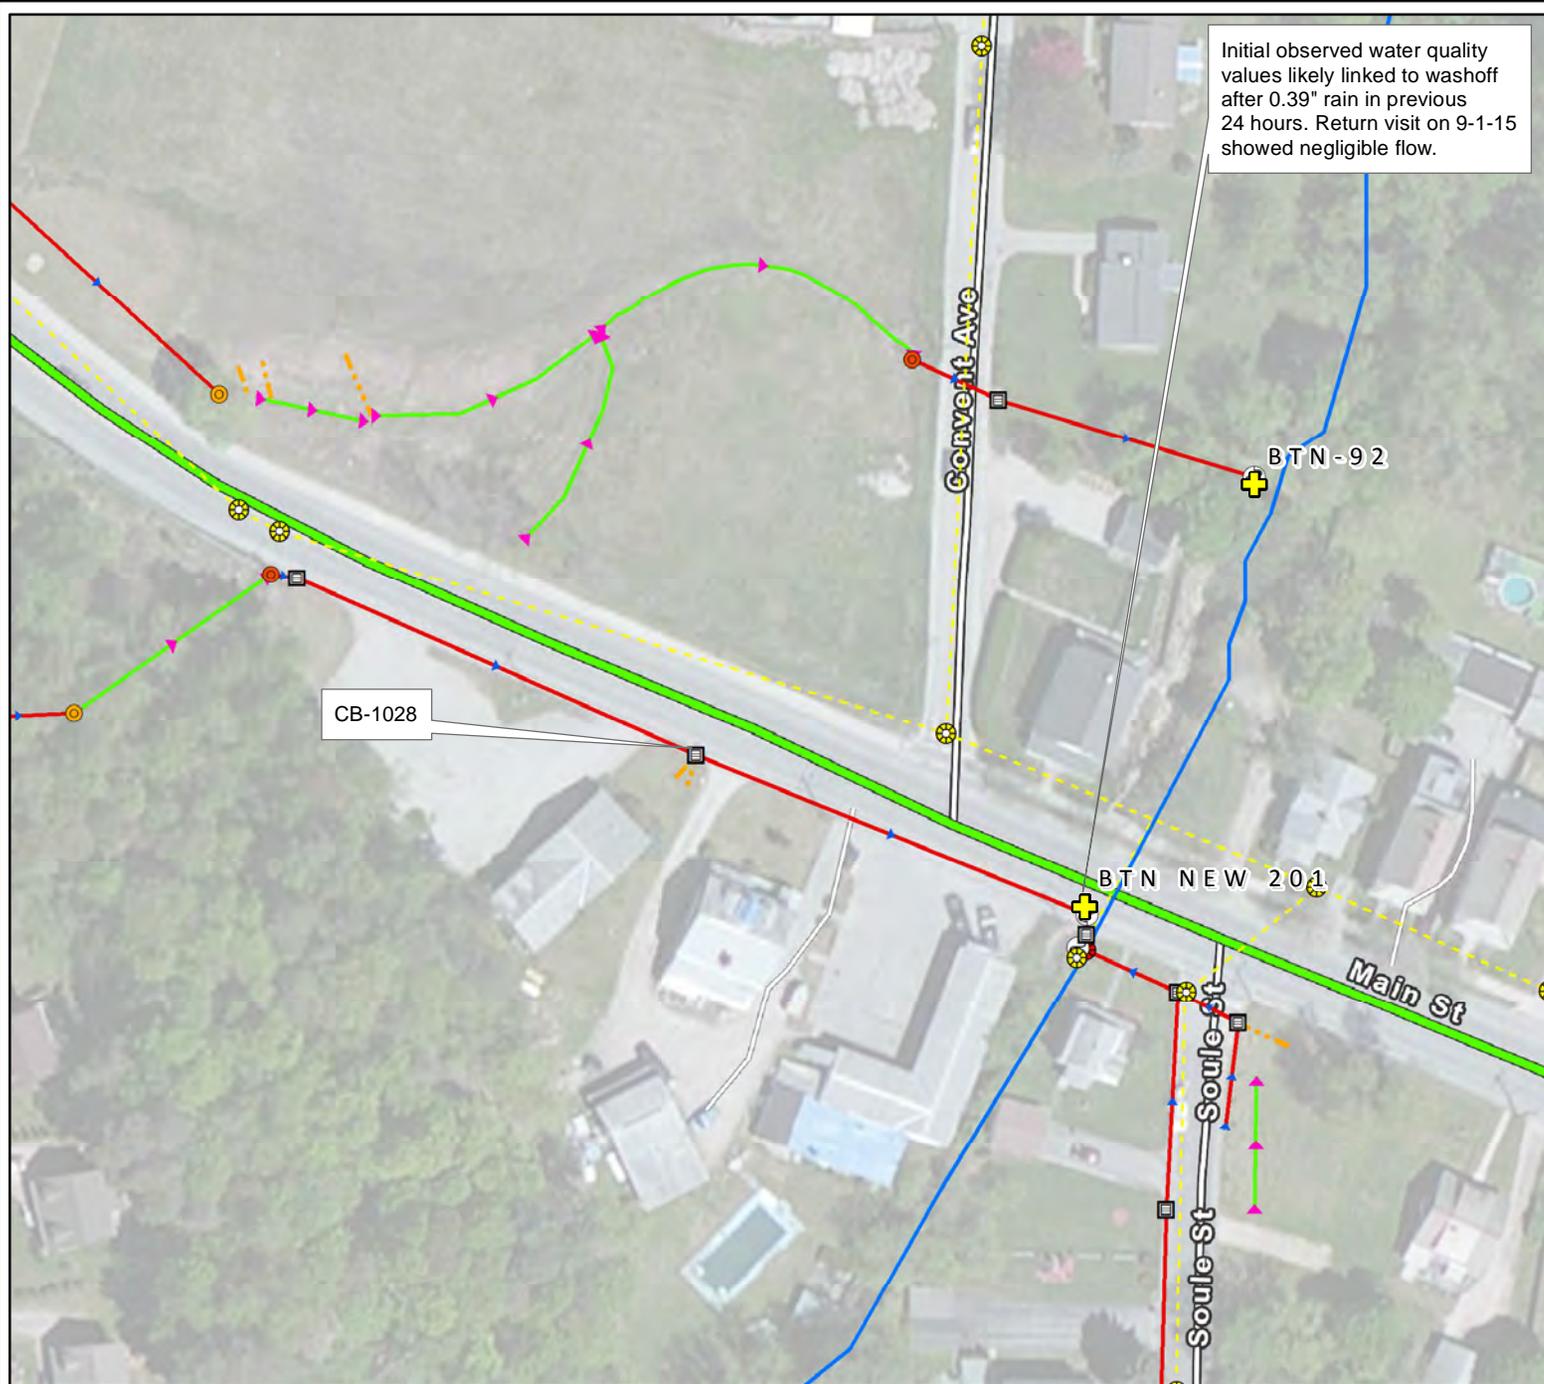
Bennington IDDE
Outfall Code: BTN-New-201

Results:
pH: 7.96
Conductivity (uS/cm): 1876
Temperature (C): 16.1
Ammonia (mg/L): 0.13
E. coli (MPN/100ml): Not Tested
Detergents (MBAS, ppm): 0.25
Chlorine (mg/L): 0.2
Potassium (ppm): 4
ECS Alert: 0x (no alert)

Follow-up investigation on 8-10-15 revealed no flow at outfall or in either catch basin. Suspect ammonia reading due to decaying organic matter in underdrain upstream of outfall.

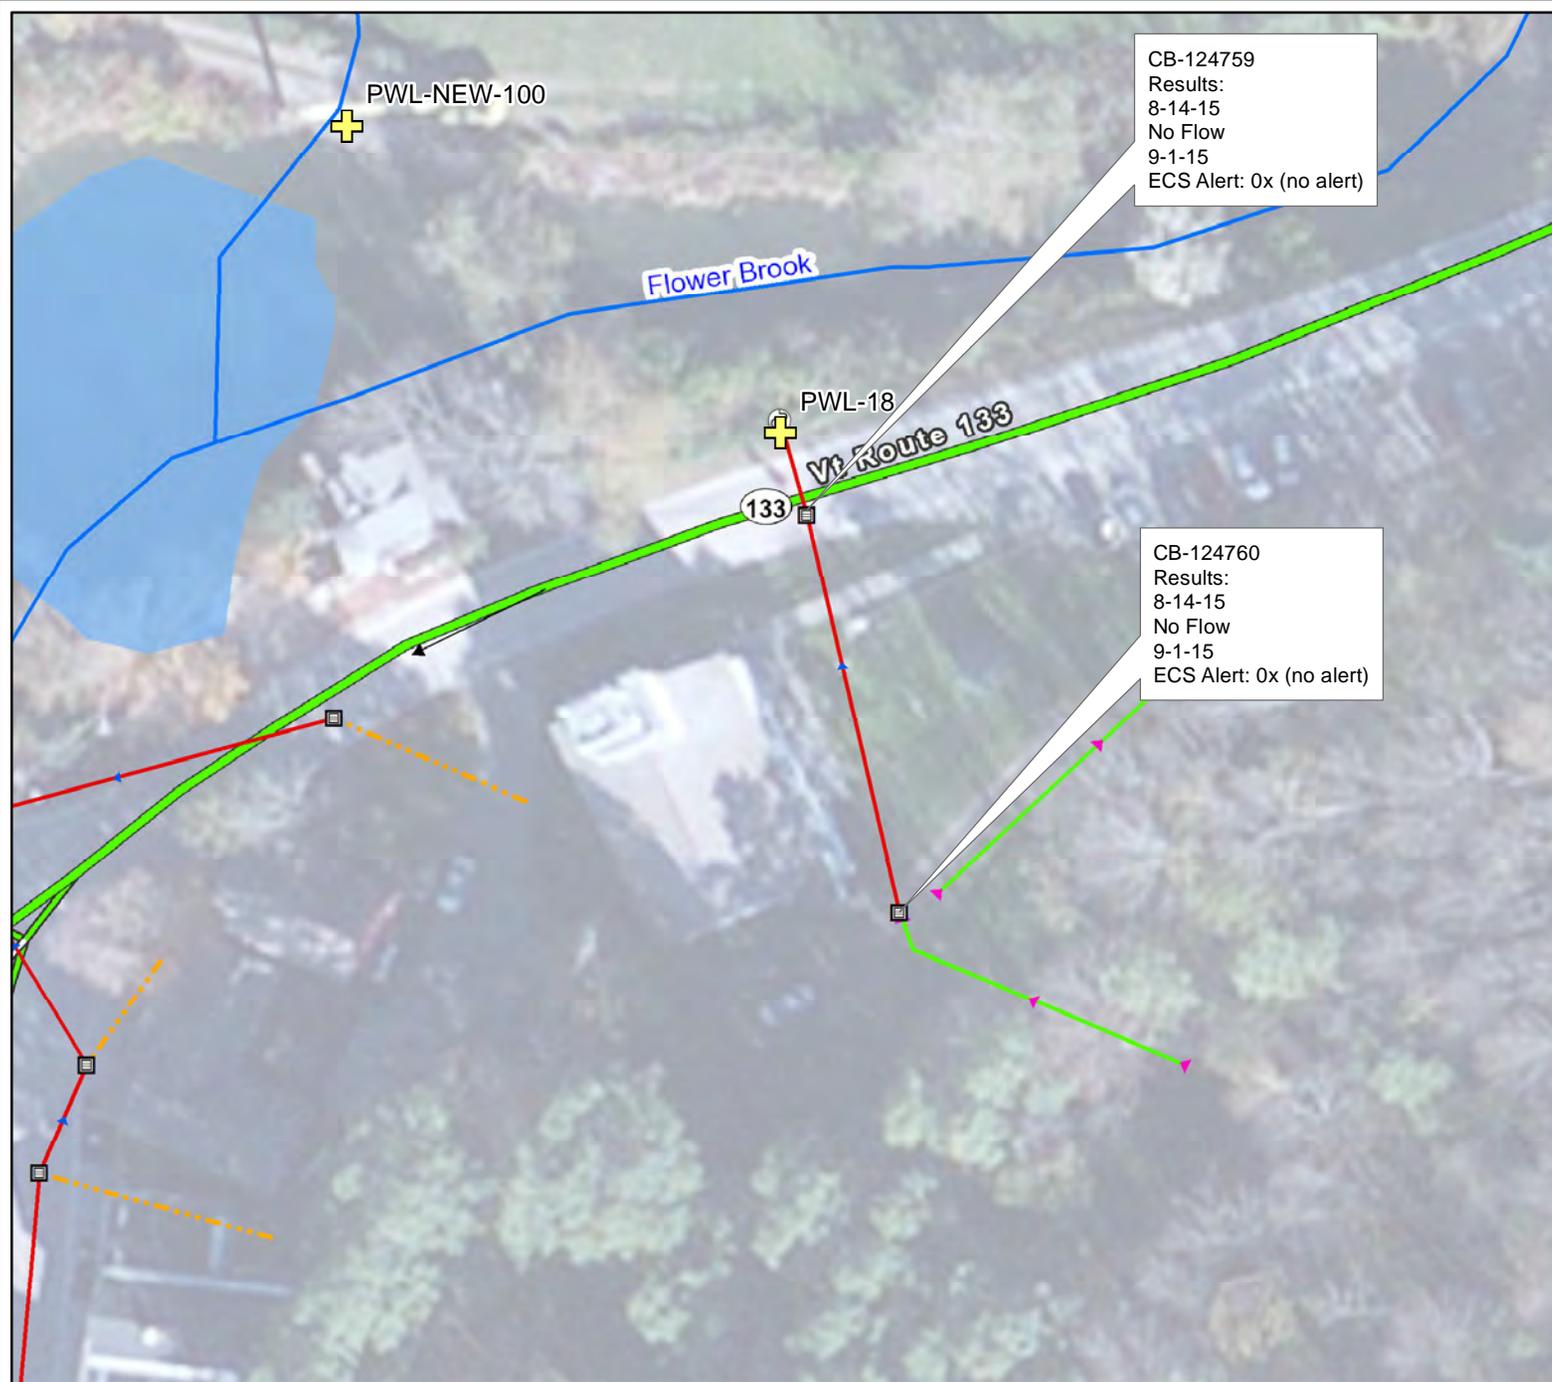
CB-124759
 Results:
 8-14-15
 No Flow
 9-1-15
 ECS Alert: 0x (no alert)

CB-124760
 Results:
 8-14-15
 No Flow
 9-1-15
 ECS Alert: 0x (no alert)

Trickle flow observed at first visit on 7-9-15. No flow on follow-up on 8-14-15. No canine alert on 9-1-15. Do not suspect illicit discharge.

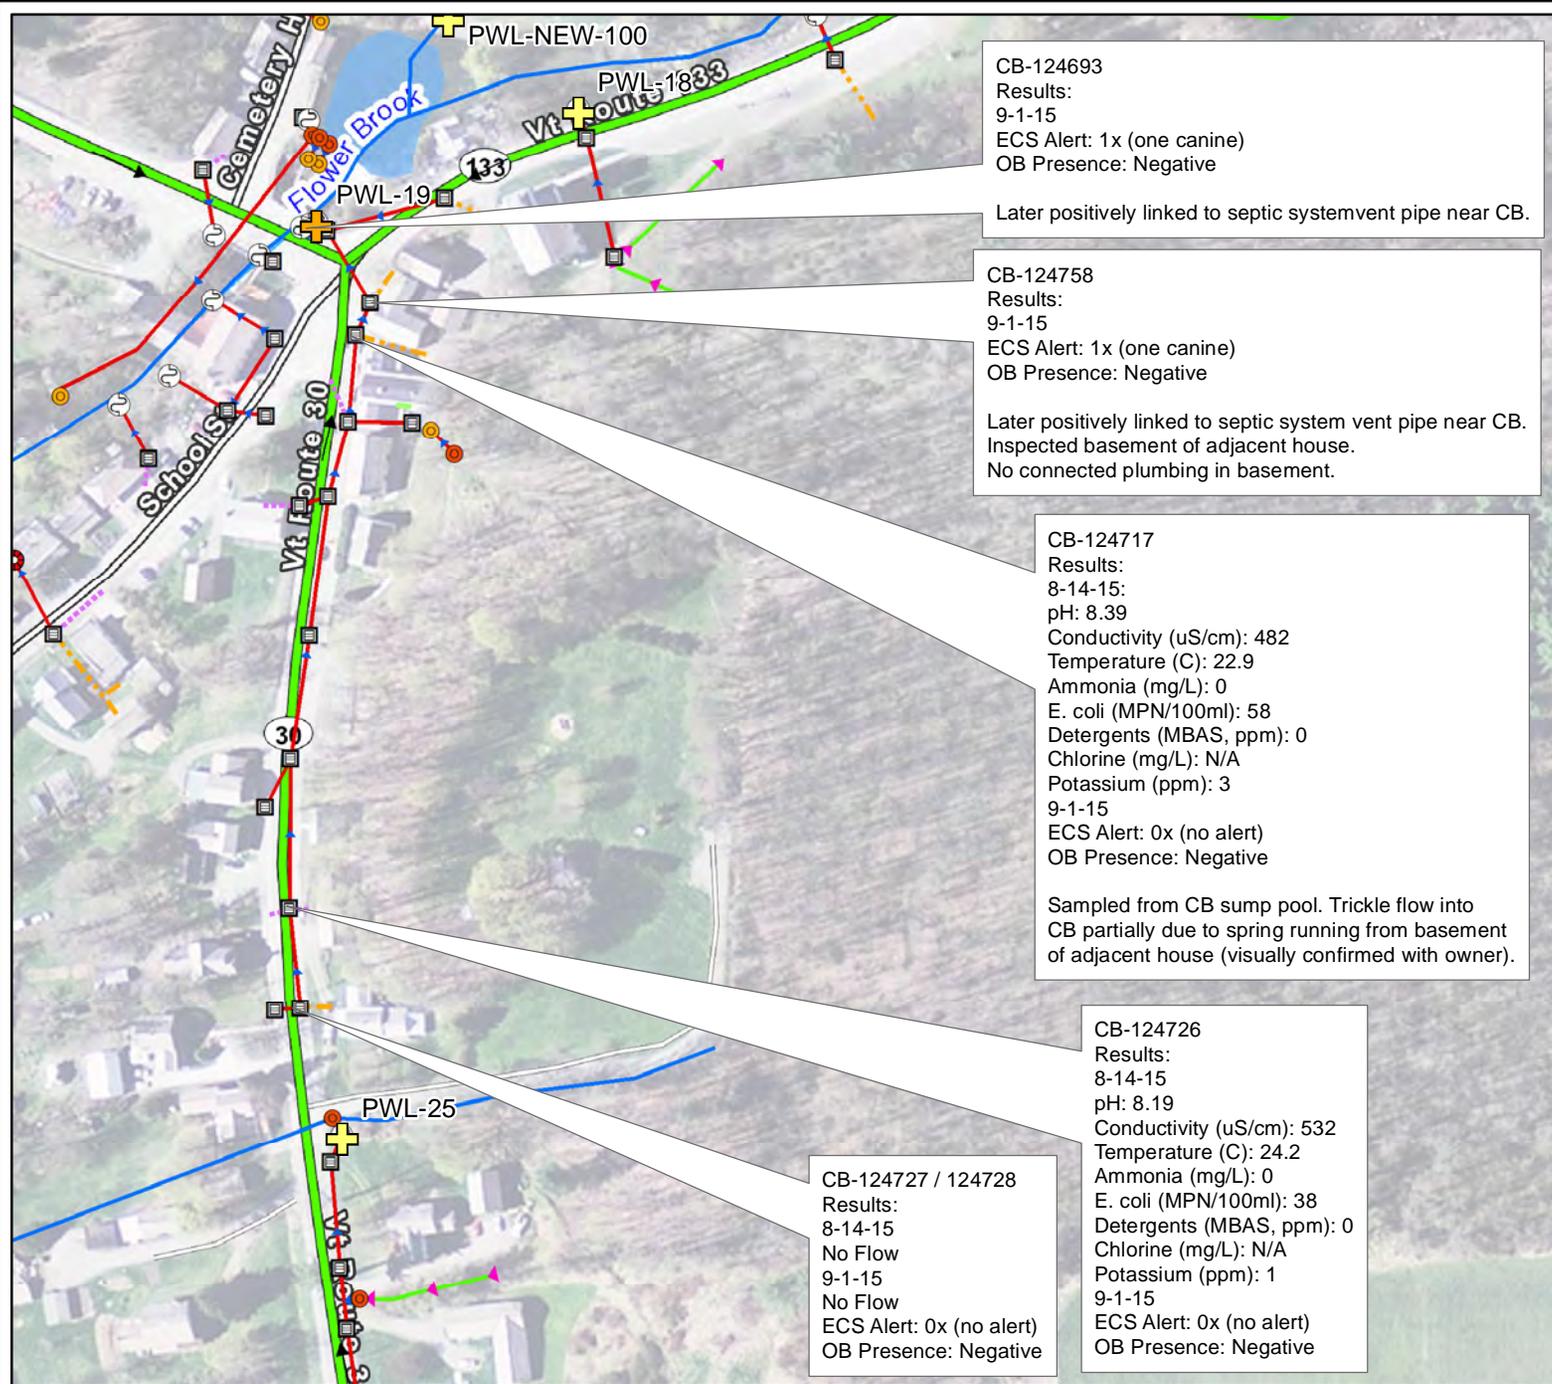
CB-124693
 Results:
 9-1-15
 ECS Alert: 1x (one canine)
 OB Presence: Negative
 Later positively linked to septic system vent pipe near CB.

CB-124758
 Results:
 9-1-15
 ECS Alert: 1x (one canine)
 OB Presence: Negative
 Later positively linked to septic system vent pipe near CB. Inspected basement of adjacent house. No connected plumbing in basement.

Trickle flow observed on 6-16-15. No flow observed on follow-up visit on 8-10-15. Canines did not alert on 9-1-15. Do not suspect illicit discharge.

Trickle flow observed on 7-9-15.
Unable to smoke test (pipes too small).
Optical Brighteners - No Presence.
Do not suspect chronic illicit discharge.

Trickle flow observed in CB sump.

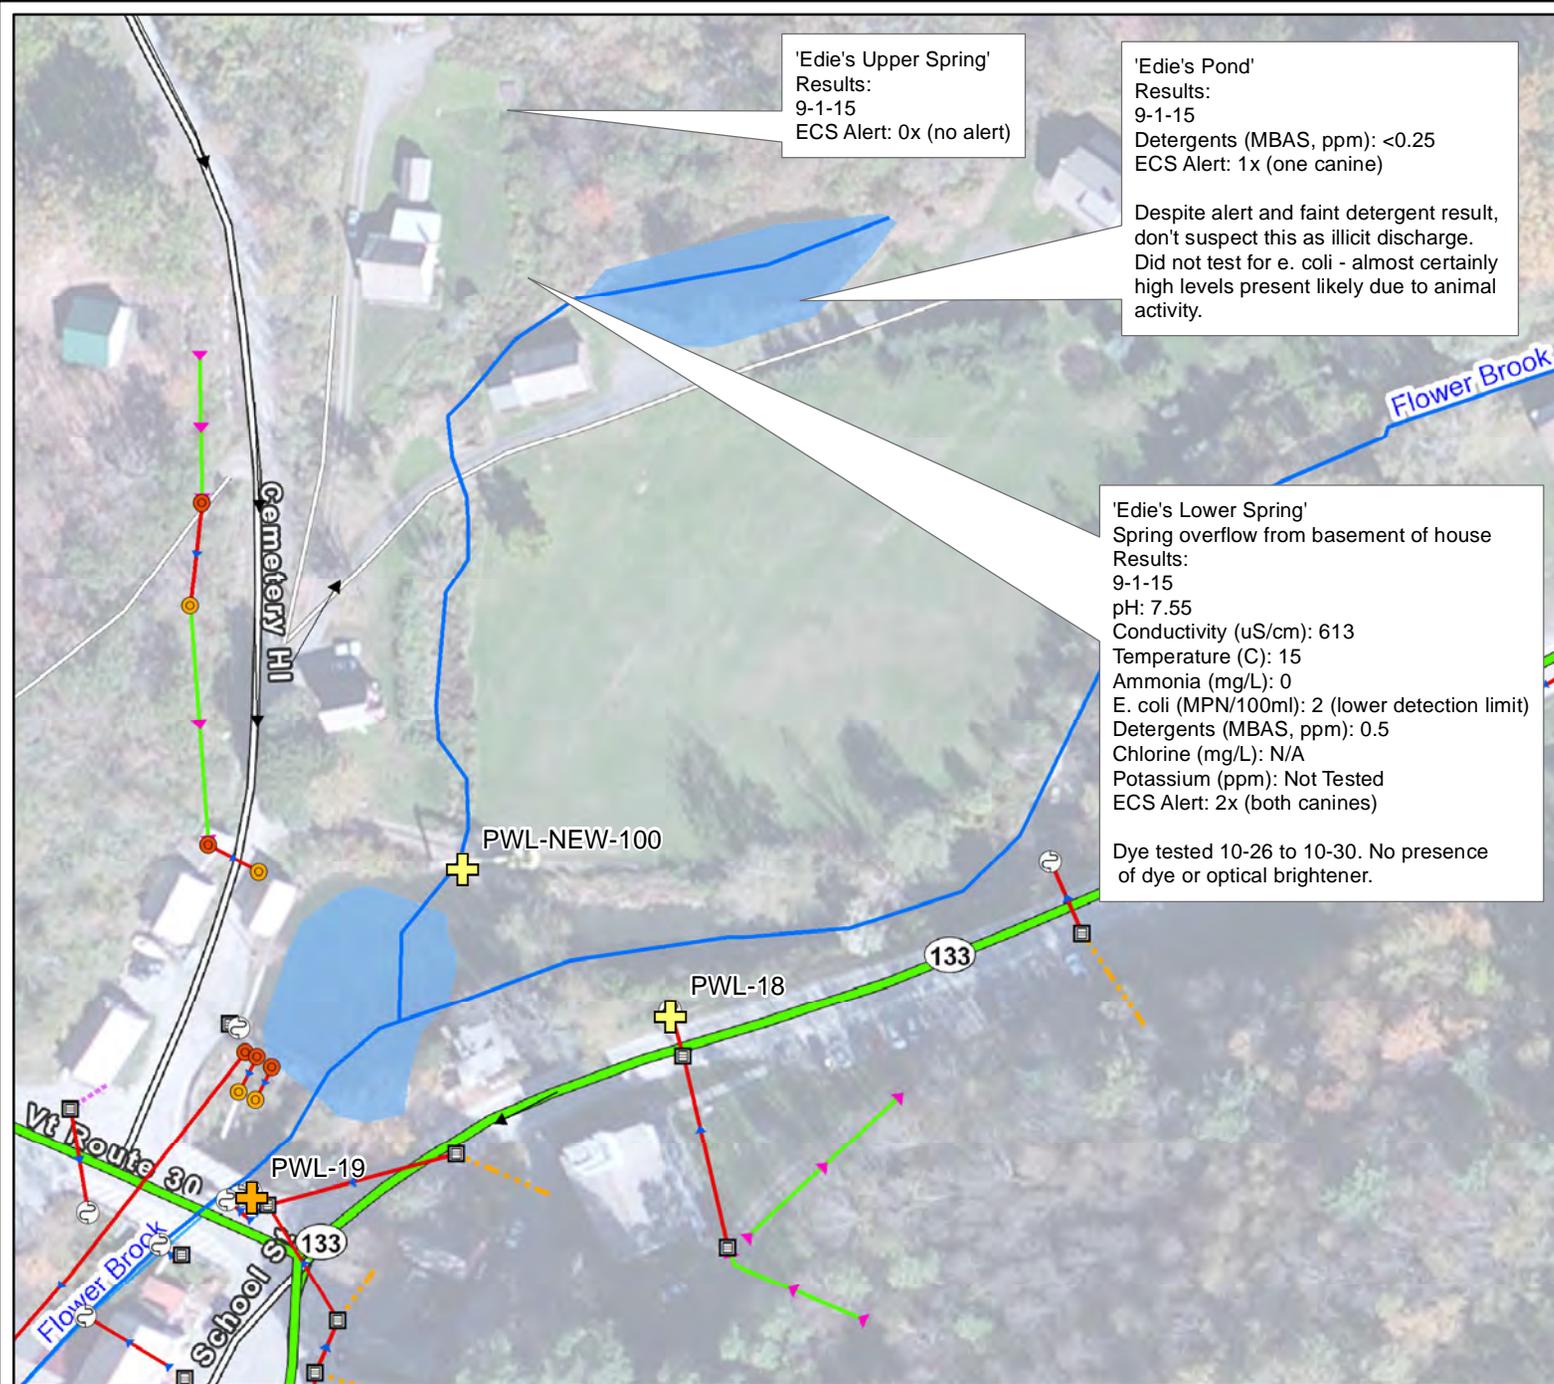
'Edie's Upper Spring'
Results:
9-1-15
ECS Alert: 0x (no alert)

'Edie's Pond'
Results:
9-1-15
Detergents (MBAS, ppm): <0.25
ECS Alert: 1x (one canine)

Outfall is culvert from channel below pond. Flow observed on 7-9-15 and 8-14-15 (follow-up sample for bacteria). Do not suspect chronic illicit discharge.

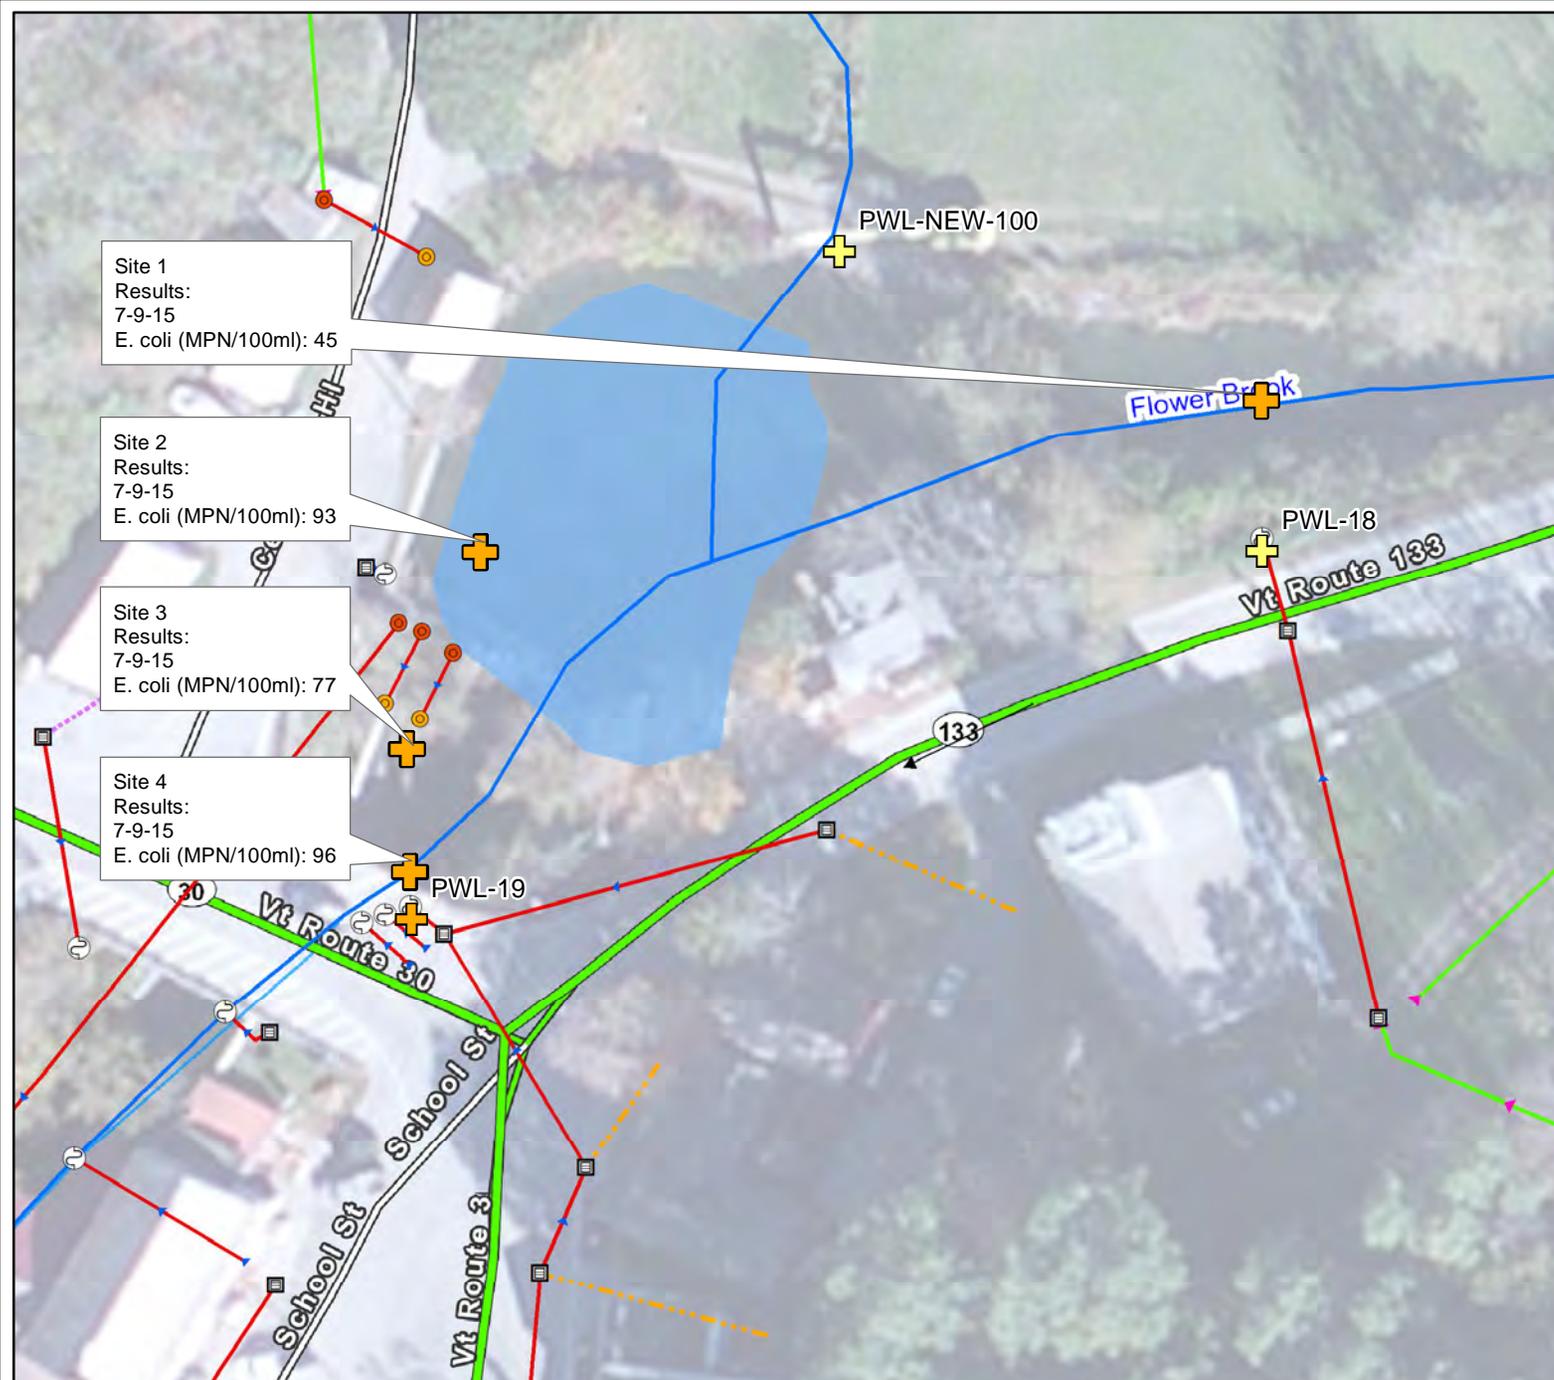
Pawlet IDDE
Outfall Code: Mill Pond

Results:
7-9-15
