Mill River River Corridor Management Plan Rutland County, Vermont

FINAL REPORT

FEBRUARY 17, 2009

Round River Design
Michael Blazewicz
www.RoundRiverDesign.com

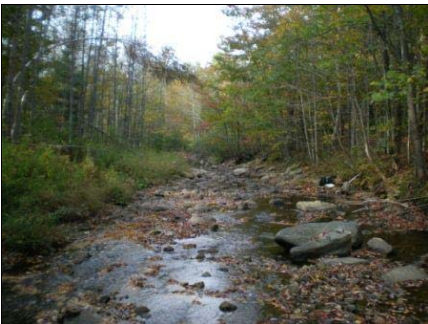
Protect River Corridor	Upstream of Constrained/ Altered Reach	Reach M15 lies upstream of the constrained and channelized reach M14 as well as those near East Wallingford Village	No major structures along river	Unk.	Open land and forest remains structure free	Town, RRPC, VTANR
	Restore Riparian Buffer	Long term stability	Buffer removal on the left bank has made this reach vulnerable in the long-term.	No major structures along river. River may remain stable for years to come and allow trees to grow.	Low	Agriculture and Residential Land to Forest	UOCWC, RNRCD, FWS
	Restore Incised Reach	Reduce flooding downstream, store sediment in the floodplain	Possible site for restoring floodplain access to improve flood and sediment load attenuation and take pressure off of downstream reaches.	Depends on method of restoration. No major structures along stream.	High	Agricultural land to floodplain	VTANR

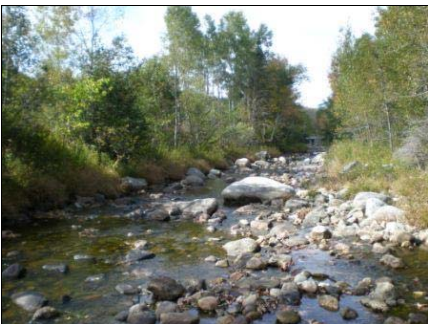
Protect River Corridor	Upstream of Constrained/ Altered Reach	Reach M14 lies upstream of the constrained and altered reaches near East Wallingford Village	Only one house along river. Out of floodway and FEH zone.	Unk.	Open space with one residence is not developed further	Town, RRPC, VTANR
	Restore Riparian Buffer	Long term stability	Buffer removal on the left bank has made this reach vulnerable in the long-term.	No major structures along river. River may remain stable for years to come and allow trees to grow.	Low	Open Land to Forest	UOCWC, RNRCD, FWS
	Restore Incised Reach	Reduce flooding downstream, store sediment in the floodplain	Possible site for restoring floodplain access to improve flood and sediment load attenuation and take pressure off of downstream reaches.	Depends on method of restoration. No major structures along stream.	High	Open land to floodplain	VTANR

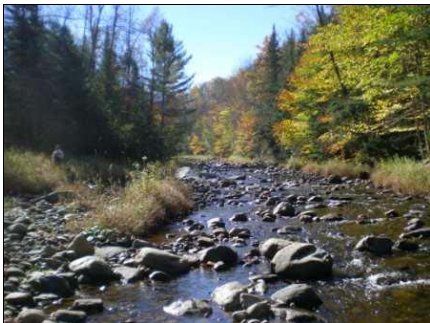
Protect River Corridor	Sediment Attenuation Area (Conserve and Enhance)	This fairly undeveloped reach is already attenuating floodwaters and sediment. Long term river corridor protection would reduce future conflict and ensure these functions are served for future generations.	No structures near the river.	Unk.	None, remains forest	Town, RRPC, VTANR
M12

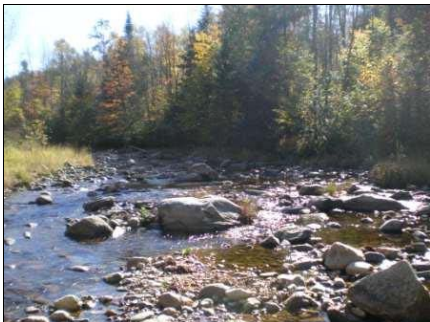
Protect River Corridor	Sediment Attenuation Area (Conserve and Enhance)	This fairly undeveloped reach has capacity for attenuating floodwaters and sediment. Long term river corridor protection would reduce future conflict and ensure these functions are served for future generations.	No structures near the river.	Unk.	None, remains forest	Town, RRPC, VTANR
M11-B

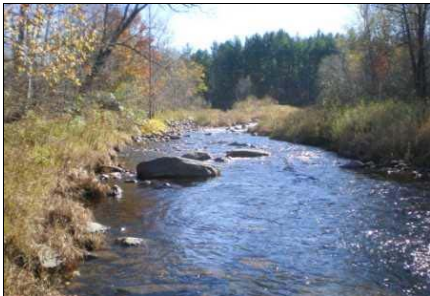
Protect River Corridor	Upstream of Constrained/ Altered Reach	Reach M11-B lies upstream of the constrained and altered reaches of those near East Wallingford Village	Agricultural land, but no significant structures along river corridor.	Unk.	None, remains agricultural land.	Town, RRPC, VTANR, NRCS

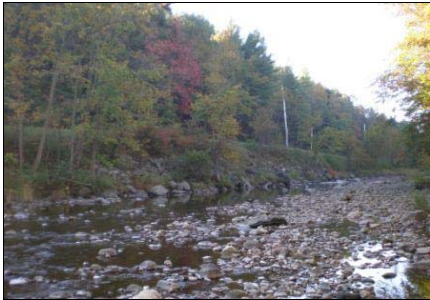
Protect River Corridor	Upstream of Constrained/ Altered Reach	Reach M09 lies upstream of the constrained and altered reaches of Cuttingsville Village	Some existing structures.	Unk.	Prevention of further development in the corridor.	Town, RRPC, VTANR
	Berm Removal Site	Improve floodplain access by removing bermed material.	Large berm on the lower end of the reach (right bank) may be removed or relocated.	Road along right corridor needs to be protected.	Med.	Remains forested land.	VTANR
M07

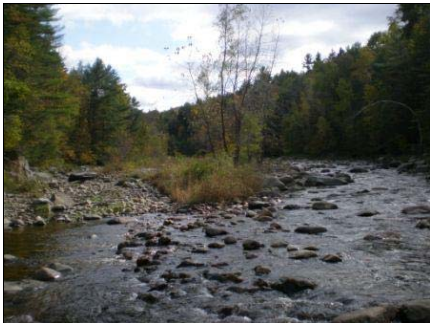
Protect River Corridor	Sediment Attenuation Area (Conserve and Enhance)	This fairly undeveloped reach is already attenuating floodwaters and sediment. Long term river corridor protection would reduce future conflict and ensure these functions are served for future generations.	Railroad has R.O.W. in corridor. Otherwise no obvious restrictions.	Unk.	Remain forested undeveloped area.	Town, RRPC, VTANR
	Protect River Corridor	Reduce FEH at Alluvial Fan	Due to the significant slope change, this area is especially susceptible to sediment aggradation and planform adjustment.	Adoption of an FEH Zone will need to go through town planning.	Unk.	Potential restriction on land-use depending on easement language.	Town, RRPC, VTANR
M01-B

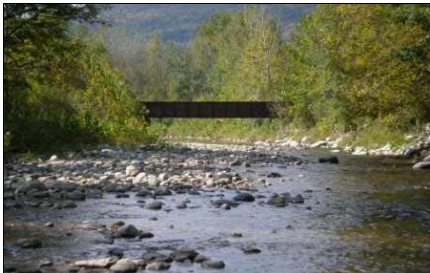
Restore Riparian Buffer	Improve shade, stability of river, habitat	Short corner of field is lacking adequate buffer.	None.	Low	Bare to forest	VTANR, RNRCD, CREP

Berm Removal Site	Improve floodplain access by removing bermed material.	Large berm on right bank may be removed or relocated.	Berm looks to be protecting farmland. Removing berm may affect crops.	Med.	Remains forested and agricultural land.	VTANR

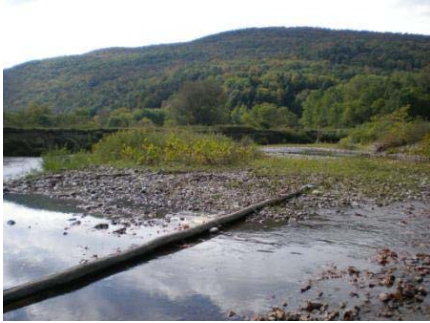
Protect River Corridor	Reduce FEH at Alluvial Fan	Due to the significant slope change, this area is especially susceptible to sediment aggradation and planform adjustment.	Landowner is interested in buffer protection.	Unk.	Remains forested and agricultural land.	VTANR, CREP, RNRCD
	Restore Riparian Buffer	Improve shade, stability of river, habitat	Buffer in area to protect stream as well as crops.	None.	Low	Bare to forest	VTANR, RNRCD, CREP
T2.01-B

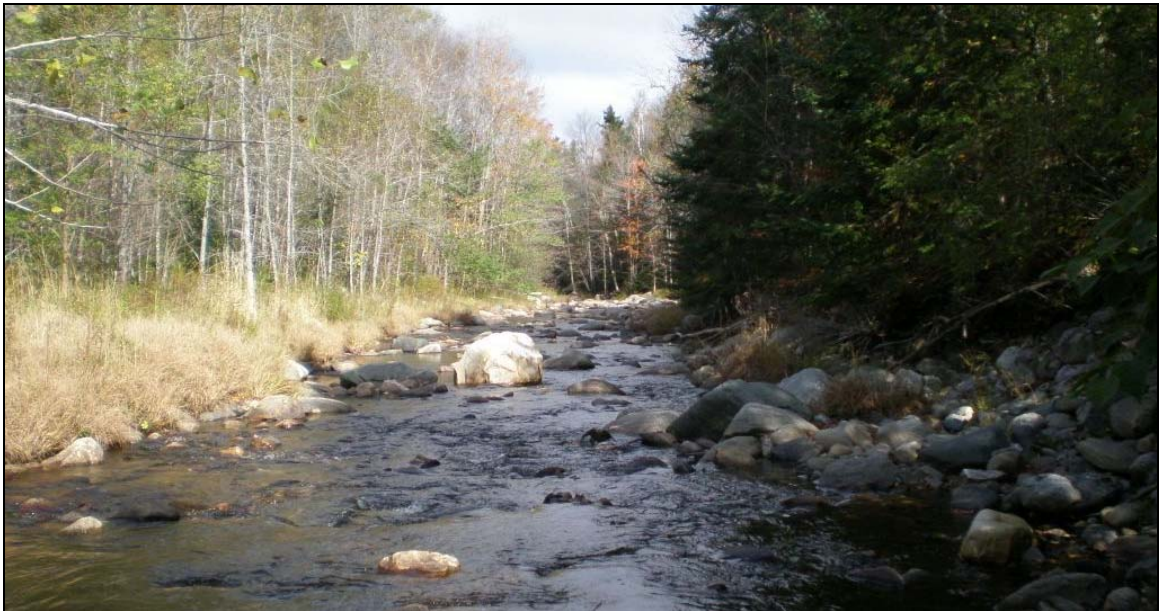
Reach M13-B is a short segment located where the valley wall of the Mill River narrows thereby creating a semi-confined channel that is a B3 planebed by reference (Figure 4). Some development has occurred along the top of the left valley wall, however, the development is well above the floodplain and is only mentioned as the landowners in this reach are in close proximity to the stream and may have an impact on its water quality. These houses are also located on top of a steep valley wall and may have some erosion hazard risks. Landowner education in this area to ensure that the forested buffer remains intact and stormwater and garbage is minimized from entering the channel would be beneficial in this segment.

In regards to the observed stream condition, the channel was found to be slightly incised. Some minor widening has occurred. Extreme adjustments are unlikely in this reach due to the stable tendencies of B3 planebed streams.

Figure 4. M13-B is a B3 planebed segment by reference.

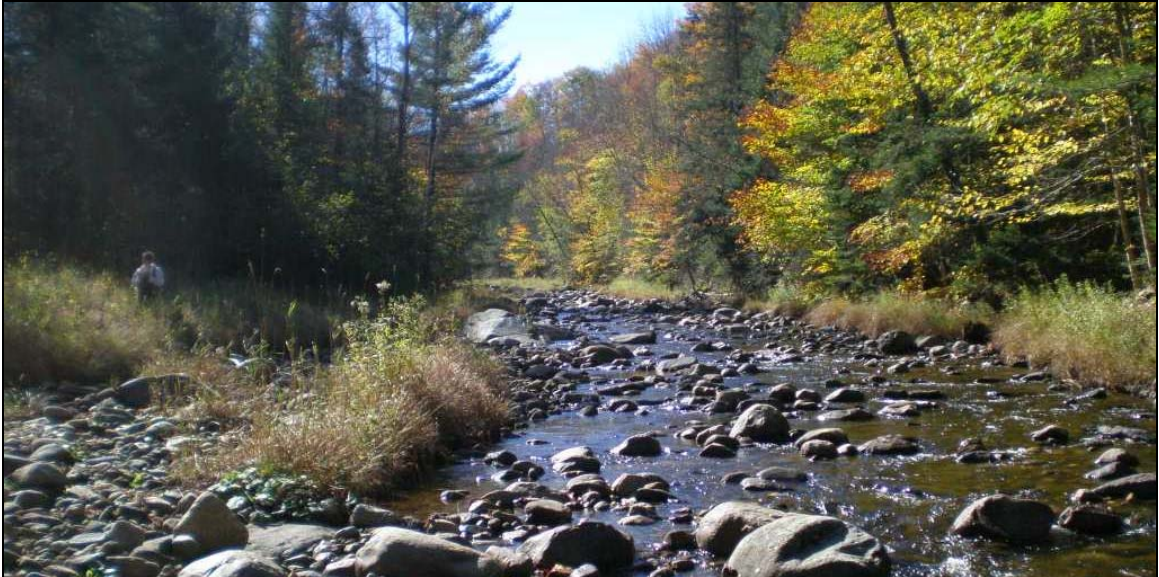
Mill River segment M13-A is a short segment located in a broad valley. Historic channel incision has led to minor channel widening and major channel planform adjustments. Despite a high degree of incision the stream has remained a C-type channel dominated by gravel substrates (Figure 5). The river is adjusting laterally through several flood chutes and has stored a significant amount of gravel in a large point bar. The well forested buffer in this corridor is an asset for the river as are the floodchutes and wetlands that will store some water and sediment during a large runoff event.

Figure 5. M13-A is a C type channel that is undergoing planform adjustment and minor widening.

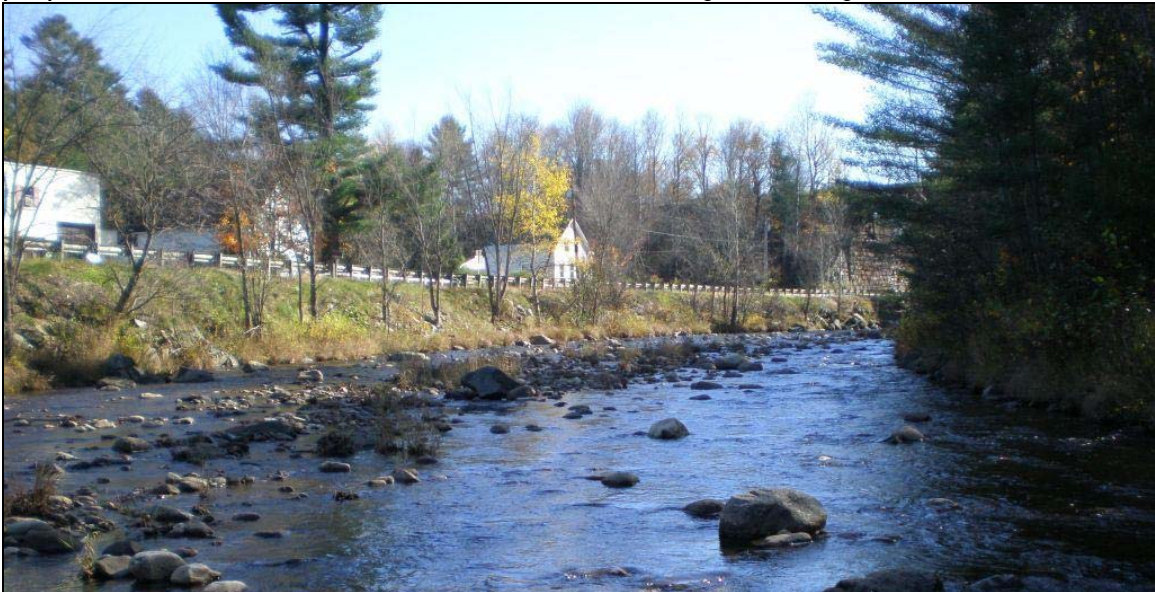
Mill River segment M11-A is one of two reaches that run through the Village of East Wallingford. Due to the relative location of the village to the river, extensive channel straightening, armoring, and dredging have altered this channel, likely in response to past flood events. These alterations have transformed riffle-pool system in a broad valley into a F-type stream with a plane bed form lacking in habitat as well as floodwater and sediment storage capabilities. Vermont Route 155 and commercial and residential development have significantly encroached on the channel (Figure 8). The bridge at the downstream end of the reach appears to be a debris/ice jam potential hazard - it already has held enough sediment behind the middle pier for a fully vegetated mid-channel bar to form. In addition a railroad bridge crossing which funnels both a road and the river underneath appears to be limiting sediment transport. The upstream aggradation the bridge is causing may be increasing an erosion issue on pasture land on the left bank of M11-B. Opportunities to increase conveyance of water and sediment underneath these bridges may be appropriate projects to reduce fluvial erosion hazard in East Wallingford Village.

Figure 8. M11-A flows through East Wallingford Village and has a high degree of incision due to channel straightening and dredging.

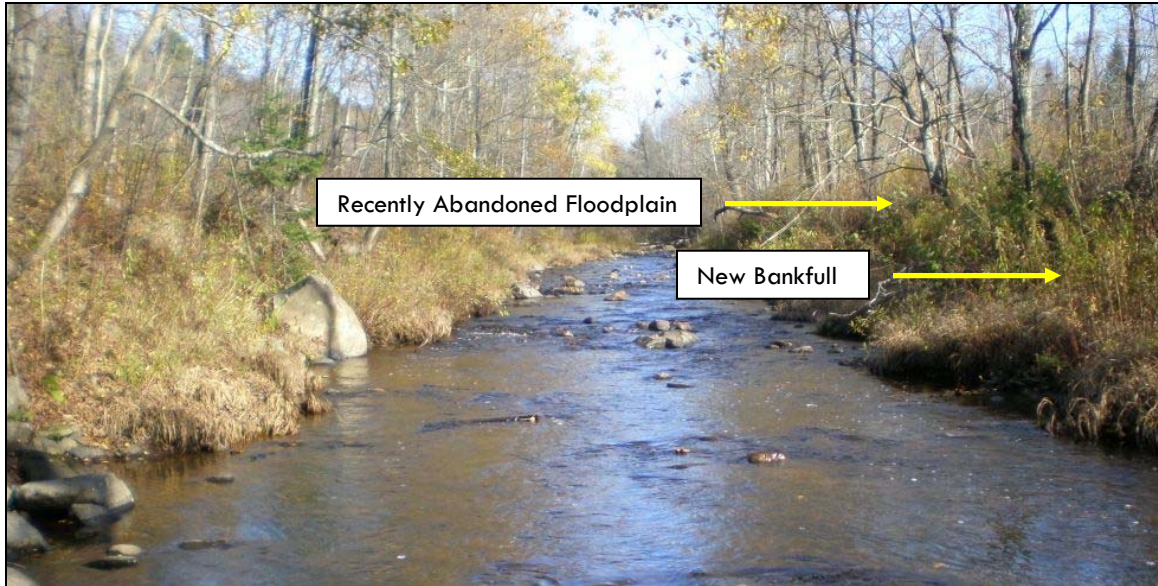
Tributary segment T2.01-A has seen extensive historic channel straightening and armoring (Figure 10). There is also evidence of dredging and windrowing just above the Route 140-East Bridge. The right side of the floodplain has been filled almost entirely by Routes 140 and 103 which create the top of the right bank. On the left side of the channel the riparian buffer has been cleared down to a thin strip of vegetation along the top of the bank. Agricultural land use dominates the left corridor while commercial and residential land use dominates the right corridor. Cross section analysis indicates that a stream type departure has occurred from a C-type channel to an F-type stream due to a high grade of incision.

Figure 10. T2.01-A has been historically straightened and is now has a plane bed system that is disconnected from its floodplain.

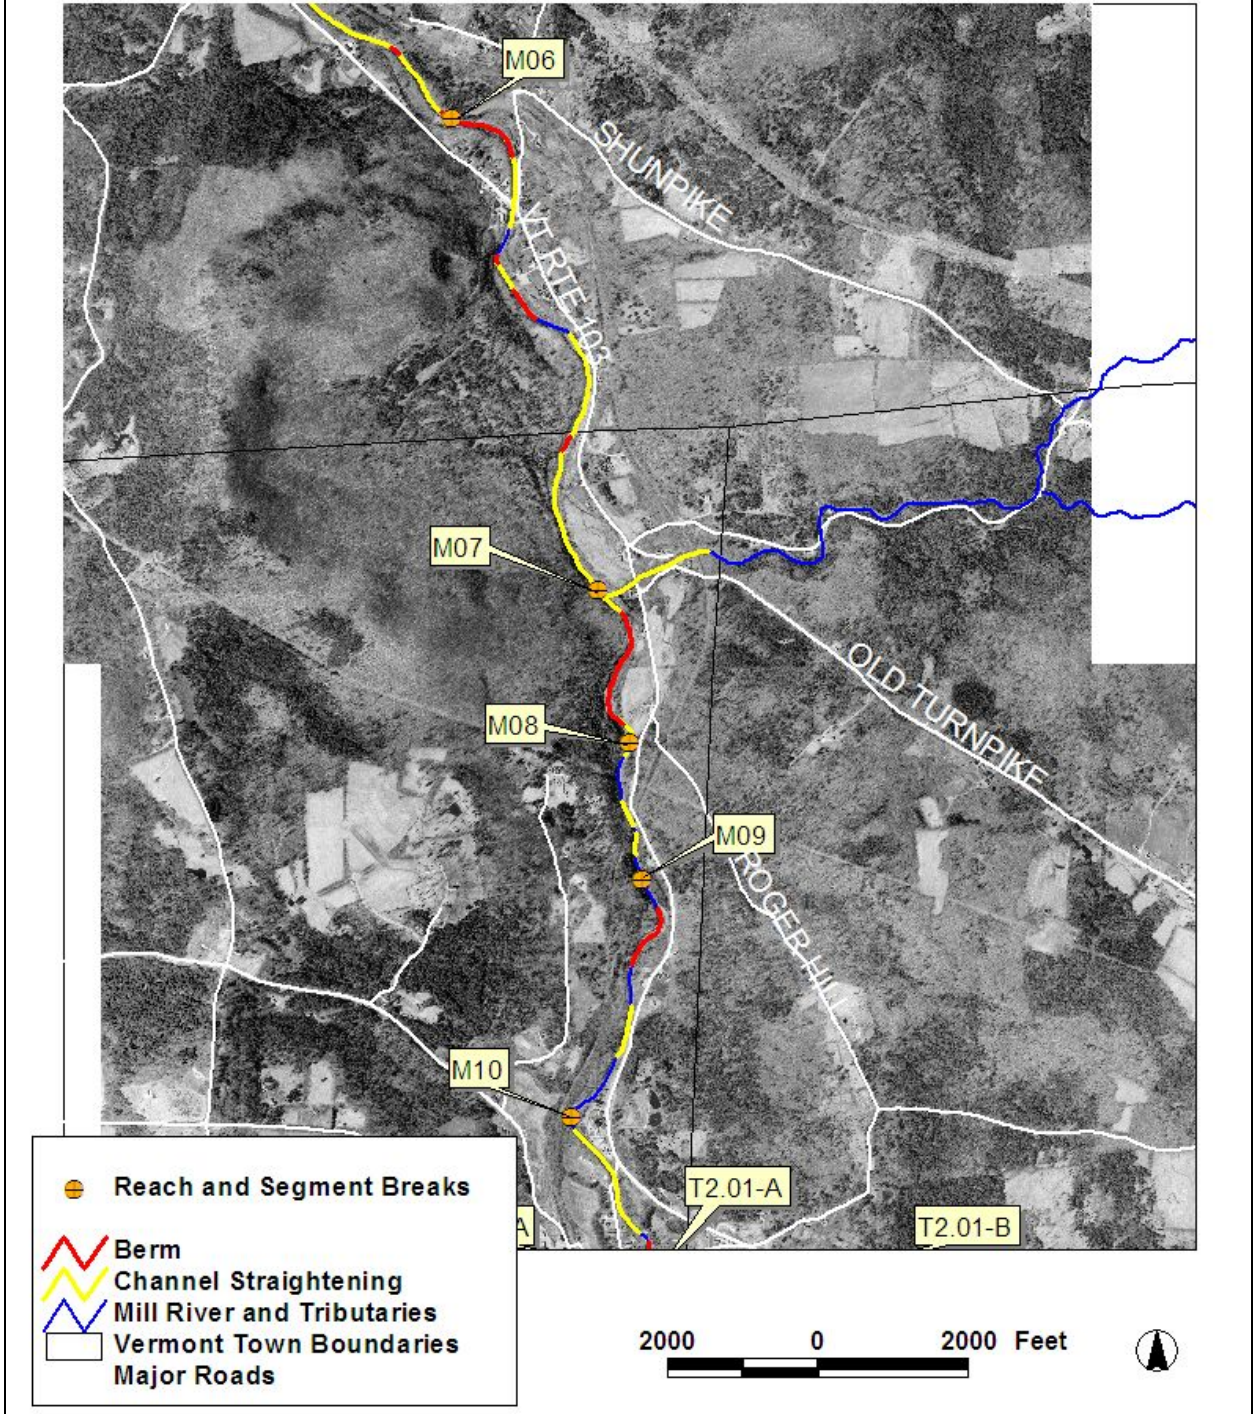
Mill River Watershed Phase 2 Geomorphic Assessment Reach Overview and Channel Alterations Map

The second section of river (illustrated in Figure 11) begins below East Wallingford Village and continues downstream to Cuttingsville. The valley alternates between very broad and narrow and the land use changes from commercial and residential in East Wallingford to agricultural and then back to development in Cuttingsville. Major significant impacts in this section include removal of riparian vegetation, channel straightening and dredging, berming, channel armoring, and floodplain encroachment.

Figure 11: Overview of reaches M06 through M10 and channel straightening and berming.

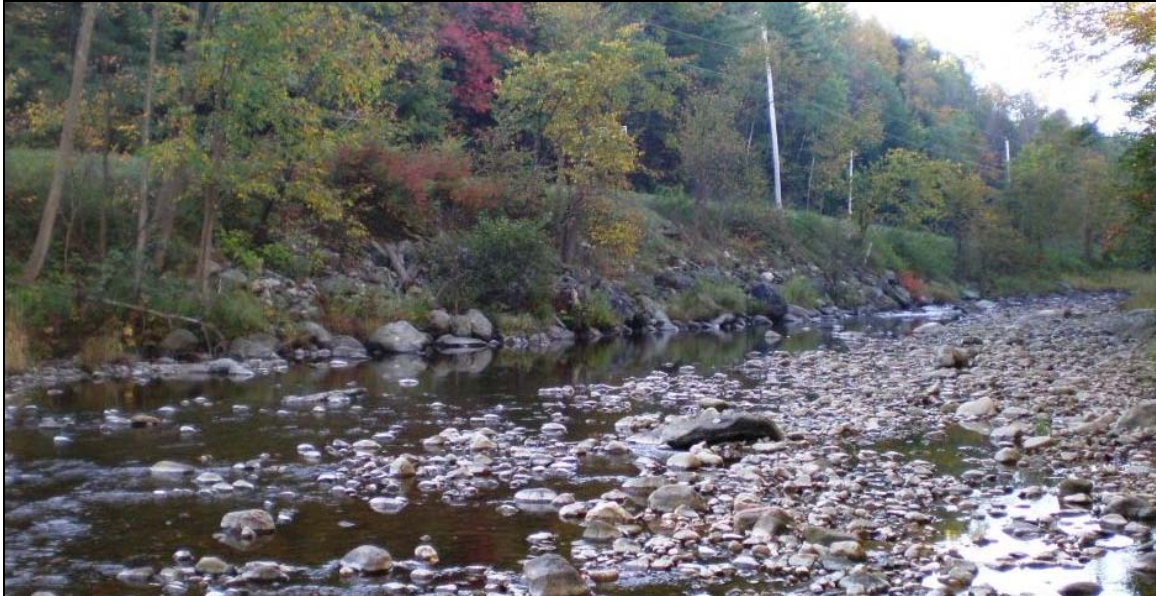
Although development pressure is not as significant as in the reach upstream, Mill River reach M09 has been impacted predominately by VT Route 103 which has changed the valley width from broad to narrow. In order to protect the roadway and a few structures located within the river corridor, extensive berming and channel armoring has occurred (Figure 13). Berming and straightening has increased the erosive forces in the channel leading to a high degree of incision (ratio of 1.8) and a stream type departure from a C riffle-pool channel to a B plane bed system. Adjusting to this incision, the stream has undergone extreme channel widening. Extensive channel management (riprap, dredging, straightening) has prevented the channel from developing new floodplain and storing sediment.

Figure 13. The valley width of M09 has been decreased due to encroachment from VT Route 103. The channel has undergone extreme widening.

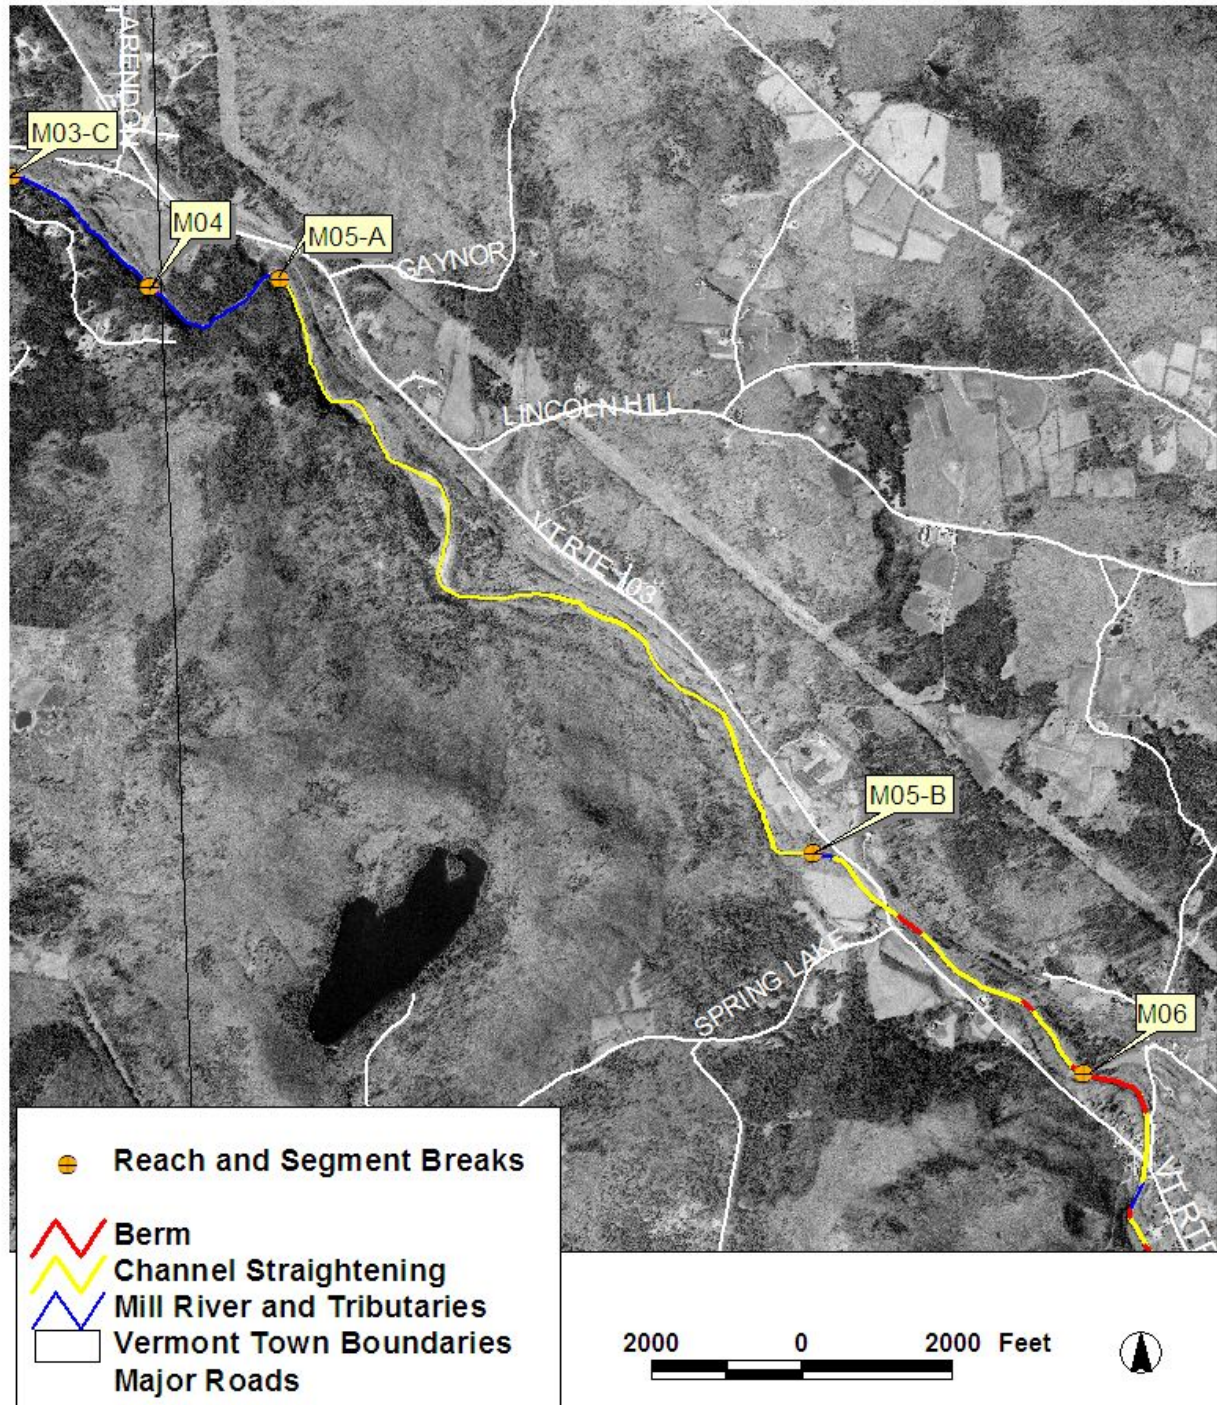
Mill River Watershed Phase 2 Geomorphic Assessment Reach Overview and Channel Alterations Map

The third major section of river (illustrated in Figure 17) begins just downstream of Cuttingsville Village. From here down to the upper Clarendon Gorge, the Mill River flows through a broad valley. Major significant impacts in this section include removal of riparian vegetation, channel straightening and dredging, corridor encroachment and an undersized bridge.

Figure 17: Overview of reaches M03-C through M06 and channel straightening and berming.

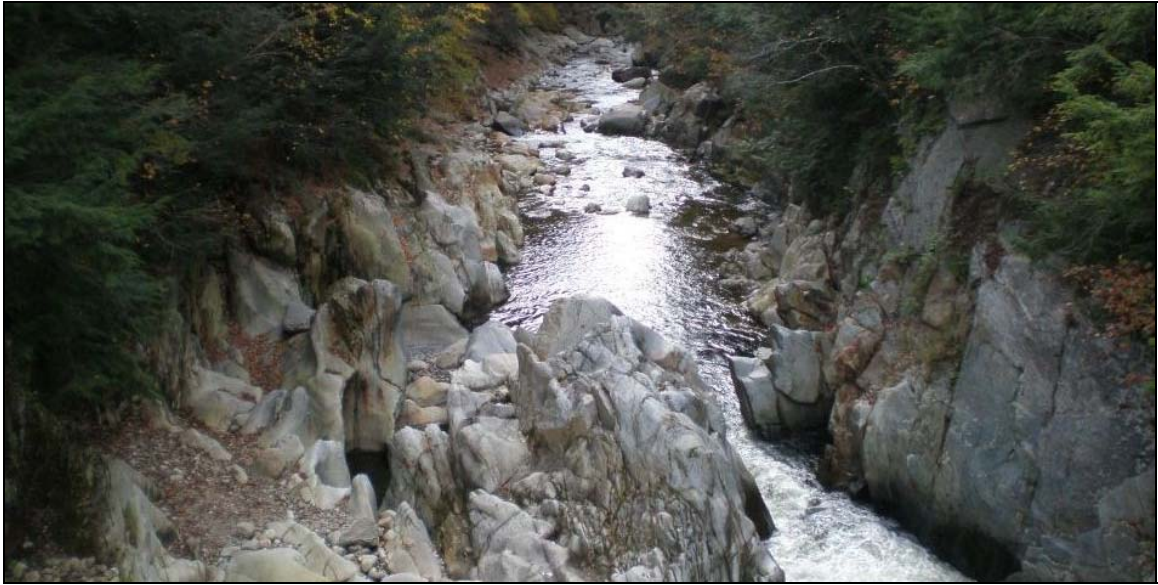
Mill River reach M04 encompasses the Upper Clarendon Gorge (Figure 20). The gorge begins at a sharp southwestward bend in the river where a Long Trail suspension bridge hangs from the bedrock cliffs on each side. The Mill River cuts through the Dalton Formation (a cambrian dolomite/conglomerate), the Mount Holly Gneiss, and the Cheshire Quartzite on its way through the gorge. Due to the bedrock this reach received only a partial Phase 2.

Figure 20. M04 consists of the Upper Clarendon Gorge.

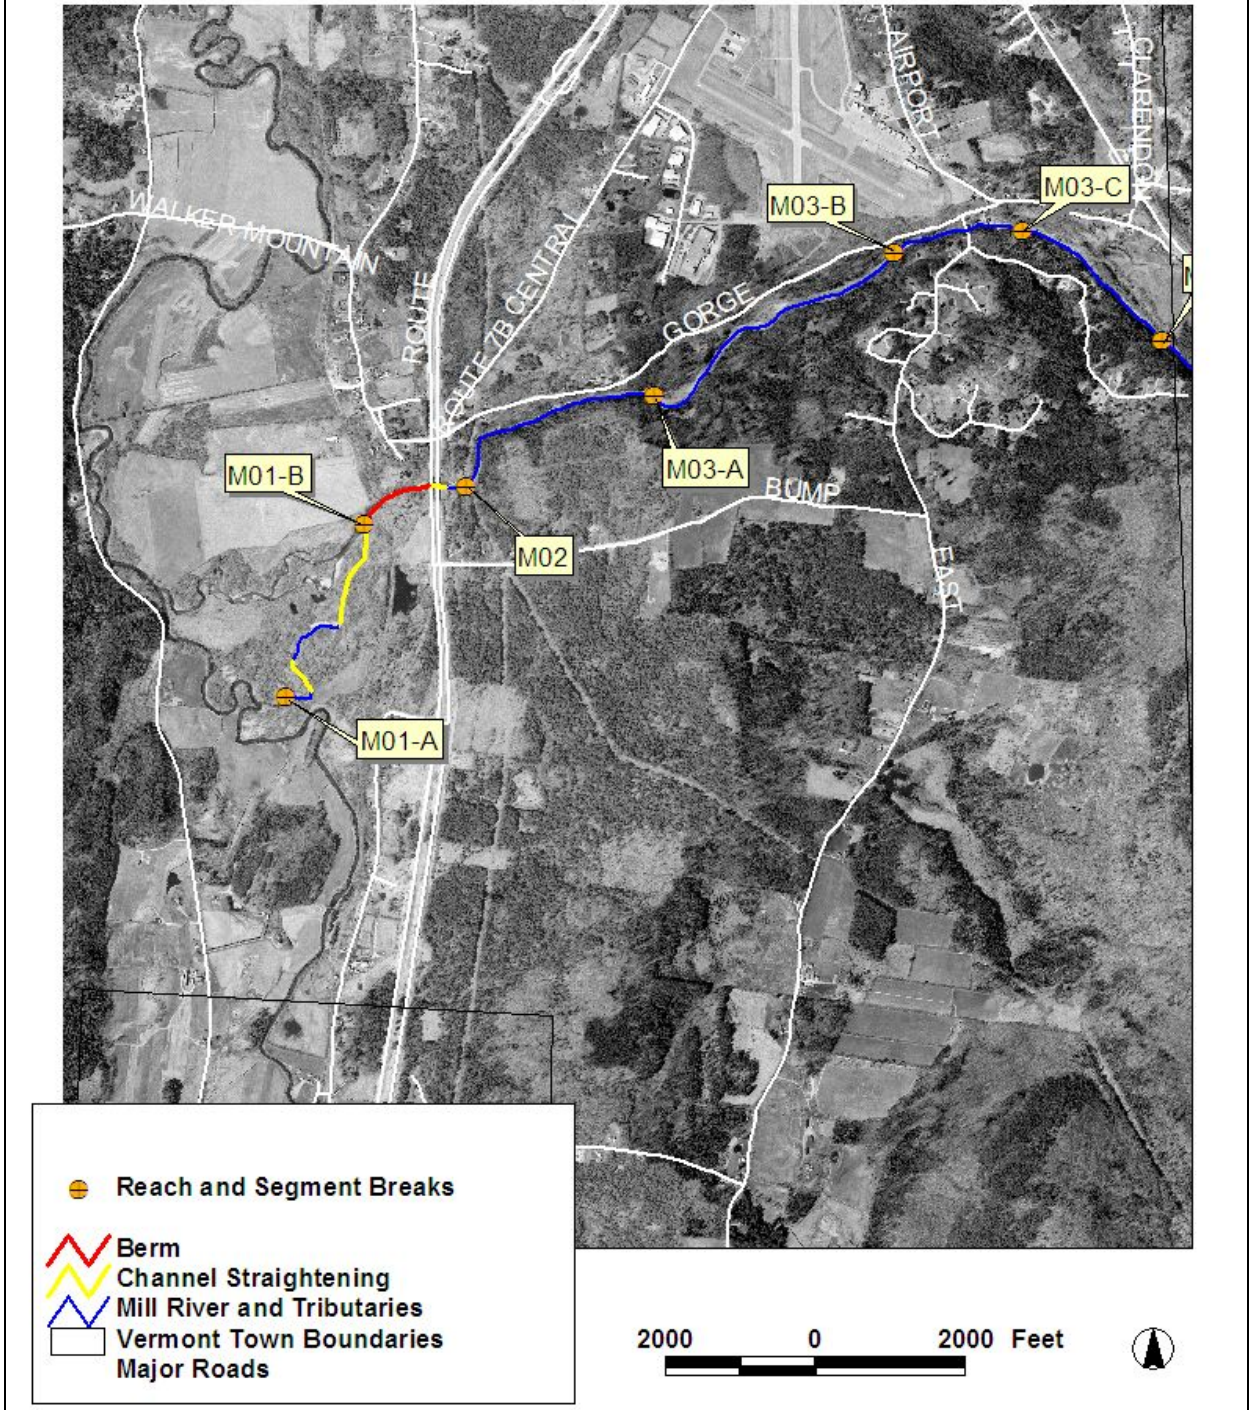
Mill River Watershed Phase 2 Geomorphic Assessment Reach Overview and Channel Alterations Map

The final section of river (illustrated in Figure 21) begins below the Upper Clarendon Gorge (near the Kingsley Covered Bridge) in the town of Clarendon. From here down to the confluence with the Otter Creek, the Mill River flows through a few bedrock dominated reaches bordered by state and federally owned wooded landscapes before spilling onto the much broader Otter Creek valley bottom. Major significant impacts in this section include removal of riparian vegetation, channel straightening, dredging, and several undersized bridges.

Figure 21: Overview of reaches M01 through M03 and channel straightening and berming.

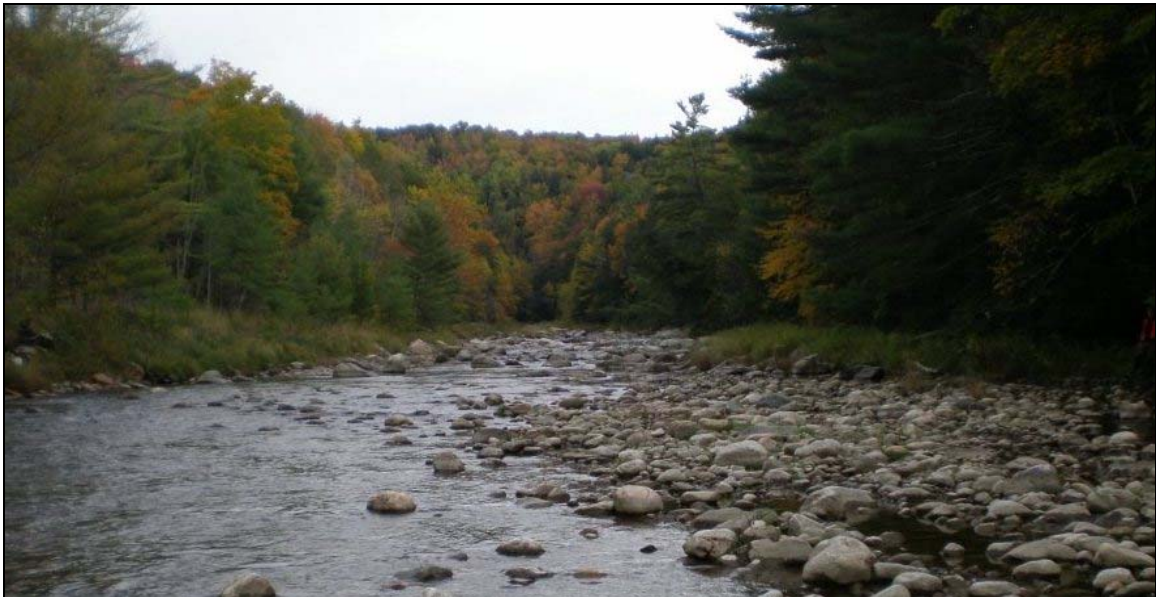
This segment is located between the Upper Clarendon Gorge (a bedrock controlled section) and the bedrock controlled segment at the former Kingsley Mill site. Channel incision observed here may be a result of the river working back through sediments that were stored when there was a mill dam, or due to a sediment imbalance upstream. The Mill was in operation from 1882 until 1935. There are residences encroaching on the river corridor on the left bank, and land was cleared for agriculture on the right of the corridor. This reach was observed to be a B-type channel with a planebed form dominated by gravel substrates (Figure 21). This is expected to be the reference stream type despite major channel widening.

Figure 21. M03-C is a short plane bed segment between two bedrock grade controls.

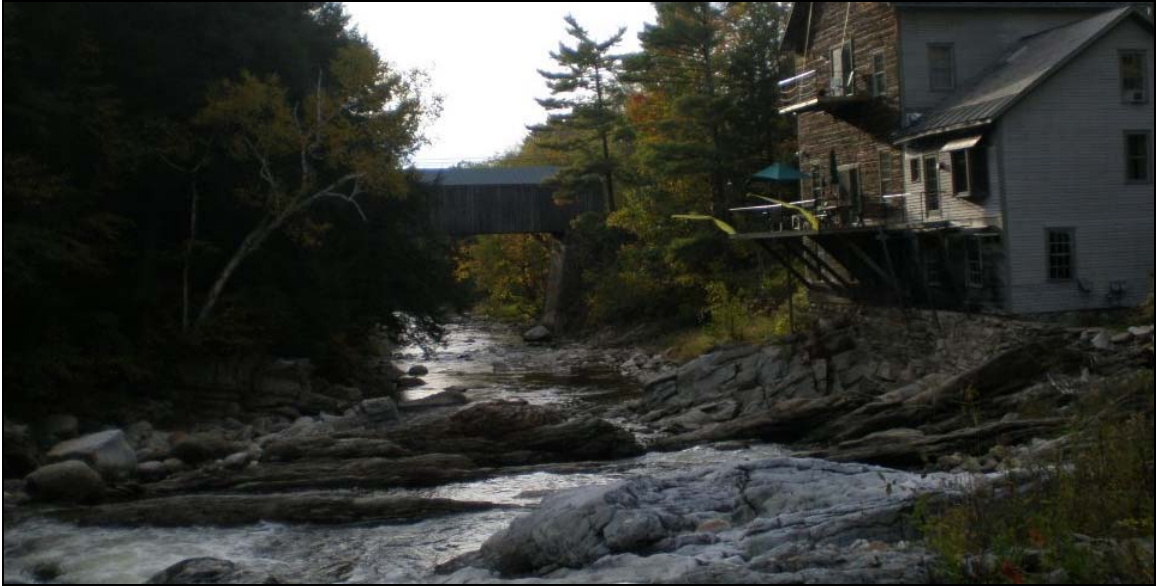
Segment M03-B is a short bedrock controlled segment that includes the former Kingsley Mill dam site (Figure 22). Bedrock grade control and bedrock on most of the banks limited this segment to receiving only a partial Phase 2 assessment. Although some residential development has affected the riparian buffer, in general the bedrock has created a stable geomorphic condition in this segment.

Figure 22. M03-B is a bedrock controlled segment at the site of the former Kingsley Mill.

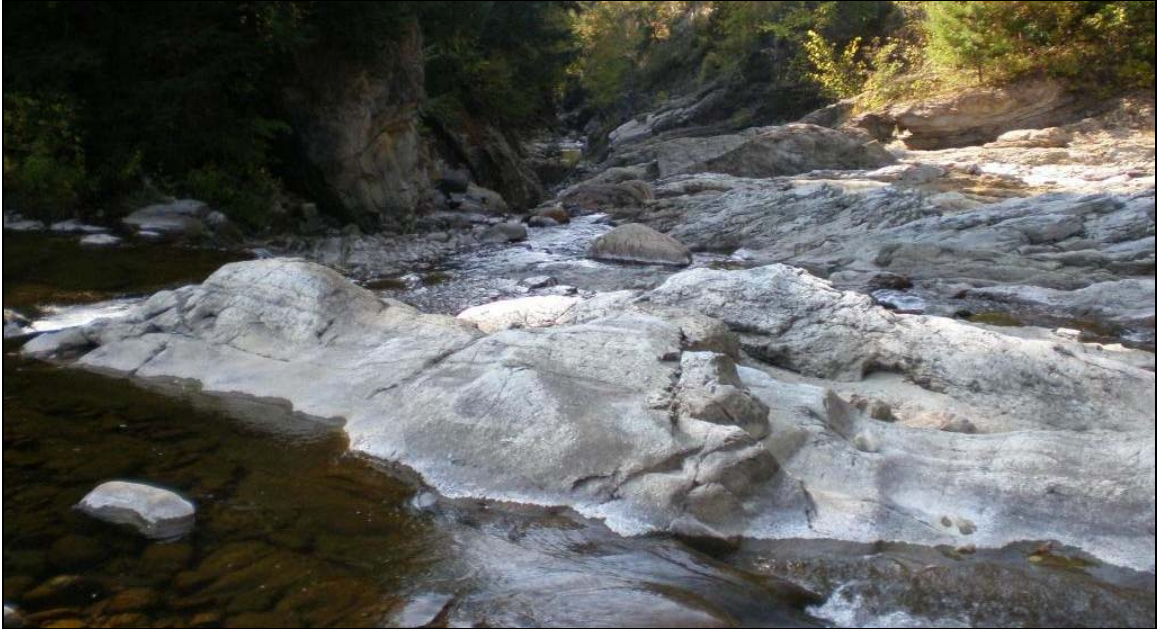
Mill River reach M02 consists of the Lower Clarendon Gorge (Figure 23). The gorge is carved through the Cambrian Dalton formation and Cheshire Quartzite (Van Diver 1987). The Dalton formation lies on Precambrian rocks of the Green Mountain core at the upstream end of the gorge. Only a partial assessment was conducted for this reach due to the bedrock controlled channel.

Figure 23. M02 is the Lower Clarendon Gorge in Clarendon.

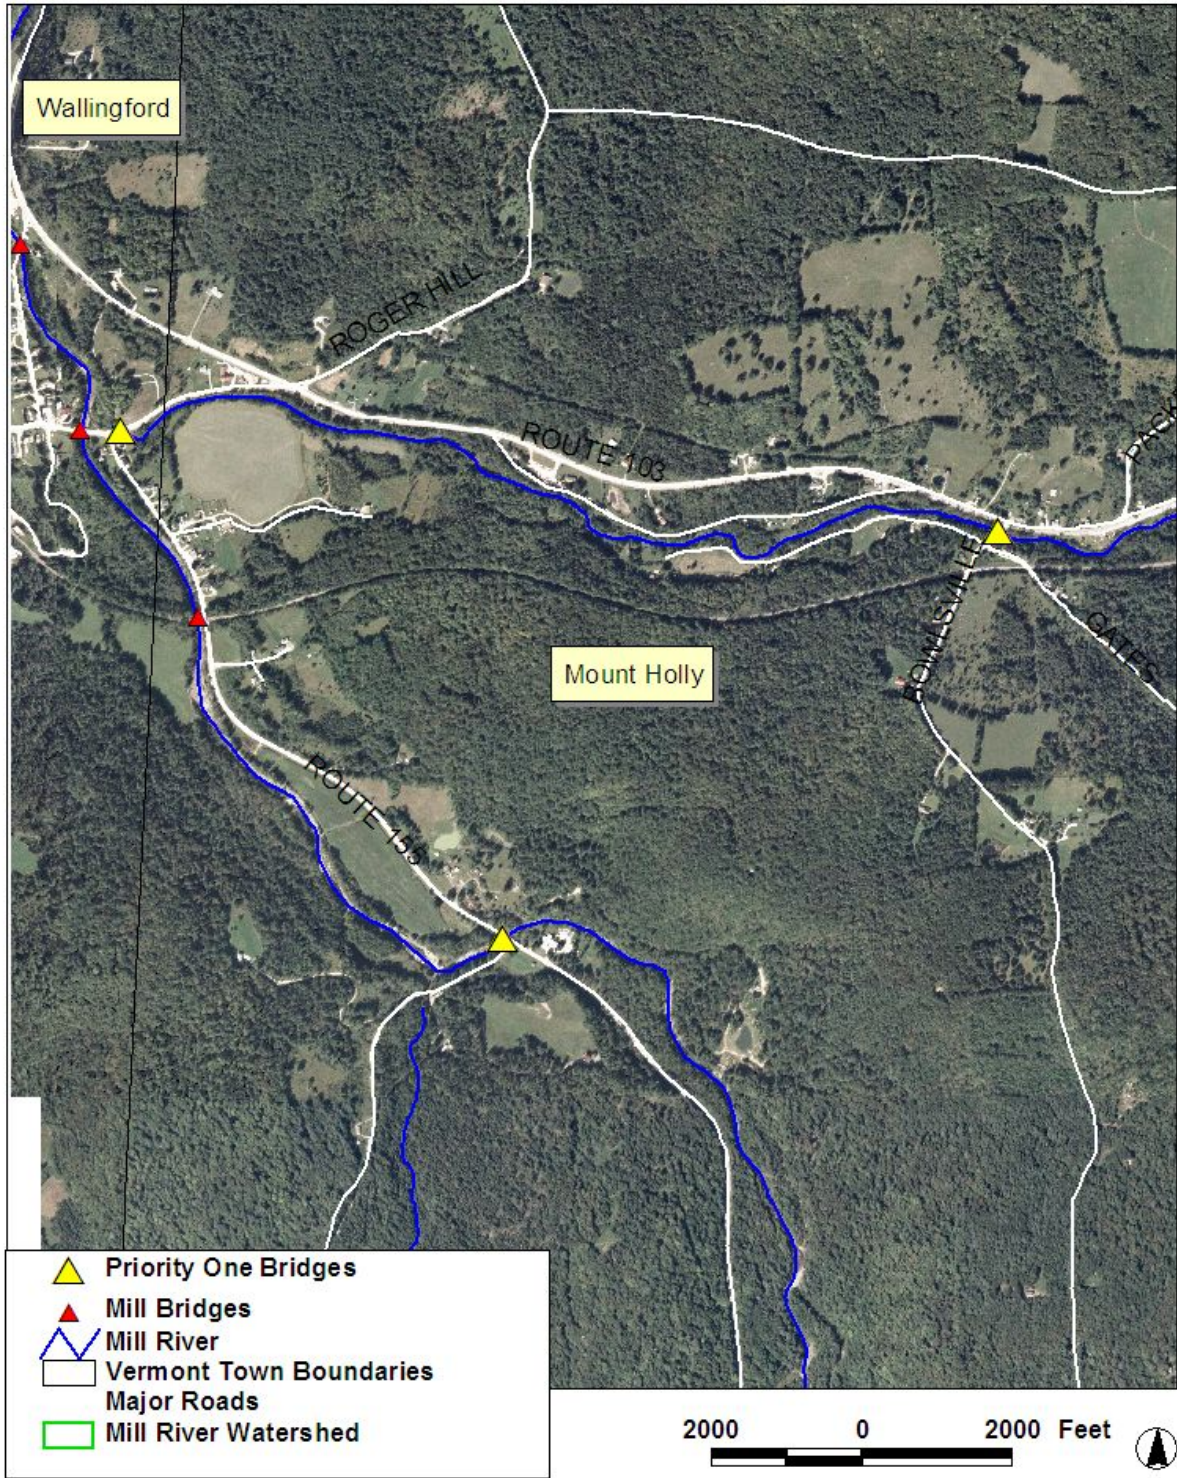
Mill River Watershed Bridge Assessment: Priority One Structures

Figure 3. Stream crossings in the Mill River watershed considered to be high priority for replacement due to geomorphic incompatibility.

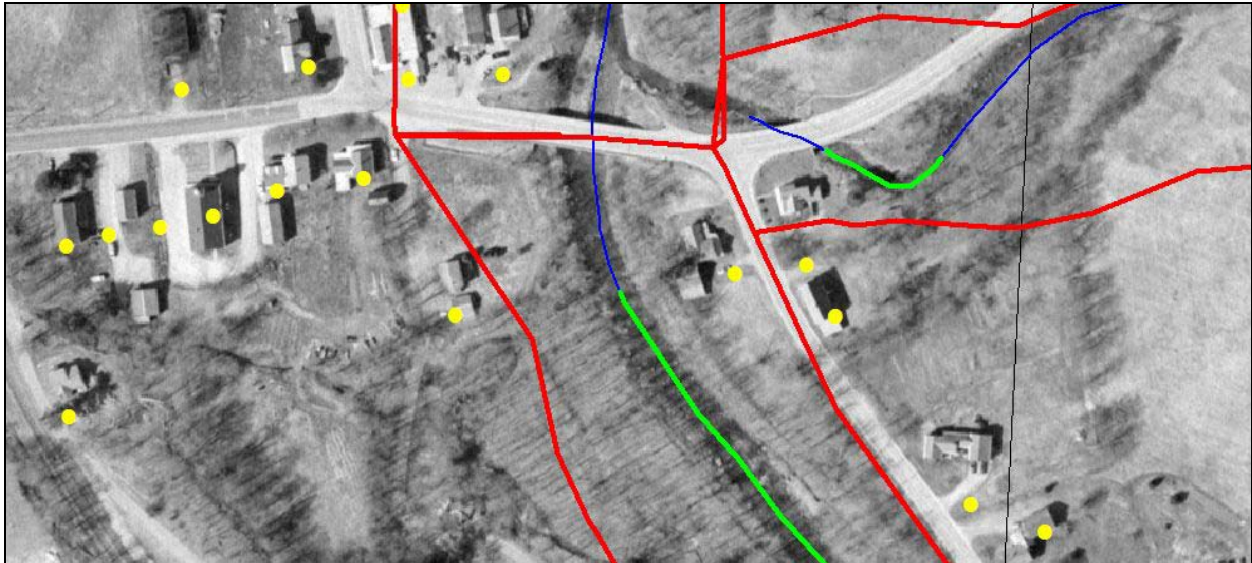
<i>Existing Zoning</i>	<ul style="list-style-type: none"> • Village B District • Flood Hazard Areas Zoning defined by FIRM Maps
<i>Existing Structures</i>	Vermont Route 155 and commercial and residential development have significantly encroached on the channel. The bridge at the downstream end of the reach appears to be a debris/ice jam potential hazard - it already has held enough sediment behind the middle pier for a fully vegetated mid-channel bar to form. In addition a railroad bridge crossing which funnels both a road and the river underneath appears to be limiting sediment transport. The upstream aggradation the bridge is likely increasing an erosion issue on pasture land on the left bank of M11-B. Surprisingly, despite the high level of development, the draft FEH corridor affects only two single-family residences located just upstream of the Route 140E bridge (Figure 2). This is largely due to Vermont Route 155 acting as a new valley wall through this reach and protecting the development on its eastern flank. Berming to protect the residence on the right bank is already significant.

Figure 2: FEH Zone (red), berms (green) and structures at end of reaches M11-A and T2.01-A.

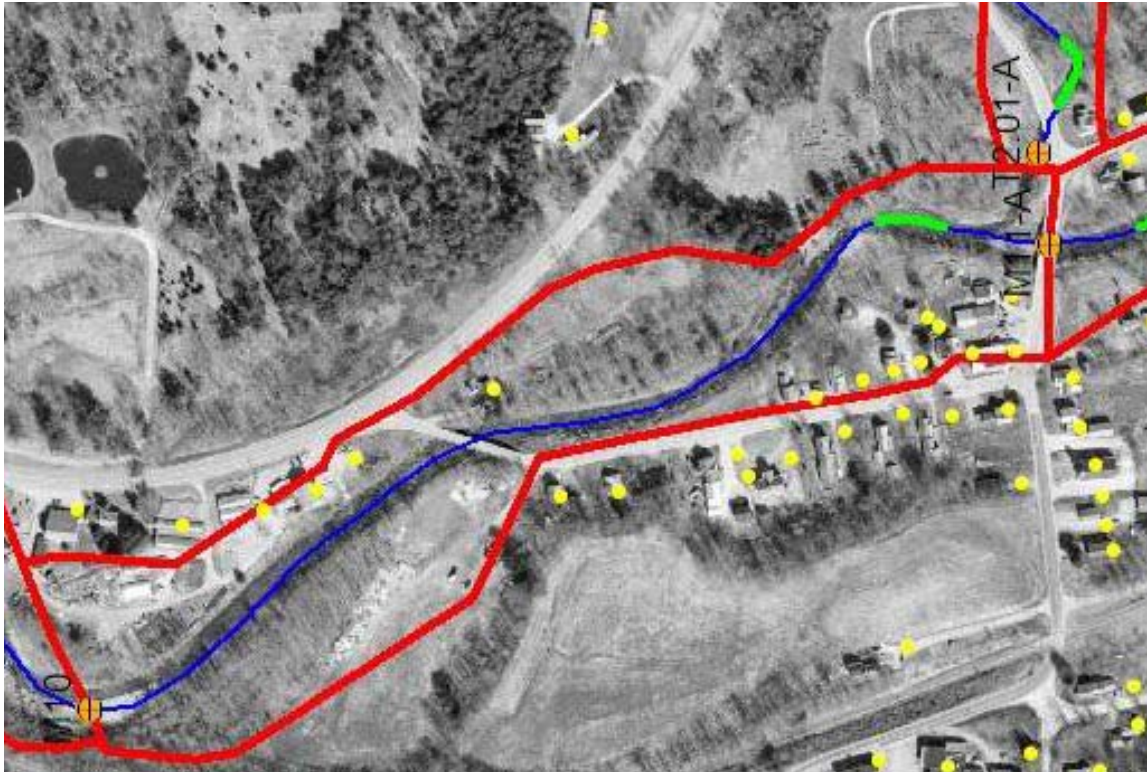
<i>Existing Zoning</i>	<ul style="list-style-type: none">• Village B District• Flood Hazard Areas Zoning defined by FIRM Maps
<i>Existing Structures</i>	Deteriorating bridge conditions on Village Street may provide an opportunity for redesigning access to the Village and or at least allowing better sediment and water transport under the bridge (which is currently holding sediment in its mid-pier and may create debris jam and flooding under the right conditions). Numerous houses exist within the FEH corridor (Figure 3).
<i>Assets and Liabilities</i>	Continued development pressure in the village may be expected.

Figure 3: Structures (yellow) located in the FEH Corridor (red) in E. Wallingford Village

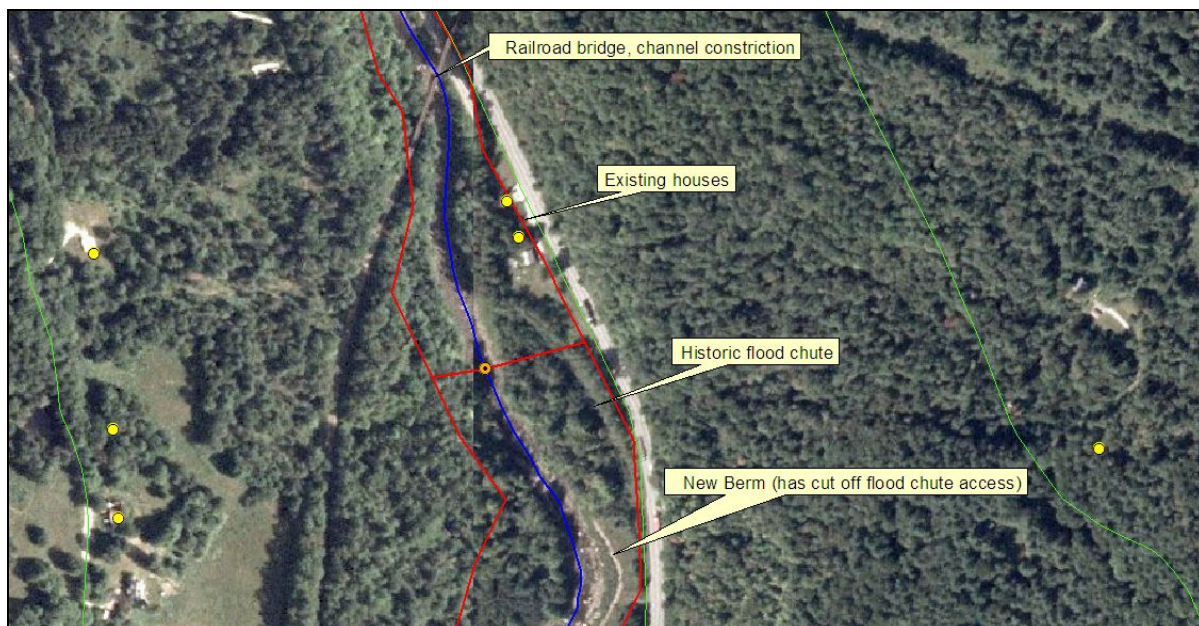
<i>Existing Zoning</i>	<ul style="list-style-type: none">• Rural District• Flood Hazard Areas Zoning defined by FIRM Maps
<i>Existing Structures</i>	Two houses are located on the edge of the proposed FEH Zone on the right bank (Figure 4).
<i>Assets and Liabilities</i>	None identified.

Figure 4: Structures located in the FEH zone in reach M08.

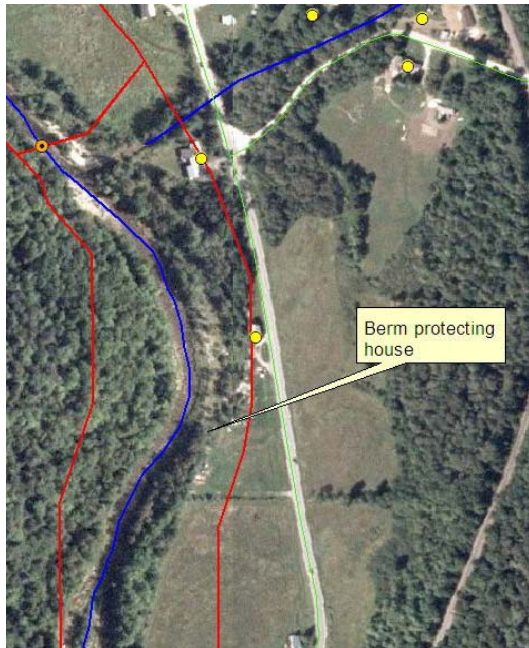
<i>Existing Zoning</i>	<ul style="list-style-type: none">• Rural District• Flood Hazard Areas Zoning defined by FIRM Maps
<i>Existing Structures</i>	Two houses are located on the edge of the proposed FEH Zone on the right bank, one of which is significantly protected by an existing berm (Figure 5).
<i>Assets and Liabilities</i>	None identified.

Figure 5: Structures in the draft FEH reach M07.

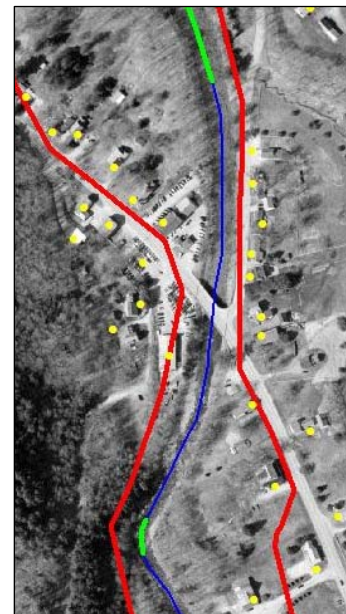
Mill River reach M06 runs directly through Cuttingsville Village (Figure 6) with a great deal of human alteration, both historic and recent. Channel straightening, berming, dredging, armoring, and windrowing were all observed. Additionally much of the floodplain has been filled by development and roads increasing stormwater inputs into the system. It appears that the stream may have been straightened and relocated up against the left valley wall through much of the reach. A high degree of incision (1.8 ratio) was observed with major channel widening and planform adjustments currently occurring.

Figure 6: Structures (yellow) existing in the draft FEH overlay zone (red) through Cuttingsville Village (reach M06).
