Mill River River Corridor Management Plan Rutland County, Vermont

FINAL REPORT

FEBRUARY 17, 2009

Round River Design
Michael Blazewicz
www.RoundRiverDesign.com

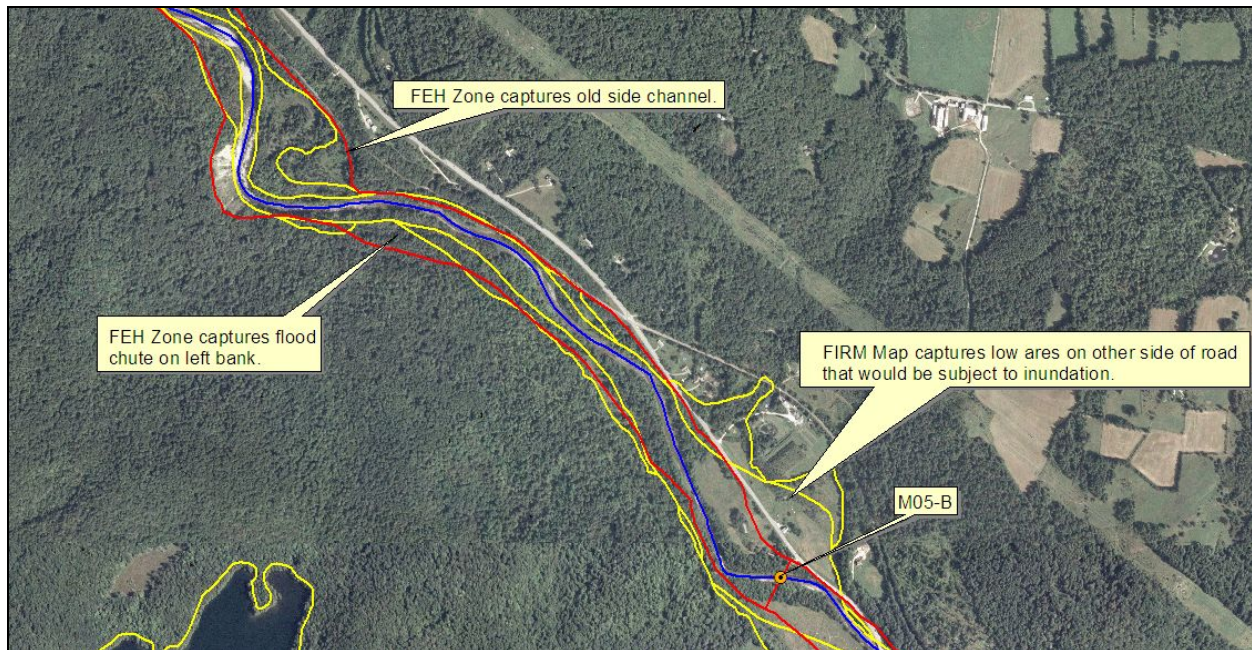
<i>Existing Zoning</i>	Rural Residential (Min lot size 4 acres on north side – right bank) Limited Residential (Min lot size 10 acres on south side – left bank)
<i>Existing Structures</i>	None
<i>Assets and Liabilities</i>	The land within the FEH corridor is predominately forested. A good portion of the lower reach is public land. Some land on the right bank is protected from development due to the railroad and the railroad r.o.w. The FIRM Map does not cover the area of land that is needed for the river to maintain long term stability (Figure 7).

Figure 7: Variations in the FIRM boundaries and FEH zone on reach M05-A.

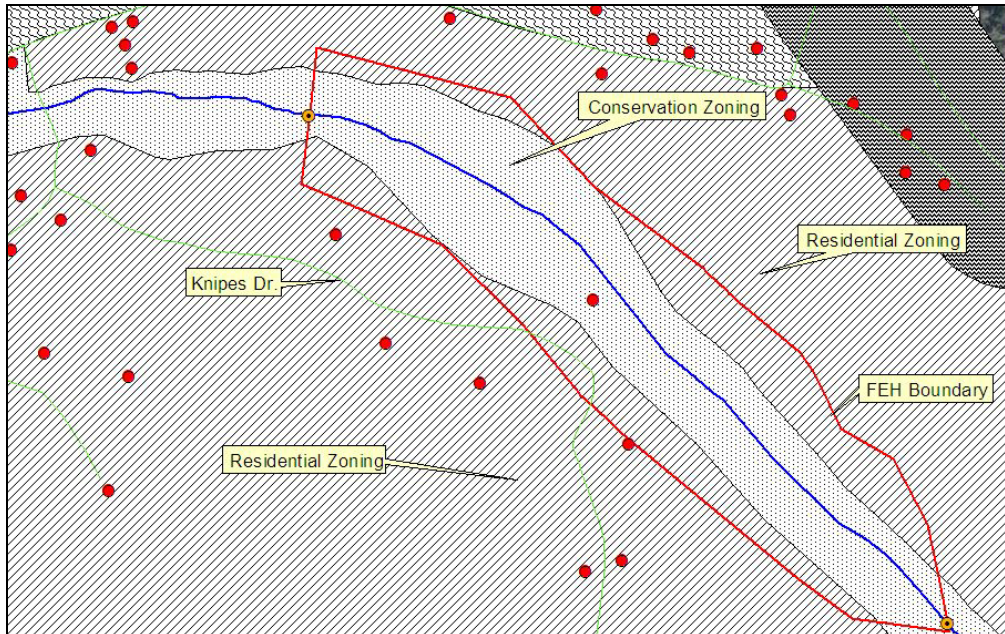
<i>Existing Zoning</i>	<ul style="list-style-type: none"> • Zoned Conservation (some residential at outer perimeter of FEH) • Flood Hazard Zoning Permit required in FIRM area
<i>Existing Structures</i>	There are several residences encroaching on the river corridor on the left bank as part of development happening on Knipes Drive.
<i>Assets and Liabilities</i>	Most of the land is zoned for Conservation, however, development may still occur (Figure 8). Also The riparian buffer has suffered in this area due to development in the FEH zone.

Figure 8: Areas where residential zoning and the FEH zone overlap in reach M03-C.

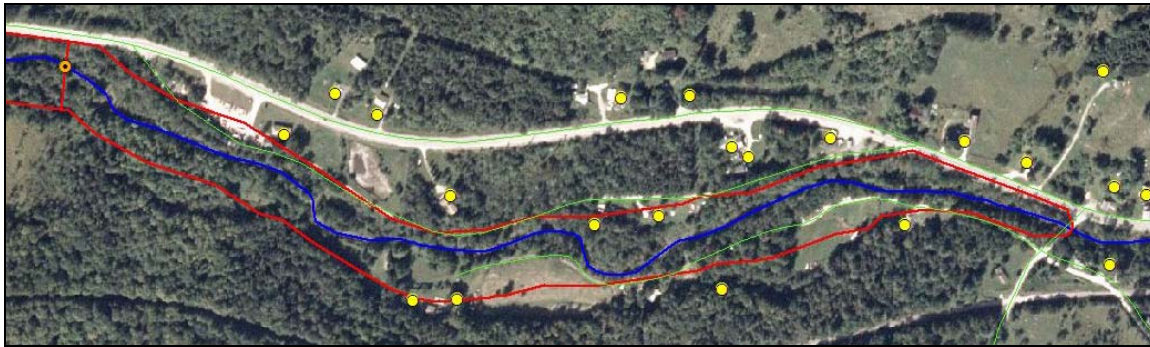
<i>Existing Zoning</i>	Flood Hazard Areas Zoning defined by FIRM Maps
<i>Existing Structures</i>	Adoption of an FEH overlay will affect numerous private landowners, six of which have homes located within or directly bordering the draft FEH corridor (Figure 9).
<i>Assets and Liabilities</i>	Stream is in fairly stable condition.

Figure 9: Houses crowd the FEH zone in reach T2.01-B.

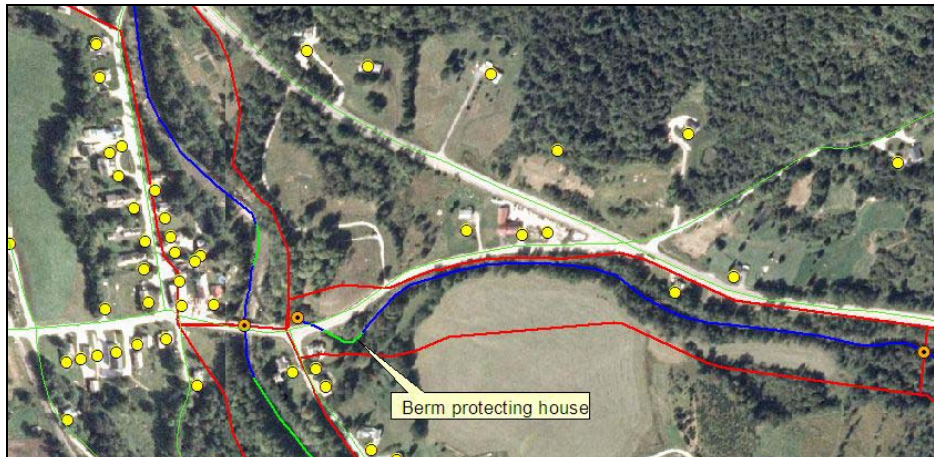
<i>Existing Zoning</i>	Flood Hazard Zoning Permit required in FIRM area
<i>Existing Structures</i>	With an extreme sensitivity rating, the two structures located within the FEH Zone of this reach are at risk (Figure 10).
<i>Assets and Liabilities</i>	Stream has been significantly altered. Much of the land is undeveloped on the left bank.

Figure 10: Encroachments and opportunities along reach T2.01-A in Mount Holly and E. Wallingford.
