# Lower Passumpsic River Tributaries River Corridor Plan

May 1, 2014

Fitzgerald Environmental Associates, LLC.  
18 Severance Green, Suite 203  
Colchester, VT 05446

Caledonia Country Natural  
Resources Conservation District  
481 Summer Street, Suite 202  
St. Johnsbury, VT 05819

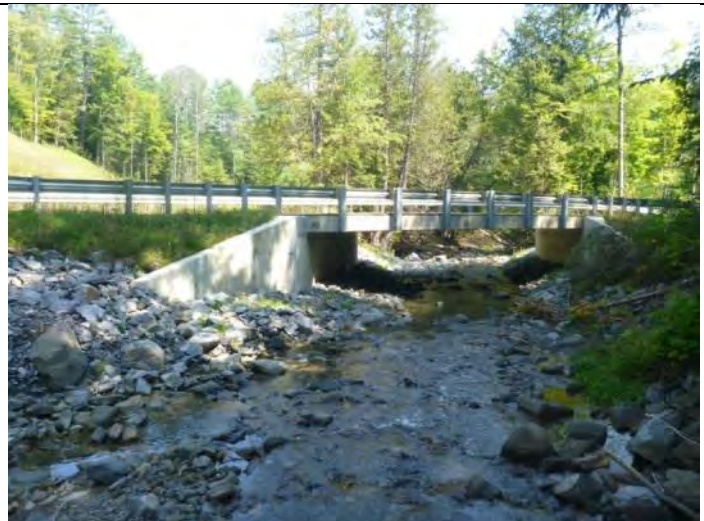
New Water Andric Rd bridge in lower segment

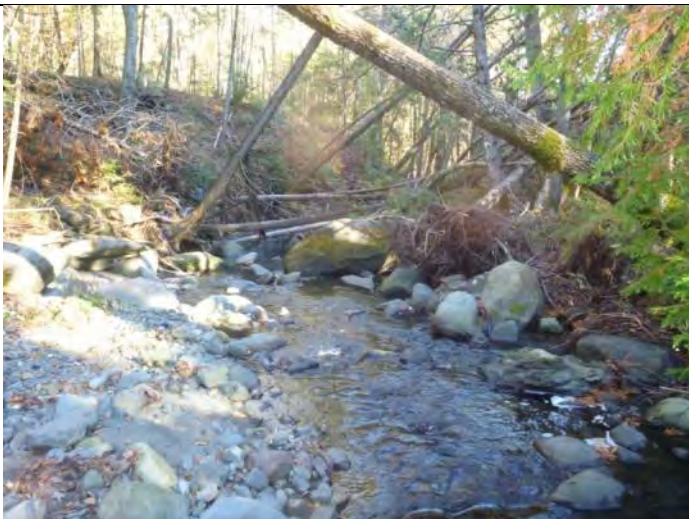
Typical channel geometry with steep scoured banks, tall depositional features along margins

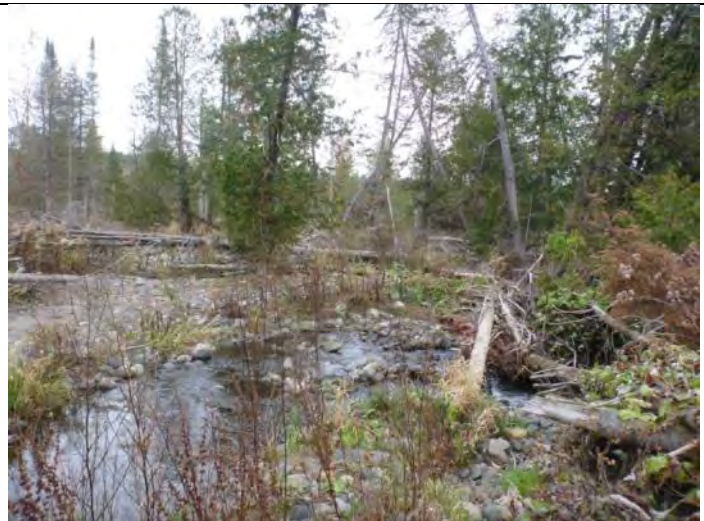
Alluvial fan at the top of segment

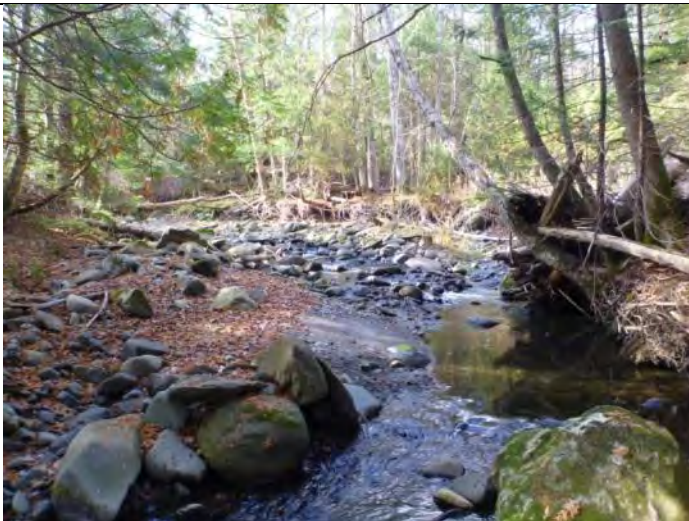
**Reach Highlights:** Aggradation and widening are the dominant processes in this reach. Large cobble/gravel bars are filling in the scoured out channel as a large volume of sediment works through following recent episodic flooding. Dense bank vegetation and roots will likely limit further channel widening as the stream re-establishes lower bank terraces.

Typical B-type geometry in reach, steep scoured bank and small floodplain storage on bars in widened channel

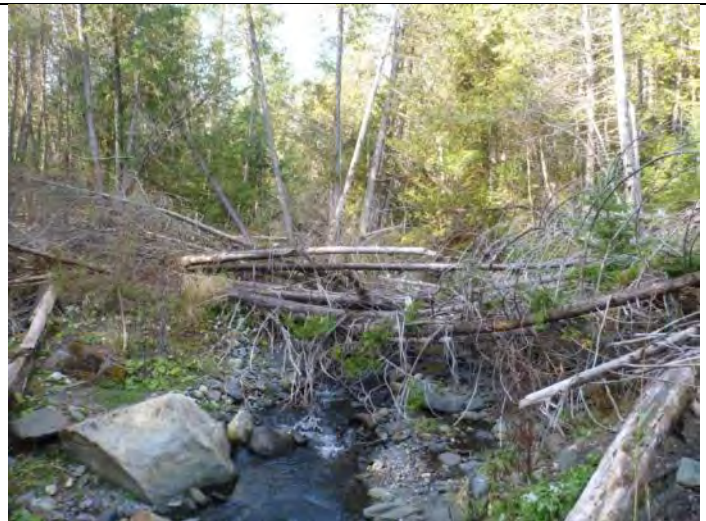
Increased sediment deposition and retention above debris jams throughout reach

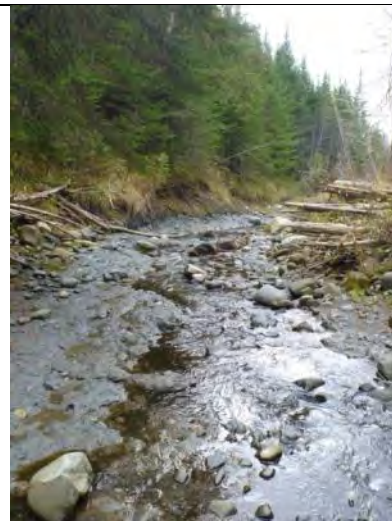
Heavy clay soils along both banks are limiting widening

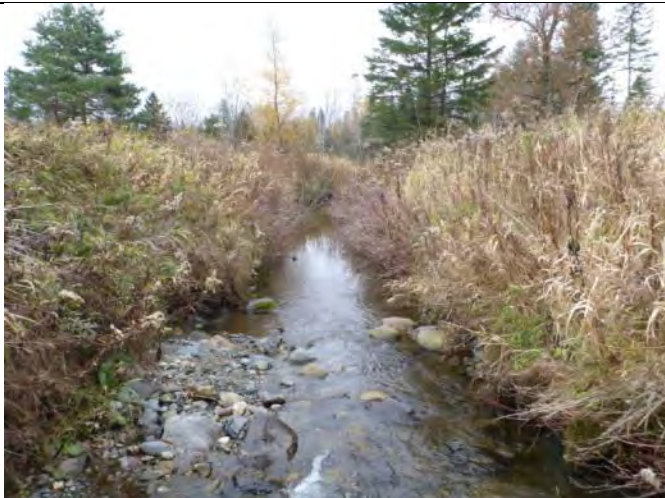
Typical B geometry with elevated floodplain on both sides.

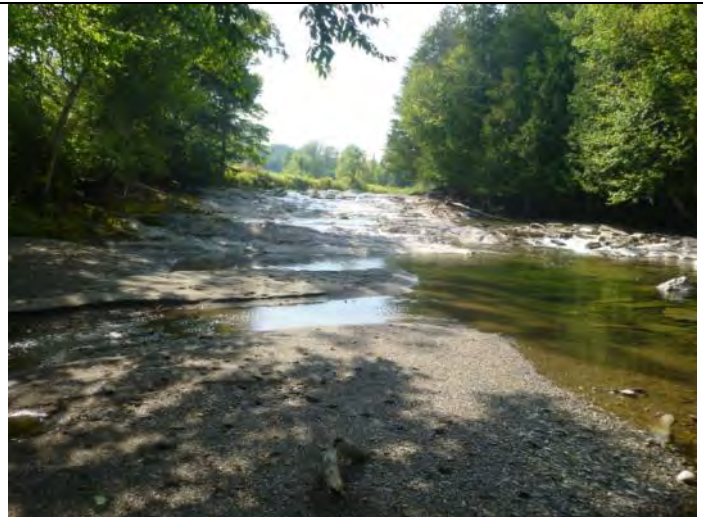
Large bedrock grade control at top of reach

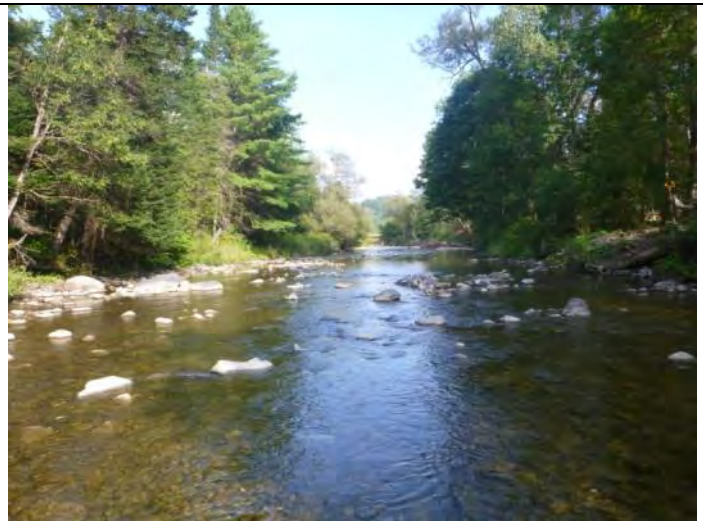
Mid-reach looking downstream - stable rocky banks and a smooth bed profile

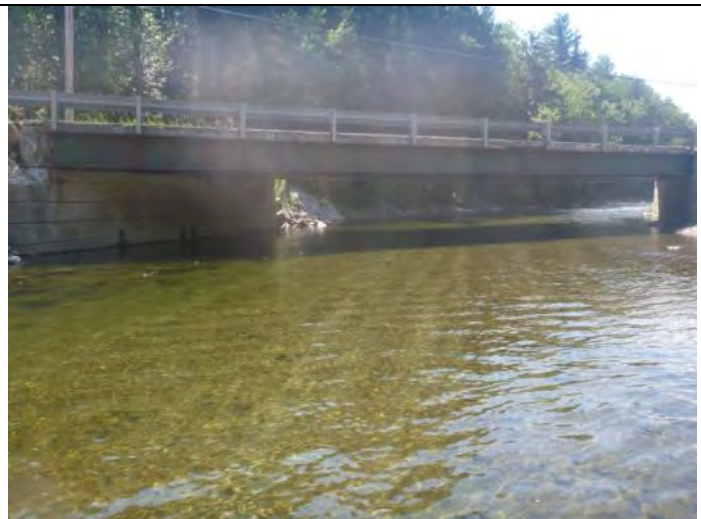
Goss Hollow Rd bridge - skewed and at a slope break, possible ice jam location

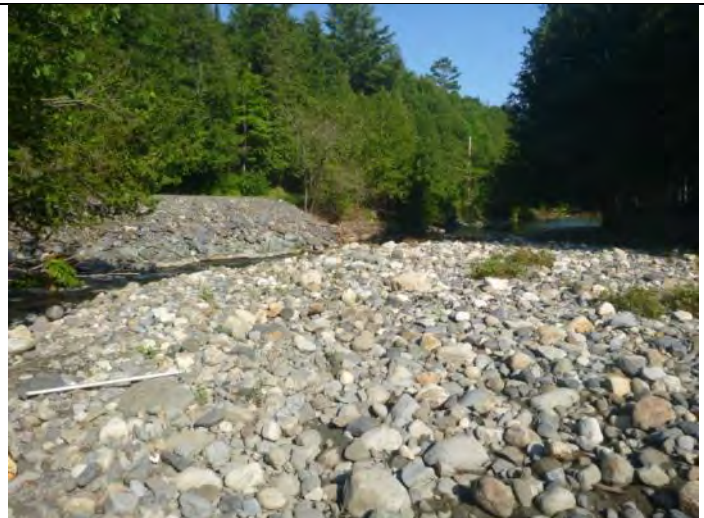
Large cobble bar and bank armor along Goss Hollow Rd

- #24 – Bank Stabilization along Goss Hollow Rd
- #25 – Corridor Protection

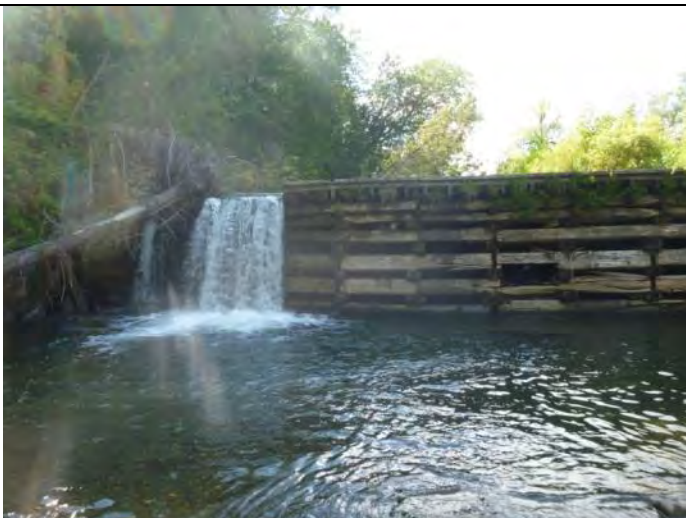
**Reach Highlights:** Channel adjustments are variable for this short reach that is strongly affected by the large timber crib dam at the bottom of the reach. The channel is attempting to reestablish planform through deep deposits of sand and gravel held by the dam. Narrow floodplain benches are forming on both sides and banks are relatively stable. Combination of adjustments suggests latter stage of channel evolution - transitioning from stage III to IV. However with the dam in place full recovery of channel equilibrium is not possible.

Timber crib dam at bottom of reach

- #31 – Channel Stabilization: Dam removal and channel restoration

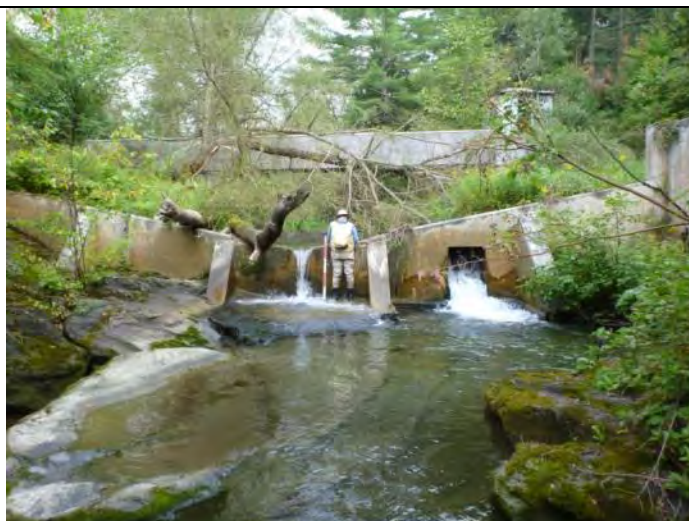
USGS weir and access bridge in lower reach

- #32 – Bridge Retrofit/Replacement: Gadapee Rd
- #33 – Bridge Retrofit/Replacement: North Church Rd
- #34 – USGS Weir Removal
- #35 – Stream Access for Cattle
- #36 – Corridor Protection and Buffer Plantings

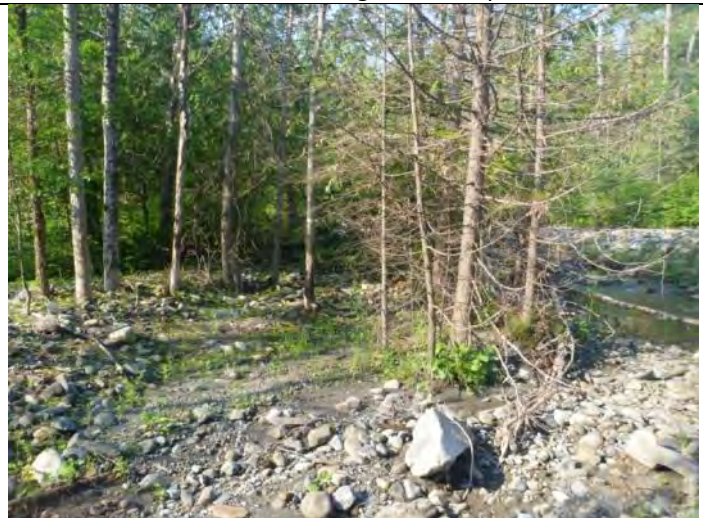
Thick cobble and gravel deposits filling floodplain along alluvial fan area

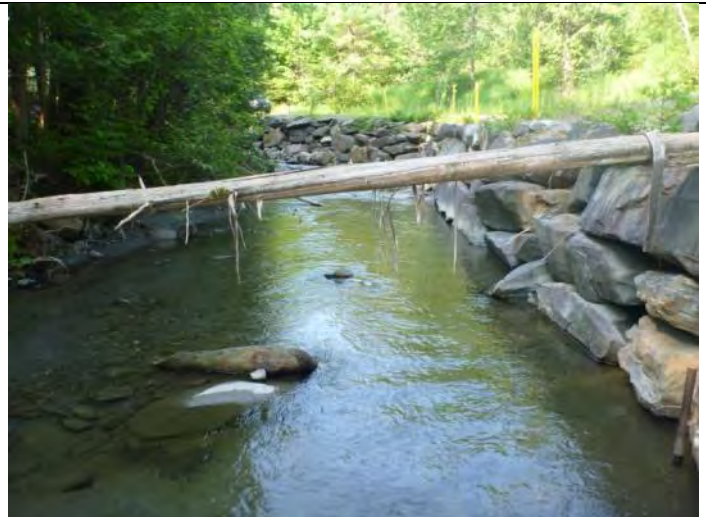
Stacked stone wall along Roy Rd

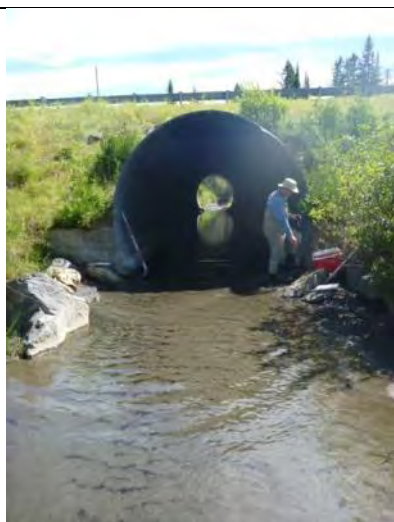
Culvert under Rt 2 near bottom of reach

- #47 – Culvert Retrofit/Replacement: Route 2
- #48 – Bank Stabilization: Route 2 embankment

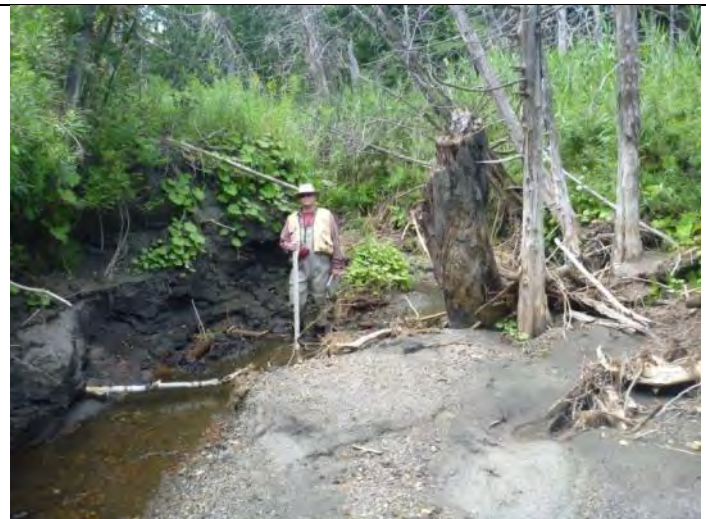
**Reach Highlights:** The channel adjustments in this segment are driven by the huge amount of sediment trapped behind the failing stone culvert beneath the VAST trail near the middle of the segment. Floodplain is accessible on one side below the culvert and has a high failing bank to an inaccessible terrace on the other side. Above the culvert, a deeply incised channel is carving through loose sand and gravel deposits that have been stored above the culvert. The stream is trying to re-establish planform by carving out meanders above the culvert and to a lesser extent, below the culvert. Major adjustments would likely occur if the stone culvert were repaired or replaced.

Deeply incised channel carving through sediments stored above culvert

- #52 – Culvert Replacement and Channel Restoration: VAST trail
- #53 – Conservation

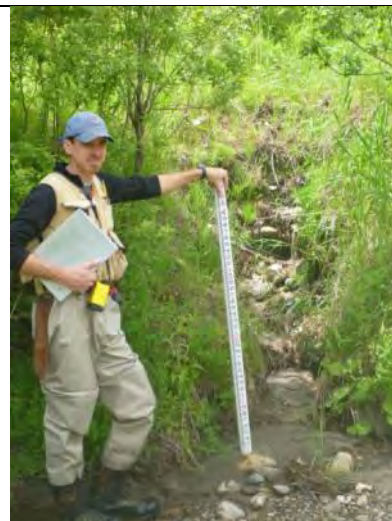
Small gully from a road ditch along New Boston Road

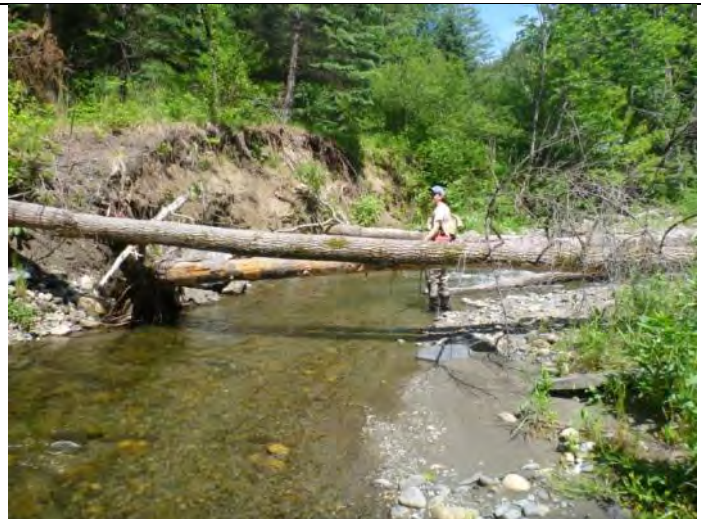
Evidence of channel widening during recent floods

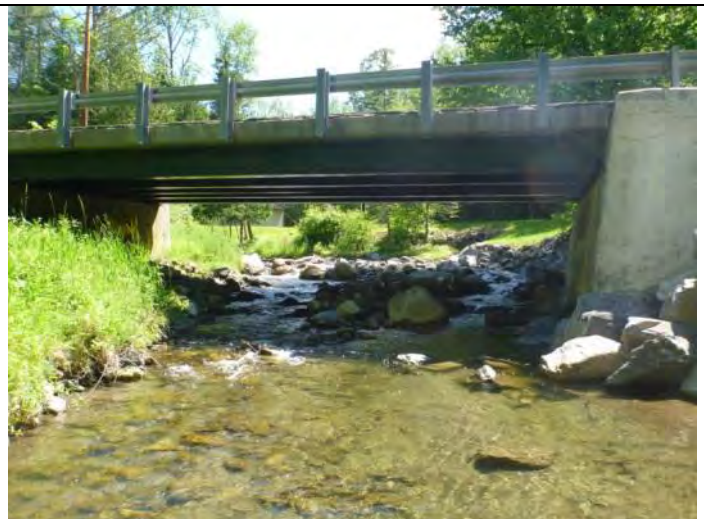
Coarse deposition upstream of undersized Red Village Road bridge

- #66 – Bridge Retrofit/Replacement: Red Village Road
- #67 – Arch Retrofit/Replacement: His Hill Road
- #68 – Bank Stabilization

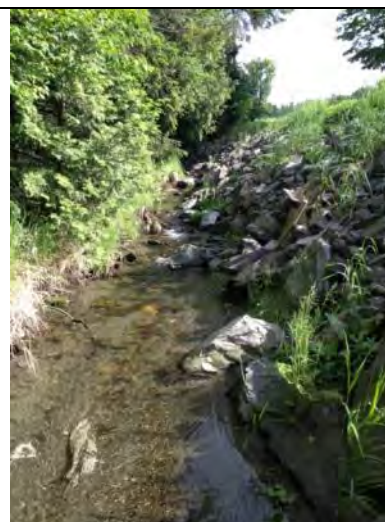
Armoring along Sheldon Brook Rd mid reach

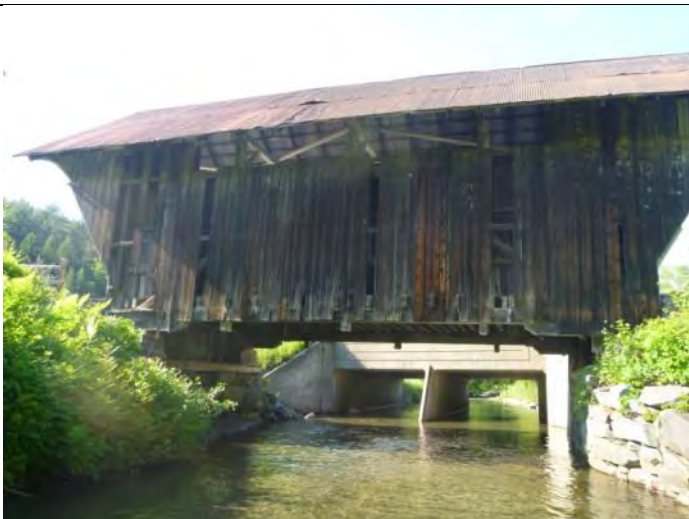
Schoolhouse covered bridge and South Wheelock Rd culvert in upper reach

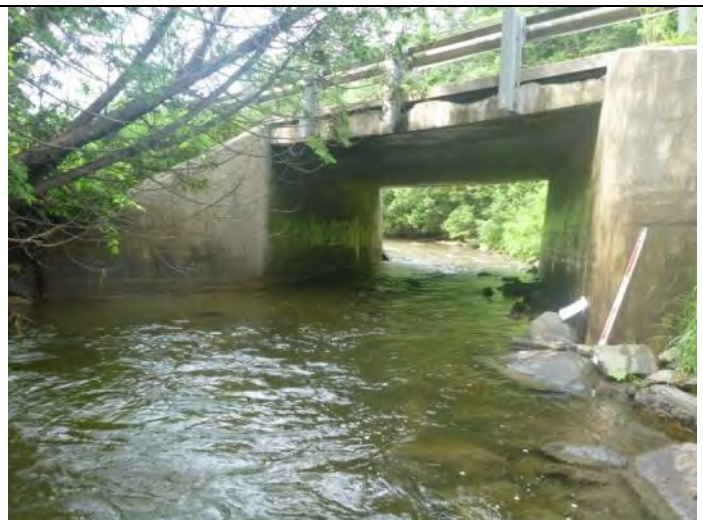
Undersized bridge at South Wheelock Road

- #81 – Bridge Replacement/Retrofit: Cold Hill Rd
- #82 – Bridge Replacement/Retrofit: South Wheelock Rd
- #83 – Stormwater Management: Sediment and runoff from Couture Flats Rd

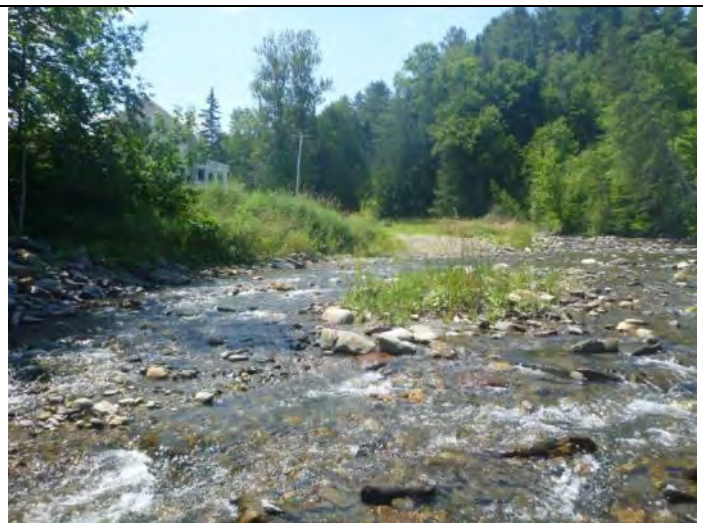
Evidence of major widening during recent floods in the upper reach

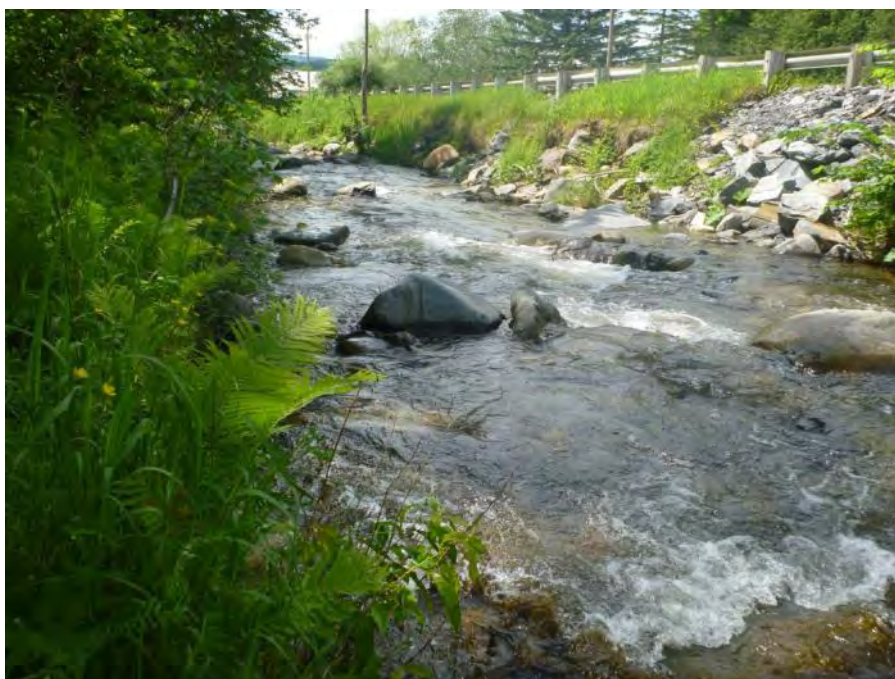
- Extreme channel straightening in segments : T3.04, T3.06, T4.01, and T5.01
- High straightening in segments: T3.05, T3.07, T3.7S1.02, T3.7S1.06A, T4.04
- Extensive corridor encroachments from adjacent roadways and embankments in segments: All of Water Andric except T2.11B and T2.12B (7 segments), All of Sleepers River except T3.11 (7 segments), T3.10S1.03, T3.7S1.01A, T3.7S1.01B, T3.7S1.03, T4.02, T4.03, All of Wheelock Brook except T5.02 (6 segments) (Figure 16)
- Dredging in segments: T3.06, T3.10, T4.01, and T5.02

**Figure 16:** Encroachment on Sheldon Brook reach T4.02.
