**River Corridor Plan for the Williams River in Rockingham,
Chester, and Andover, Vermont**

September 29, 2016

Fitzgerald Environmental Associates, LLC.
18 Severance Green, Suite 203
Colchester, VT 05446

**Windham County Natural Resources
Conservation District**
28 Vernon Street
Brattleboro, VT, 05301

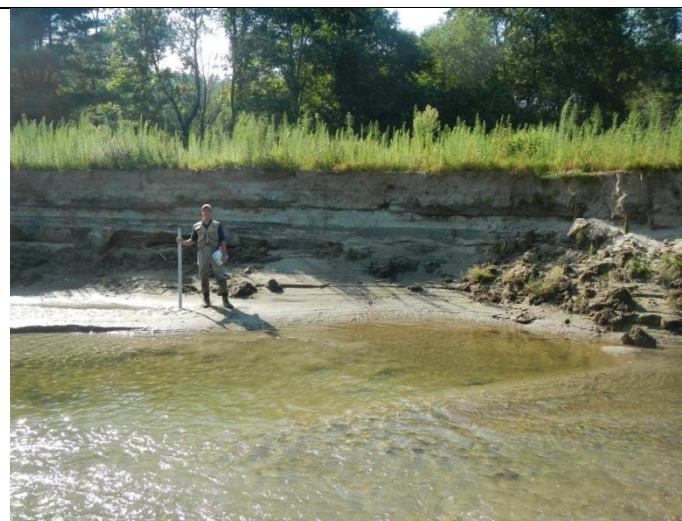
Eroding banks provide a large source of sediment

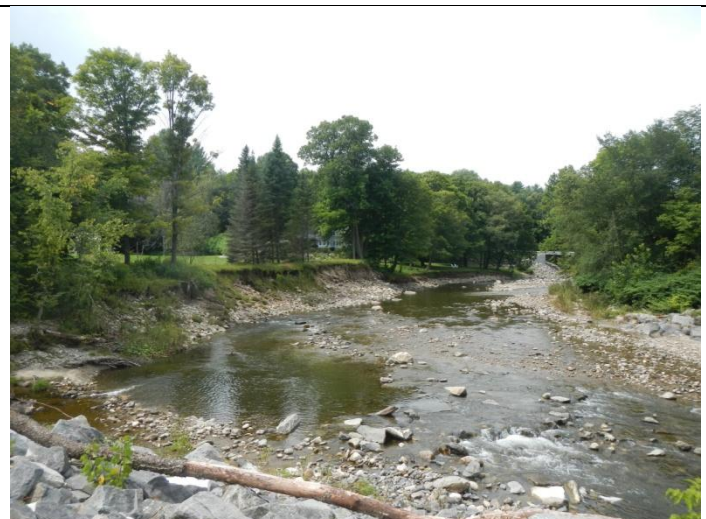
Bank erosion at confluence with tributary

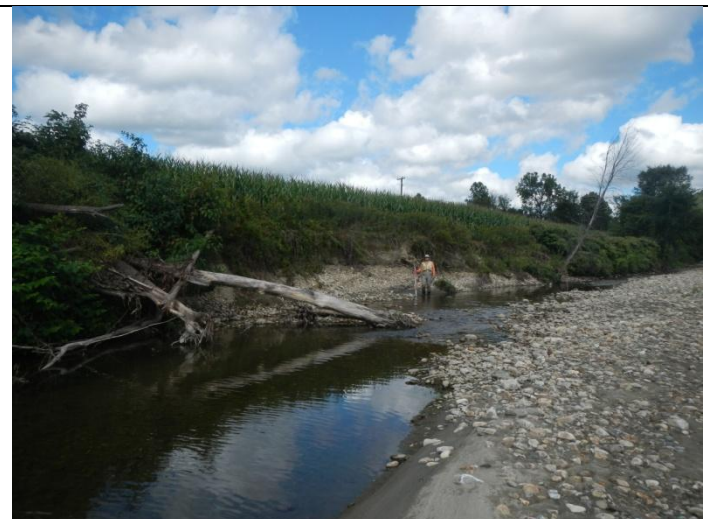
Major bank erosion source of material for deposition

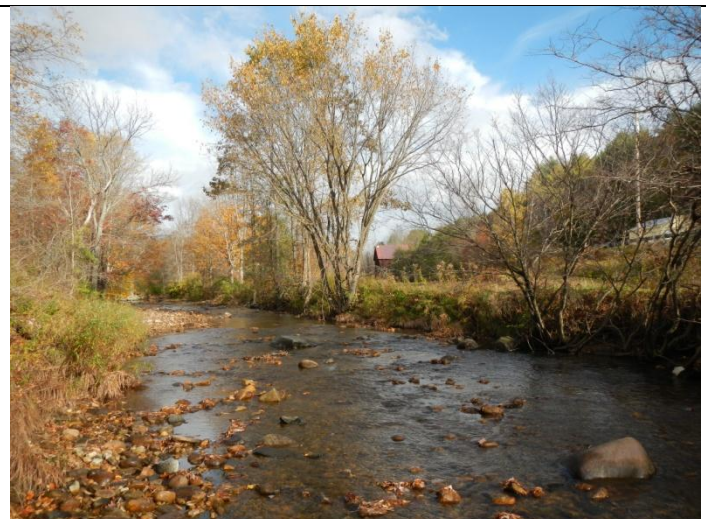
No floodplain benches due to bank scour and armor

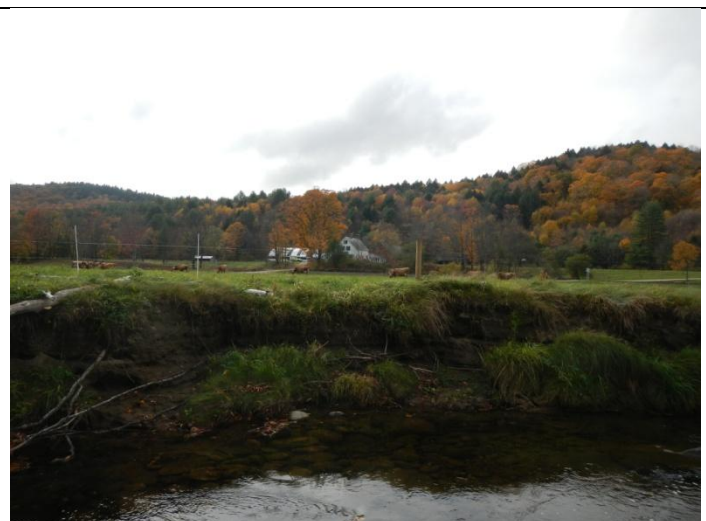
Banks erode as the channel moves away from the armor

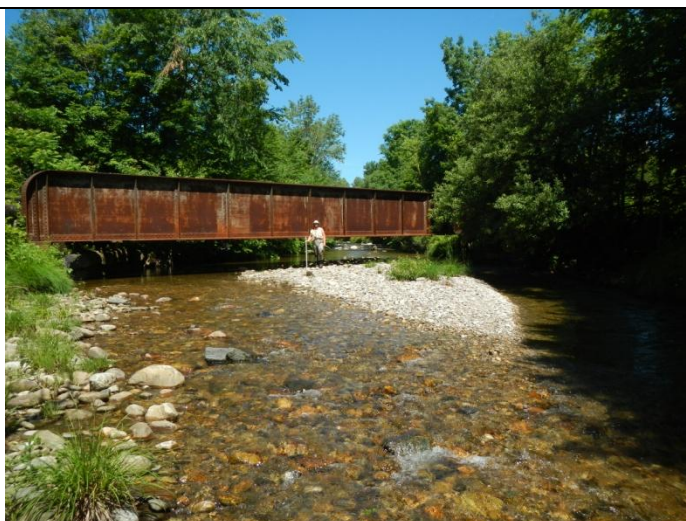
Reach Highlights: Berms, the railroad, and Rt-103 all have encroached and reduced potential floodplain for reach M17. Many mid-channel and side bars were formed from the deposition that occurred during T.S. Irene. The possibility of channel widening and planform adjustment is greatly reduced in this reach due to armoring along both banks; therefore this reach is expected to remain in Stage II.

Railroad bridge with low capacity due to aggradation

- UWR-9: Assess feasibility of raising the railroad bridge to increase capacity for sediment and floodwaters, since it is located in an area of active aggradation.
- UWR-10: Remove the berm along Rt-103 to restore floodplain access.

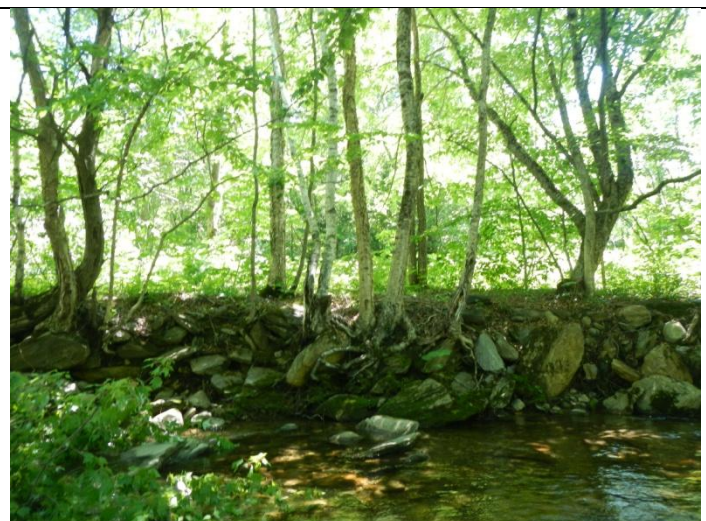
Historic bank armoring eliminated floodplain access

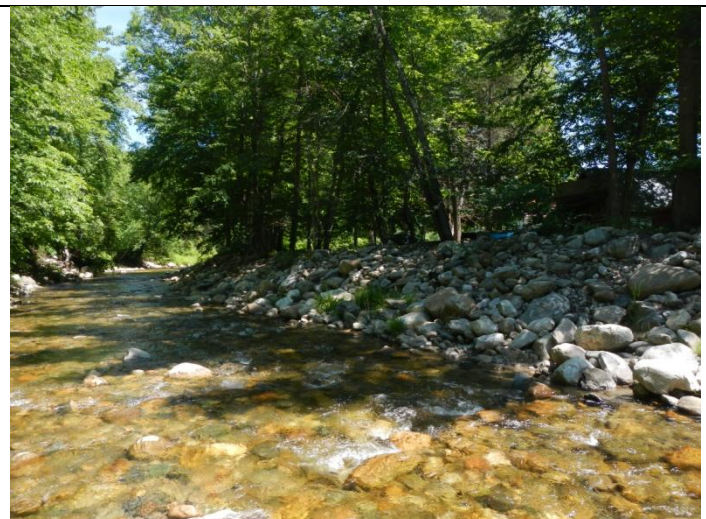
A berm on the right bank protects houses

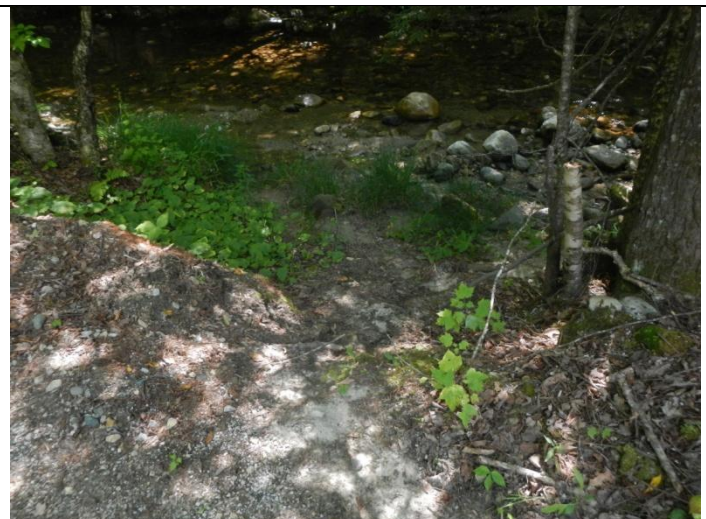
Smokeshire Rd. ditches add sediment in the river

- UWR-5d: Assess road embankment stability and replace or install riprap as necessary.
- UWR-11: Reduce sedimentation along Smokeshire Rd by improving ditch maintenance, installing check dams, and improving road grading.

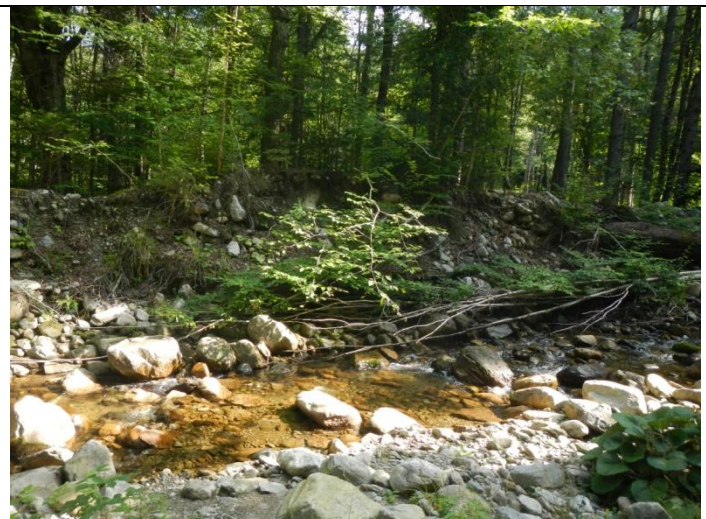
Consistent bank scour illustrates channel widening

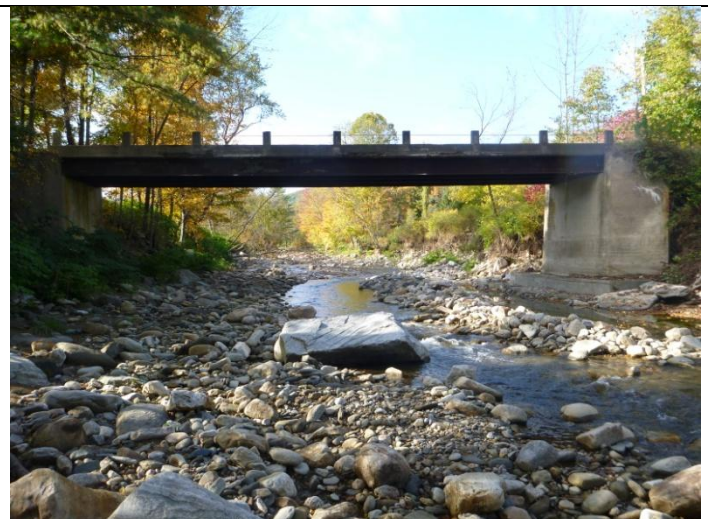
Channel working through July 2014 deposits

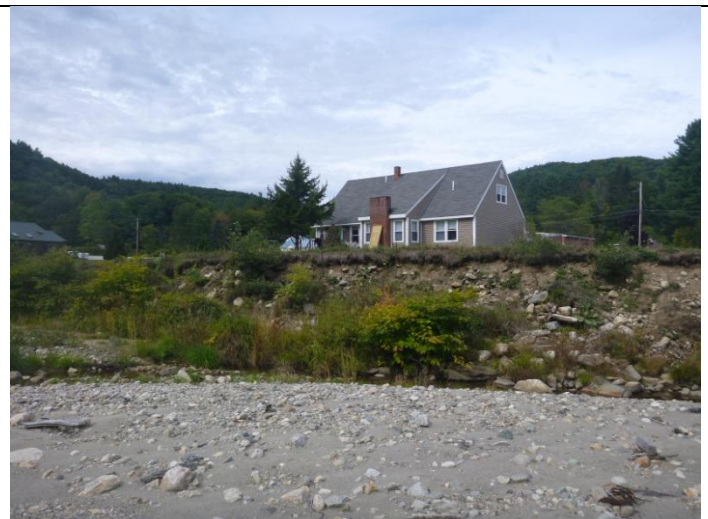
Banks are scoured and eroded from channel widening

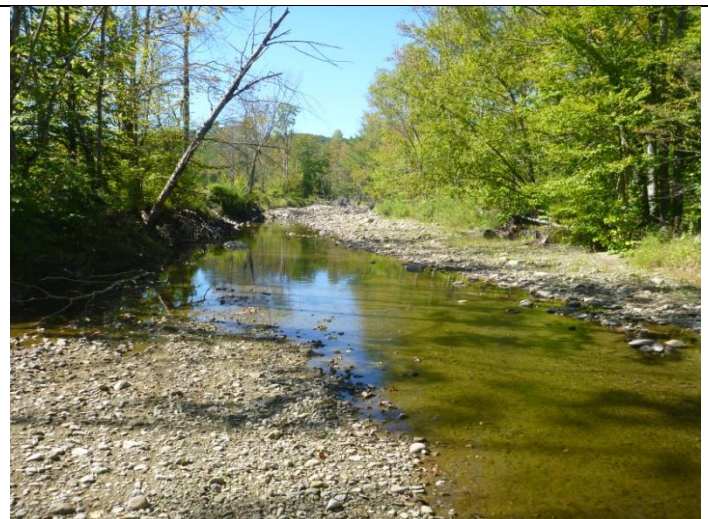
Channel bed is aggrading after recent channel scouring

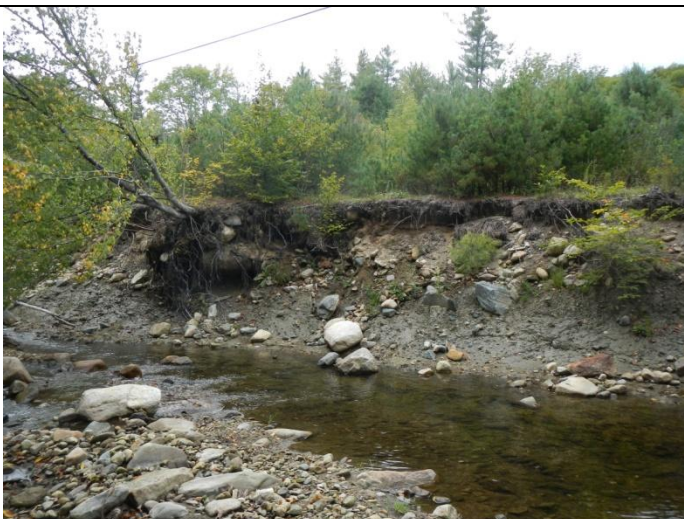
Reach Highlights: T.S. Irene and subsequent flooding (July 2014) scoured the channel bottom disconnecting much of the reach from its floodplain. The channel has since filled in with flood deposits generating large side and point bars. There are still some areas of active incision, while others have active widening and deposition. Due to the lack of migration features this reach remains in Stage III, but the presence of diagonal and mid-channel bars indicate that it is progressing towards stage IV.

Raw eroding banks are present throughout the reach

- MBWR-6: The property immediately upstream of the Rt-11 bridge is part of a FEMA buyout. Following removal of the house the existing berms should be removed and the road embankment armor should be assessed for stability.

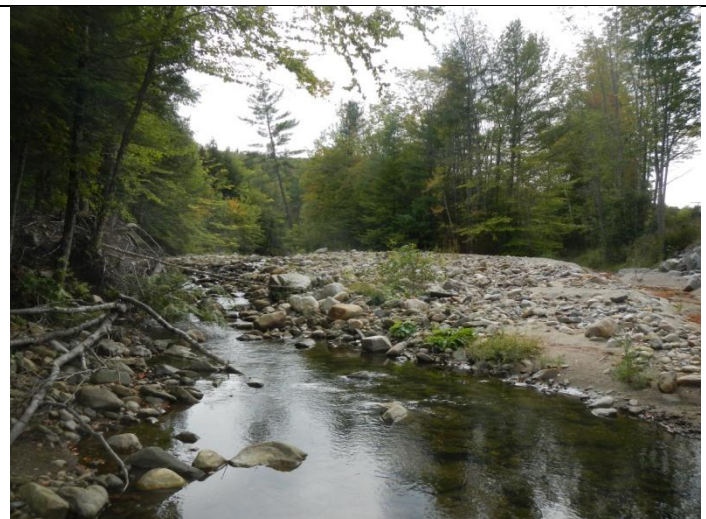
Large depositional bars and channel widening

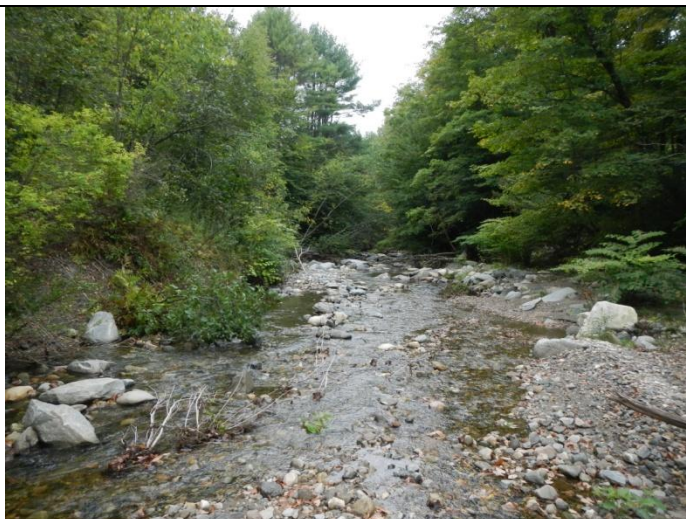
Scouring and widening removed floodplain benches

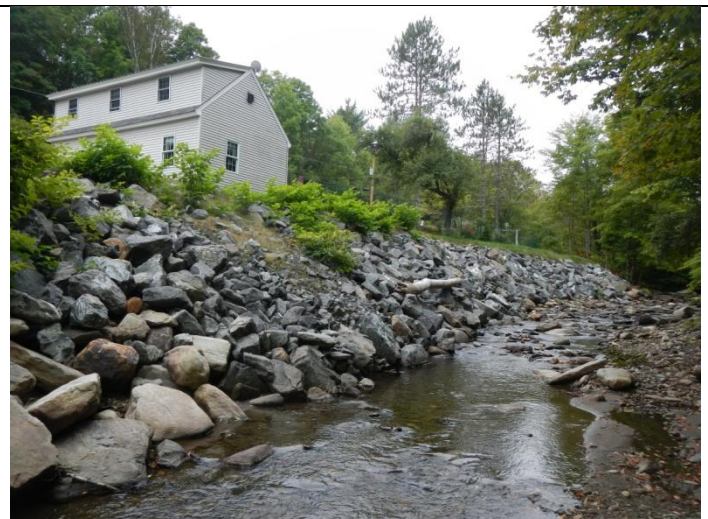
Riprap armor along south bank mid-segment

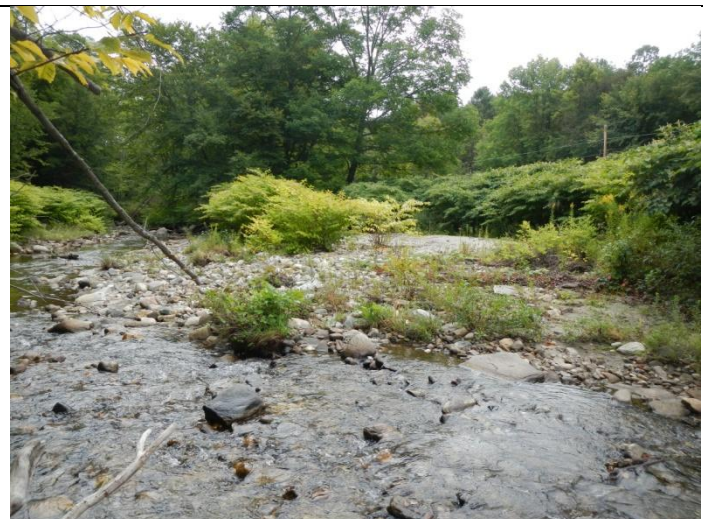
Channel widened to 90' and filled with 2-3' of deposits

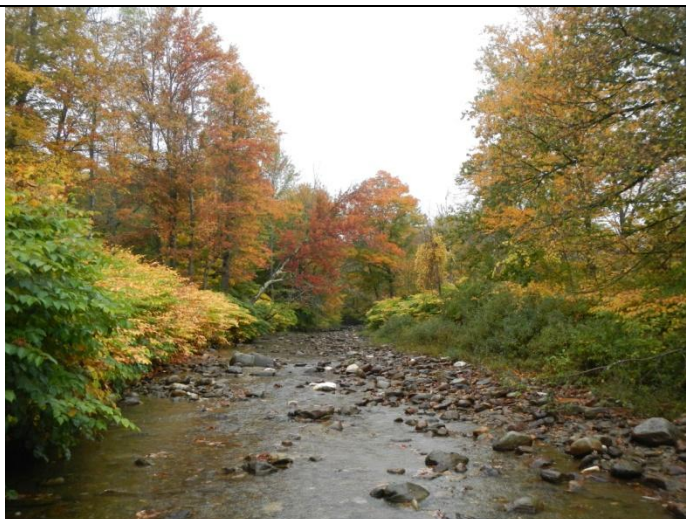
Channel widened and still maintained floodplain bench

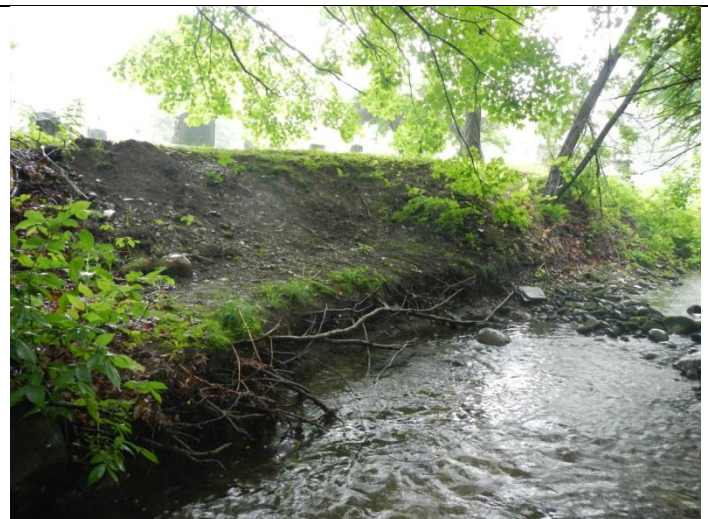
Bank scour along cemetery downstream from armor

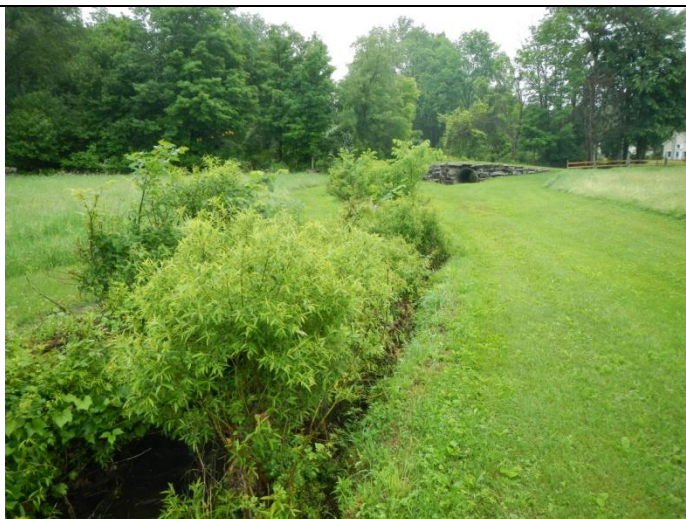
Channel shrinks along historical armor and straightening

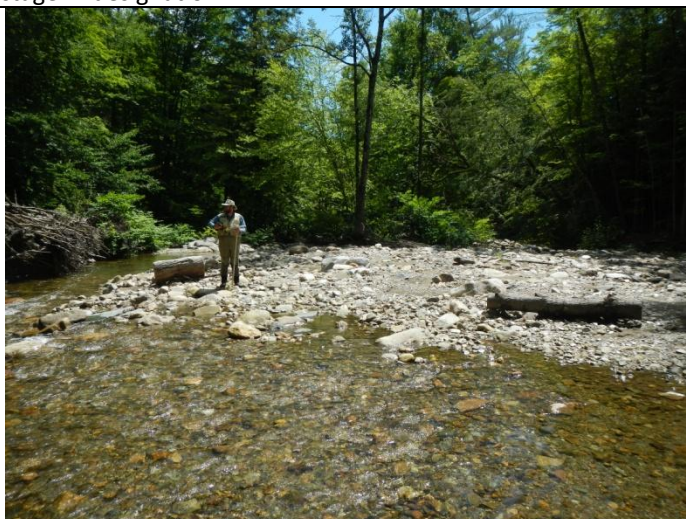
Diagonal riffle where channel is adjusting planform

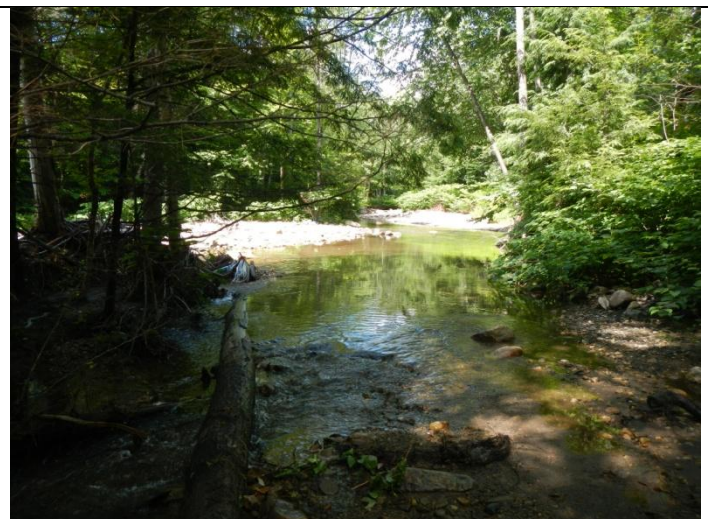
Potential avulsion site with undersized culvert

- AB-3: Replace Potash Brook Rd culvert for the flood chute with a much larger structure that has an overflow pipe to mitigate damage in high flow events. This larger structure will allow the flood chute to function properly and reduce flooding in storm events. An engineering study commissioned by the Town of Chester is currently in progress. An aluminum box culvert with a span of 26ft is expected to be installed to replace the undersized culvert in late 2016 or 2017.

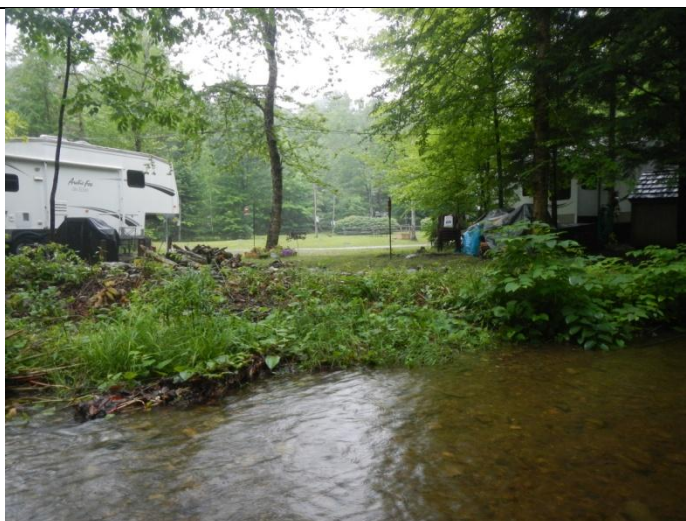
Floodplain access along campground

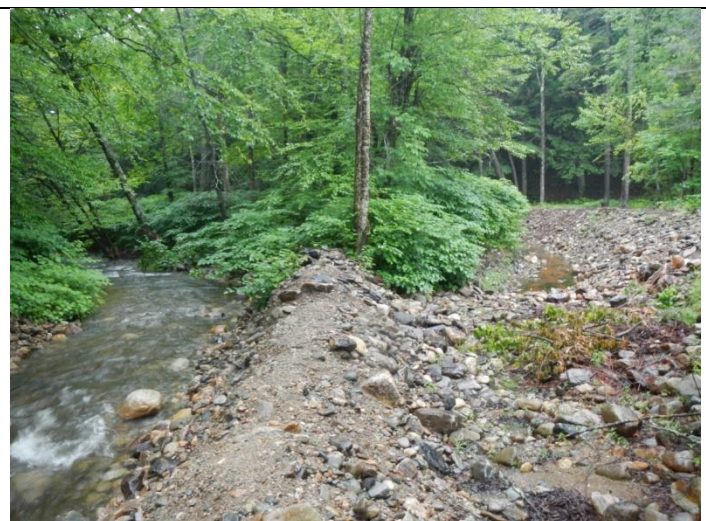
Berm cutting off access to flood chute by campground

- AB-2b: Suggested corridor protection for undeveloped floodplain that plays an important role in sediment and floodwater attenuation.
- AB-5: Remove a berm along the eastern edge of Horseshoe Acres Campground in order to restore access to an important historic flood chute.
- AB-6: Remove portions of a 350ft historic berm to restore floodplain access along Weston Andover Rd. To ensure road embankment stability new armor should be installed along road if berm is removed.

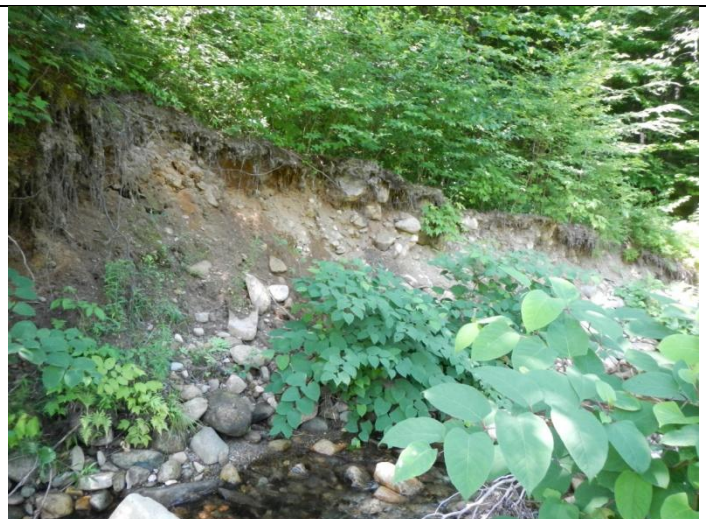
Scoured banks depict recent widening by the channel

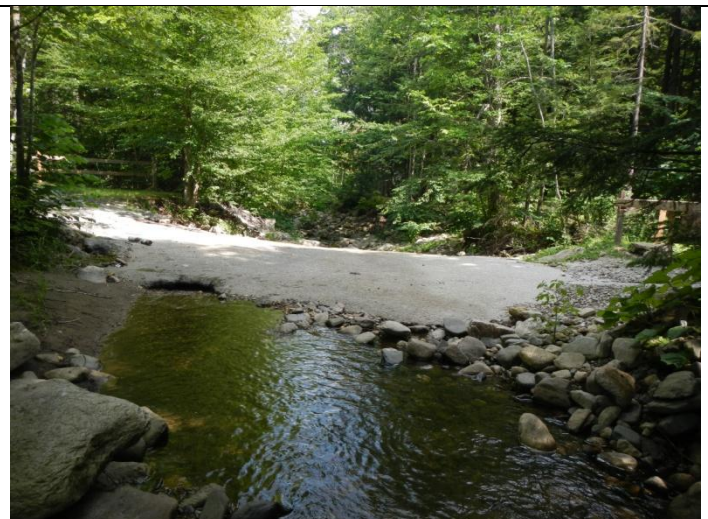
Channel aggrades enough to overtop old bridge

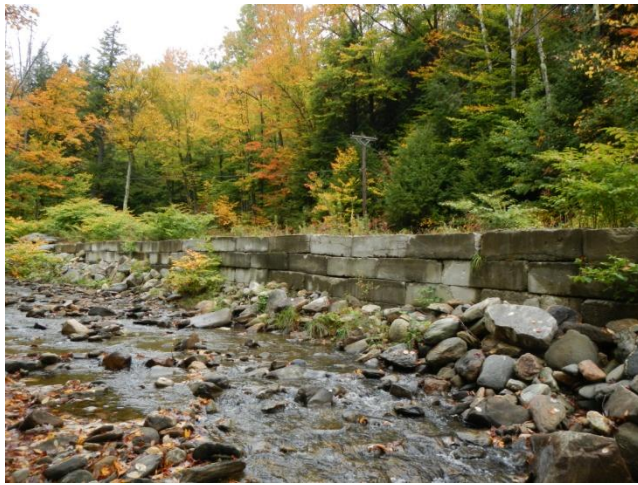
Figure 4.10: Stacked stone wall along Nudist Camp Rd in reach T5.S1.08.

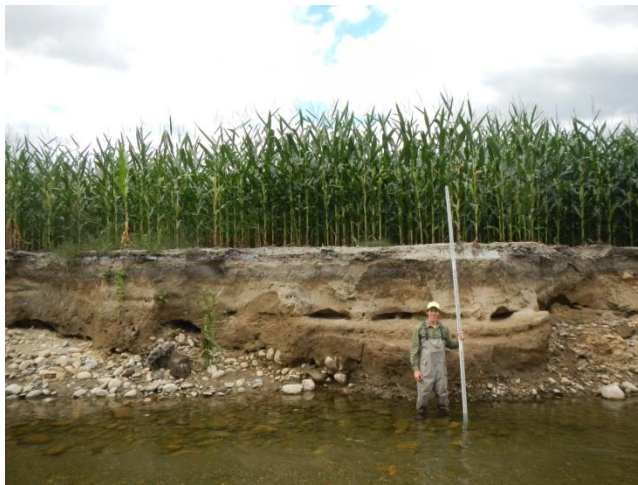
Figure 4.12: Major bank erosion in reach T5.01.

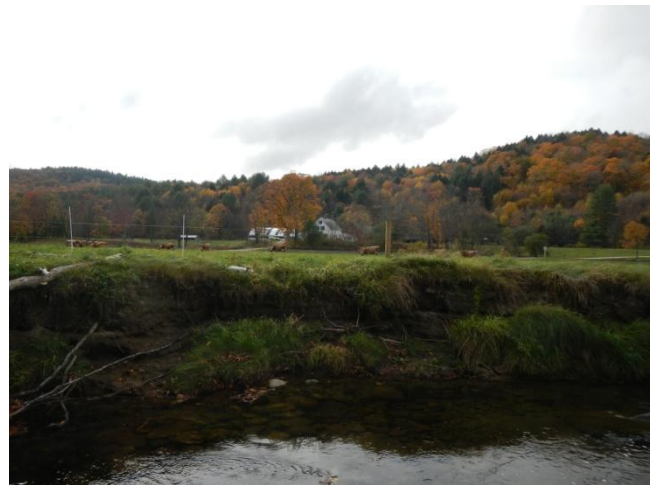
Figure 4.13: Extensive bank erosion along a pasture in reach M14.

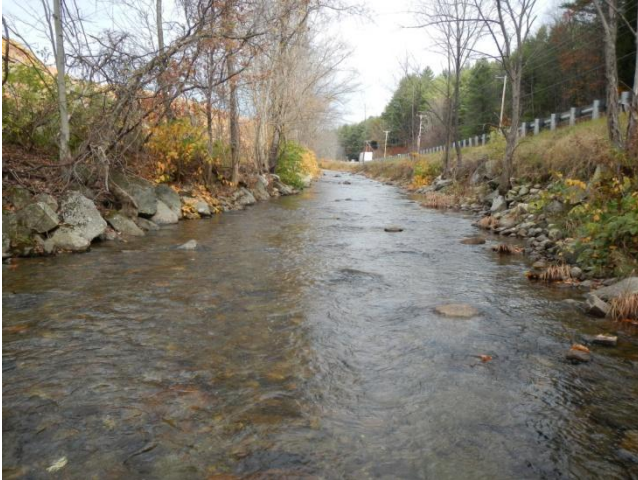
Figure 4.19: Reach M14 straightened along Rt-103.

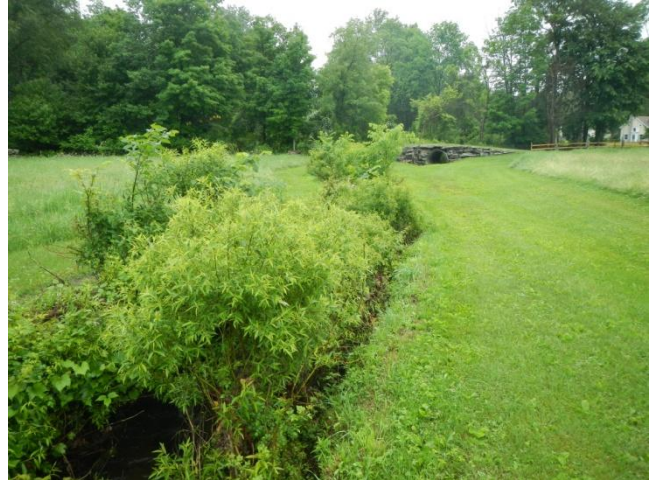
Figure 4.20: Stream straightened and pinned at the back edge of field along segment T5.S2.01.C.

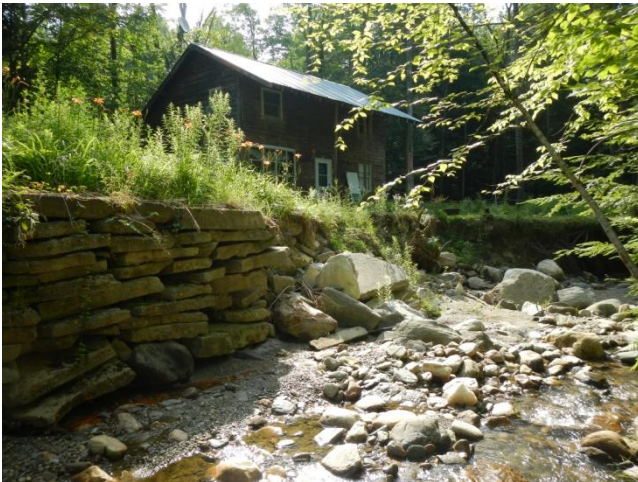
Figure 4.21: Encroachment from development along Potash Brook (T5.S3.a.01).

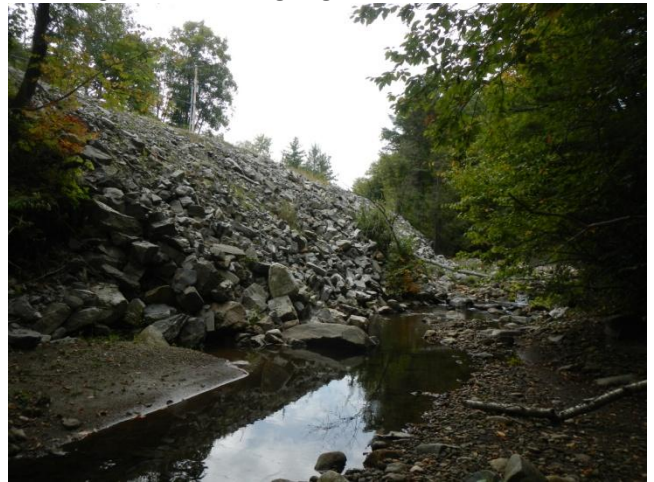
Figure 4.22: Extreme encroachment along Route 11 on reach T5.08.
