# **Black Creek Corridor Plan**

**Franklin County  
April 2009**

Re: Black Creek Corridor Plan  
Franklin County, Vermont  
JCO Project No. 3-1313-3

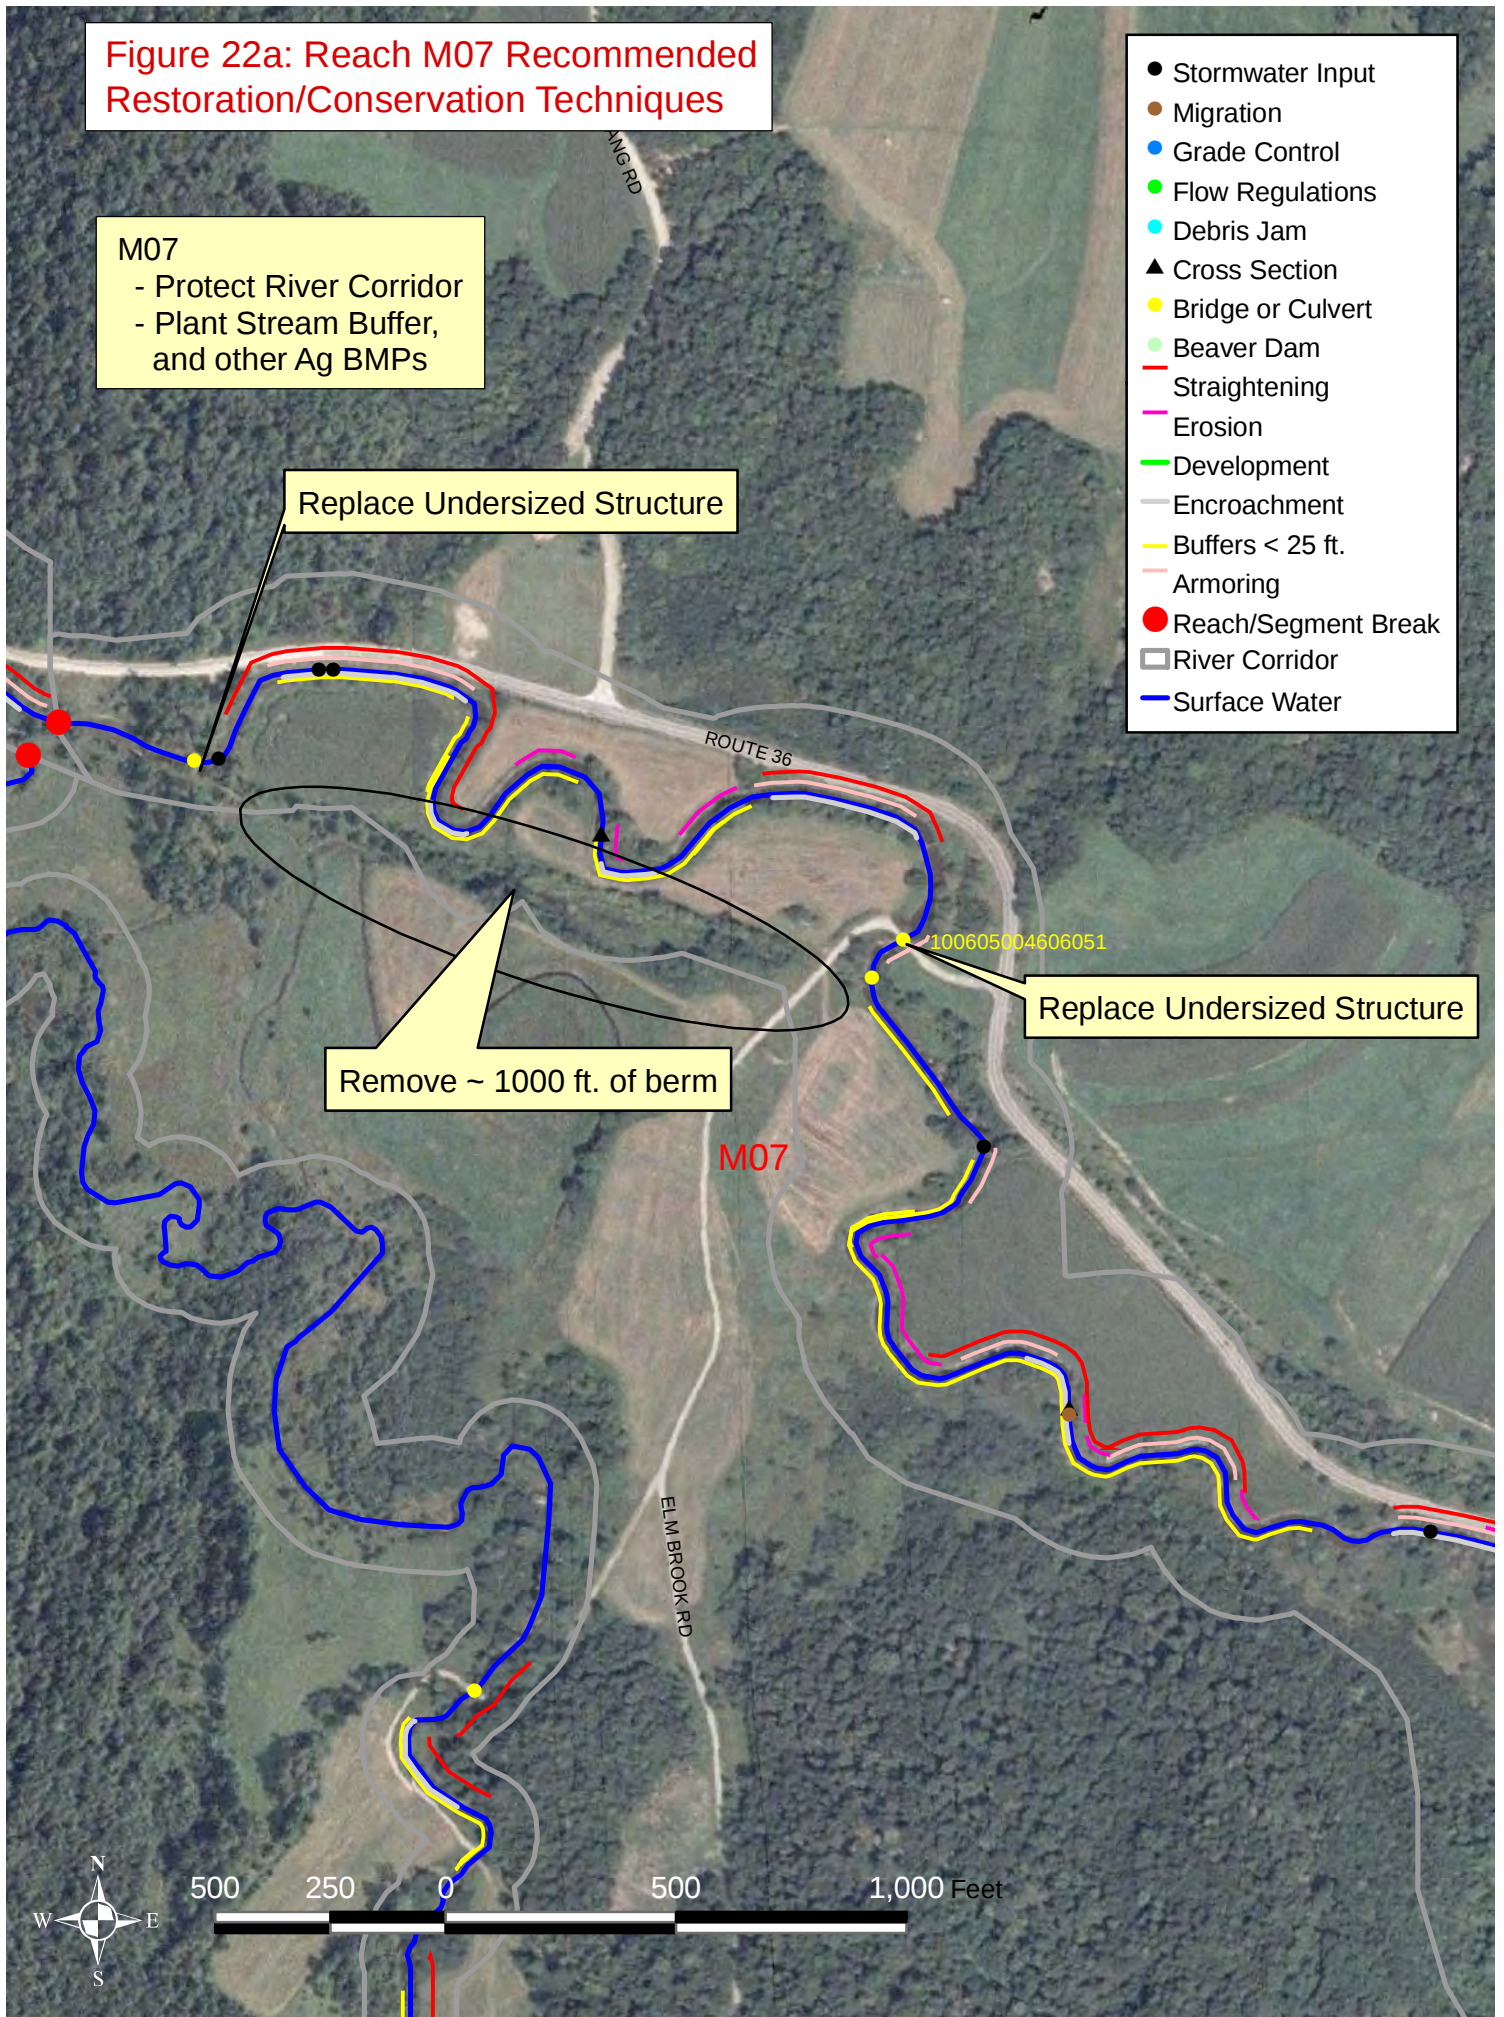
**Figure 22a: Reach M07 Recommended Restoration/Conservation Techniques**

Reach M07 extends from the confluence with Elm Brook upstream for approximately two miles to the village of East Fairfield. The reach was found to be slightly incised (ratio of 1.2) with minor active widening and aggradation. The existing stream type of E5 Dune-Ripple was consistent with its reference type. Moderate bank erosion was noted, mostly on the outside of meander bends. The riparian corridor was dominated by a mix of hay and forest, with large areas of inadequate buffers less than 25 feet. The abandoned elevated rail bed runs within the river corridor in the upstream half of the reach and represents a major floodplain constriction. The upstream portion of the reach near East Fairfield village is dominated by two large bedrock gorges and could not be assessed. Remnants of old concrete dams were present in these gorges, though their impact on the channel dynamics is rather minimal given their location inside natural bedrock constrictions. Five bridges cross the channel within the reach. Two of these are for the former railroad, and the remainder are town owned structures. Two of them, the railroad bridge at the downstream end of reach, and Elm Brook Road bridge, were identified as channel and floodplain constrictions with structure to channel width ratios of 53% and 87% respectively.

| River Segment | Restoration/Conservation Technique | Reach Priority | Watershed Priority | Table 22 Project Number | Completed Independent of other Practices | Next Steps/Project Notes |
|---|---|---|---|---|---|---|
| M07 | Replace undersized structures - Elm Brook Road bridge noted as channel and floodplain constriction in phase 2 with structure/channel width ratio of 53%. Railroad bridge located near downstream reach break also noted as constriction with structure/channel width ratio of 87%. | Medium | Medium | 35 | Yes | More detailed bridge and culvert assessments needed to determine if replacement warranted. One structure owned by Town of Fairfield, other privately owned structure. |

Given the current conditions of M07, the recommended remedial strategies are to protect the existing river corridor, implement adequate riparian buffers, replace the undersized bridges, and remove or retrofit the elevated rail bed. The reach currently has good floodplain access, though portions of the floodplain are limited by Route 36 on one side and the rail bed on the other. The rail bed in the downstream end of the reach should be removed, lowered, or retrofitted with bridges and/or adequately sized culverts to restore the lost floodplain access. In addition, the two undersized bridges should be replaced with newer structures with adequate widths. Increasing the buffer widths along the agricultural fields is also an important strategy here. An aerial view of the reach is shown on Figures 22a and 22b, and descriptions of the recommended projects are shown in Table 11.

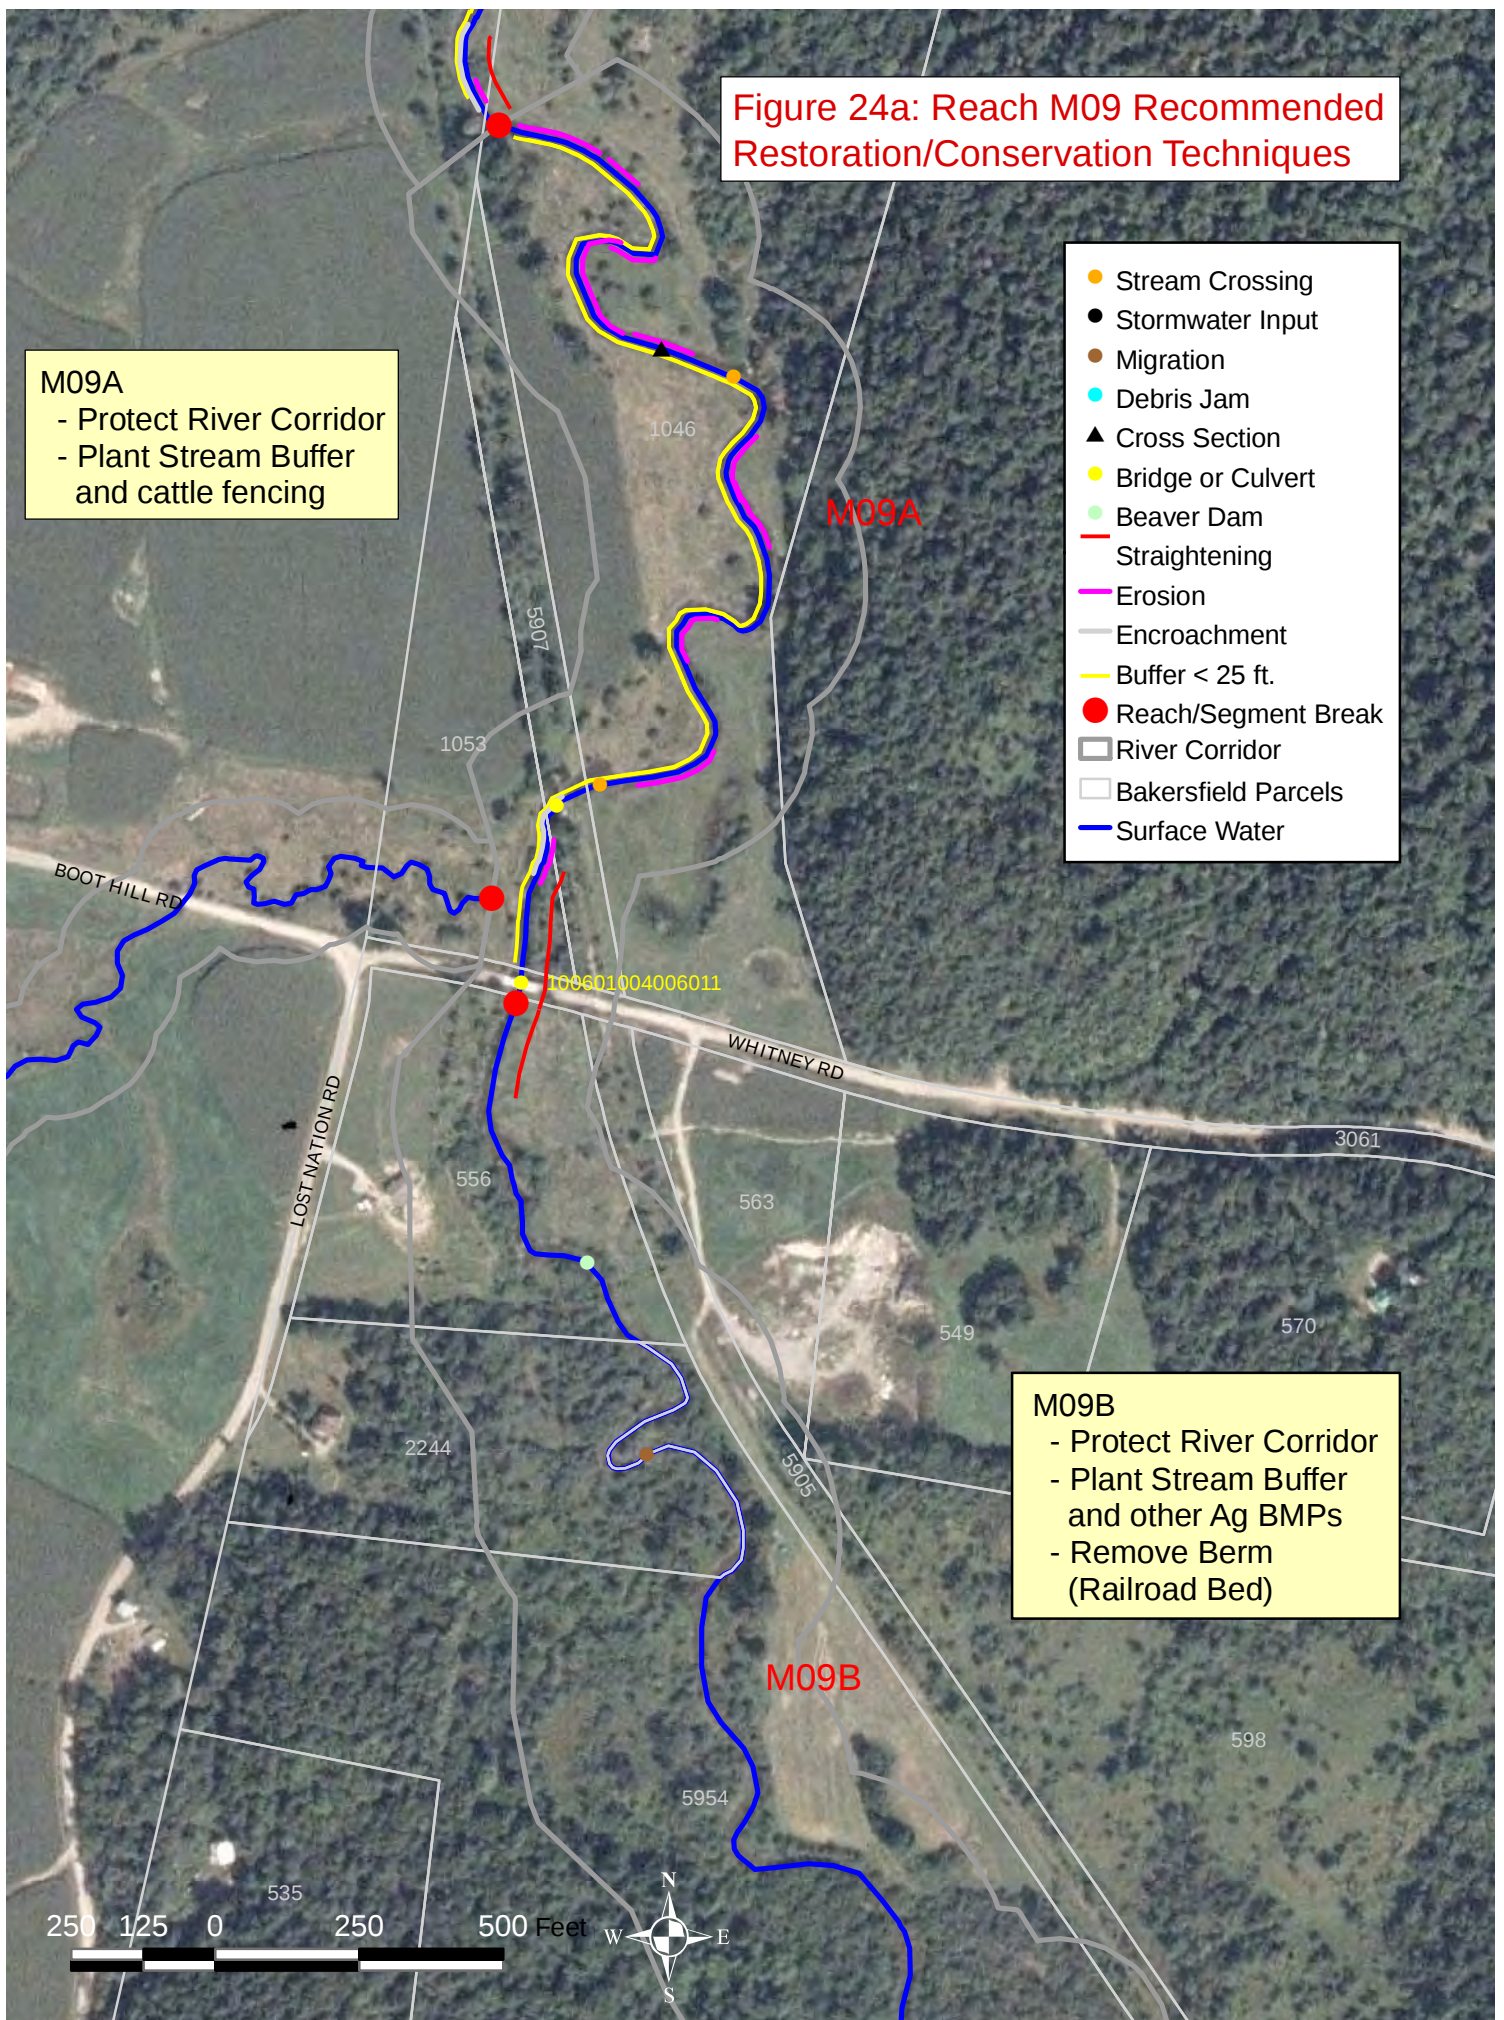
**Figure 24a: Reach M09 Recommended Restoration/Conservation Techniques**

Reach M09 extends from the upstream end of M08 upstream for approximately 2.8 miles to just south of the confluence with M9T8.01. It was segmented into two parts, M09A and M09B due to land use differences. M09A extends from the downstream end of the reach upstream for approximately 0.5 miles to Whitney Road. The segment was relatively stable with very little incision (ratio of 1.1) and minor planform adjustments. The existing stream type of E5 Dune-Ripple was consistent with its reference type. The riparian corridor was dominated by pasture with extensive erosion and little to no existing buffers. Cows were observed within the stream channel throughout the reach. The habitat assessment showed relatively poor aquatic habitat primarily due to a lack of adequate woody cover and few favorable sediment types and flow patterns.

| River Segment | Restoration/Conservation Technique | Reach Priority | Watershed Priority | Table 22 Project Number | Completed Independent of other Practices | Next Steps/Project Notes |
|---|---|---|---|---|---|---|
| M09B | Replace undersized structure - Culvert crossing Lost Nation Road highly undersized with structure to channel width of 27%. Replacement with bridge or arch would improve flow, limit flooding/erosion hazards, limit debris jam potential, and improve aquatic habitat. | Medium | High | 30 | Yes | More detailed bridge and culvert assessments needed to determine if replacement warranted. Town of Bakersfield owned structure. |

Given the relative stable condition of M09A, the recommended remedial strategies are to protect the existing undeveloped river corridor to retain the reach's nutrient attenuation assets, and enhance the riparian buffer to increase those assets. Cattle fencing and improved stream crossing structures should also be incorporated to reduce nutrient inputs into the stream. Corridor protection and buffer enhancement are also important in Segment B. Removal or retrofitting of the railroad berm should also be done where it encroaches upon the floodplain to enhance the sediment and nutrient retention potential of the reach. The culverts that cross Lost Nation Road are

severely undersized and should be replaced with a bridge or arch to reduce flood hazards around the road. An aerial view of the reach is shown on Figures 24a, b, and c, and descriptions of the recommended projects are shown in Table 13. A prioritized list of all identified projects for the watershed is shown in Table 22.

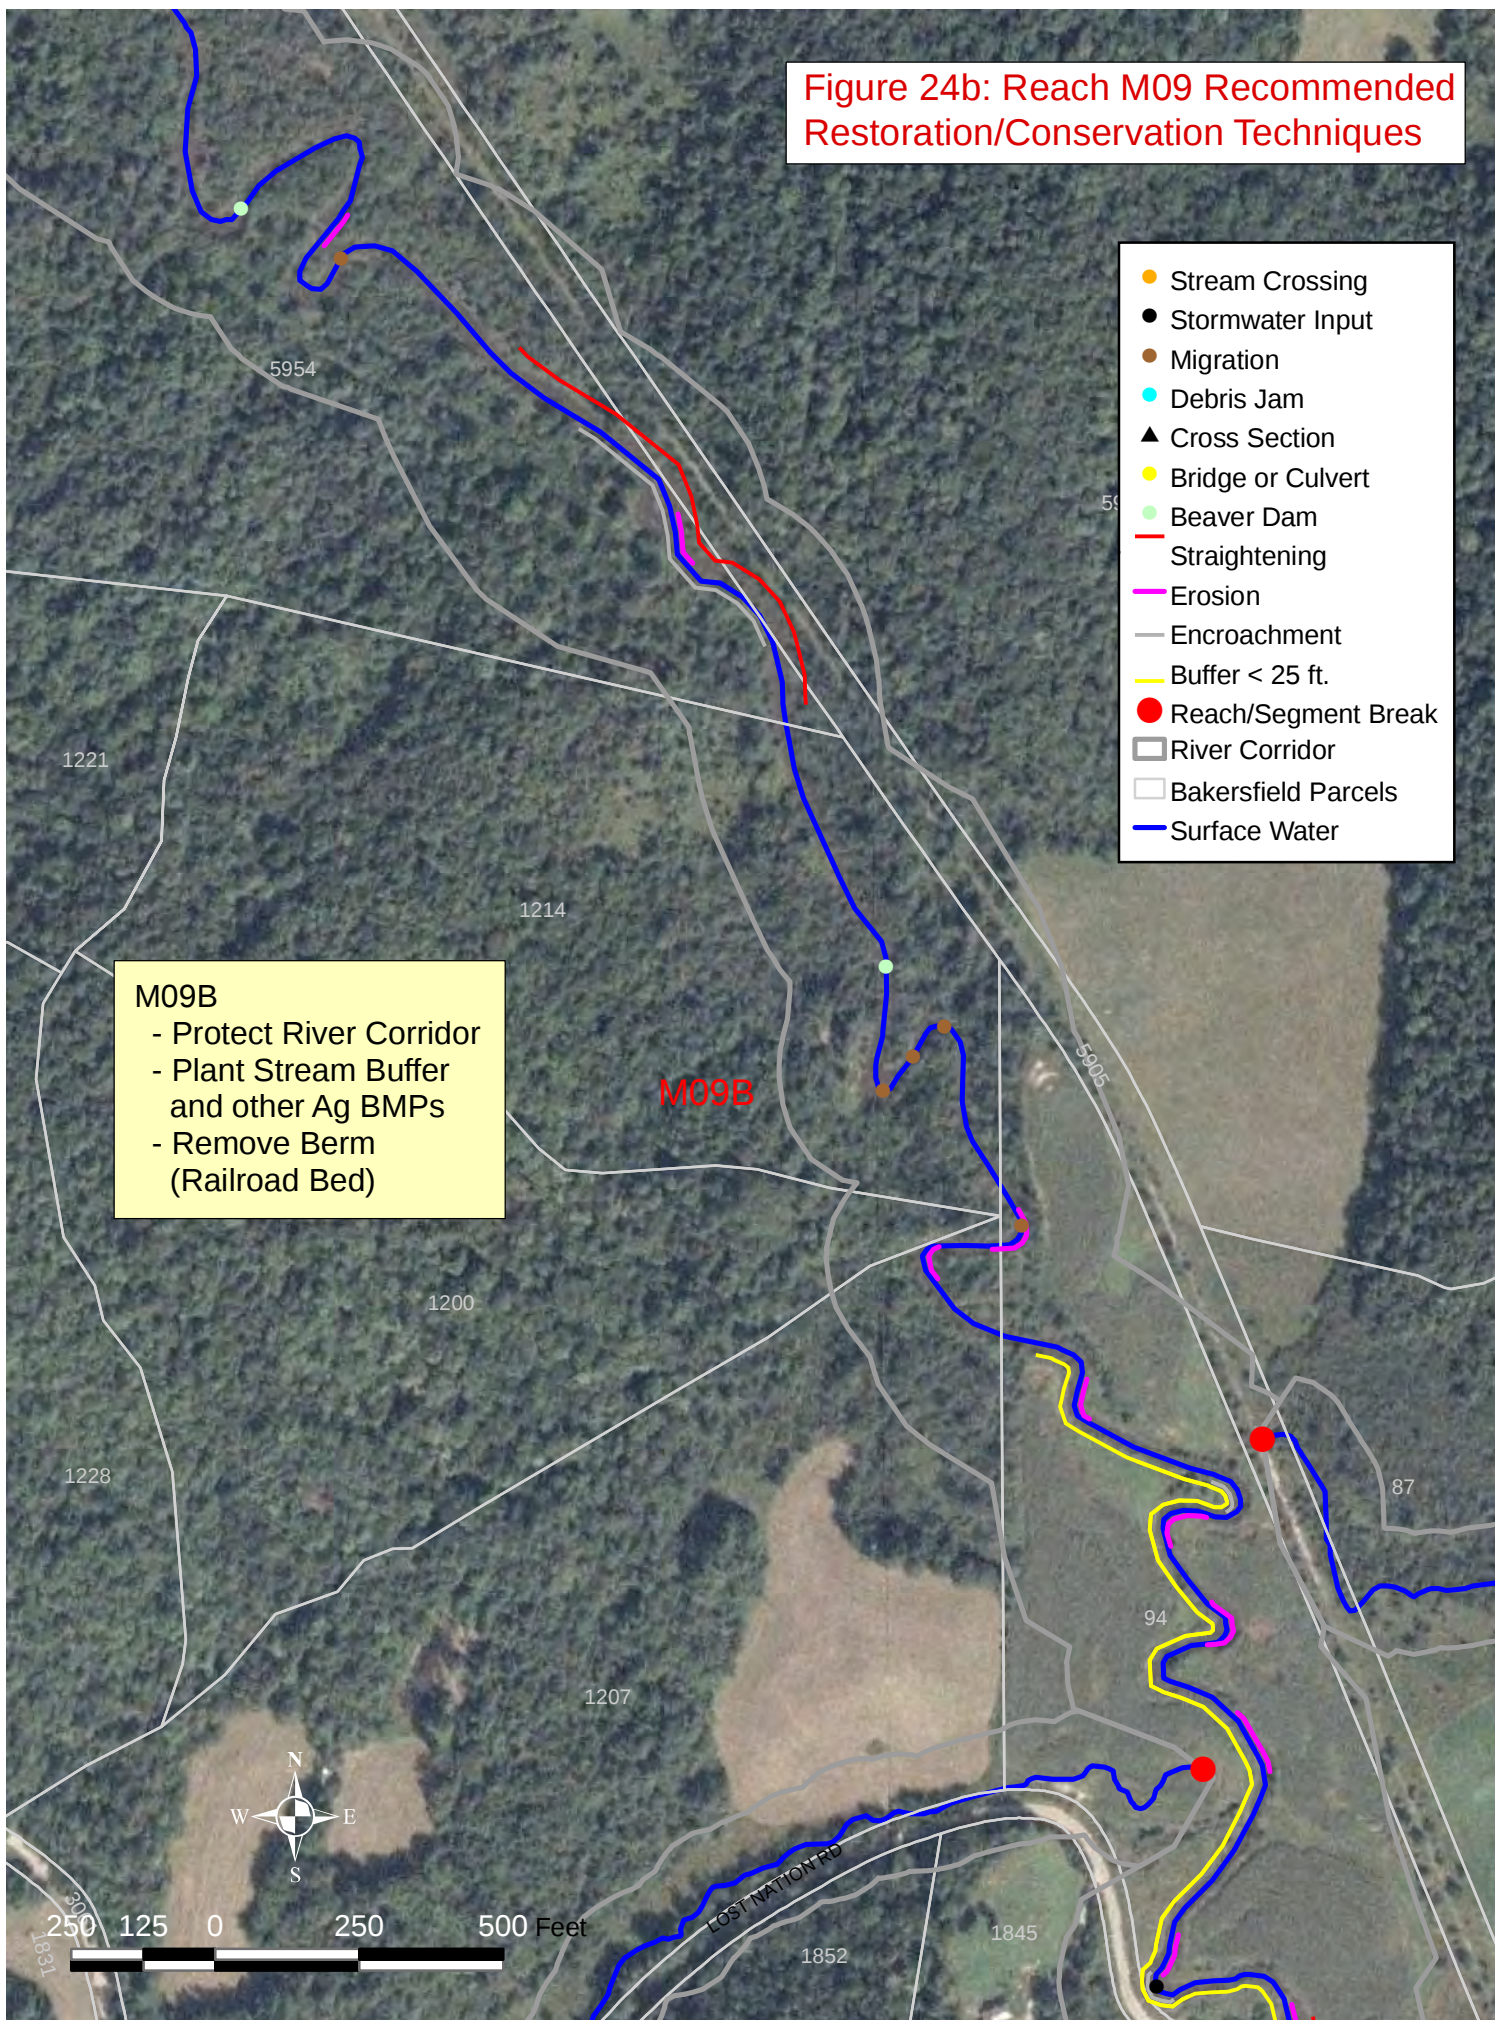
Figure 24b: Reach M09 Recommended Restoration/Conservation Techniques

M09B is the downstream end of the reach and extends from Whitney Road upstream for approximately 2.3 miles to just south of M9T8.01. This segment was also relatively stable with no incision or other major ongoing adjustments. The existing stream type of E5 Dune-Ripple was consistent with its reference type. The riparian corridor was dominated by a mix of forest and hay fields with little to no buffer between the fields and stream channel (though only minor erosion was noted). Multiple beaver dams were noted throughout the reach. Like much of the other main stem reaches, the abandoned rail bed runs through portions of the river corridor and represents a major floodplain constriction. The culvert crossing Lost Nation Road is severely undersized and represents a major channel and floodplain constriction.

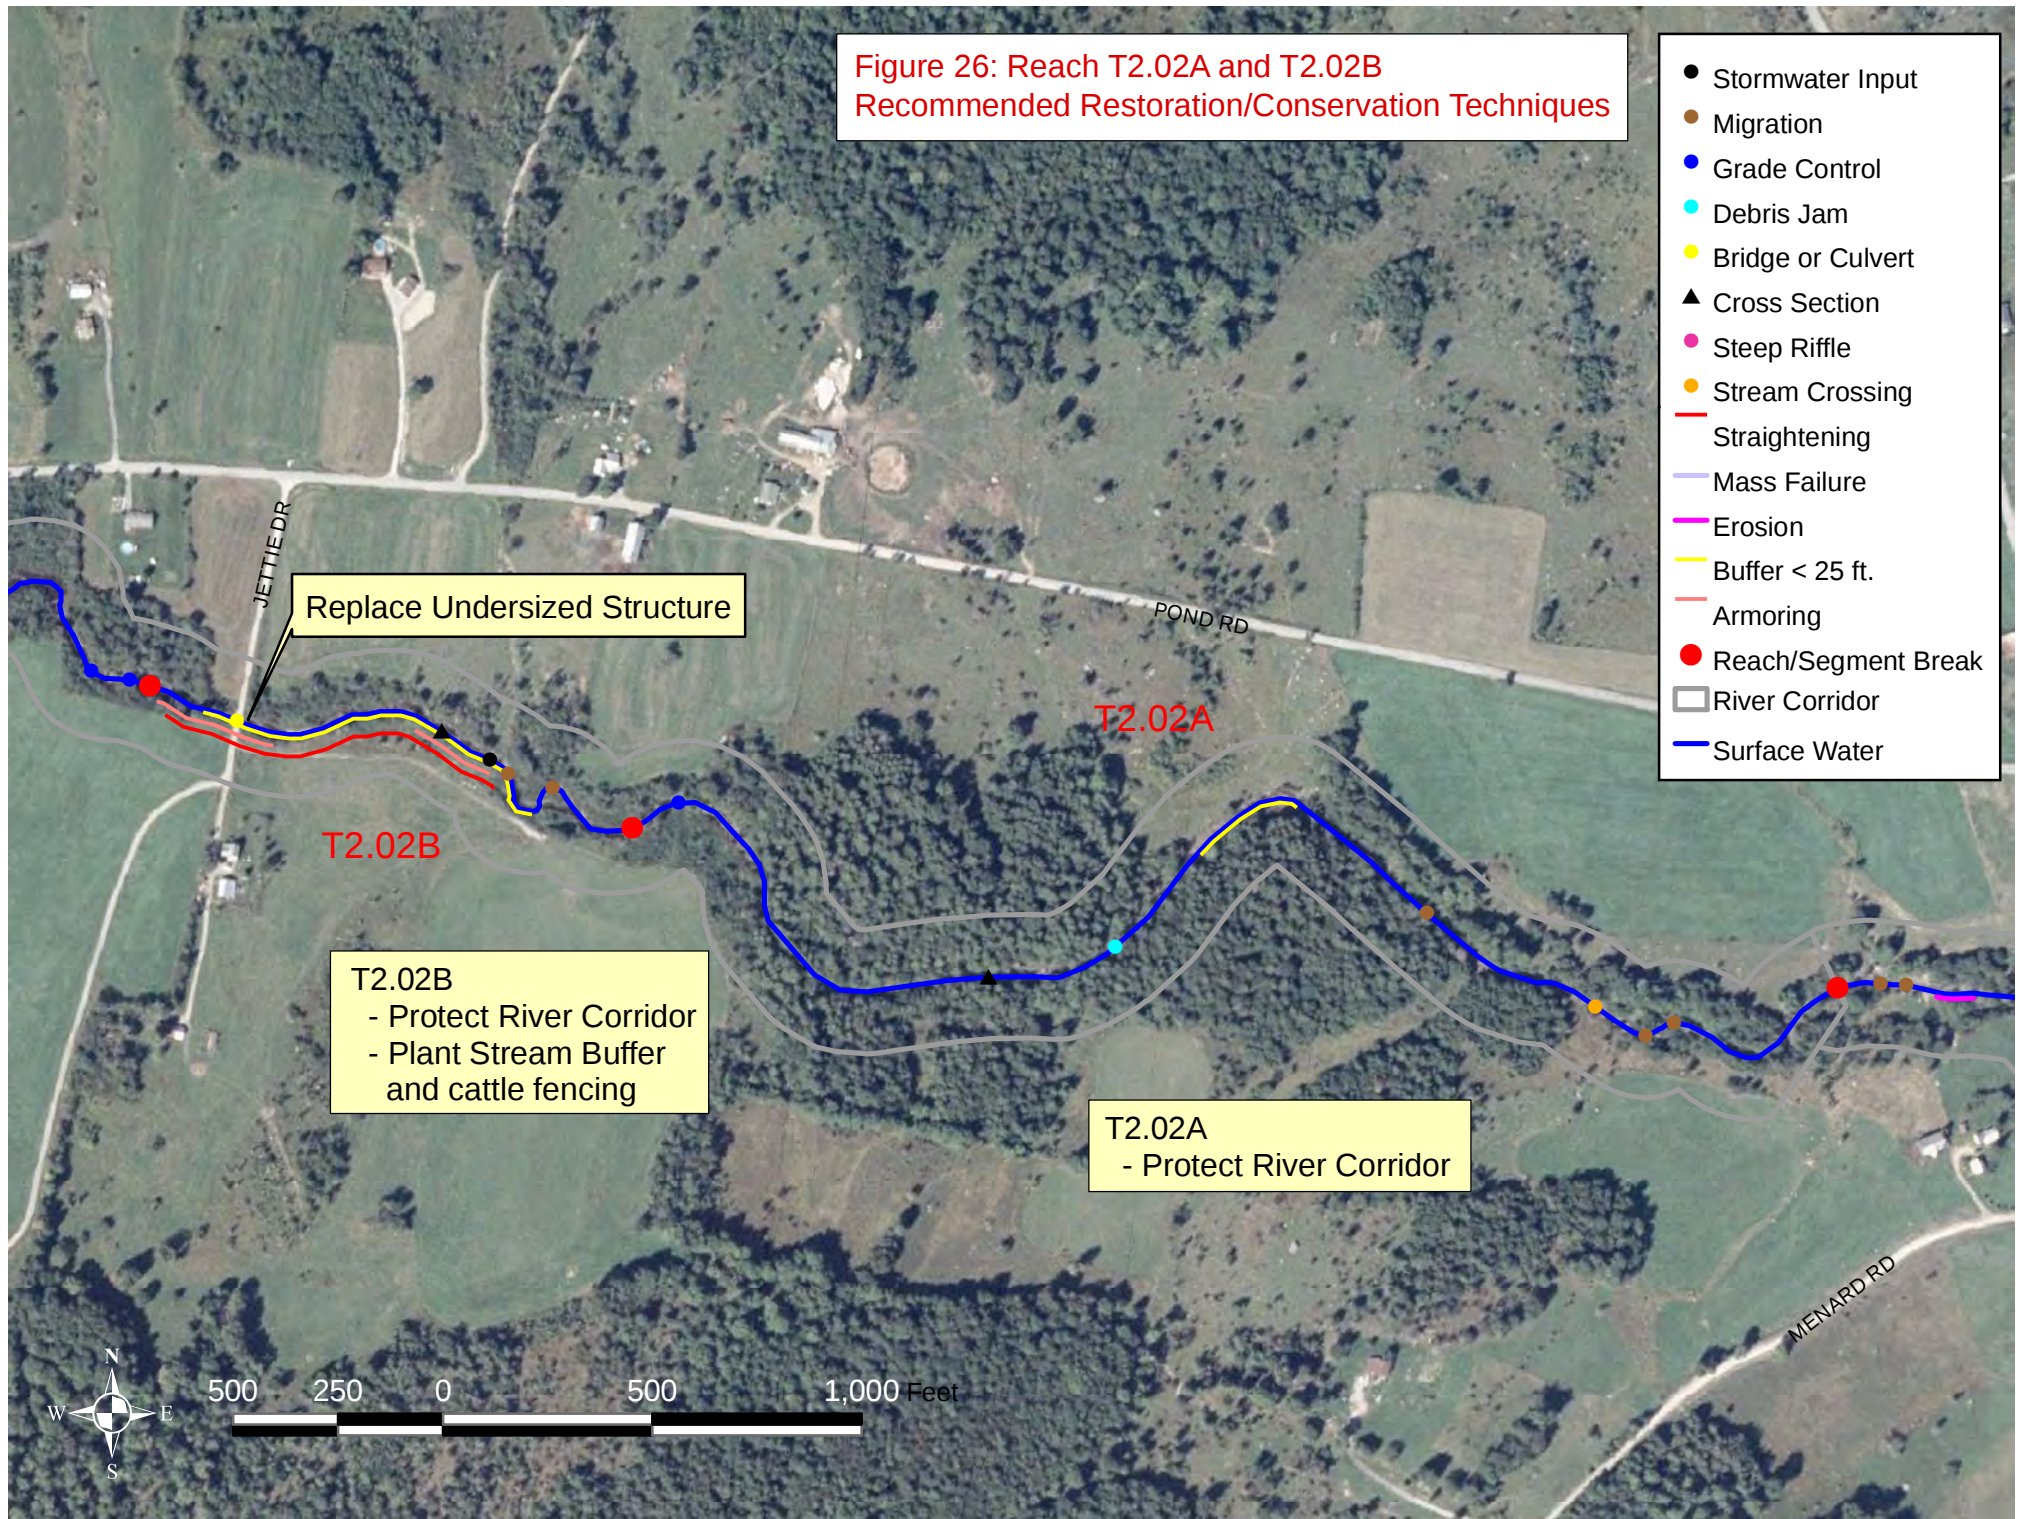
Figure 26: Reach T2.02A and T2.02B  
Recommended Restoration/Conservation Techniques

Reach T2.02 extends from the end of T2.01 upstream for approximately 1.5 miles. The reach was segmented into T2.02A, T2.02B, and T2.02C due to differences in the channel dimensions and streambank and boundary conditions. T2.02A is the downstream end of the reach and is approximately 0.7 miles long. The segment was classified as a C3 – Riffle-Pool, consistent with its reference stream type, and overall the reach was stable and in reference condition. No erosion or other adjustments were noted. The riparian corridor was dominated by forest with buffers greater than 100 feet. The habitat assessment showed excellent aquatic habitat.

T2.02B is the middle of the reach and is approximately 0.3 miles long. This segment has been historically straightened and intensely managed for agriculture. Despite this, only minor aggradation was noted and the stream still has good floodplain access. The C4-Riffle-Pool stream type was consistent with its reference type. The riparian corridor was dominated by pasture and hayfields with little to no buffer along the right bank. Cows were observed in the stream channel throughout the segment. The new bridge crossing Jettie Drive was found to be highly undersized with a structure to channel width ratio of 60%. T2.02C was dominated by beaver dams and several bedrock gorges and could not be fully assessed.

| River Segment | Restoration/Conservation Technique | Reach Priority | Watershed Priority | Table 22 Project Number | Completed Independent of other Practices | Next Steps/Project Notes |
|---|---|---|---|---|---|---|
| T2.02B | Replace undersized structure - Bridge crossing Jettie Drive undersized with structure to channel width of 60%. Replacement with wider structure to improve flow, limit flooding/erosion hazards, limit debris jam potential, and improve aquatic habitat. | Medium | Medium | 38 | Yes | More detailed bridge and culvert assessments needed to determine if replacement warranted. Town of Fairfield owned structure. |

Both T2.02A and T2.02B are currently relatively stable, so the river corridor should be protected to prevent development and channel management, and retain the reaches sediment and nutrient retention functions. Buffer planting and cattle fencing are needed along the right bank in segment B to limit cows access to the stream, reduce sediment and nutrient inputs, and improve bank stability. In addition, the bridge on Jettie Drive is undersized. This appeared to be a relatively new structure so replacement in the short term is probably unlikely, though a wider structure would reduce future flood and erosion hazards and improve the flow regime of the stream. Table 15 and Figure 26 below describe and show the locations of the recommended projects. A prioritized list of all identified projects for the watershed is shown in Table 22.

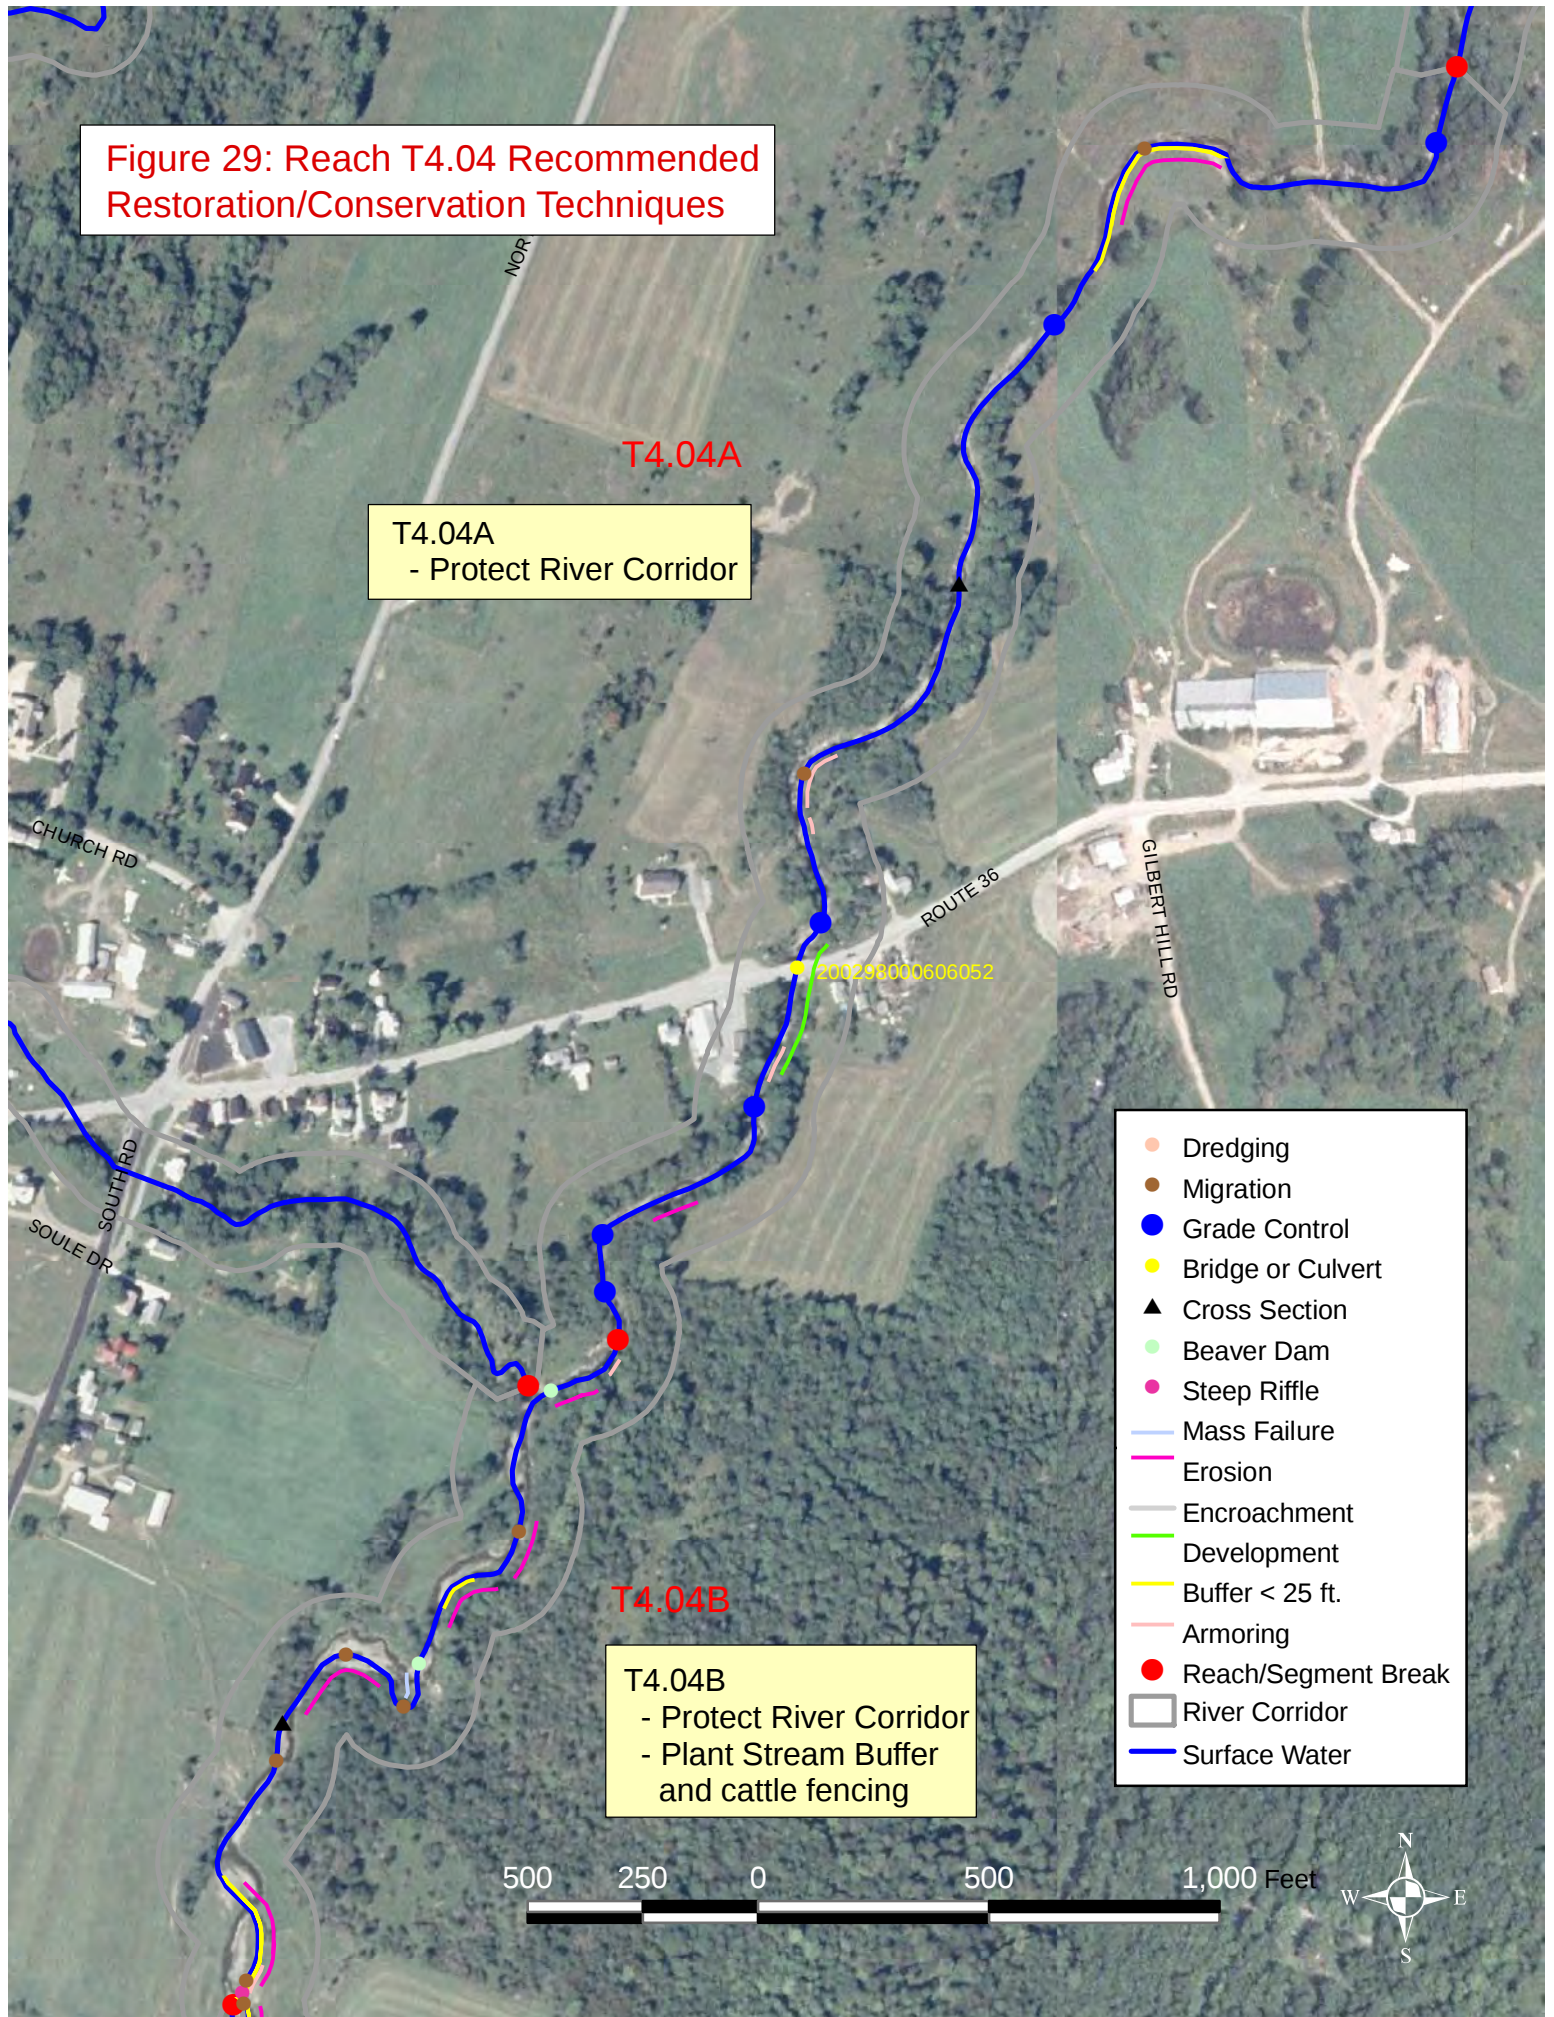
Figure 29: Reach T4.04 Recommended Restoration/Conservation Techniques

Reach T4.04 extends from the upstream end of T4.03 upstream for approximately 1.3 miles. The reach was segmented into two parts, T4.04A and T4.04B, due to differences in valley width and slope. T4.04A is the downstream end of the reach and is approximately 0.8 miles long. It is located in a naturally narrow, steeper portion of the valley, and is characterized as a B4-step-pool stream type, consistent with its reference type. Overall, the reach was relatively stable with no incision or other adjustment processes noted. Several bedrock grade controls and gorges were noted throughout the reach. The riparian corridor was dominated by a mix of pasture, hay, and forest with narrow buffer widths ranging from 25 to 100 feet. A few areas of inadequate buffer were noted, though tree plantings had recently been done to address these areas. The bridge crossing Route 36 was found to be adequately sized with a structure to channel width ratio of 165%.

T4.04B is the upstream portion of the reach and is approximately 0.5 miles long. It was moderately incised (ratio of 1.4) with active widening and aggradation (channel evolution stage III). This segment is located in a broader, shallower portion of the valley and was classified as a C4 – riffle-pool stream, consistent with its reference type. Moderate bank erosion was noted on the outside of meander bends and cows were noted in the stream channel in the upper portion of the segment. The riparian corridor was dominated by forest on the right and a mix of hay and pasture on the left with buffers ranging from 0 to 50 feet.

| River Segment | Restoration/Conservation Technique | Reach Priority | Watershed Priority | Table 22 Project Number | Completed Independent of other Practices | Next Steps/Project Notes |
|---|---|---|---|---|---|---|
| T4.04B | Plant Stream Buffer and cattle fencing - Majority of river corridor dominated by hay and pasture on left with ~800 feet of buffers less than 25 feet. Cows in stream in upstream portion of segment, fencing needed to reduce erosion and limit nutrient inputs. | High | Medium | 20 | Yes | Landowner cooperation required. Could be CREP eligible |

Given the location of T4.04 and relative stability, there are no recommended projects. The reach is currently stable and undeveloped. This should be maintained through corridor protection, though because this reach is naturally a transport type environment, preference should be given to protecting those areas in other reaches that can improve or retain needed sediment and nutrient retention. T4.04B is less stable and naturally a sediment and nutrient attenuation zone, so protecting the river corridor here is more important than downstream. Segment B is moderately incised and in the process of widening and aggrading to re-establish floodplain

connection. The existing undeveloped corridor should be protected to allow these functions to continue. In addition, buffers should be established between the hay and pasture on the left bank and the stream channel. Fencing is needed in the pasture to limit the cows access to the stream channel. An aerial view of the reach is shown on Figure 29, and descriptions of the recommended projects are shown in Table 18. A prioritized list of all identified projects for the watershed is shown in Table 22.

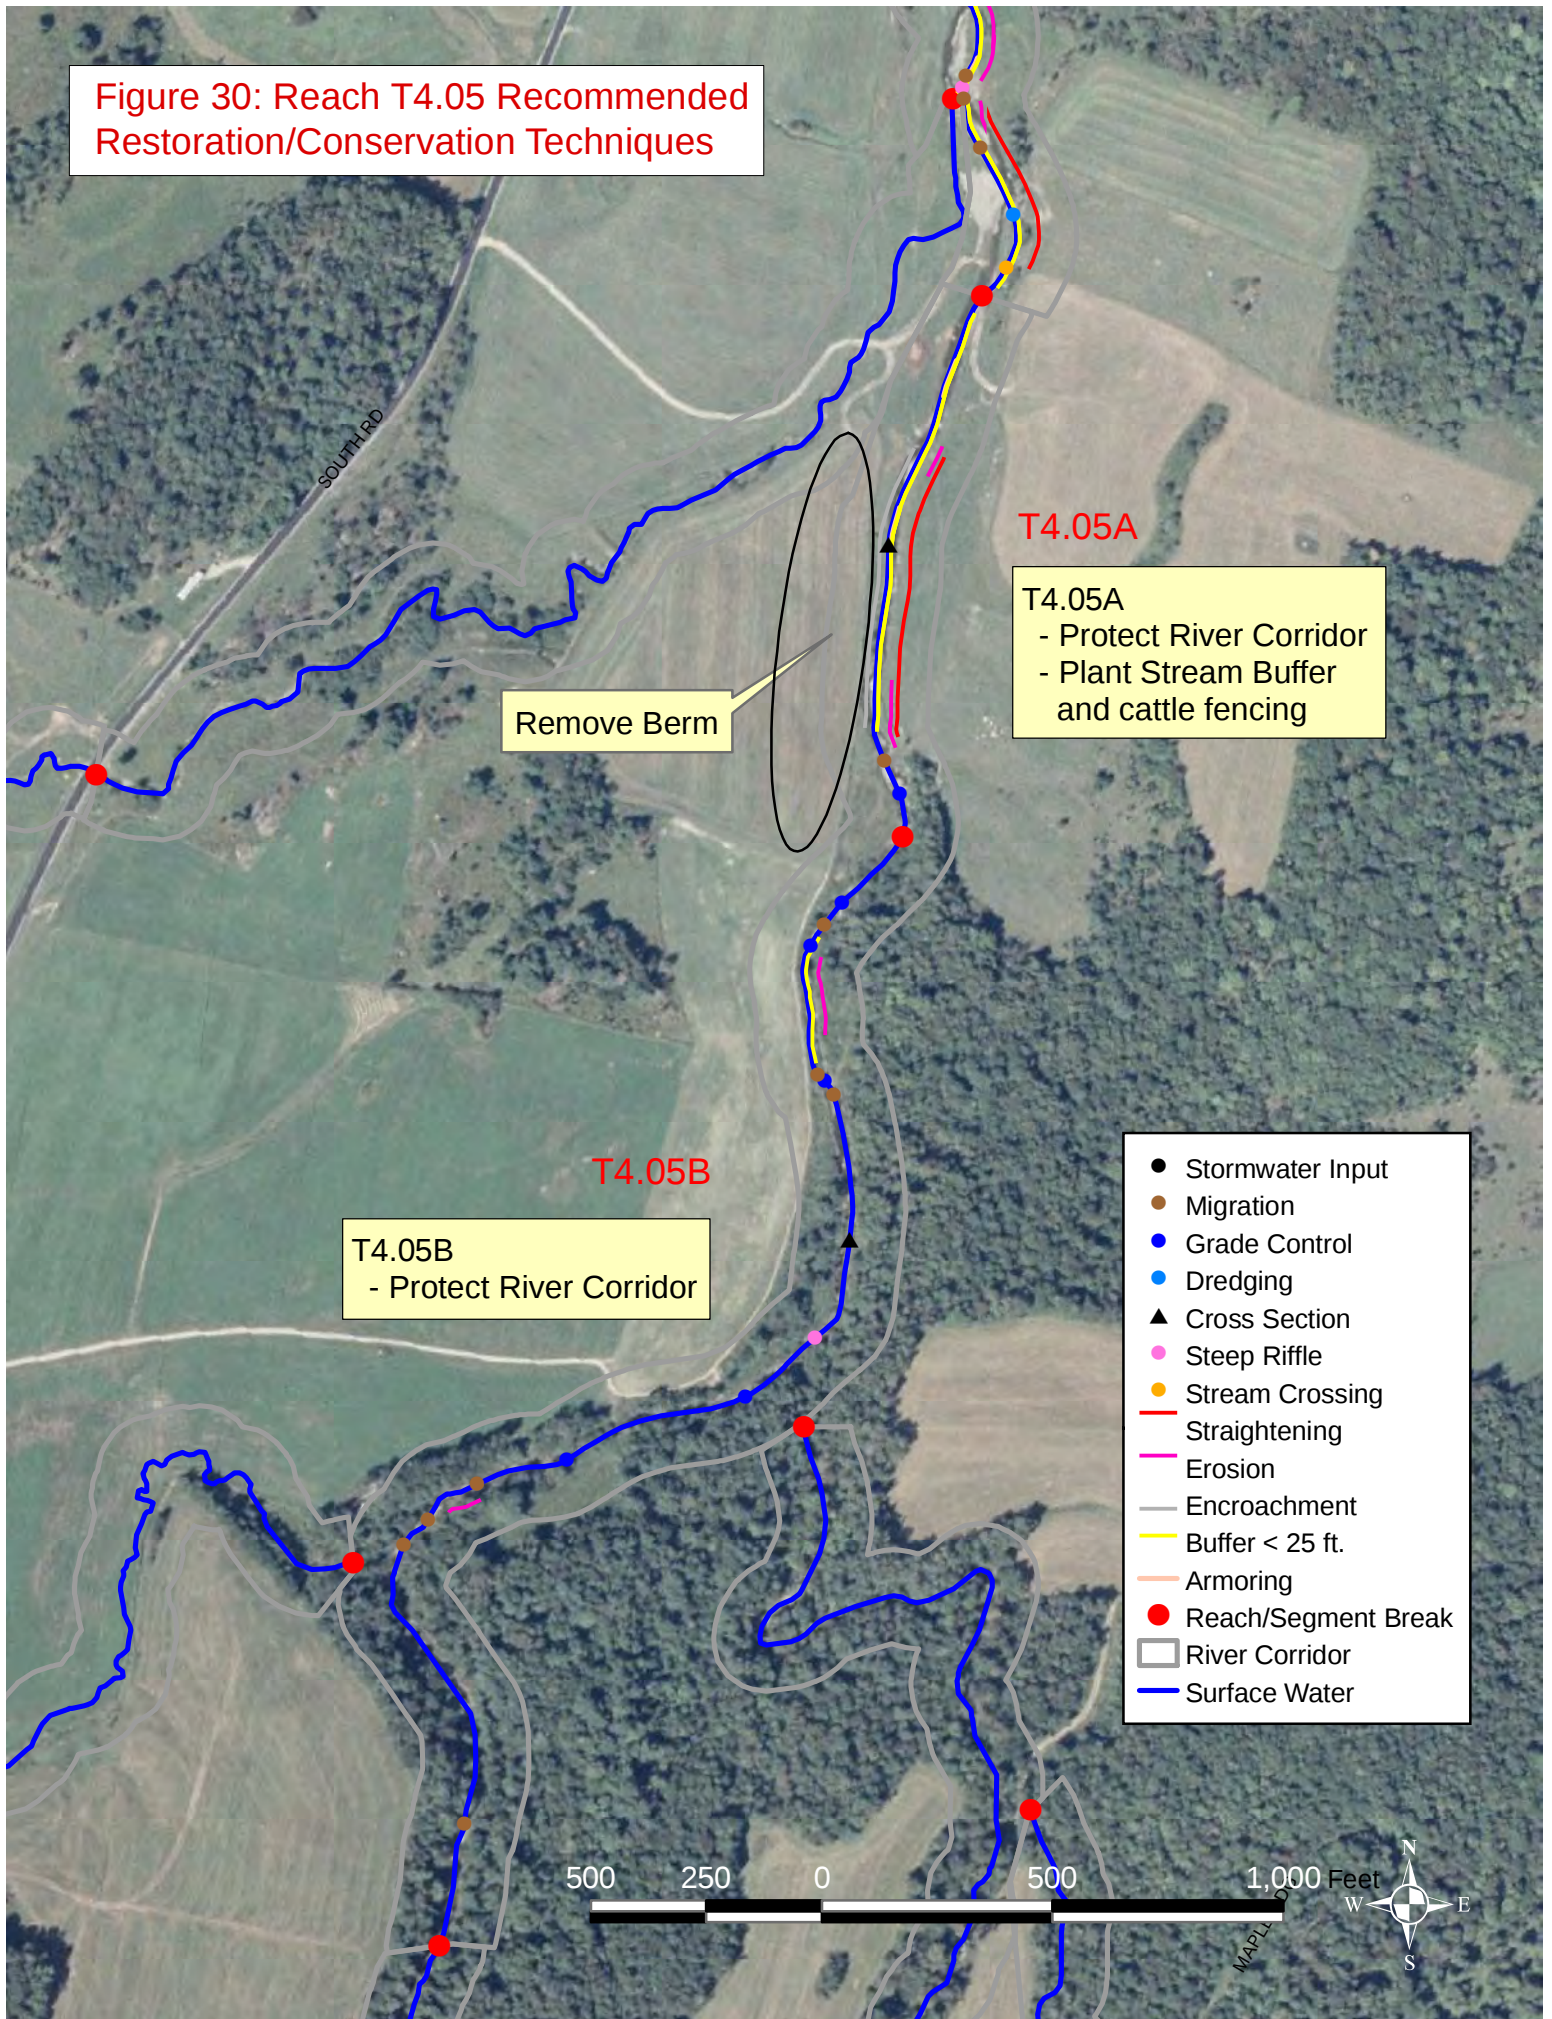
Figure 30: Reach T4.05 Recommended Restoration/Conservation Techniques

Reach T4.05 extends from the end of T4.04 upstream for approximately 0.8 miles. The Reach was segmented into T4.05A and T4.05B due to differences in valley width and corridor land use. T4.05A is the downstream portion of the reach and is approximately 0.25 miles long. It was moderately incised (ratio of 1.4) with minor widening and planform adjustments (channel evolution stage IV). The existing stream type (C4 – plane-bed) was consistent with its reference type, but lacked distinct riffles and pools as would be expected with this type of system. The riparian corridor was dominated by a mix of corn and pasture with little to no buffers. Cows were observed in the stream channel throughout the segment. A small berm runs along the left bank for approximately 600 feet, protecting the adjacent cornfield from flooding.

| River Segment | Restoration/Conservation Technique | Reach Priority | Watershed Priority | Table 22 Project Number | Completed Independent of other Practices | Next Steps/Project Notes |
|---|---|---|---|---|---|---|
| T4.05B | Protect River Corridor - Reach is mostly undeveloped forest. Reach stable with little adjustments. Reach located in narrow, steeper portion of valley acts a transport system. Corridor protection less important here than in attenuation areas. | Low | Low | 67 | Yes | Landowner cooperation |

Recommended project types for segment A include river corridor protection, buffer planting and fencing, and removal of the berm along the left bank. The stream is currently moderately incised, but still has floodplain access during most high flow events. The existing river corridor should be protected to retain the sediment and nutrient retention capacity of this area. Removal of the berm along the left side would enhance these functions. To reduce nutrient inputs and improve aquatic habitat, buffers should be established along with fencing to limit the cows' access to the stream channel. Segment B is relatively stable with little ongoing adjustments. This should be maintained through corridor protection, though because this reach is naturally a transport type environment, preference should be given to protecting those areas in other reaches that can improve or retain needed sediment and nutrient retention. Table 19 and Figure 30 below describe and show the locations of the recommended projects. A prioritized list of all identified projects for the watershed is shown in Table 22.
