# **Black Creek Corridor Plan**

**Franklin County  
April 2009**

Re: Black Creek Corridor Plan  
Franklin County, Vermont  
JCO Project No. 3-1313-3

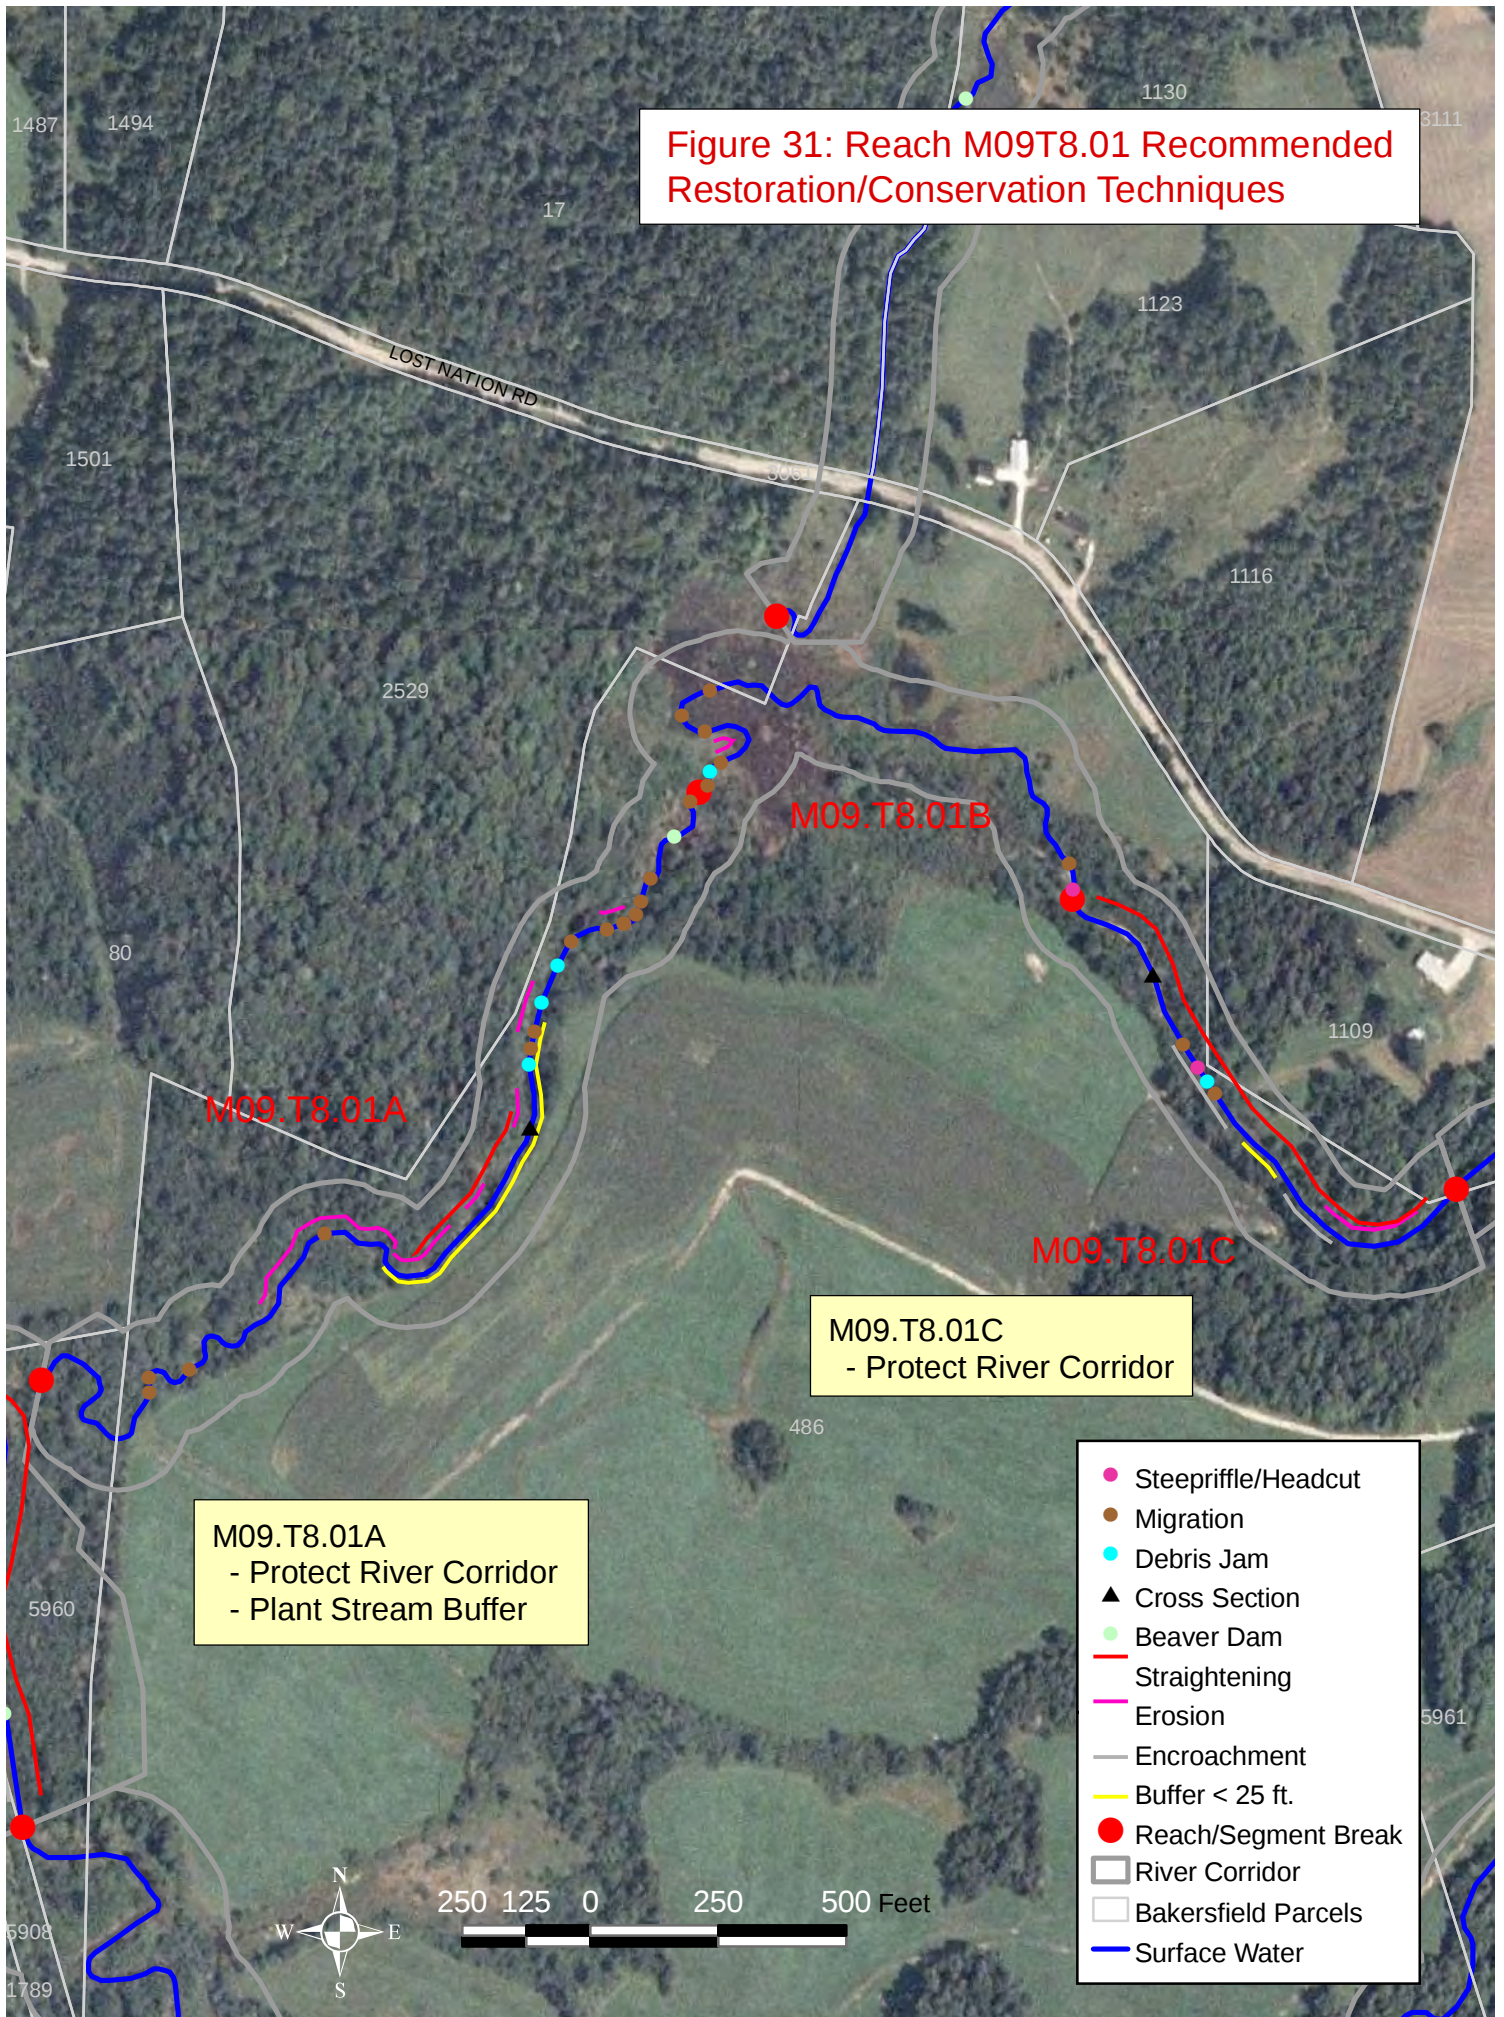
Figure 31: Reach M09T8.01 Recommended Restoration/Conservation Techniques

Reach M9T8.01 extends from its confluence with Black Creek in M09 upstream for approximately one mile. The reach was segmented into M9T8.01A, M9T8.01B, and M9T8.01C based on channel dimensions and the presence of grade controls. M9T8.01A is the downstream portion of the reach and is approximately 0.5 miles long. It was not incised (ratio of 1.0) and generally stable with minor planform adjustments (channel evolution stage I). The riparian corridor was dominated by forest on the right and a mix of hay and corn on the left. Approximately 600 feet along the left bank had inadequate buffers of less than 25 feet. The existing stream type (C4) was consistent with its reference type.

| River Segment | Restoration/Conservation Technique | Reach Priority | Watershed Priority | Table 22 Project Number | Completed Independent of other Practices | Next Steps/Project Notes |
|---|---|---|---|---|---|---|
| M9T8.01C | Protect River Corridor - Reach is mostly undeveloped forest. Reach stable with little adjustments. Corridor protection needed to retain attenuation assets. | Low | Low | 63 | Yes | Landowner cooperation |

Given the current relatively stable condition of M9T8.01, the recommended project types include corridor protection and buffer enhancement. The reach serves as important sediment and nutrient attenuation and wildlife habitat area. Corridor protection is needed to retain these assets. Buffer enhancement is needed in segment A where approximately 600 feet along the right bank has little to no buffer between the stream channel and the corn field. An aerial view of the reach is shown on Figure 31, and descriptions of the recommended projects are shown in Table 20. A prioritized list of all identified projects for the watershed is shown in Table 22.

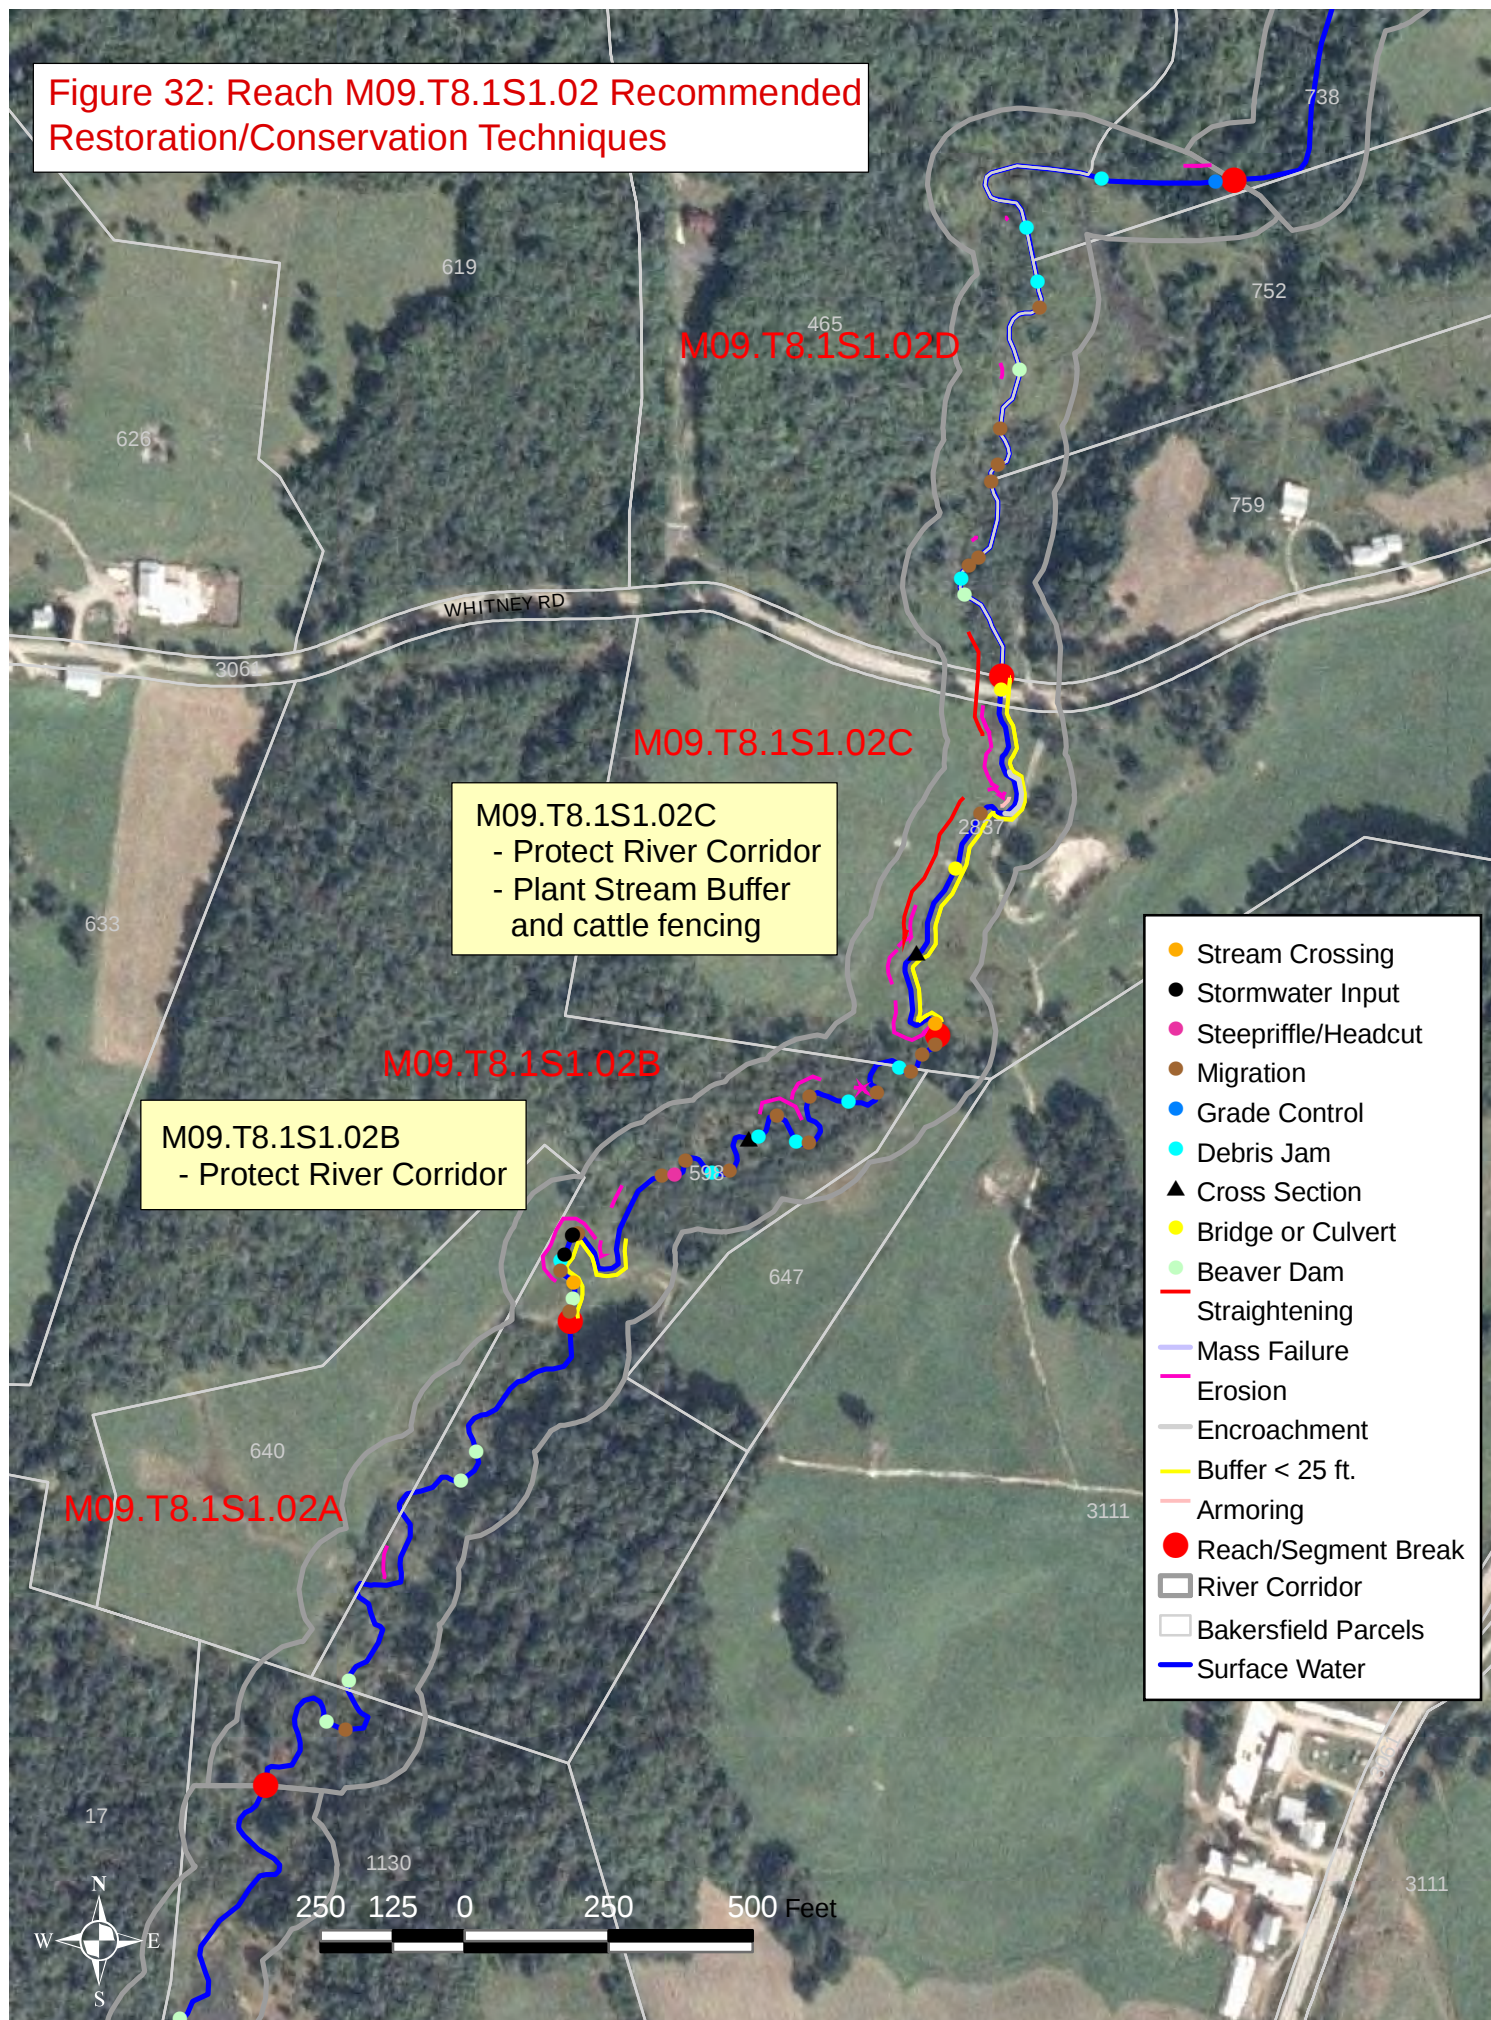
**Figure 32: Reach M09.T8.1S1.02 Recommended Restoration/Conservation Techniques**

Reach M9T8.1S1.02 extends from the end of M9T8.1S1.01 upstream for approximately 1 mile. The reach was segmented into four parts, segments A, B, C, and D due to differences in corridor land use and presence of bedrock grade controls. Segment A was not fully assessed, as was the case with M9T8.1S1.01, due to significant beaver activity and multiple bedrock grade controls. Segment B was found to be relatively stable, despite slight incision (ratio of 1.2). Its C4-riffle-pool stream type was consistent with its reference type. Several bedrock grade controls and waterfalls were noted throughout the reach. The riparian corridor was dominated by forest. M9T8.1S1.02C extends from the end of segment B upstream to just above the culvert on Whitney Road. This segment was also relatively stable with no major adjustment processes, despite significant impacts related to agricultural activity. The riparian corridor was dominated by pasture with no fencing or buffers present. Cows were observed in the stream channel throughout the segment. The culvert crossing Whitney Road was significantly undersized with a structure to channel width ratio of 25%. Segment D was not assessed due to significant beaver activity and multiple bedrock grade controls and waterfalls.

| River Segment | Restoration/Conservation Technique | Reach Priority | Watershed Priority | Table 22 Project Number | Completed Independent of other Practices | Next Steps/Project Notes |
|---|---|---|---|---|---|---|
| M9T8.1S1.02C | Replace undersized structure - Culvert crossing Whitney Road highly undersized with structure to channel width of 25%. Replacement with bridge or arch would improve flow, limit flooding/erosion hazards, limit debris jam potential, and improve aquatic habitat | Medium | High | 31 | Yes | More detailed bridge and culvert assessments needed to determine if replacement warranted. Town of Sheldon owned structure. |

Given the current relatively stable condition of this reach, the recommended project types include corridor protection and buffer enhancement. The reach serves as important sediment and nutrient attenuation and wildlife habitat areas. Corridor protection is needed to retain these assets. Buffer enhancement and fencing is needed in segment C where approximately 800 feet along both banks have little to no buffer or fencing to limit the cows access to the stream channel. Two undersized culverts were also noted in the area. The first is in reach M9T8.1S1.01, which was not fully assessed due to extensive beaver activity. The culvert crossing Lost Nation Road is severely undersized with a structure to channel width ratio of 60%. The culvert on Whitney Road in M9T8.1S1.02C is also undersized with a structure to channel width ratio of 25%. An aerial view of the reach is shown on Figure 32, and descriptions of the recommended projects are shown in Table 21. A prioritized list of all identified projects for the watershed is shown in Table 22.
