# **Black Creek Corridor Plan**

**Franklin County  
April 2009**

Re: Black Creek Corridor Plan  
Franklin County, Vermont  
JCO Project No. 3-1313-3

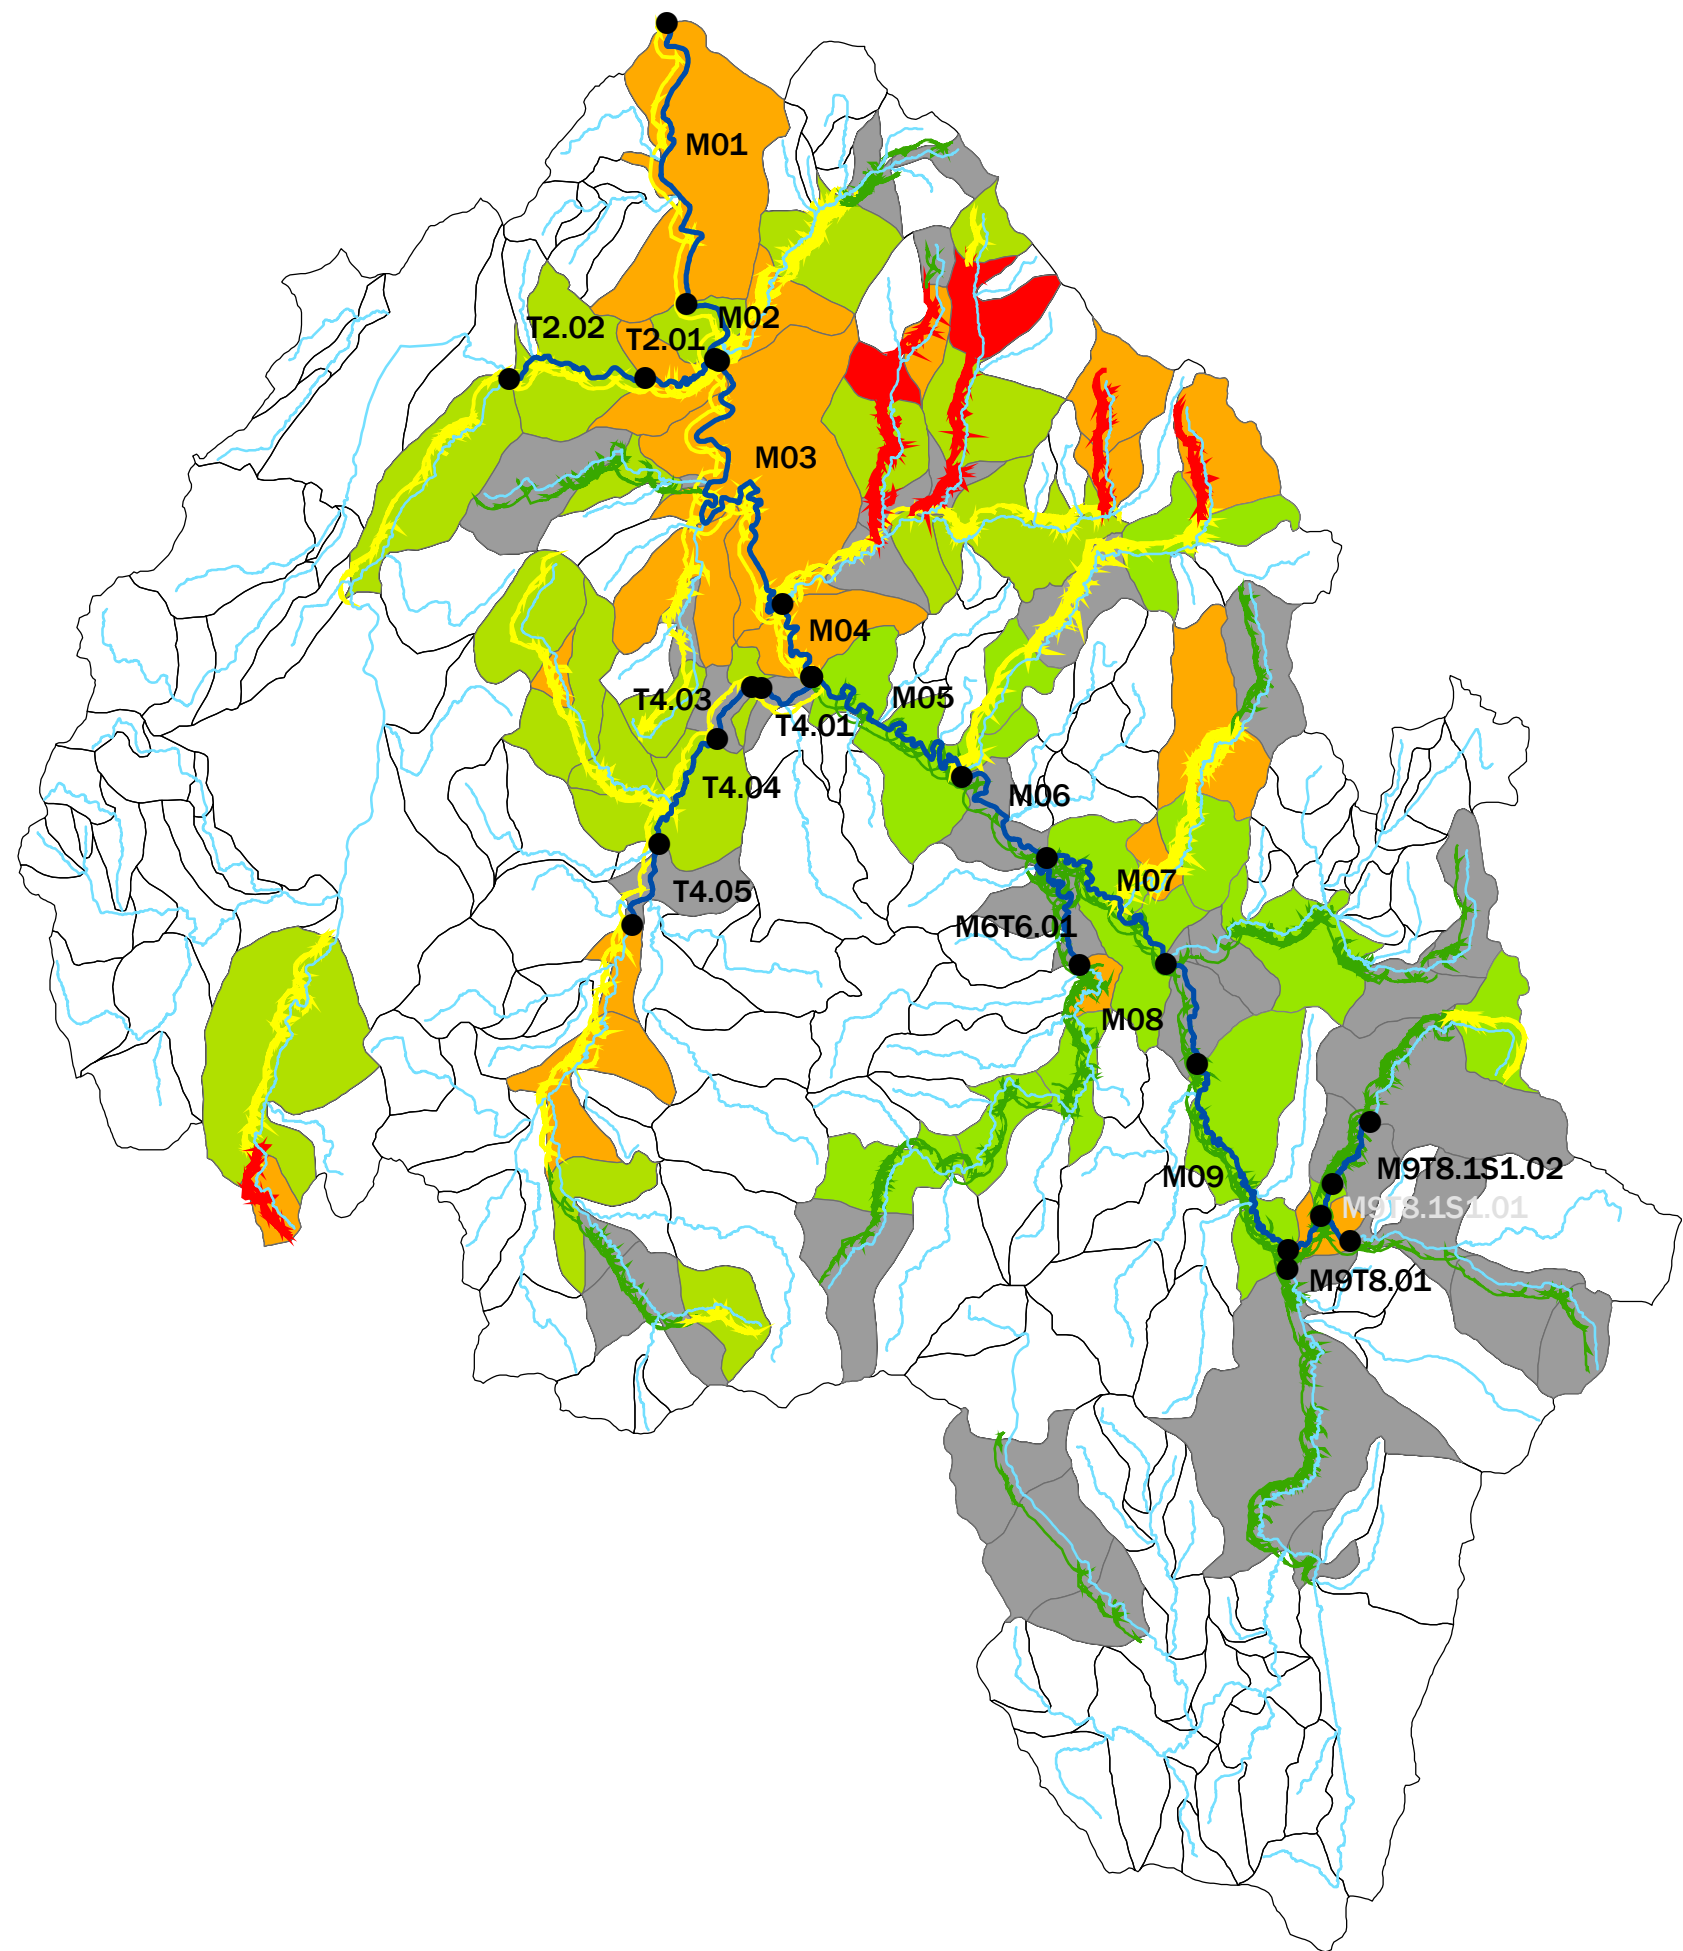
Figure 7: Land Use/Land Cover Map  
(Agriculture)  
Black Creek Watershed  
Head and Mouth Reaches

As described above, land use and land cover have a significant impact on the hydrologic regime of a watershed, particularly small intensely agricultural ones such as Black Creek. Figures 7, 8, and 9 show the current land use and cover for the study area. As is evident on

Figures 7 and 9, agriculture is by far the dominant land use in the watershed, however urbanization and road density are also contributing factors to changes in hydrology. Table 2 shows the percent urbanization for each reach. Altered hydrology may be a significant stressor once urban land use reaches greater than 5% of the watershed (VT ANR, 2007). While the Black Creek watershed is a rather rural community, the urban land use within the study area is still slightly greater than 5% for many reaches. This urban and agricultural land use has caused an increase in the magnitude and duration of large flow events through increased runoff and decreased infiltration capacity. This is particularly true in agricultural lands that were converted from wetlands. As is shown in Figures 9a and 9b, a majority of the historic wetlands have been converted into agricultural land through subsurface drainage and ditching. The light green layer on Figure 9 represents significant wetlands, including swamps, bogs, and other areas normally saturated for most of the year. The dark green layer represents hydric soils, or areas where the soil is saturated for a minimum of two weeks each year, but usually dries out for a period of time in the summer months. Large areas of both types of wetlands have been converted to agricultural use. Wetlands are very important flood mitigation features, capturing excess rainfall or snowmelt and slowly releasing it into the surrounding soils. The conversion of these wetlands not only increases the magnitude and rate of runoff into the stream channel, it also increases the sediment and nutrient inputs into the system as fertilizers and topsoil are washed from the land surface. These and other sediment load stressors are discussed below.

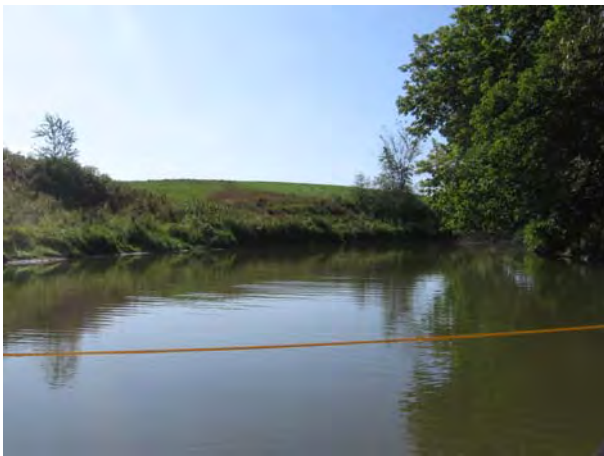
Reach M02 extends from the end of reach M01 upstream for approximately 0.8 miles to the confluence with Dead Creek. This reach was found to be only slightly incised (ratio of 1.1) and still has adequate floodplain access. The existing stream type of E5 Dune-Ripple was consistent with its reference stream type. Minor bank erosion was noted along small portions of the reach, though most of the banks were found to be relatively stable. The reach was found to be in channel evolution stage V, with little active adjustments occurring and a rapid geomorphic score of 0.73 (good). The riparian corridor was dominated by a mix of hay and crop with a large

area of forest on the right bank. Buffer widths were generally 0-25 feet, with approximately 1,500 feet having less than 25 foot buffers. The habitat assessment was fair primarily due to lack of woody cover, embeddedness, and very few favorable sediment types and flow patterns.

Given the current, relatively stable condition of M02, the recommended remedial strategies are to protect the existing undeveloped river corridor to retain the reach's nutrient attenuation assets, and enhance the current buffer. Several large areas have riparian buffers of less than 25 feet, particularly upstream of Bridge Street. Buffer planting should be concentrated in these areas to reduce sediment and nutrient inputs, improve aquatic habitat, and improve bank stability. Buffer establishment along the field ditches at the northern end of the reach is also important to reduce sediment and nutrient inputs. An aerial view of the reach is shown on Figure 17, and descriptions of the recommended projects are shown in Table 6. A prioritized list of all identified projects for the watershed is shown in Table 22.

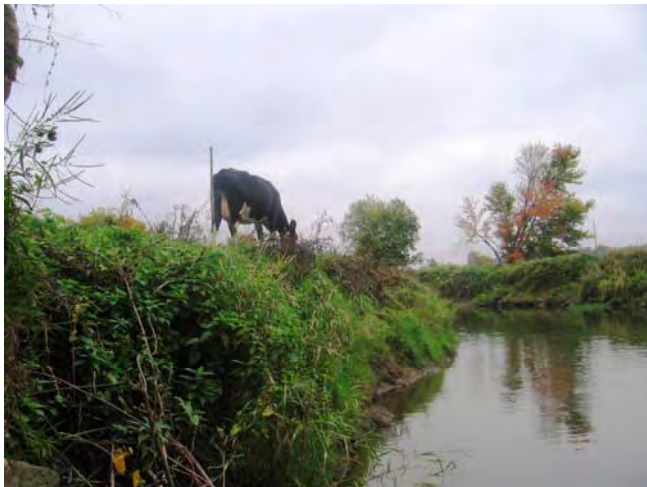
M05B is the upstream portion of the reach and extends to just south of Bruso Road. It was found to be less stable than segment A with an incision ratio of 1.3, and active widening and planform adjustments. Documented flooding in M05 suggests that despite the measured incision, the stream regularly floods over its banks. The reach was classified as an E5 Dune-Ripple, consistent with its reference type and in Evolution Stage III (widening). The riparian corridor was dominated by a mix of corn and hay with large areas of buffers less than 25 feet. The abandoned rail bed runs along a significant portion of the river corridor, though it is less of a constriction than in segment A as it is close to the natural valley wall. The bridge on Bruso Road, and a private bridge located upstream were identified as channel and floodplain constrictions within the segment. The structures had structure to channel width ratios of 94% and 75% respectively.

Recommended projects for Reach M05 include corridor protection, buffer planting/cattle exclusion, berm removal, and replacement of undersized structures. Documented flooding in this reach indicates that the stream regularly accesses the floodplain. Corridor protection would protect this important asset by limiting development and channel management. More importantly the elevated railroad bed which runs along a large portion of the segment is a significant floodplain constriction. Removal of this berm, or retrofitting the existing berm by adding bridges or adequately sized culverts would significantly improve the flow regime and sediment and nutrient retention functions of the reach. These actions are not needed in segment B because the berm runs along the natural valley wall. The entire reach suffers from a lack of adequate buffer. Tree and buffer planting should be implemented to reduce sediment and nutrient inputs. Cattle fencing is needed to limit cows access to the stream channel mid-reach.

Finally, four undersized bridges were identified in the reach; two private structures and two town owned structures on Ryan Road and Brusco Road. Replacement of these structures combined with the other techniques described above would improve the flow and sediment regimes of the reach. Table 9 and Figures 20a and 20b below describe and show the locations of the recommended projects. A prioritized list of all identified projects for the watershed is shown in Table 22.

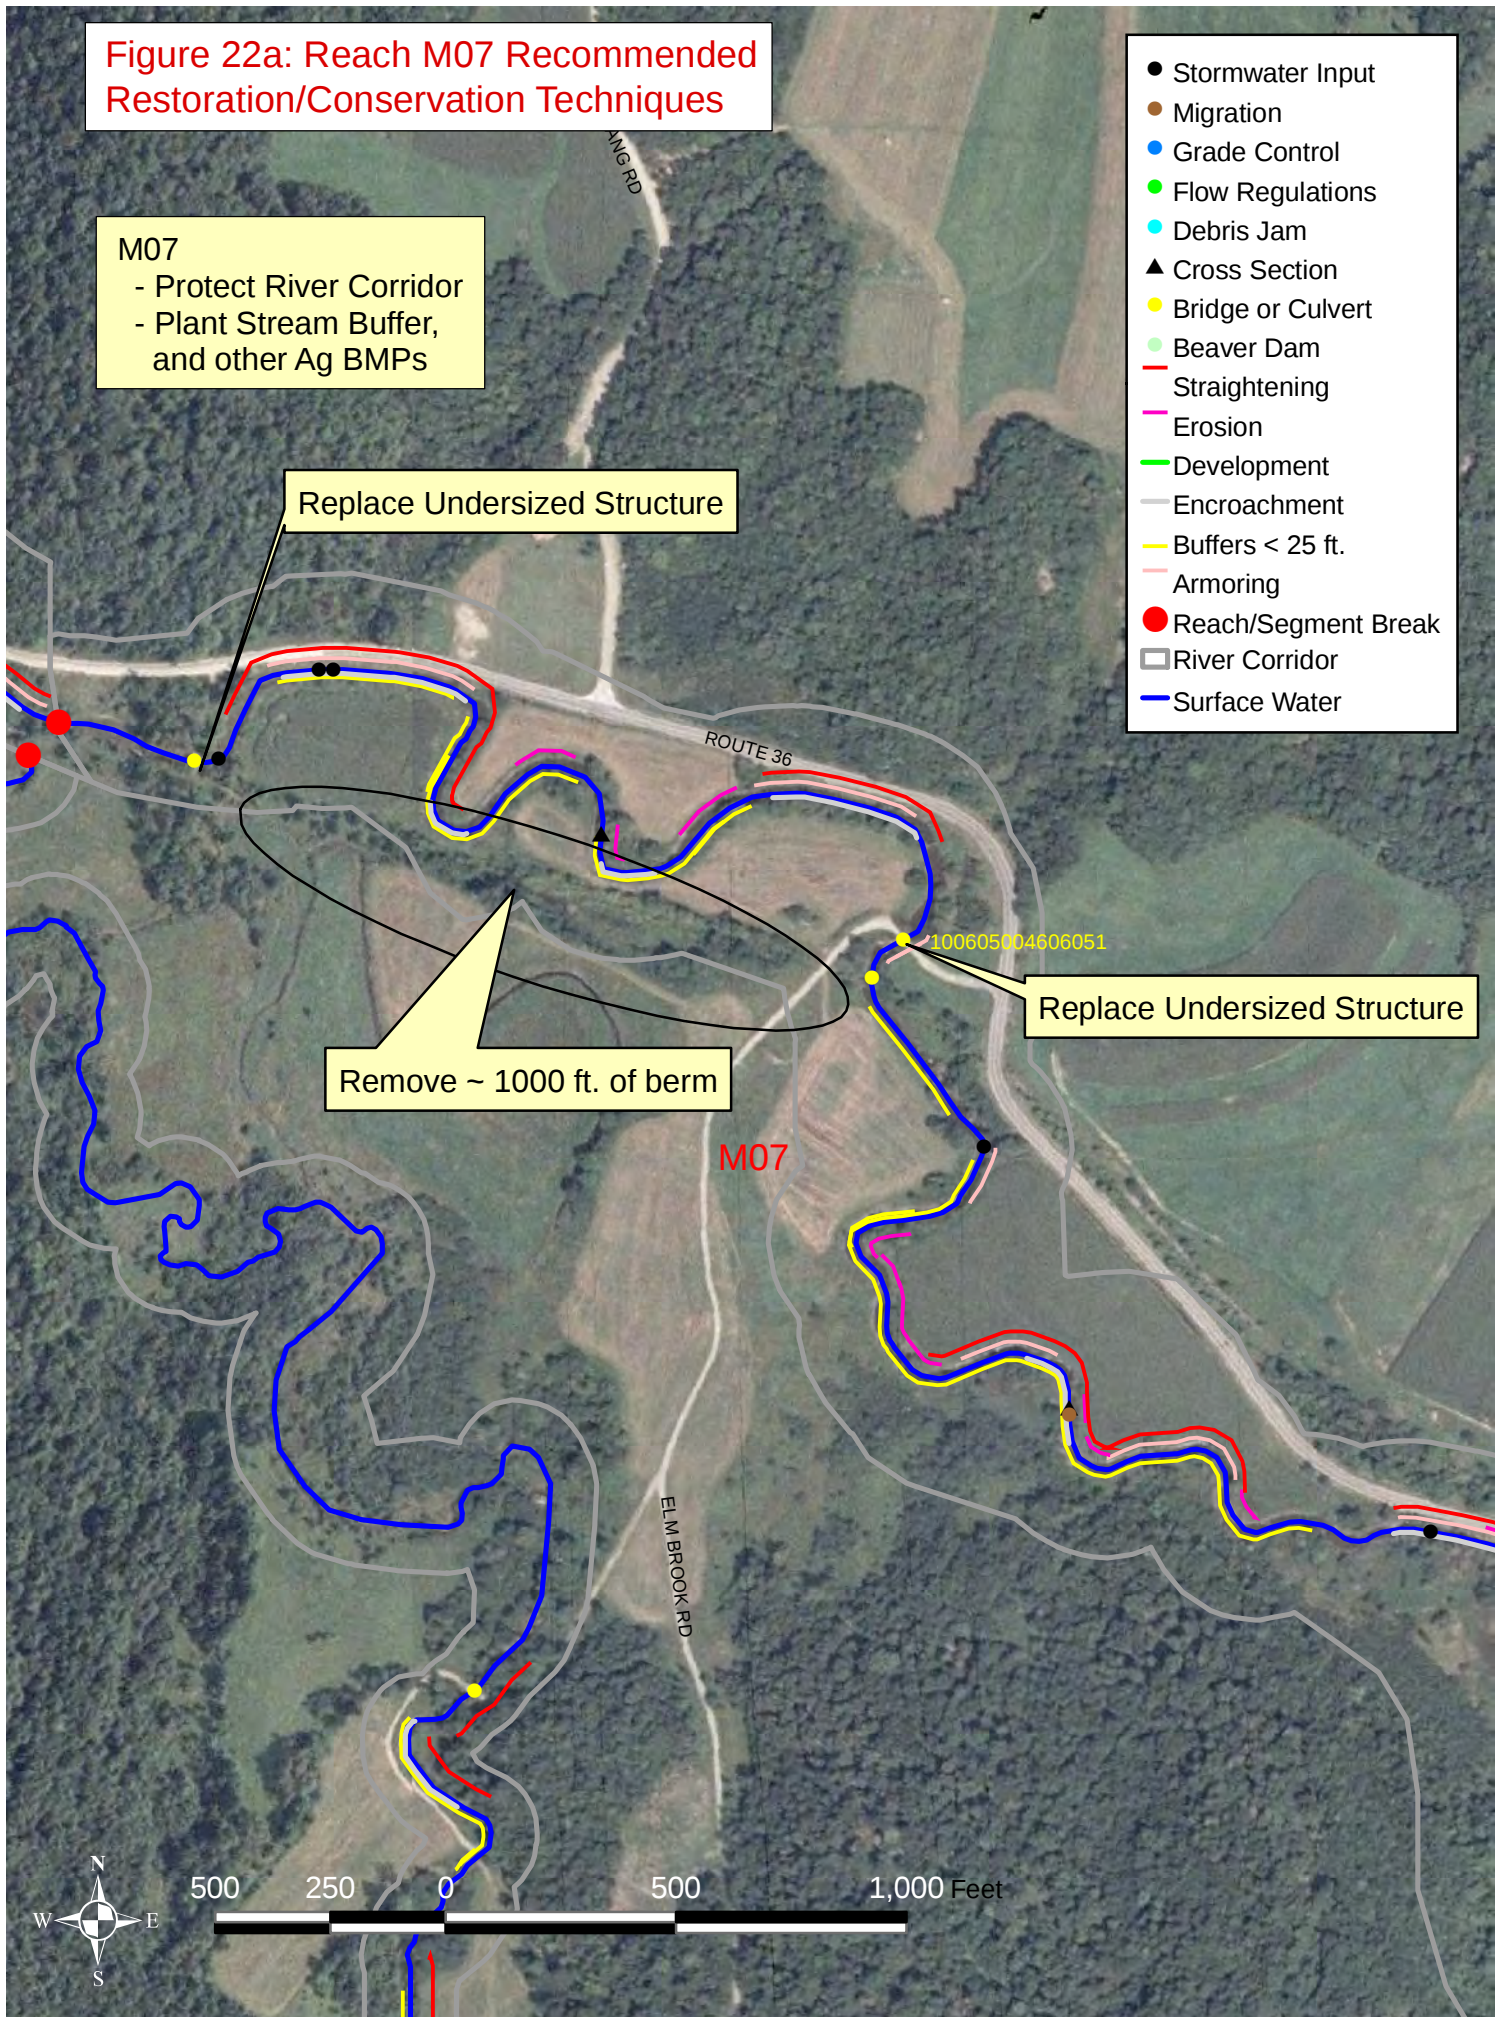
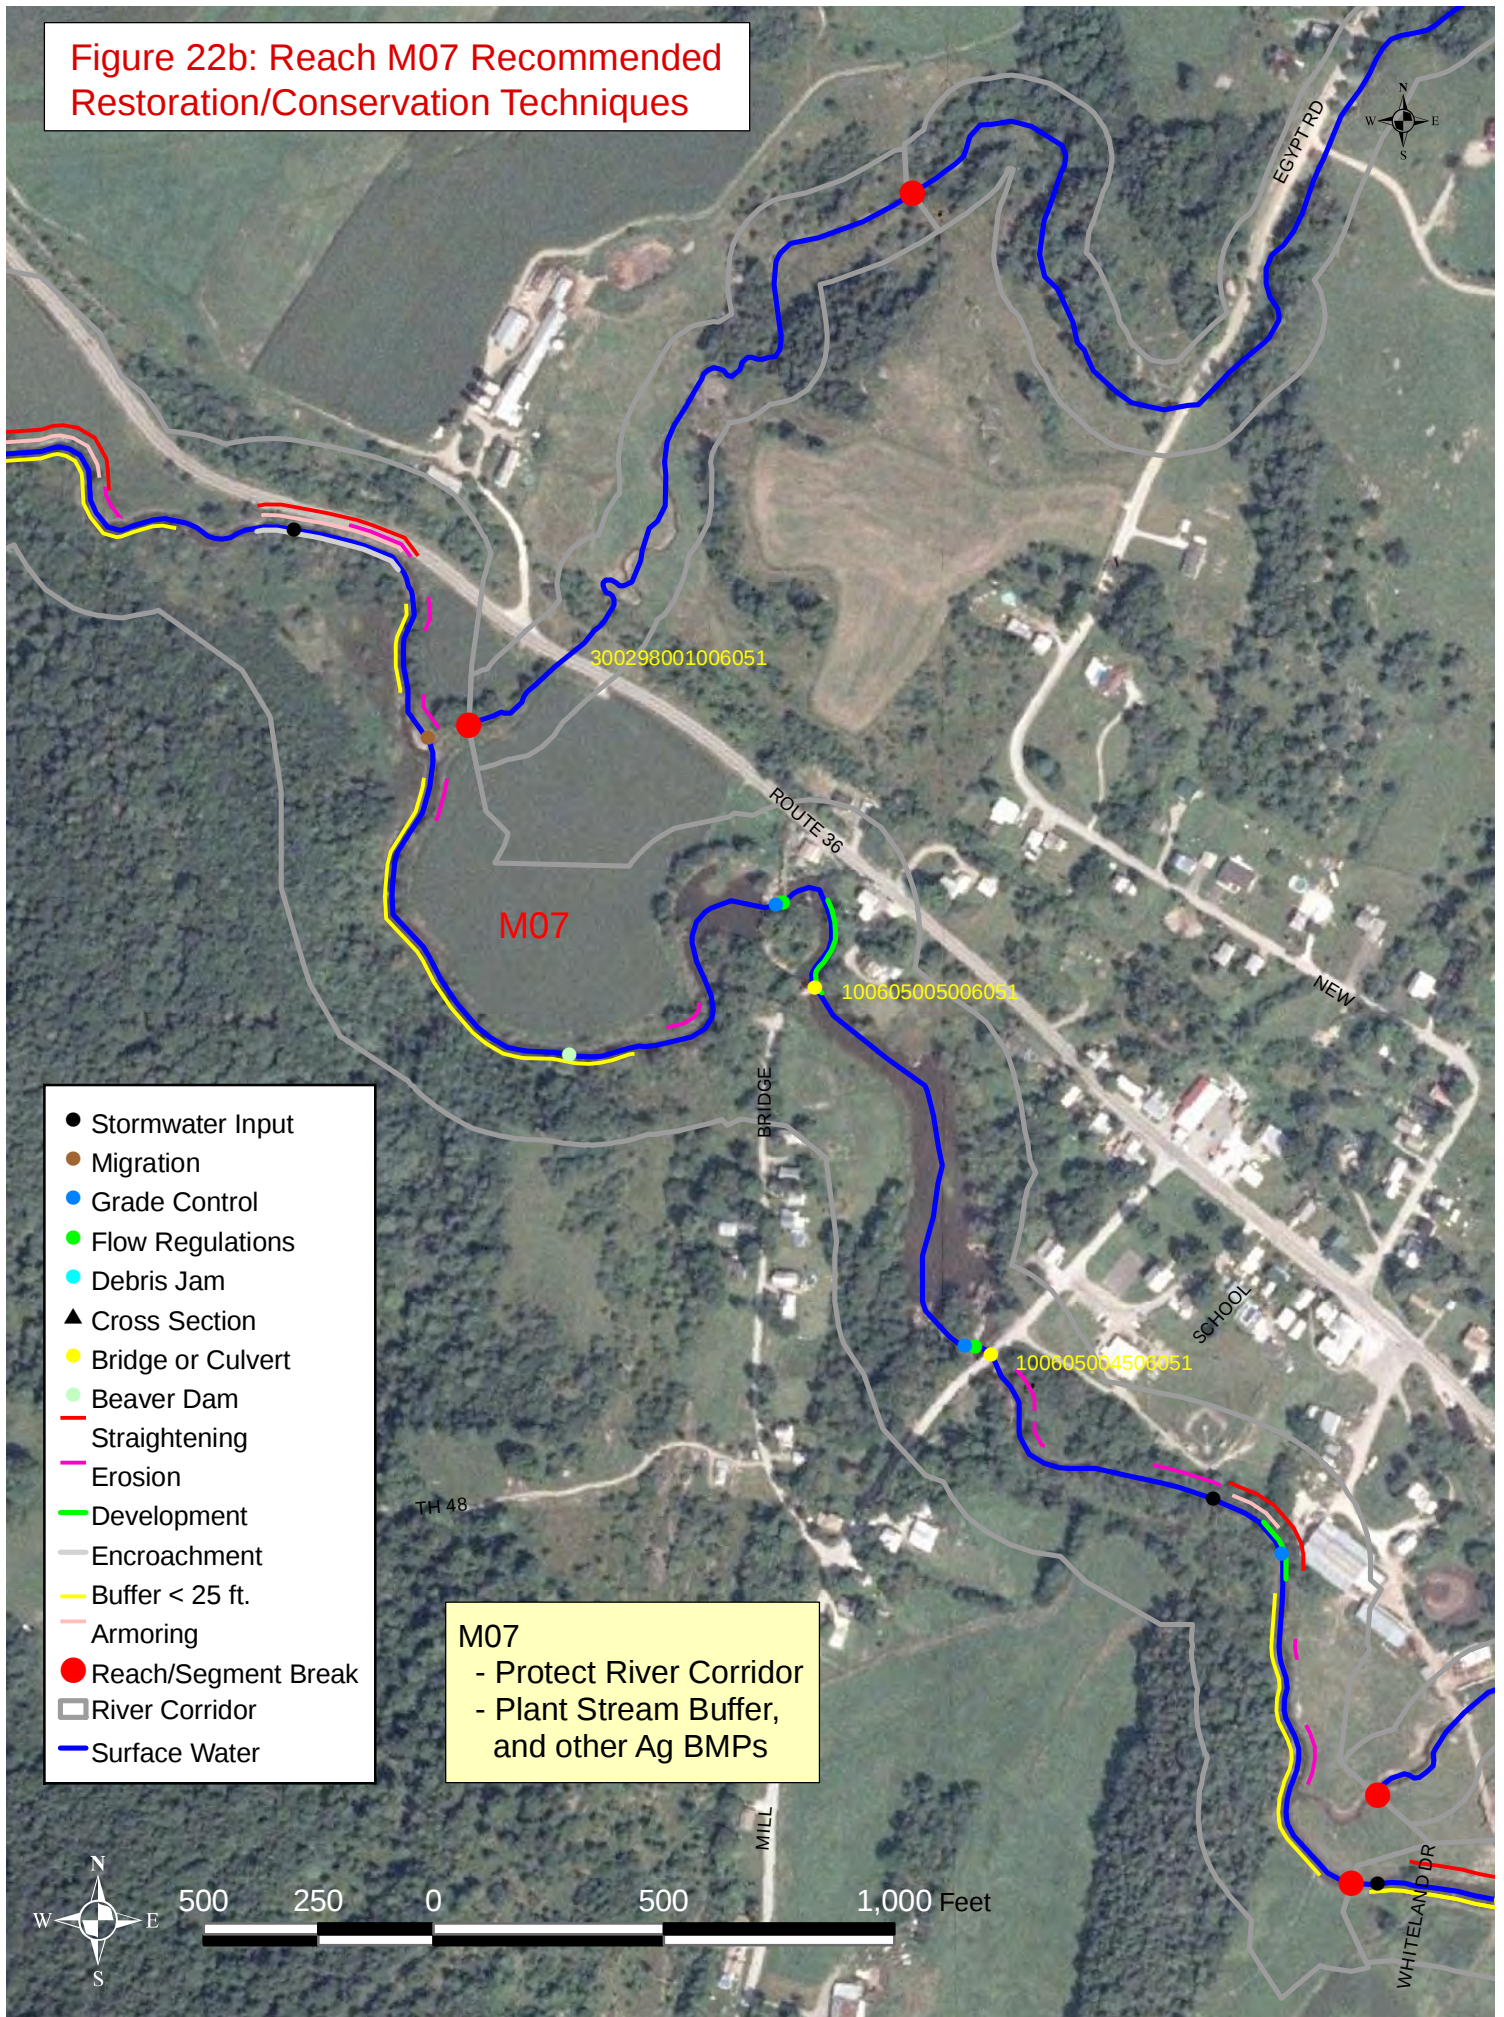
**Figure 22a: Reach M07 Recommended Restoration/Conservation Techniques**

Reach M07 extends from the confluence with Elm Brook upstream for approximately two miles to the village of East Fairfield. The reach was found to be slightly incised (ratio of 1.2) with minor active widening and aggradation. The existing stream type of E5 Dune-Ripple was consistent with its reference type. Moderate bank erosion was noted, mostly on the outside of meander bends. The riparian corridor was dominated by a mix of hay and forest, with large areas of inadequate buffers less than 25 feet. The abandoned elevated rail bed runs within the river corridor in the upstream half of the reach and represents a major floodplain constriction. The upstream portion of the reach near East Fairfield village is dominated by two large bedrock gorges and could not be assessed. Remnants of old concrete dams were present in these gorges, though their impact on the channel dynamics is rather minimal given their location inside natural bedrock constrictions. Five bridges cross the channel within the reach. Two of these are for the former railroad, and the remainder are town owned structures. Two of them, the railroad bridge at the downstream end of reach, and Elm Brook Road bridge, were identified as channel and floodplain constrictions with structure to channel width ratios of 53% and 87% respectively.

Given the current conditions of M07, the recommended remedial strategies are to protect the existing river corridor, implement adequate riparian buffers, replace the undersized bridges, and remove or retrofit the elevated rail bed. The reach currently has good floodplain access, though portions of the floodplain are limited by Route 36 on one side and the rail bed on the other. The rail bed in the downstream end of the reach should be removed, lowered, or retrofitted with bridges and/or adequately sized culverts to restore the lost floodplain access. In addition, the two undersized bridges should be replaced with newer structures with adequate widths. Increasing the buffer widths along the agricultural fields is also an important strategy here. An aerial view of the reach is shown on Figures 22a and 22b, and descriptions of the recommended projects are shown in Table 11.

| River Segment | Restoration/Conservation Technique | Reach Priority | Watershed Priority | Table 22 Project Number | Completed Independent of other Practices | Next Steps/Project Notes |
|---|---|---|---|---|---|---|
| M07 | Replace undersized structures - Elm Brook Road bridge noted as channel and floodplain constriction in phase 2 with structure/channel width ratio of 53%. Railroad bridge located near downstream reach break also noted as constriction with structure/channel width ratio of 87%. | Medium | Medium | 35 | Yes | More detailed bridge and culvert assessments needed to determine if replacement warranted. One structure owned by Town of Fairfield, other privately owned structure. |

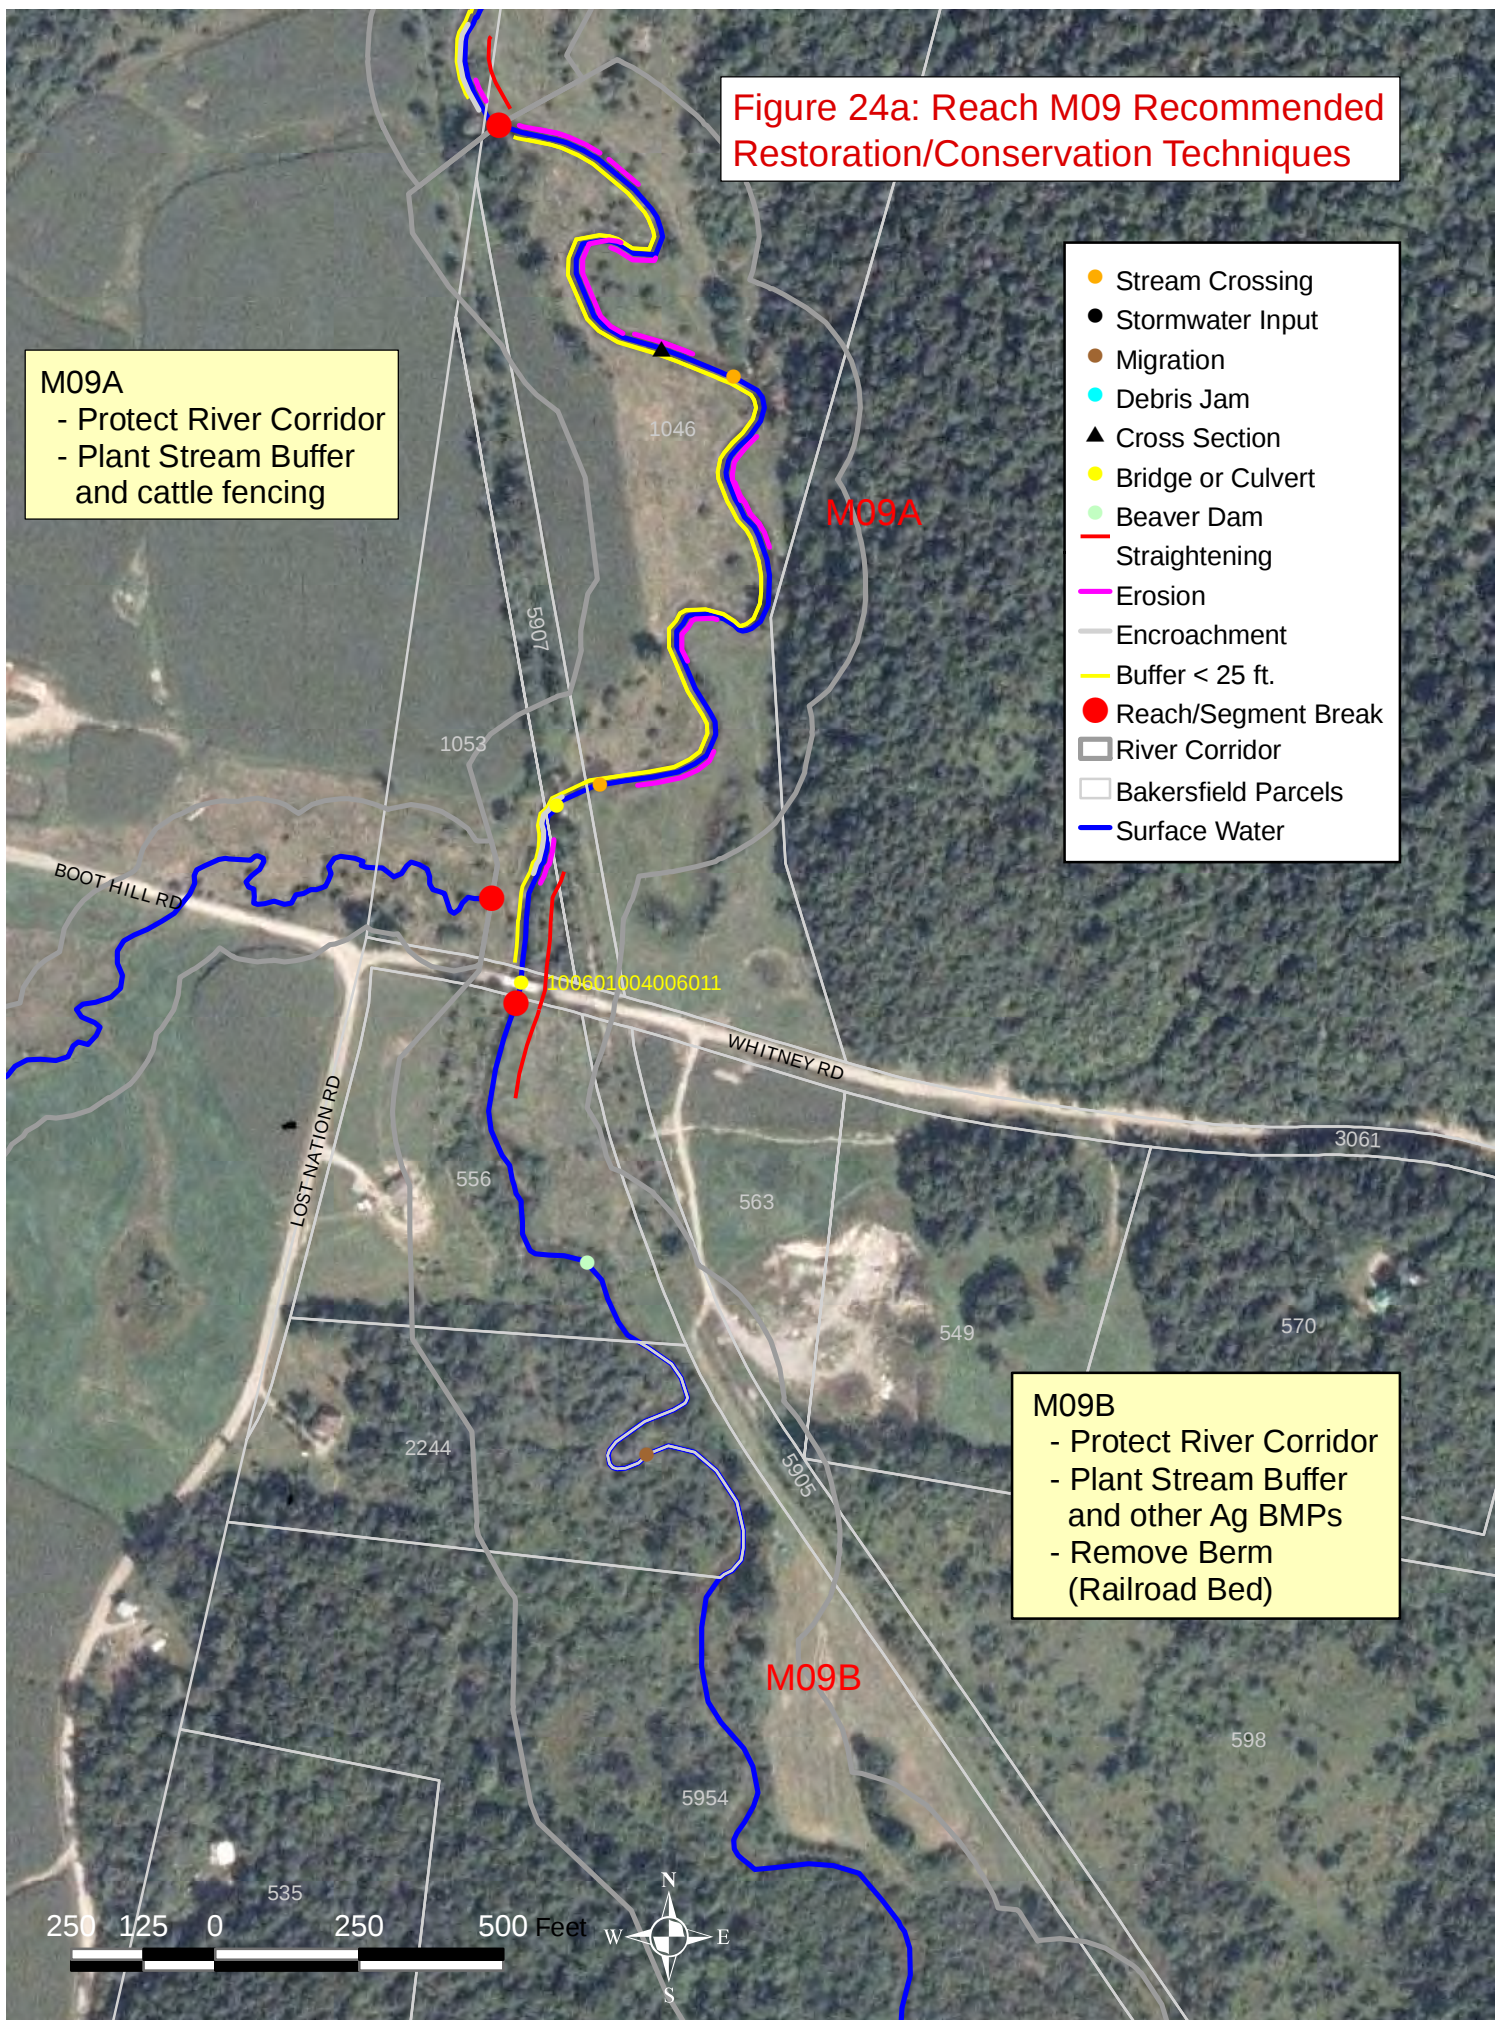
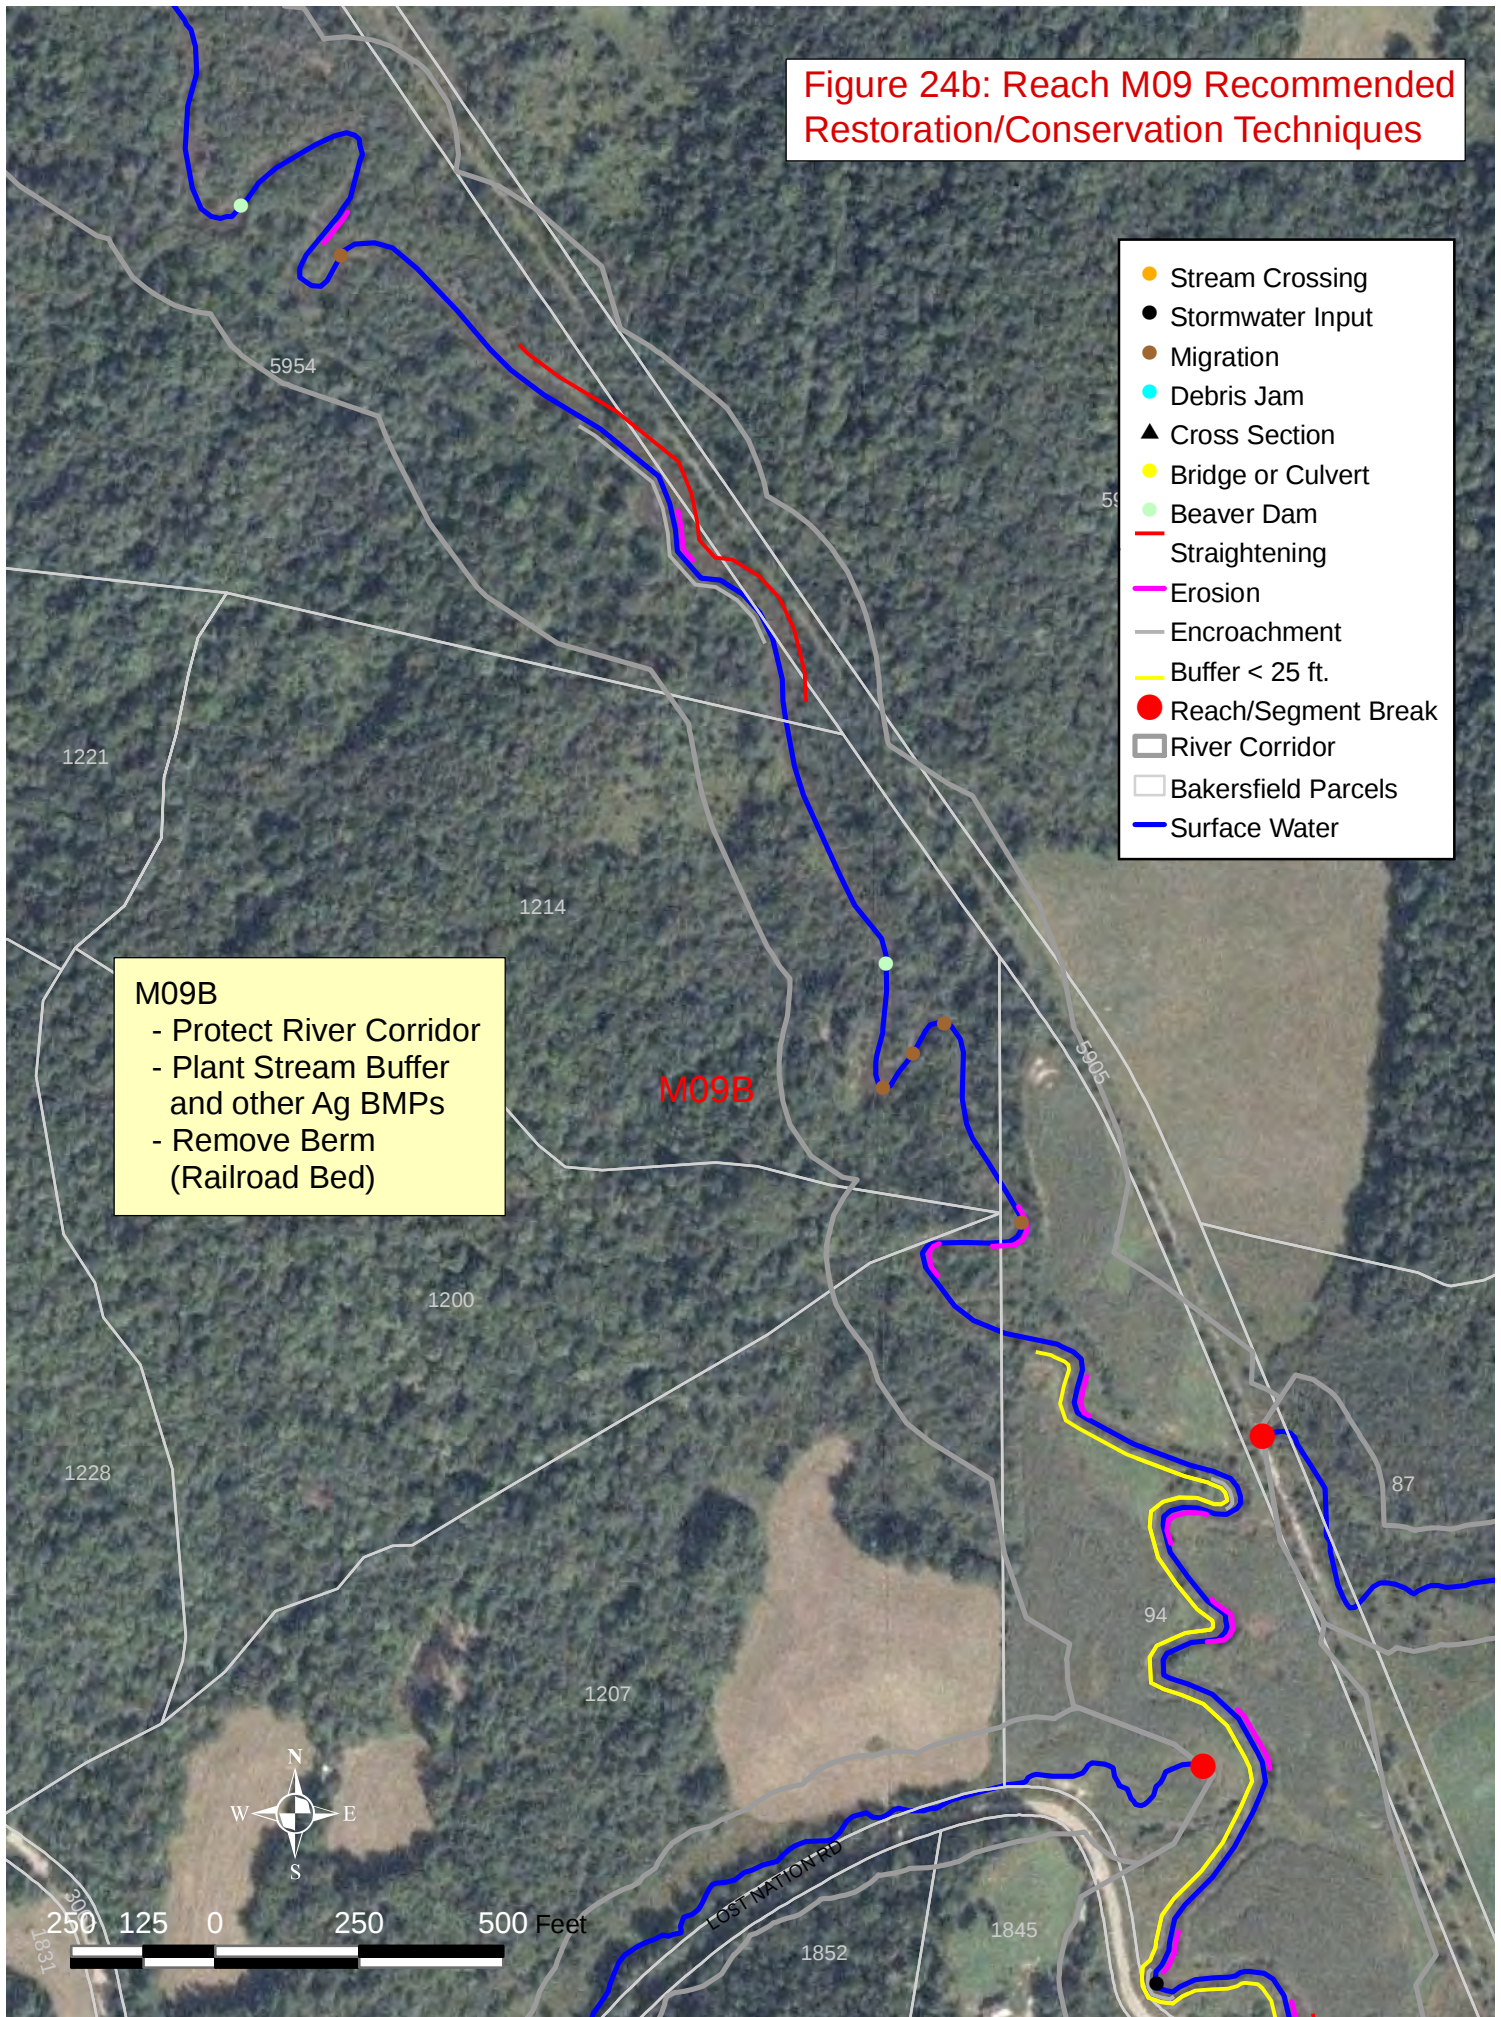
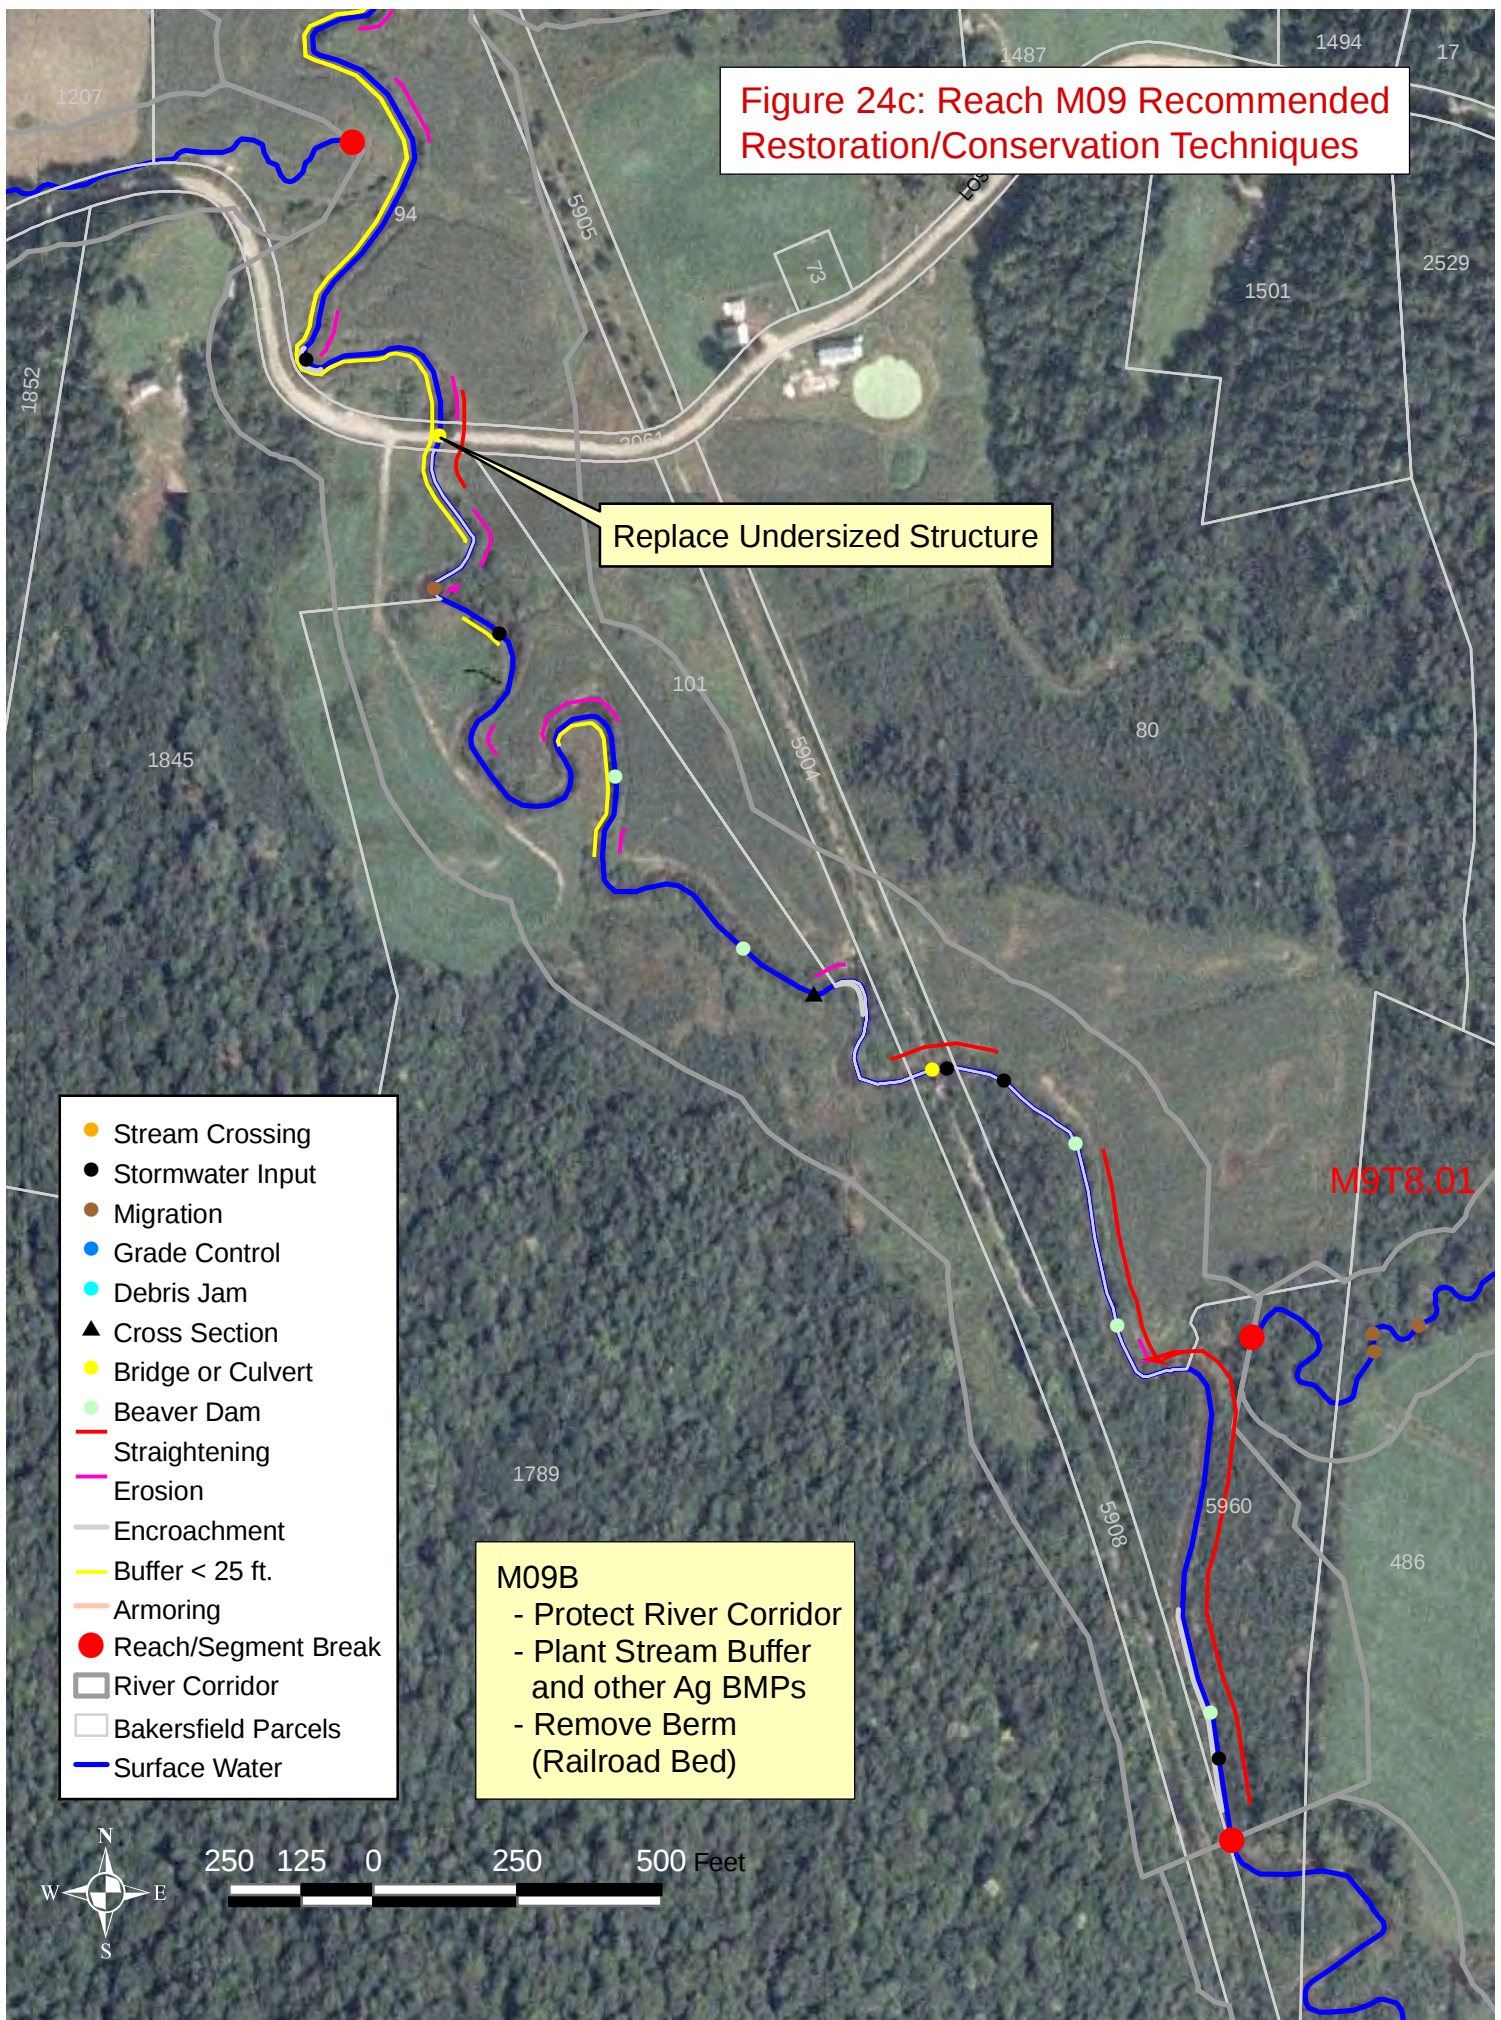
**Figure 24a: Reach M09 Recommended Restoration/Conservation Techniques**

Reach M09 extends from the upstream end of M08 upstream for approximately 2.8 miles to just south of the confluence with M9T8.01. It was segmented into two parts, M09A and M09B due to land use differences. M09A extends from the downstream end of the reach upstream for approximately 0.5 miles to Whitney Road. The segment was relatively stable with very little incision (ratio of 1.1) and minor planform adjustments. The existing stream type of E5 Dune-Ripple was consistent with its reference type. The riparian corridor was dominated by pasture with extensive erosion and little to no existing buffers. Cows were observed within the stream channel throughout the reach. The habitat assessment showed relatively poor aquatic habitat primarily due to a lack of adequate woody cover and few favorable sediment types and flow patterns.

M09B is the downstream end of the reach and extends from Whitney Road upstream for approximately 2.3 miles to just south of M9T8.01. This segment was also relatively stable with no incision or other major ongoing adjustments. The existing stream type of E5 Dune-Ripple was consistent with its reference type. The riparian corridor was dominated by a mix of forest and hay fields with little to no buffer between the fields and stream channel (though only minor erosion was noted). Multiple beaver dams were noted throughout the reach. Like much of the other main stem reaches, the abandoned rail bed runs through portions of the river corridor and represents a major floodplain constriction. The culvert crossing Lost Nation Road is severely undersized and represents a major channel and floodplain constriction.

Given the relative stable condition of M09A, the recommended remedial strategies are to protect the existing undeveloped river corridor to retain the reach's nutrient attenuation assets, and enhance the riparian buffer to increase those assets. Cattle fencing and improved stream crossing structures should also be incorporated to reduce nutrient inputs into the stream. Corridor protection and buffer enhancement are also important in Segment B. Removal or retrofitting of the railroad berm should also be done where it encroaches upon the floodplain to enhance the sediment and nutrient retention potential of the reach. The culverts that cross Lost Nation Road are

severely undersized and should be replaced with a bridge or arch to reduce flood hazards around the road. An aerial view of the reach is shown on Figures 24a, b, and c, and descriptions of the recommended projects are shown in Table 13. A prioritized list of all identified projects for the watershed is shown in Table 22.

| River Segment | Restoration/Conservation Technique | Reach Priority | Watershed Priority | Table 22 Project Number | Completed Independent of other Practices | Next Steps/Project Notes |
|---|---|---|---|---|---|---|
| M09B | Replace undersized structure - Culvert crossing Lost Nation Road highly undersized with structure to channel width of 27%. Replacement with bridge or arch would improve flow, limit flooding/erosion hazards, limit debris jam potential, and improve aquatic habitat. | Medium | High | 30 | Yes | More detailed bridge and culvert assessments needed to determine if replacement warranted. Town of Bakersfield owned structure. |
