# **Black Creek Corridor Plan**

**Franklin County  
April 2009**

Re: Black Creek Corridor Plan  
Franklin County, Vermont  
JCO Project No. 3-1313-3

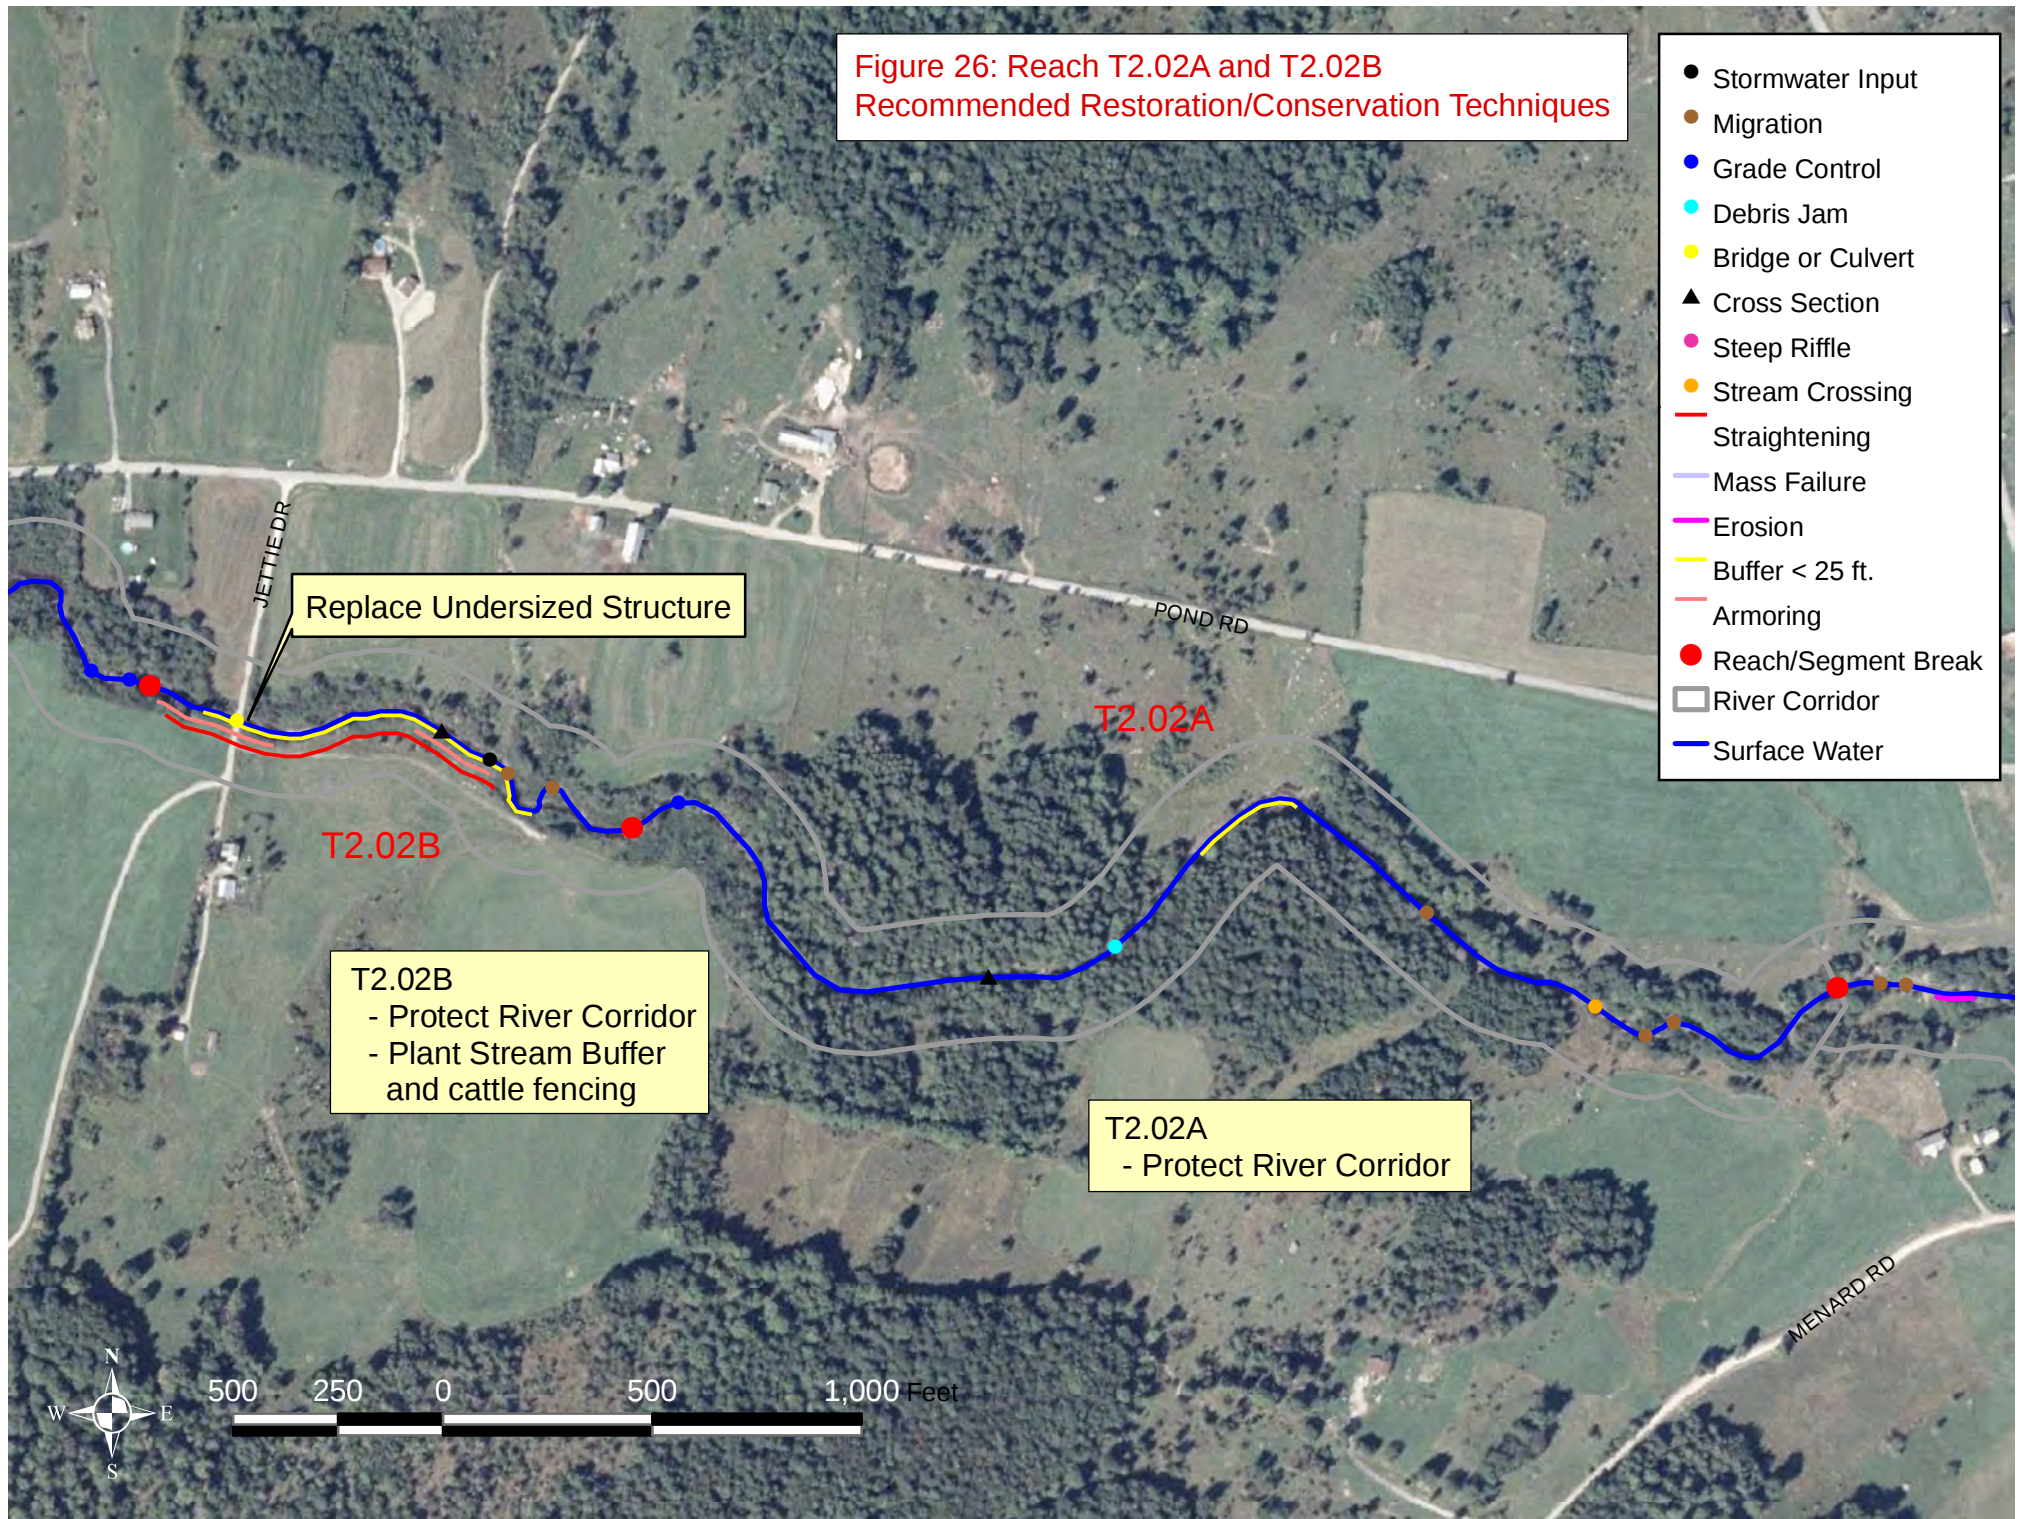
Figure 26: Reach T2.02A and T2.02B  
Recommended Restoration/Conservation Techniques

Reach T2.02 extends from the end of T2.01 upstream for approximately 1.5 miles. The reach was segmented into T2.02A, T2.02B, and T2.02C due to differences in the channel dimensions and streambank and boundary conditions. T2.02A is the downstream end of the reach and is approximately 0.7 miles long. The segment was classified as a C3 – Riffle-Pool, consistent with its reference stream type, and overall the reach was stable and in reference condition. No erosion or other adjustments were noted. The riparian corridor was dominated by forest with buffers greater than 100 feet. The habitat assessment showed excellent aquatic habitat.

T2.02B is the middle of the reach and is approximately 0.3 miles long. This segment has been historically straightened and intensely managed for agriculture. Despite this, only minor aggradation was noted and the stream still has good floodplain access. The C4-Riffle-Pool stream type was consistent with its reference type. The riparian corridor was dominated by pasture and hayfields with little to no buffer along the right bank. Cows were observed in the stream channel throughout the segment. The new bridge crossing Jettie Drive was found to be highly undersized with a structure to channel width ratio of 60%. T2.02C was dominated by beaver dams and several bedrock gorges and could not be fully assessed.

Both T2.02A and T2.02B are currently relatively stable, so the river corridor should be protected to prevent development and channel management, and retain the reaches sediment and nutrient retention functions. Buffer planting and cattle fencing are needed along the right bank in segment B to limit cows access to the stream, reduce sediment and nutrient inputs, and improve bank stability. In addition, the bridge on Jettie Drive is undersized. This appeared to be a relatively new structure so replacement in the short term is probably unlikely, though a wider structure would reduce future flood and erosion hazards and improve the flow regime of the stream. Table 15 and Figure 26 below describe and show the locations of the recommended projects. A prioritized list of all identified projects for the watershed is shown in Table 22.

| River Segment | Restoration/Conservation Technique | Reach Priority | Watershed Priority | Table 22 Project Number | Completed Independent of other Practices | Next Steps/Project Notes |
|---|---|---|---|---|---|---|
| T2.02B | Replace undersized structure - Bridge crossing Jettie Drive undersized with structure to channel width of 60%. Replacement with wider structure to improve flow, limit flooding/erosion hazards, limit debris jam potential, and improve aquatic habitat. | Medium | Medium | 38 | Yes | More detailed bridge and culvert assessments needed to determine if replacement warranted. Town of Fairfield owned structure. |

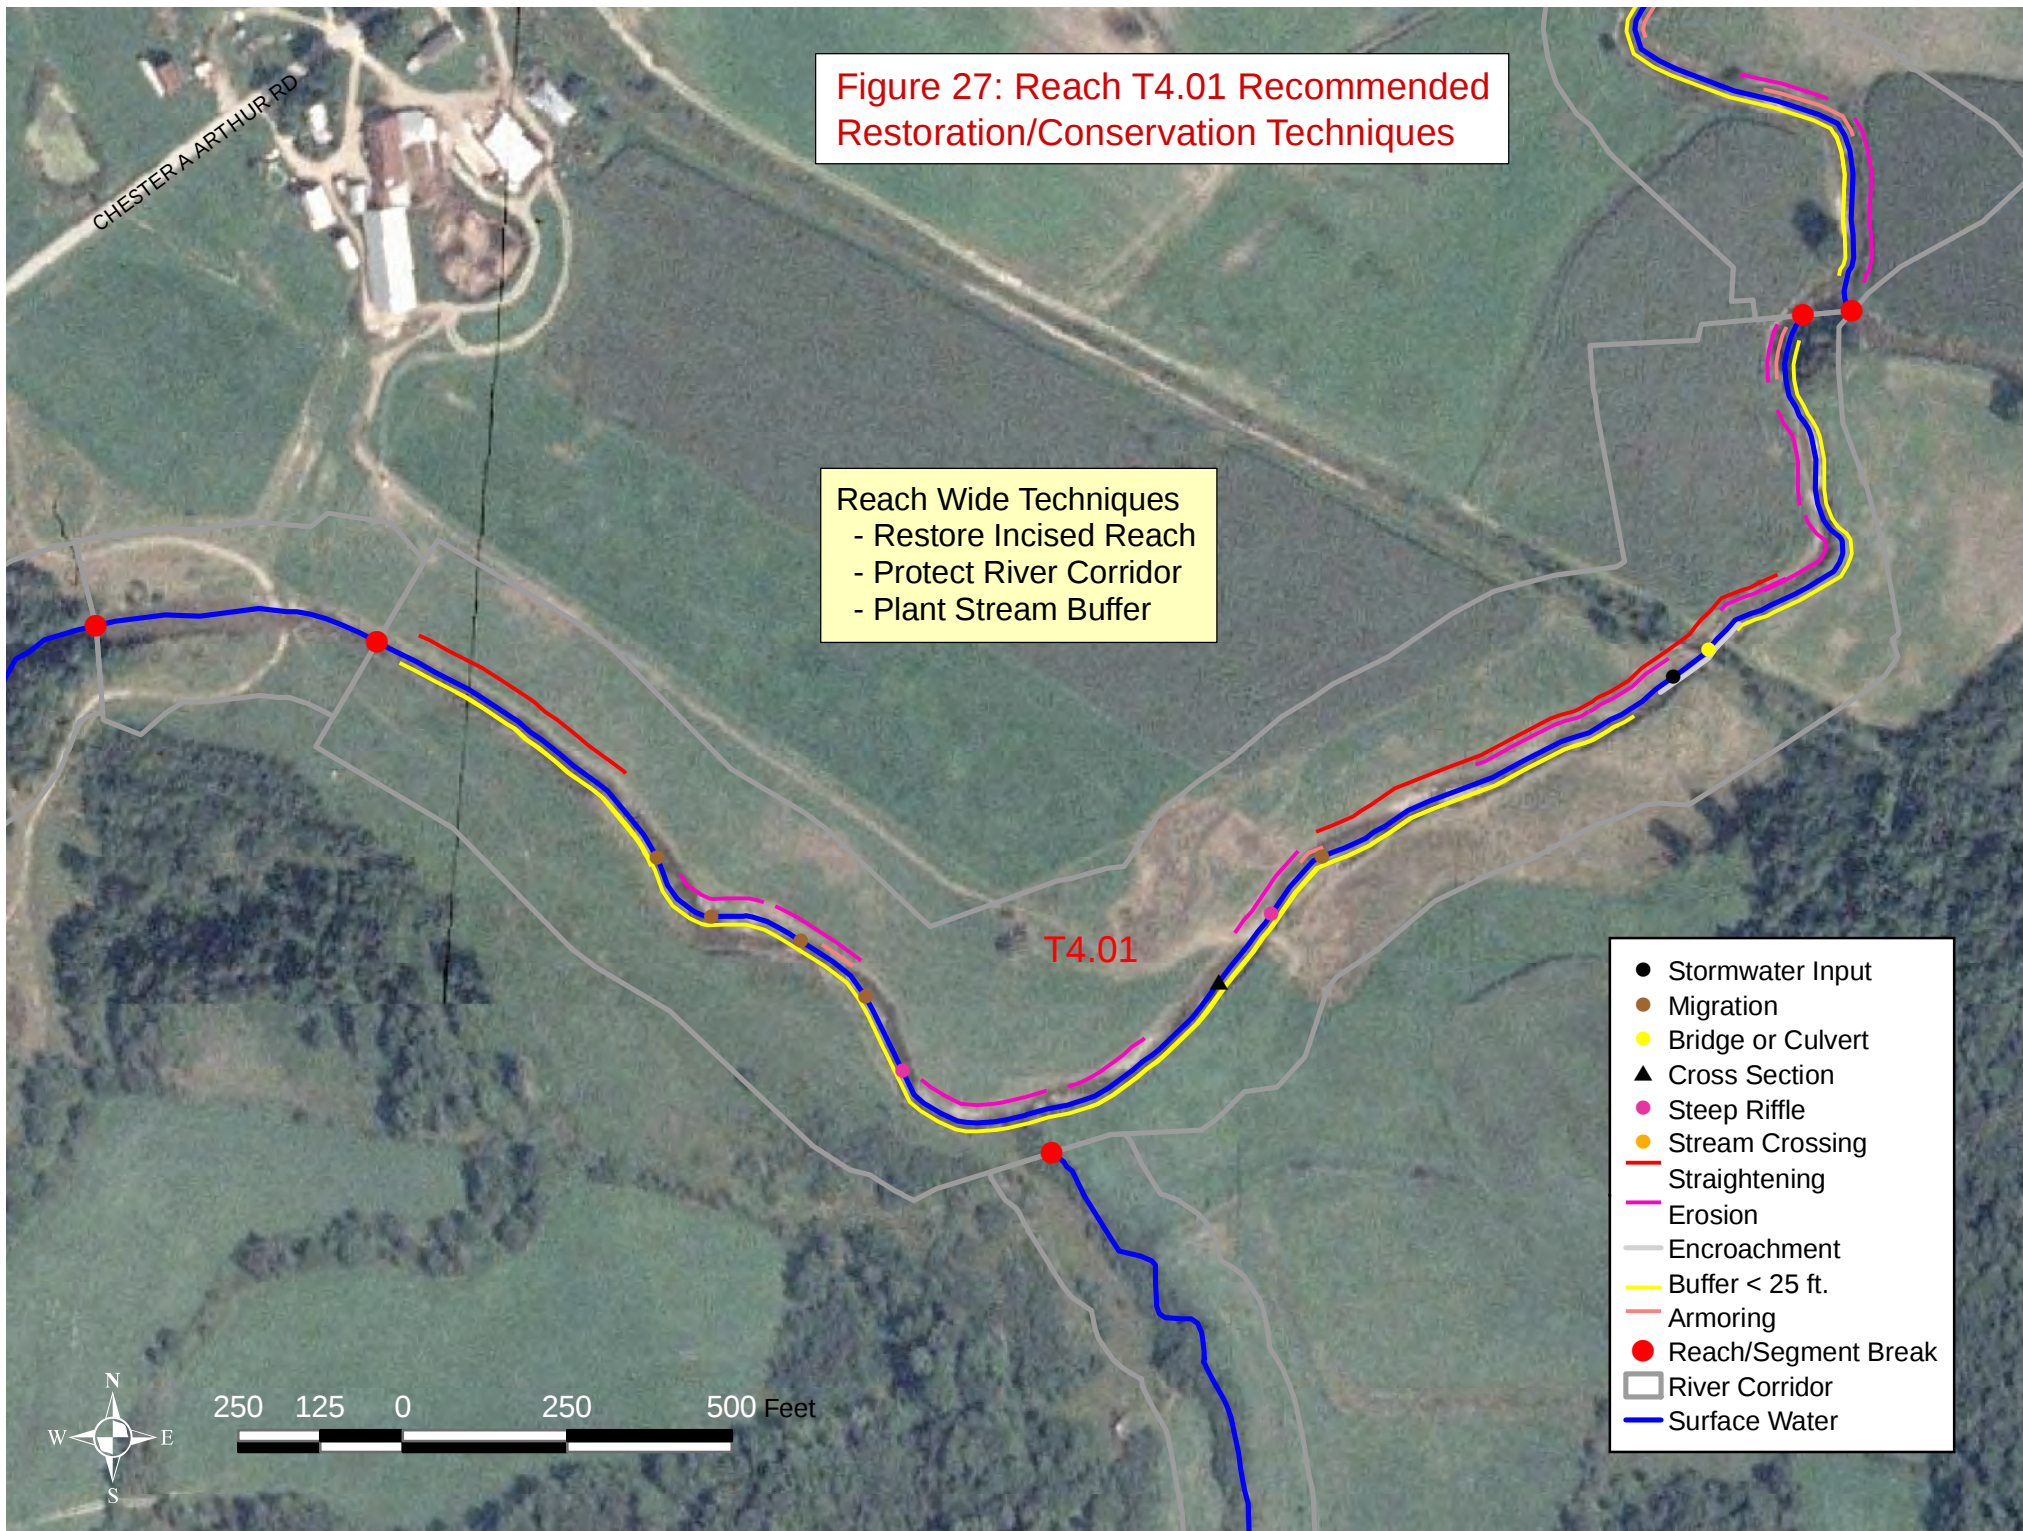
Figure 27: Reach T4.01 Recommended Restoration/Conservation Techniques

Reach T4.01 extends from its confluence with Black Creek upstream for approximately 0.6 miles to where the valley becomes narrower and steeper. This reach was found to be highly incised with an incision ratio of 1.8 due to historic straightening, extensive agricultural activities, and other channel management techniques, and has only limited floodplain access. Despite the incision, the phase 2 stream type of C4 – Plane bed was consistent with its reference type, though it lacked the expected riffle pool sequences common with C type streams. Extensive erosion was noted along both banks as the stream attempts to widen and create new floodplain access at a

lower elevation (channel evolution stage III). The riparian corridor was dominated by a mix of pasture and hay fields with little to no buffer. The habitat assessment showed relatively poor aquatic habitat due to a lack of woody cover, channel alterations, and very few favorable sediment types and flow patterns. The bridge crossing the abandoned rail bed located at

| Project # (Figure #) | Project Type | Reach/Segment Condition-Sensitivity | Site Description including Stressors and Constraints | Project or Strategy Description | Technical Feasibility & Priority | Other Social Benefits | Cost | Land Use Conversion & Landowner Commitment | Potential Partner Commitments |
|---|---|---|---|---|---|---|---|---|---|
| 13 (27) | Buffer Enhancement and other BMPs | T4.01 - Fair - Very High | Segment highly incised (1.8), but otherwise relatively stable. Corridor dominated by hay and pasture with large areas of little to no buffer. Ideally combined with active floodplain restoration (project #39) to restore floodplain access and reduce future erosion hazards. | Tree/buffer planting project to reduce nutrient inputs, buffers needed along field ditches as well. | Feasible; medium watershed priority | Wildlife habitat improvement, possible demonstration project for other reaches, reduce nutrient inputs, improve water quality | Planting design and installation, possible CREP payments | hay and pasture to buffer | VT RMP, NRCS, F&W, MRBA |

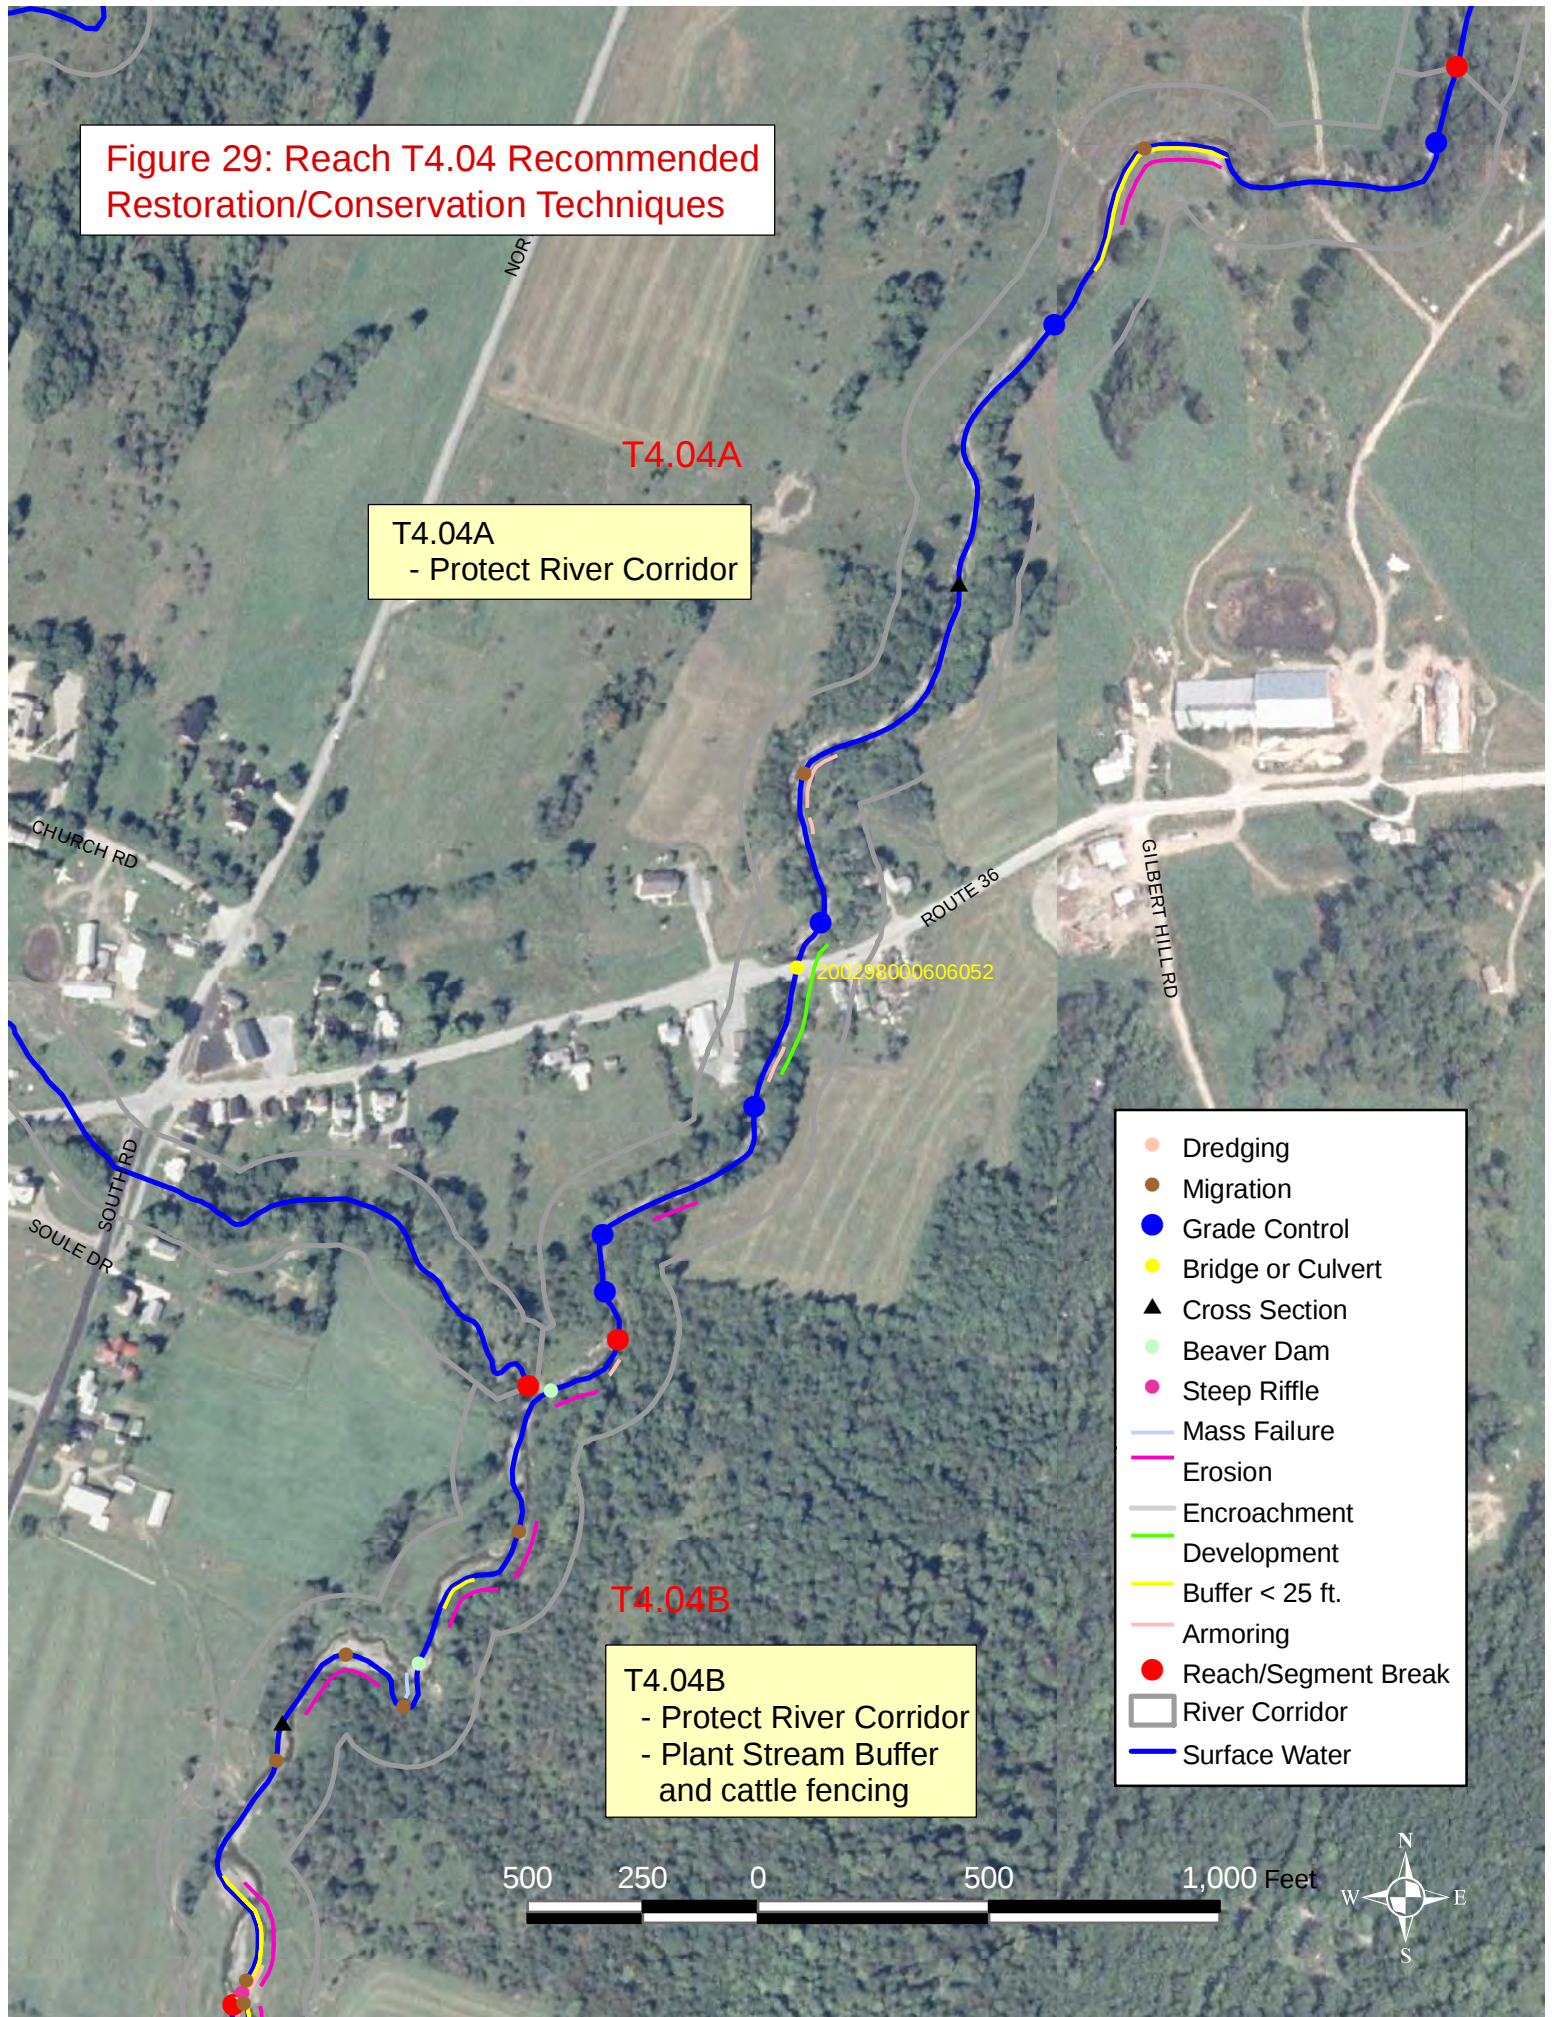
Figure 29: Reach T4.04 Recommended Restoration/Conservation Techniques

Reach T4.04 extends from the upstream end of T4.03 upstream for approximately 1.3 miles. The reach was segmented into two parts, T4.04A and T4.04B, due to differences in valley width and slope. T4.04A is the downstream end of the reach and is approximately 0.8 miles long. It is located in a naturally narrow, steeper portion of the valley, and is characterized as a B4-step-pool stream type, consistent with its reference type. Overall, the reach was relatively stable with no incision or other adjustment processes noted. Several bedrock grade controls and gorges were noted throughout the reach. The riparian corridor was dominated by a mix of pasture, hay, and forest with narrow buffer widths ranging from 25 to 100 feet. A few areas of inadequate buffer were noted, though tree plantings had recently been done to address these areas. The bridge crossing Route 36 was found to be adequately sized with a structure to channel width ratio of 165%.

T4.04B is the upstream portion of the reach and is approximately 0.5 miles long. It was moderately incised (ratio of 1.4) with active widening and aggradation (channel evolution stage III). This segment is located in a broader, shallower portion of the valley and was classified as a C4 – riffle-pool stream, consistent with its reference type. Moderate bank erosion was noted on the outside of meander bends and cows were noted in the stream channel in the upper portion of the segment. The riparian corridor was dominated by forest on the right and a mix of hay and pasture on the left with buffers ranging from 0 to 50 feet.

Given the location of T4.04 and relative stability, there are no recommended projects. The reach is currently stable and undeveloped. This should be maintained through corridor protection, though because this reach is naturally a transport type environment, preference should be given to protecting those areas in other reaches that can improve or retain needed sediment and nutrient retention. T4.04B is less stable and naturally a sediment and nutrient attenuation zone, so protecting the river corridor here is more important than downstream. Segment B is moderately incised and in the process of widening and aggrading to re-establish floodplain

connection. The existing undeveloped corridor should be protected to allow these functions to continue. In addition, buffers should be established between the hay and pasture on the left bank and the stream channel. Fencing is needed in the pasture to limit the cows access to the stream channel. An aerial view of the reach is shown on Figure 29, and descriptions of the recommended projects are shown in Table 18. A prioritized list of all identified projects for the watershed is shown in Table 22.

| River Segment | Restoration/Conservation Technique | Reach Priority | Watershed Priority | Table 22 Project Number | Completed Independent of other Practices | Next Steps/Project Notes |
|---|---|---|---|---|---|---|
| T4.04B | Plant Stream Buffer and cattle fencing - Majority of river corridor dominated by hay and pasture on left with ~800 feet of buffers less than 25 feet. Cows in stream in upstream portion of segment, fencing needed to reduce erosion and limit nutrient inputs. | High | Medium | 20 | Yes | Landowner cooperation required. Could be CREP eligible |

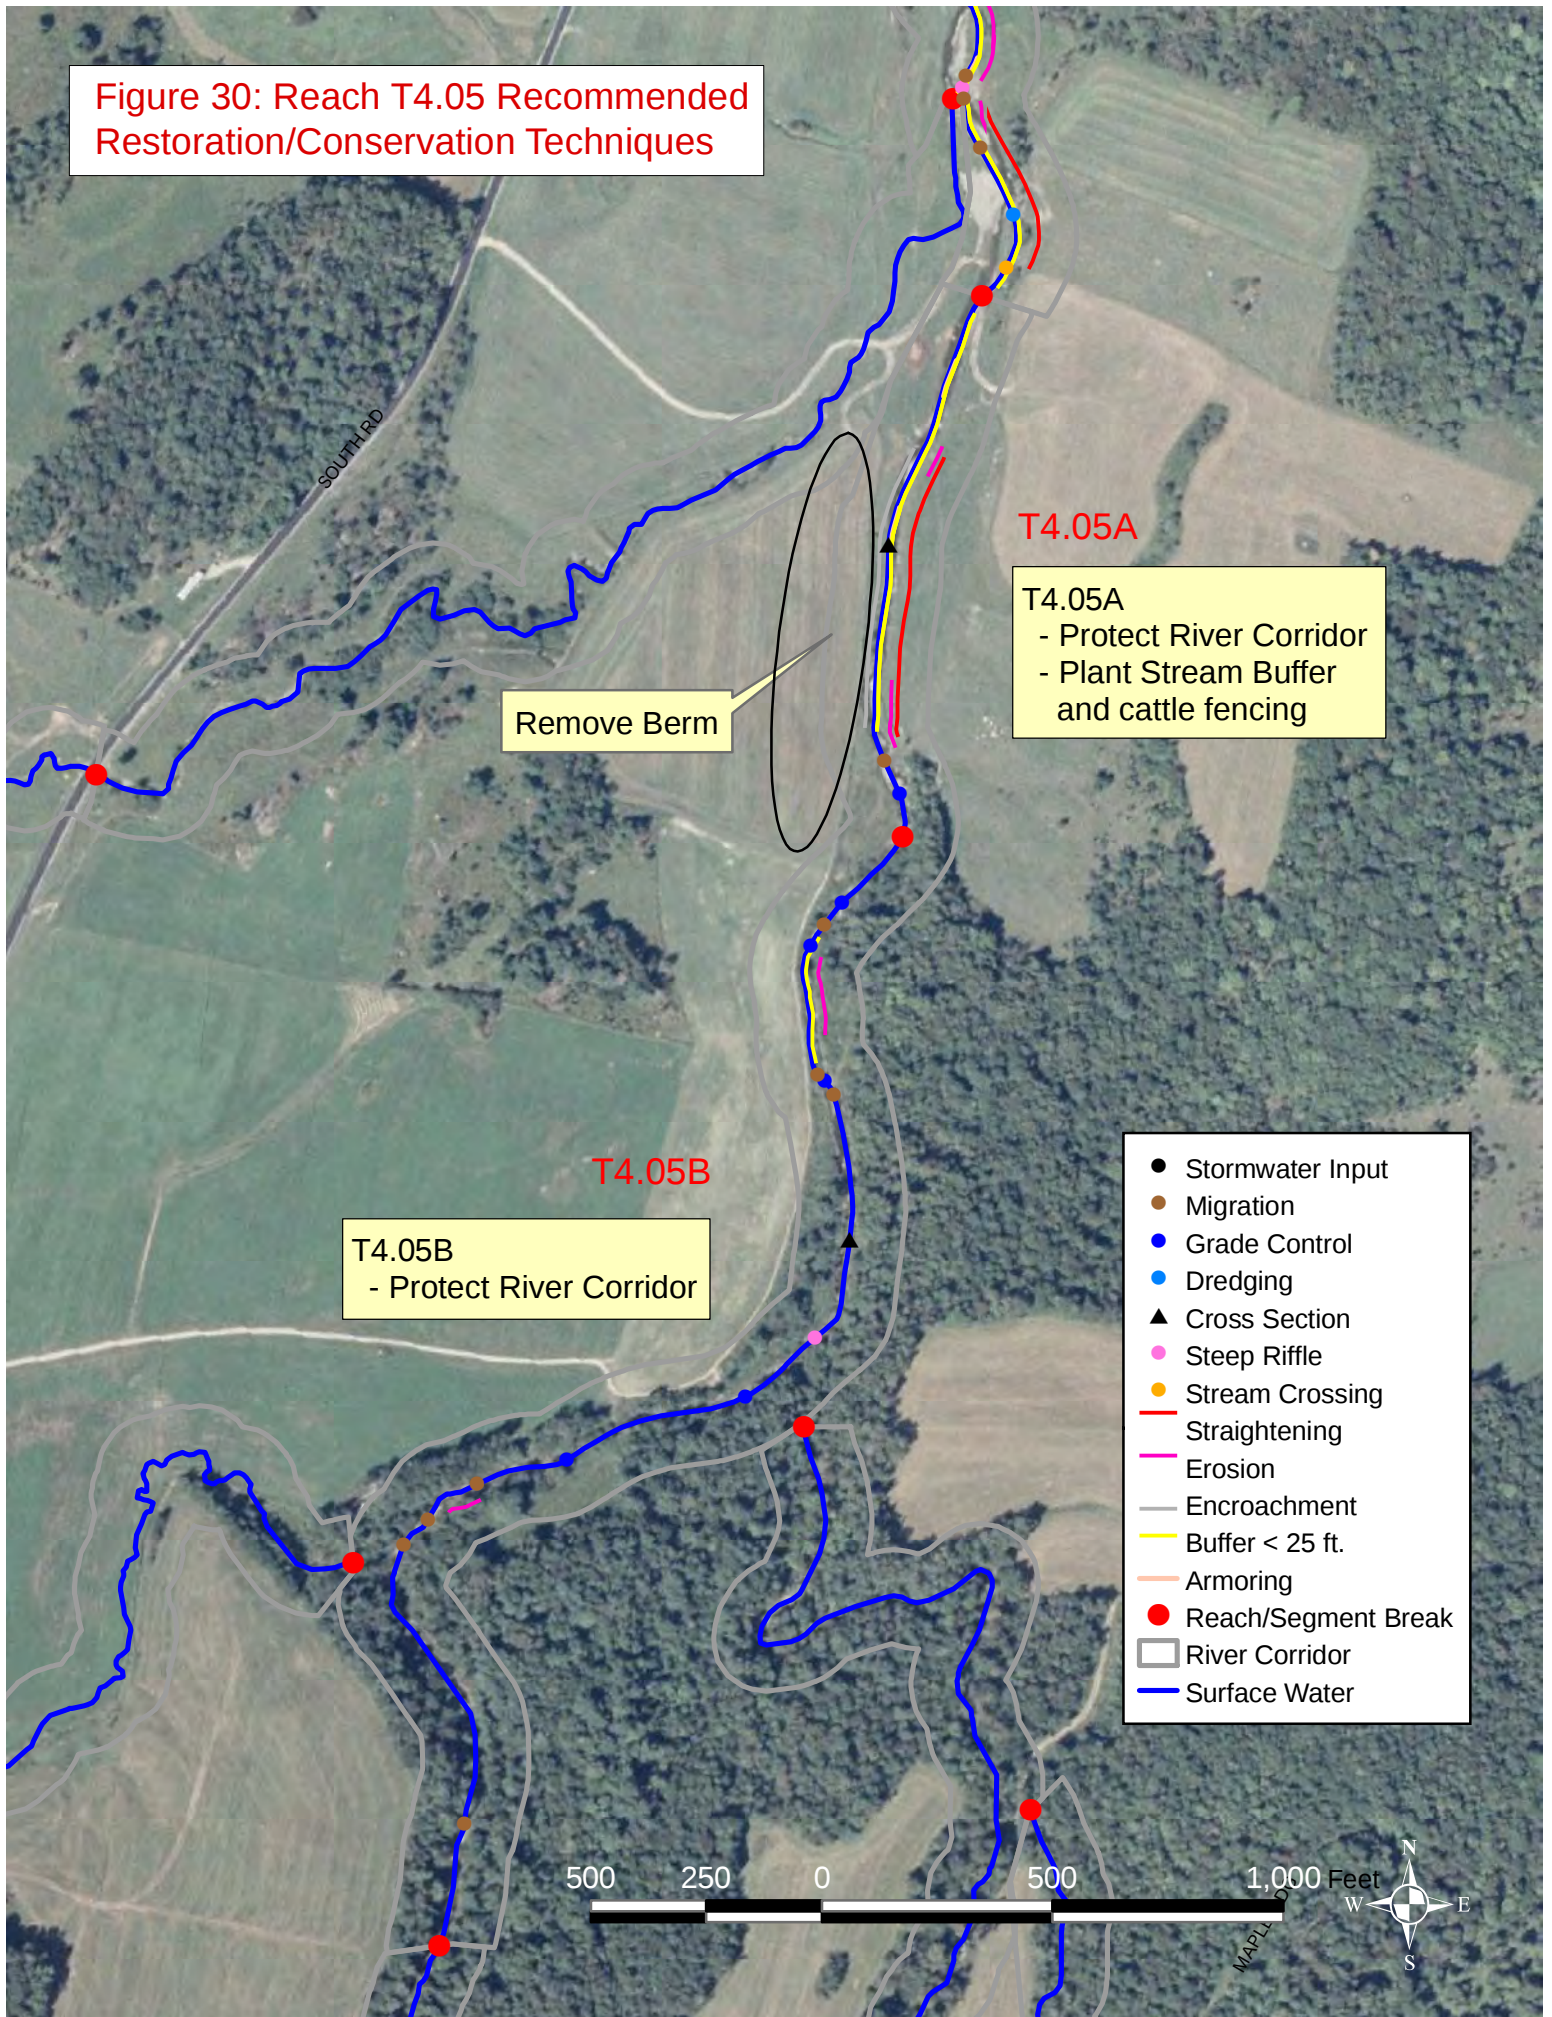
Figure 30: Reach T4.05 Recommended Restoration/Conservation Techniques

Reach T4.05 extends from the end of T4.04 upstream for approximately 0.8 miles. The Reach was segmented into T4.05A and T4.05B due to differences in valley width and corridor land use. T4.05A is the downstream portion of the reach and is approximately 0.25 miles long. It was moderately incised (ratio of 1.4) with minor widening and planform adjustments (channel evolution stage IV). The existing stream type (C4 – plane-bed) was consistent with its reference type, but lacked distinct riffles and pools as would be expected with this type of system. The riparian corridor was dominated by a mix of corn and pasture with little to no buffers. Cows were observed in the stream channel throughout the segment. A small berm runs along the left bank for approximately 600 feet, protecting the adjacent cornfield from flooding.

T4.05B was less developed and located in a narrow portion of the valley. It was relatively stable with no major adjustments noted. The riparian corridor was dominated by forest and shrub/sapling. Several bedrock grade controls were observed scattered throughout the reach.

Recommended project types for segment A include river corridor protection, buffer planting and fencing, and removal of the berm along the left bank. The stream is currently moderately incised, but still has floodplain access during most high flow events. The existing river corridor should be protected to retain the sediment and nutrient retention capacity of this area. Removal of the berm along the left side would enhance these functions. To reduce nutrient inputs and improve aquatic habitat, buffers should be established along with fencing to limit the cows' access to the stream channel. Segment B is relatively stable with little ongoing adjustments. This should be maintained through corridor protection, though because this reach is naturally a transport type environment, preference should be given to protecting those areas in other reaches that can improve or retain needed sediment and nutrient retention. Table 19 and Figure 30 below describe and show the locations of the recommended projects. A prioritized list of all identified projects for the watershed is shown in Table 22.

| River Segment | Restoration/Conservation Technique | Reach Priority | Watershed Priority | Table 22 Project Number | Completed Independent of other Practices | Next Steps/Project Notes |
|---|---|---|---|---|---|---|
| T4.05B | Protect River Corridor - Reach is mostly undeveloped forest. Reach stable with little adjustments. Reach located in narrow, steeper portion of valley acts a transport system. Corridor protection less important here than in attenuation areas. | Low | Low | 67 | Yes | Landowner cooperation |

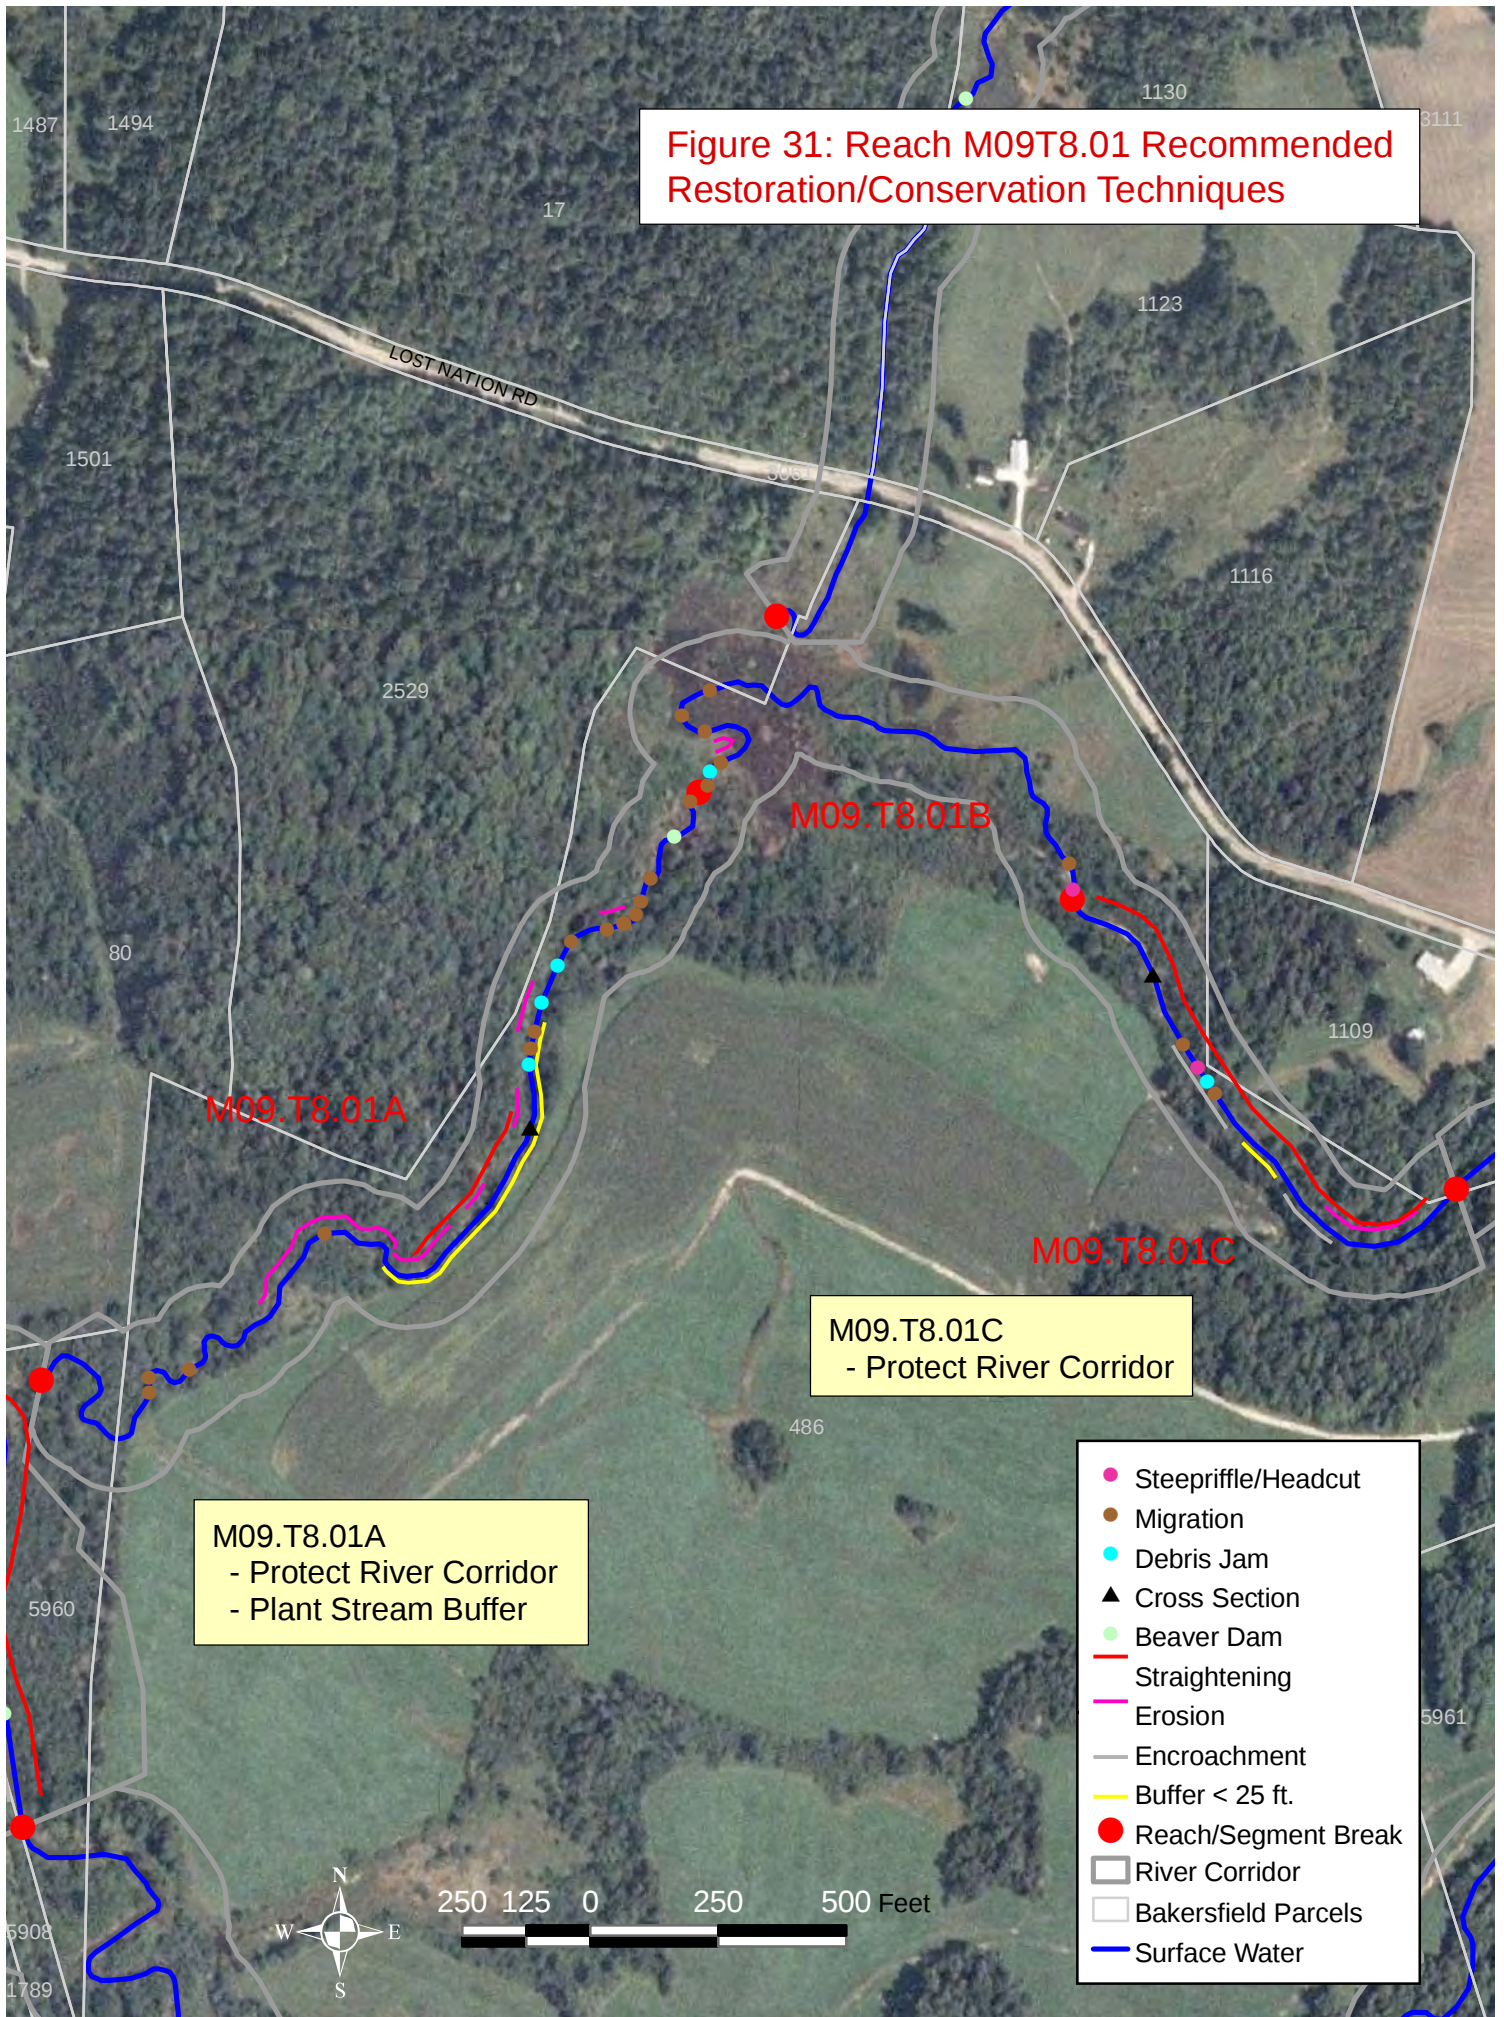
Figure 31: Reach M09T8.01 Recommended Restoration/Conservation Techniques

Reach M9T8.01 extends from its confluence with Black Creek in M09 upstream for approximately one mile. The reach was segmented into M9T8.01A, M9T8.01B, and M9T8.01C based on channel dimensions and the presence of grade controls. M9T8.01A is the downstream portion of the reach and is approximately 0.5 miles long. It was not incised (ratio of 1.0) and generally stable with minor planform adjustments (channel evolution stage I). The riparian corridor was dominated by forest on the right and a mix of hay and corn on the left. Approximately 600 feet along the left bank had inadequate buffers of less than 25 feet. The existing stream type (C4) was consistent with its reference type.

Given the current relatively stable condition of M9T8.01, the recommended project types include corridor protection and buffer enhancement. The reach serves as important sediment and nutrient attenuation and wildlife habitat area. Corridor protection is needed to retain these assets. Buffer enhancement is needed in segment A where approximately 600 feet along the right bank has little to no buffer between the stream channel and the corn field. An aerial view of the reach is shown on Figure 31, and descriptions of the recommended projects are shown in Table 20. A prioritized list of all identified projects for the watershed is shown in Table 22.

| River Segment | Restoration/Conservation Technique | Reach Priority | Watershed Priority | Table 22 Project Number | Completed Independent of other Practices | Next Steps/Project Notes |
|---|---|---|---|---|---|---|
| M9T8.01C | Protect River Corridor - Reach is mostly undeveloped forest. Reach stable with little adjustments. Corridor protection needed to retain attenuation assets. | Low | Low | 63 | Yes | Landowner cooperation |
