# **Black Creek Corridor Plan**

**Franklin County  
April 2009**

Re: Black Creek Corridor Plan  
Franklin County, Vermont  
JCO Project No. 3-1313-3

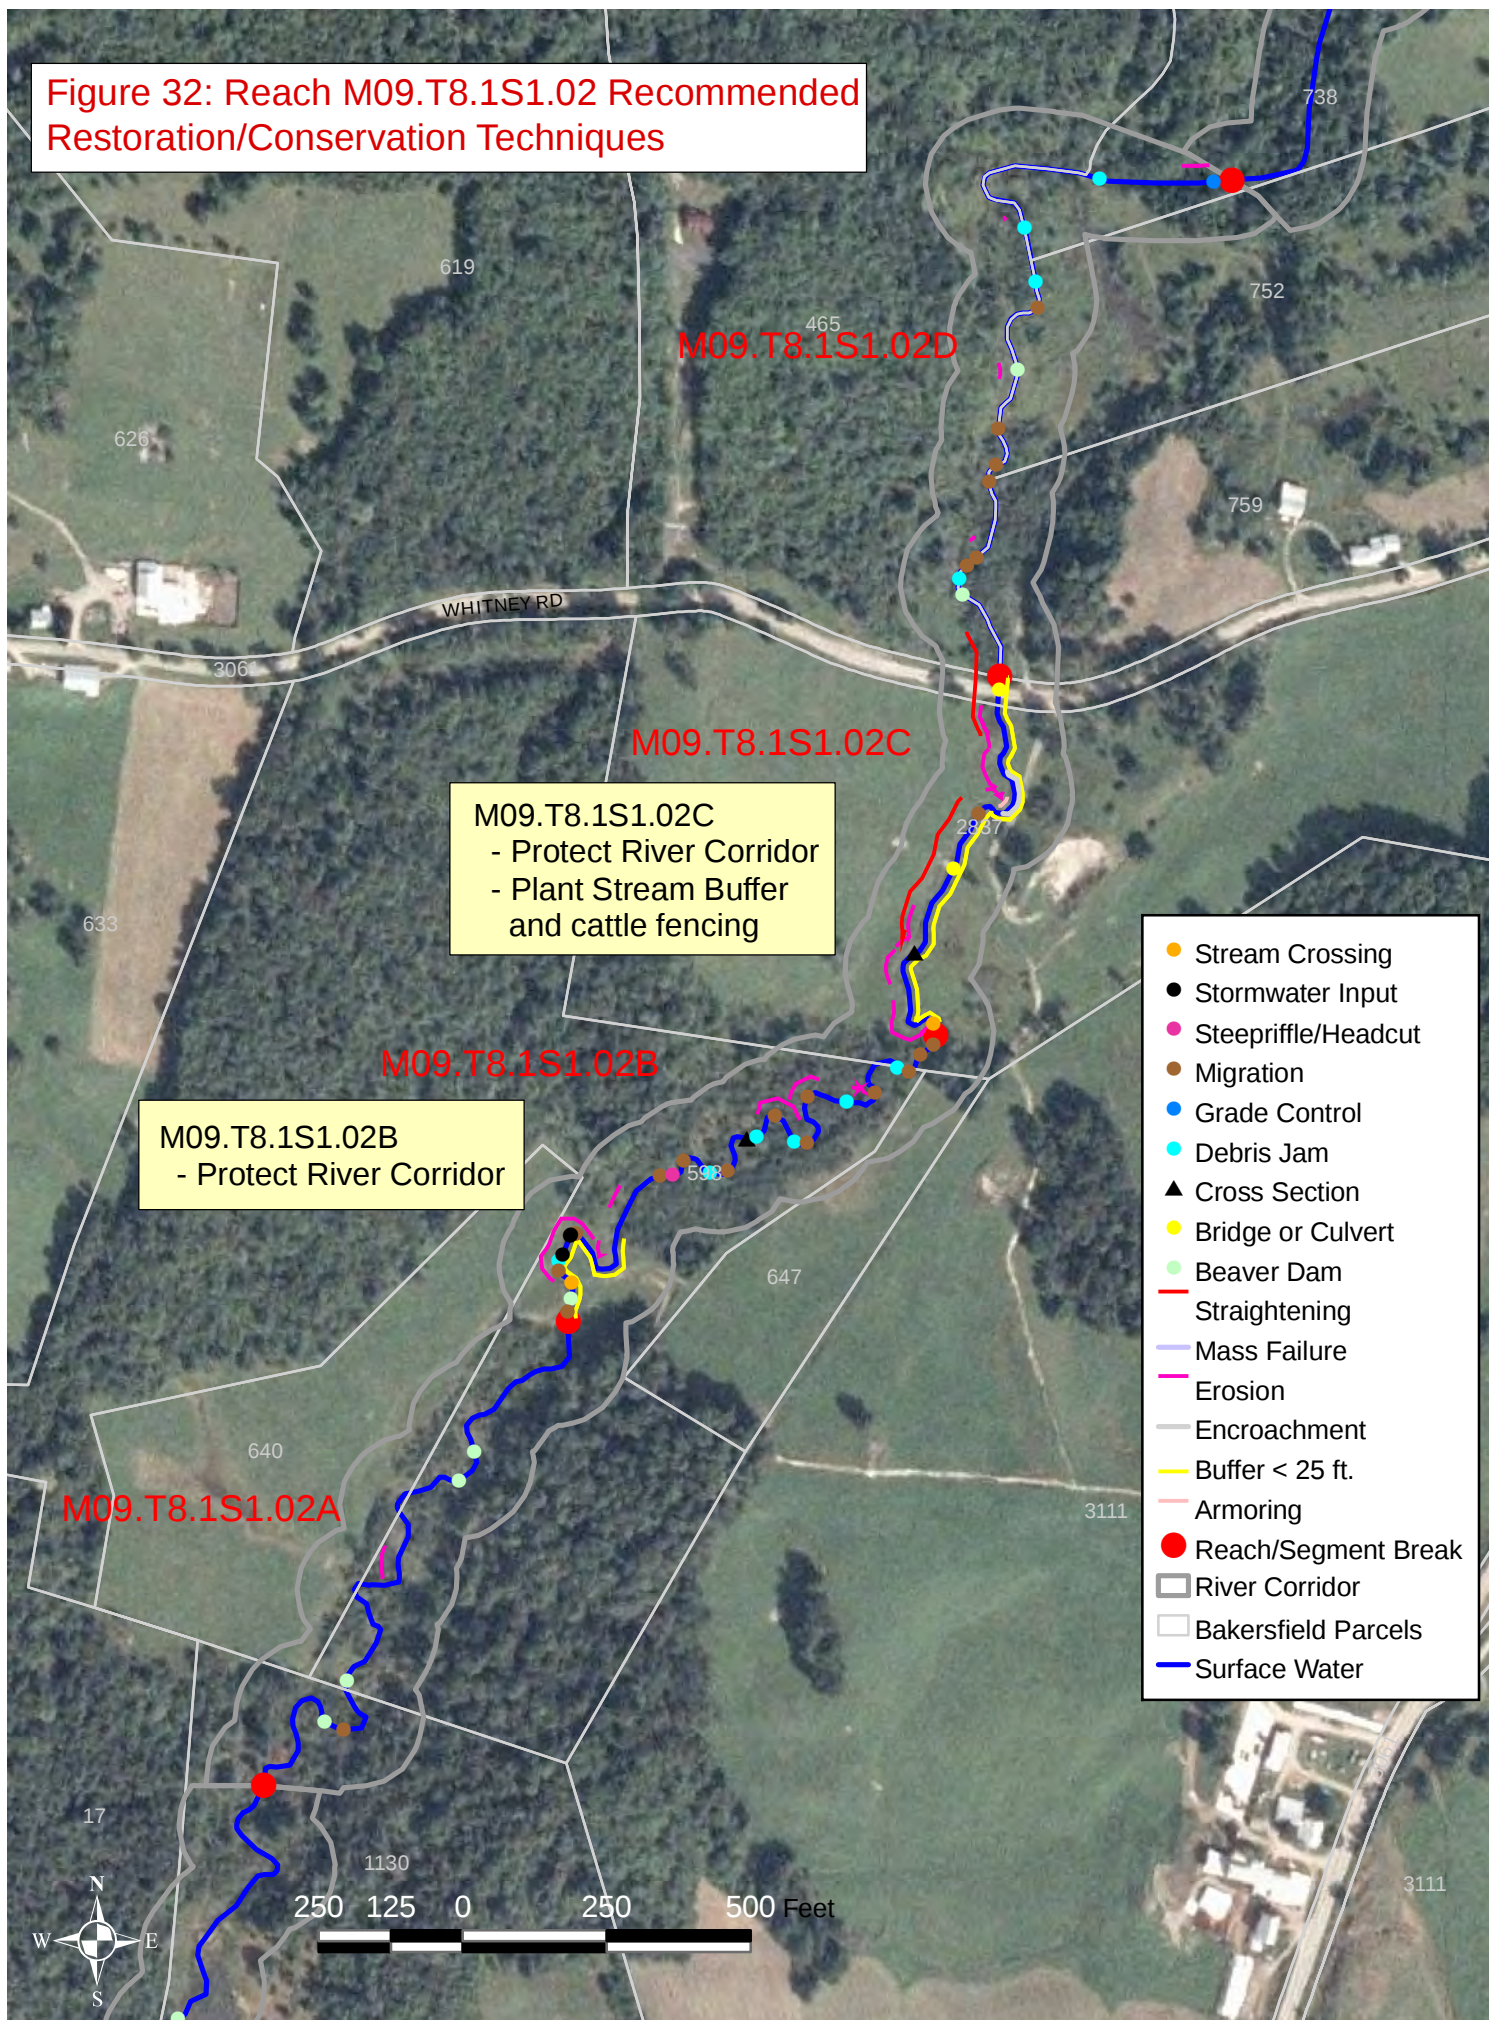
**Figure 32: Reach M09.T8.1S1.02 Recommended Restoration/Conservation Techniques**

Reach M9T8.1S1.02 extends from the end of M9T8.1S1.01 upstream for approximately 1 mile. The reach was segmented into four parts, segments A, B, C, and D due to differences in corridor land use and presence of bedrock grade controls. Segment A was not fully assessed, as was the case with M9T8.1S1.01, due to significant beaver activity and multiple bedrock grade controls. Segment B was found to be relatively stable, despite slight incision (ratio of 1.2). Its C4-riffle-pool stream type was consistent with its reference type. Several bedrock grade controls and waterfalls were noted throughout the reach. The riparian corridor was dominated by forest. M9T8.1S1.02C extends from the end of segment B upstream to just above the culvert on Whitney Road. This segment was also relatively stable with no major adjustment processes, despite significant impacts related to agricultural activity. The riparian corridor was dominated by pasture with no fencing or buffers present. Cows were observed in the stream channel throughout the segment. The culvert crossing Whitney Road was significantly undersized with a structure to channel width ratio of 25%. Segment D was not assessed due to significant beaver activity and multiple bedrock grade controls and waterfalls.

Given the current relatively stable condition of this reach, the recommended project types include corridor protection and buffer enhancement. The reach serves as important sediment and nutrient attenuation and wildlife habitat areas. Corridor protection is needed to retain these assets. Buffer enhancement and fencing is needed in segment C where approximately 800 feet along both banks have little to no buffer or fencing to limit the cows access to the stream channel. Two undersized culverts were also noted in the area. The first is in reach M9T8.1S1.01, which was not fully assessed due to extensive beaver activity. The culvert crossing Lost Nation Road is severely undersized with a structure to channel width ratio of 60%. The culvert on Whitney Road in M9T8.1S1.02C is also undersized with a structure to channel width ratio of 25%. An aerial view of the reach is shown on Figure 32, and descriptions of the recommended projects are shown in Table 21. A prioritized list of all identified projects for the watershed is shown in Table 22.

| River Segment | Restoration/Conservation Technique | Reach Priority | Watershed Priority | Table 22 Project Number | Completed Independent of other Practices | Next Steps/Project Notes |
|---|---|---|---|---|---|---|
| M9T8.1S1.02C | Replace undersized structure - Culvert crossing Whitney Road highly undersized with structure to channel width of 25%. Replacement with bridge or arch would improve flow, limit flooding/erosion hazards, limit debris jam potential, and improve aquatic habitat | Medium | High | 31 | Yes | More detailed bridge and culvert assessments needed to determine if replacement warranted. Town of Sheldon owned structure. |
