# **Phase 2 Stream Geomorphic Assessment**

**Trout River Watershed  
Towns of Berkshire, Enosburg, Richford, and Montgomery  
Franklin County, Vermont**

**April 2007**

Re: Phase 2 Stream Geomorphic Assessment  
Trout River Watershed  
Franklin County, Vermont  
JCO Project No. 3-1313-2

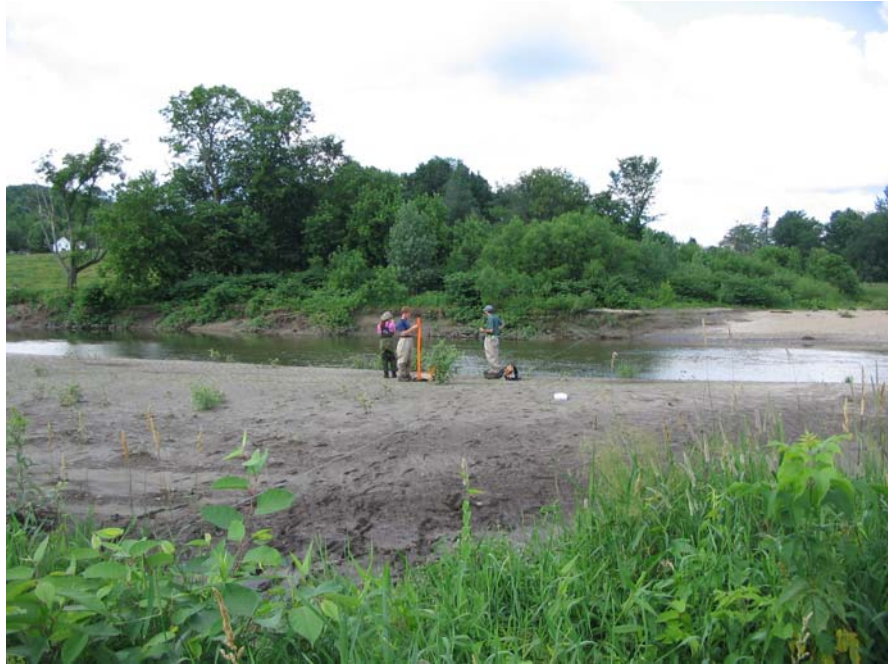
**Figure 1: M01 Cross Section.**

Given the current adjustment processes and boundary conditions, no large scale restoration projects have been identified within this reach. It is likely that the reach may continue to widen slightly in some areas, and the aggradational processes will continue to re-establish floodplain connection. Attempts should be made to limit channel management in these areas to allow the channel to move toward geomorphic equilibrium. There are a few areas along

the reach where buffers could be widened to improve wildlife habitat and increase resistance to erosion. As with all of the studied reaches, future human encroachments within the river corridor should be avoided to prevent potential flooding and erosion hazards.

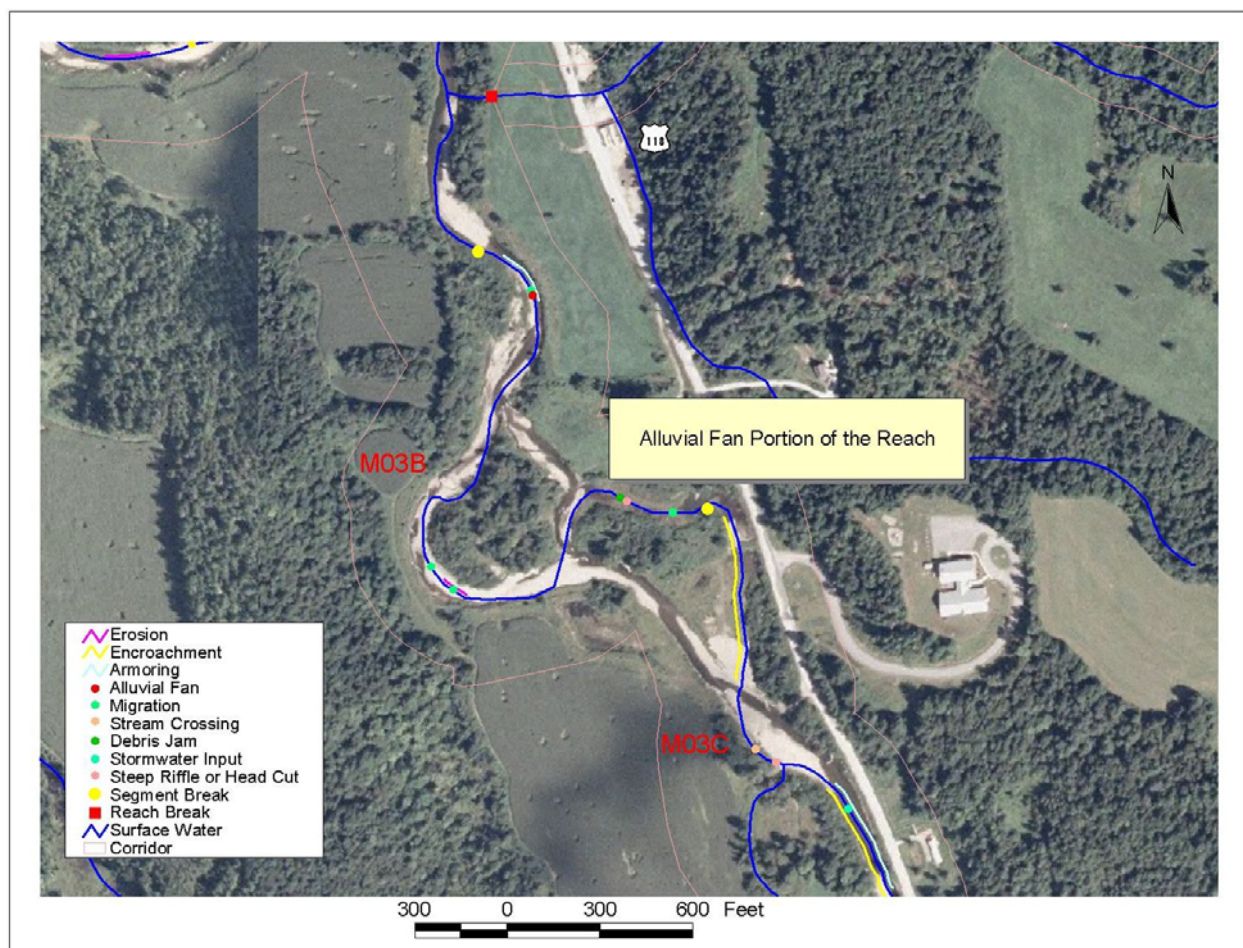
**Figure 5: M03B and C**

Reach M03 extends from the confluence with Black Falls Brook upstream to just north of Montgomery Center. The reach was segmented into three parts, M03A, M03B, and M03C. M03A and C were very similar and found to be in regime with their reference Phase 1 stream type of C-gravel, riffle-pool. Segment B is located in the southern portion of the reach and was found to be a braided D-type channel. The segment was characterized as an alluvial fan where the valley widens, and the river slows down as it comes out of the steeper valley above and drops out a great deal of sediment. This area is inherently unstable with an extreme sensitivity value, and saw a great deal of adjustments during the 1997 flood event. The Trout River Restoration Project was completed here by VT ANR in 2000, to restore some of the damage done during 1997. The work of the restoration project succeeded in moving this unstable section of stream away from the road and other vulnerable infrastructure to an area where it could naturally move around without causing further structural damage. All three segments were found to be in evolution stage III, with aggradation and widening to be the dominant adjustment processes. All three segments were found to be slightly incised, though they still have some access to their floodplain during high flow events. A few minor areas of erosion were noted throughout the reach, though most of the eroding banks have been rip-rapped. The riparian corridor was dominated by agricultural lands with sparse residential properties scattered along Route 118, which runs along the northern and eastern portions of the river corridor.

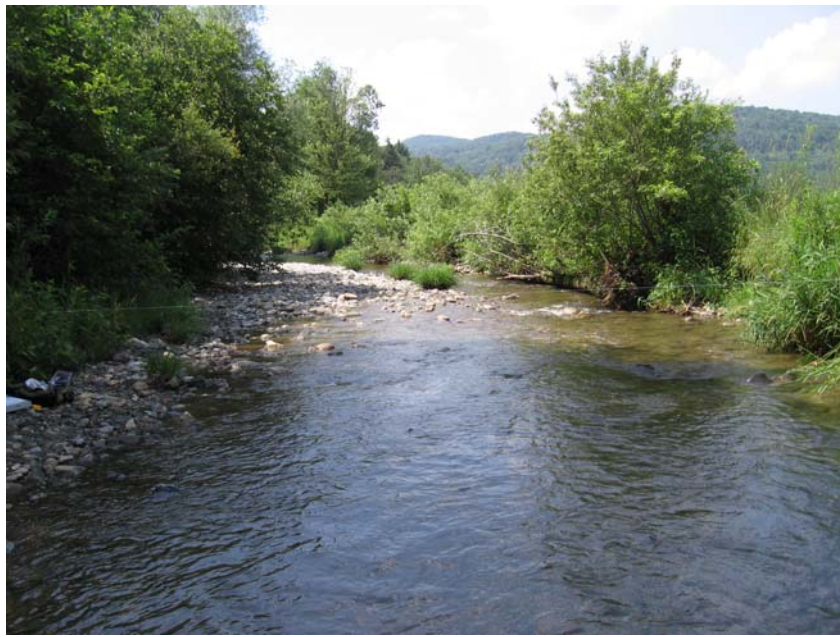
**Figure 8: Cross Section location T1-01**

Reach T1-01 is the downstream end of Alder Brook, the first major tributary of the Trout River. This reach extends from the confluence with the Trout just upstream of Hopkins Bridge Road to approximately 1 mile upstream where the valley narrows and the stream channel steepens. The reach was found to be in regime with its Phase 1 reference type (C-gravel, riffle pool) and the dominant adjustment processes were minor aggradation and widening, placing the stream in evolution stage III with a high sensitivity rating. The habitat and geomorphic scores

were 0.7 and 0.72 respectively, both in the “good” range. With an incision ratio of 1.2, the stream still has access to most of its historic floodplain. Some minor planform adjustments in the form of enlarged bars and a future potential neck cut-off were observed at the downstream end of the reach near the confluence with the Trout River. The riparian corridor was dominated by hay and pasture on the right and forest on the left. Buffer widths ranged from 5 feet to >100 feet. Overall the reach appeared relatively stable with no major problem areas noted. No large scale restoration and/or conservation projects were identified for this reach.

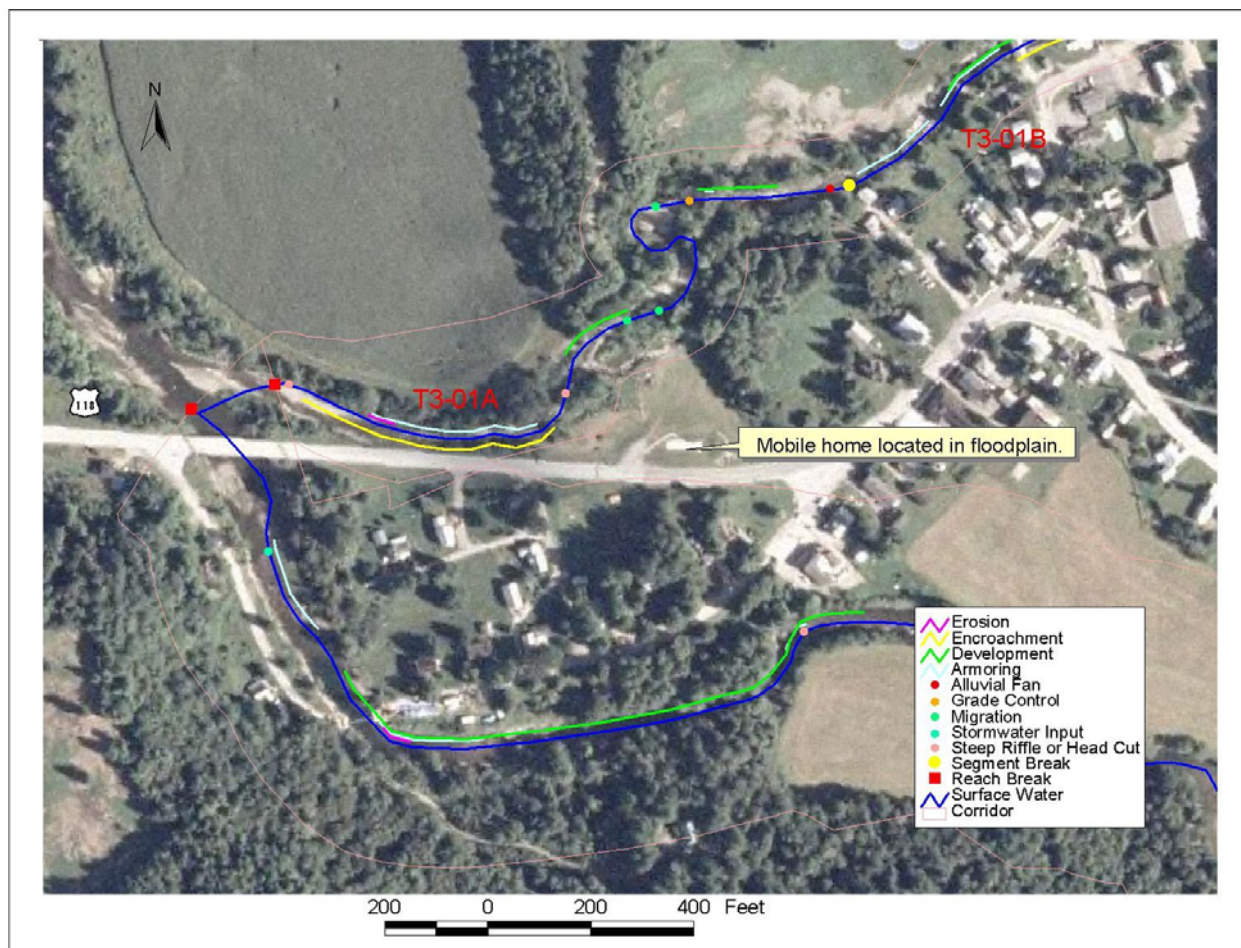
**Figure 10: T3-01A and B**

- **Reach T3-01** – Two major problems were identified in T3-01. One is an eroding bank and failed rip-rap in the middle of the reach which is threatening a nearby mobile home. Given the current level of residential development in this area the only valid restoration technique appears to be re-stabilization of the eroding bank to prevent future structural damage. The other area of concern in T3-01 is the downstream end of the reach which is on an alluvial fan. Currently a mobile home is located in the floodplain and may be damaged during future flood events. In order to retain this important sediment and nutrient storage asset, the ideal project would involve moving the mobile home to restore the area to its natural depositional role. If this cannot be accomplished, then more traditional flood prevention measures may be required.

Reach T3-01 is the most downstream reach of Black Falls Brook and extends from its confluence with the Trout River upstream to the bridge on Black Falls Road. The reach was segmented into T3-01A and T3-01B due to differences in channel dimensions and reference stream types. T3-01A is the downstream end of the reach and was found to be an alluvial fan. The segment was in regime with its Phase 1 reference stream type (C-gravel) and in evolution stage III. Dominant adjustment processes were active aggradation, widening and planform adjustments and historic degradation. The habitat and geomorphic scores were 0.64 and 0.61, both fair conditions. Being an alluvial fan, the reach had a very high sensitivity rating. The incision ratio of 1.5 suggests that the stream still has some access to its historic floodplain during high flow events. Historic dredging was noted during the Phase 1 Assessment, though no active dredging was observed during the Phase 2 Assessment. The riparian corridor was dominated by corn and hay fields with some residential development on the left bank. Multiple floodchutes

and a channel avulsion were present showing the amount of historic adjustment the segment has undergone. The main problem area associated with this segment is the mobile home located within the floodplain in the lower part of the segment. The home was heavily damaged during the 1997 flood, and a newer structure was put in the same spot after the flood. Given the inherent instability of this segment, and the location of the current mobile home, it is likely that the structure will be further damaged during the next flood event if no action is taken. The most appropriate action for this area would be to move the mobile home out of the floodplain. Dredging or berming the stream would not be valid techniques here as they would simply transmit the instability of the area to upstream or downstream portions of the river.

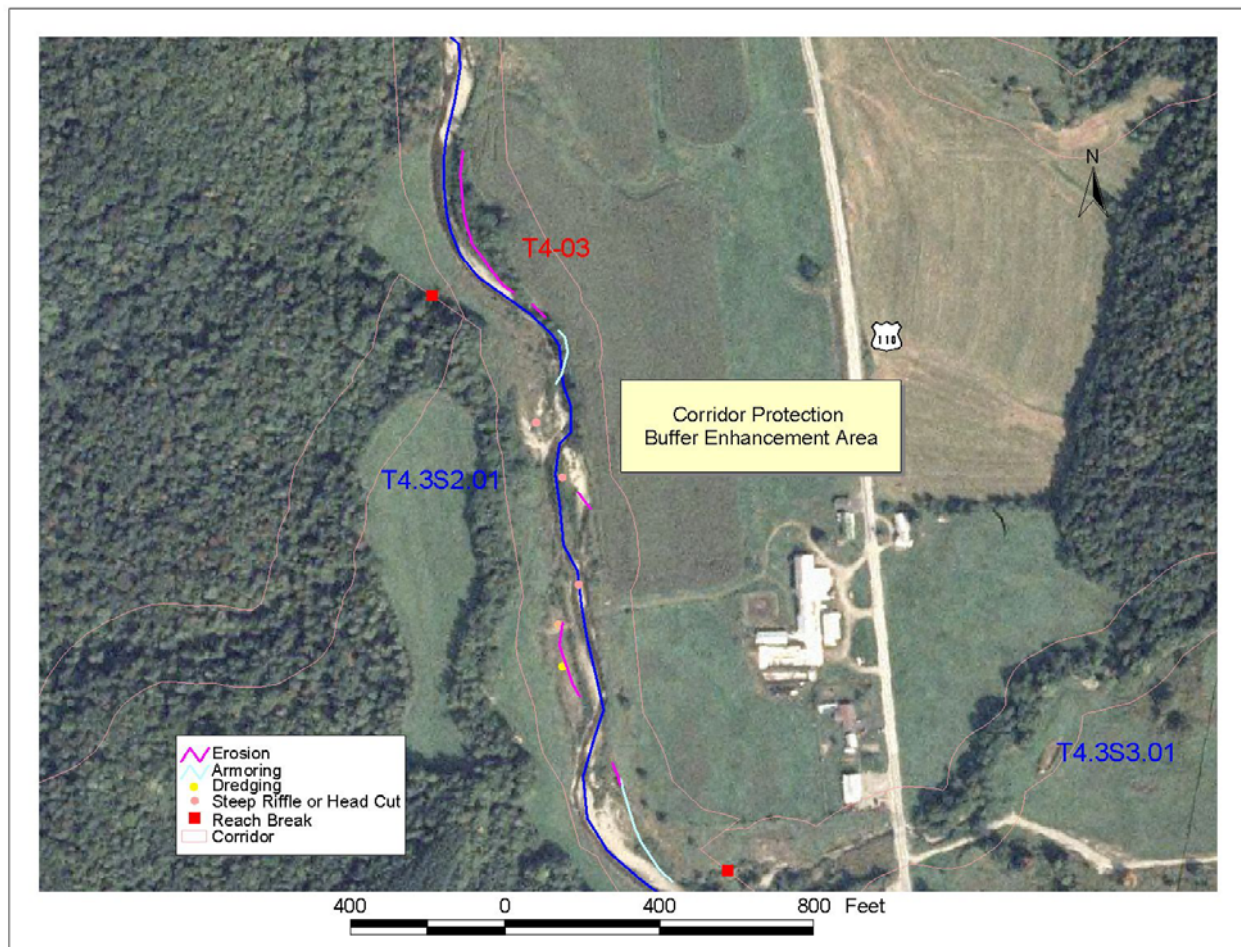
**Figure 14: T4-03**

Reach T4-03 extends from the end of T4-02 upstream for approximately  $\frac{3}{4}$  mile to the Sundell Road Bridge. The reach was in regime with its Phase 1 reference stream type (C-gravel riffle pool) though major aggradation, widening, and planform adjustments were observed. The

habitat and geomorphic scores were 0.58 and 0.64, both in the “fair” range, and the reach was found to be in evolution stage III. Historic degradation has increased the incision ratio to 1.3, though the channel still has access to most of its historic floodplain during high flow events. Significant planform adjustments were observed between the Phase 1 river center line and the current meander centerline. Bar scalping was observed on a few of the large point bars in the middle of the reach. The riparian corridor was dominated by hay and corn fields with relatively narrow buffers ranging from 0 to 25 feet.

- **Reach T4-03** – Given the observed planform adjustments which have been documented in T4-03, and the expected future adjustments, a corridor protection plan should be established for reach T4-03. The plan would limit channel management and encroachments to allow for the expected widening, aggradation, and planform adjustments to occur as the channel evolves toward geomorphic equilibrium. A key part

of any corridor protection plan should include re-establishment of adequate woody buffers to filter out excess nutrients, stabilize streambanks, and improve wildlife habitat.

Given the current adjustment processes observed, and the very high sensitivity rating, the most appropriate restoration/conservation projects for this reach are corridor protection and buffer enhancement. These techniques would allow the expected channel adjustments to occur

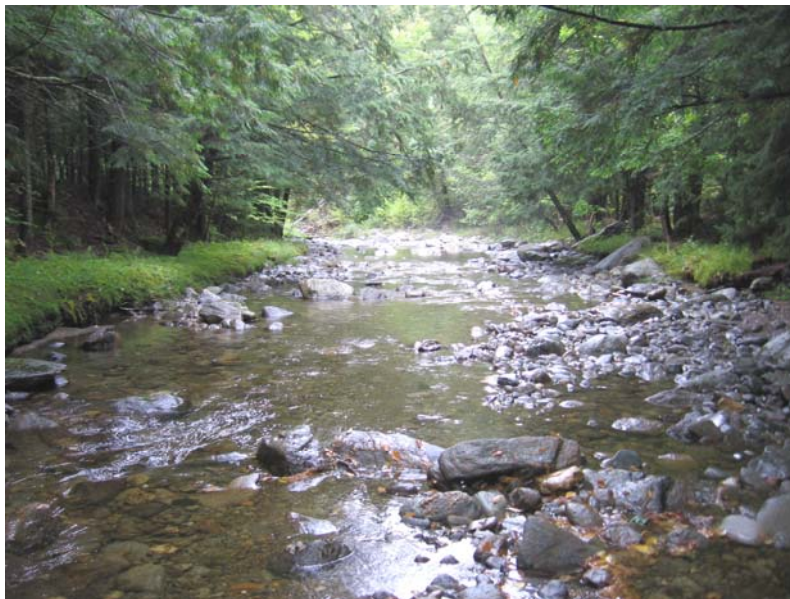
**Figure 16: Cross Section Location Reach T7-01**

Reach T7-01 (Wade Brook) extends from the confluence with Jay Brook upstream for approximately 2 miles to the Amadon Road Bridge. The stream was found to be in reference condition with no major adjustment processes observed. The B-cobble step pool stream type was consistent with the Phase 1 reference type. The riparian corridor was dominated by forests on both sides with no human related encroachments observed. Multiple bedrock grade controls were noted throughout the reach. No major areas of erosion were noted with the exception of four mass failures located where the channel has bumped against the valley wall. Overall, the reach appeared relatively stable and no restoration/conservation projects were identified.

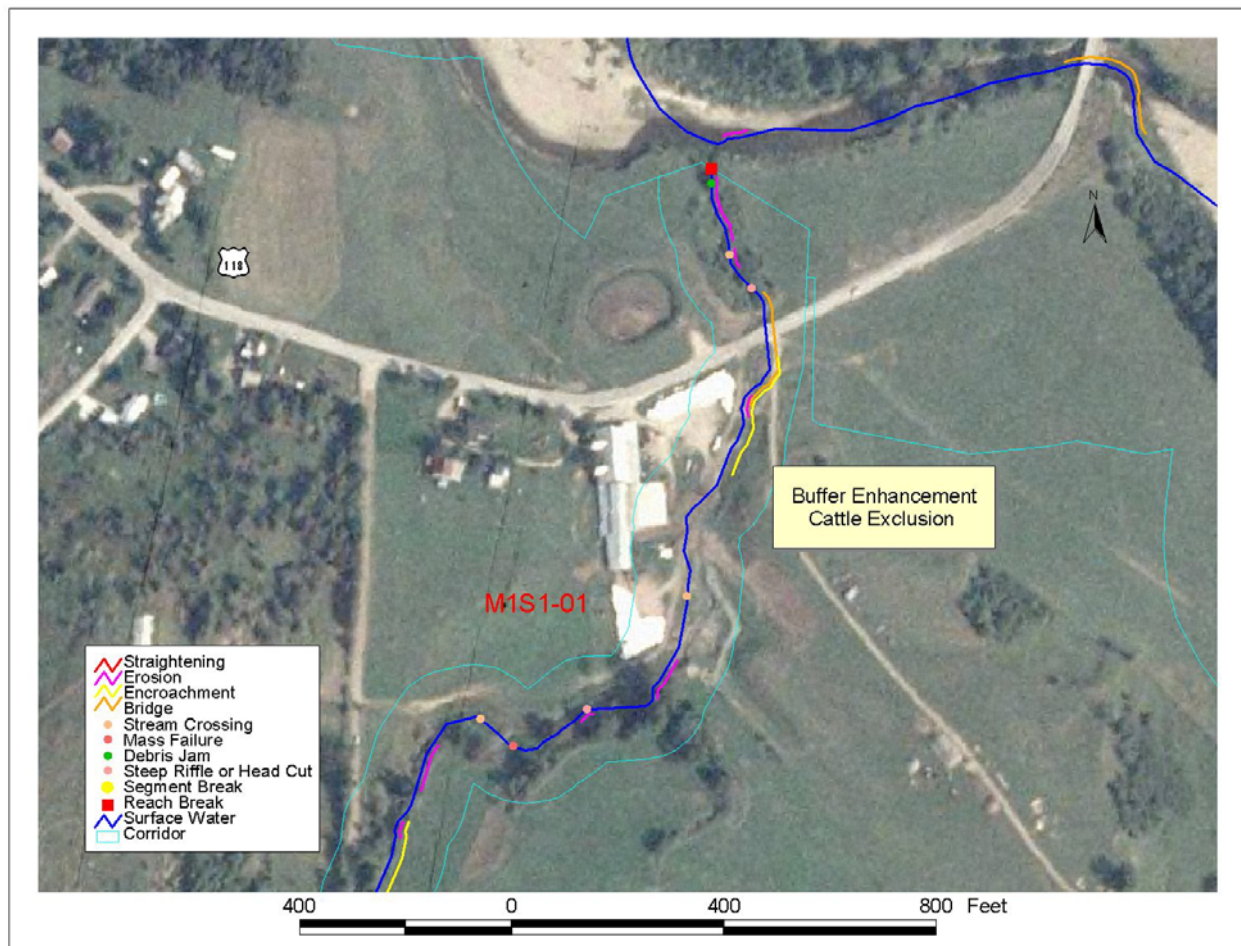
**Figure 17: M1S1.01**

Reach M1S1.01 is the first small unnamed tributary of the Trout located approximately 1 mile upstream of its confluence with the Missisquoi River. The reach extends from its confluence with the Trout upstream to where the valley narrows approximately  $\frac{3}{4}$  mile upstream. The B-cobble step pool stream type was consistent with the Phase 1 reference stream type. The major adjustment factor was found to be historic degradation which has increased the incision ratio to 2.0. The habitat and geomorphic scores were 0.52 and 0.59 both in the “fair” range and the reach had a very high sensitivity rating. Active widening was observed in the downstream

end of the reach below the culvert crossing Route 118. The riparian corridor was dominated by pasture and hay fields and the middle of the reach runs through a barn yard where cows have access to the stream channel. Narrow buffers of 0 to 25 feet were observed throughout, except downstream of the Route 118 culvert where willow trees have been planted by Missisquoi River Basin Association providing adequate buffer space. The major restoration/conservation project associated with this reach is to exclude the cattle from the stream channel within the barnyard and increase the buffer widths throughout the reach.
