Subject: Final Site Inspection Report
Whitney Blake Company of Vermont
Rockingham, Vermont
W.A. No. 08-1JZZ
Reference No. 1-636-009-0-1J75, TDD No. 9107-10-ATS
CERCLIS No. VTD064440365

Site Inspection
Final Report

# SITE INSPECTION
# WHITNEY BLAKE COMPANY OF VERMONT
# ROCKINGHAM (BELLOWS FALLS), VT

FINAL REPORT

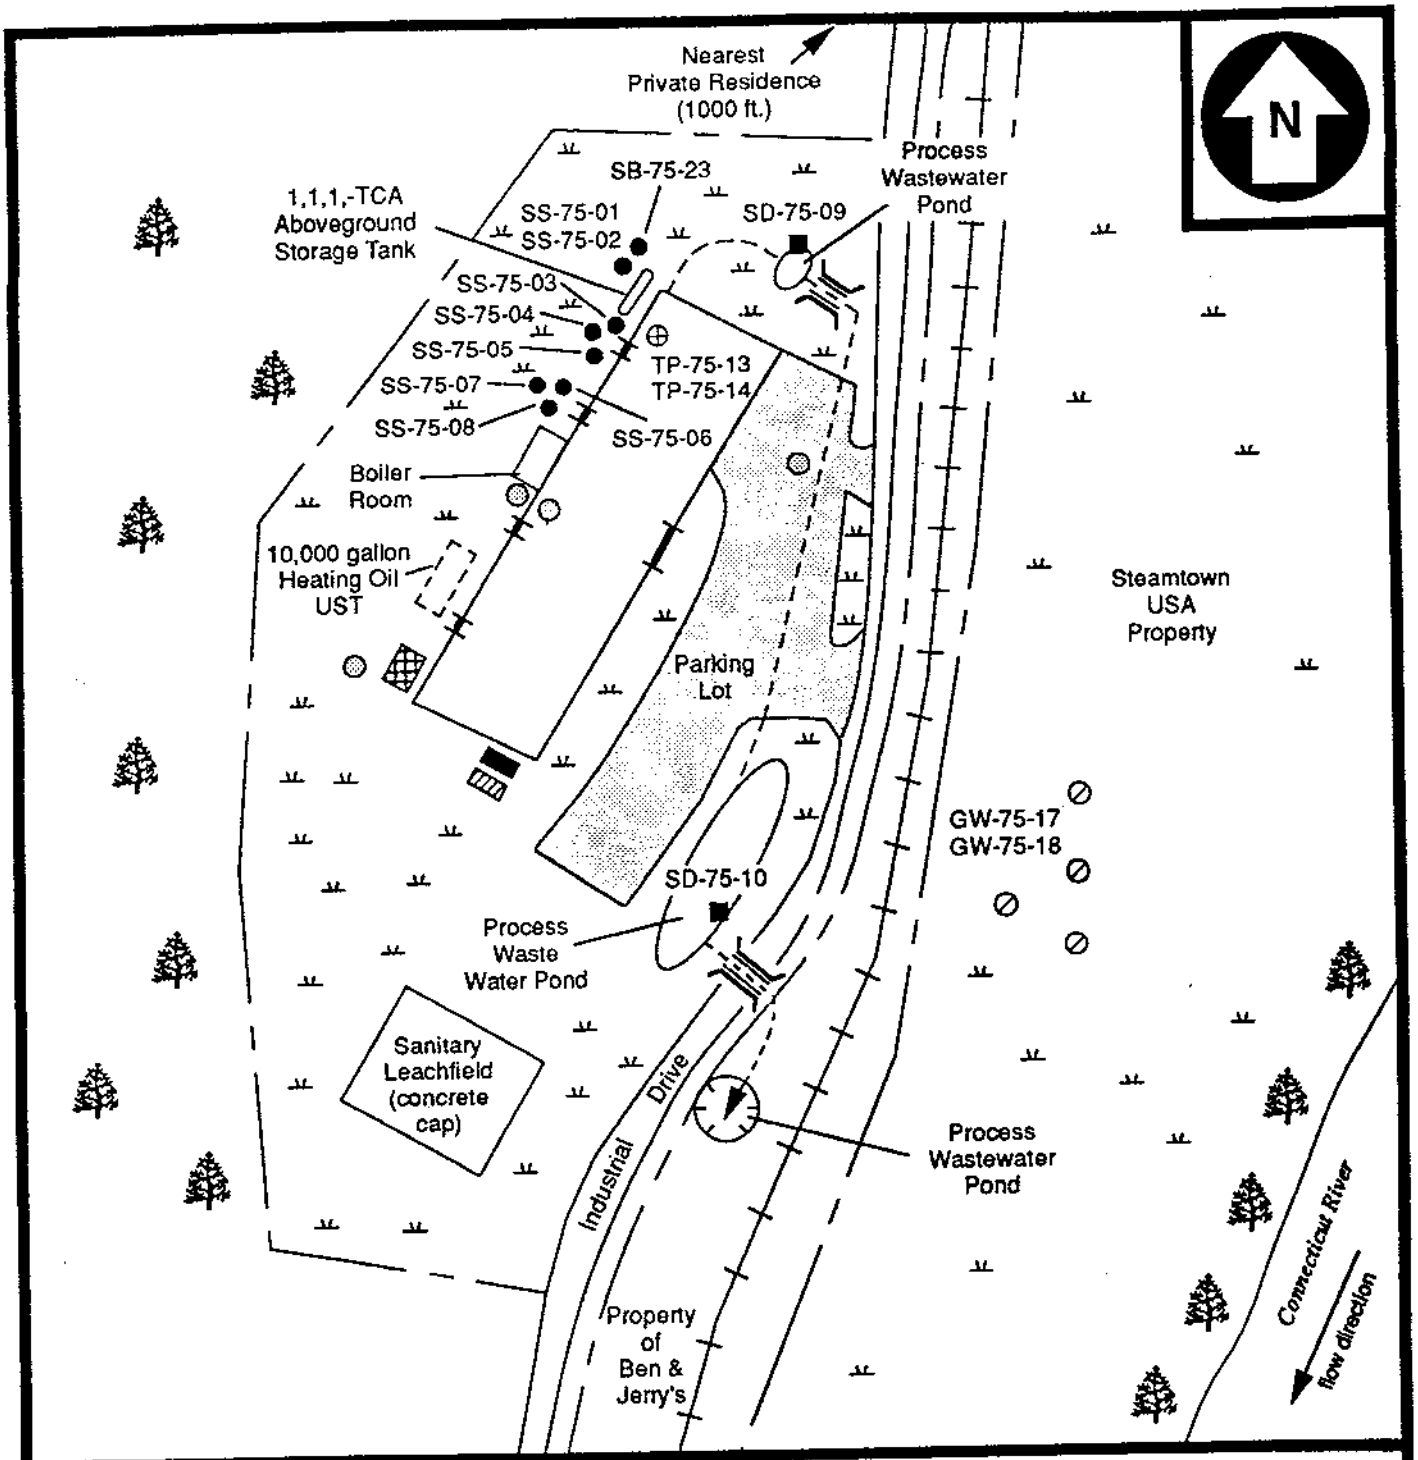
Figure 2.

The site consists of a large production building, with a paved parking lot and driveway, underbrush on the west and north sides, and a grassy area which covers a sanitary leachfield along the south side of the property (Figure 2) (TRCC, 1992). Whitney Blake also maintains three process waste water ponds. The first and smallest of the ponds is located outside the rear of the building (north), the second is off the southeastern corner of the parking lot and the third is across Industrial Drive, on the southeastern edge of the property (see Figure 2) (TRCC, 1992). These are all connected to each other by drainpipes (TRCC, 1992).

holding tanks prior to use in manufacturing processes (TRCC, 1992) . Reportedly from 1974-1977 1-2 quarts per month of 1,1,1-TCA were poured onto the soil along the west side of the building.
