FLOWER BROOK STORMWATER MASTER PLAN

Submitted to the Vermont Agency of Natural Resources
January 22, 2016
Funding provided through ANR's Ecosystems Restoration Program
Grant Number 2015-ERP-1-02

Introduction

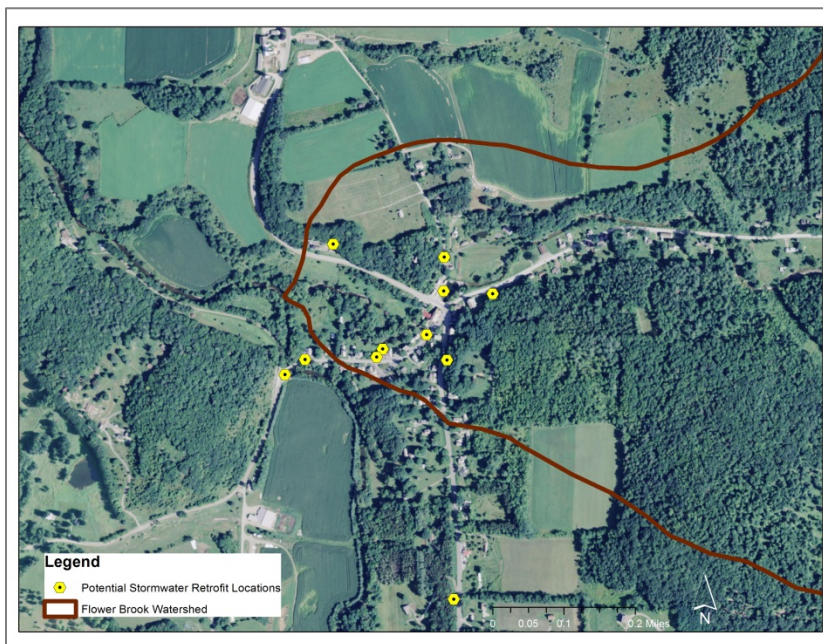
Figure 1: The final 13 stormwater projects selected in Pawlet Village (one of the sites has three associated projects).

While each of the top 13 projects were seen as high-priority, six of the top-scoring projects received conceptual designs (please refer to Attachments C and D for more information on the initial projects identified and to see the concept designs for the highest-ranking projects).

Stone Environmental, Inc. completed a field screening that identified approximately 20 potential stormwater retrofit projects in the Village of Pawlet. Stone then completed a basic physical feasibility assessment for each project area, defining the contributing drainage area and the area available for treatment, and reviewed soil condition information presented in the NRCS Soil Survey. Based on this evaluation, and feedback received by PMNRCD during committee meetings and a door-to-door survey of Pawlet residents, several projects were eliminated from further consideration.

Each of the 13 remaining potential projects received a score relative to the following criteria: **Environmental priority** – relative environmental impact caused by this source on the nearest receiving water; **Constructability** – relative ease with which a project could be implemented, including whether the recommended practice(s) could be constructed on town-owned land or with a willing landowner partner, existing access to the site, and the amount of engineering design work that would be required to move the project to implementation; **Ease of operation** – including the amount and frequency of maintenance likely to be required and whether maintenance activities will be straightforward to complete, and **Anticipated pollutant abatement** – including the ability of the recommended practice to reduce runoff volumes and/or address sediment and nutrient pollution.
