# Base Lodge Tributary, Dover, Vermont

# Base Lodge Tributary-Mt Snow Dover, VT

DEC Stormwater Infrastructure Mapping Project

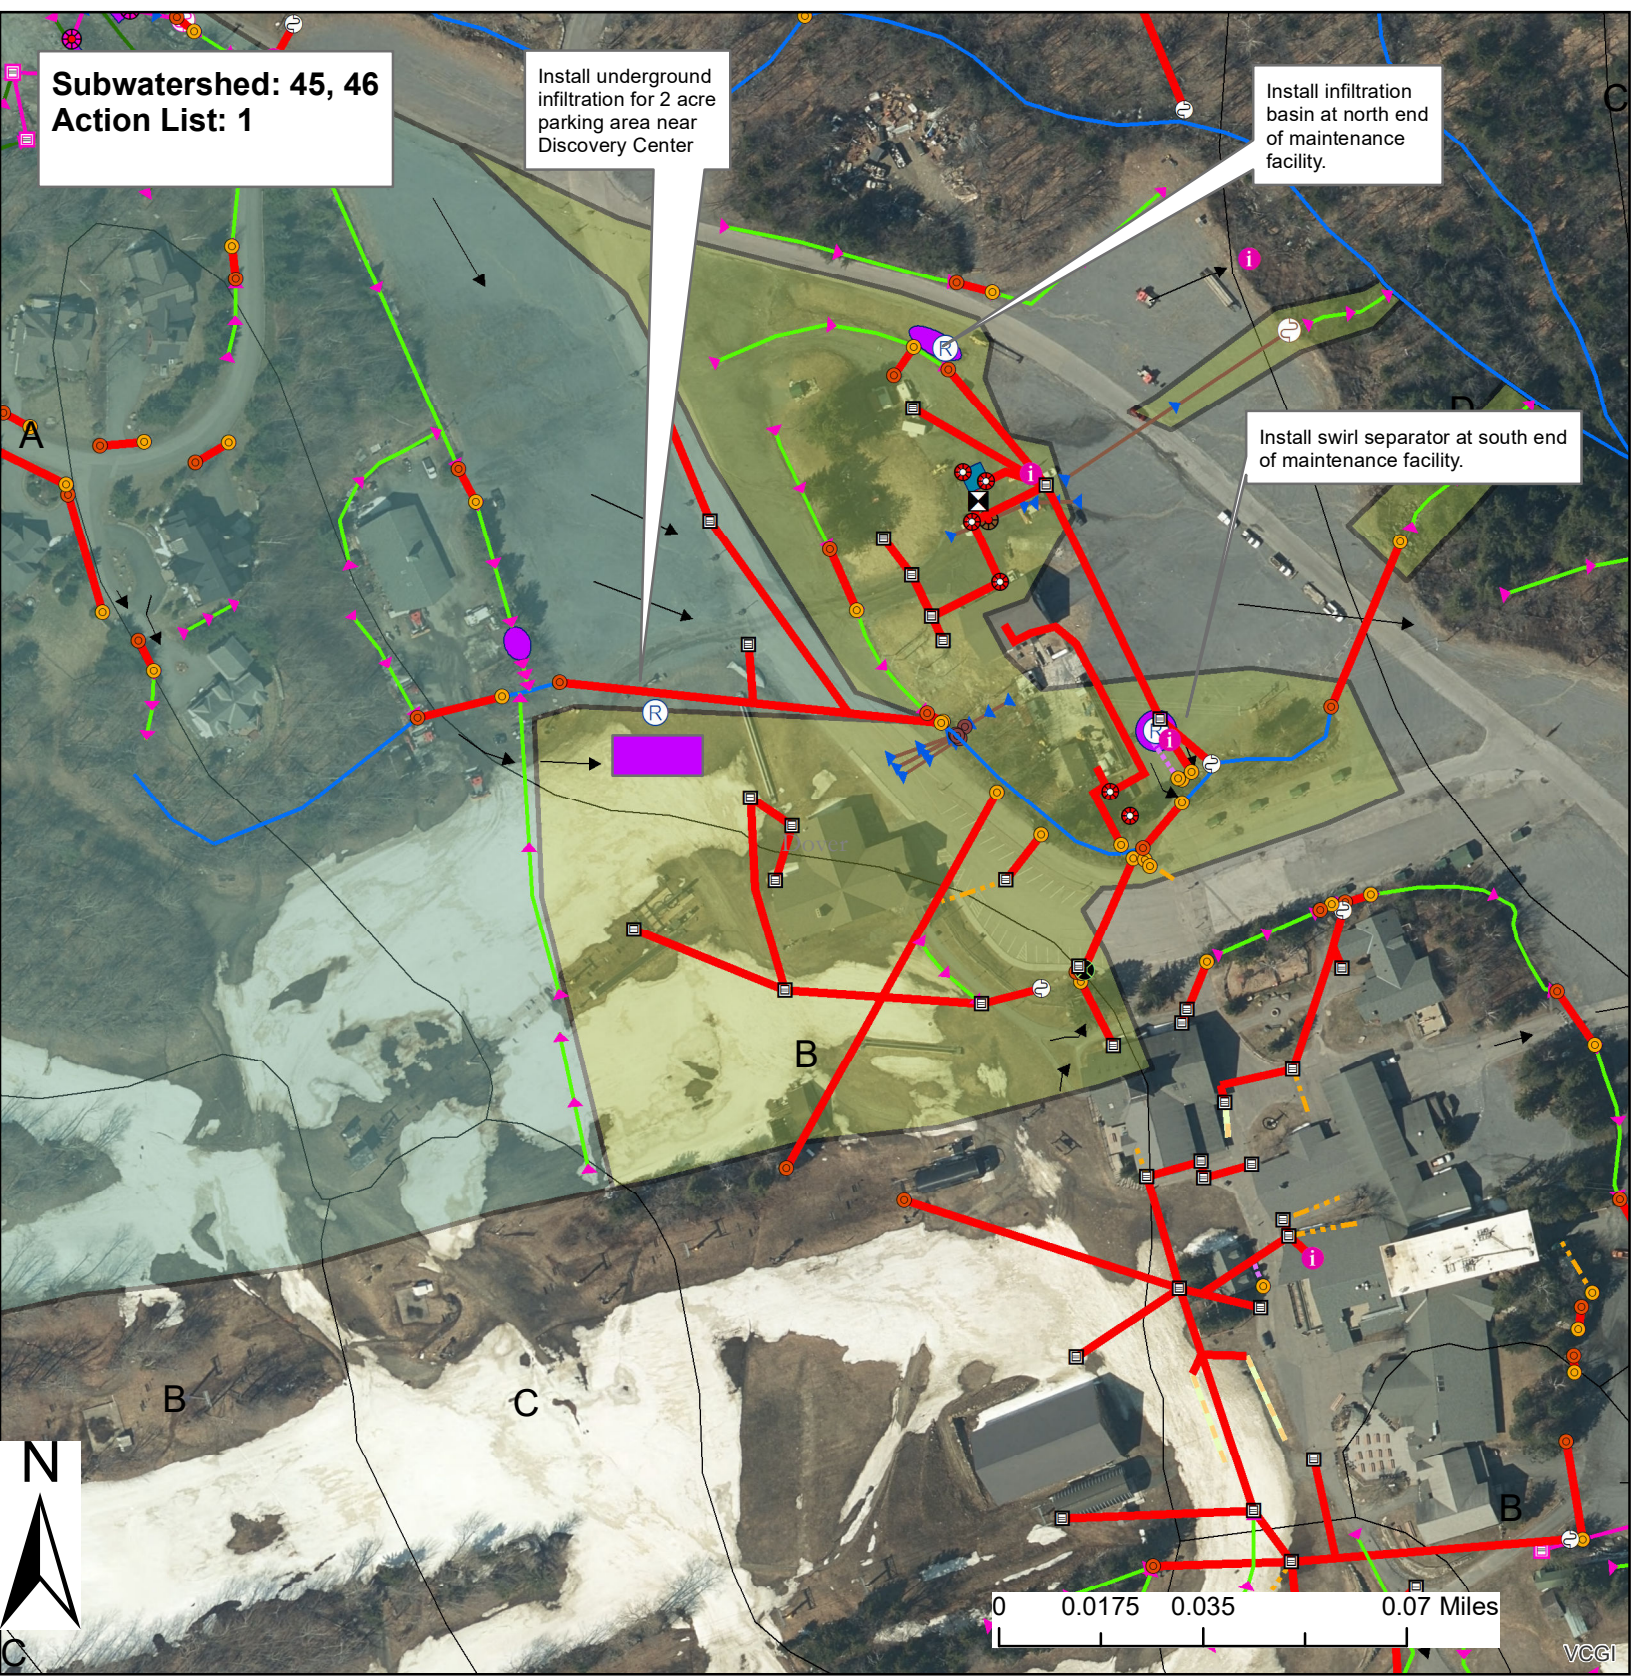
**Subwatershed: 45, 46**  
**Action List: 1**

Install underground infiltration for 2 acre parking area near Discovery Center

Install infiltration basin at north end of maintenance facility.

Install swirl separator at south end of maintenance facility.

This map shows high priority subwatersheds which are ranked by connectedness, percent of impervious cover, field observations, and potential retrofit measures and locations.

46 Dover	1	Install infiltration basin at north end of maintenance facility and swirl separator at south end	IB/VS/GS/CB	5228-INDS	8.38	0%	5808	50%	2904	48.40	0.00	48.40	24	\$157,000		\$54	\$6,488	CWIP,SRF,LISF
