**Ball Mountain Brook Watershed  
River Corridor Conservation Plan  
Phase 2 Report  
May, 2007**

**Prepared by:**

**Landslide Natural Resource Planning**  
P O Box 311  
East Middlebury, VT 05740

Windham County Natural Resources Conservation District  
28 Vernon Street  
Brattleboro, VT 05301

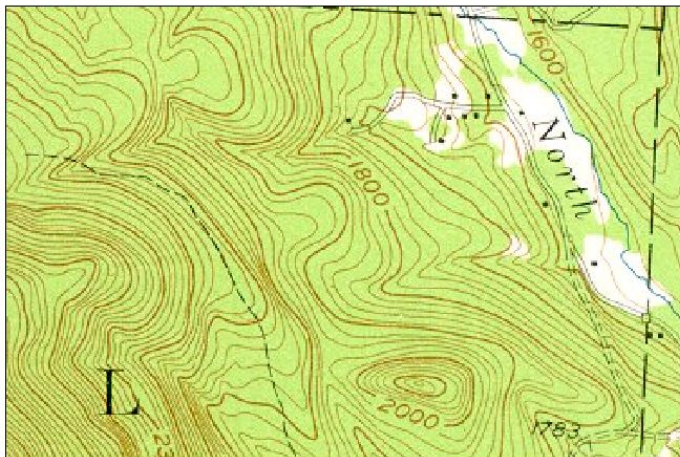
**Figure 2. Historic Topographic Maps**

Ball Mountain Brook  
 Historic USGS Topographic Maps  
 Reach T08.04-S1.04-S1.01  
 Dalewood Brook

Ball Mountain Brook  
Historic USGS Topographic Maps  
Brazer's and Styles Brooks

Ball Mountain Brook  
 Historic USGS Topographic Maps  
 T08.04-S1.11

Storm water inputs are an impact associated with increased human development. Storm water inputs concentrate flows that would otherwise be spread out over land, causing them to discharge directly into the stream, thus increasing the amount of water the stream carries at a given time. There are relatively few storm water inputs in this watershed, with the highest concentration being found on the upper portion of T08.04-S1.10-S1.01 (Styles Brook). (See Figure 2 in Appendix A.)

A total of 1.8 miles or 9% of the assessed channel length on 9 segments were found to be straightened. (See Figures 2 and 5 in Appendix A.) Channel straightening increases stream power by increasing channel gradient and flow velocity, causing a downcutting the channel bed (increasing slope) and triggering disequilibrium. Eventually, the stream banks will fail and the stream will over-widen. Development on one or both banks occurred in 27% of the channel corridor length. Roads occur along 60% of one or both sides of the channel corridor. Development within the corridor increases the volume of water flowing into the stream, causing bed degradation and an increase in slope. Thirteen of the 26 assessed reaches have channel constrictions, which can increase channel slope down stream by concentrating flows and reducing the amount of sediment available to the stream.
