# **Hungerford Brook Corridor Plan**

**Franklin County  
April 2008**

**Prepared for:  
Northwest Regional Planning Commission  
155 Lake Street  
St. Albans, VT 05478**

**Prepared by:  
The Johnson Company, Inc.  
100 State Street  
Montpelier, VT 05602**

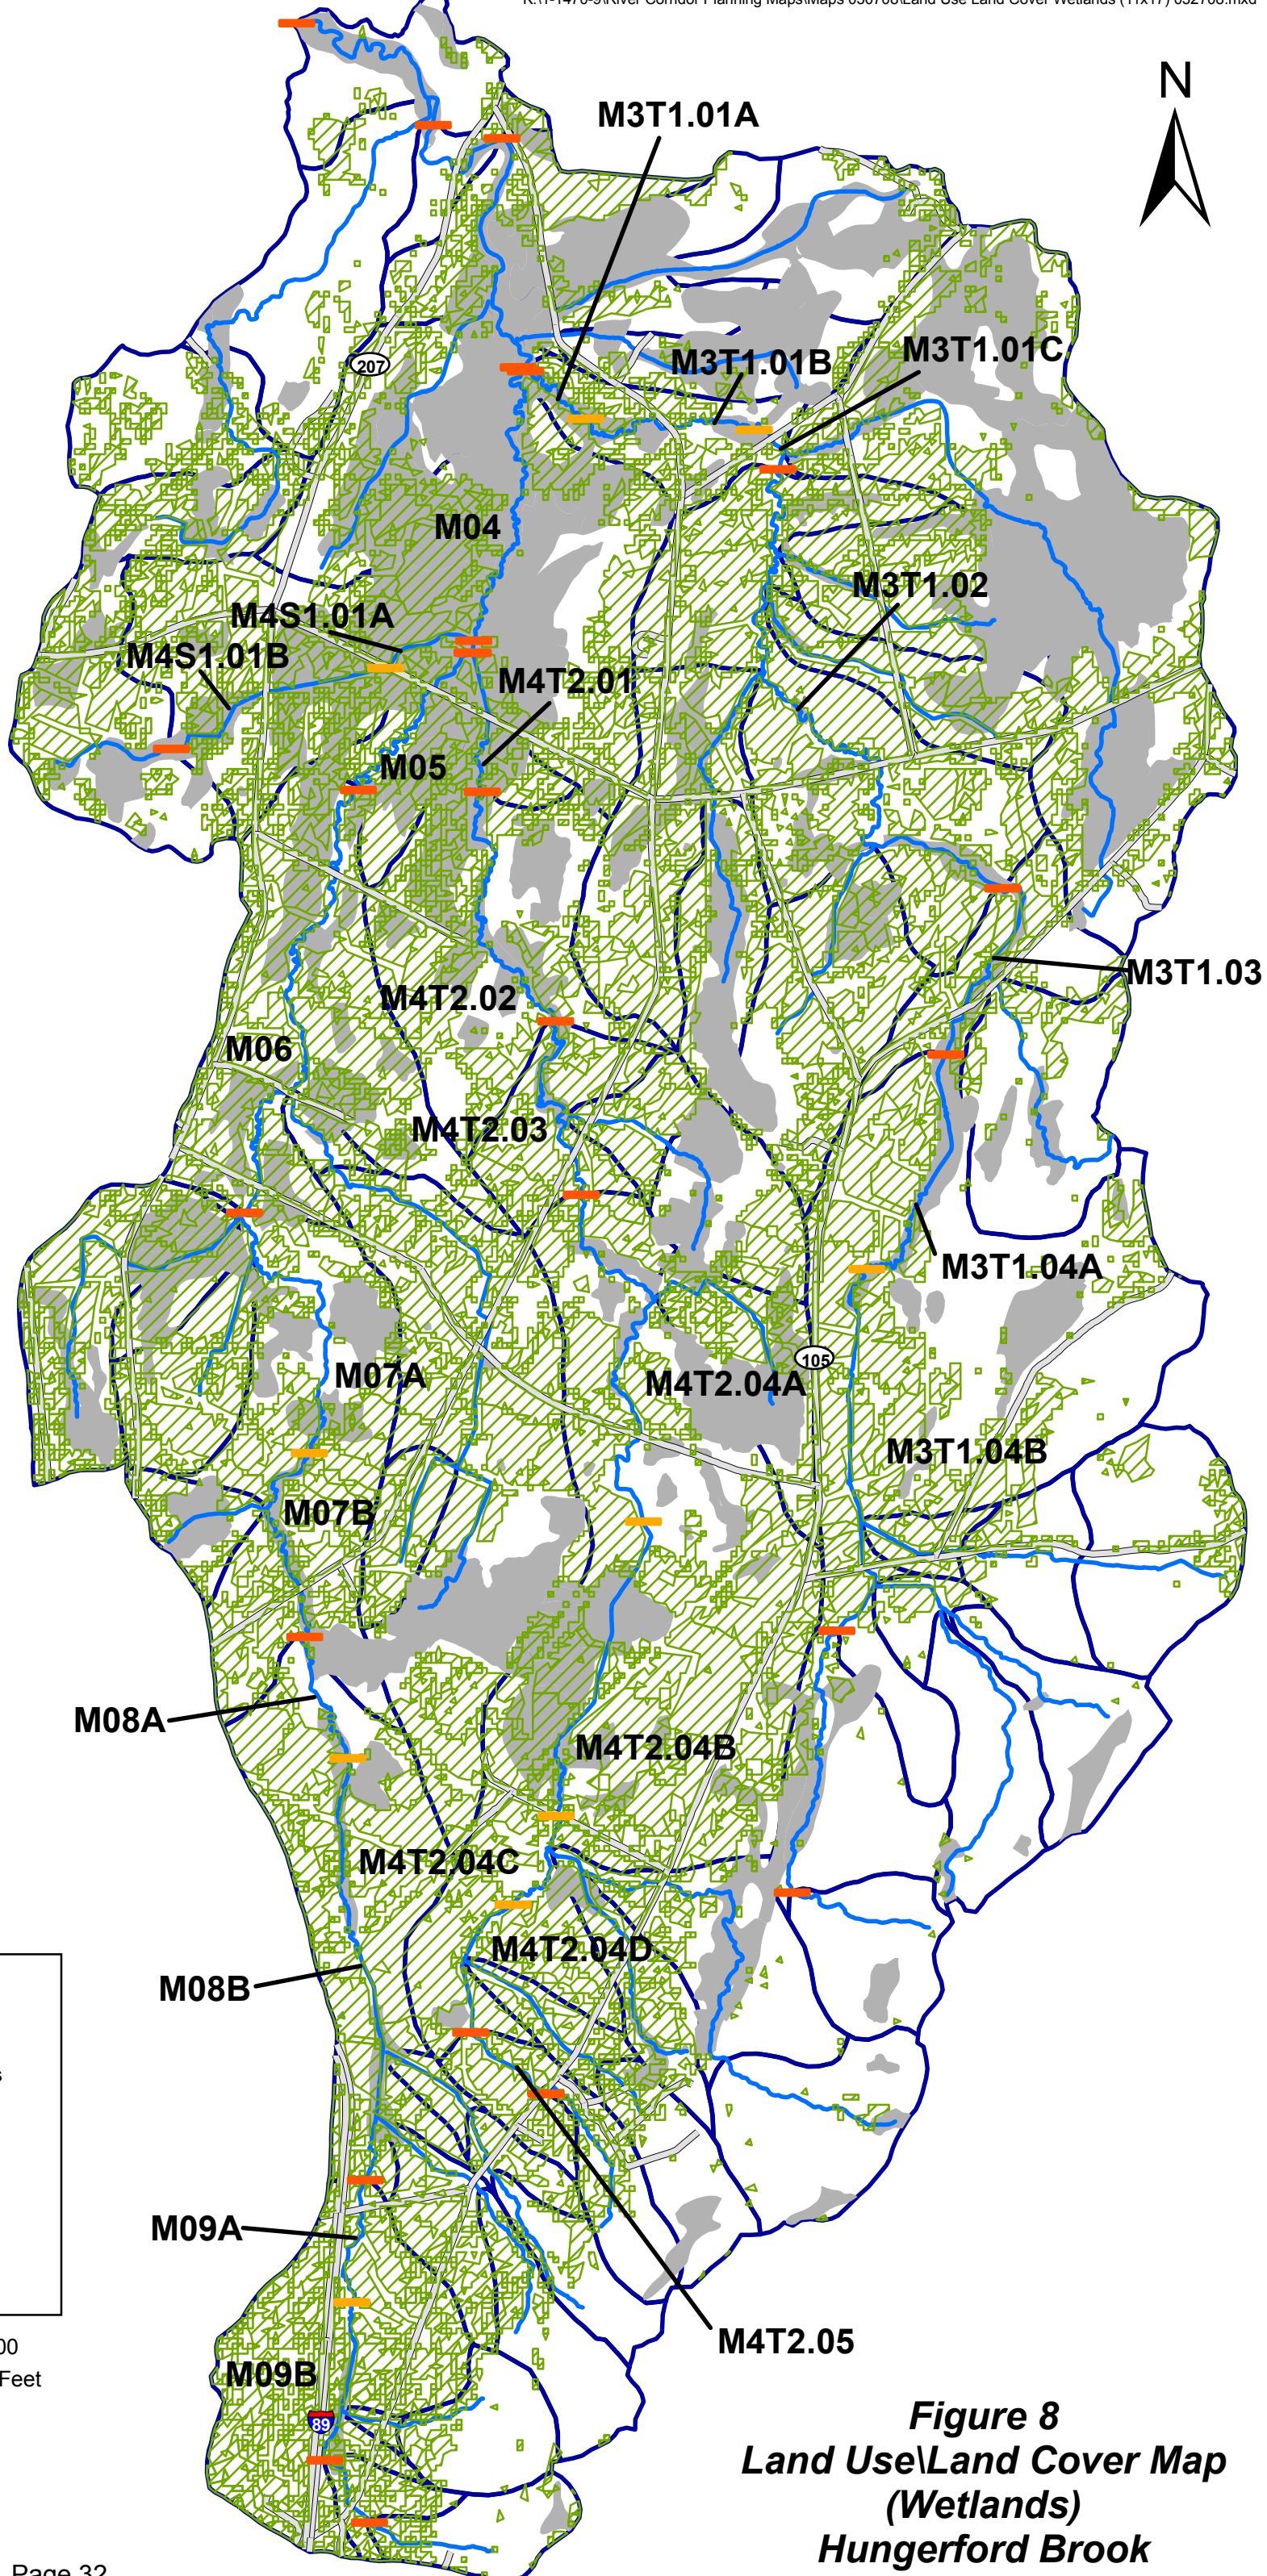
**Figure 8**  
**Land Use/Land Cover Map**  
**(Wetlands)**  
**Hungerford Brook**

- Agricultural Landuse
- Vermont Significant Wetlands Inventory and/or Hydric Soils
- Reach Break
- Segment Break
- Roads
- Hungerford Brook
- Sub-Watershed

an increase in the magnitude and duration of large flow events through increased runoff and decreased infiltration capacity. This is particularly true in agricultural lands that were converted from wetlands. As is shown in Figure 8, a majority of the historic wetlands (i.e. hydric soils) have been converted through subsurface drainage and other means into agricultural lands. The conversion of these wetlands not only increases the magnitude and rate of runoff into the stream channel, it also increases the sediment and nutrient inputs into the system as fertilizers and topsoil are washed from the land surface. These and other sediment load stressors are discussed below.
