# **Town of Hyde Park Road Erosion Inventory Report**

**Lamoille County Planning Commission**

**December 2017**

*Inventory and report funded by the Vermont Agency of Transportation 2016 Better Roads Program*

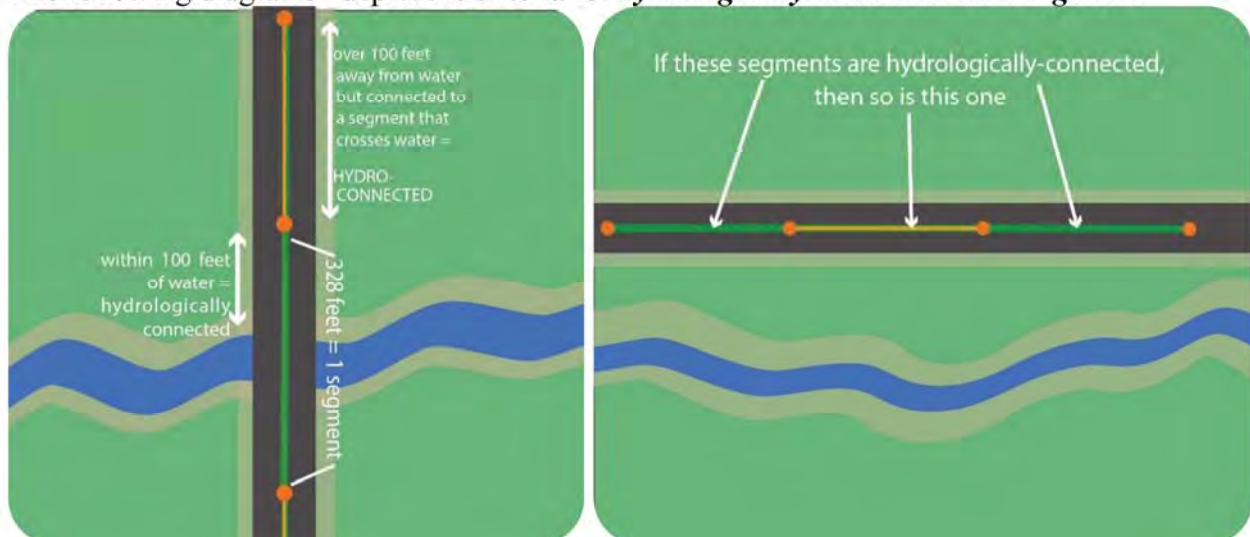
- Within 100 feet to water resources (perennial and intermittent streams, wetlands, lakes and ponds)
- Road segments that bisect a water resource
- Adjacent segments to connected segments
- Catch basin outfall pipe is 500 feet or less from a water of the state

The following diagrams\* depict the criteria for *hydrologically-connected road segment*:

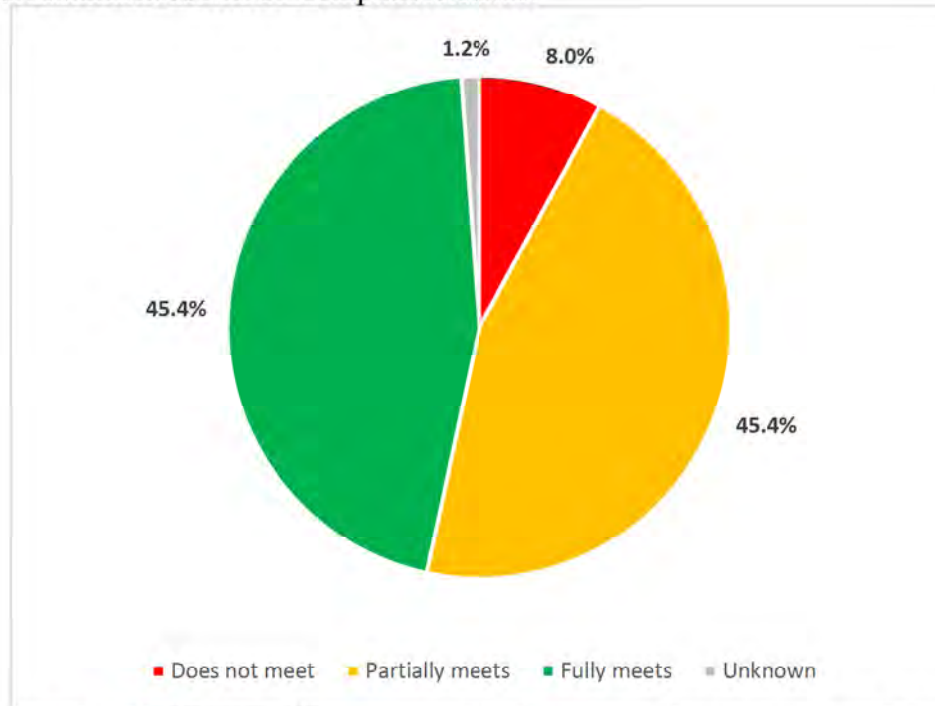
This pie-chart summarizes MRGP compliance status:

- There are 339 hydrologically-connected road segments in Hyde Park, or 21.1 miles (including class 4 roads)
- Of these, 55% (185 segments) do not fully meet standards; which equals approximately 11.5 miles of road

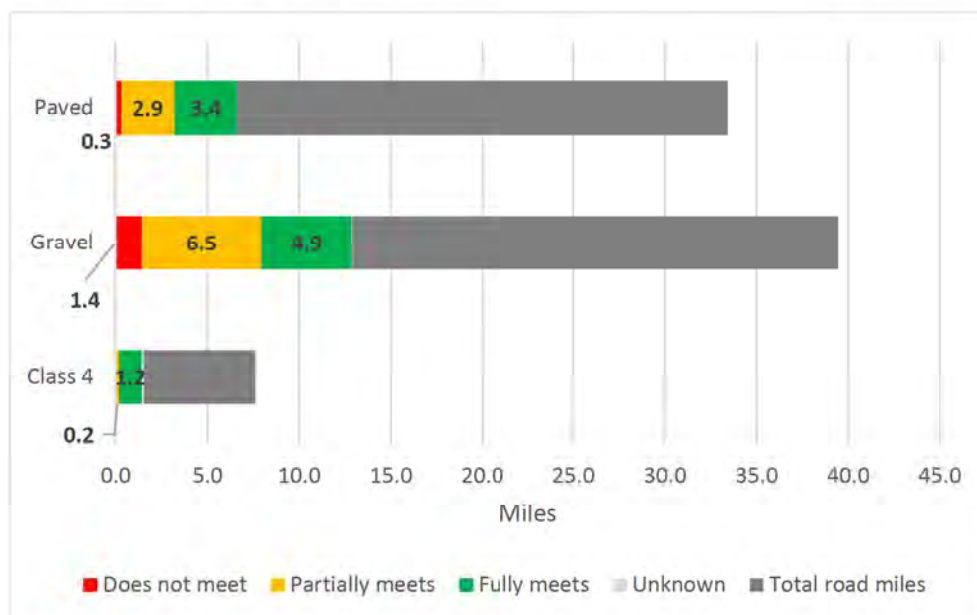
The following bar chart depicts the scoring breakdown (fully meets, partially meets, does not meet) by road type for hydrologically-connected road miles within the town's total road miles.

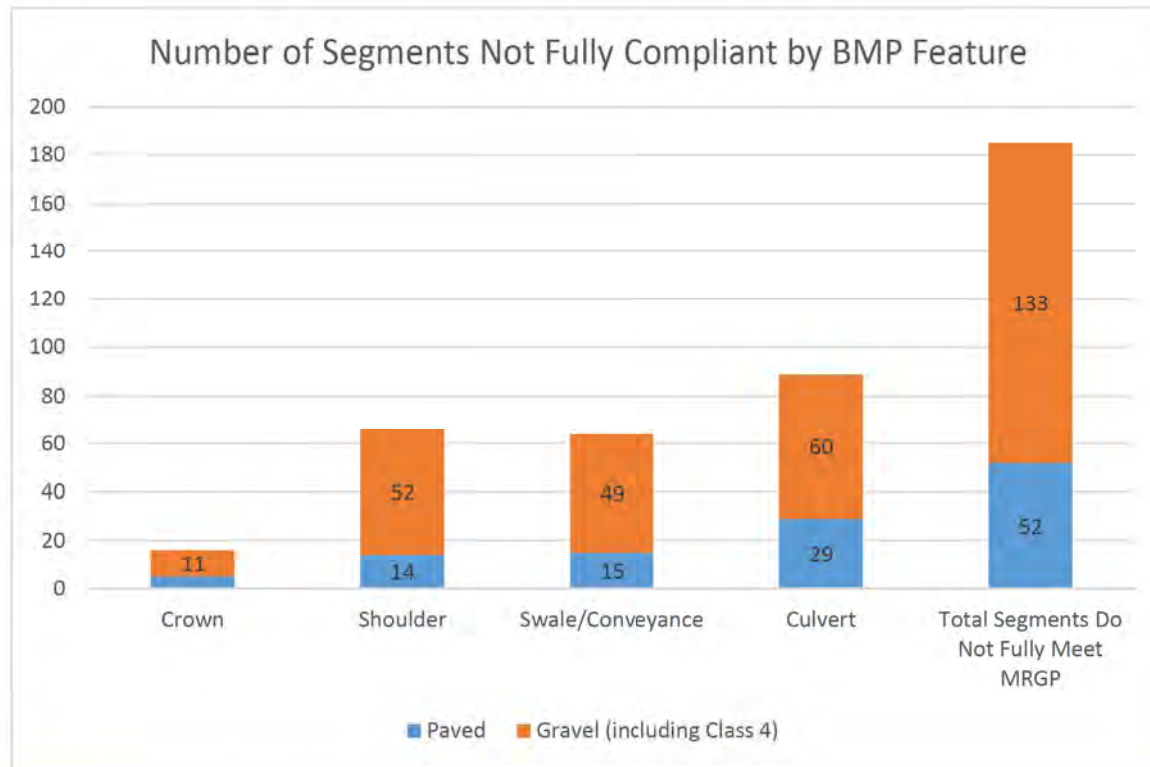
The following graph depicts the number of segments not in full compliance with the MRGP, by BMP categories (crown, shoulder, swale & conveyances, culverts). Some non-compliant segments have more than one BMP category in need of improvement, therefore the sum of the BMP features exceeds the total count of segments not fully meeting MRGP standards.

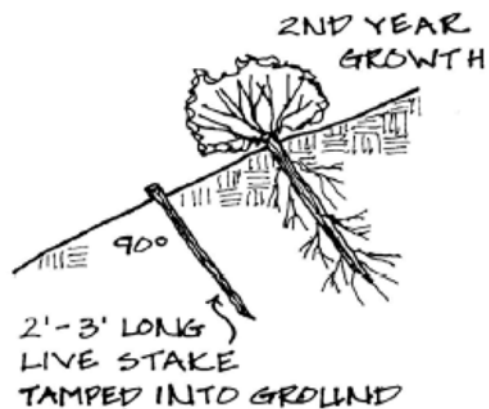
## LIVE STAKES

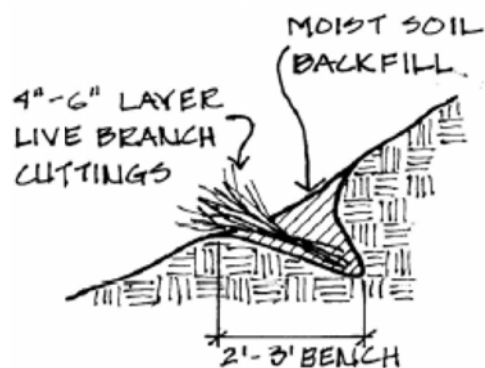
## BRUSHLAYERING

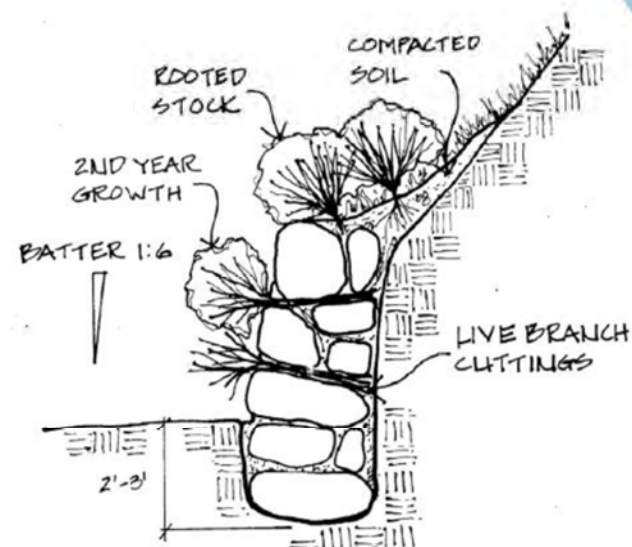
## VEGETATED ROCK WALL (BBR Manual – pg. 44)

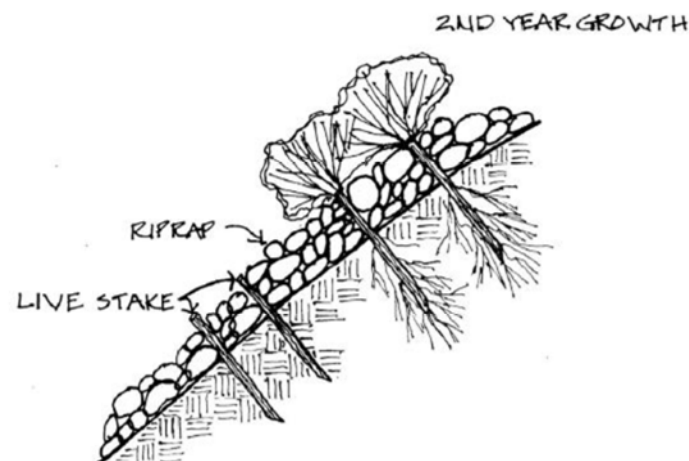
## VEGETATED RIPRAP (BBR Manual – pg. 45)

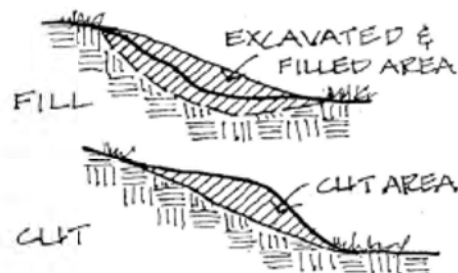
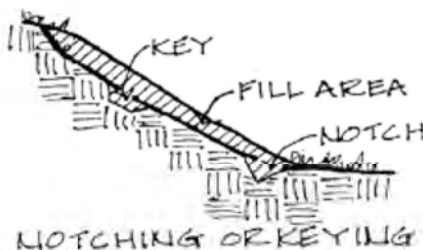
The removal or addition of soil to the bank to create the desired 2:1 or flatter slope, often times removing less stable soils and replacing them in the process of regrading the slope.

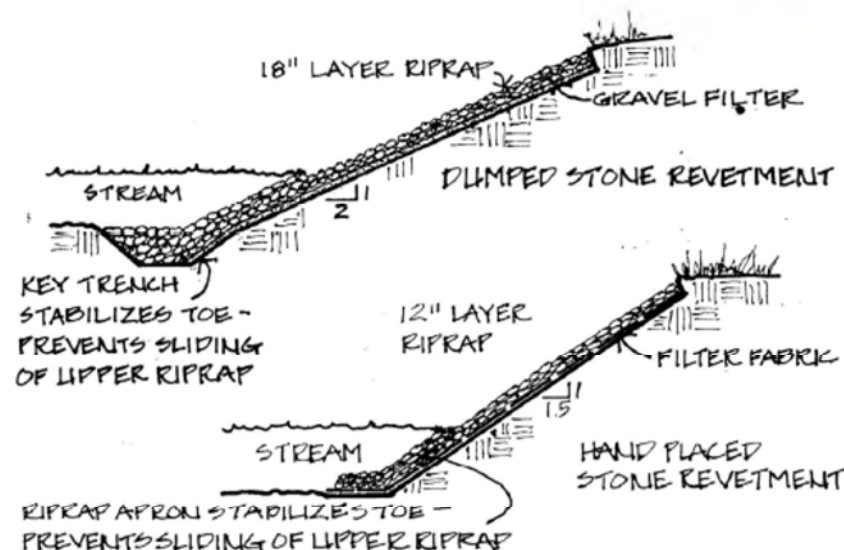
RIPRAP REVETMENT  
(BBR Manual – pg. 41)

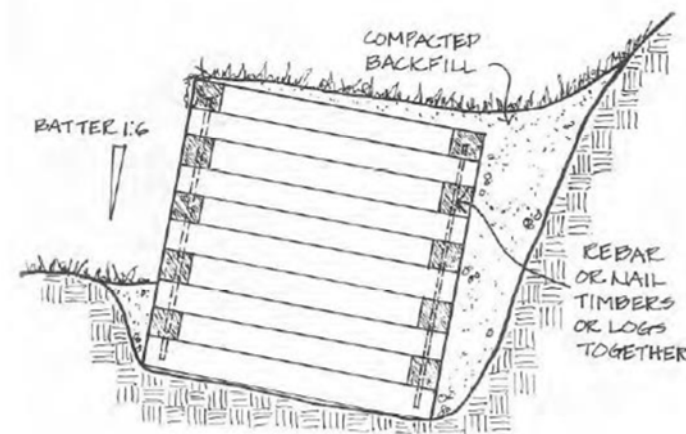
LOG OR TIMBER CRIB  
(BBR Manual – pg. 40)

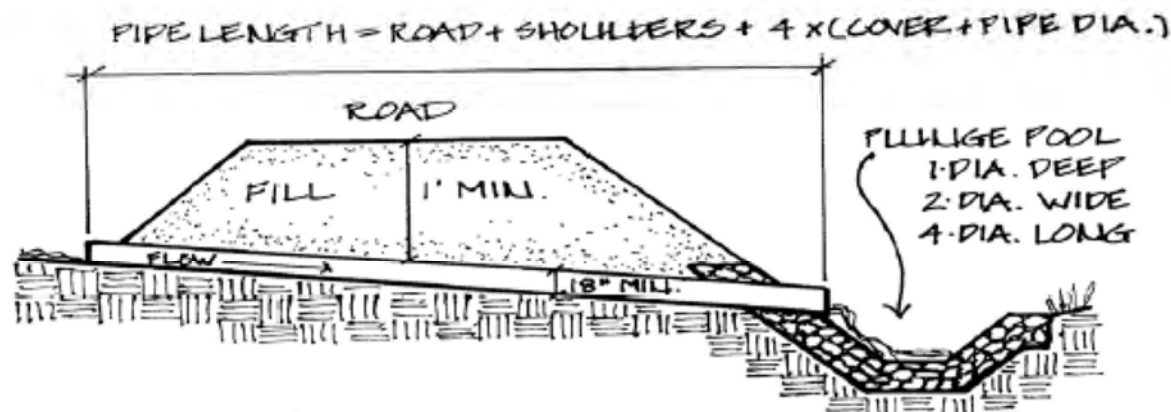
**CULVERT PROFILE & CROSS SECTION**

(BBR Manual – pg. 20)

Step 1: Pipe length =  $28 + 4(1.5 + 1.5)$ Step 2: Pipe length =  $28 + 4(3)$ Step 3: Pipe length =  $28 + 12$

Step 4: Pipe length = 40

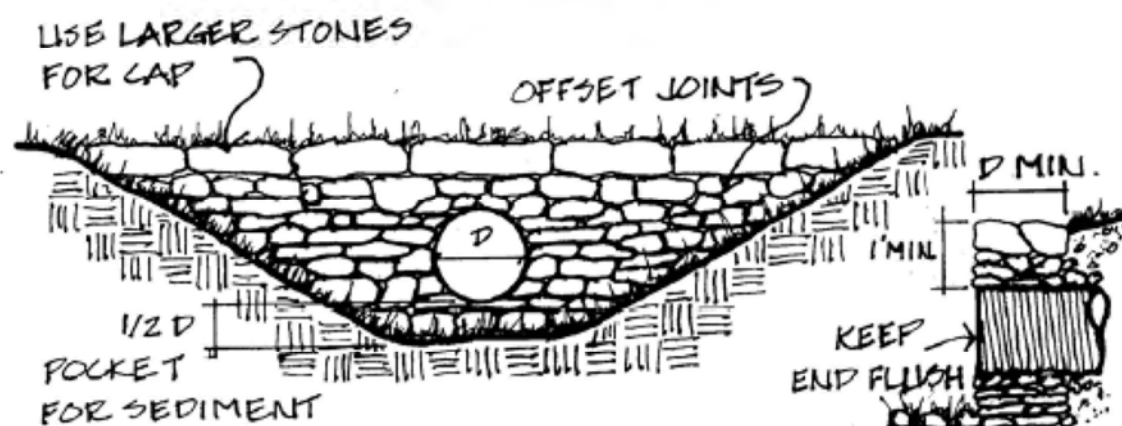
**HEADER**

(BBR Manual – pg. 24)

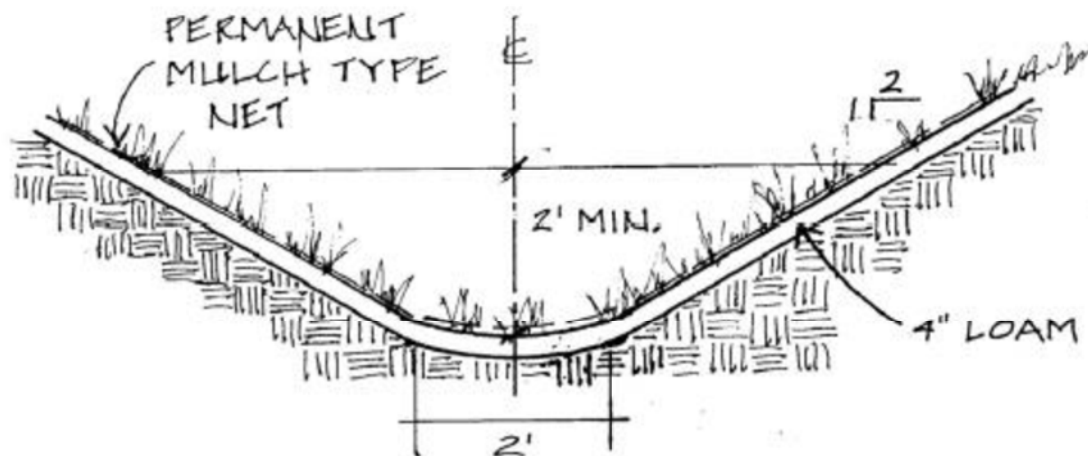
**GRASS LINED DITCH**

(BBR Manual – pg. 12)

TABLE 1: DITCH LININGS		
Channel Slope	Lining	Thickness
0-5%	grass	
5-10%	R#3 (2 - 6 inch) diameter rock	7.5"
> 10%	R#4 (3-12 inch) diameter rock	12"

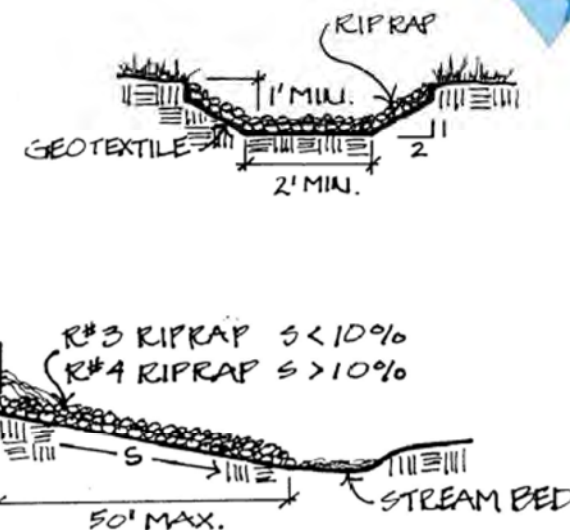
**RIPRAP CONVEYANCE CHANNEL**

(BBR Manual – pg. 30)

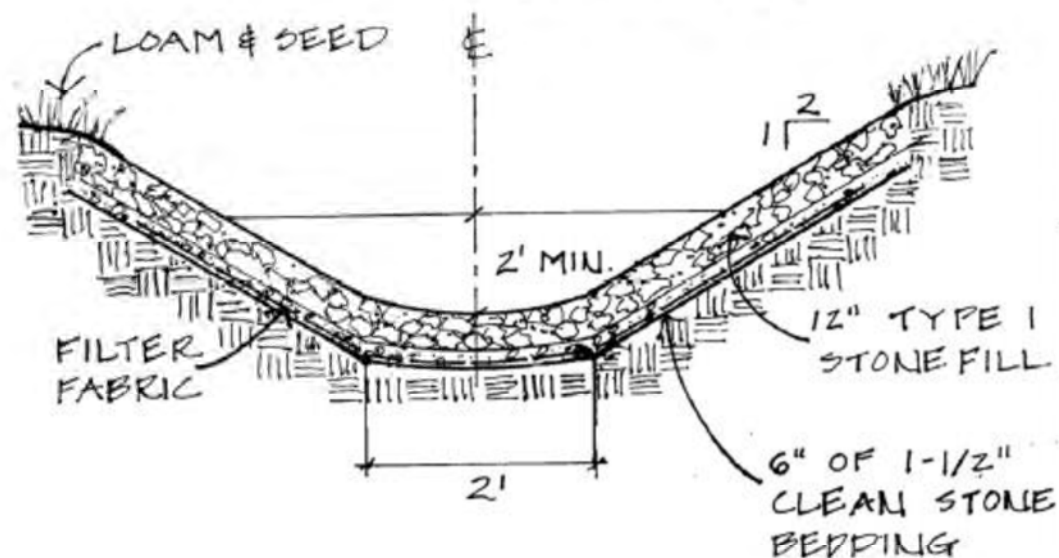
**STONE LINED DITCH**

(BBR Manual – pg. 13)

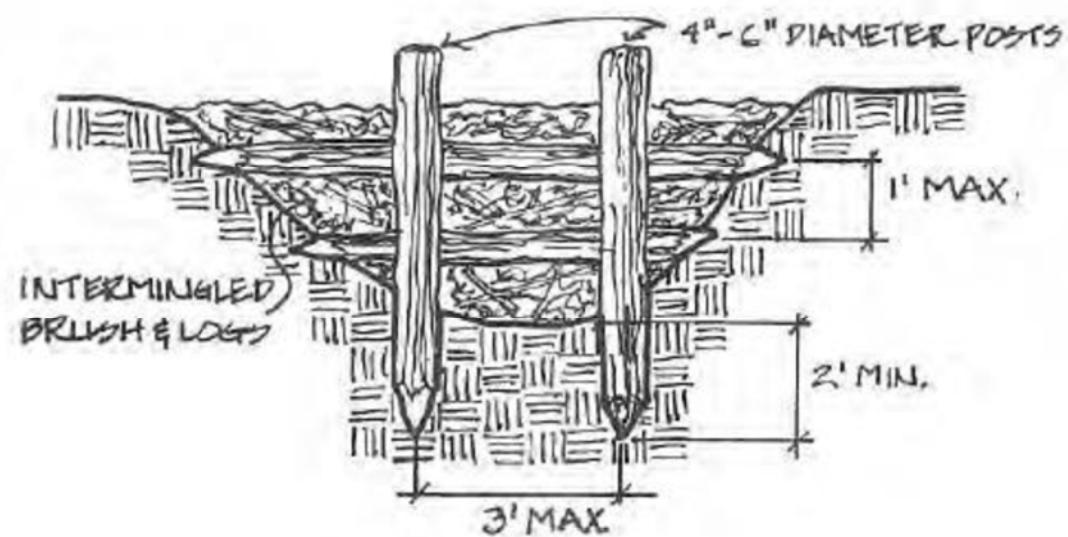
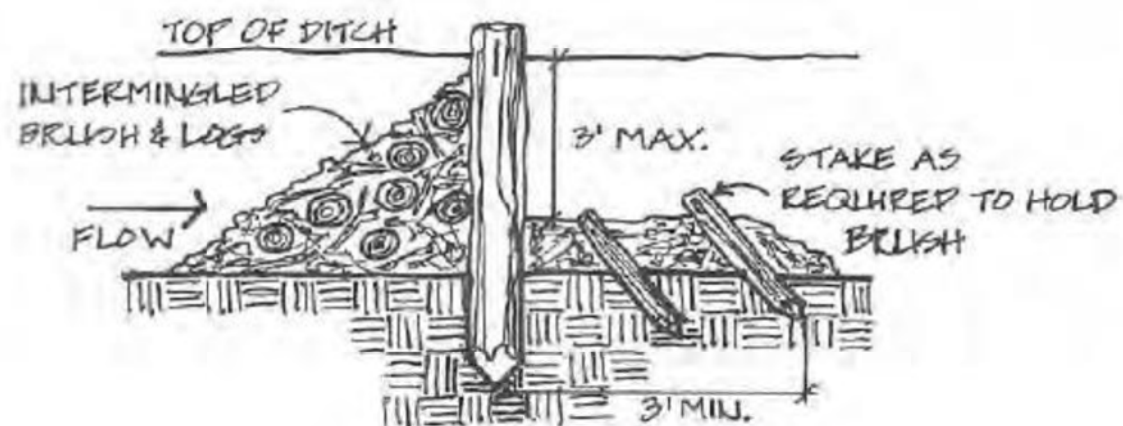
**LOG & BRUSH CHECK DAMS**

(BBR Manual – pg. 18)

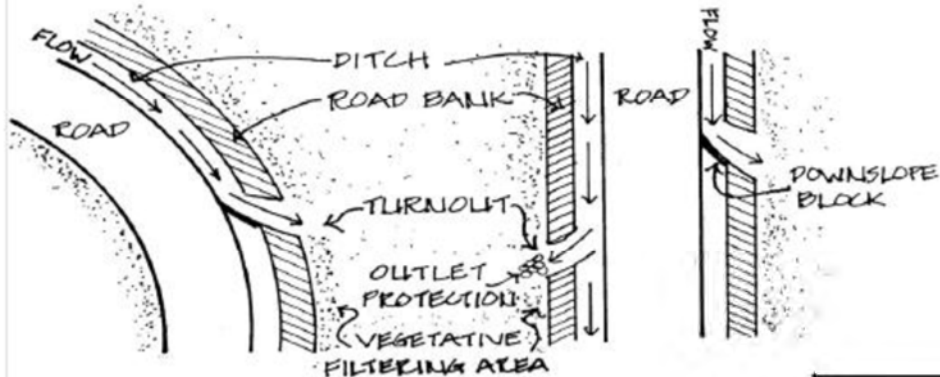
**TURNOUTS**

(BBR Manual – pg. 28)

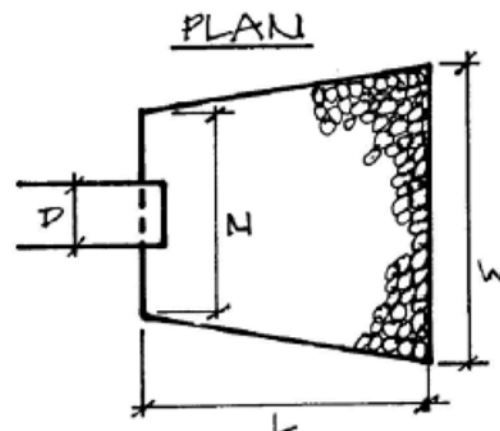
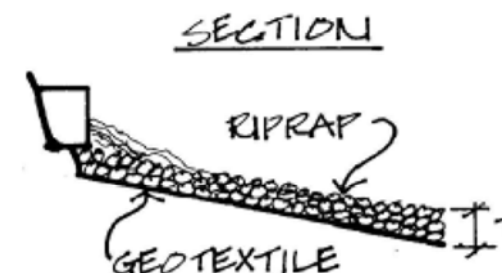
Culvert Diameter (D)	Riprap Size	T (in.)	N (ft.)	W (ft.)	L (ft.)
18 inches	(3-12 inch)	18	4.5	14.5	10.0
24 inches	(3-12 inch)	18	6.0	20.0	14.0

D= diameter of culvert  
 T= depth of stone in apron  
 N= width of apron near culvert  
 W= width at downhill end of apron  
 L= length of apron

**ROCK APRON**

(BBR Manual – pg. 29)

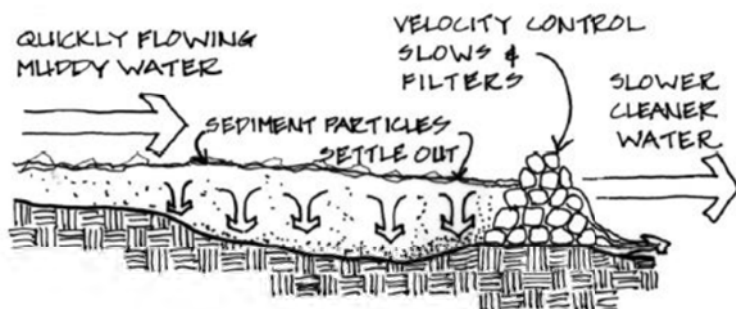
VELOCITY CONTROL  
(BBR Manual – pg. 16)

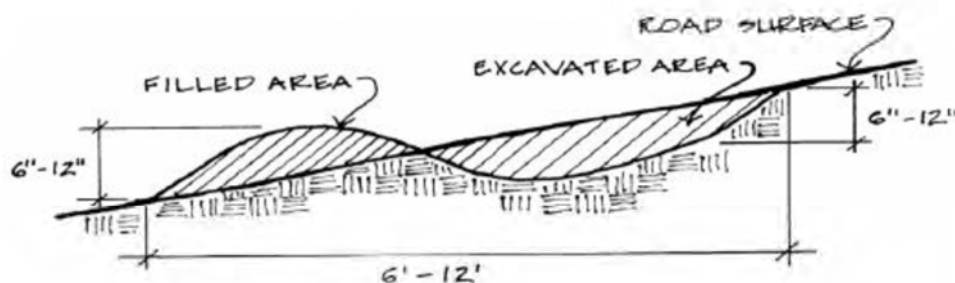
WATERBAR CROSS-SECTION  
(BBR Manual – pg. 51)

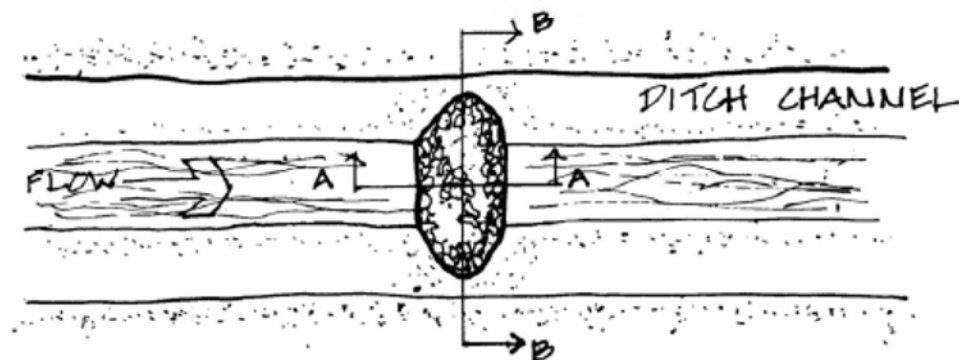
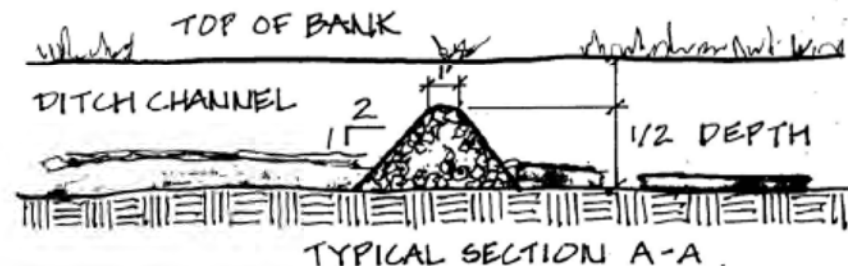
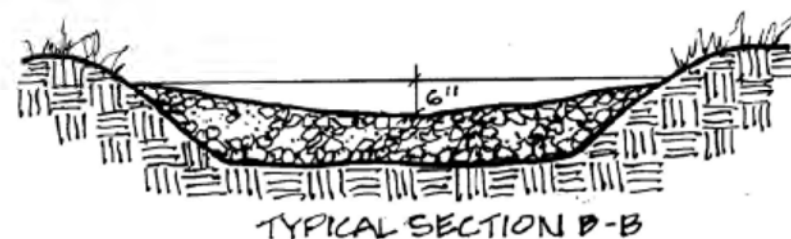
STONE CHECK DAMS  
(BBR Manual – pg. 17)

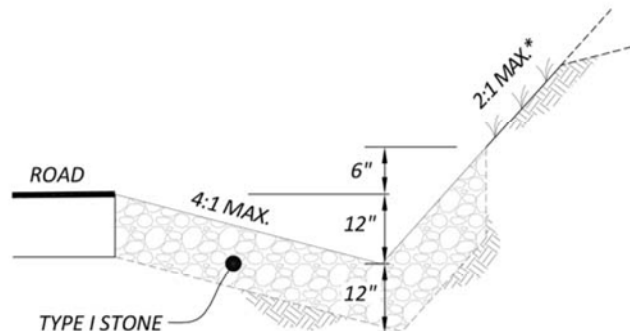
SECTION VIEW

THE LONGEST DIMENSION OF THE STONE SHALL VARY FROM 1 INCH TO 12 INCHES, AND AT LEAST 50 PERCENT OF THE VOLUME OF THE STONE IN PLACE SHALL HAVE A LEAST DIMENSION OF 4 INCHES.

\* IF EXISTING SIDE SLOPES ARE STEEPER THAN 2:1, BUT STABLE, DO NOT REGRADE SLOPE.  
IF THERE IS INSUFFICIENT WIDTH FOR 2:1 SIDE SLOPES, USE A STEEPER SLOPE ON THE BACKSIDE OF THE SWALE, AWAY FROM THE ROAD, AND STABILIZE WITH NORTH AMERICAN GREEN S150 EROSION BLANKET (SEE DETAIL B).  
IF STEE SLOPE IS SATURATED WITH GROUNDWATER, FACE WITH 2-4" DIA. CRUSHED STONE AT LEAST 6" DEEP.

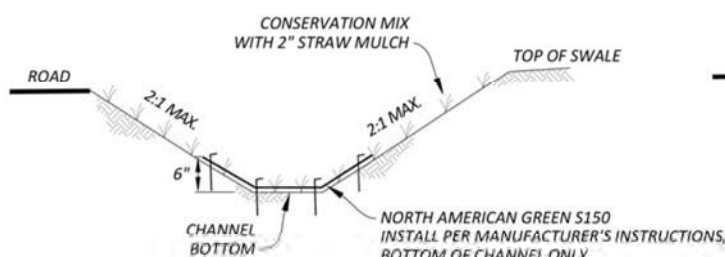
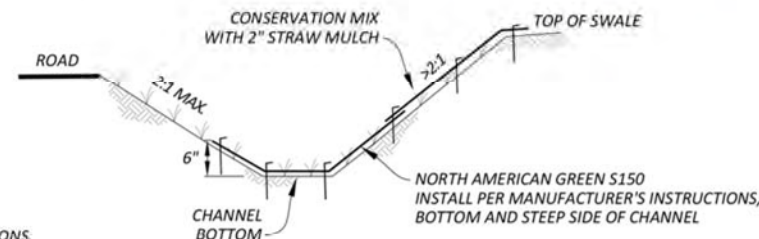
## DETAIL B VEGETATIVE CHANNEL STABILIZATION WITH AND WITHOUT EROSION BLANKET

USE DETAIL A WHEN STABILIZED ROADSIDE SWALE IS "SQUEEZED" BETWEEN ROAD AND STEEP SIDE SLOPE. INTENT IS THAT VEHICLES CAN RUN ONTO ADJACENT 4:1 SLOPE IN EMERGENCY.

PLAN VIEW

SECTION VIEW WITHOUT STEEP BACK SLOPE

SECTION VIEW WITH STEEP BACK SLOPE

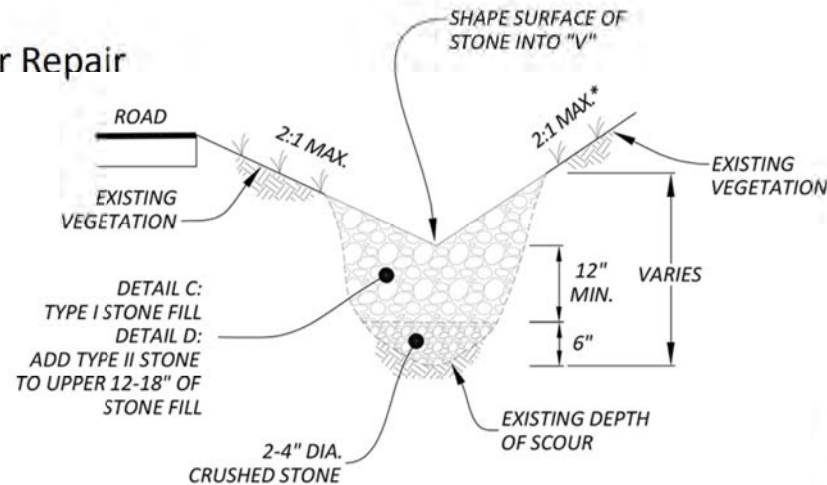
### DETAIL C/D SWALE SCOUR REPAIR

THE LONGEST DIMENSION OF THE STONE SHALL VARY FROM 2 INCHES TO 36 INCHES, AND AT LEAST 50 PERCENT OF THE VOLUME OF THE STONE IN PLACE SHALL HAVE A LEAST DIMENSION OF 12 INCHES.

\* IF EXISTING SIDE SLOPES ARE STEEPER THAN 2:1, BUT STABLE, DO NOT REGRADE SLOPE. IF THERE IS INSUFFICIENT WIDTH FOR 2:1 SIDE SLOPES, USE A STEEPER SLOPE ON THE BACKSIDE OF THE SWALE, AWAY FROM THE ROAD, AND STABILIZE WITH NORTH AMERICAN GREEN S150 EROSION BLANKET (SEE DETAIL B).

1. USE DETAIL C/D TO REPAIR EXISTING GRASS SWALES WITH ACTIVE CUTTING.
2. USE DETAIL C WITH ONLY TYPE I STONE FOR SWALES WITH SLOWER FLOW VELOCITIES.
3. USE DETAIL D WITH TYPE II STONE FOR SWALES WITH HIGHER FLOW VELOCITIES.

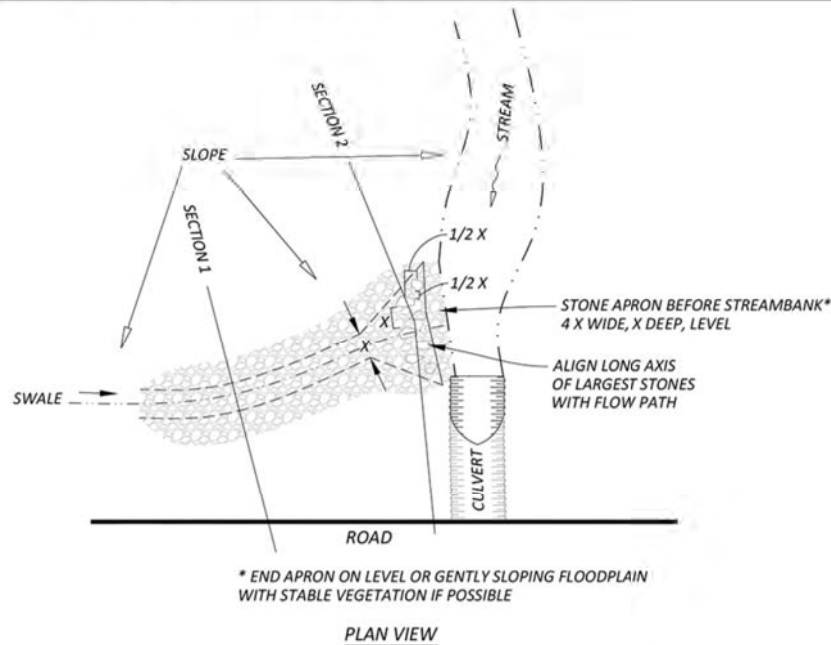
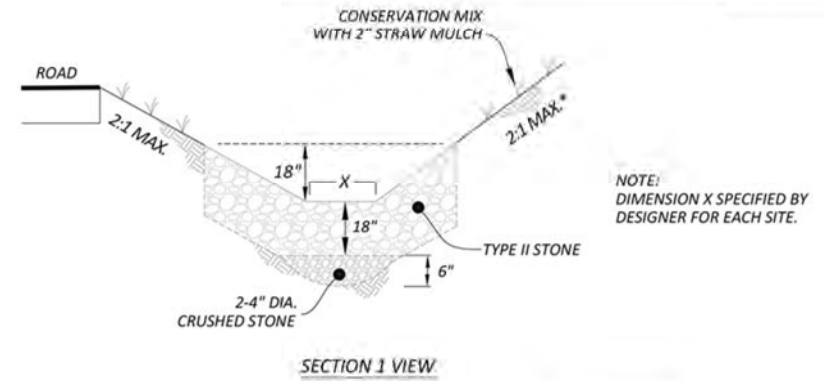
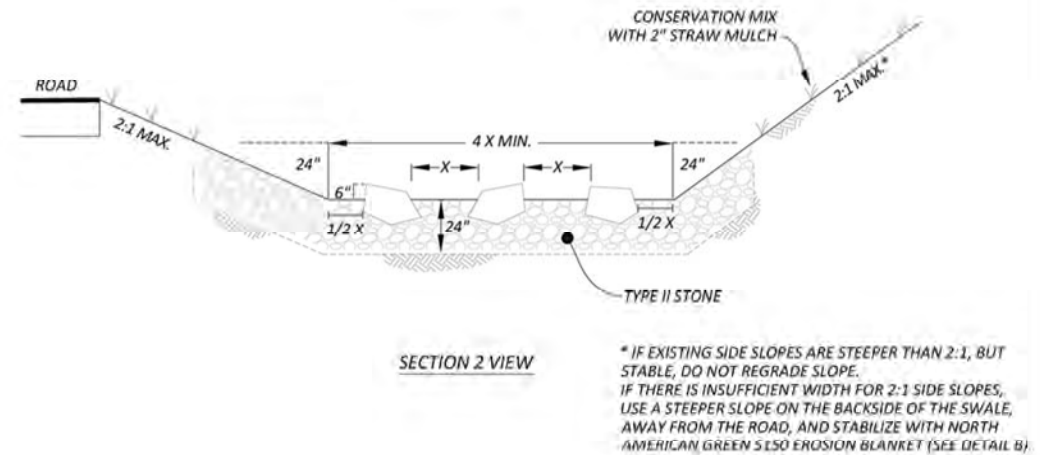
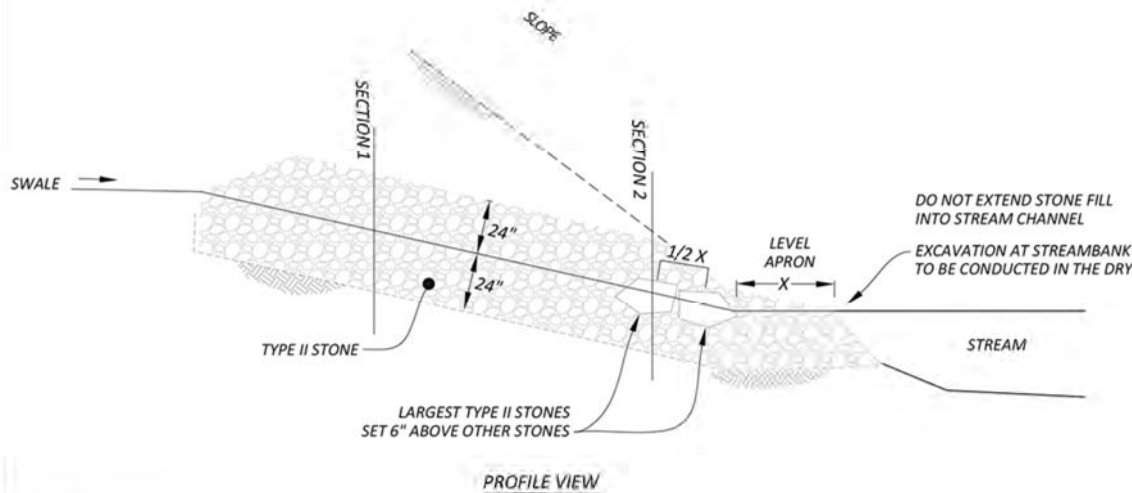
## DETAIL G STONE CHUTE AND SPREADER

TYPE II STONE FILL  
(VAOT SEC. 706.04(A))  
THE LONGEST DIMENSION OF THE STONE SHALL VARY  
FROM 2 INCHES TO 36 INCHES, AND AT LEAST 50 PERCENT  
OF THE VOLUME OF THE STONE IN PLACE SHALL HAVE A  
LEAST DIMENSION OF 12 INCHES.

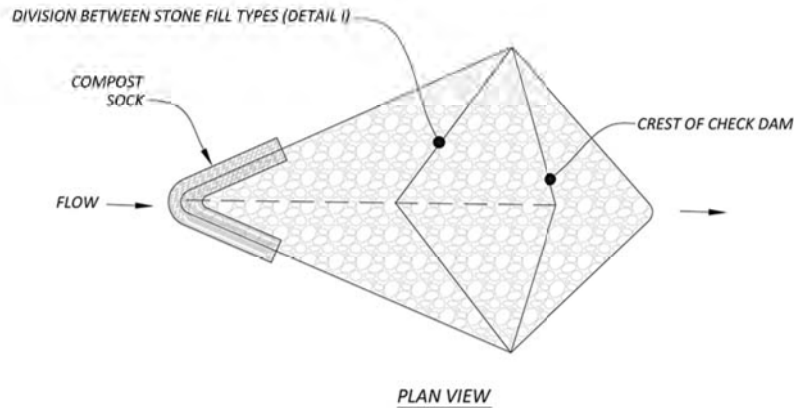
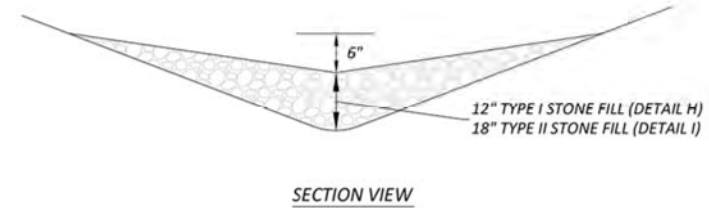
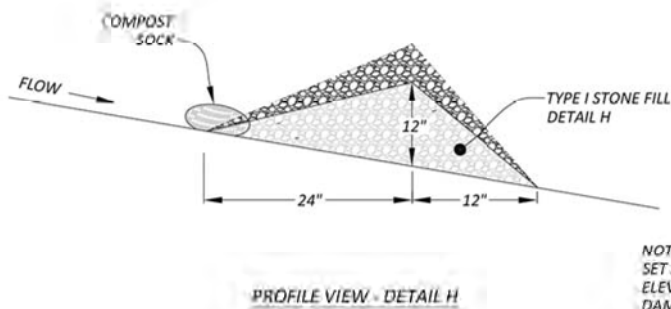
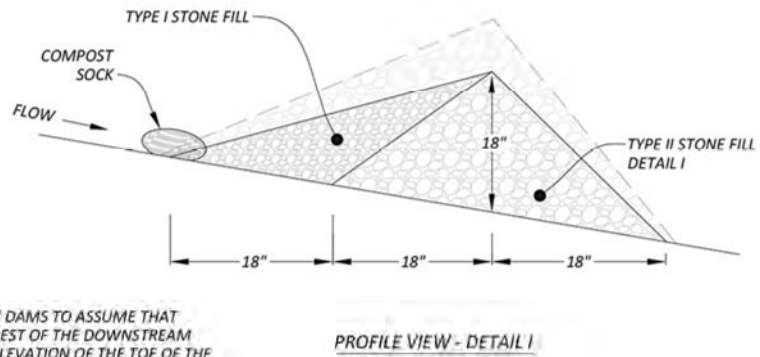
## DETAIL H/I STONE CHECK DAM

NOTE:  
SET SPACING OF CHECK DAMS TO ASSUME THAT  
ELEVATIONS OF THE CREST OF THE DOWNSTREAM  
DAM IS AT THE SAME ELEVATION OF THE TOE OF THE  
UPSTREAM DAM"

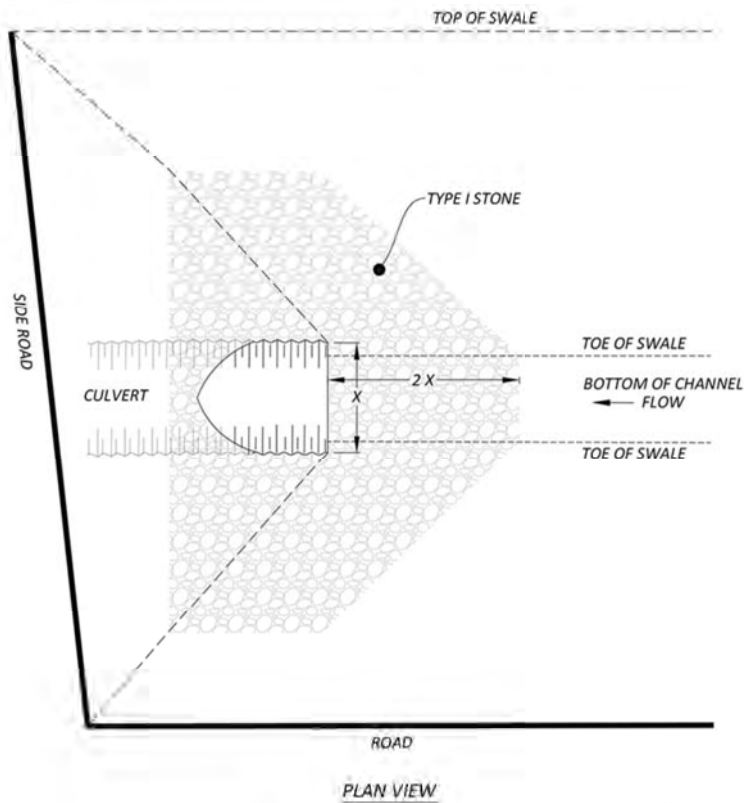
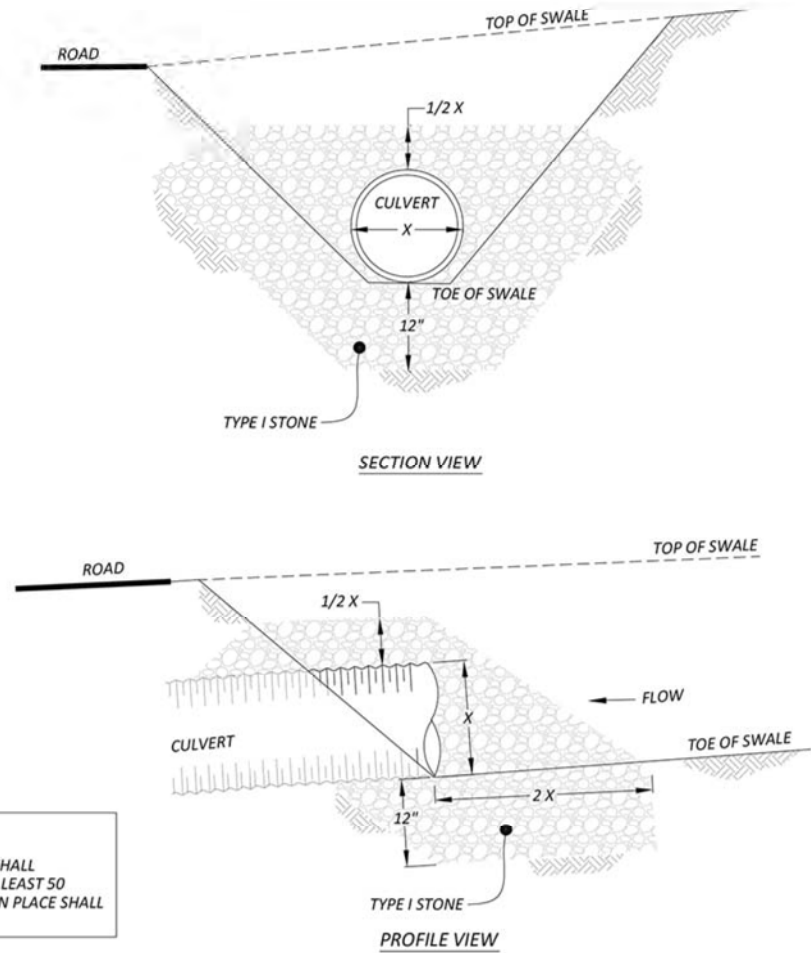
## DETAIL J CULVERT ENTRANCE STABILIZATION

TYPE I STONE FILL  
(VAOT SEC. 706.04(A))  
THE LONGEST DIMENSION OF THE STONE SHALL  
VARY FROM 1 INCH TO 12 INCHES, AND AT LEAST 50  
PERCENT OF THE VOLUME OF THE STONE IN PLACE SHALL  
HAVE A LEAST DIMENSION OF 4 INCHES.

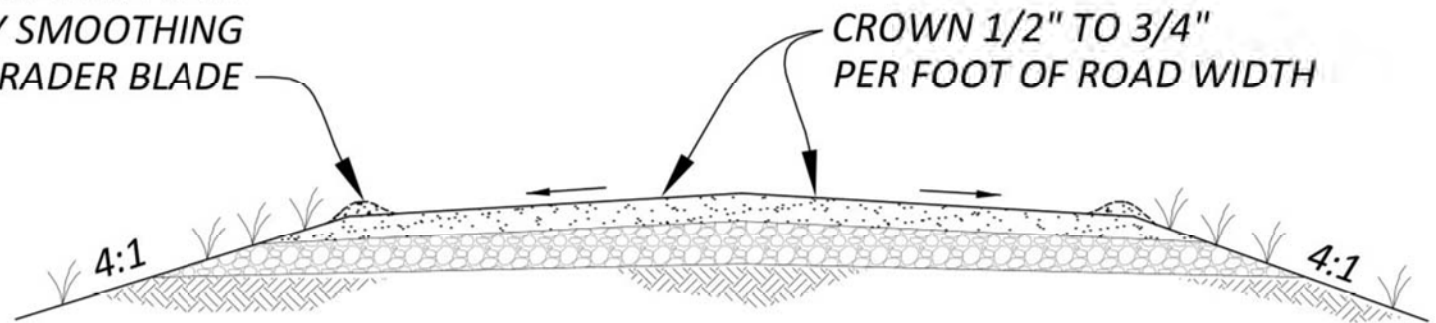
# **TYPICAL ROAD CROWN SECTION**

WINTER SAND BUILD-UP AND  
SAND FROM GRADER TO BE  
ELIMINATED BY SMOOTHING  
EDGE OF ROAD WITH GRADER BLADE
