Lamoille River Watershed

Updated Water Quality/Aquatic Habitat

Assessment Report

February 2016

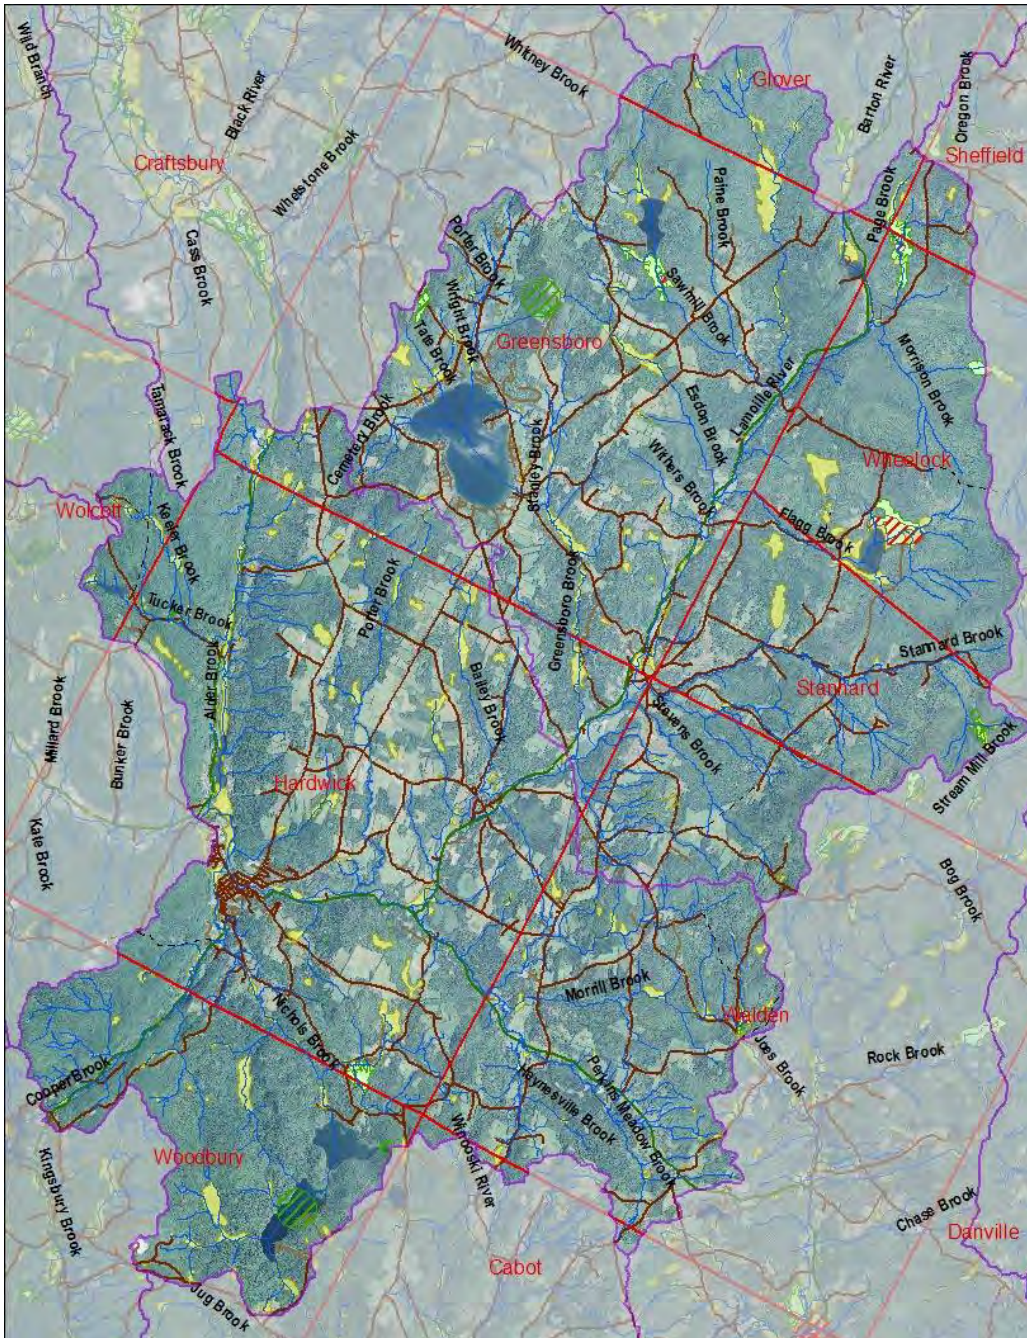
Figure 1. Upper Lamoille with wetlands, RTE & significant natural communities

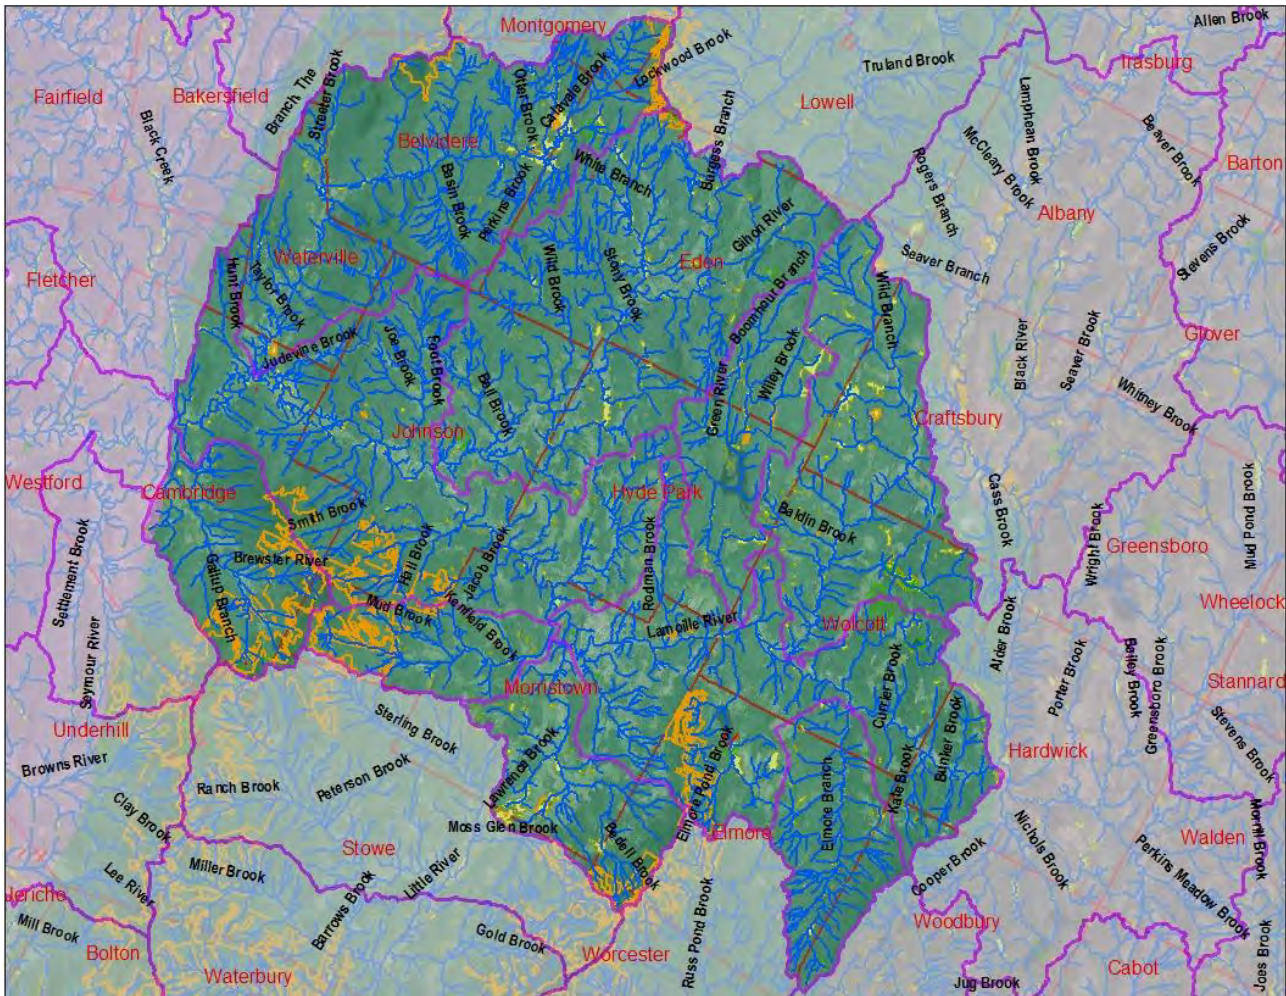
Figure 3. Mid Lamoille watershed largely within the Green Mountains biophysical region (green shading) with wetlands yellow & significant natural communities orange outline

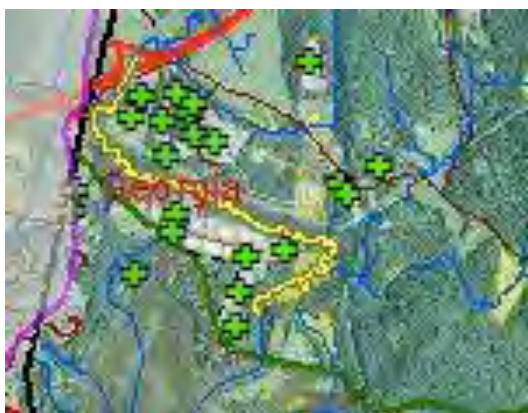
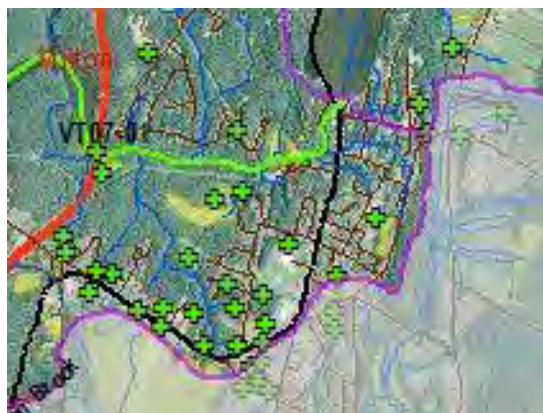
Two areas in the Lower Lamoille watershed have high concentrations of stormwater permits. One area is that around the impaired Deer Brook (yellow stretch below) and the other is the area south of the Lamoille mainstem just downstream from Arrowhead Reservoir. (The green crosses are issued stormwater permits.)
